PE09-024

HONDA

Q12A PAGE 2, Q12B  
E PG 12, Q12 BJ PG  
17, Q12 C E PG 22,  
Q12 C J PG 30, Q12 D  
E PG 38, Q12 D J PG  
40, Q12 E E PG 42  
AND Q12 E J PG 49

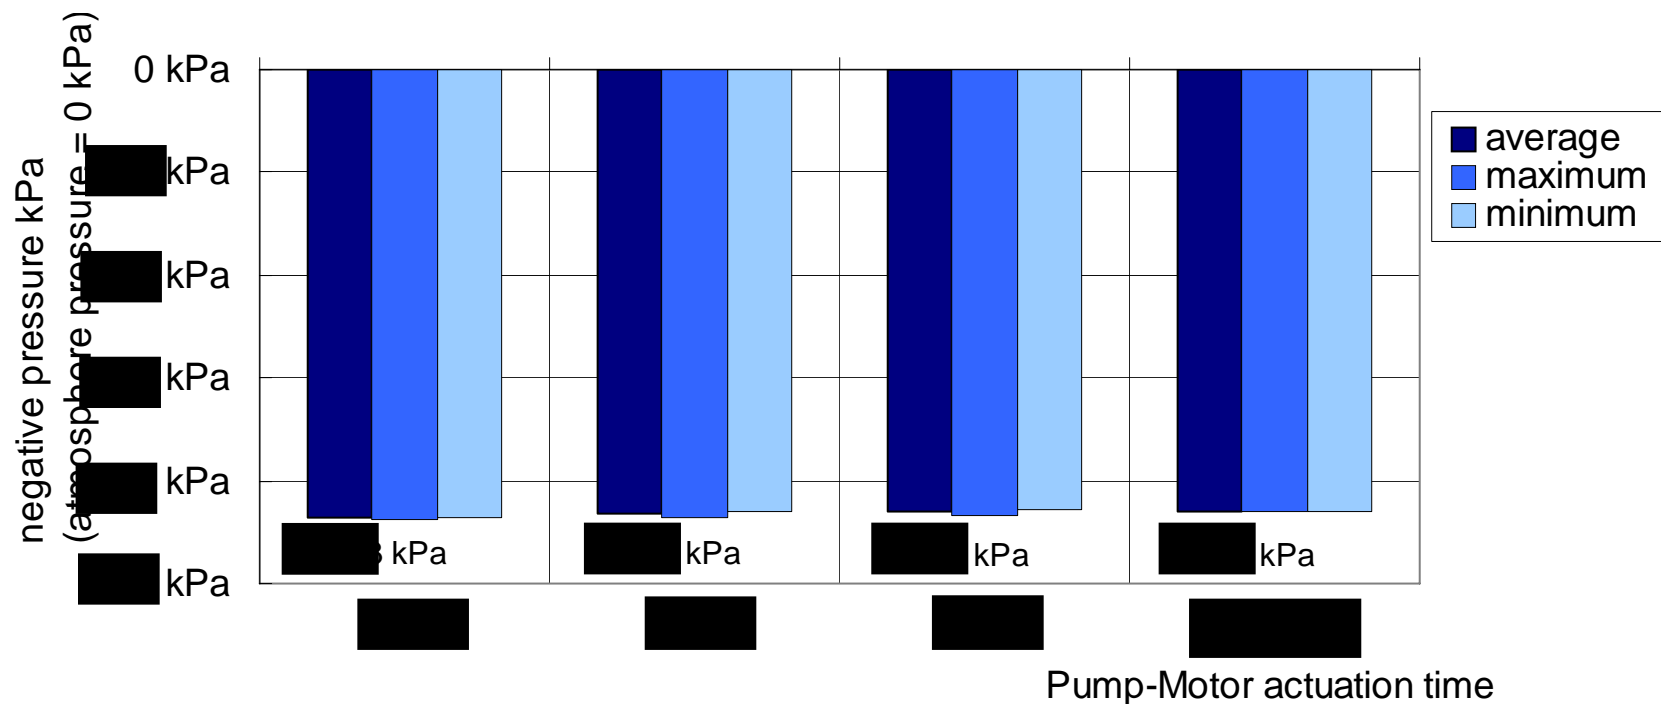
Graph 1, occurred negative pressure

### ② Relation between pump actuation and occurred negative pressure

- Maximum negative pressure around [REDACTED] kPa
  - Maximum negative pressure can be generated over [REDACTED] ms pump actuation
  - Maximum negative pressure is determined by opening pressure of suction valve
- That means it can generate negative pressure above [REDACTED] kPa
