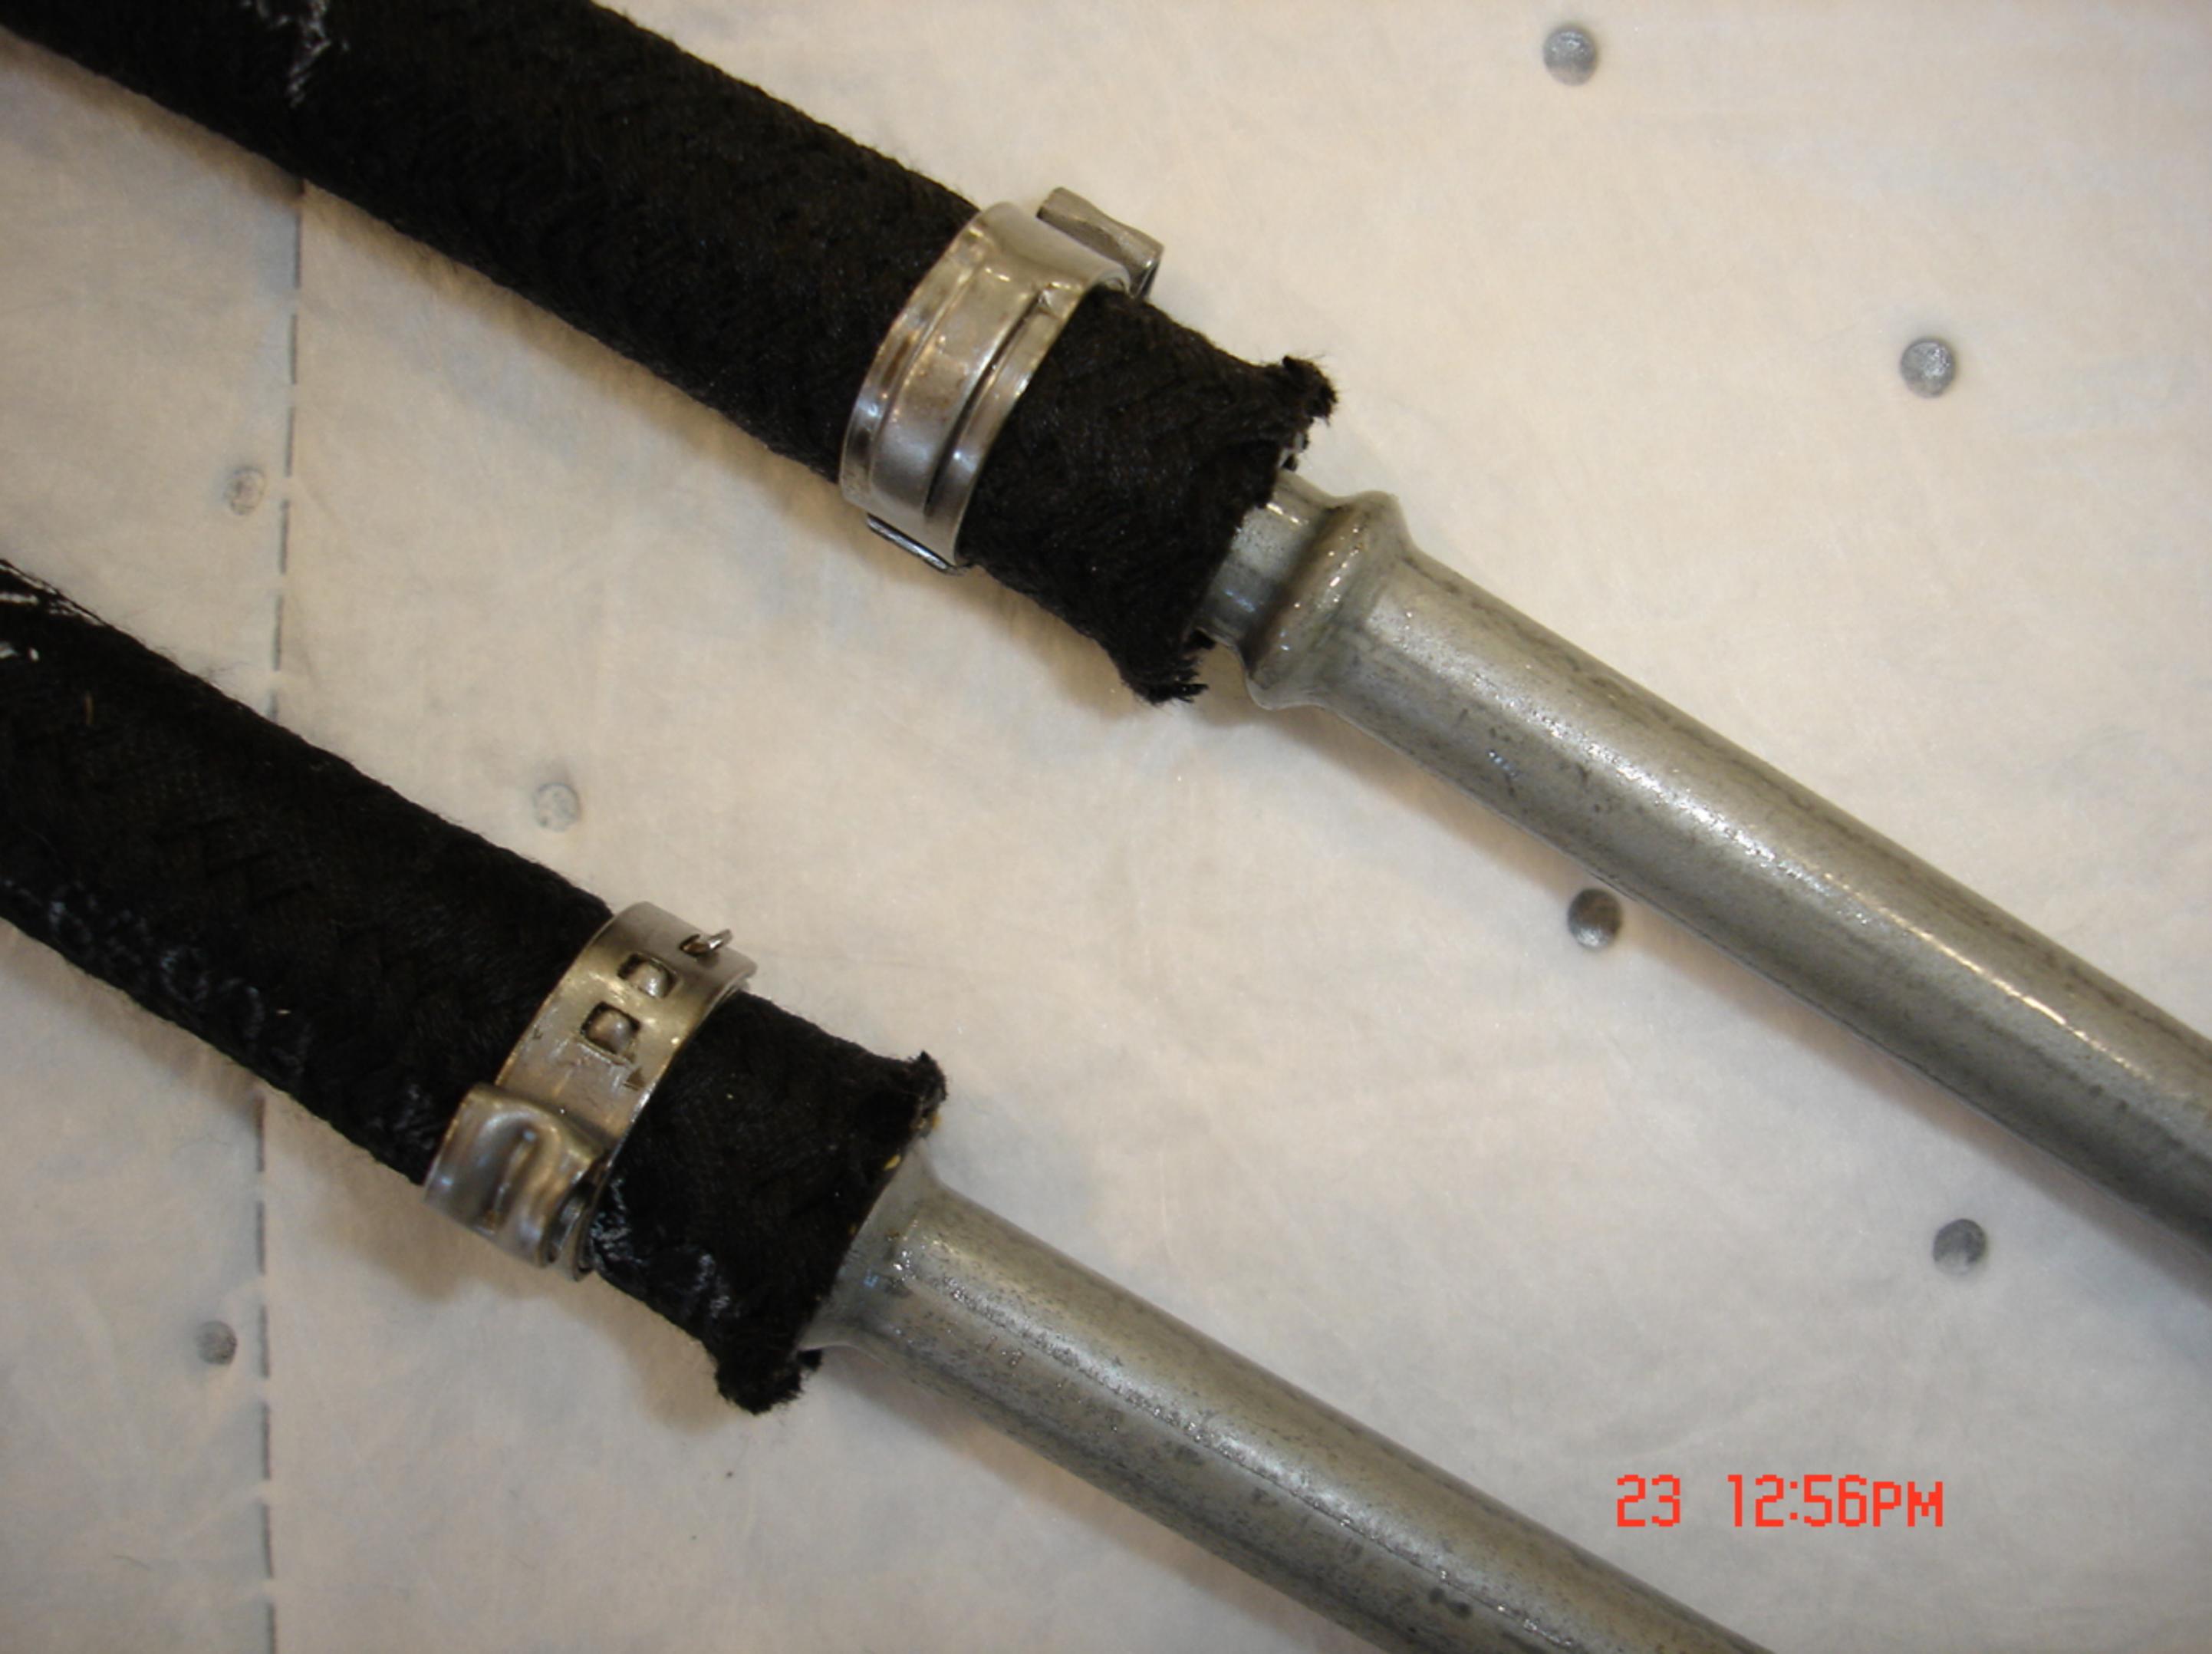
Formed hose, no leaking, inner wall with surface irregularities

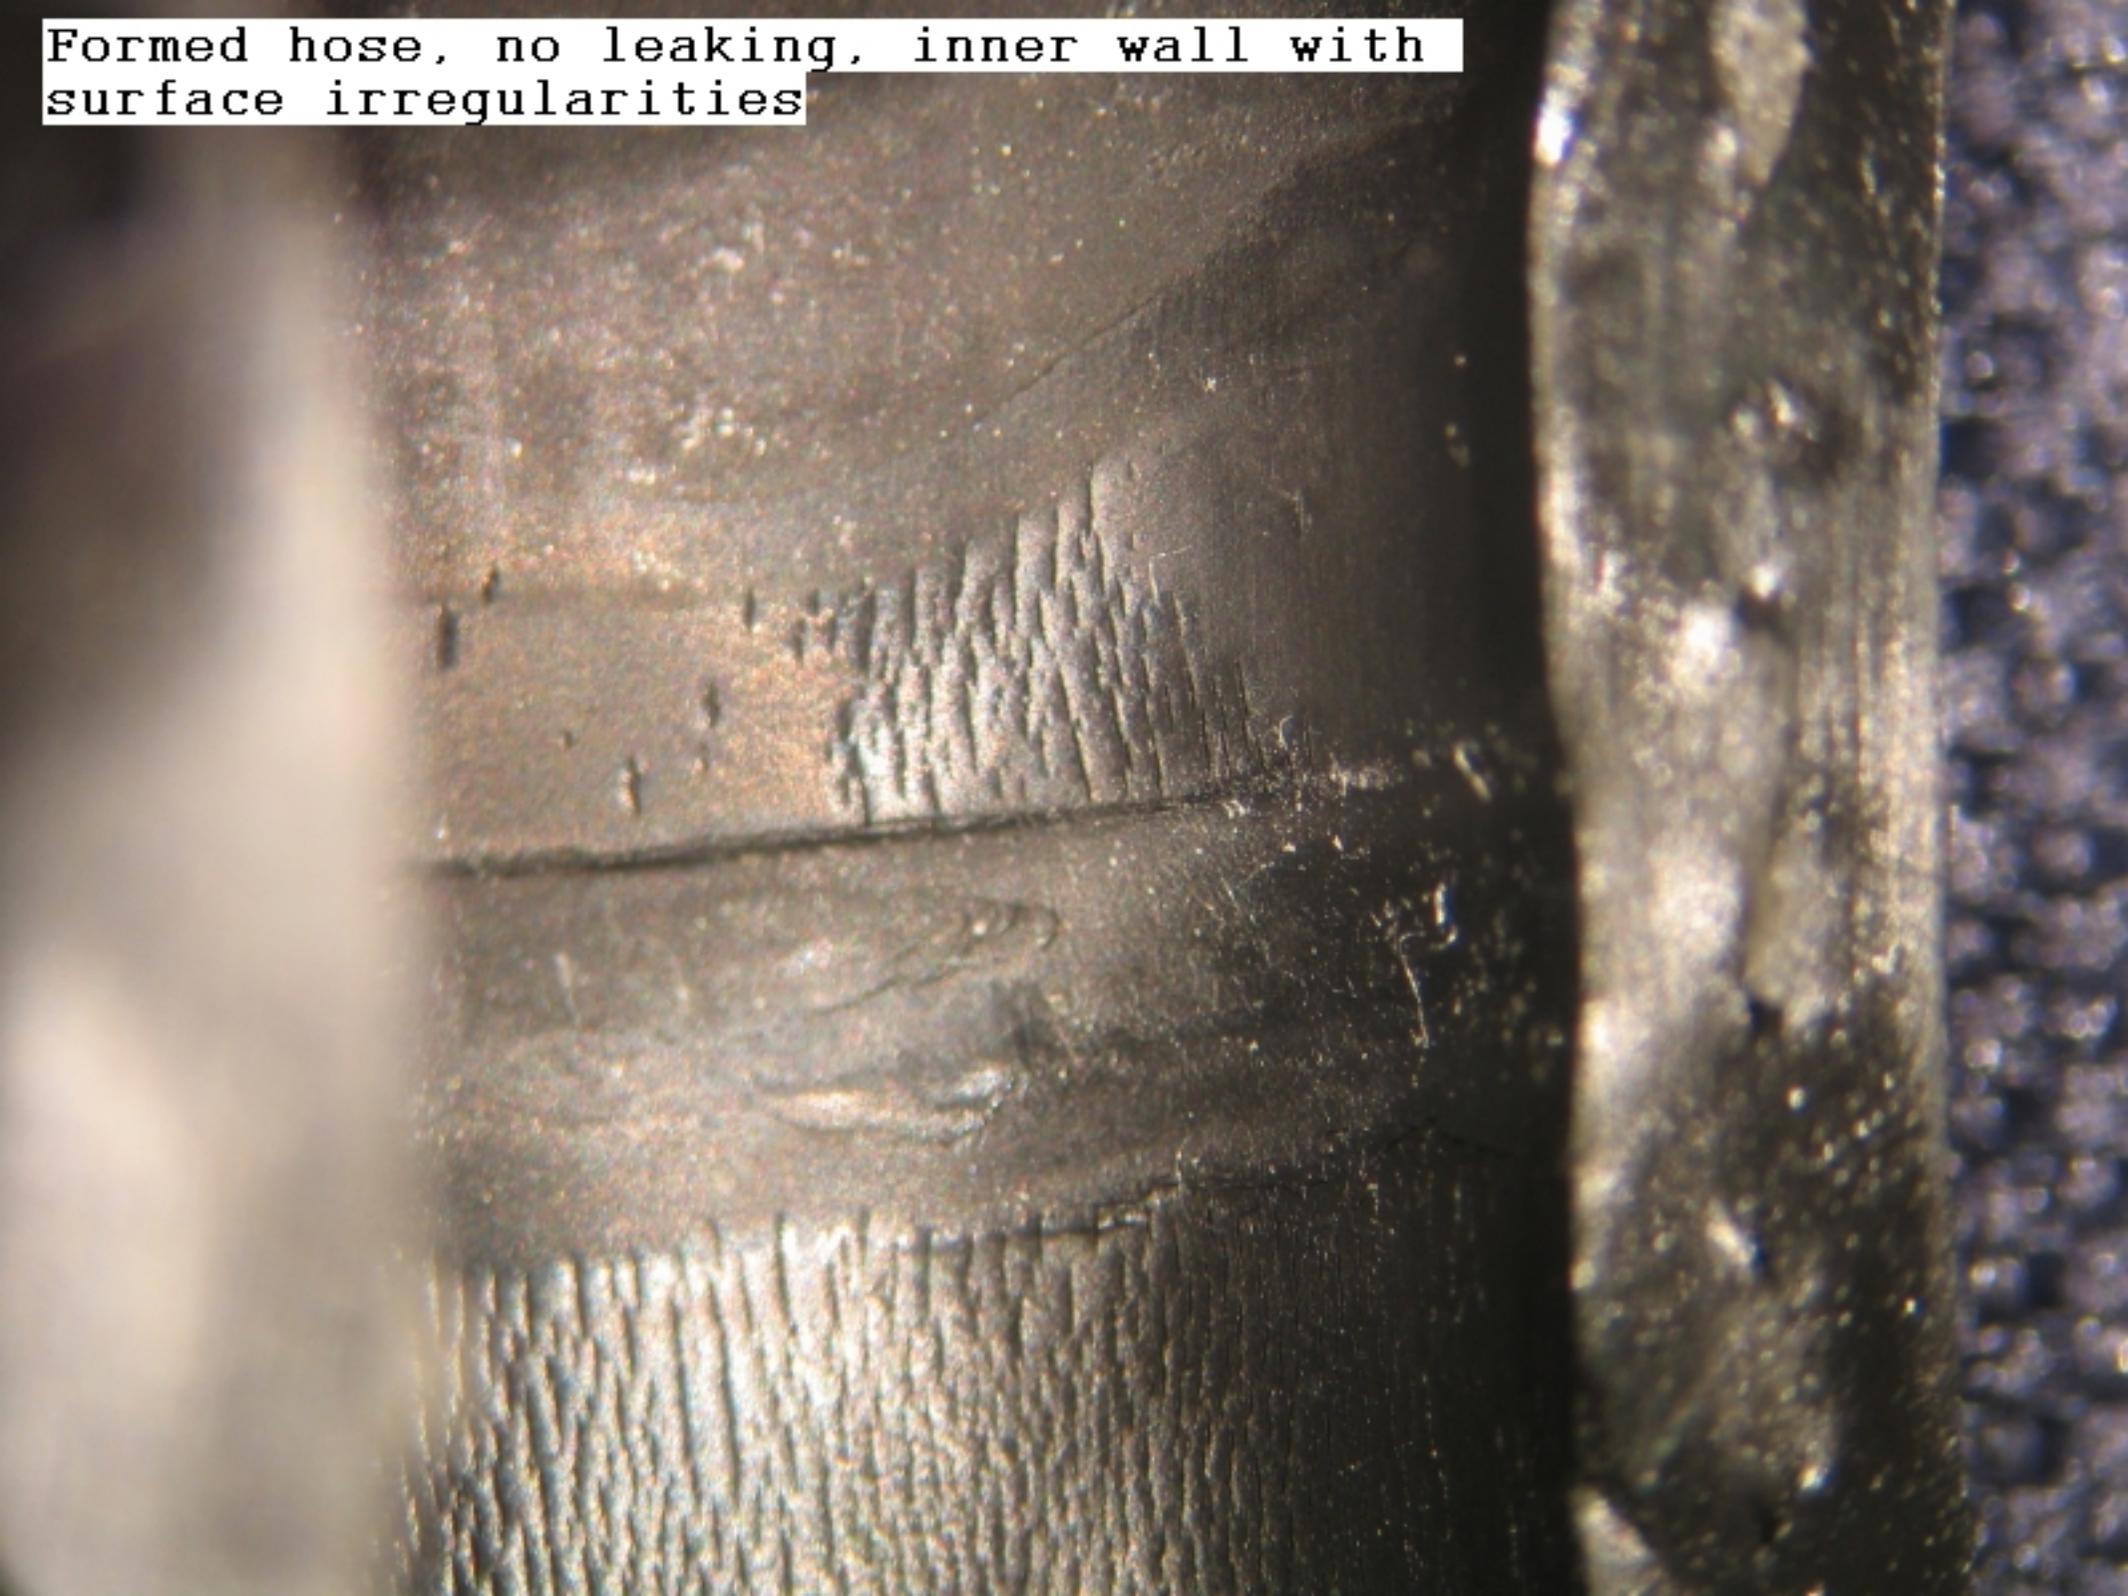
Formed hose, no leaking, inner wall with surface irregularities, small cracks in "clip" areas

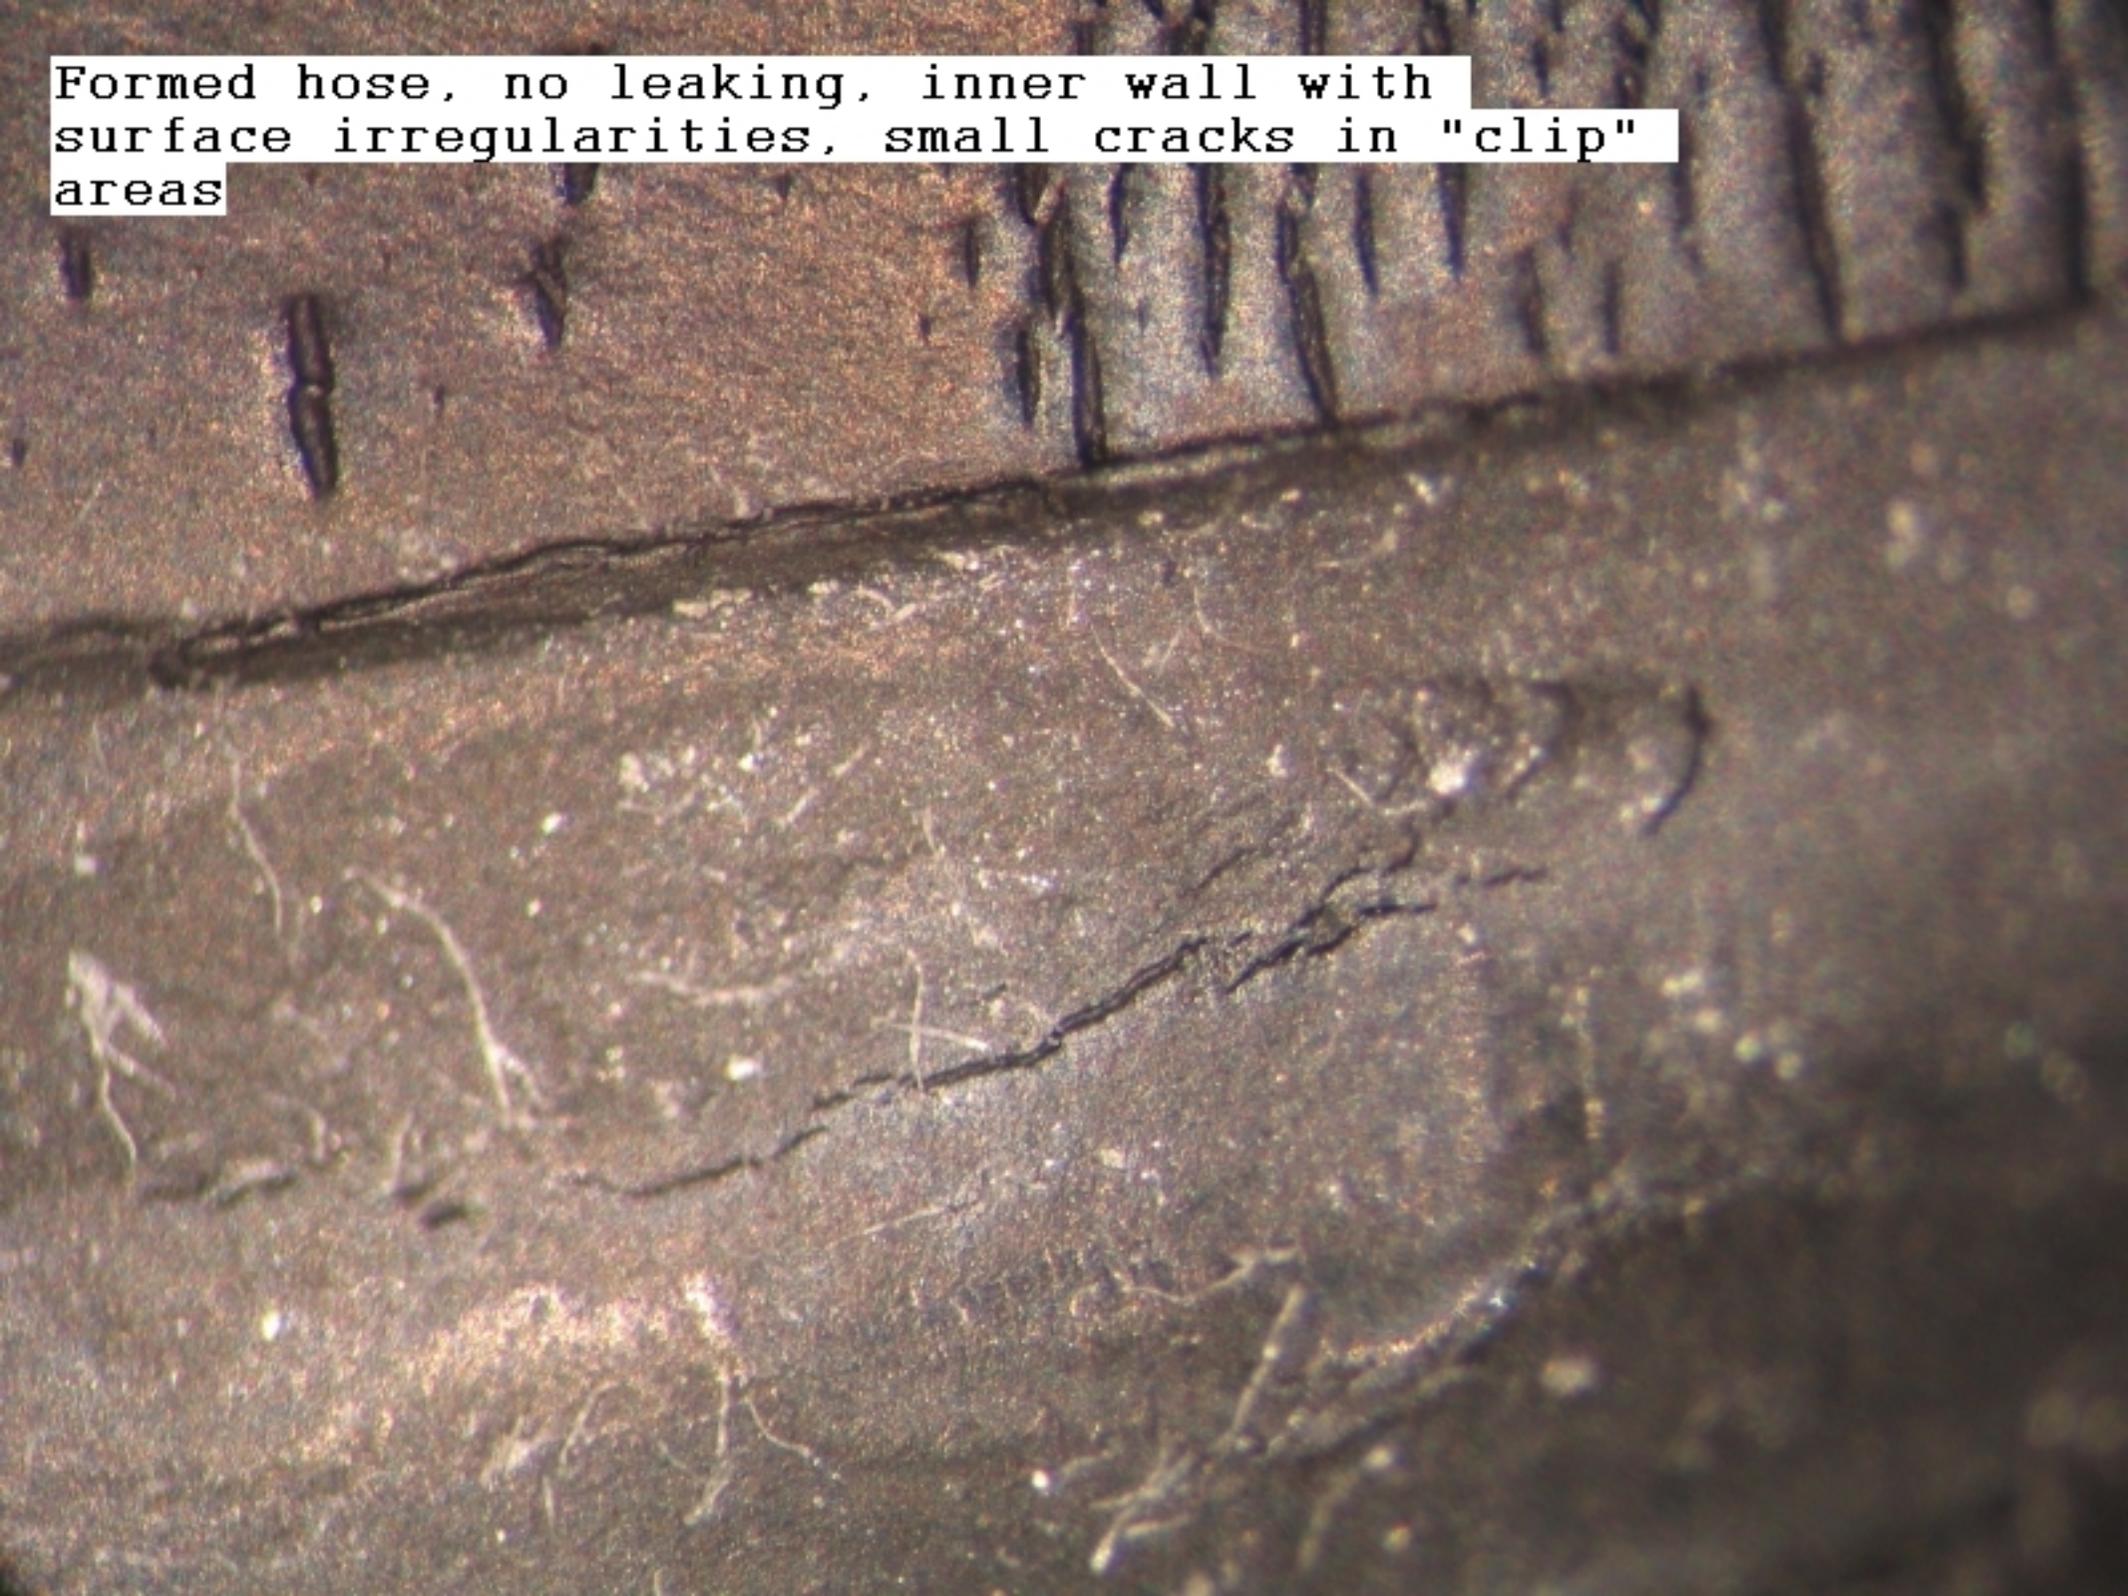
Formed hose, no leaking, inner wall with surface irregularities and smooth surface

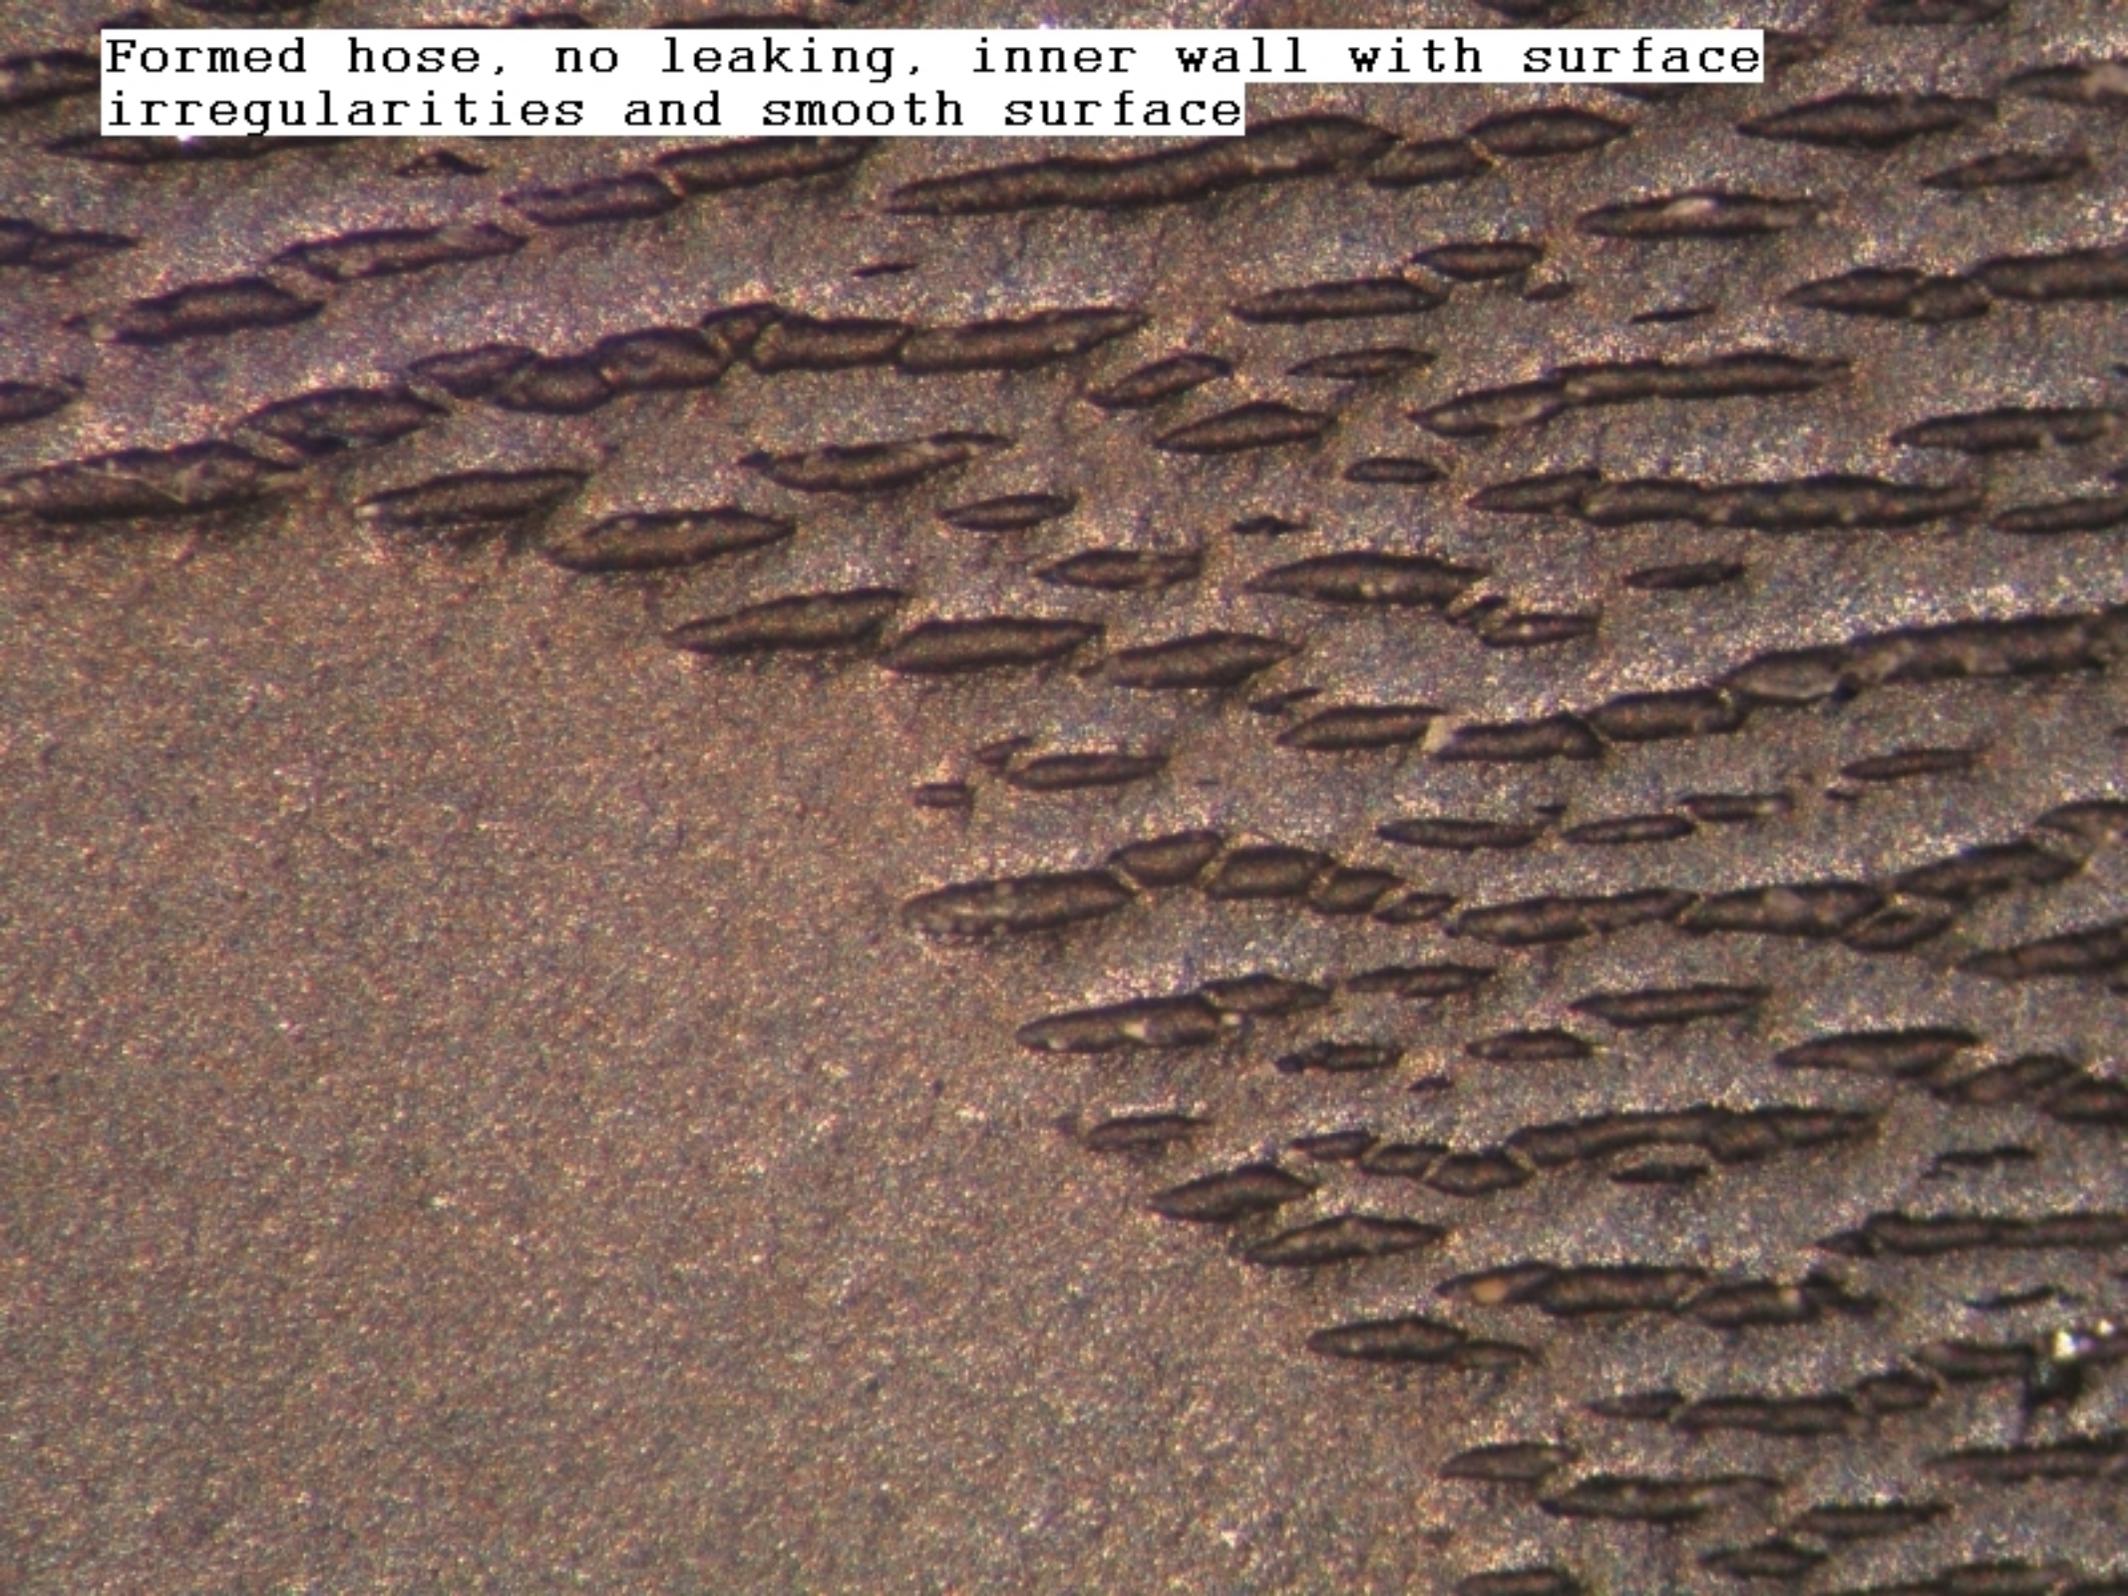
Straight hose with an "opening" on outer wall of the hose

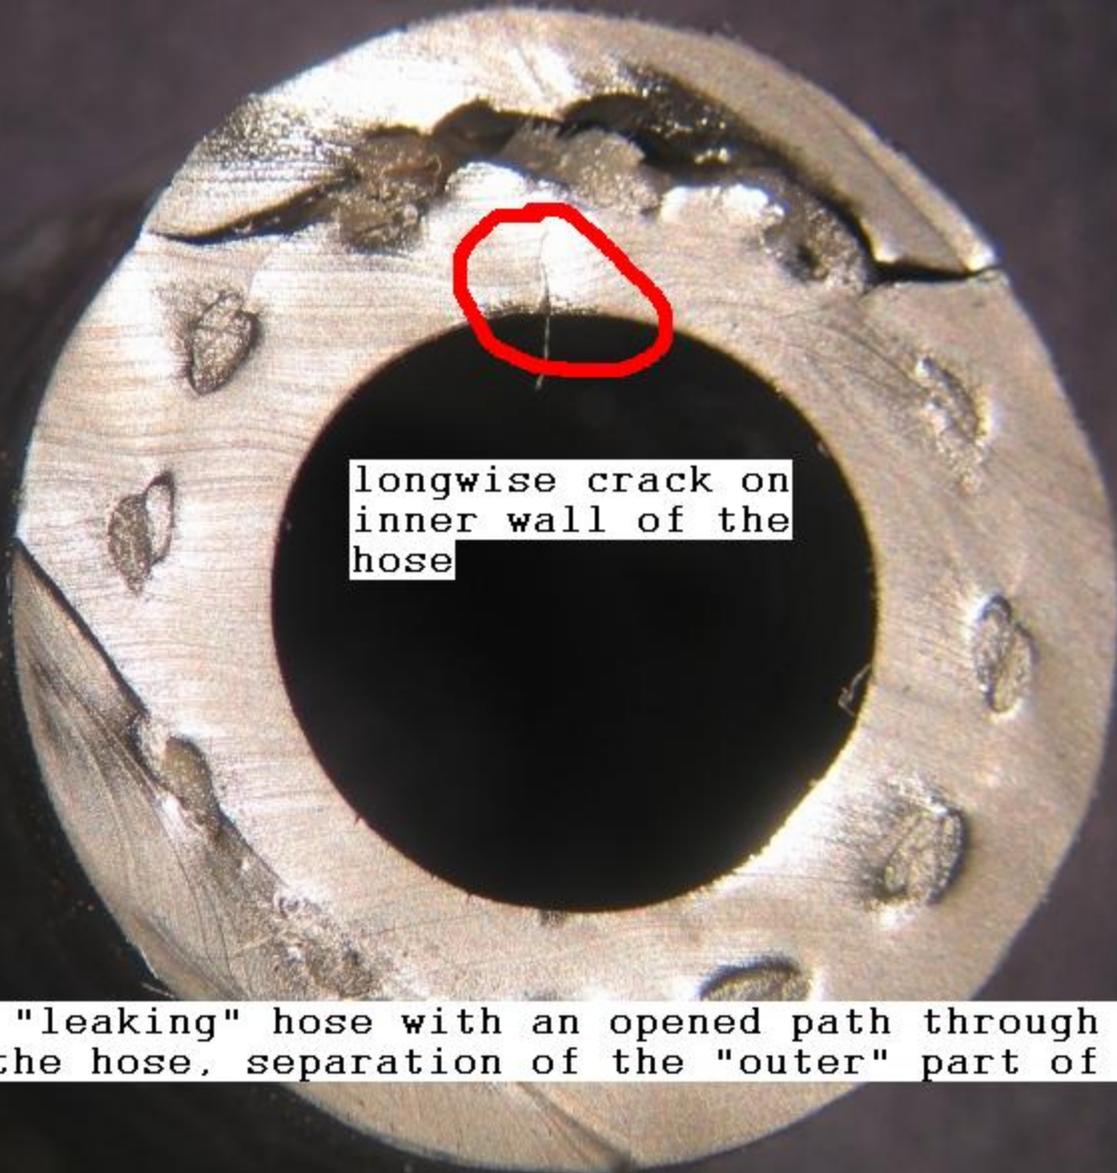
longwise crack on  
inner wall of the  
hose

Straight "leaking" hose with an opened path through the wall of the hose, separation of the "outer" part of the hose

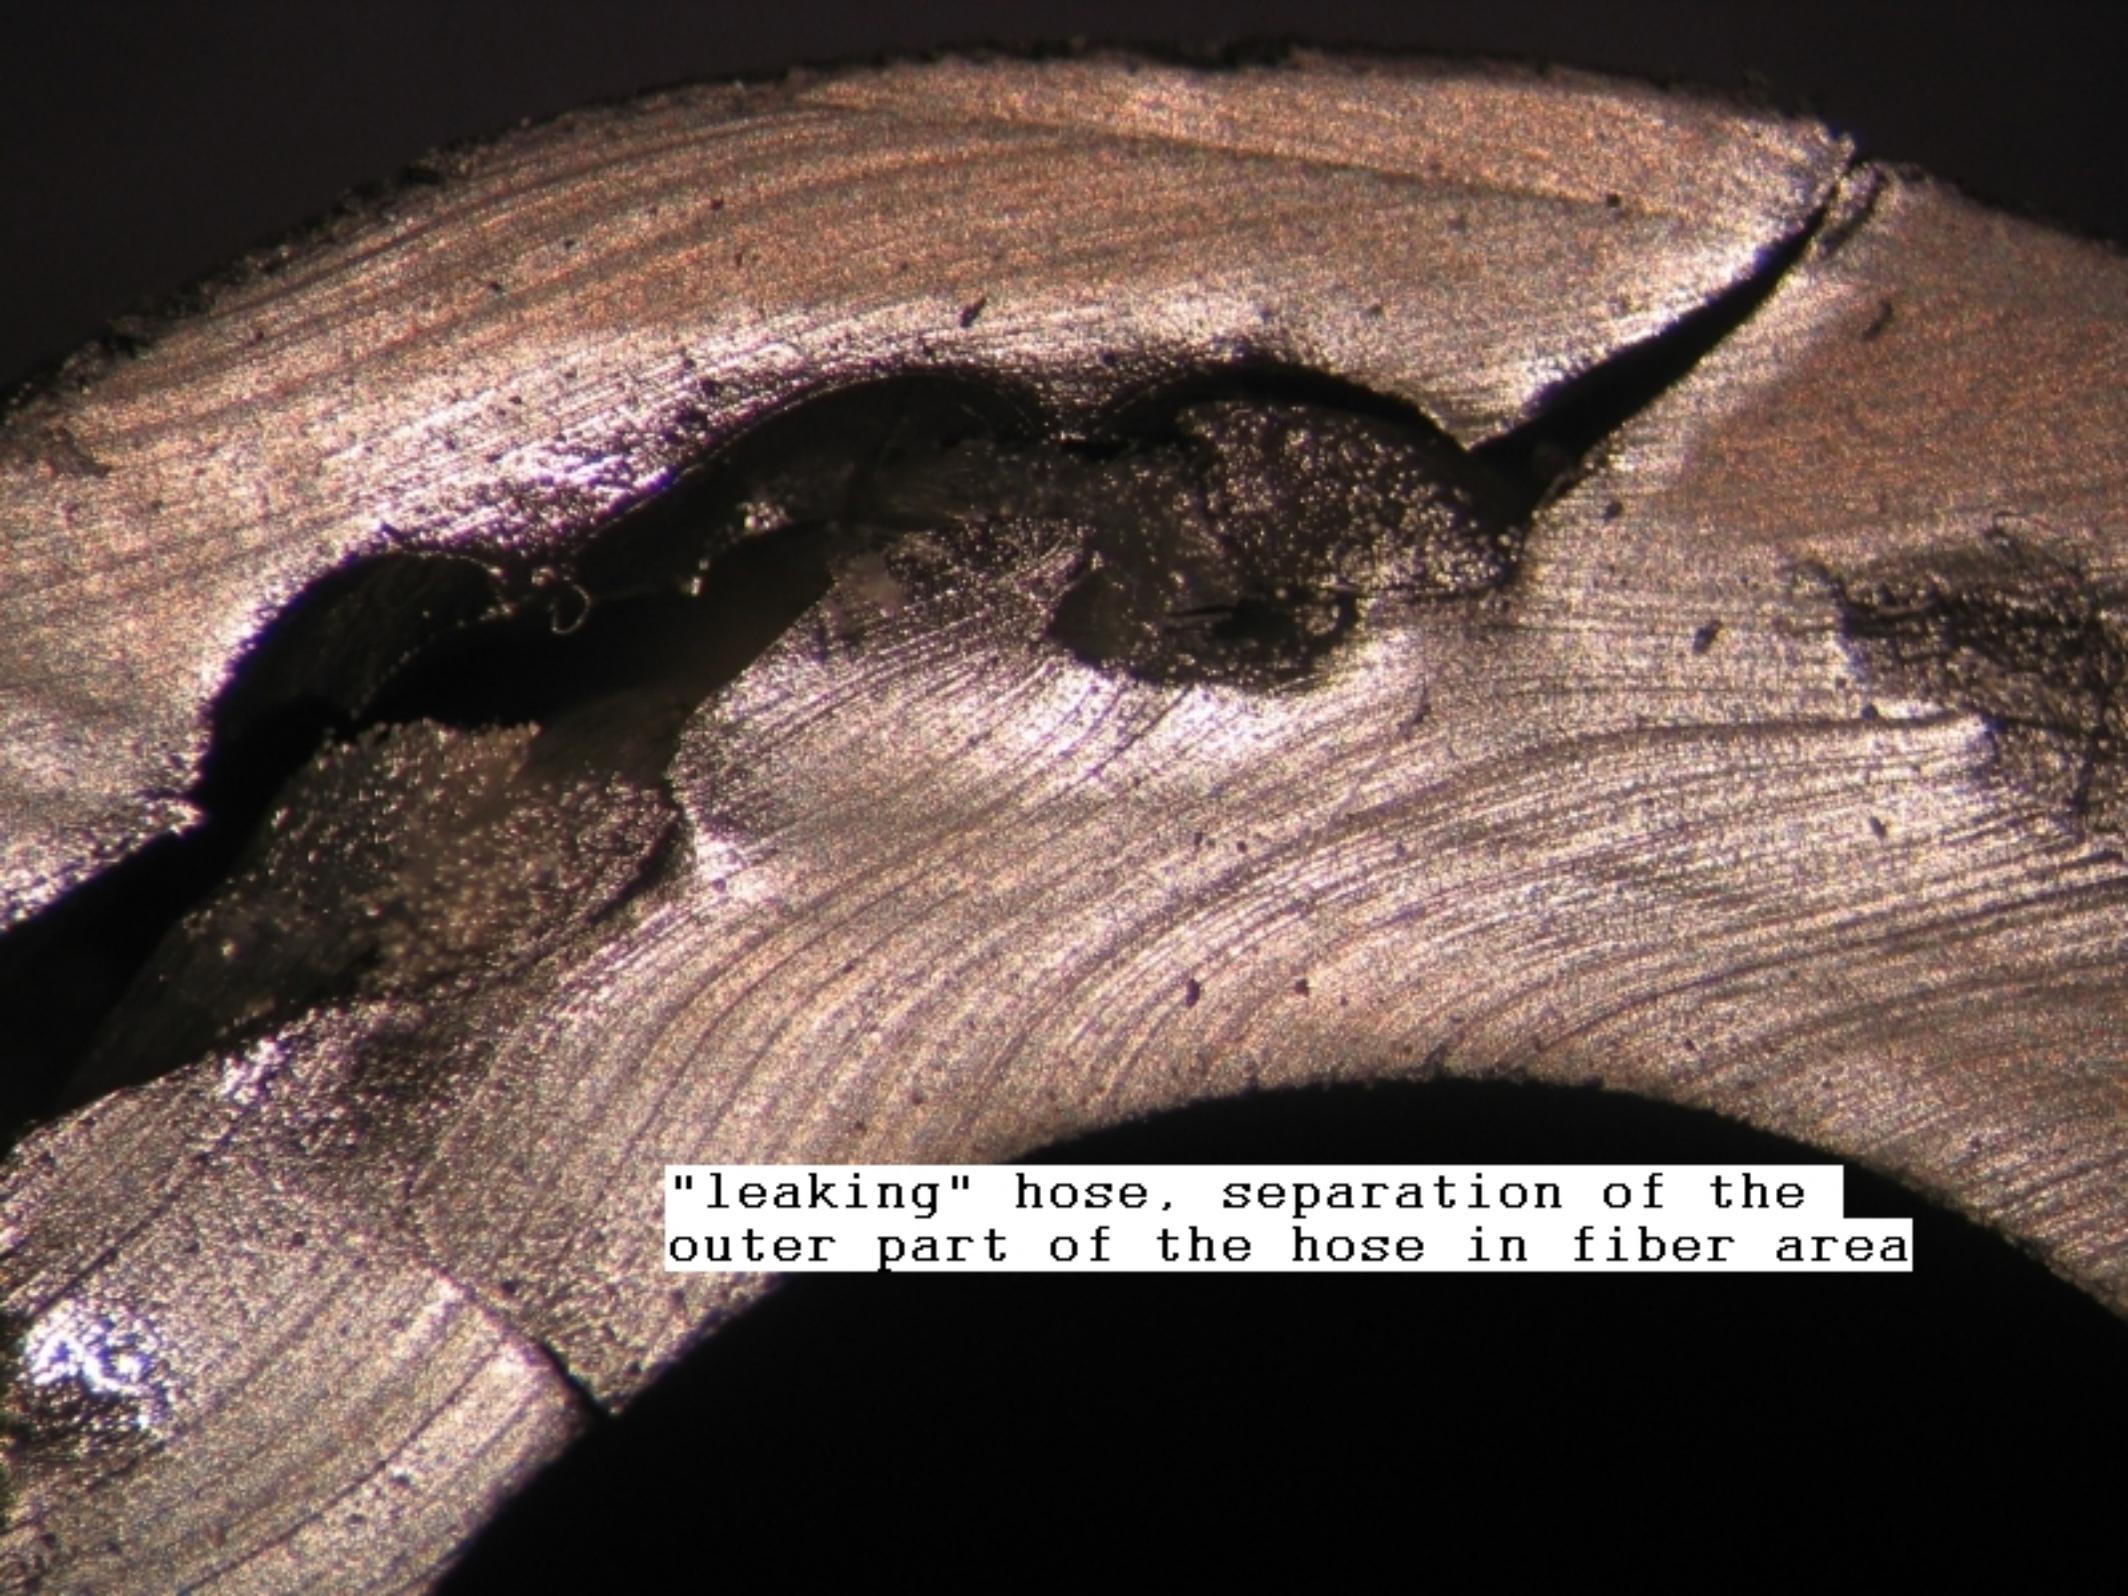
"leaking" hose, separation of the outer part of the hose in fiber area

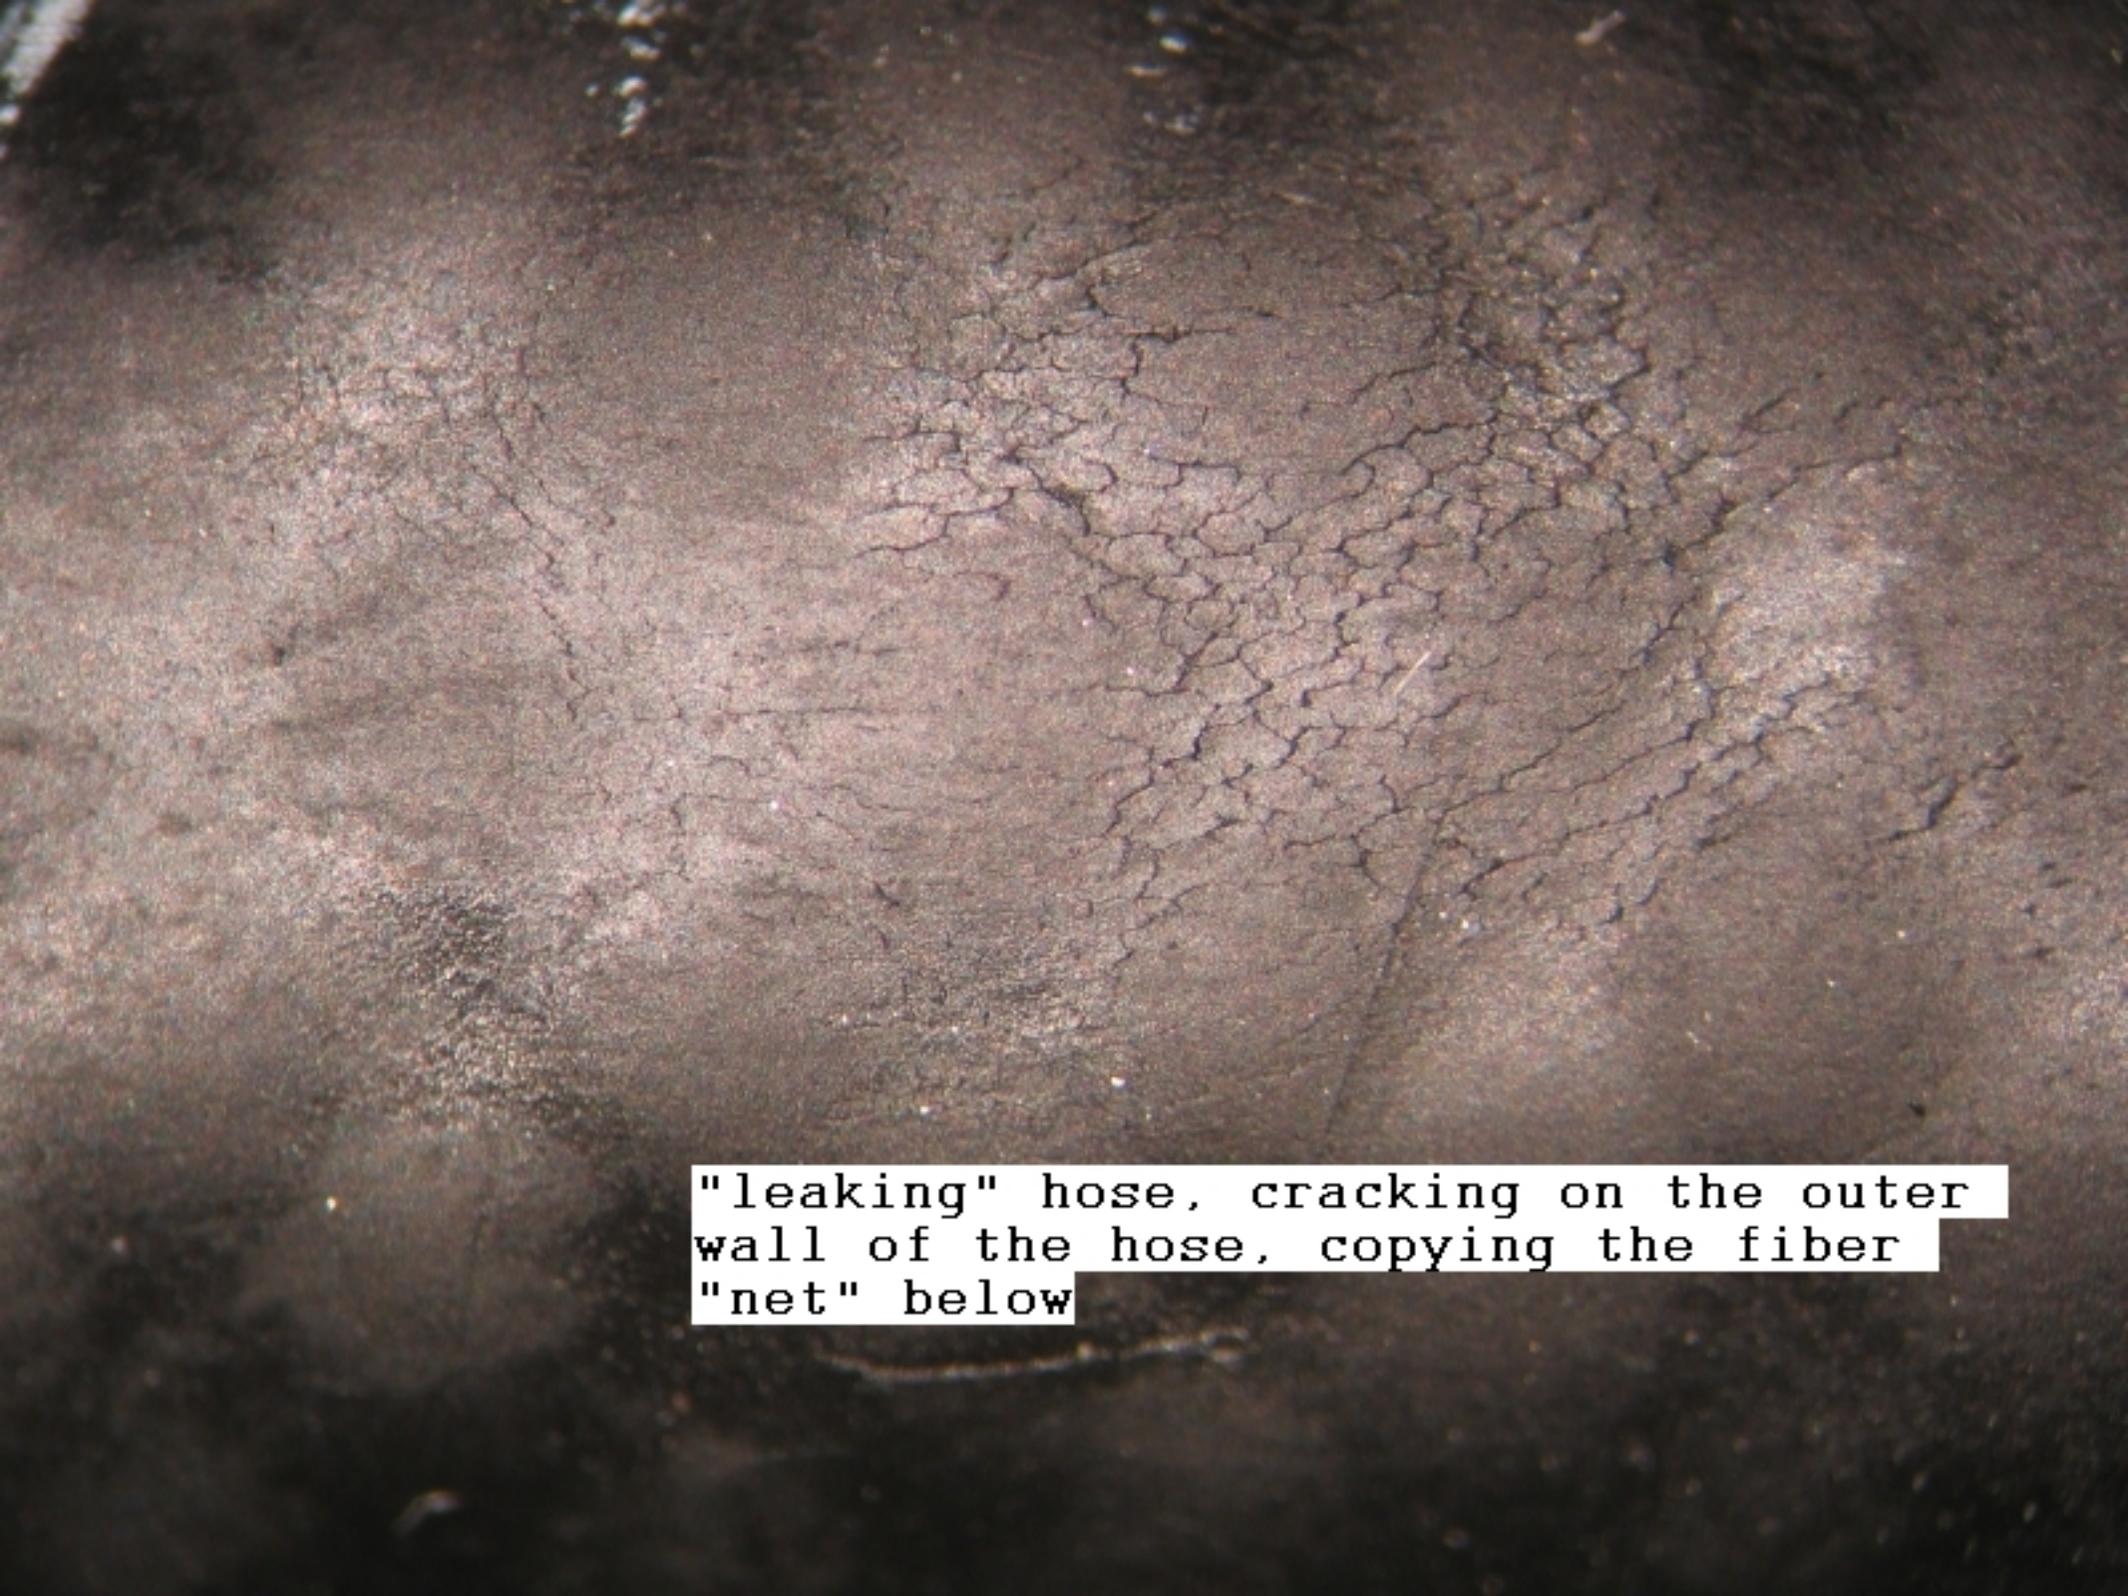
"leaking" hose, cracking on the outer  
wall of the hose, copying the fiber  
"net" below
