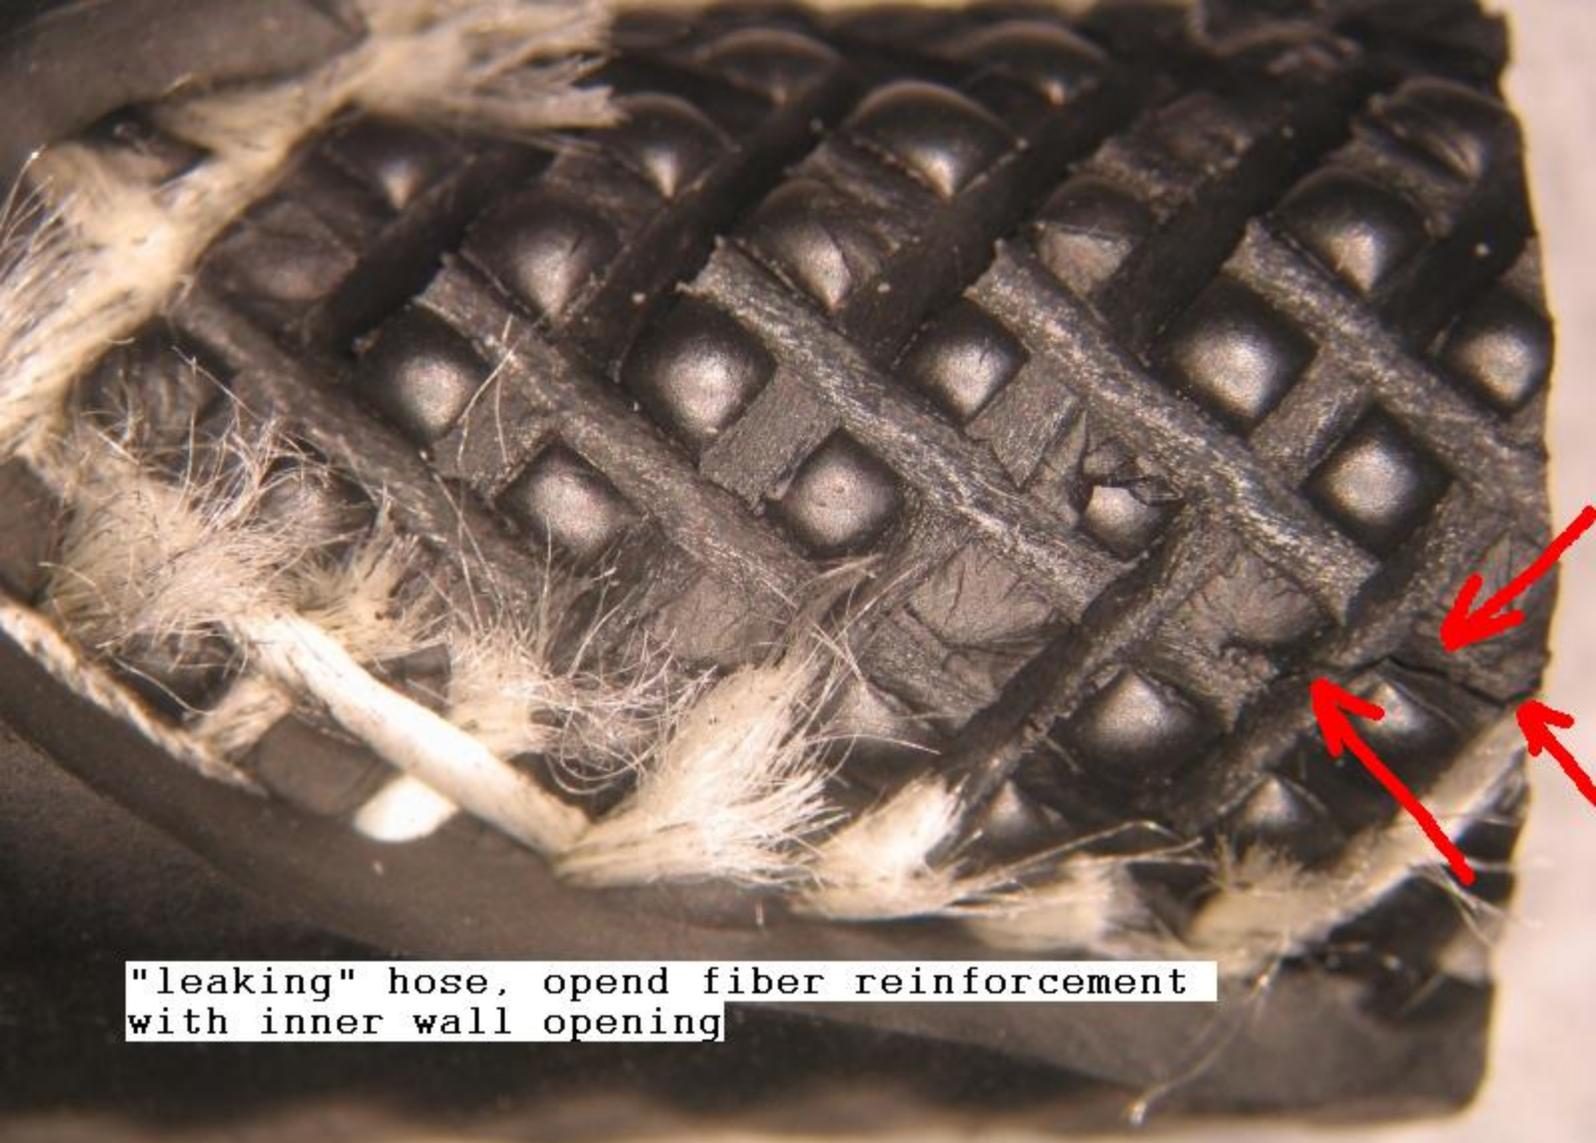
"leaking" hose, opened fiber reinforcement with inner wall opening
