#### **DEALERSHIP PRODUCT REPORT**

TQCN DOC#	Affiliate	Affiliate			Source		Dealer Code		Ref	Date	
PR-16050-1025	TMS		QA-Powertrain		MDT/DS			16050		26524-1	4/13/2005
Dealer Name	Dealer City				State			Region			
KERRY TOYOTA FLORENCE				KY			CIN				
Primary Model		Model Y	/ear	Production Date O		Ode	ometer		VIIV	·	
CorollaNUMMI		2005		22-DEC	-04	79	909 mi	i	11	NXBR32E55Z	
Condition Title	Condition Title										
'05 Corolla "No Start" ECM	'05 Corolla "No Start" ECM Failure

TQCN DOC#		Affiliate	Dept.	Source	Location	Ref	Date
FTR-VFE412051 TMS		QA-Powertrain	FPE	TMS-CIN	26918-1	5/2/2005	
Problem Area Primary Model			Model Year	Production Date	Odometer	VIN (confirm 17 characters):	
Base Vehicle	Vehicle CorollaNUMMI		2005	10-Nov-2004	2144 mi	1NXBR32E85Z	
Condition Title							
MIL "ON" Code P0010, ENGINE STALL - VVTI VALVE STICKING

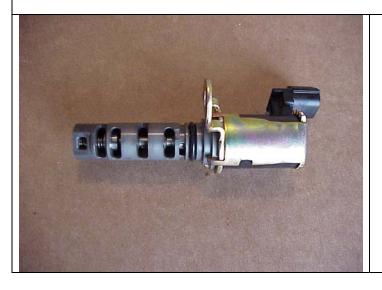
Probable root cause of complaint condition appears to be sticking VVTI oil control valve assembly.

Oil control valve sticking.

Replacement of VVTI oil control valve corrected complaint condition and customer is satisfied with repairs.

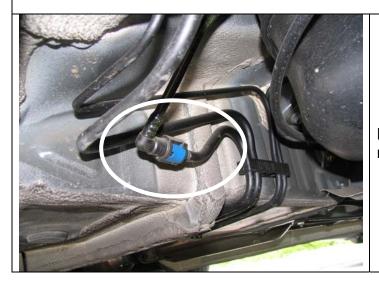
The engine started and ran normally at the time of the inspection. The fuel connection and lines located ahead of the left-rear wheel were inspected with no problems found. The connection was tested using the push-pull method several times, and the connection checked okay for proper locking.

Fuel line connection located ahead of the leftrear wheel.

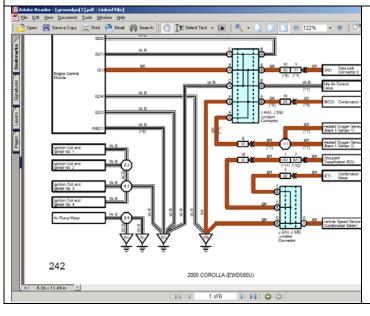
Retaining bolt at ECM ground (EB) was loose (not tightened into cylinder head. Bolt was 4-5 mm out (from fully seated position).

EB terminal provides ground for ECM signals.

Tightening bolt at EB ground point corrected complaint condition.

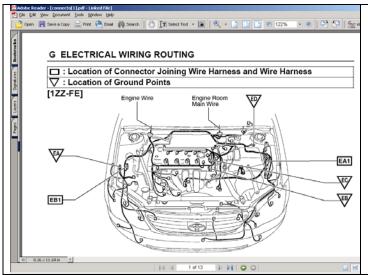
EB ground located on cylinder head.

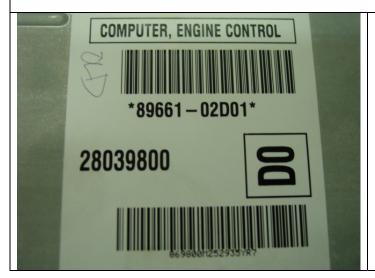
Internal condition in ECM.

Note: Small print under lower bar code reads – 869800M252935YR7

New ECM corrected complaint condition.

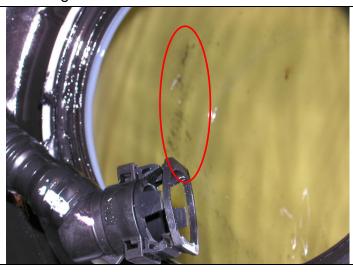
- Check fuel pressure, no fuel pressure
- Check power supply to the pump, 10.50 ~ 11.0 V (Spec between 9 to 12 Volt)
- Check continuity at the pump, no continuity (Spec 0.2 Ω to 3.0Ω at 20°C)
- Remove pump from the gas tank, found black deposit in the fuel tank
- Insert magnet to see if the black deposit was of a ferrous composition, the black deposit was attracted to the magnet
- Disassemble the SIFS (SIFS assembly include fuel suction plate sub-assy, fuel filter assy, Fuel pump and fuel pump filter assy) and found black deposit in the bottom portion of the SIFS.
- Remove the fuel pump from the SIFS assembly and apply current from 0V to 4V, there was no rotation of the pump
- Found black deposit on the top of the fuel pump

Black deposit found at the bottom of the tank when the fuel pump was removed

Replace fuel tank, fuel pump and full filler neck. Vehicle started OK. All parts will be ship to Denso in Michigan

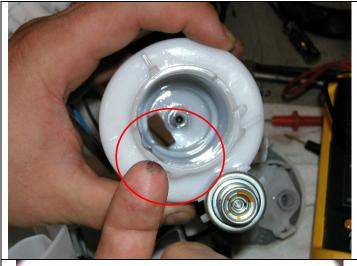
Black deposit was found in the cap going on top of the fuel pump

• Zoom of the top of the cap of fuel pump

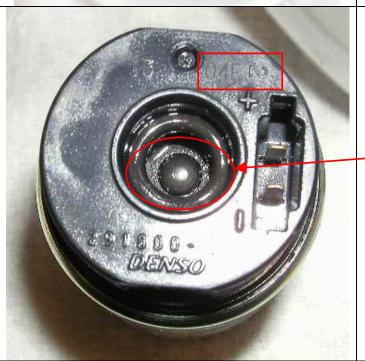
- Black deposit is found on the top of the pump
- Picture showing manufacturing markings (square box)

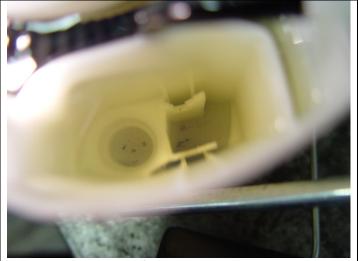
- Visual check of the inside of the Fuel pump module case > very small amount of black dust was found.
- The black dust material would not stick to a magnet.

Black dust in fuel pump module case.

- The dealership will replace the fuel pump module and ECM.
- (TMS-NY FPE will return the recovered fuel pump module to TMS-PRC.)

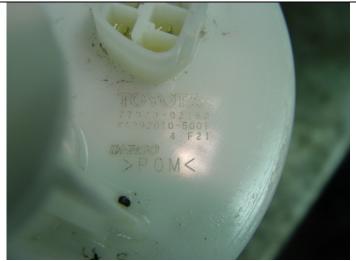
Part# and date code. 77020-02180, 4F21

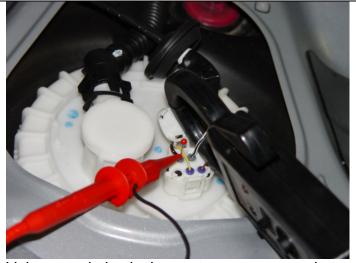
Voltage and electical curent were measured at Fuel pump module connector Pin#4 and Pin#5.

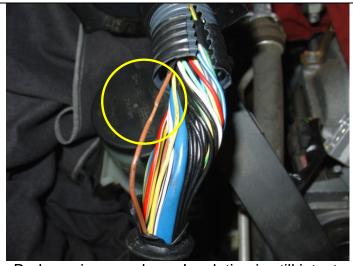
Broken wire seen here. Insulation is still intact.

Repair wire harness and road test.

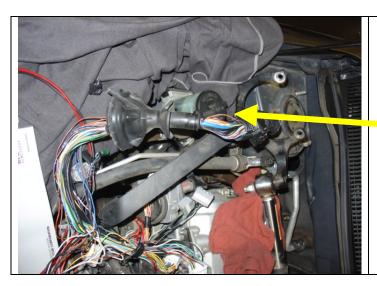
Overview of harness. Break is here.

Loom has been removed from computer side for repair.

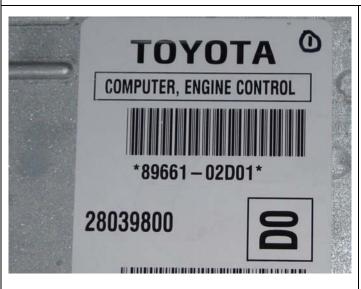
Engine Control ECU (P/N 89661-02D01) 28039800

Replaced engine ECU (P/N 89661-02D20).

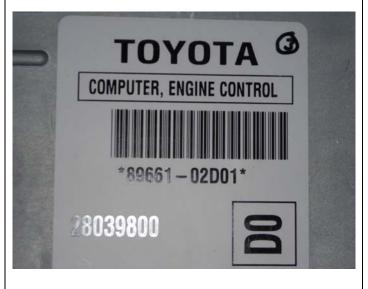
P/N 89661-02D01 28039800

Replaced engine ECU (P/N 89661-02D20).

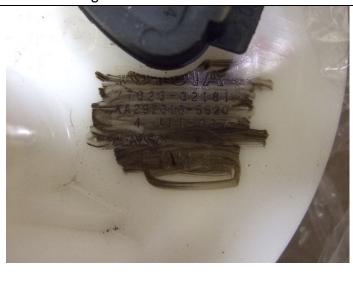
P/N 77020-02181 KA292010-5520 4 J 11 037

The technician replaced the to remedy the condition Part was shipped UPS for further quality evaluation purposes to TMS UPS tracking # 1Z 4X4 15X 06 3202 0842.

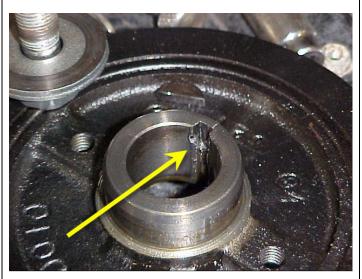
Internal damage to crankshaft pulley keyway

Because of the low mileage on this vehicle the engine short block assembly and crankshaft pulley were replaced to correct the condition.

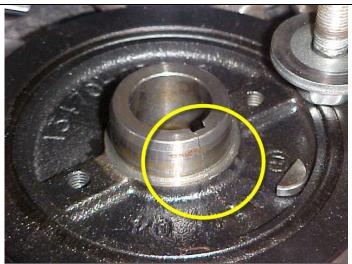
Crack in crankshaft pulley.

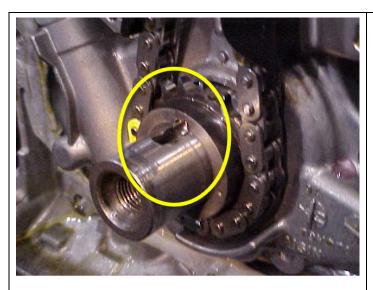
This shows the damage to the front of the crankshaft.
