Re: **Preliminary Evaluation (PE09-034)**
Passenger Air Bag System (MY) 2007-2008 Kia Sorento

KIA MOTOR	GROUP Service Campaign	MODEL 2007~2008 Sorento (BL)
	NUMBER SC 076	DATE May 2009
VOLUNTARY SERVICE CAMPAIGN TECHNICAL SERVICE BULLETIN		
SUBJECT: 2007-2008 SORENTO OCCUPANT CLASSIFICATION SYSTEM (OCS) REPROGRAM

SC 076 - 2007 – 2008 SORENTO OCCUPANT CLASSIFICATION SYSTEM (OCS) REPROGRAMMING VOLUNTARY SERVICE CAMPAIGN

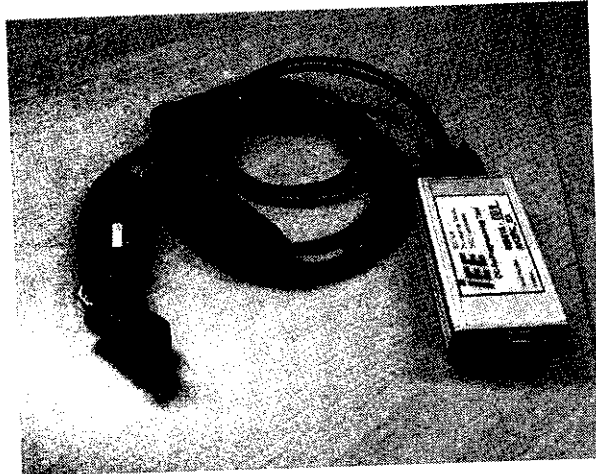
- Model:** Sorento
- Description:** Re-flash of the OCS system to improve occupant detection
- # of Vehicles:** 7,283 vehicles - Contact KMA Distribution Dept. for VIN list.
- Verification:** Check that the vehicle is one of the affected vehicles by the vehicle's VIN.
- Tools Needed:** Re-flash tool

1. Slide the front passenger seat to the full forward position and fold the seat back forward.
2. Remove the inner seat track cover.

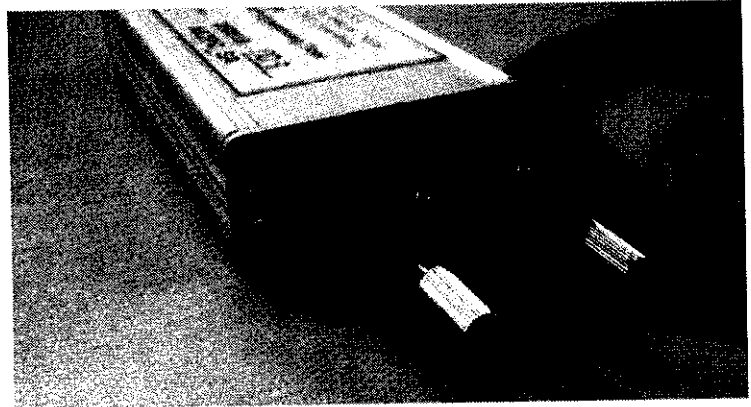
3. Disconnect the OCS wire harness connector. Connect the OCS tool to the wiring harness and plug the power connector to the 12V outlet at the base of the rear console.
4. Turn the ignition key to the ACC position. Both the red and green LEDs on the re-flash tool will light up after 1~3 seconds. If the LEDs do not power-up, check the power outlet for proper operation.

5. You are now ready to re-flash the OCS control module. Push the start button on the tool to perform the re-flash.
6. While the re-flash is occurring, the green and red LEDs will flash back and forth for approximately 60 seconds.

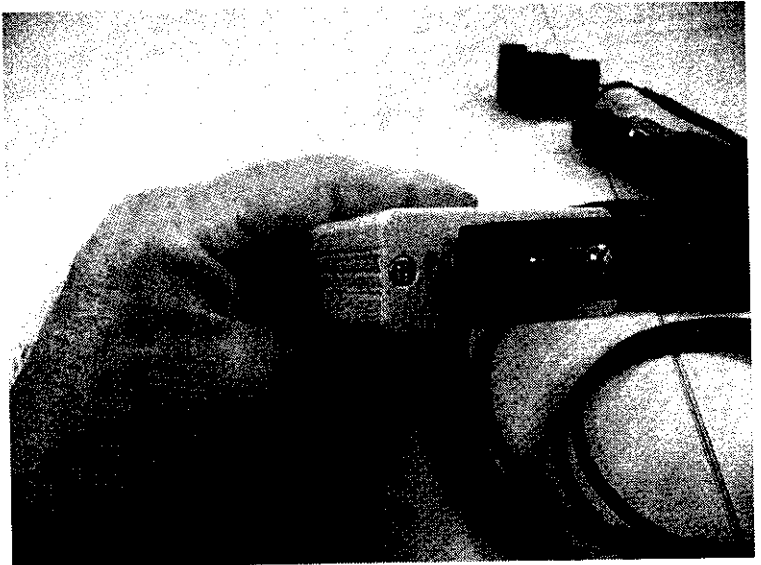
9. After completion of the re-flash, turn the ignition switch to the OFF position. Disconnect the power plug to the center console and the connection from the tool to the OCS wiring harness. Re-connect the harness to the seat.

10. Install the seat track cover.

11. Perform a functional check of the OCS system.
 - a. Turn the ignition switch ON and monitor the tell tale lamp on the center fascia panel. The "PASSENGER AIR BAG OFF" should light up initially and then turn OFF and back ON.
 - b. Sit in the front passenger seat if you weight at least 105 lbs. The air bag light should then go OFF.

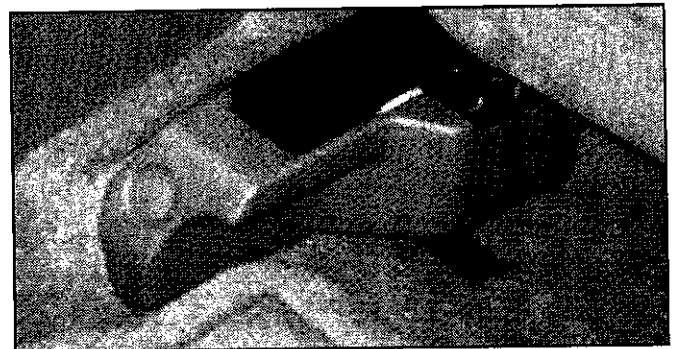
1. Slide the R/F seat to the full forward position.
2. Remove the seat track cover from the left rear mounting stud of the R/F seat. Grasp the cover and pull to the rear, the cover will be removed to access the OCS electrical connector.
3. Disconnect the electrical connector for the OCS system.

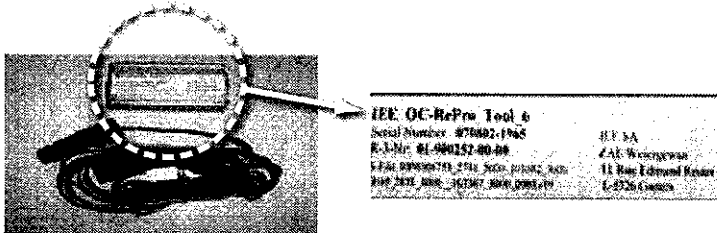
Part Name	Part No.	Figure
OC Reprogramming Box	IEE OC- RePro_ Tool_6

The OCS reprogramming tool number six (6) has been sent to your dealer during the 2008 calendar year. Contact your DPSM for shipment information if this tool is unaccounted for at your dealership.
