Cards For Redemption

**GM World Card**

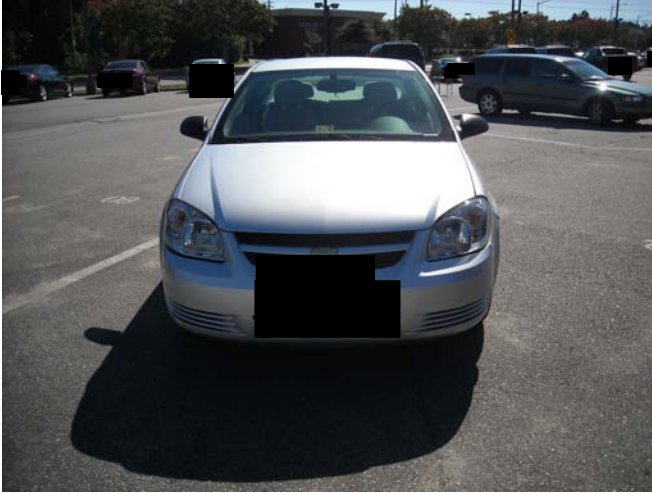
4. Left front view – In this photo you can see that there is light damage to the left fender. The headlight has been replaced.

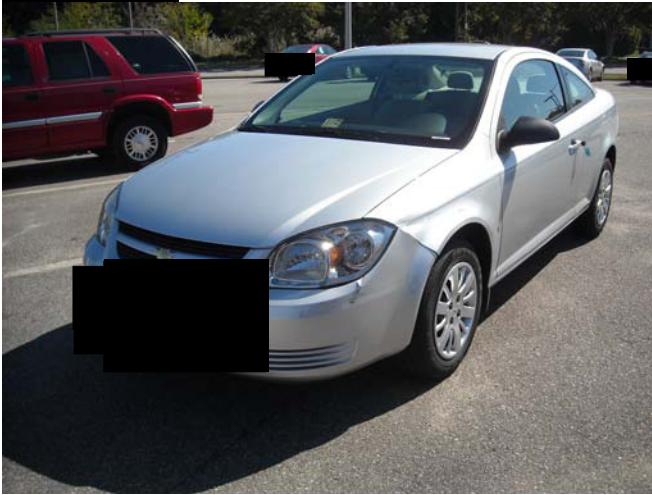
5. Looking across the front from the left side you can get a better view of the damage to the fender.

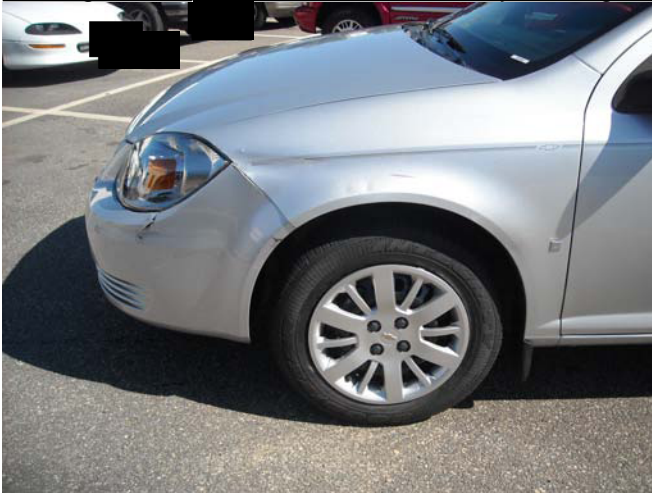
**PRODUCT ALLEGATION RESOLUTION
PRELIMINARY INSPECTION
FIELD PHOTOGRAPHIC NOTES**

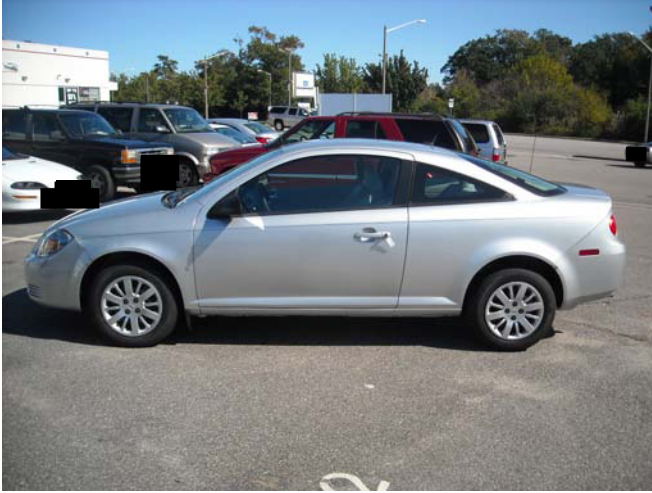
7. In this left rear view you can see the small area of damage on the bumper at the wheel opening.

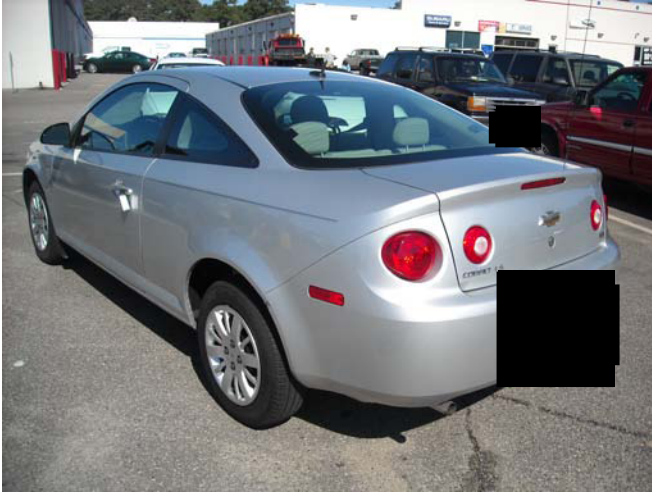
8. Rear view – no damage

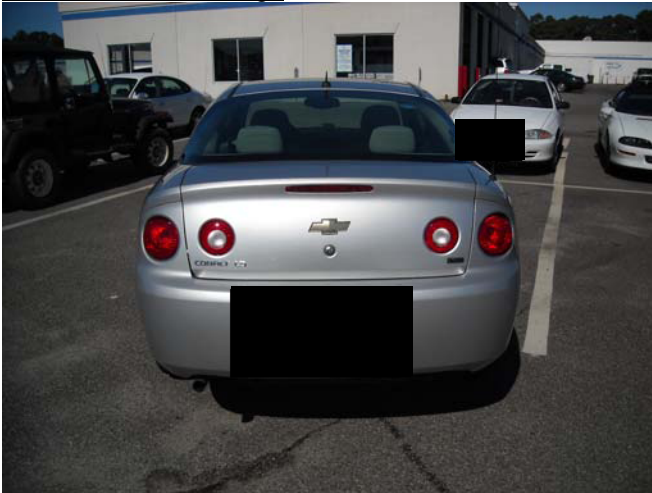
**PRODUCT ALLEGATION RESOLUTION
PRELIMINARY INSPECTION
FIELD PHOTOGRAPHIC NOTES**

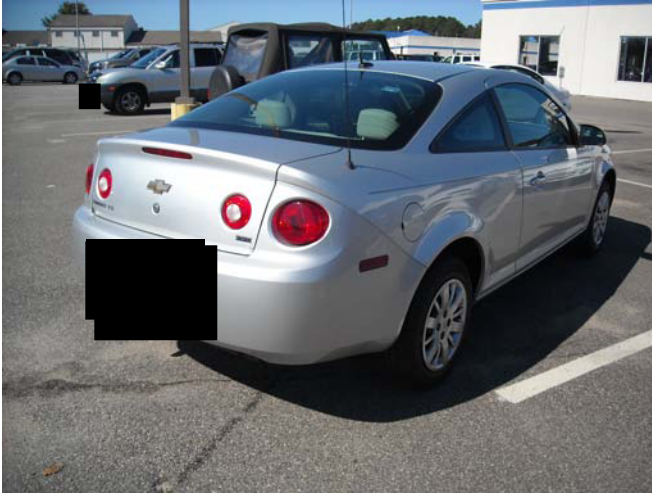
10. Right side view – No damage

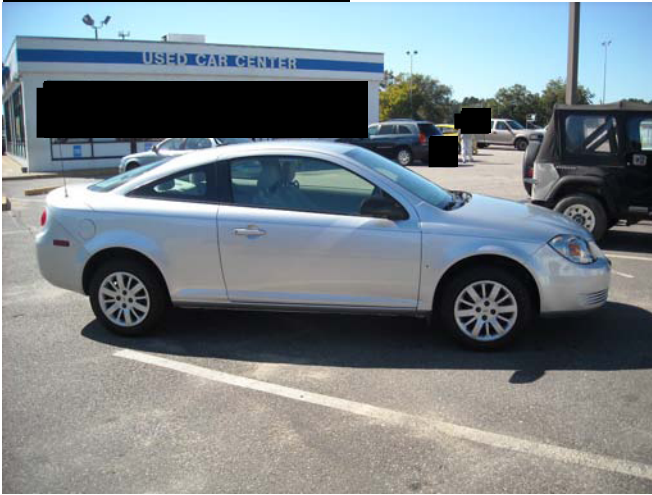
11. Looking across the front from the right side you can see that there is no fender damage and no frontal impact.

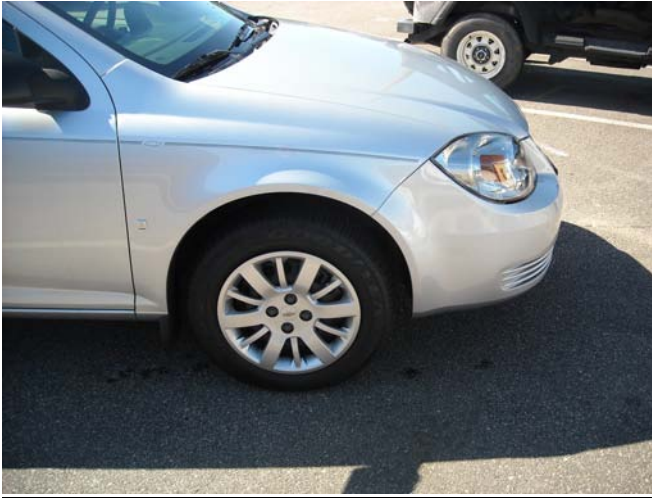
12. Right front view – no damage

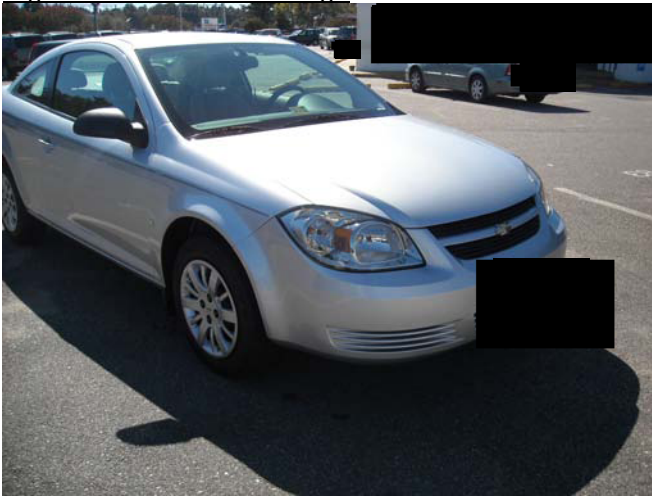
13. A closer overview of the damage to the left fender and bumper

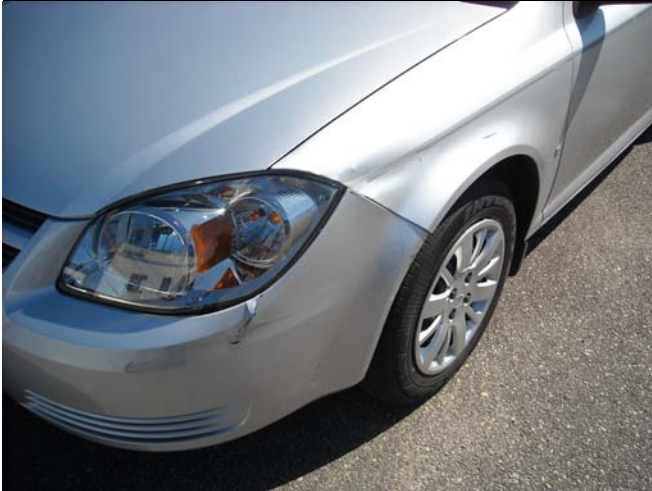
14. A closer look at the bumper damage

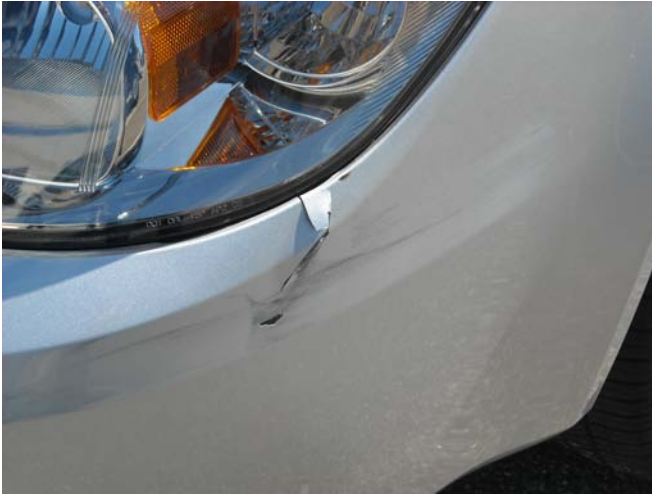
15. Another view of the damage to the left front fender.

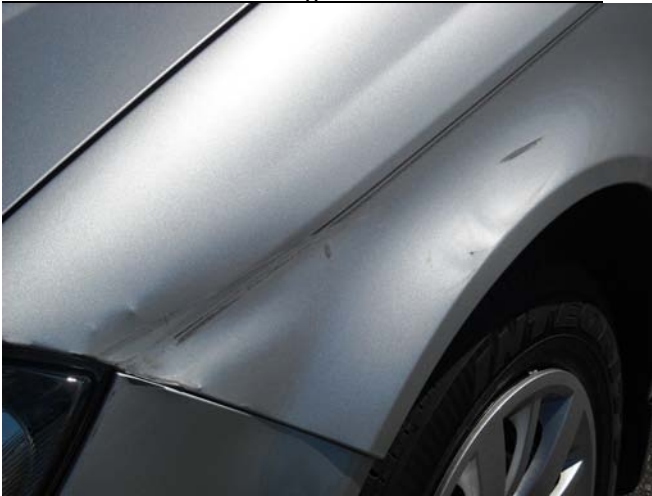
16. Another view of the damage to the left front fender.

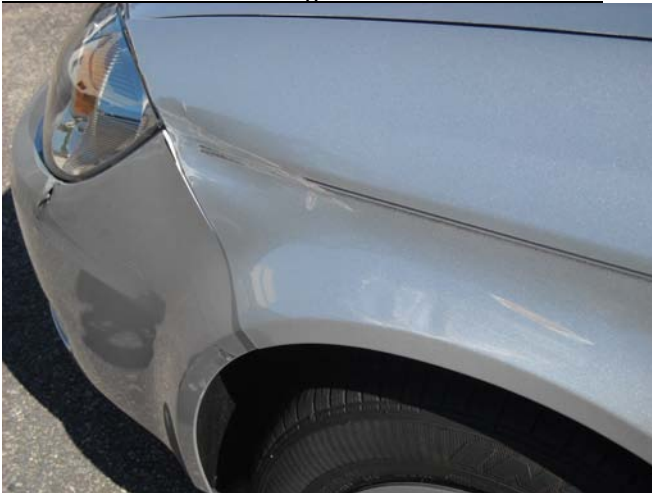
17. The left front tire is original and was not damaged in the incident. The wheel cover and wheel have been

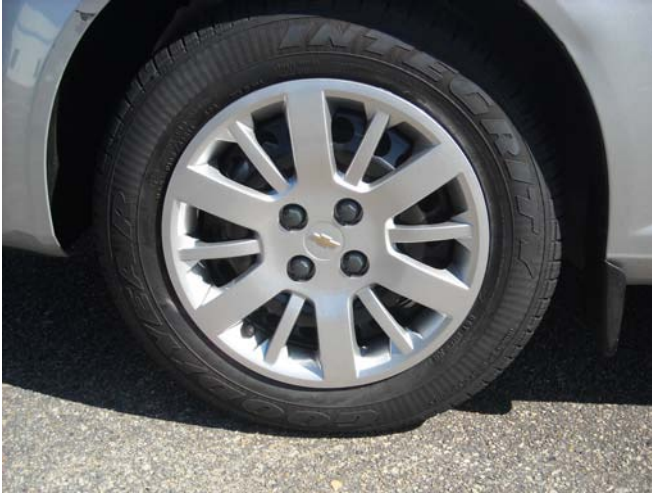
18. Another look at the damage to the left rear bumper.

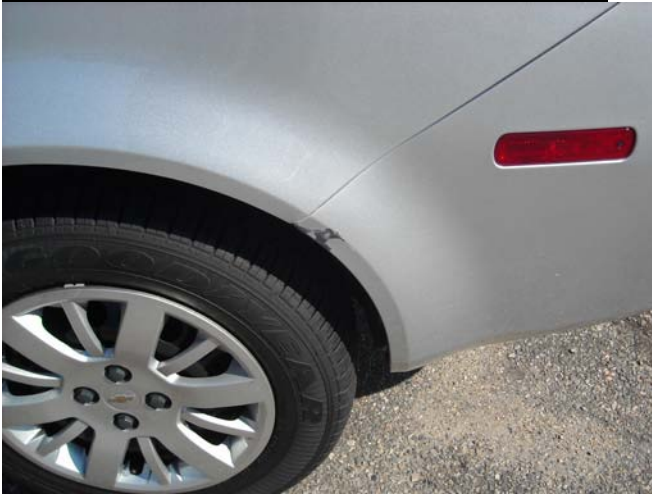
19. A closer look at the damage to the left rear bumper.

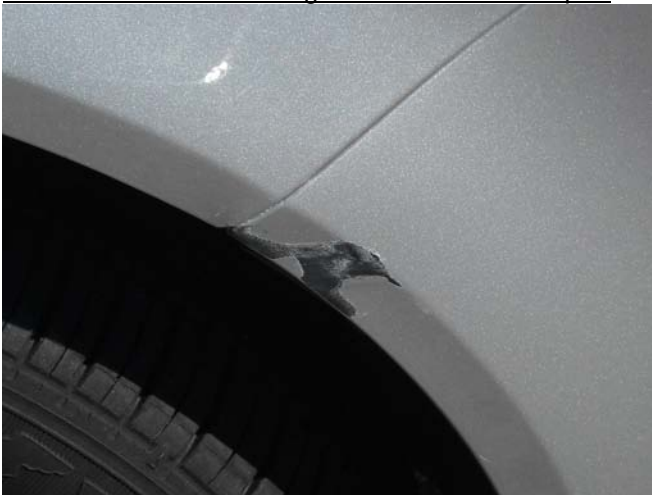
**PRODUCT ALLEGATION RESOLUTION
PRELIMINARY INSPECTION
FIELD PHOTOGRAPHIC NOTES**

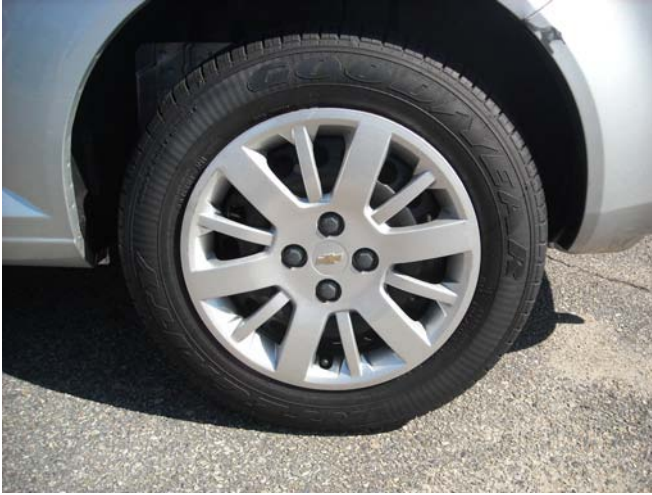
21. A closer look at some of the damage to the left rear wheel cover.

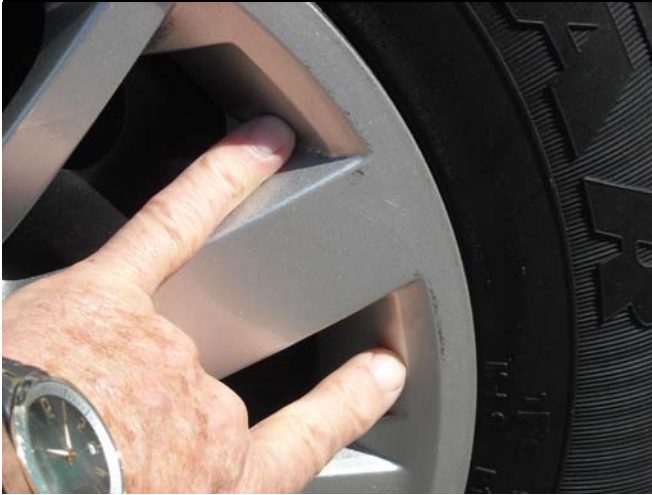
22. Another close look at some of the damage to the left rear wheel cover.

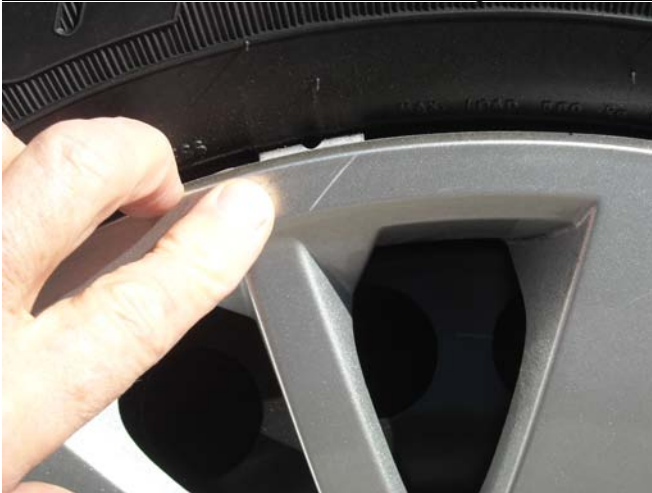
**PRODUCT ALLEGATION RESOLUTION
PRELIMINARY INSPECTION
FIELD PHOTOGRAPHIC NOTES**

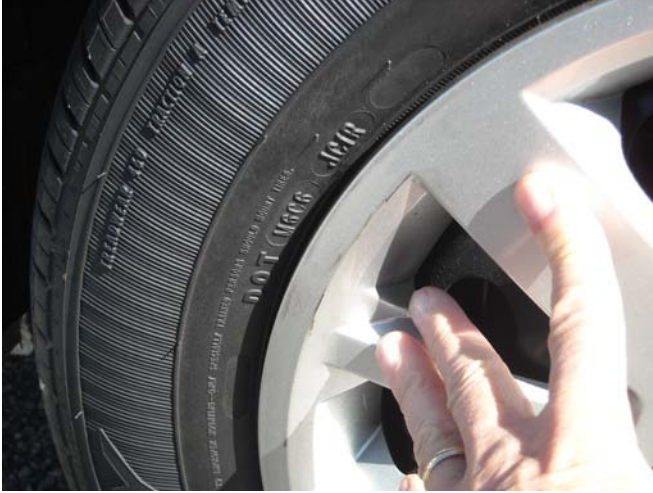
24. Overview of the engine compartment – no damage

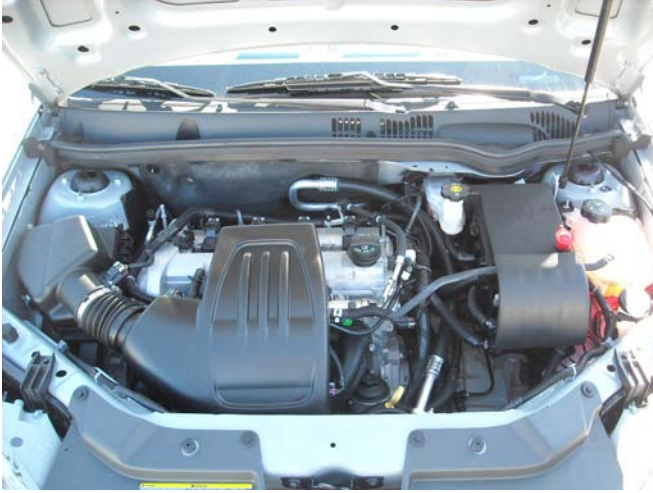
25. A view of the engine compartment from the left side – no damage

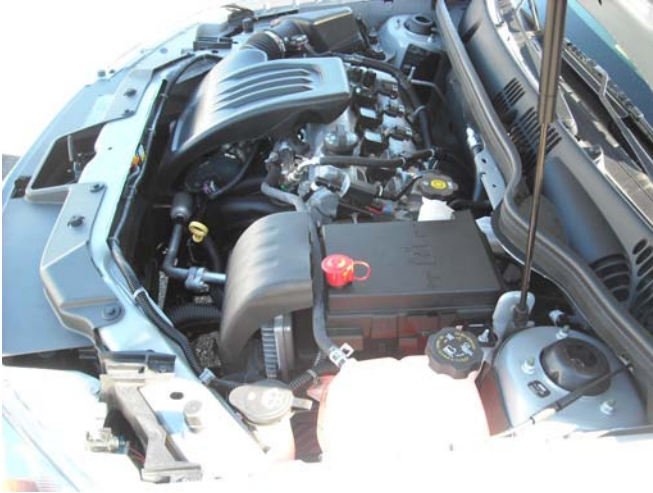
**PRODUCT ALLEGATION RESOLUTION
PRELIMINARY INSPECTION
FIELD PHOTOGRAPHIC NOTES**

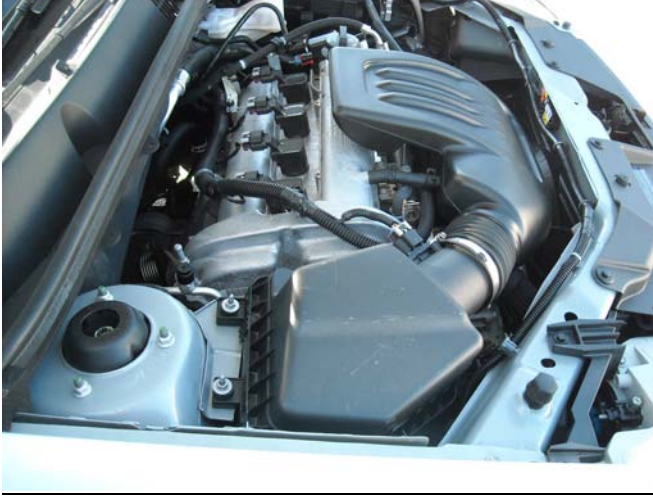
27. A view of the steering rack assembly from the top – no damage, abnormal wear condition

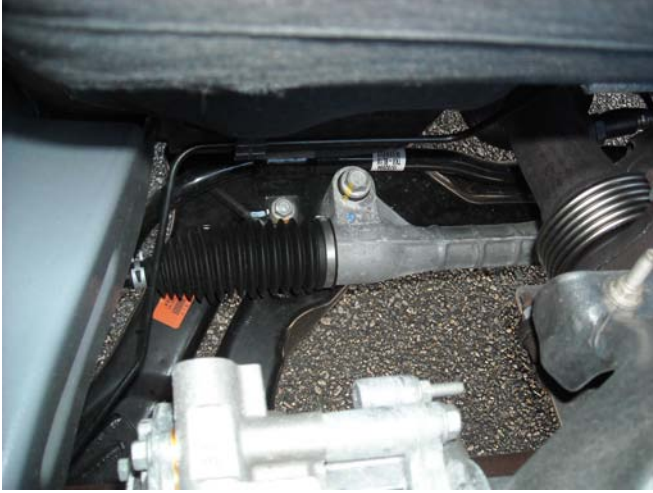
28. Another view of the steering rack assembly from the top – no damage

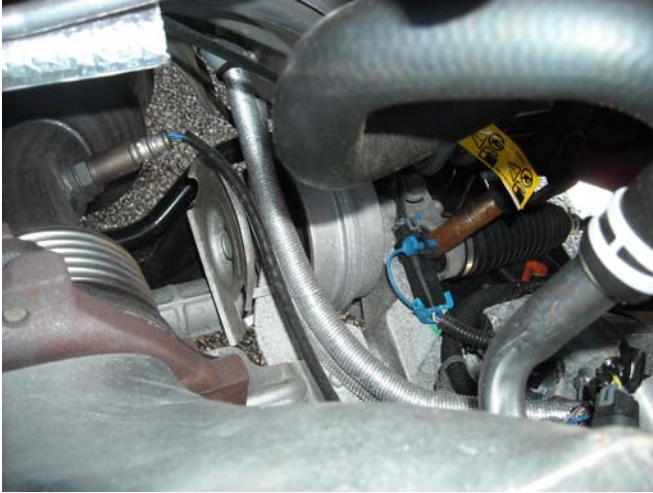
**PRODUCT ALLEGATION RESOLUTION
PRELIMINARY INSPECTION
FIELD PHOTOGRAPHIC NOTES**

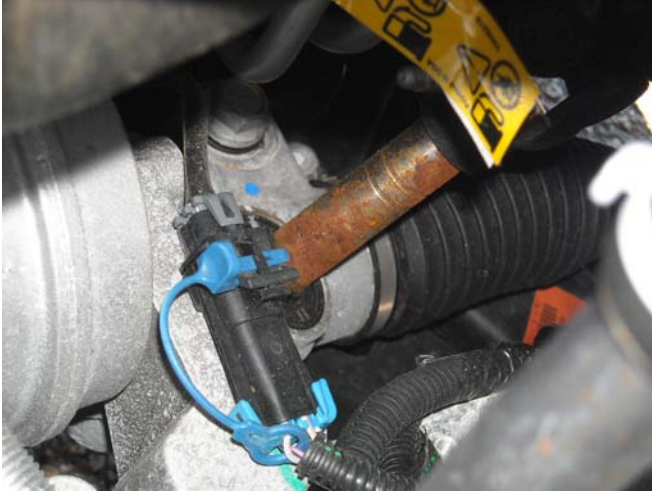
30. There were no warning lights illuminated on the instrument panel.

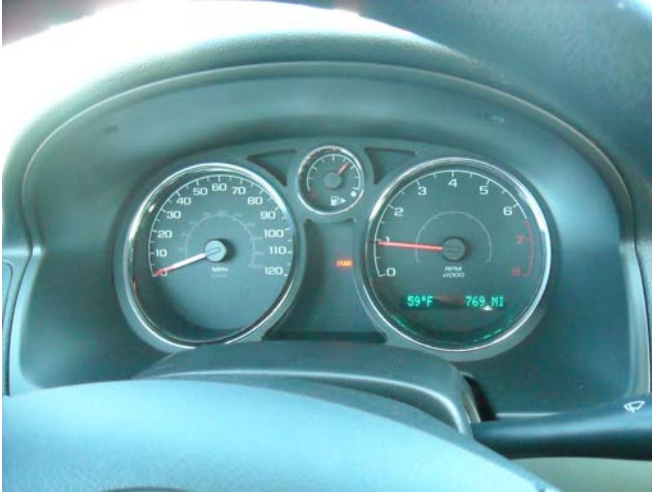
31. No damage to the driver's door trim

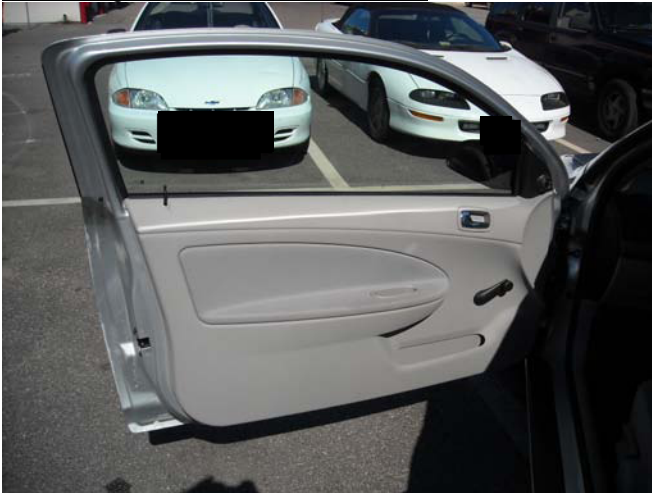
**PRODUCT ALLEGATION RESOLUTION
PRELIMINARY INSPECTION
FIELD PHOTOGRAPHIC NOTES**

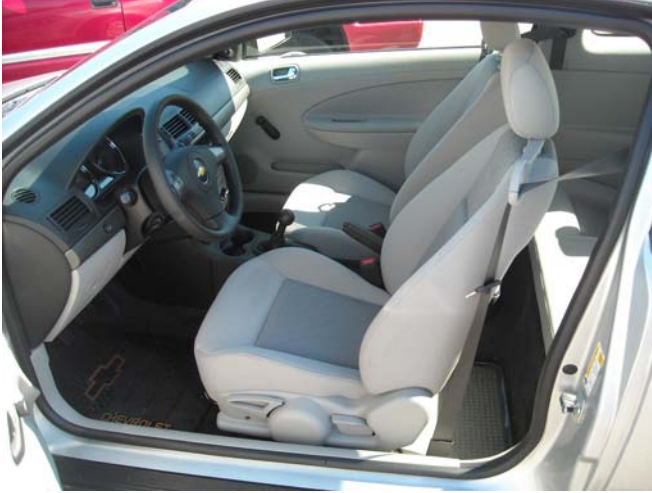
33. There is no damage to the driver's side of the instrument panel and the steering wheel.

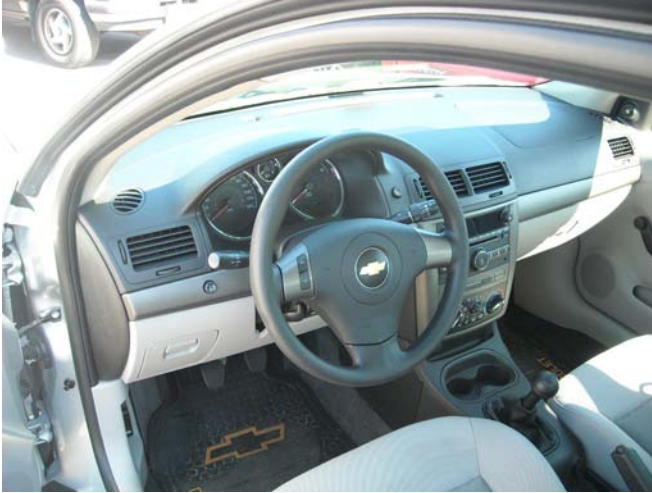
34. The driver's knee blocker is not damaged.

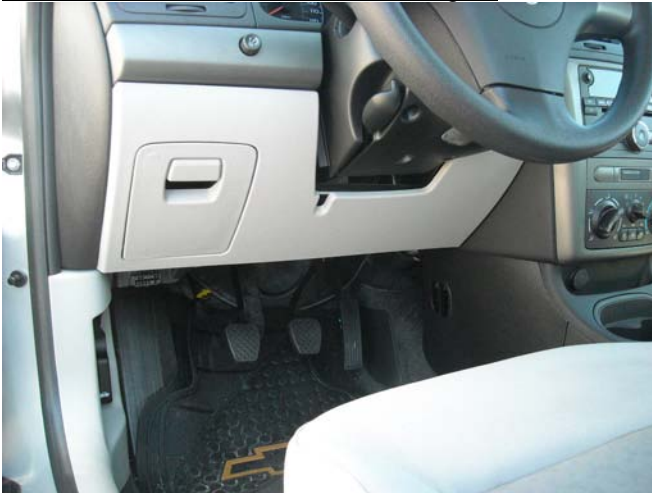
**PRODUCT ALLEGATION RESOLUTION
PRELIMINARY INSPECTION
FIELD PHOTOGRAPHIC NOTES**

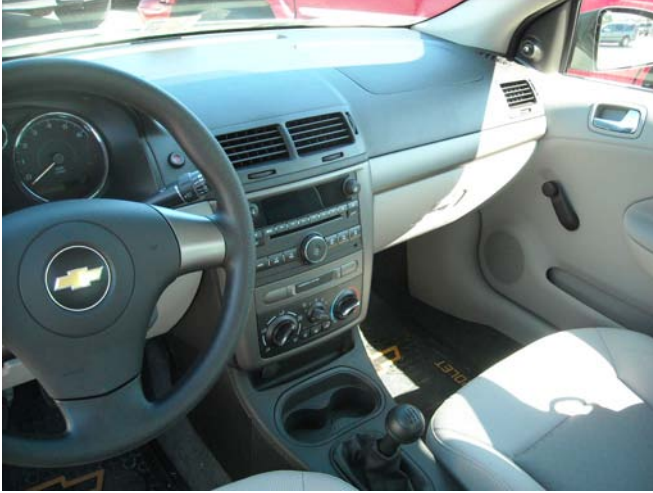
36. There is no damage to the driver side headliner, sun visor, windshield header and rear view mirror.

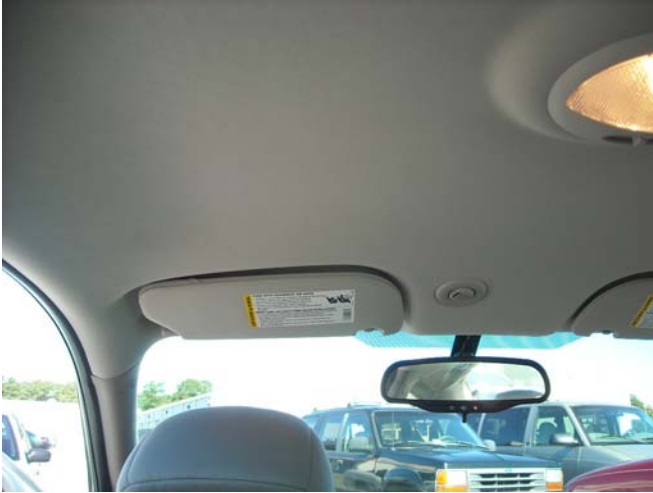
37. There is no damage to the passenger side headliner, sun visor, windshield header and rear view mirror.

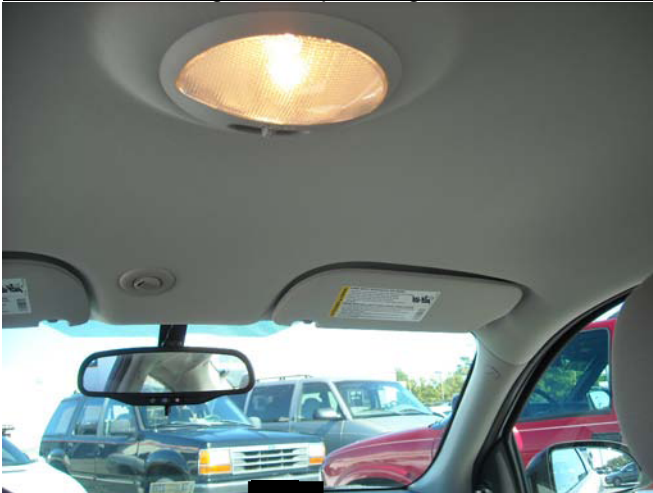
**PRODUCT ALLEGATION RESOLUTION
PRELIMINARY INSPECTION
FIELD PHOTOGRAPHIC NOTES**

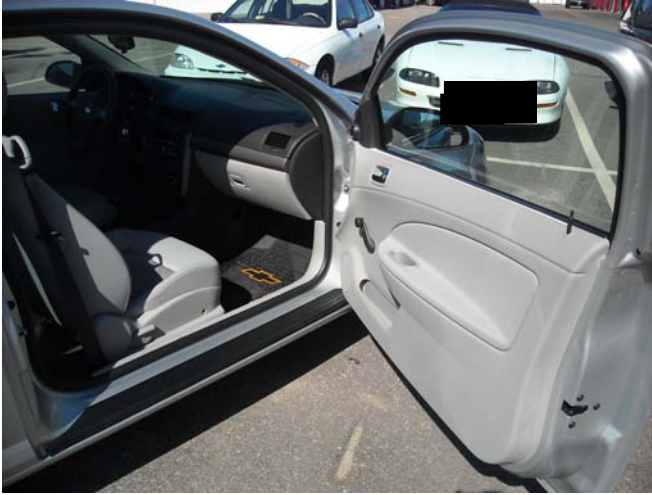
- 39 Overview of the front seating area from the passenger side. No interior damage.

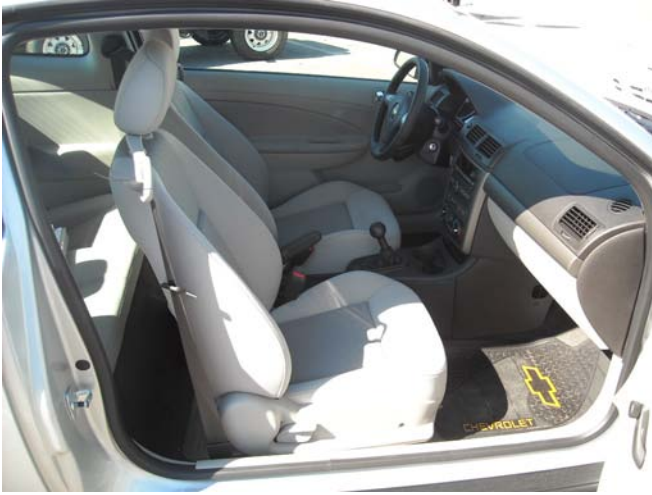
- 40 The passenger side of the dash is not damaged

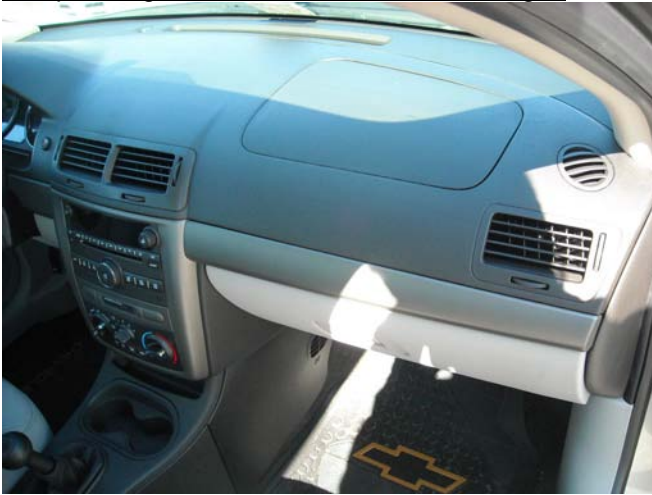
**PRODUCT ALLEGATION RESOLUTION
PRELIMINARY INSPECTION
FIELD PHOTOGRAPHIC NOTES**

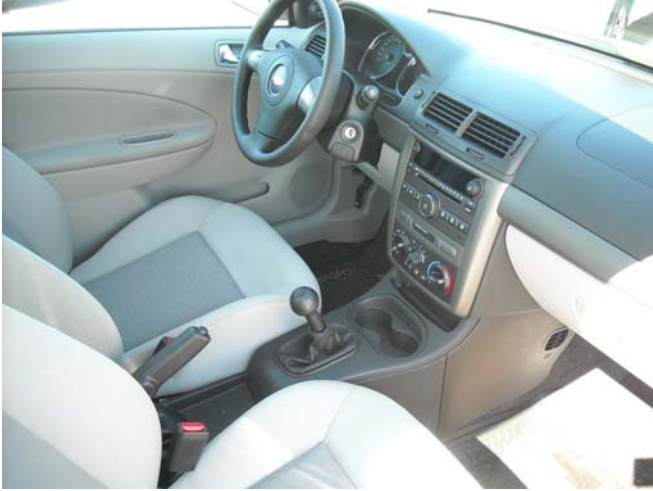
- 42 There are no leaks at the brake fluid reservoir.

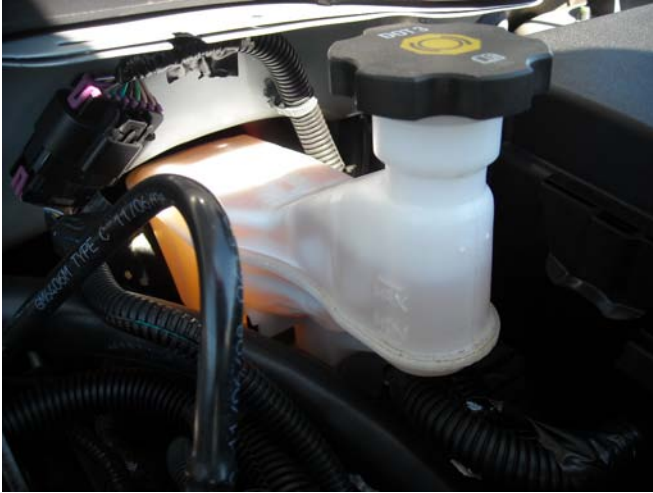
- 43 The brake fluid is clean and full

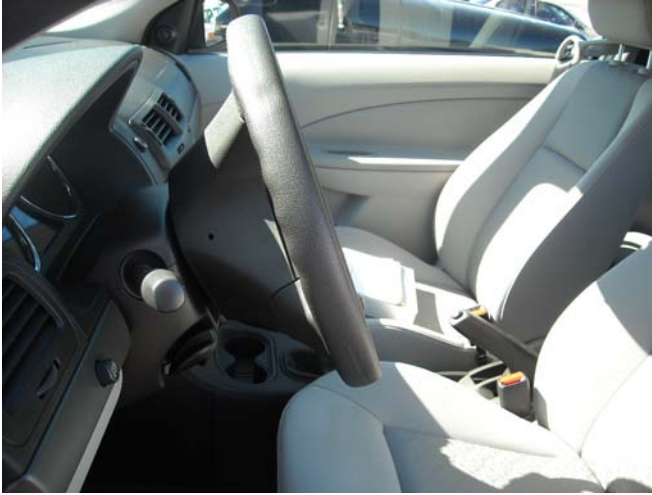
- 45 The steering column and couplings are not damaged and show no sign of abnormal wear.

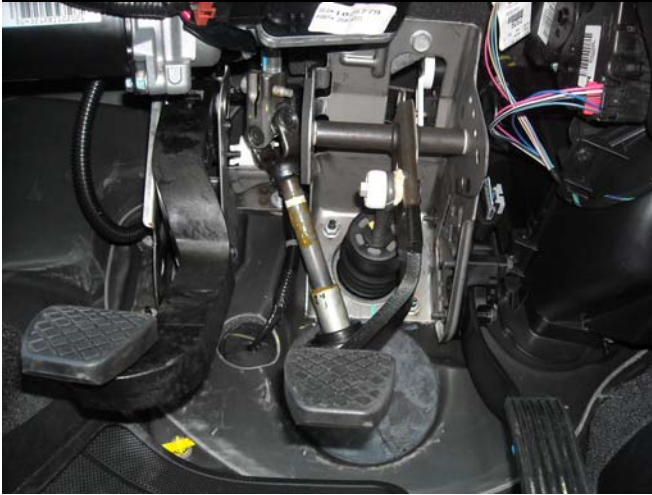
- 46 The angle of the driver seat backrest

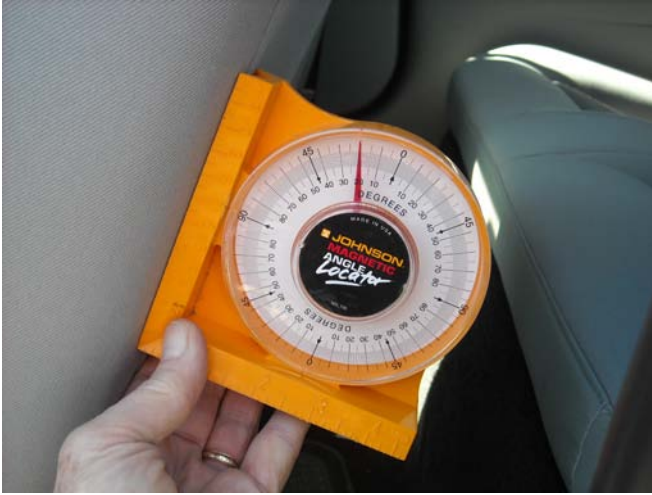
- 48 The driver seatbelt was found fully retracted

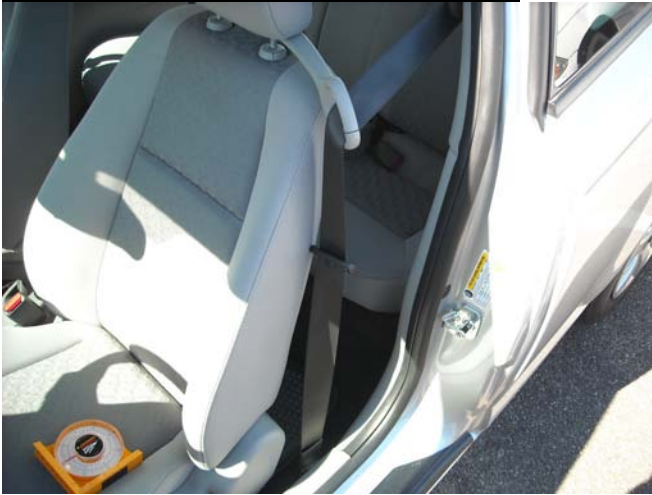
49. The driver's seatbelt latchplate is not damaged

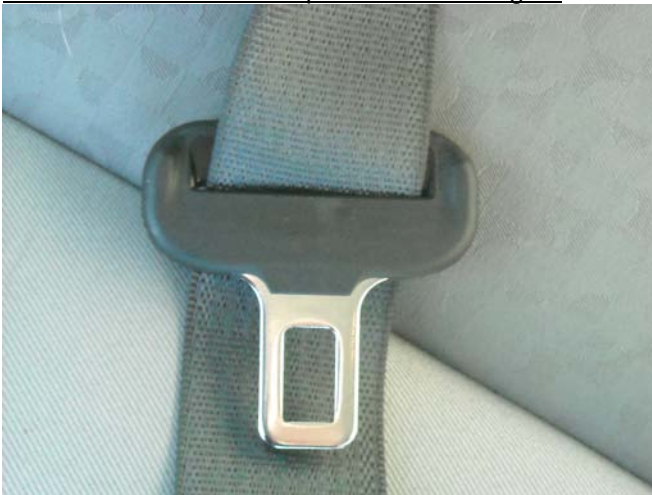
**PRODUCT ALLEGATION RESOLUTION
PRELIMINARY INSPECTION
FIELD PHOTOGRAPHIC NOTES**

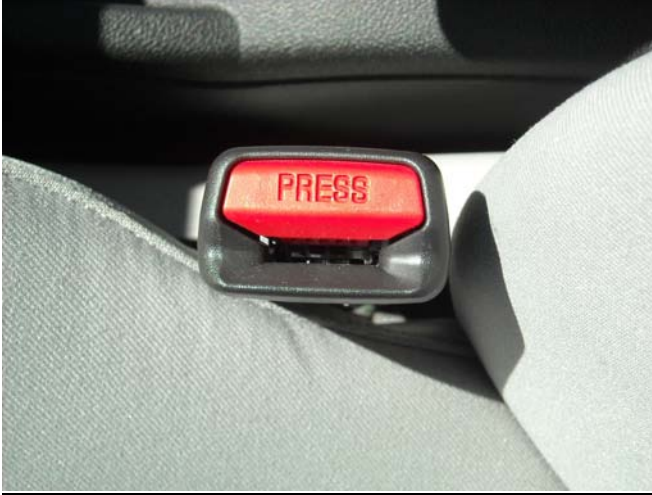
57. A side view of the driver's seatbelt latch assembly.

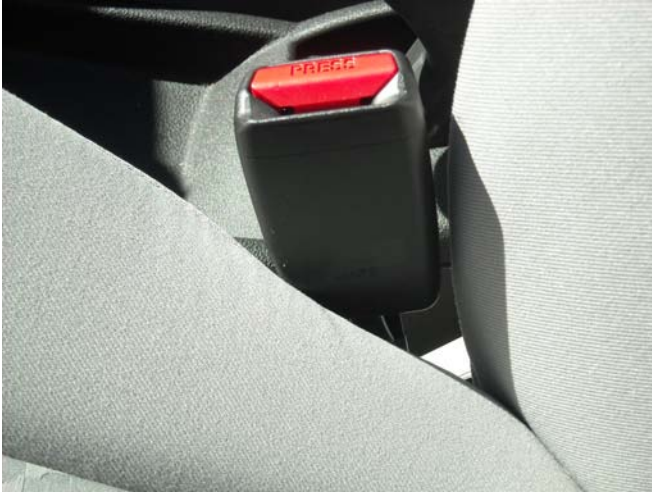
58. Overview of the left front wheel cover that had been replaced.

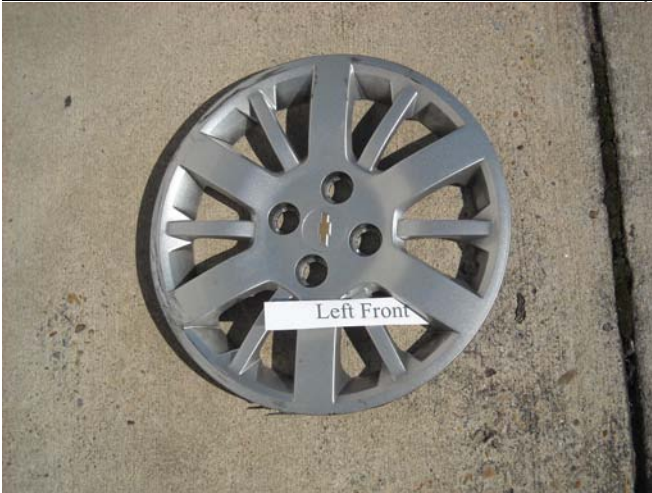
**PRODUCT ALLEGATION RESOLUTION
PRELIMINARY INSPECTION
FIELD PHOTOGRAPHIC NOTES**

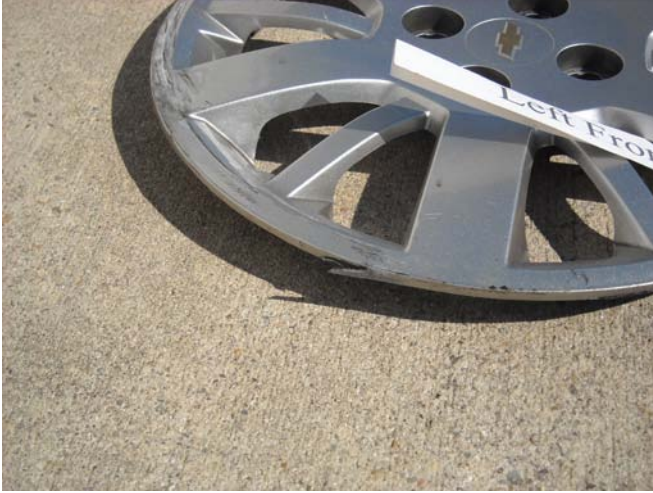
60. Another closer look at the damage to the replaced left front wheel cover.

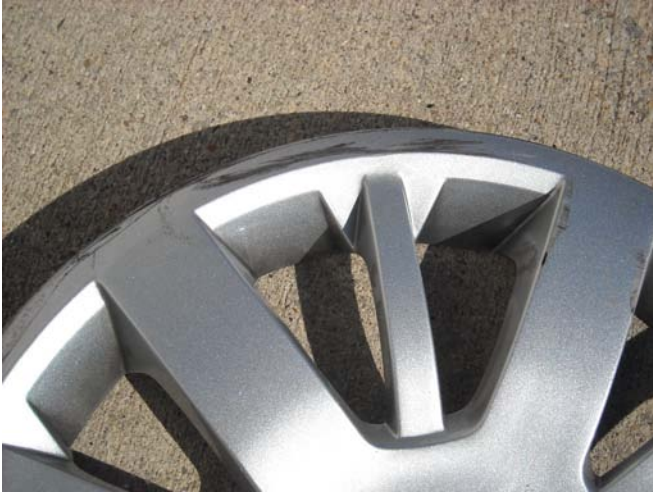
61. Another closer look at the damage to the replaced left front wheel cover.

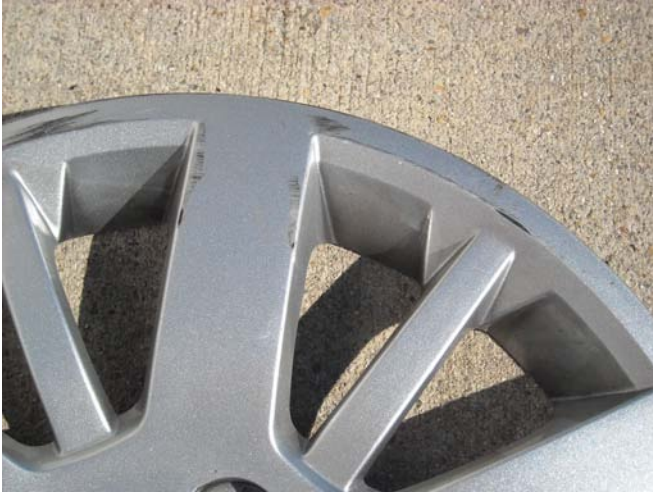
**PRODUCT ALLEGATION RESOLUTION
PRELIMINARY INSPECTION
FIELD PHOTOGRAPHIC NOTES**

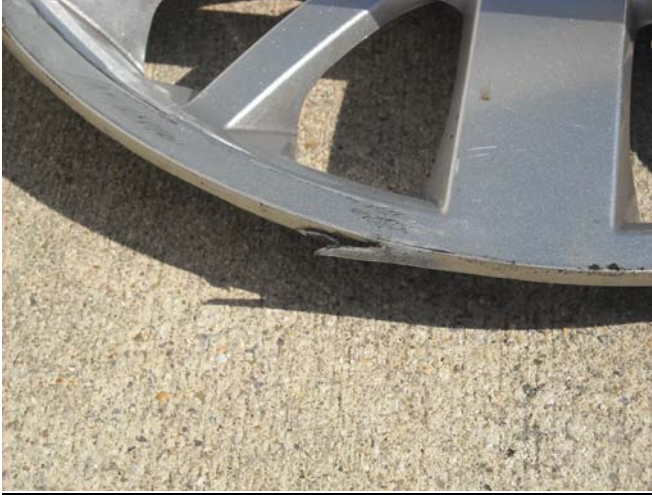
63. Overview of the damaged left front wheel.

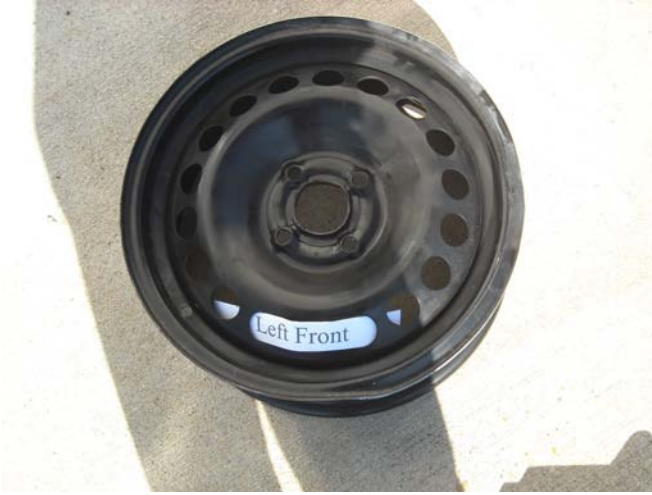
64. Another view of the damage to the left front wheel.

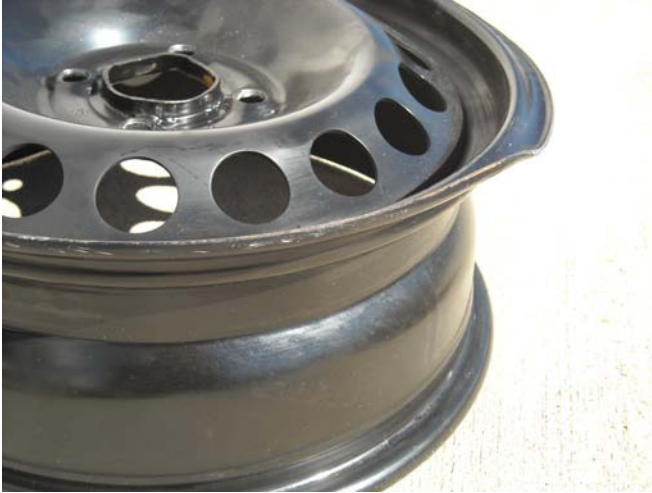
**PRODUCT ALLEGATION RESOLUTION
PRELIMINARY INSPECTION
FIELD PHOTOGRAPHIC NOTES**

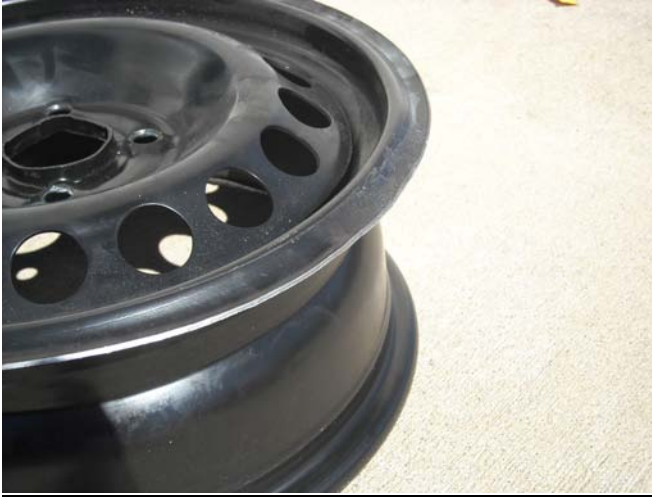
66. Another view of the damage to the left front wheel.

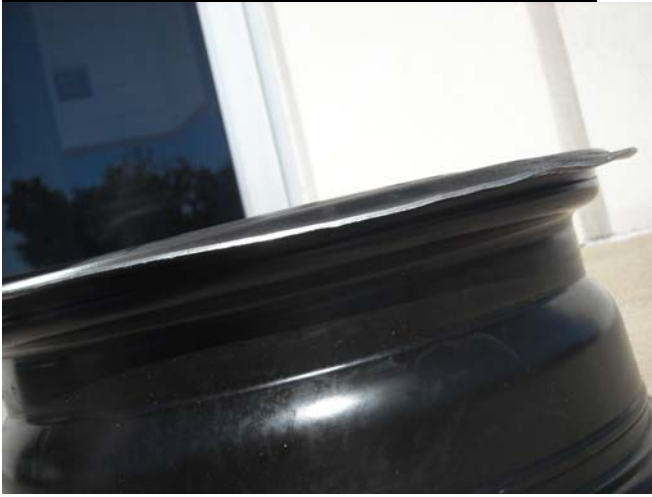
67. Another view of the damage to the left front wheel.

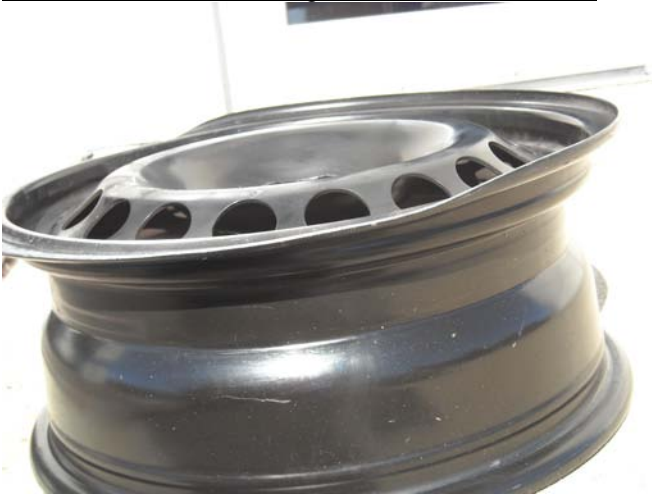
**PRODUCT ALLEGATION RESOLUTION
PRELIMINARY INSPECTION
FIELD PHOTOGRAPHIC NOTES**

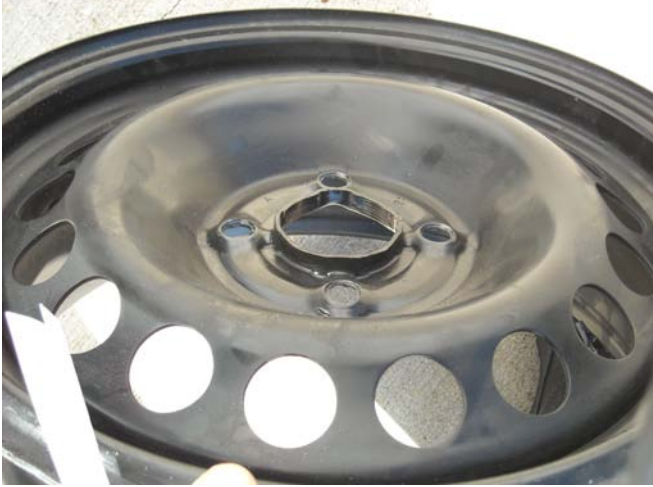
69. Another view of the damage to the left front wheel.

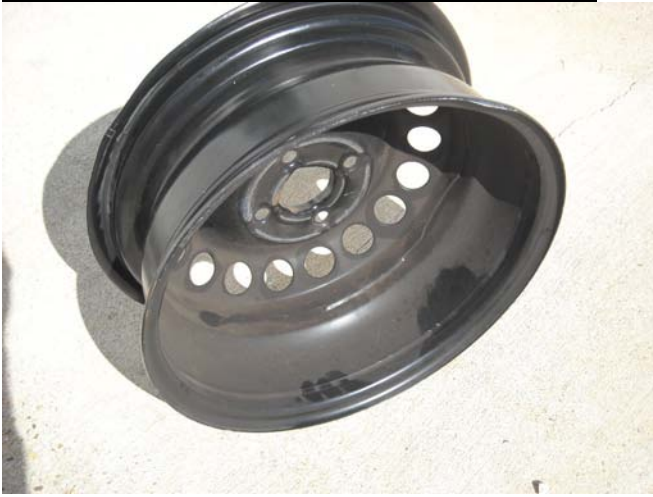
70. Another view of the damage to the left front wheel.

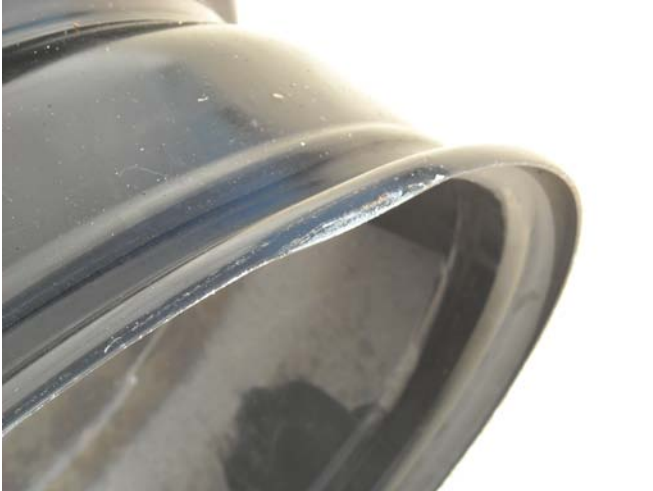
**PRODUCT ALLEGATION RESOLUTION
PRELIMINARY INSPECTION
FIELD PHOTOGRAPHIC NOTES**

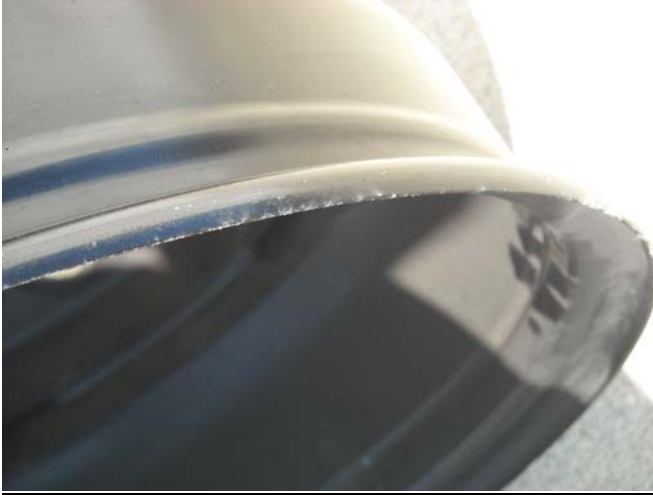
72. The damaged left front headlamp that had been replaced.

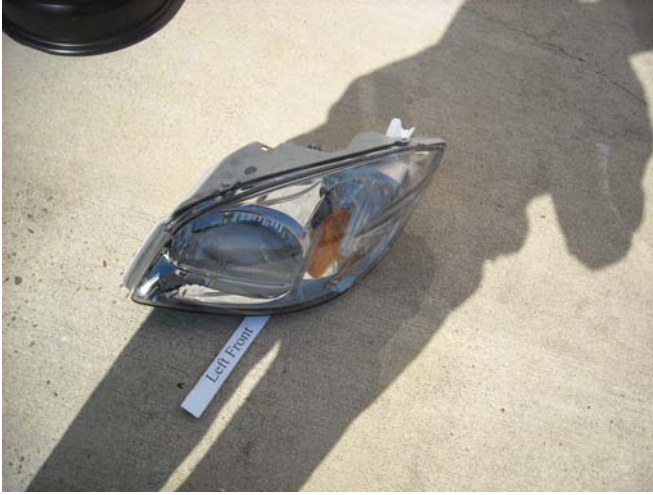
73. Another view of the damaged left front headlamp that had been replaced.

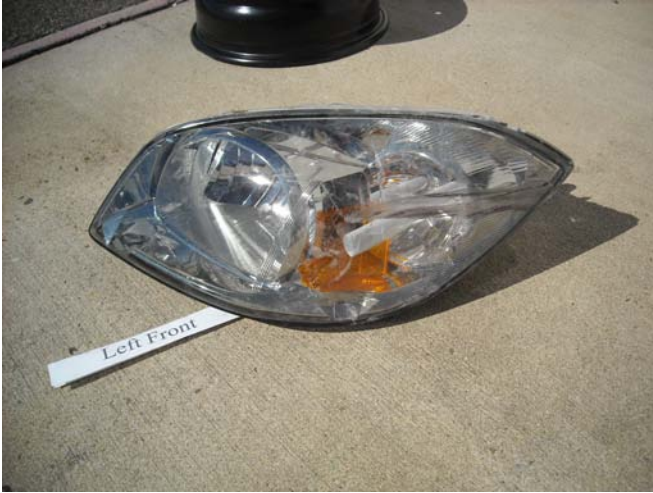
**PRODUCT ALLEGATION RESOLUTION
PRELIMINARY INSPECTION
FIELD PHOTOGRAPHIC NOTES**

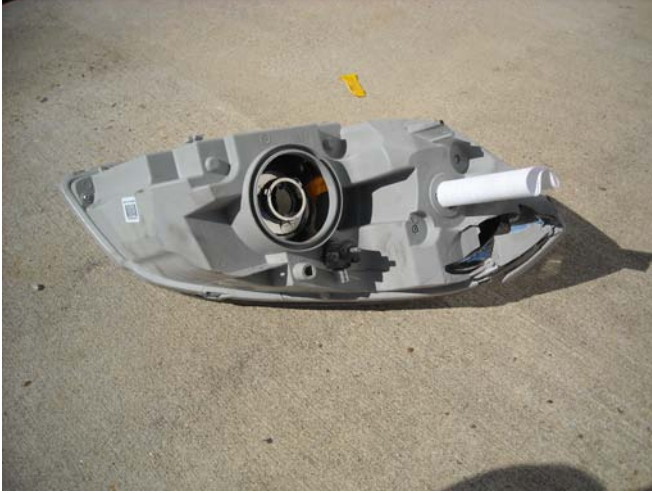
75. Another view of the damaged left front headlamp that had been replaced.

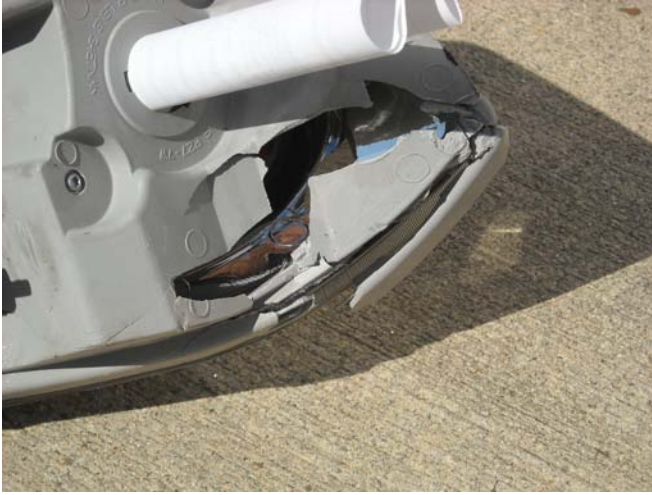
76. There were no ECM DTCs.

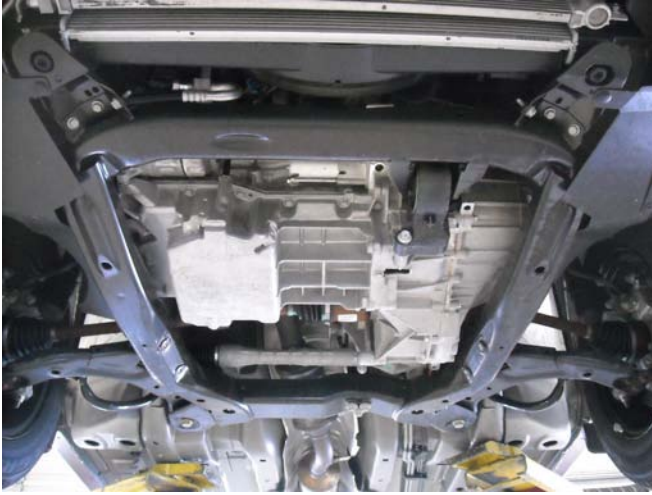
79. A look at the right front steering and suspension – no damage and no abnormal wear condition noted.

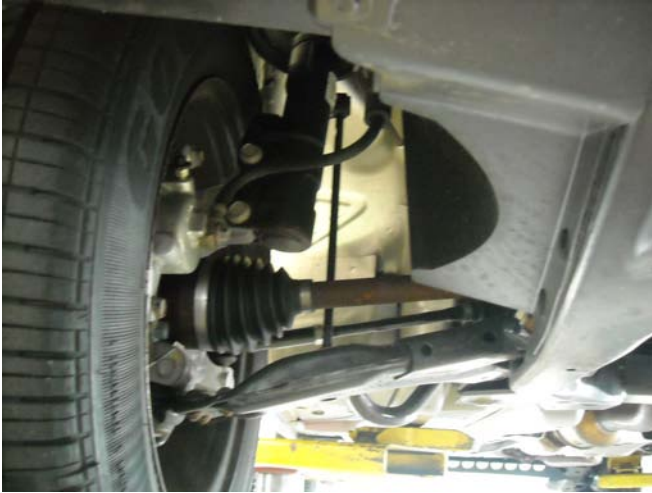
**PRODUCT ALLEGATION RESOLUTION
PRELIMINARY INSPECTION
FIELD PHOTOGRAPHIC NOTES**

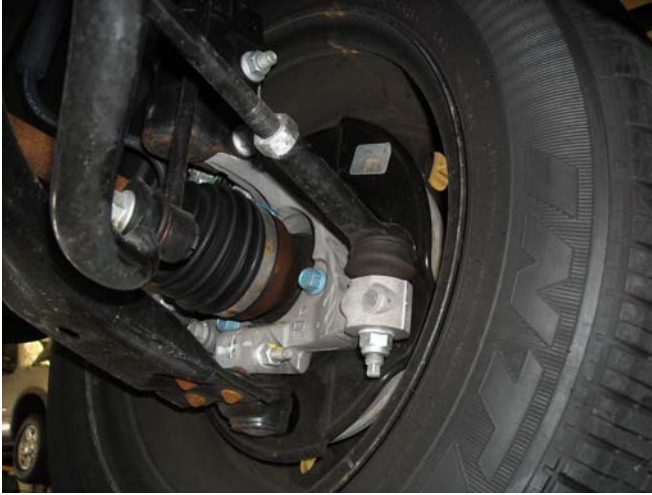
81. A look at the steering assembly – no damage and no abnormal wear conditions noted.
