Cards For Redemption

**GM World Card**

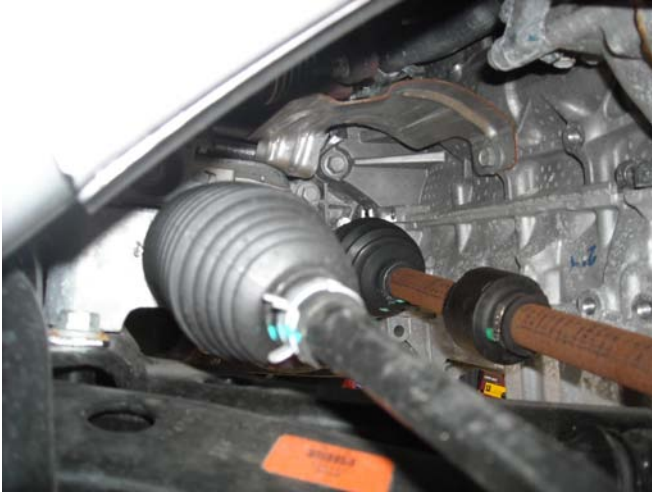
82. Another look at the steering assembly – no damage and no abnormal wear conditions noted.

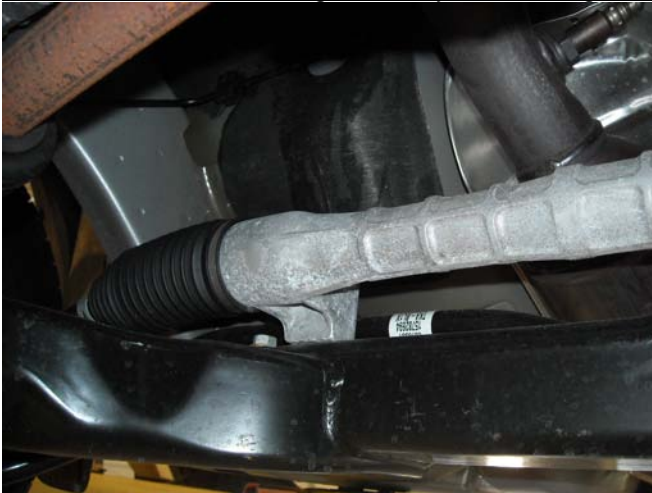
**PRODUCT ALLEGATION RESOLUTION
PRELIMINARY INSPECTION
FIELD PHOTOGRAPHIC NOTES**

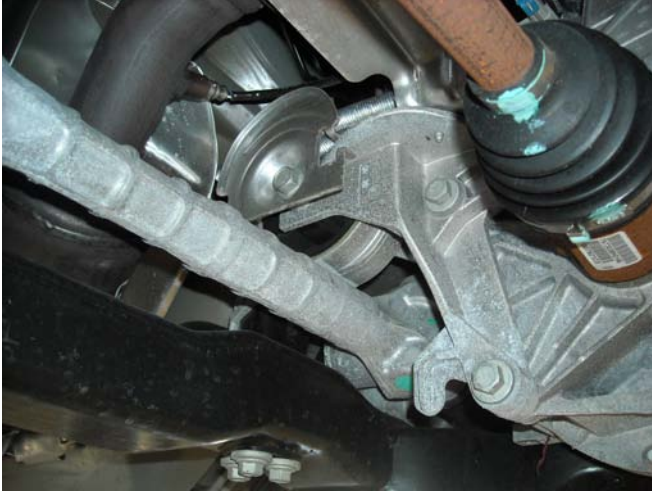
84. Another look at the steering assembly – no damage and no abnormal wear conditions noted.

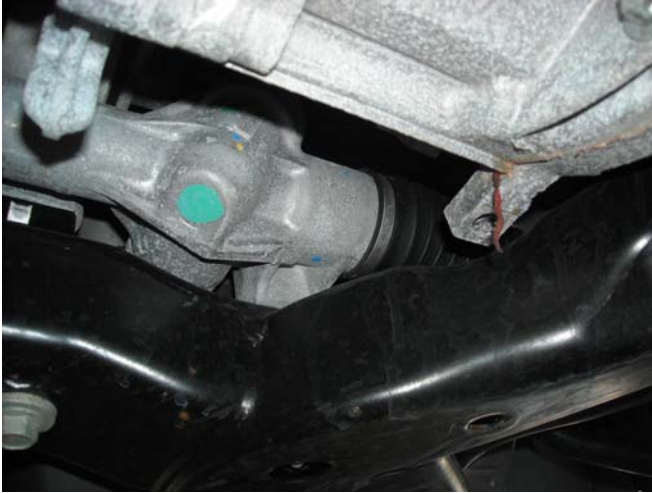
85. Another look at the steering assembly – no damage and no abnormal wear conditions noted.

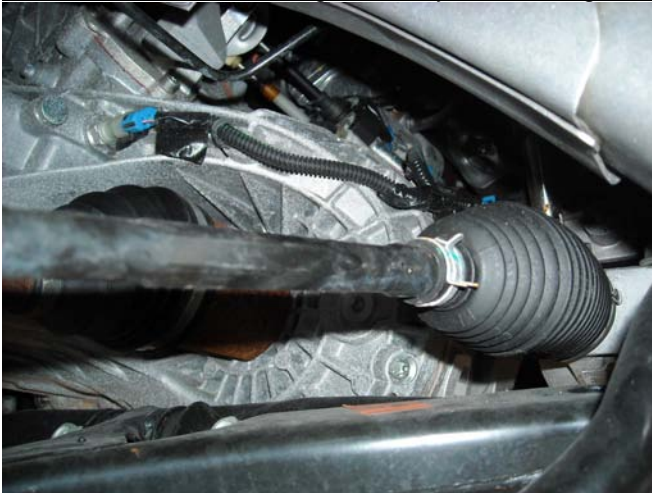
**PRODUCT ALLEGATION RESOLUTION
PRELIMINARY INSPECTION
FIELD PHOTOGRAPHIC NOTES**

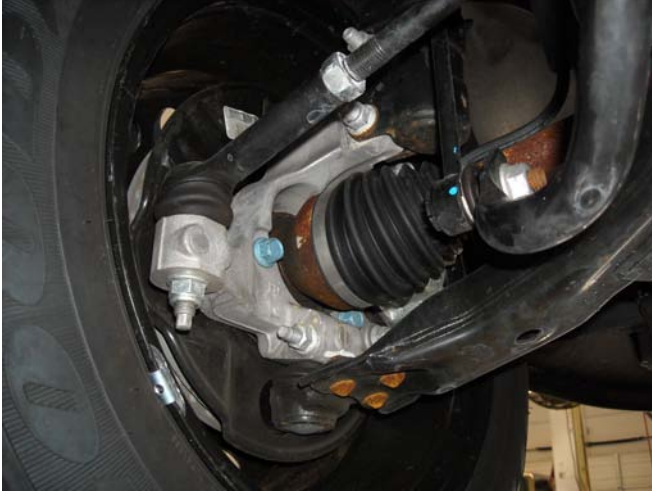
87. Another look at the left front steering and suspension – no damage and no abnormal wear condition noted.

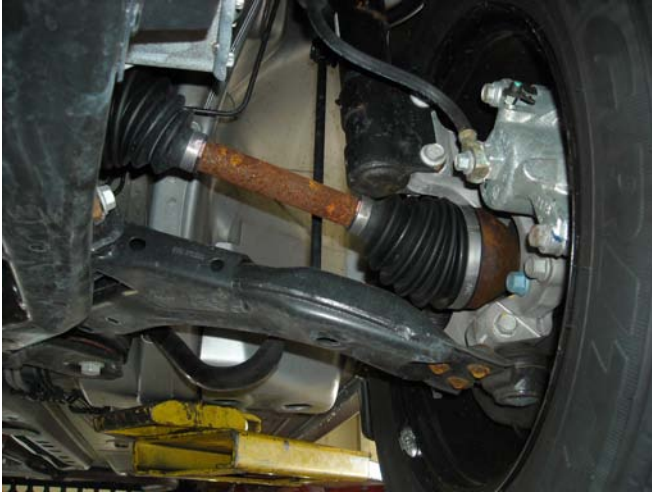
88. There is no damage to the center section of the undercarriage.

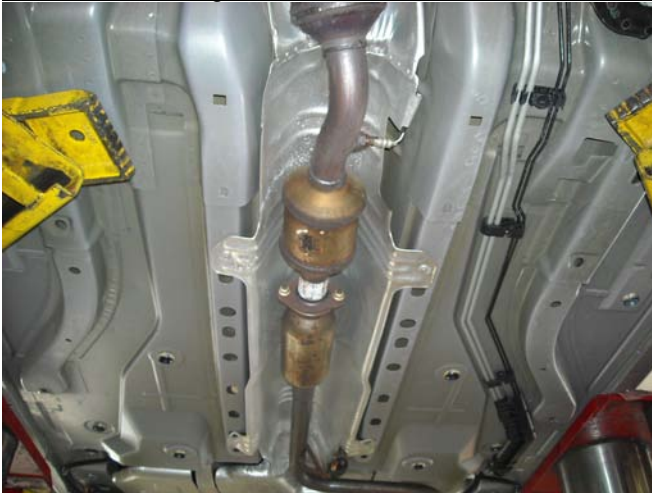
**PRODUCT ALLEGATION RESOLUTION
PRELIMINARY INSPECTION
FIELD PHOTOGRAPHIC NOTES**

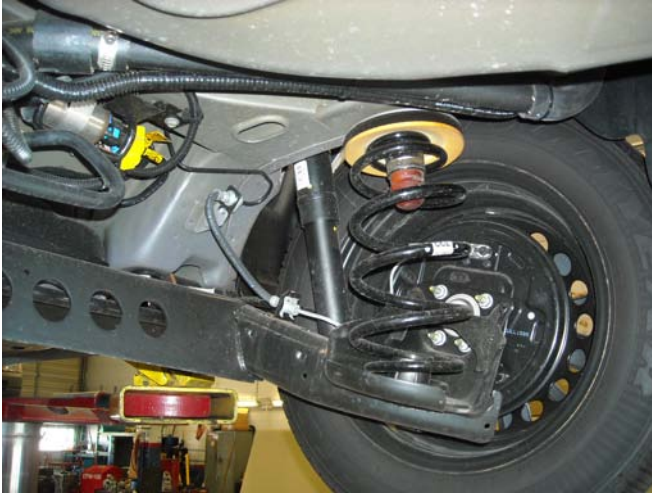
90. There is no damage to the left rear suspension.

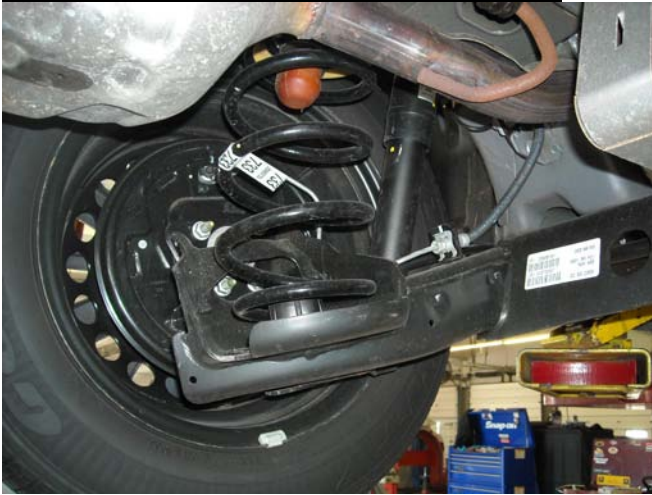
91. Another view of the undamaged left rear suspension.

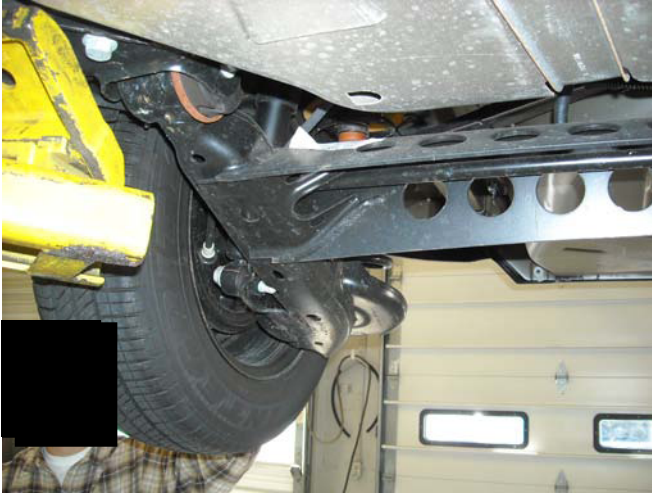
93. The rear suspension crossmember is not damaged.

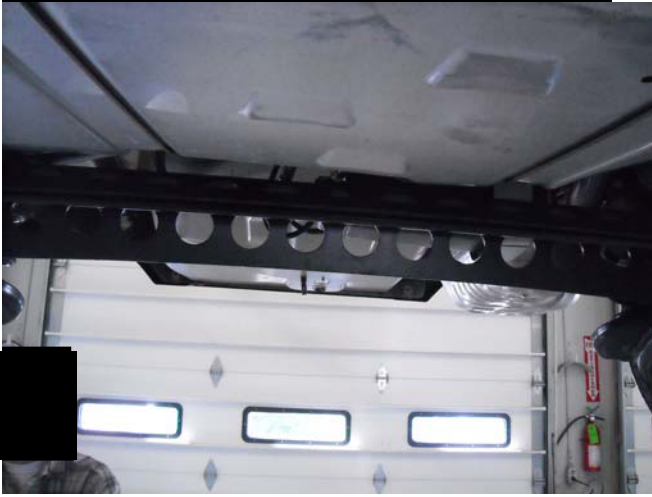
94. _____
95. _____
96. _____
97. _____
98. _____
99. _____

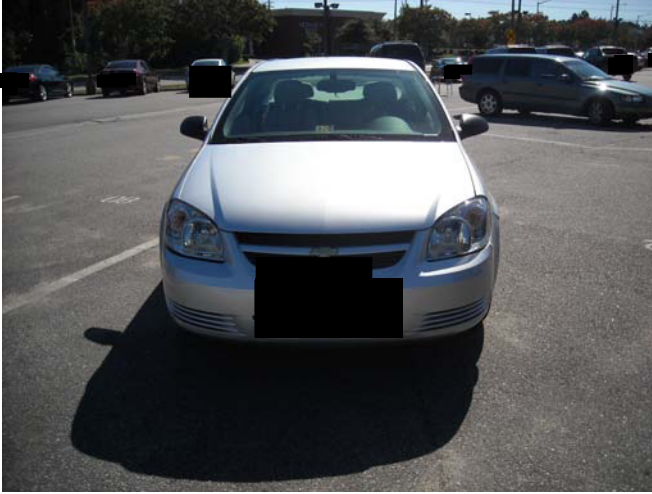
4. Left front view – In this photo you can see that there is light damage to the left fender. The headlight has been replaced.

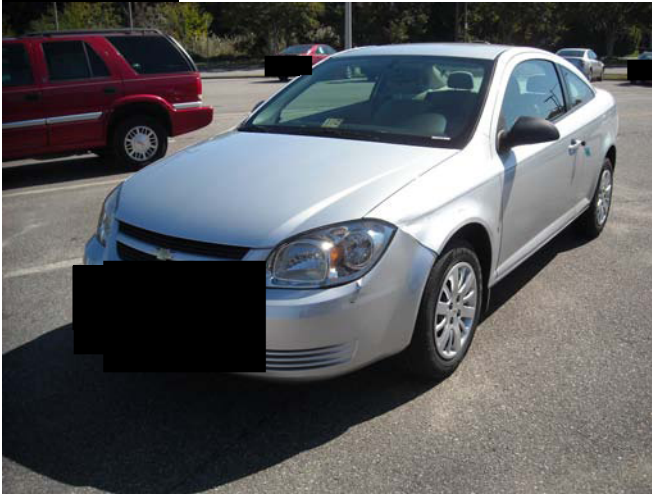
5. Looking across the front from the left side you can get a better view of the damage to the fender.

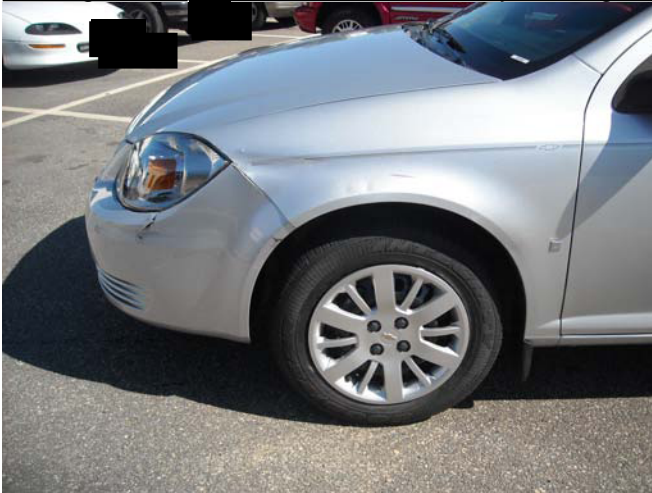
**PRODUCT ALLEGATION RESOLUTION
PRELIMINARY INSPECTION
FIELD PHOTOGRAPHIC NOTES**

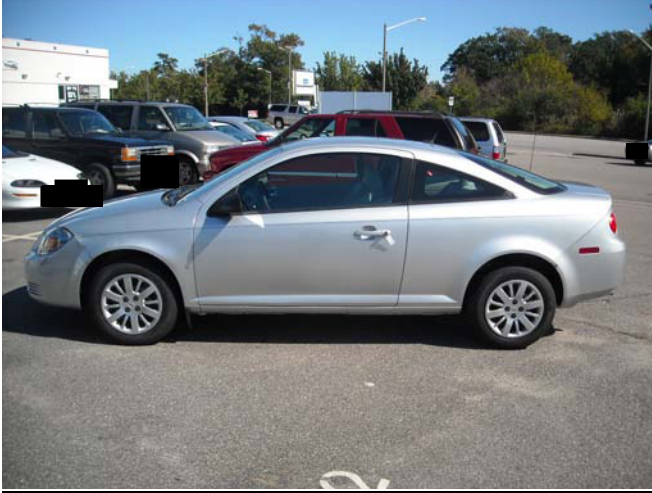
7. In this left rear view you can see the small area of damage on the bumper at the wheel opening.

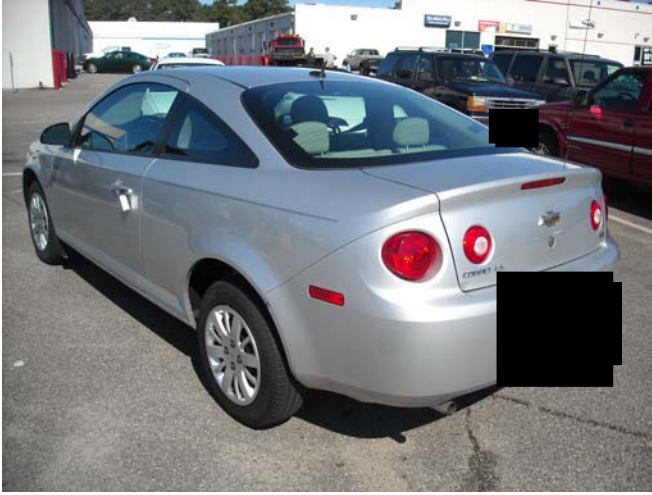
8. Rear view – no damage

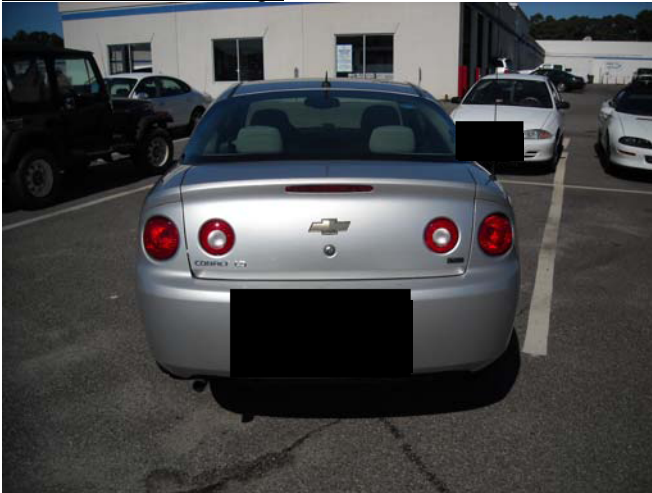
**PRODUCT ALLEGATION RESOLUTION
PRELIMINARY INSPECTION
FIELD PHOTOGRAPHIC NOTES**

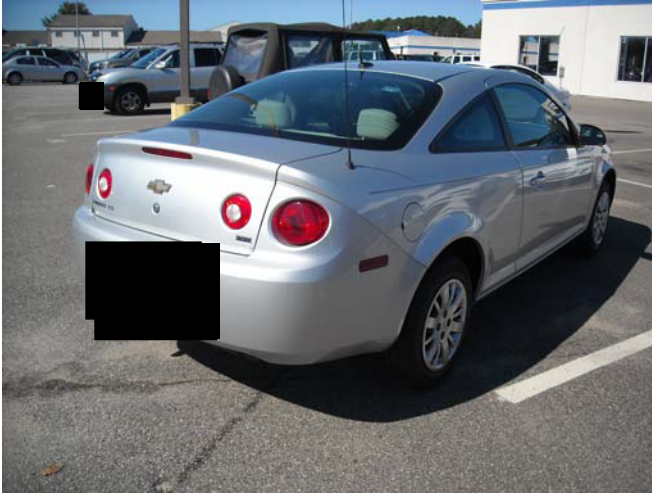
10. Right side view – No damage

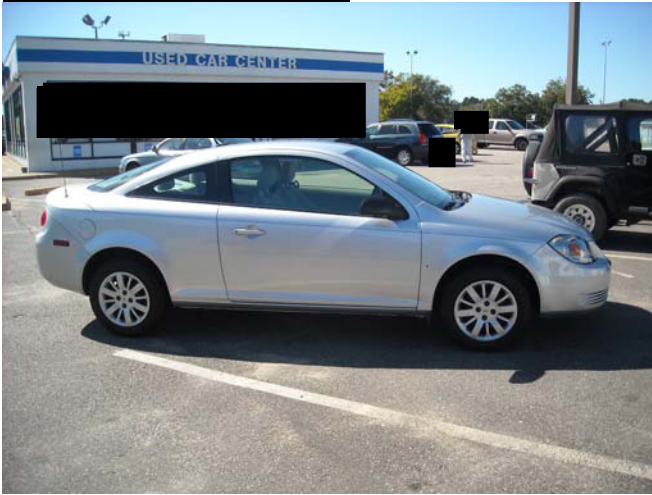
11. Looking across the front from the right side you can see that there is no fender damage and no frontal impact.

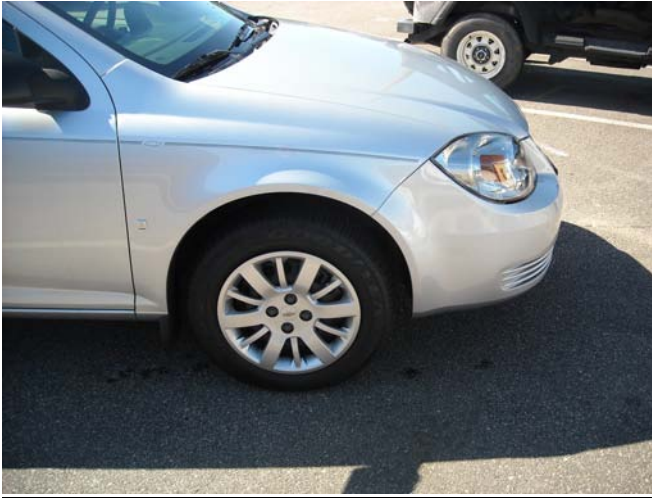
12. Right front view – no damage

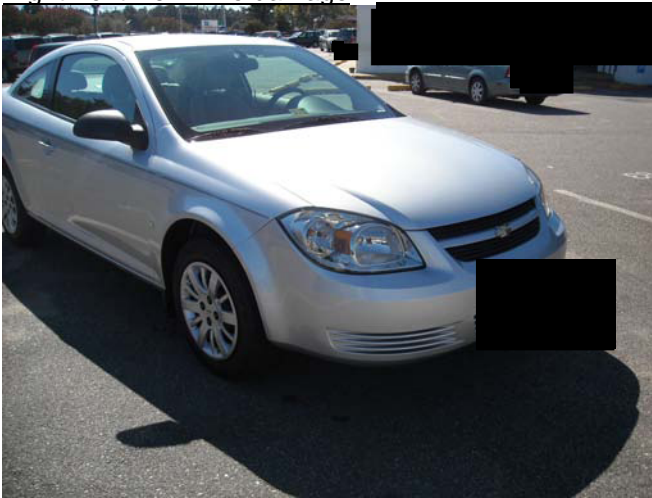
13. A closer overview of the damage to the left fender and bumper

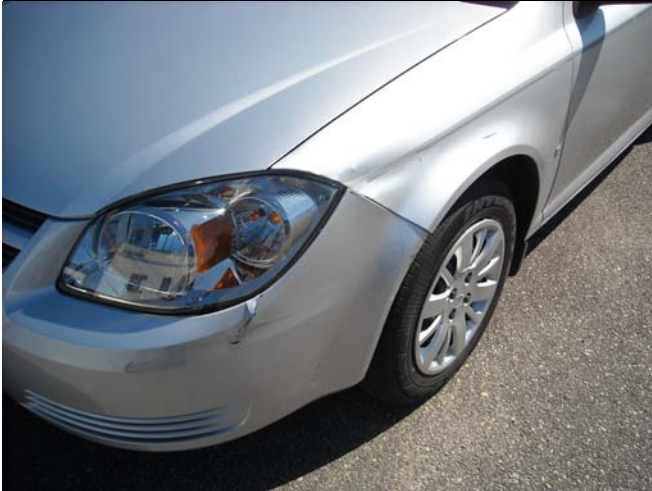
14. A closer look at the bumper damage

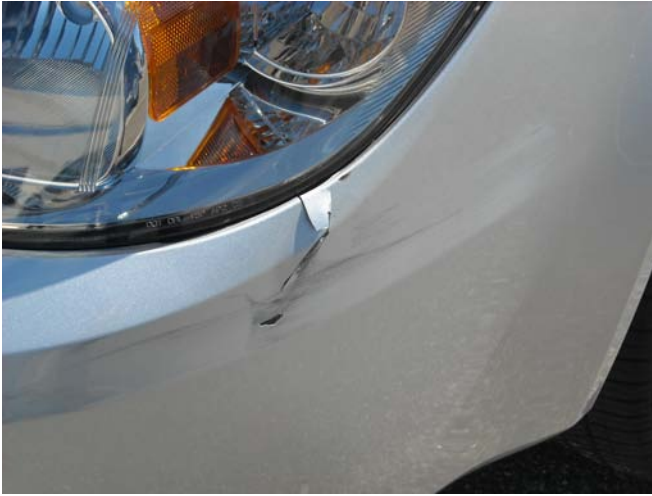
15. Another view of the damage to the left front fender.

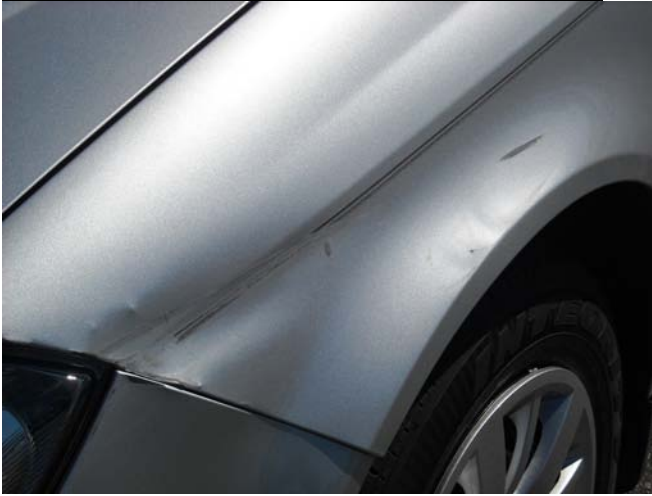
16. Another view of the damage to the left front fender.

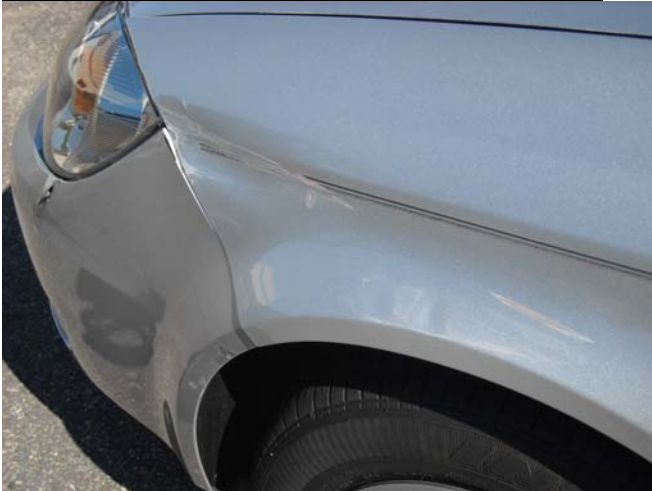
17. The left front tire is original and was not damaged in the incident. The wheel cover and wheel have been

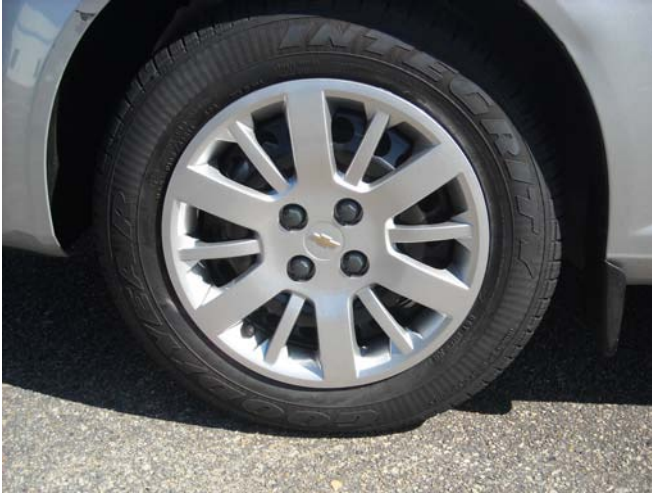
18. Another look at the damage to the left rear bumper.

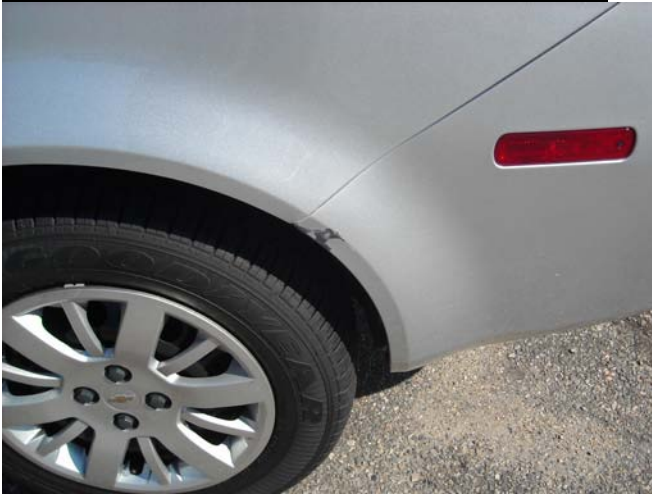
19. A closer look at the damage to the left rear bumper.

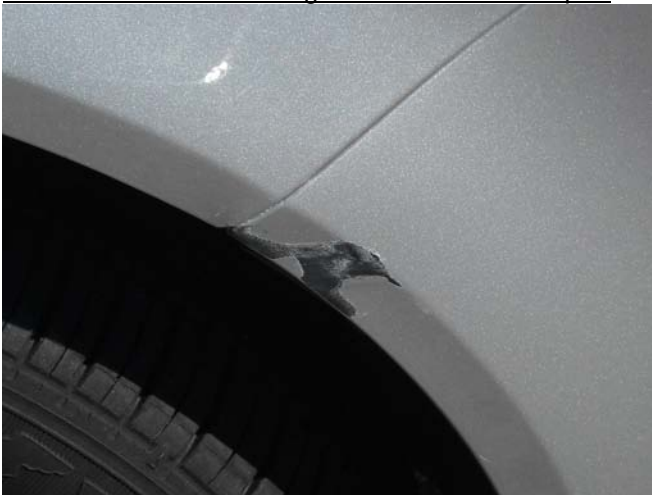
**PRODUCT ALLEGATION RESOLUTION
PRELIMINARY INSPECTION
FIELD PHOTOGRAPHIC NOTES**

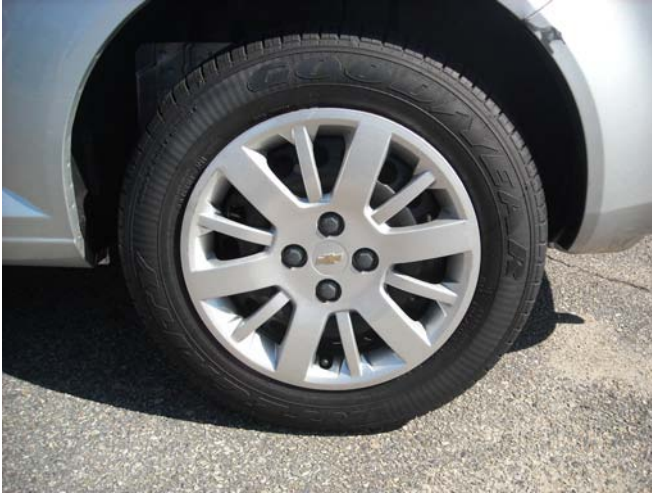
21. A closer look at some of the damage to the left rear wheel cover.

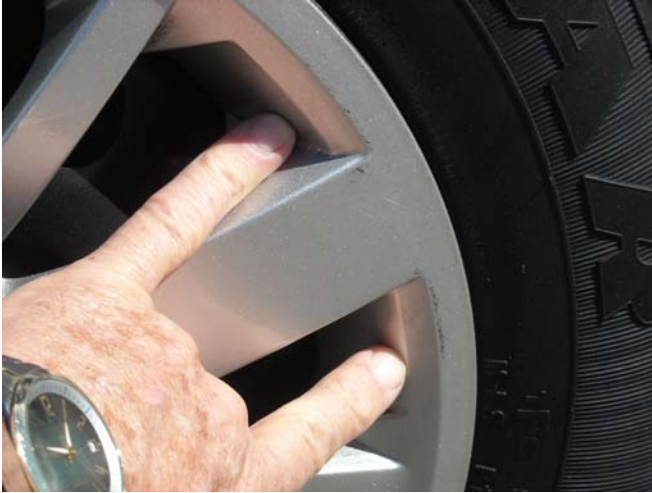
22. Another close look at some of the damage to the left rear wheel cover.

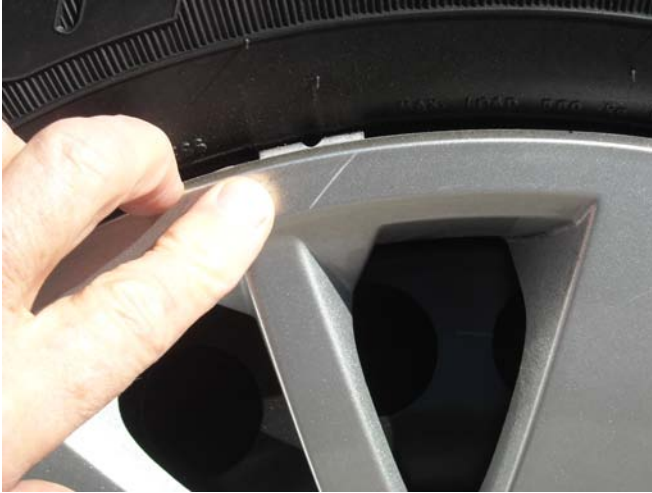
**PRODUCT ALLEGATION RESOLUTION
PRELIMINARY INSPECTION
FIELD PHOTOGRAPHIC NOTES**

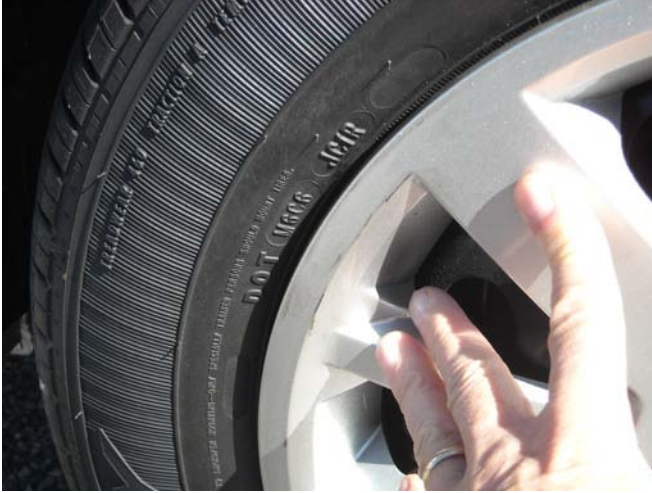
24. Overview of the engine compartment – no damage

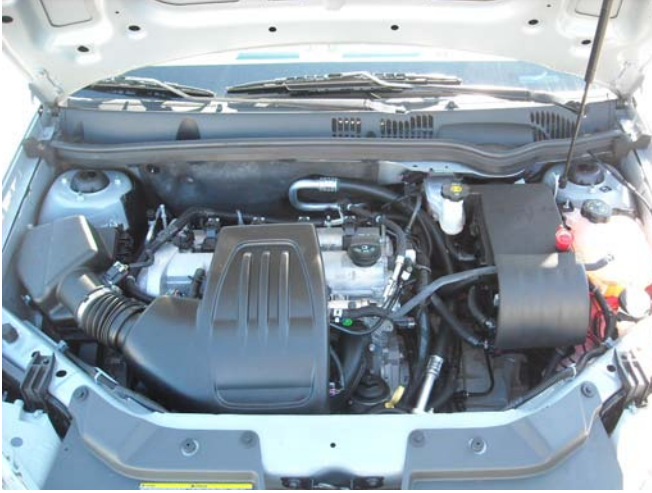
25. A view of the engine compartment from the left side – no damage

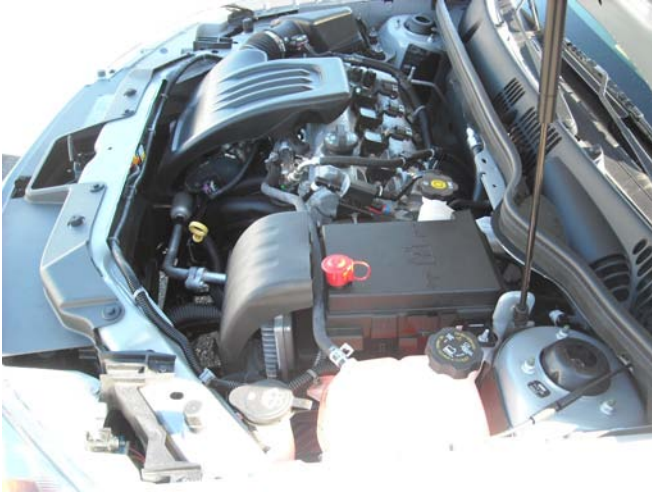
**PRODUCT ALLEGATION RESOLUTION
PRELIMINARY INSPECTION
FIELD PHOTOGRAPHIC NOTES**

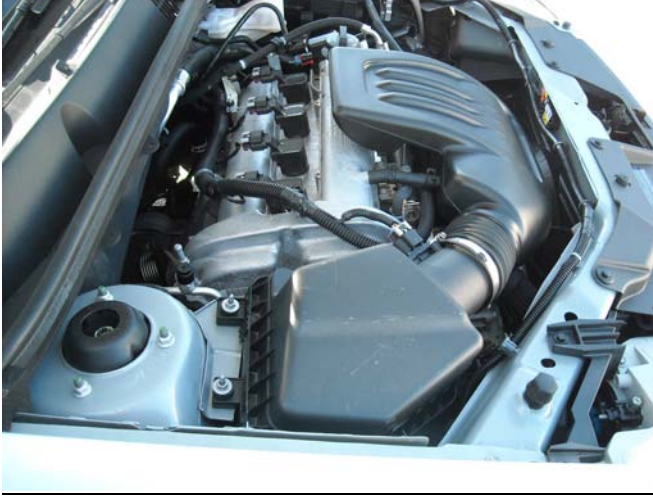
27. A view of the steering rack assembly from the top – no damage, abnormal wear condition

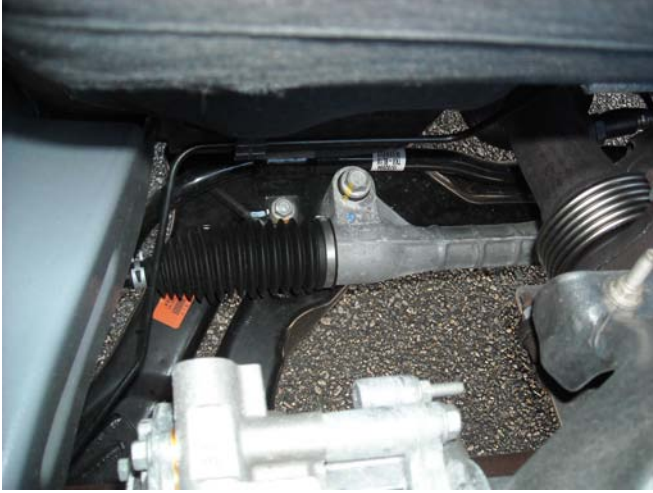
28. Another view of the steering rack assembly from the top – no damage

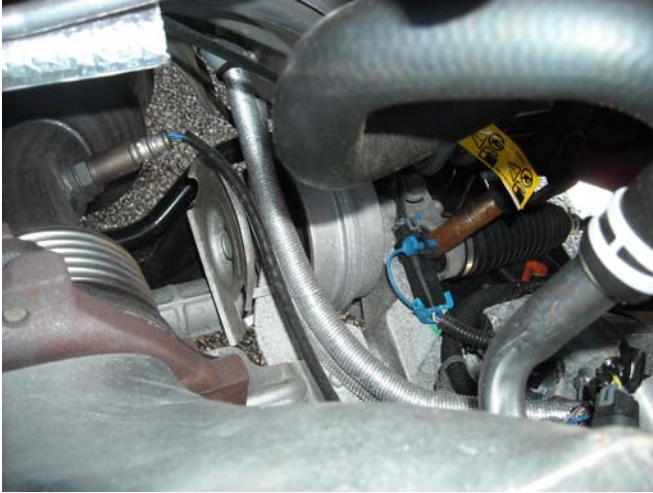
**PRODUCT ALLEGATION RESOLUTION
PRELIMINARY INSPECTION
FIELD PHOTOGRAPHIC NOTES**

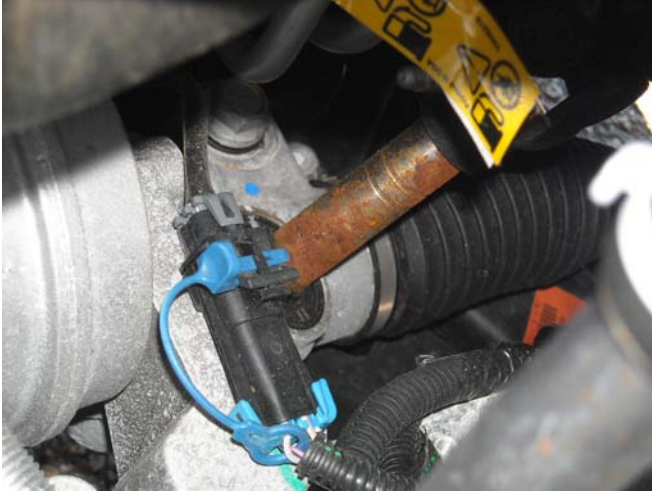
30. There were no warning lights illuminated on the instrument panel.

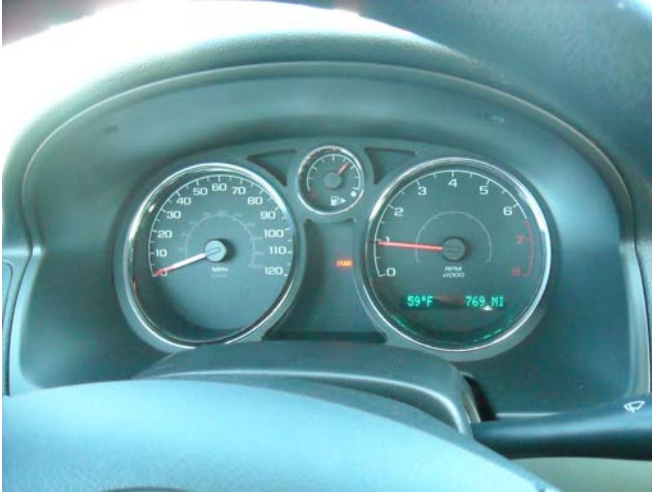
31. No damage to the driver's door trim

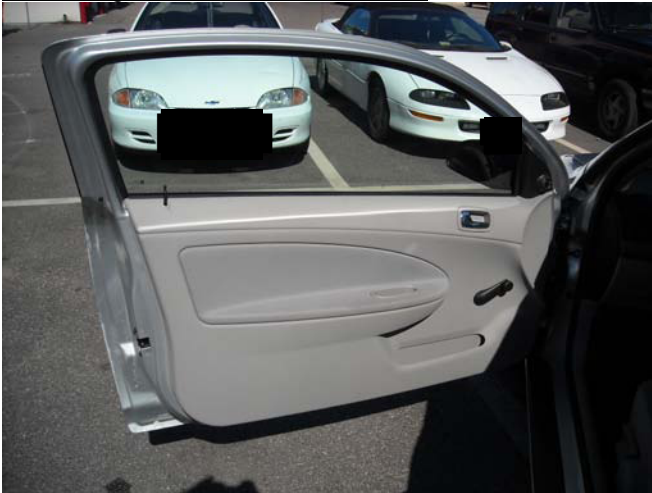
**PRODUCT ALLEGATION RESOLUTION
PRELIMINARY INSPECTION
FIELD PHOTOGRAPHIC NOTES**

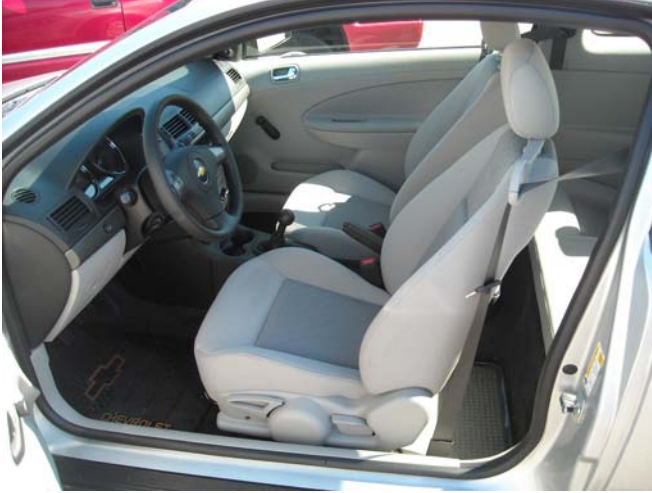
33. There is no damage to the driver's side of the instrument panel and the steering wheel.

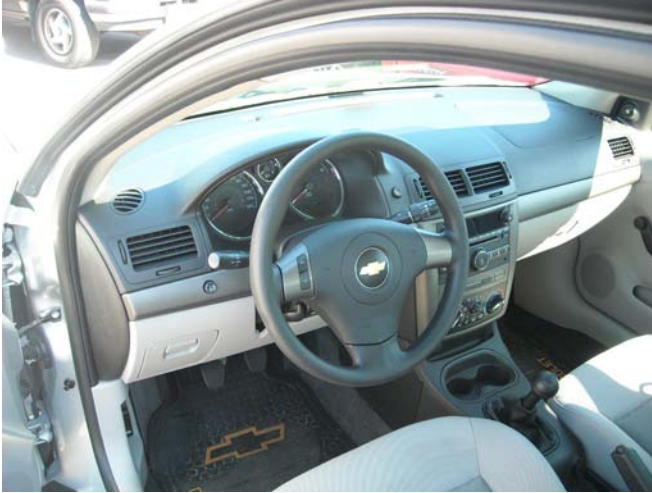
34. The driver's knee blocker is not damaged.

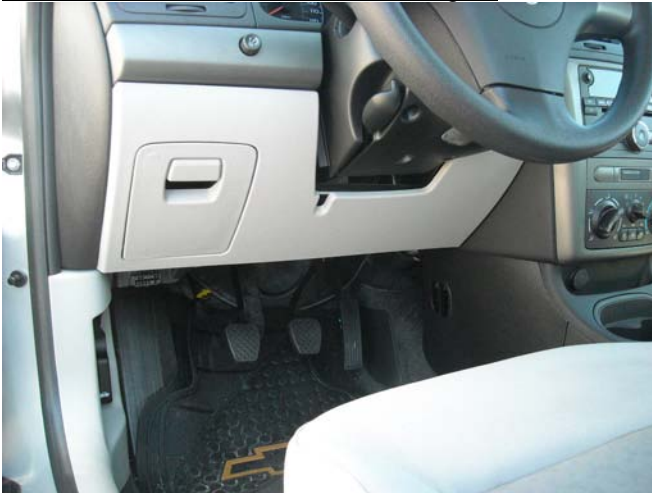
**PRODUCT ALLEGATION RESOLUTION
PRELIMINARY INSPECTION
FIELD PHOTOGRAPHIC NOTES**

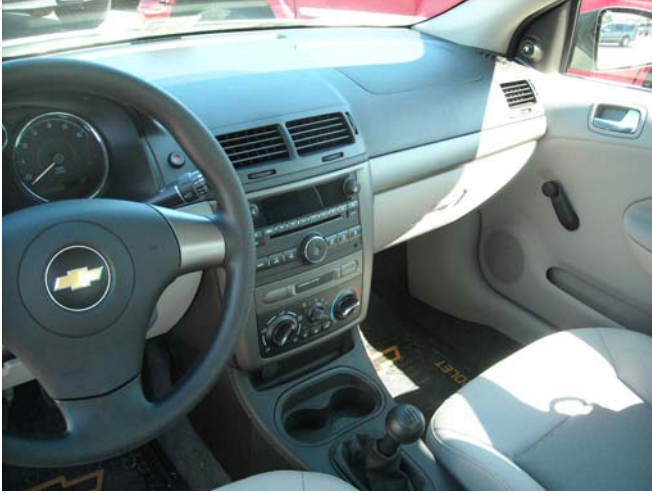
36. There is no damage to the driver side headliner, sun visor, windshield header and rear view mirror.

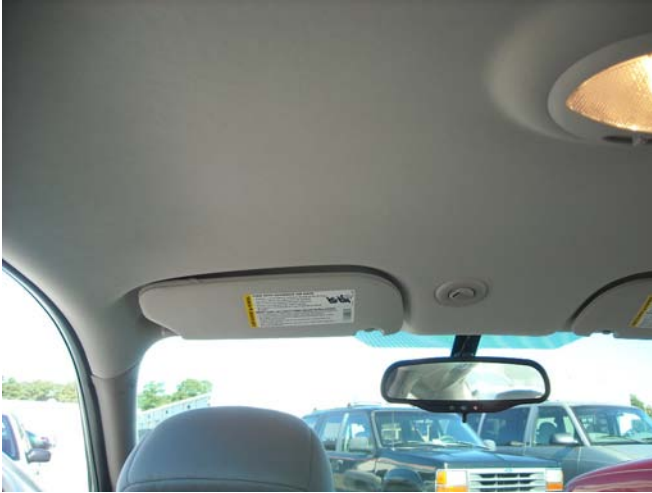
37. There is no damage to the passenger side headliner, sun visor, windshield header and rear view mirror.

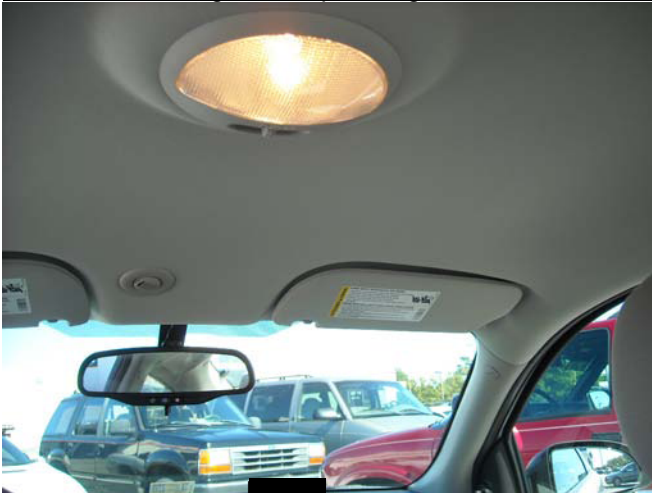
**PRODUCT ALLEGATION RESOLUTION
PRELIMINARY INSPECTION
FIELD PHOTOGRAPHIC NOTES**

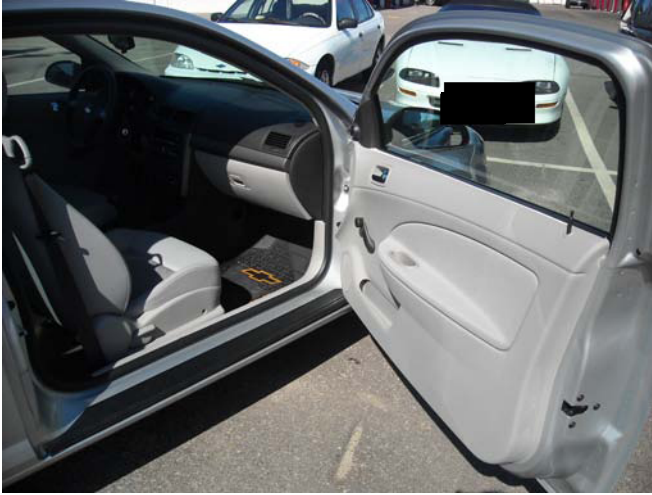
39 Overview of the front seating area from the passenger side. No interior damage.

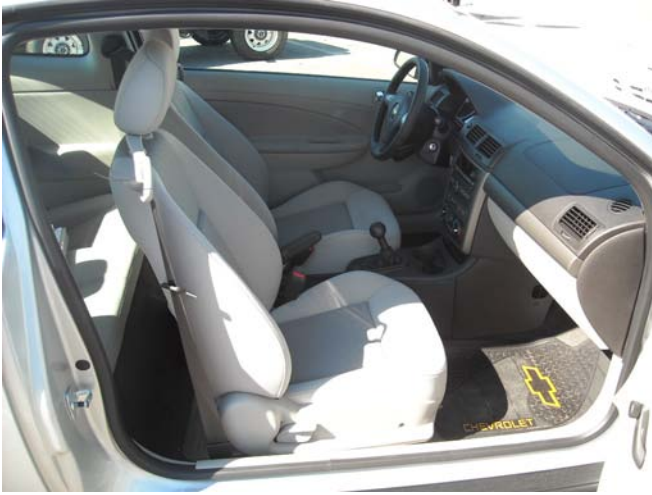
40 The passenger side of the dash is not damaged

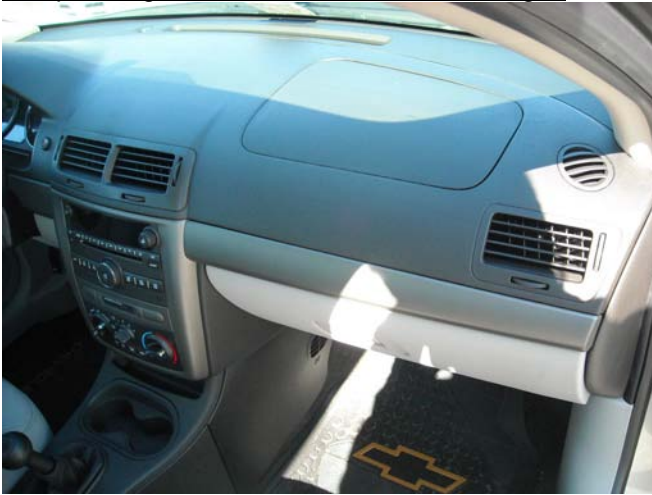
**PRODUCT ALLEGATION RESOLUTION
PRELIMINARY INSPECTION
FIELD PHOTOGRAPHIC NOTES**

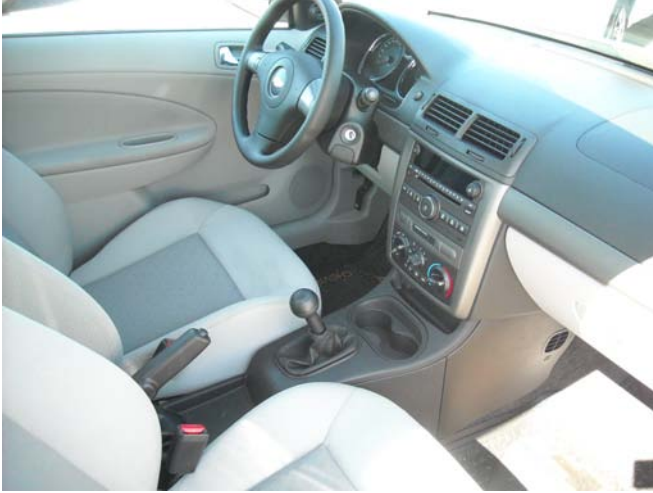
- 42 There are no leaks at the brake fluid reservoir.

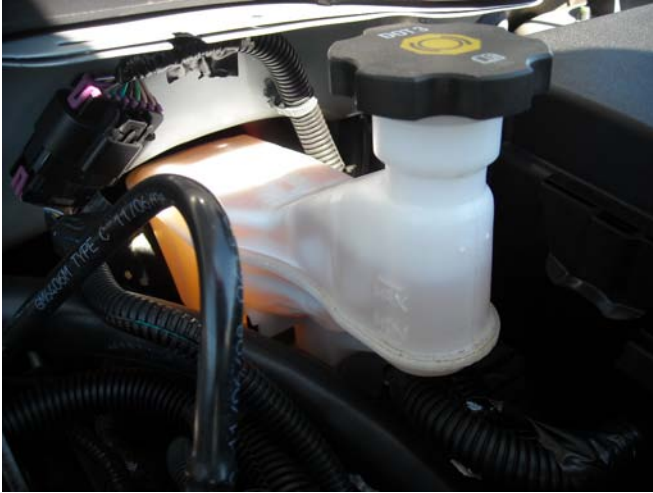
- 43 The brake fluid is clean and full

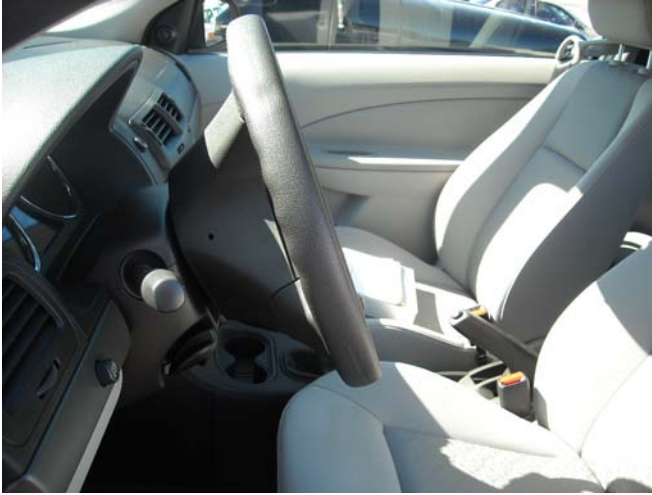
- 45 The steering column and couplings are not damaged and show no sign of abnormal wear.

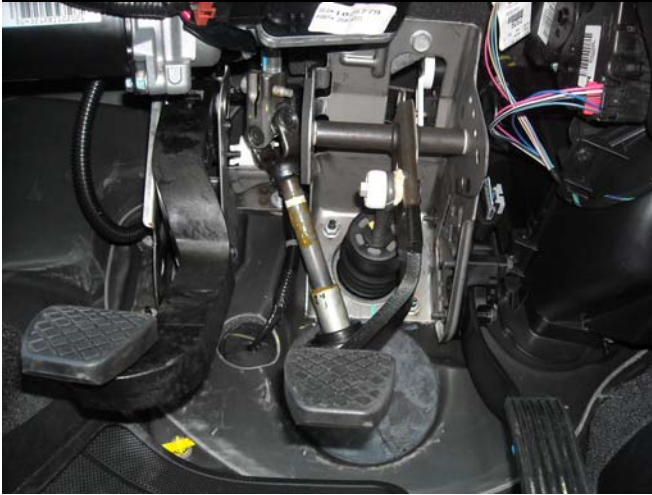
- 46 The angle of the driver seat backrest

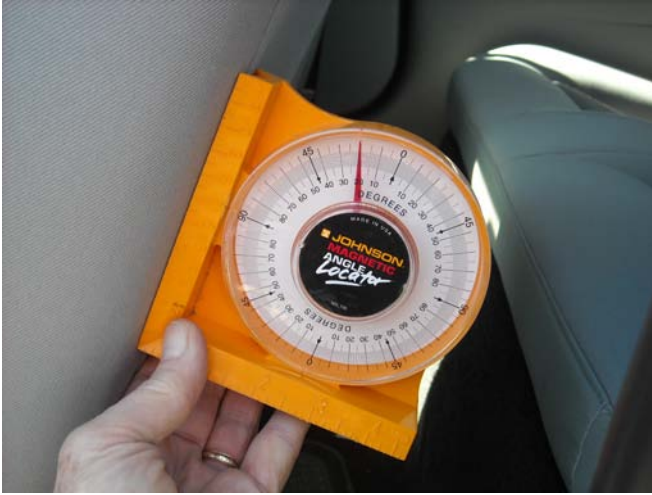
- 48 The driver seatbelt was found fully retracted

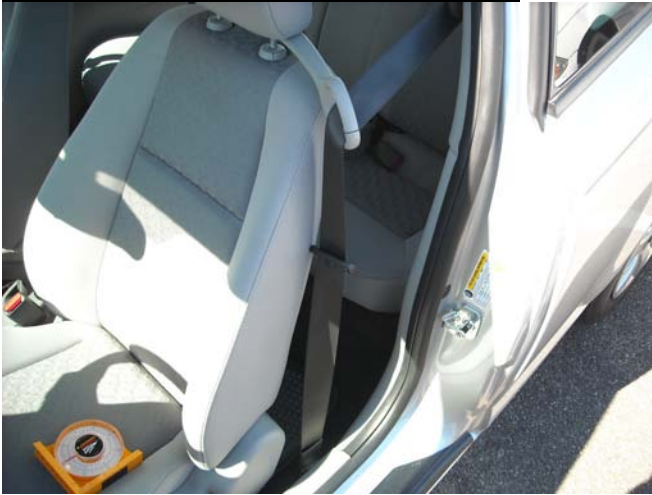
49. The driver's seatbelt latchplate is not damaged

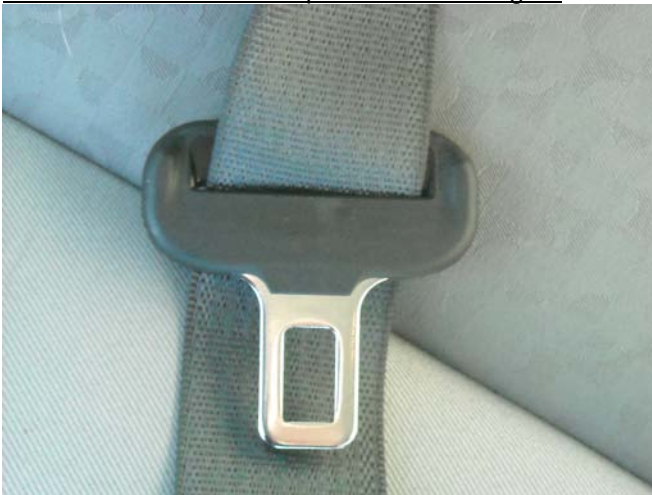
**PRODUCT ALLEGATION RESOLUTION
PRELIMINARY INSPECTION
FIELD PHOTOGRAPHIC NOTES**

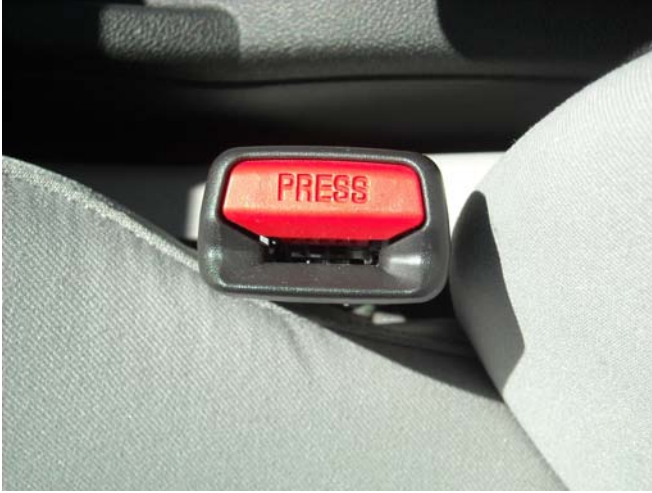
57. A side view of the driver's seatbelt latch assembly.

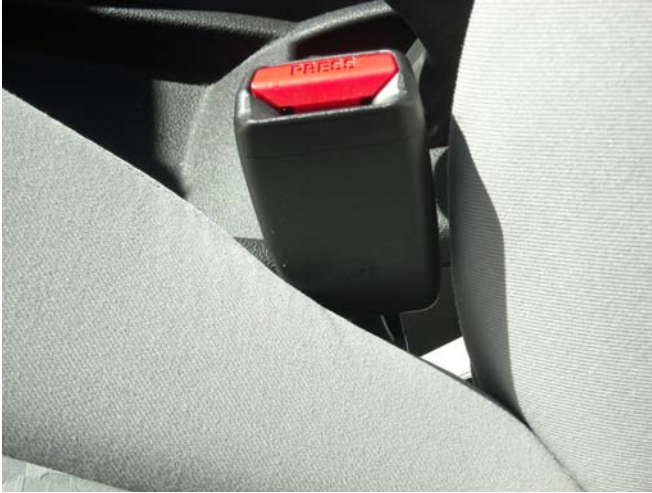
58. Overview of the left front wheel cover that had been replaced.

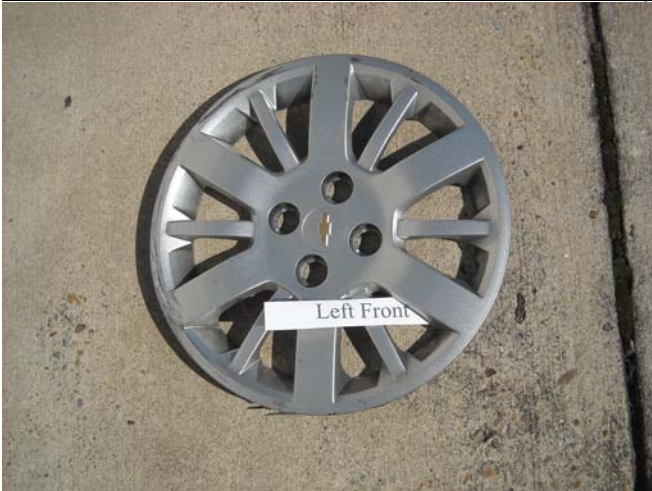
**PRODUCT ALLEGATION RESOLUTION
PRELIMINARY INSPECTION
FIELD PHOTOGRAPHIC NOTES**

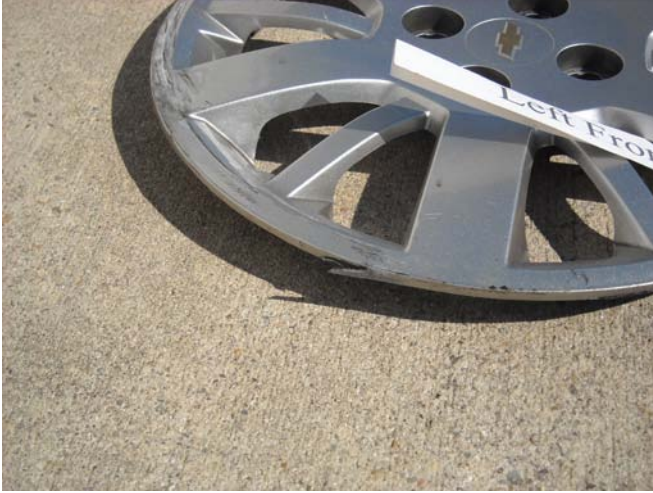
60. Another closer look at the damage to the replaced left front wheel cover.

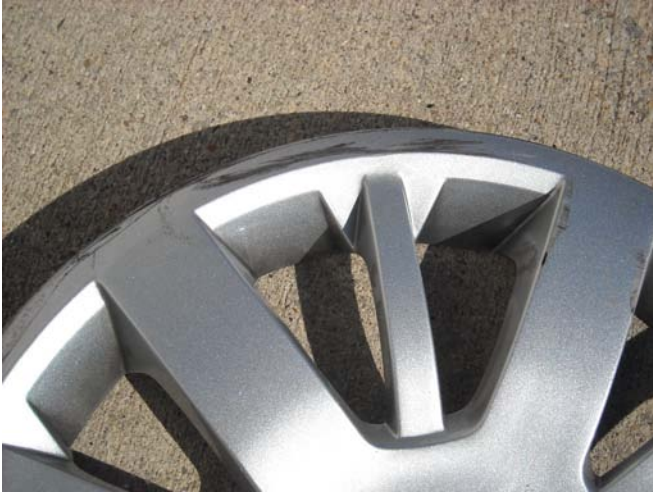
61. Another closer look at the damage to the replaced left front wheel cover.

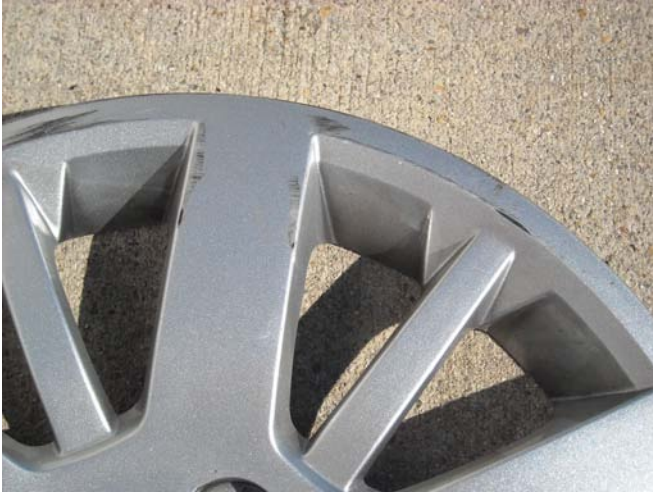
**PRODUCT ALLEGATION RESOLUTION
PRELIMINARY INSPECTION
FIELD PHOTOGRAPHIC NOTES**

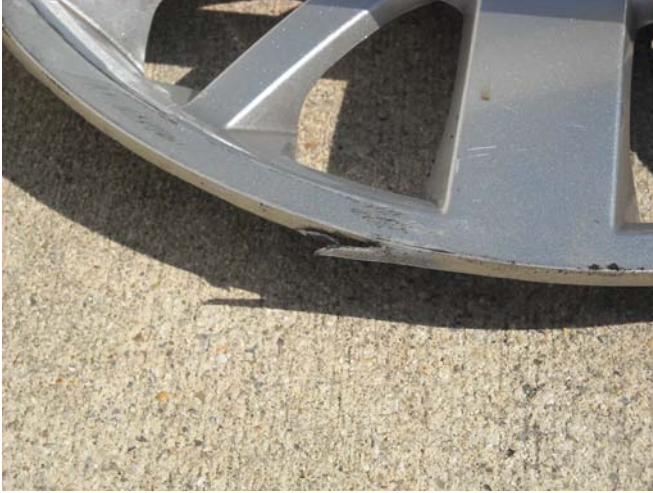
63. Overview of the damaged left front wheel.

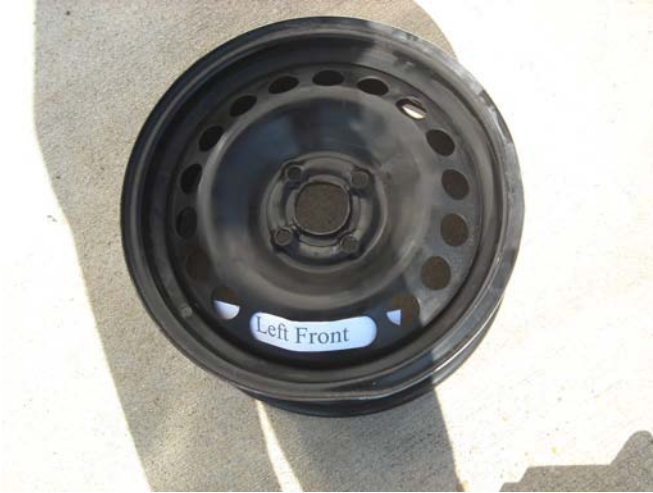
64. Another view of the damage to the left front wheel.

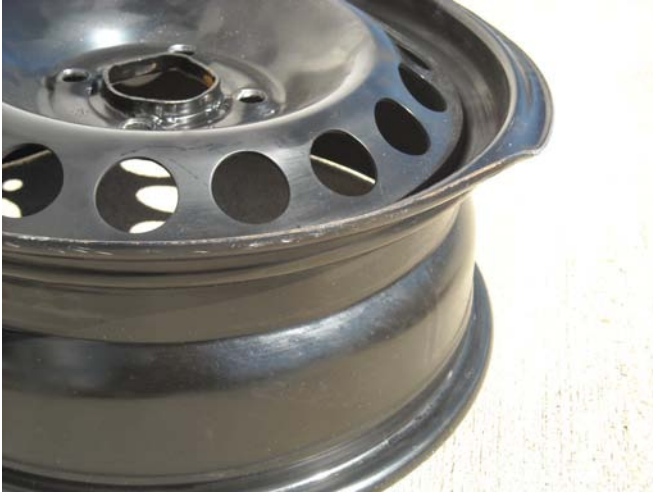
**PRODUCT ALLEGATION RESOLUTION
PRELIMINARY INSPECTION
FIELD PHOTOGRAPHIC NOTES**

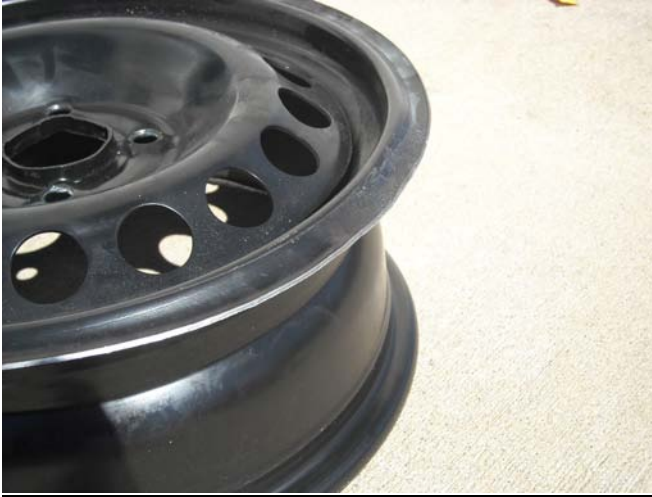
66. Another view of the damage to the left front wheel.

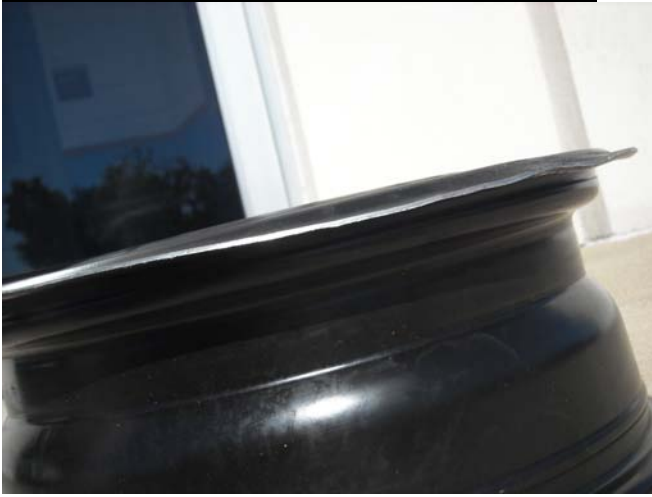
67. Another view of the damage to the left front wheel.
