Cards For Redemption

**GM World Card**

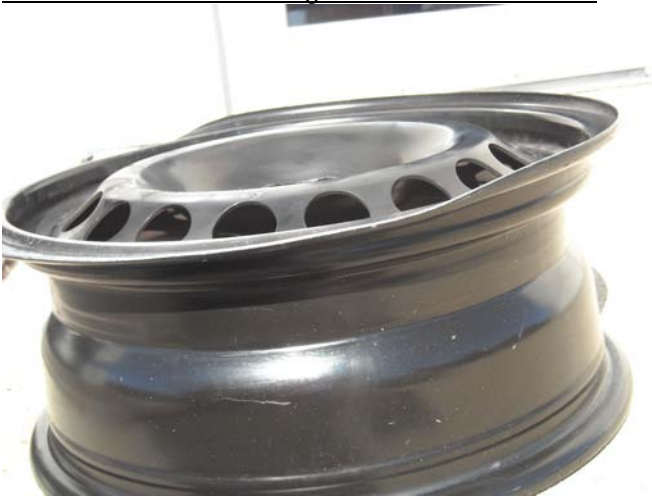
**PRODUCT ALLEGATION RESOLUTION
PRELIMINARY INSPECTION
FIELD PHOTOGRAPHIC NOTES**

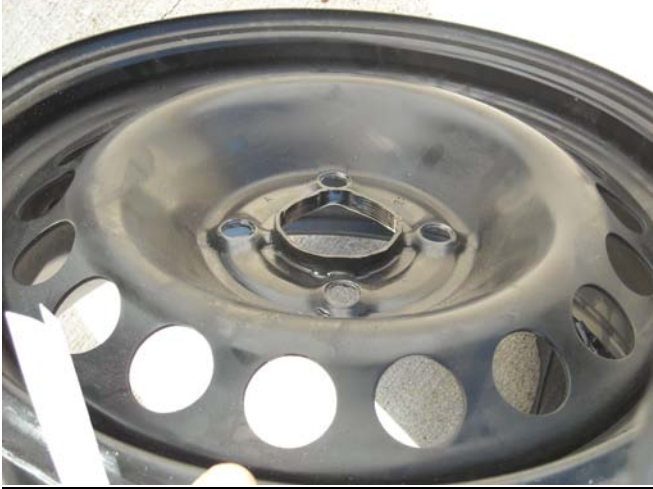
69. Another view of the damage to the left front wheel.

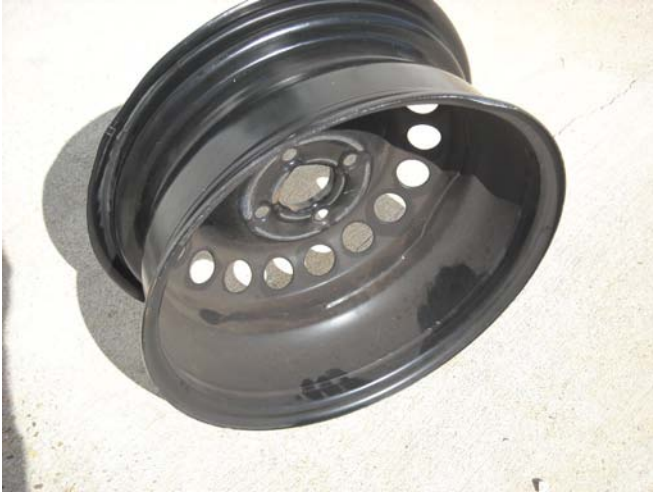
70. Another view of the damage to the left front wheel.

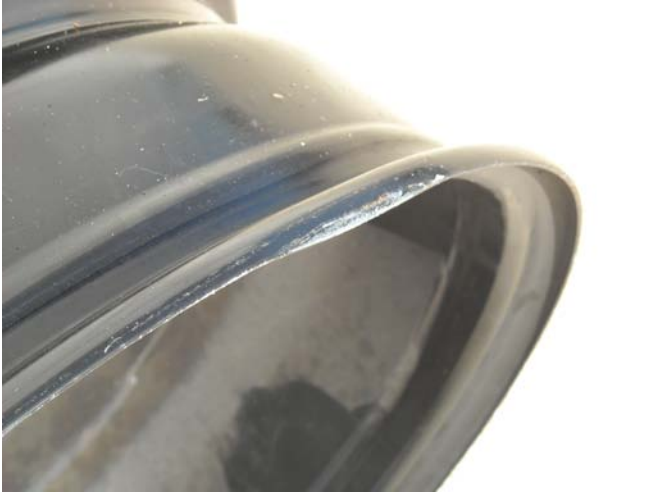
**PRODUCT ALLEGATION RESOLUTION
PRELIMINARY INSPECTION
FIELD PHOTOGRAPHIC NOTES**

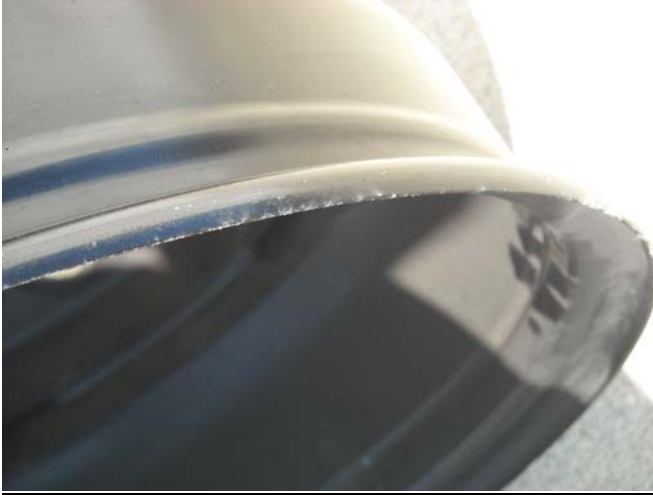
72. The damaged left front headlamp that had been replaced.

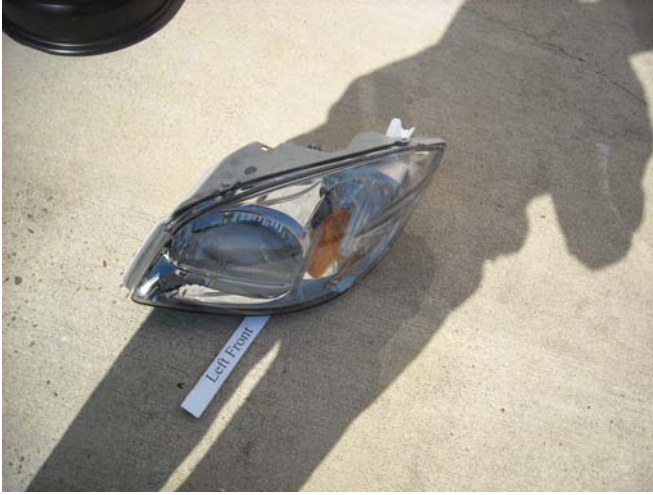
73. Another view of the damaged left front headlamp that had been replaced.

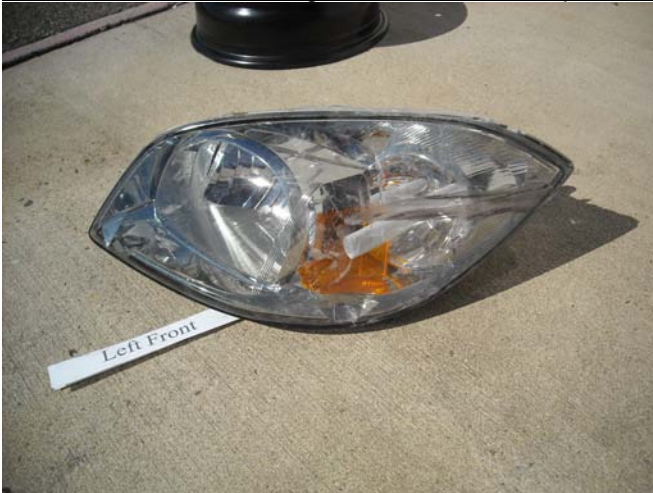
**PRODUCT ALLEGATION RESOLUTION
PRELIMINARY INSPECTION
FIELD PHOTOGRAPHIC NOTES**

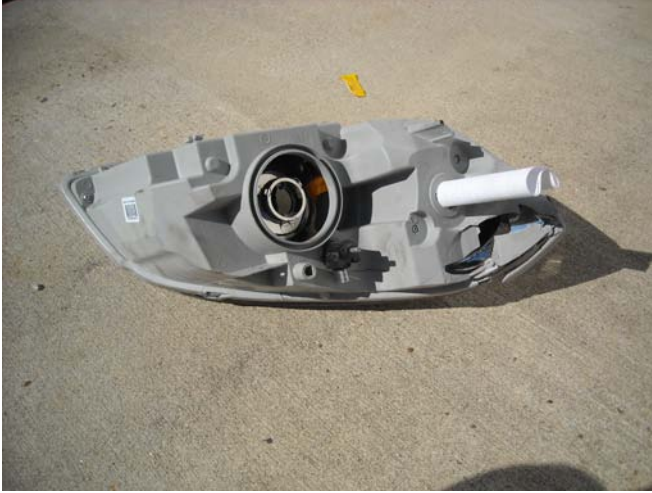
75. Another view of the damaged left front headlamp that had been replaced.

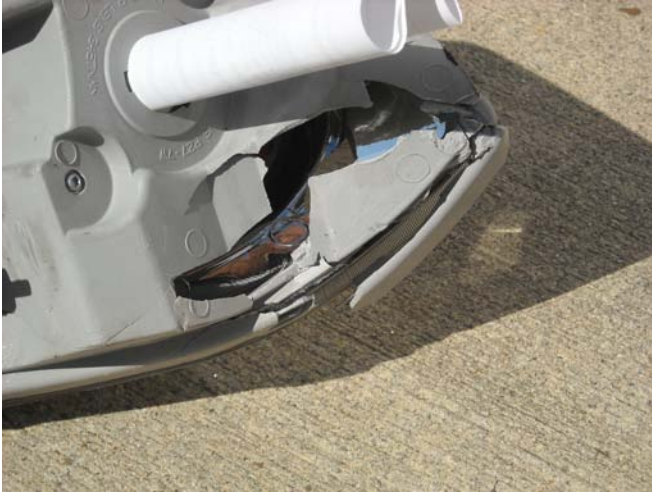
76. There were no ECM DTCs.

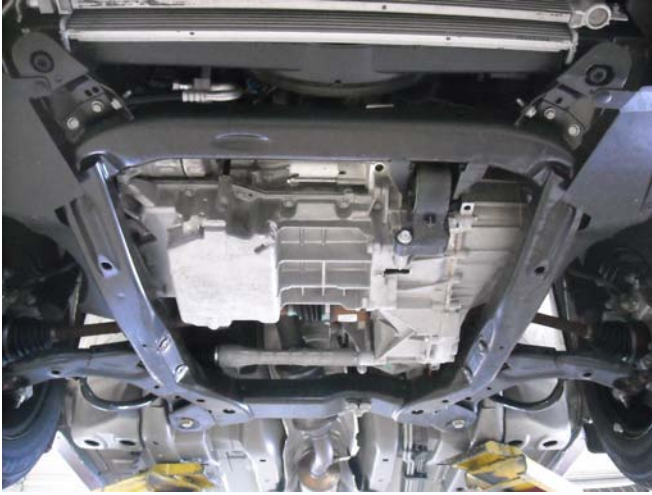
79. A look at the right front steering and suspension – no damage and no abnormal wear condition noted.

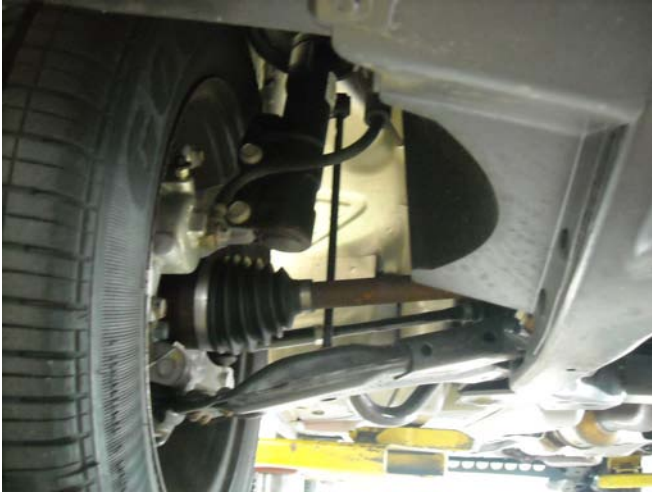
**PRODUCT ALLEGATION RESOLUTION
PRELIMINARY INSPECTION
FIELD PHOTOGRAPHIC NOTES**

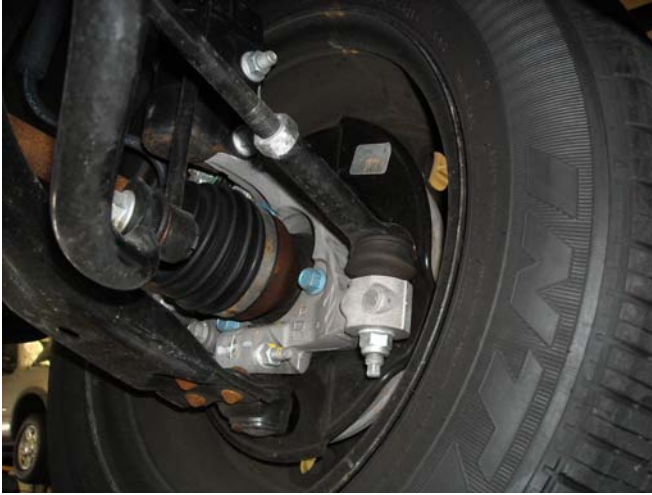
81. A look at the steering assembly – no damage and no abnormal wear conditions noted.

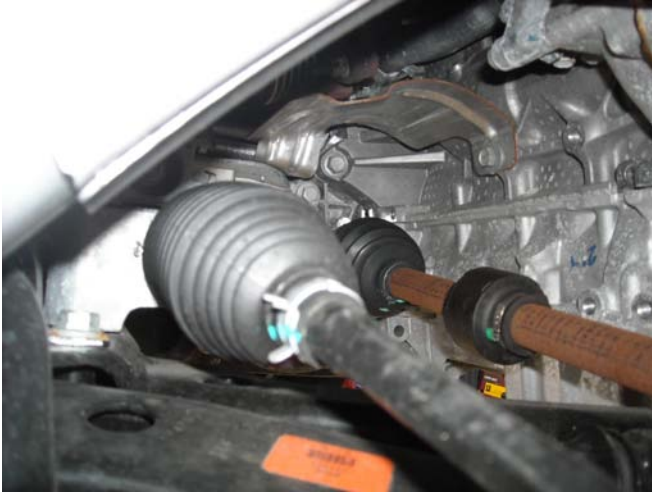
82. Another look at the steering assembly – no damage and no abnormal wear conditions noted.

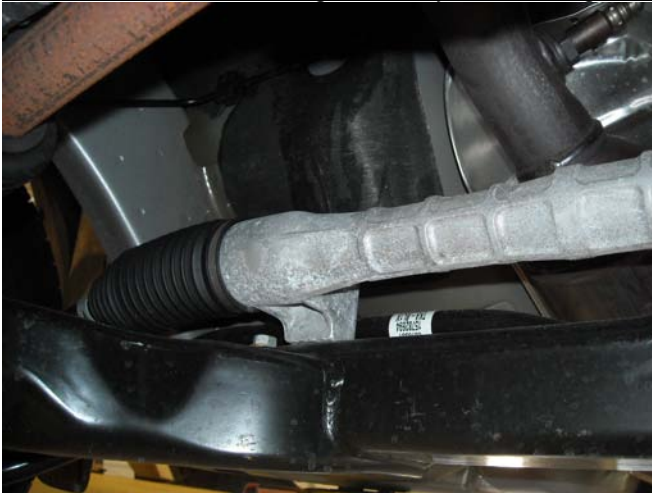
**PRODUCT ALLEGATION RESOLUTION
PRELIMINARY INSPECTION
FIELD PHOTOGRAPHIC NOTES**

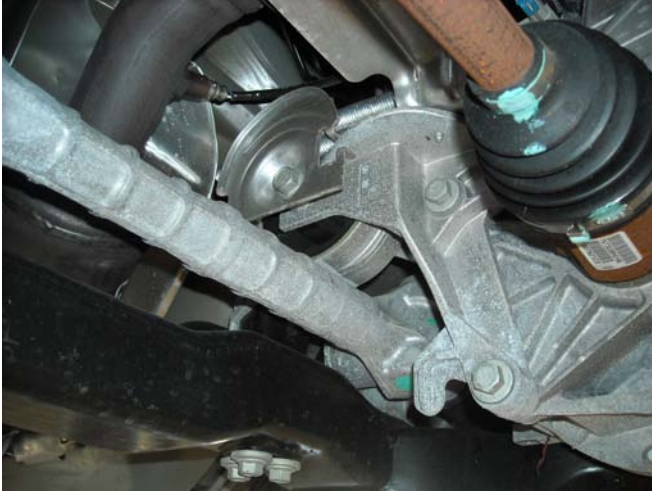
84. Another look at the steering assembly – no damage and no abnormal wear conditions noted.

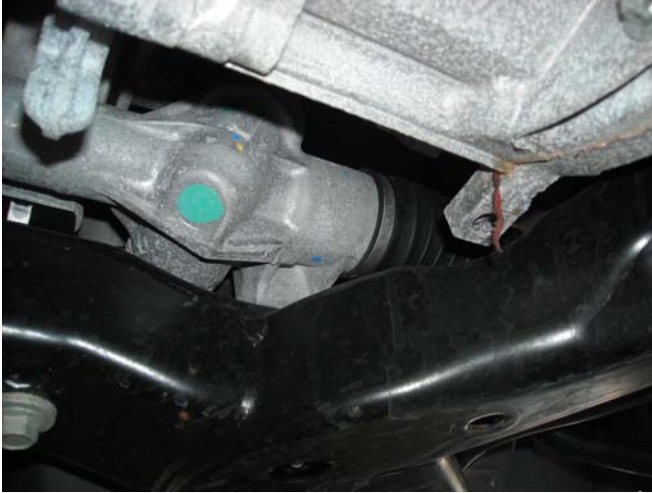
85. Another look at the steering assembly – no damage and no abnormal wear conditions noted.

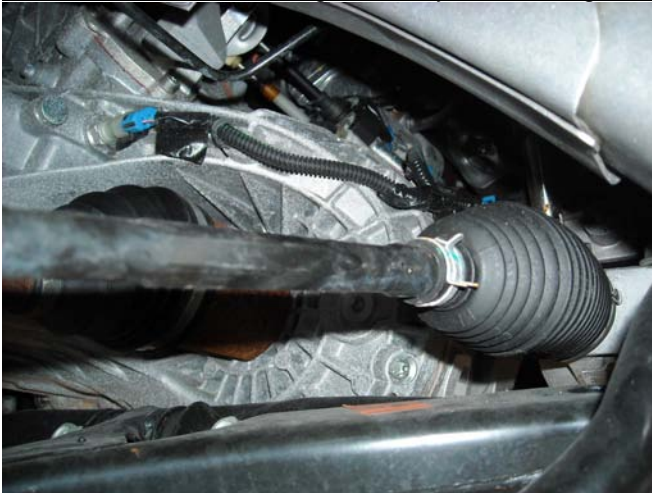
**PRODUCT ALLEGATION RESOLUTION
PRELIMINARY INSPECTION
FIELD PHOTOGRAPHIC NOTES**

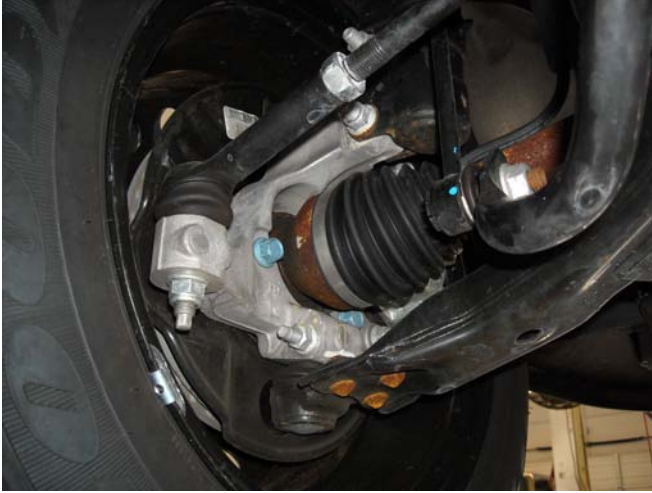
87. Another look at the left front steering and suspension – no damage and no abnormal wear condition noted.

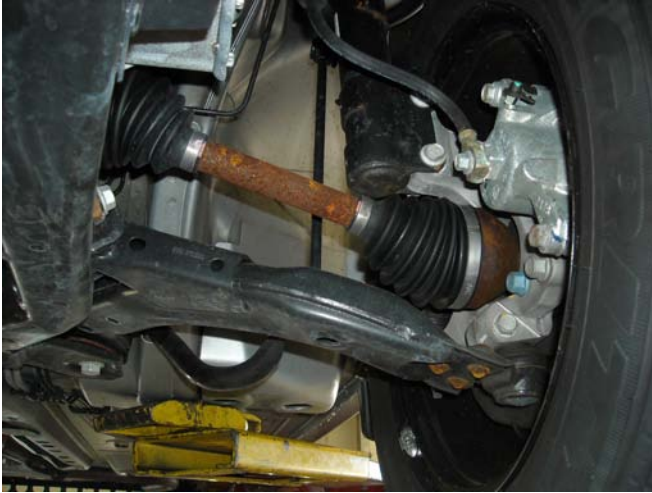
88. There is no damage to the center section of the undercarriage.

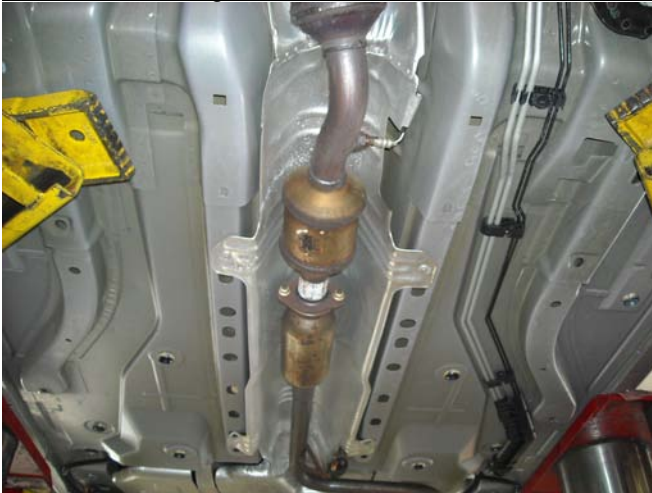
**PRODUCT ALLEGATION RESOLUTION
PRELIMINARY INSPECTION
FIELD PHOTOGRAPHIC NOTES**

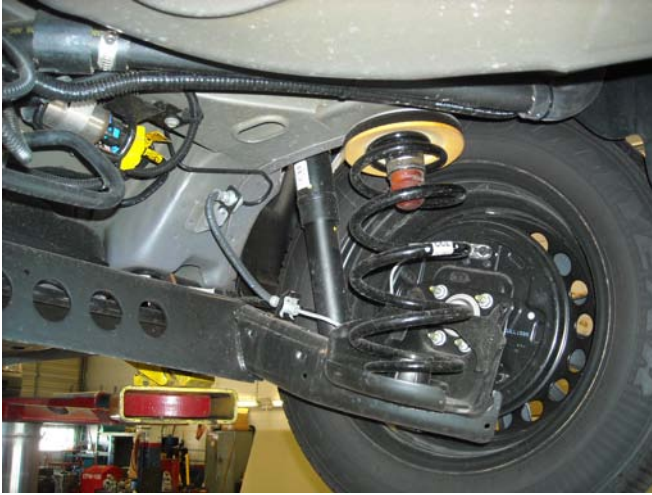
90. There is no damage to the left rear suspension.

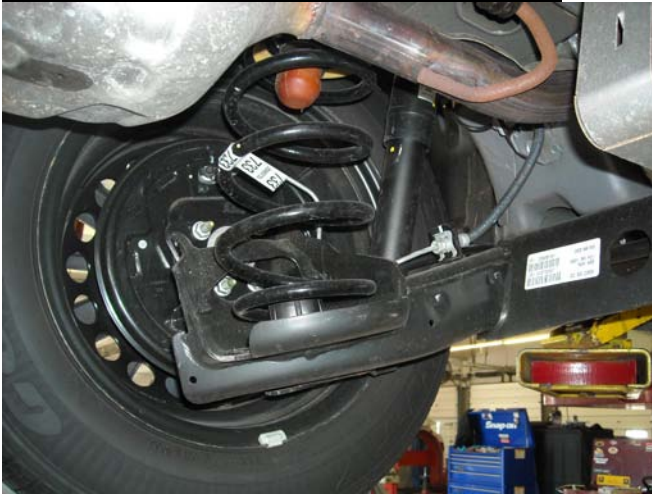
91. Another view of the undamaged left rear suspension.

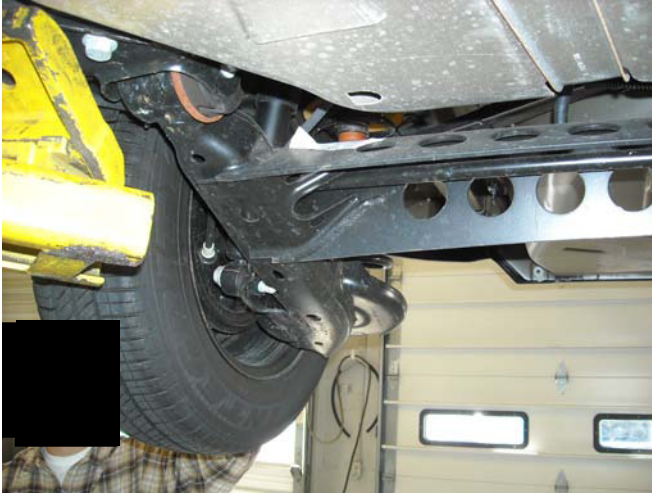
93. The rear suspension crossmember is not damaged.

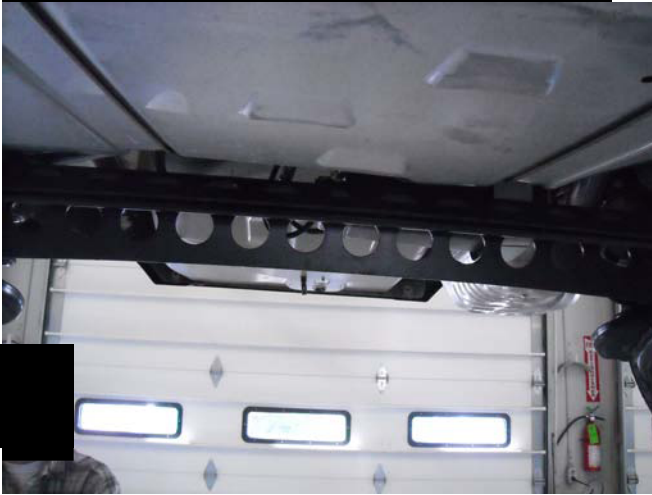
94. _____
95. _____
96. _____
97. _____
98. _____
99. _____

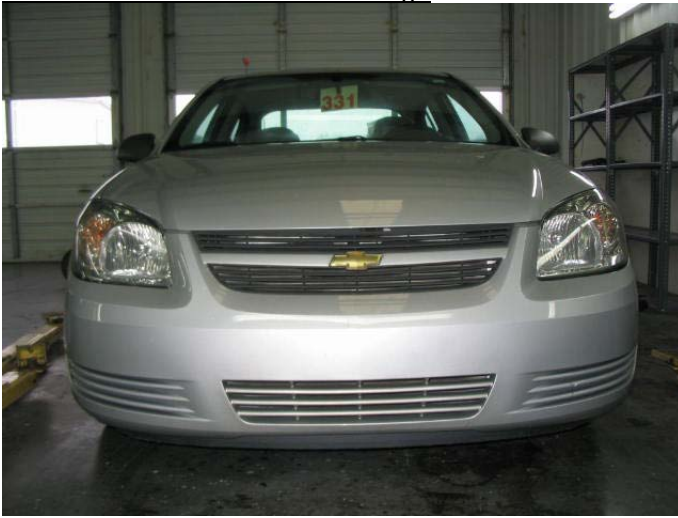
002 Left front corner, left side – No observable damage

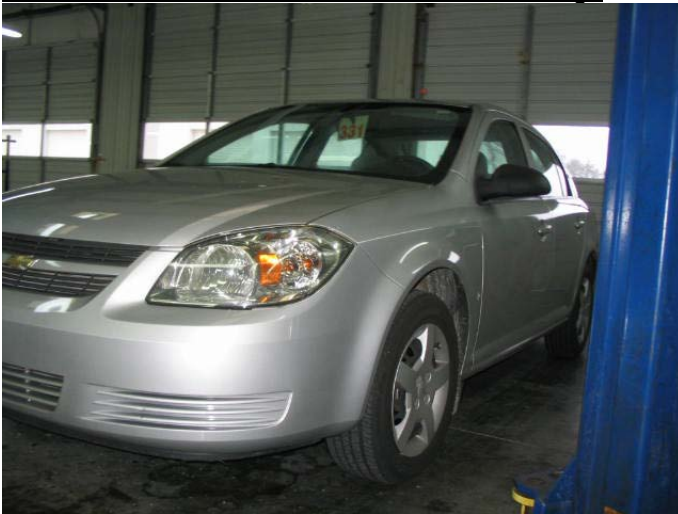
003 Left rear corner, left side – No observable damage

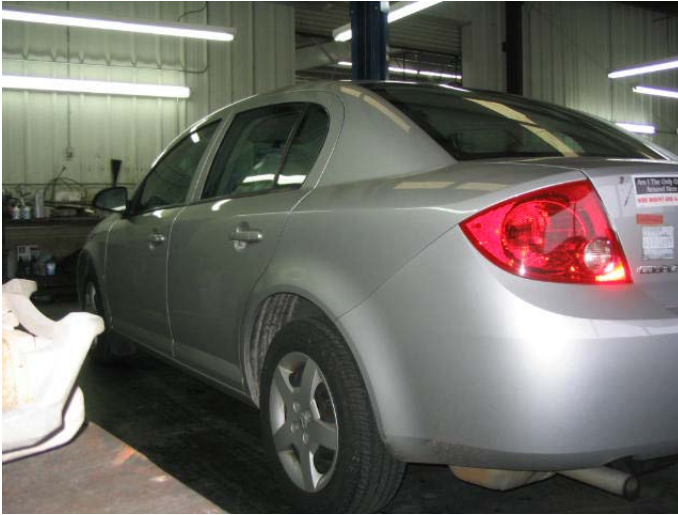
004 Right rear corner, right side – No observable damage

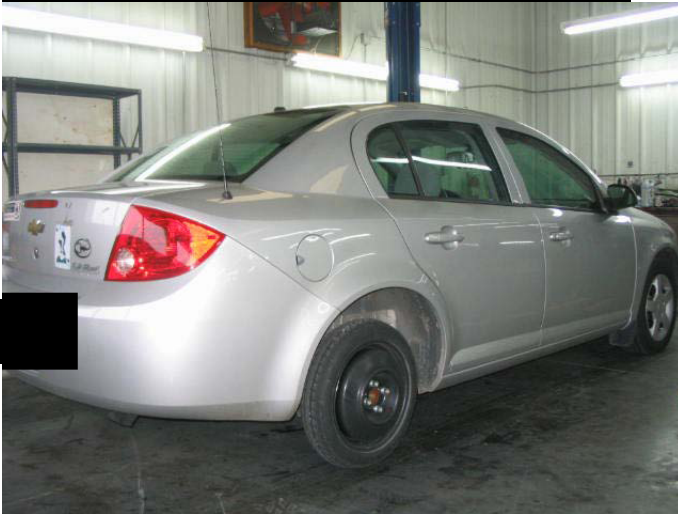
005 Right front corner, right side – No observable damage

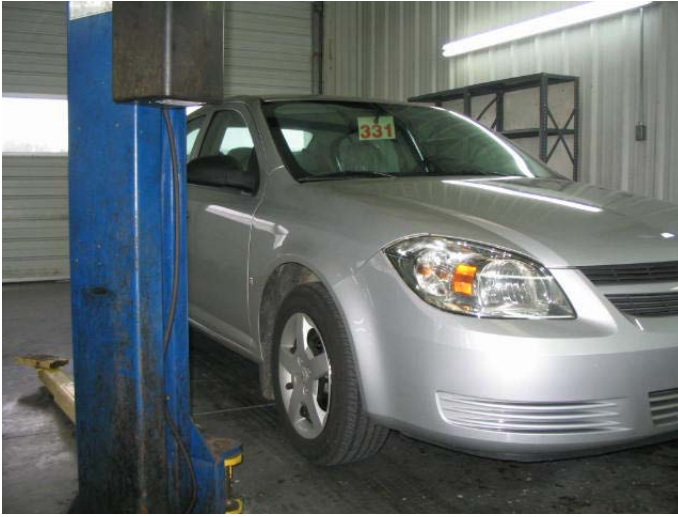
006 Driver side interior – No observable damage

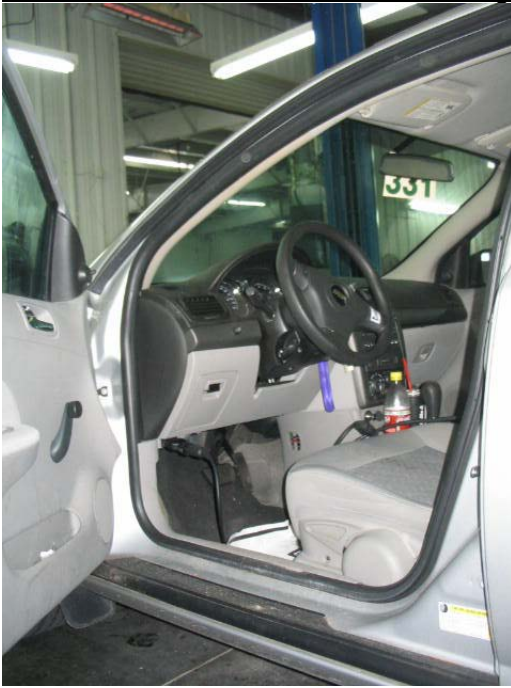
007 Left rear interior – No observable damage – Driver and passenger seat position – Rear seat area cluttered with miscellaneous personal items

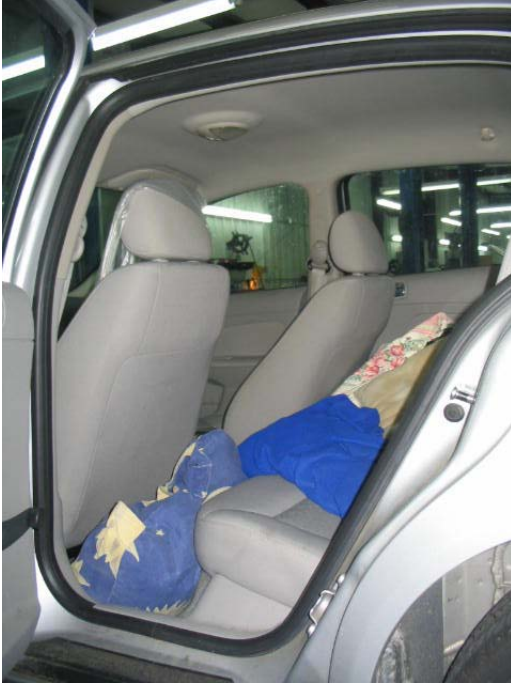
008 Right front side interior – No observable damage

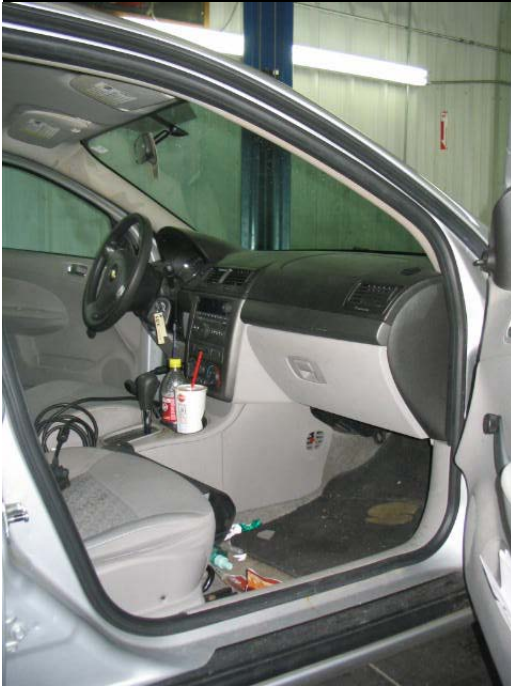
009 Right rear interior – No observable damage – Driver and passenger seat position – Rear seat area cluttered with miscellaneous personal items

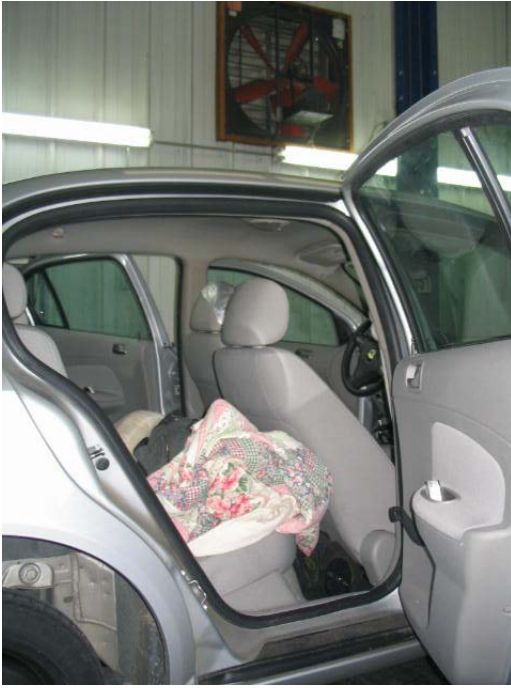
010 Right front wheel and tire found in trunk – Wheel, tire and plastic wheel cover damage observable – Wheel, tire and wheel cover removed by claimant after incident and placed in trunk

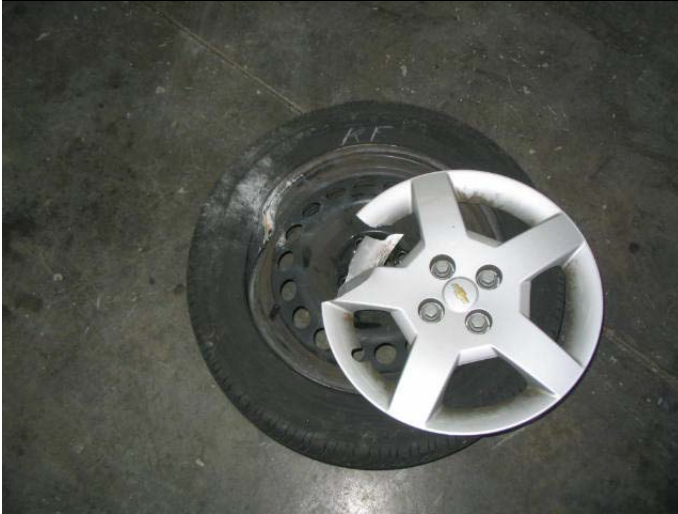
011 Right front wheel, tire and wheel cover damage observed

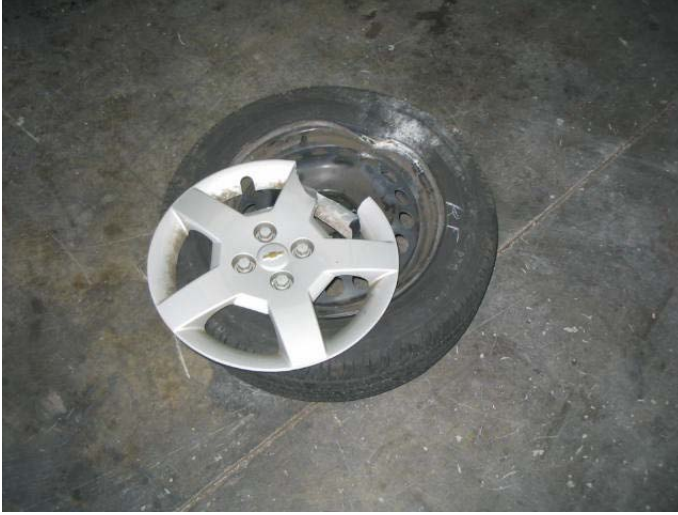
- 012 Right rear wheel, tire and wheel cover damage – Wheel, tire and wheel cover had been removed from right rear and moved to right front by claimant after incident to allow for compact spare to be installed on right rear of vehicle – Damage to wheel, tire and wheel cover observable

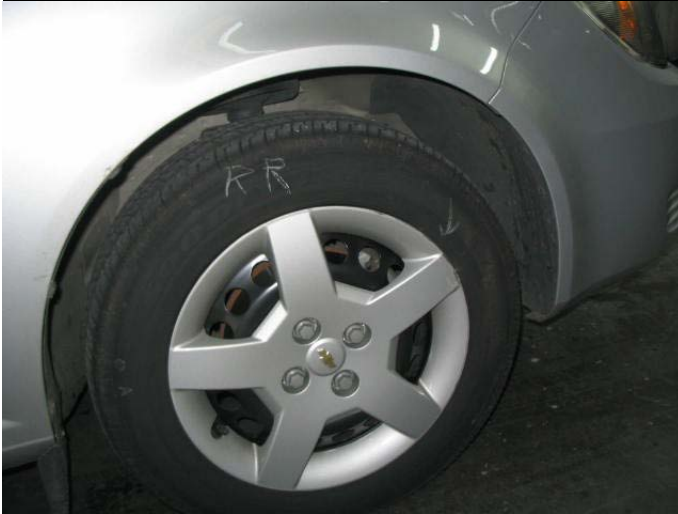
- 013 Same as 12 above

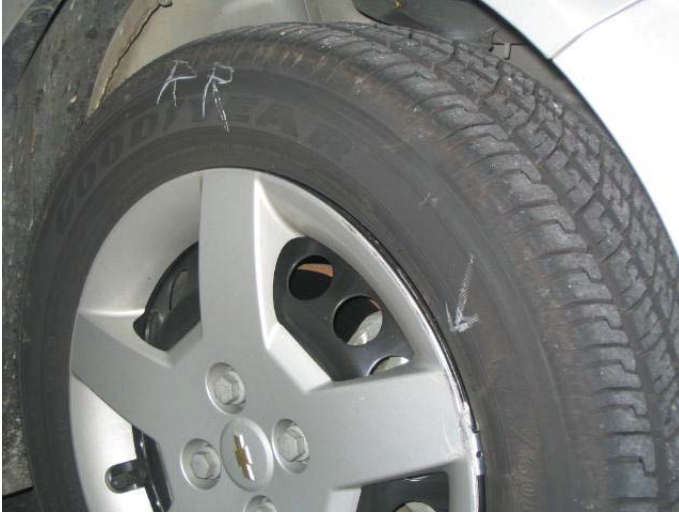
- 014 Engine compartment front top view – Plastic cover removed to allow view of engine controls – No observable damage – No observable missing parts or after-market items

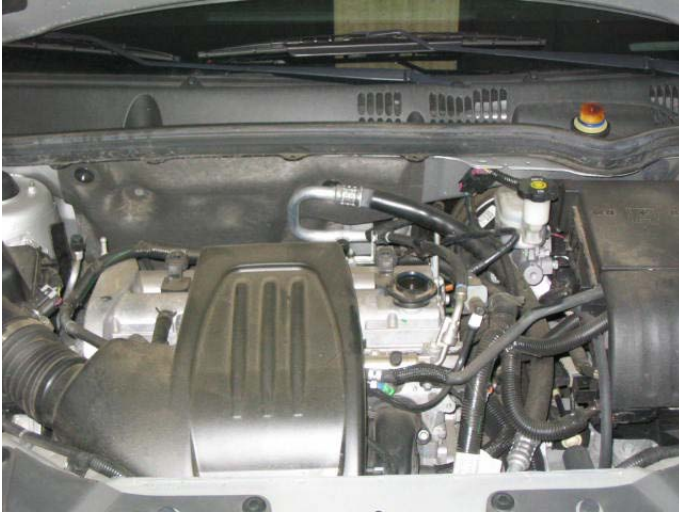
- 015 Deleted – Poor quality photo
016 Deleted – Poor quality photo
017 Instrument panel driver information center – Service tire monitor message viewable

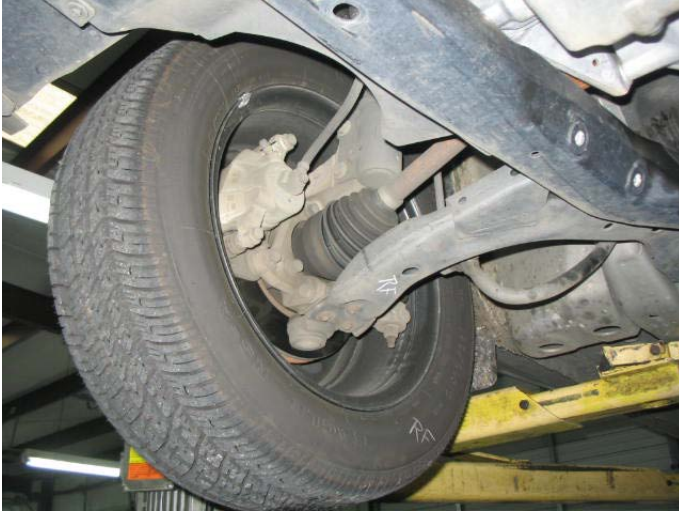
023 Right front suspension from front – No observable damage

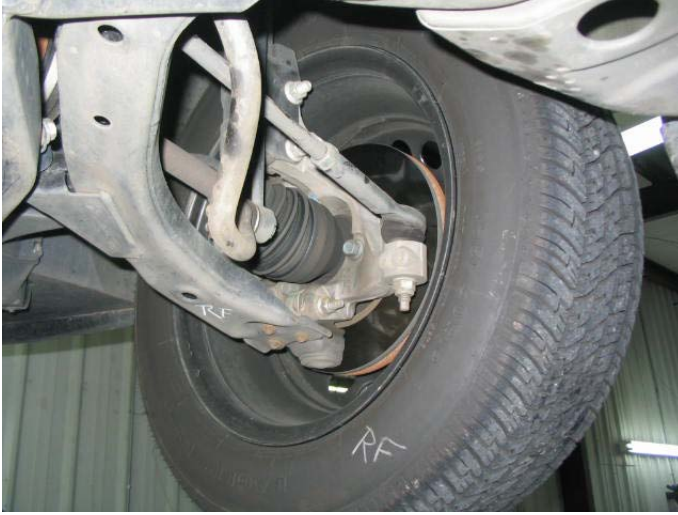
024 Left front suspension from rear – No observable damage

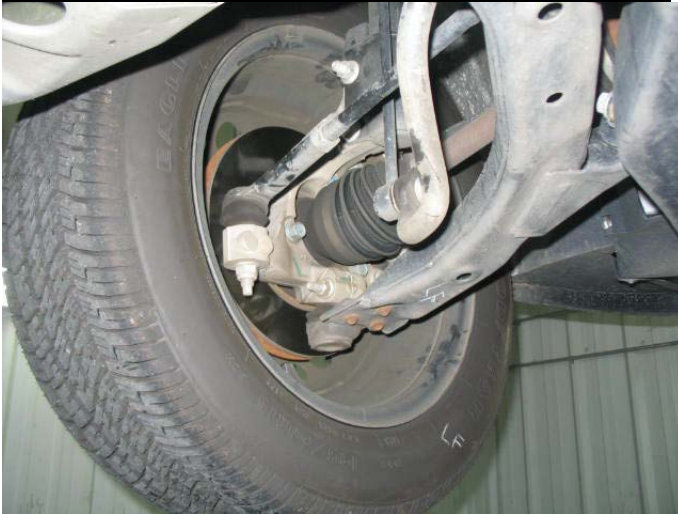
025 Left front suspension from front – No observable damage

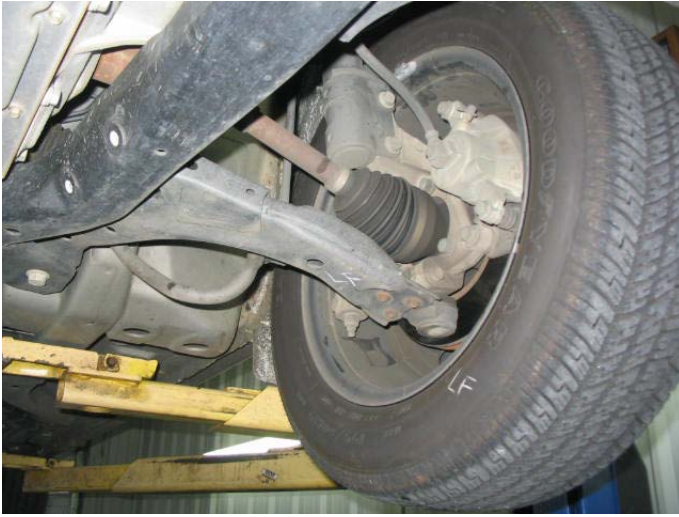
026 Right rear suspension from rear – No observable damage

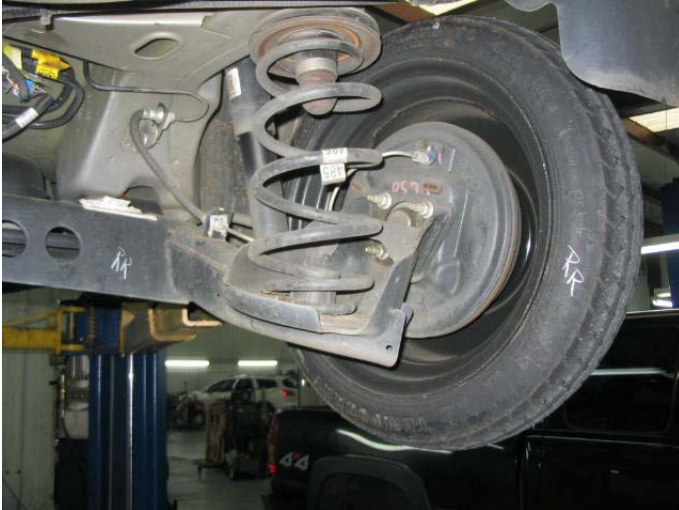
027 Right rear suspension from front – No observable damage

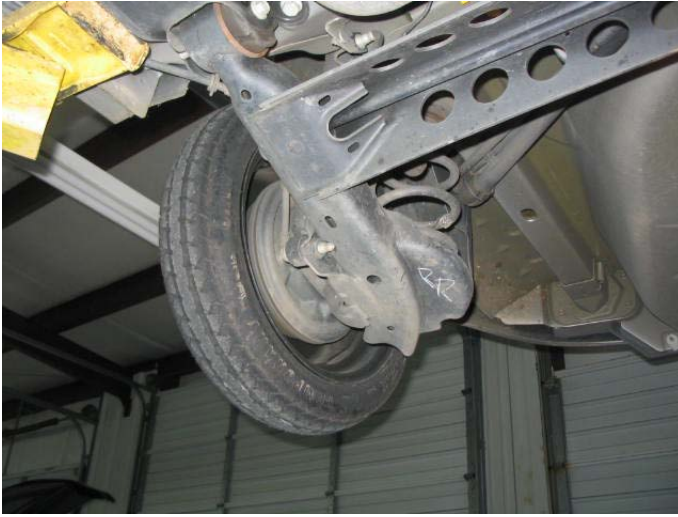
028 Left rear suspension from rear – No observable damage

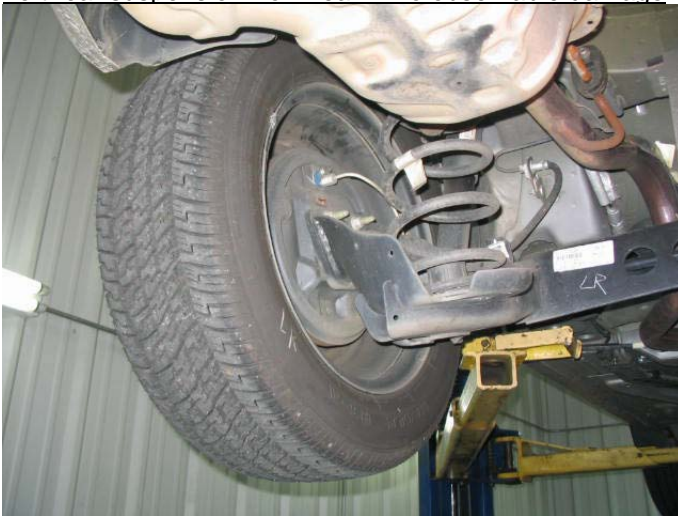
029 Left rear suspension from front – No observable damage

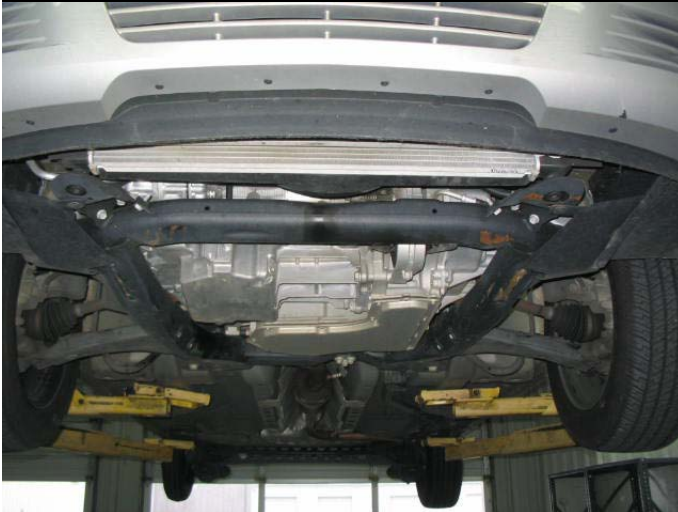
031 Undercarriage and floor pan from front – No observable damage

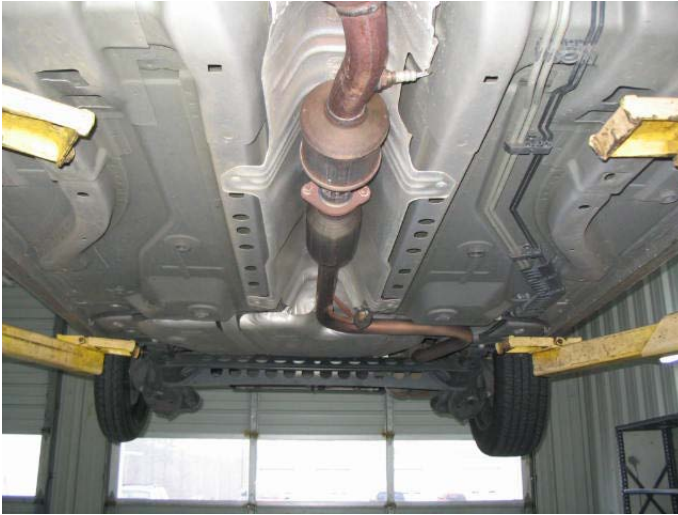
032 Undercarriage and rear cross-member and suspension from rear – No observable damage

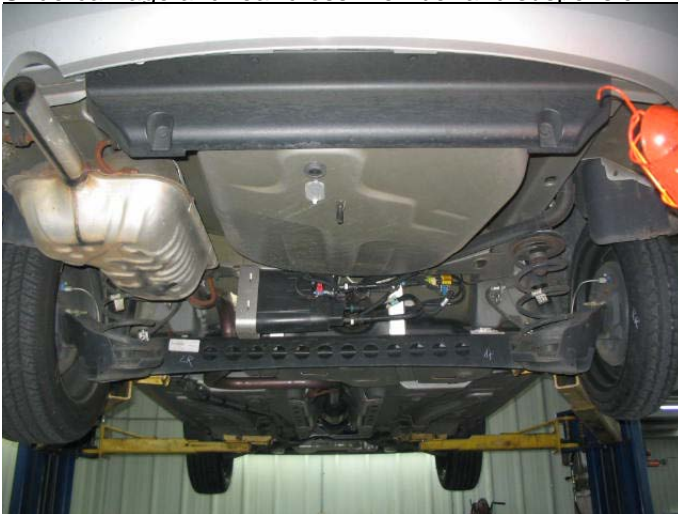
033 Undercarriage and floor pan from rear – No observable damage

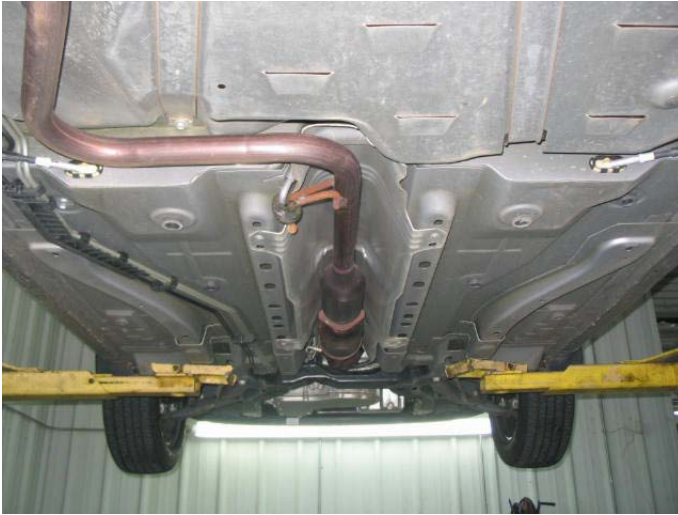
034 Engine cradle and R/L suspension from rear – No observable damage

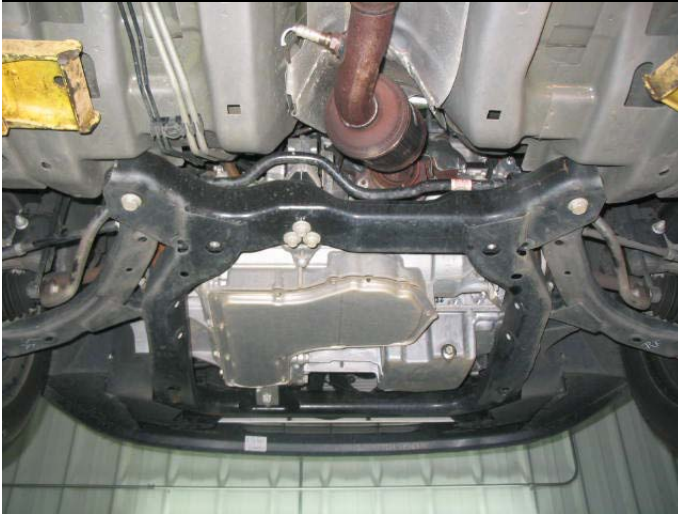
035 Close-up of damage to wheel, tire and wheel cover on right rear that was moved to right front by claimant after accident

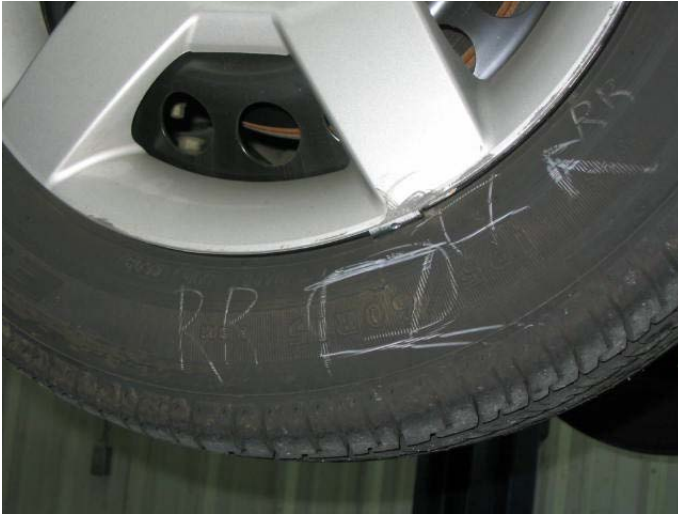
036 Left rear wheel, tire and wheel cover – No observable damage

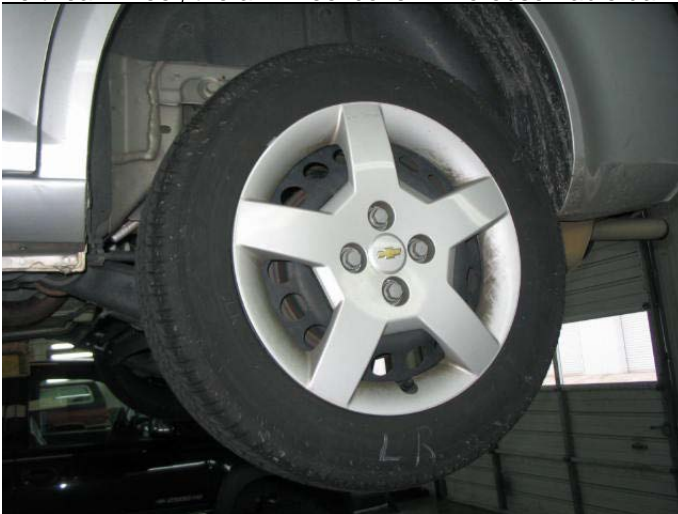
037 Left front wheel, tire and wheel cover – No observable damage

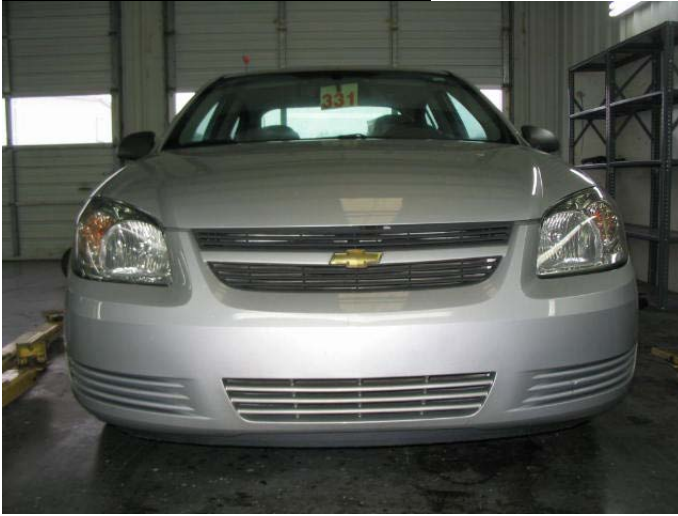
002	Left front corner, left side – No observable damage
-----	---

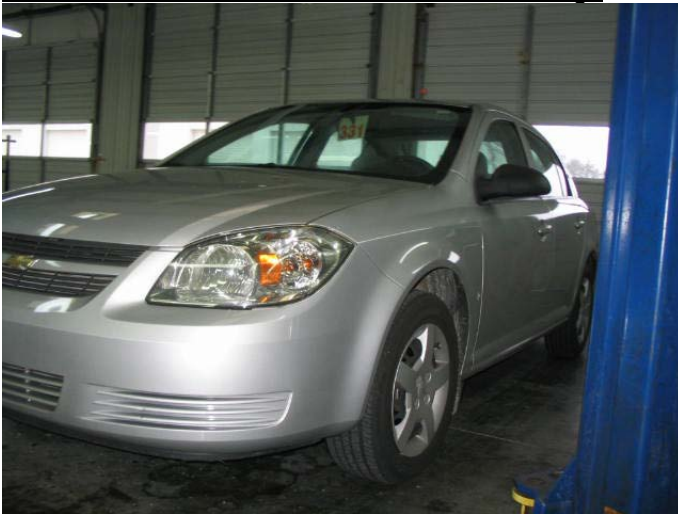
003	Left rear corner, left side – No observable damage
-----	--

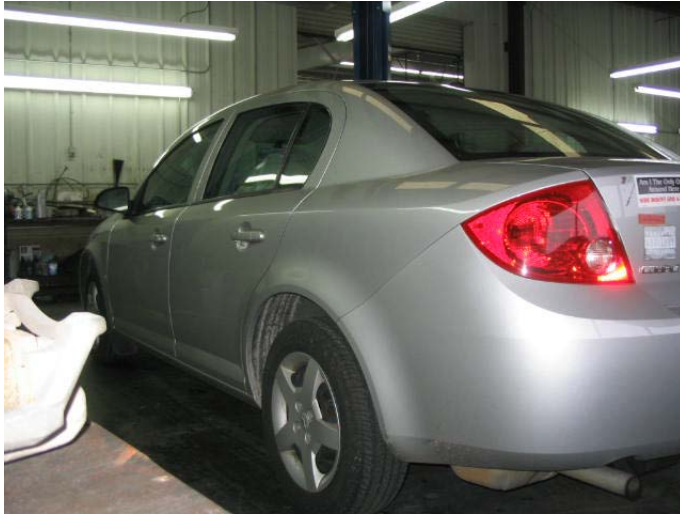
004 Right rear corner, right side – No observable damage

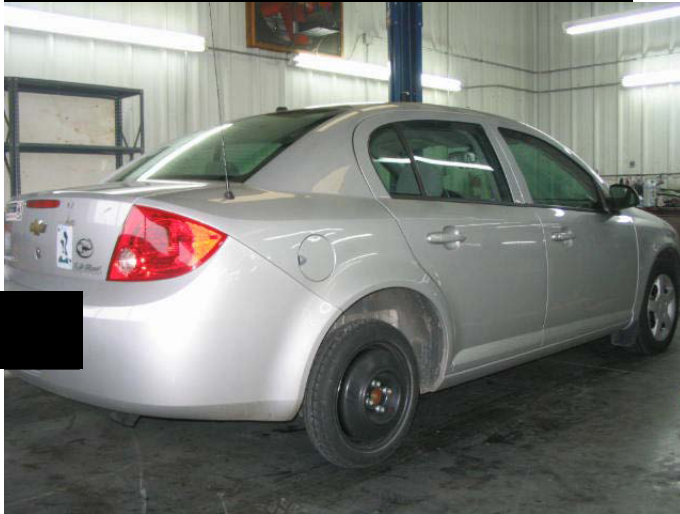
005 Right front corner, right side – No observable damage

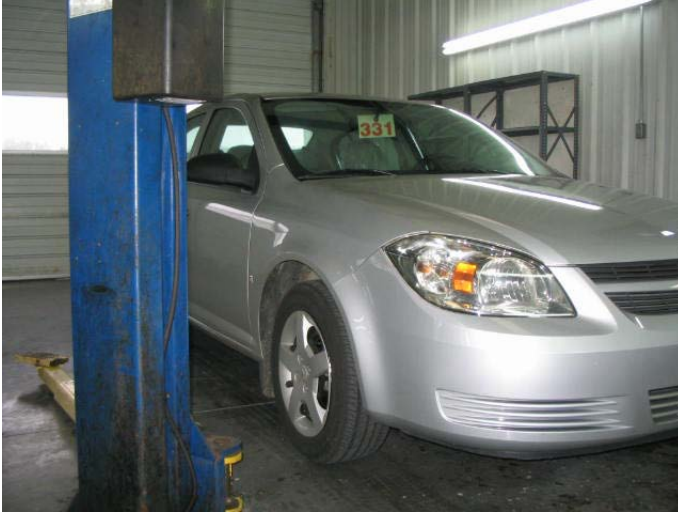
006 Driver side interior – No observable damage

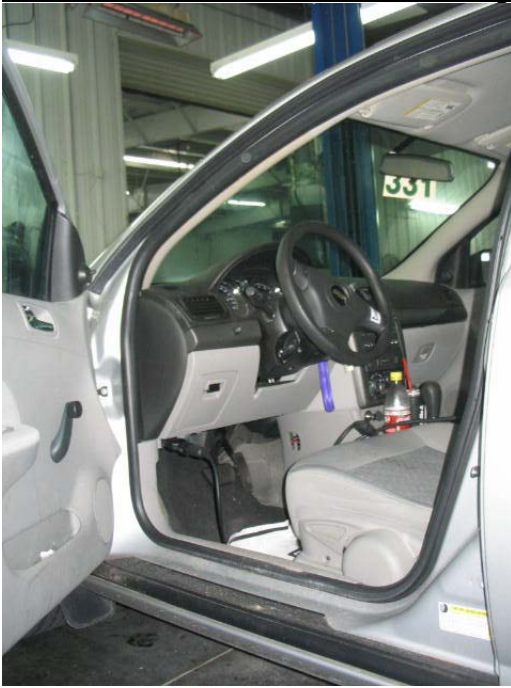
007 Left rear interior – No observable damage – Driver and passenger seat position – Rear seat area cluttered with miscellaneous personal items

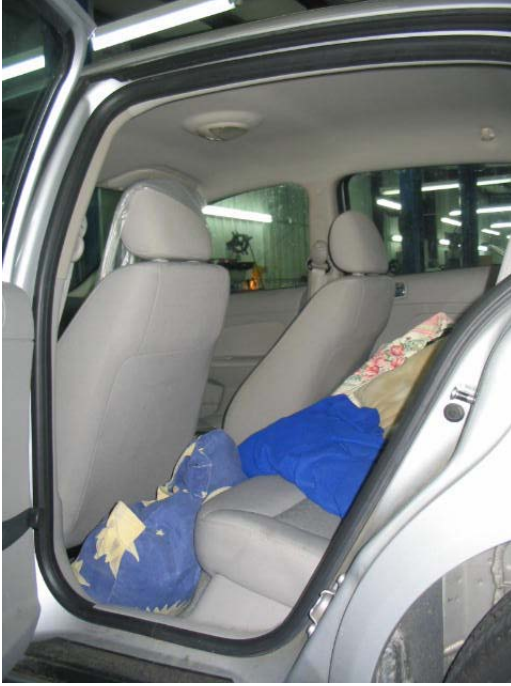
008 Right front side interior – No observable damage

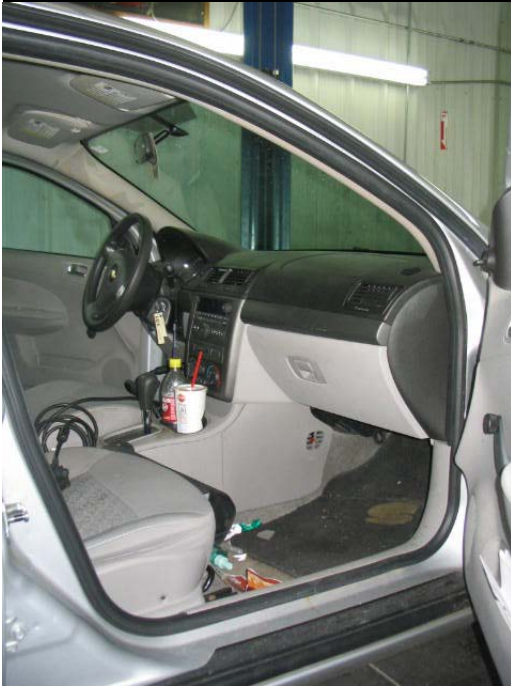
009 Right rear interior – No observable damage – Driver and passenger seat position – Rear seat area cluttered with miscellaneous personal items

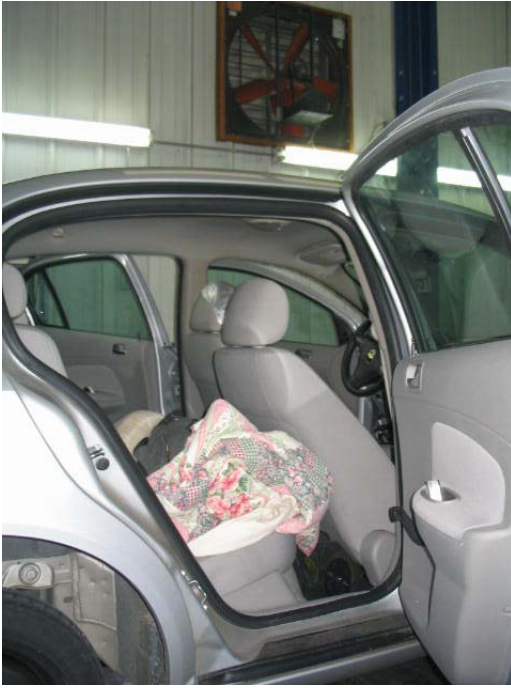
010 Right front wheel and tire found in trunk – Wheel, tire and plastic wheel cover damage observable – Wheel, tire and wheel cover removed by claimant after incident and placed in trunk

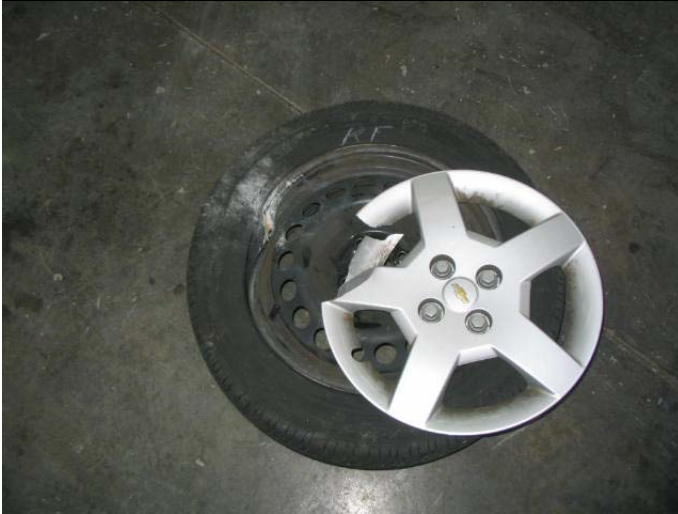
011 Right front wheel, tire and wheel cover damage observed

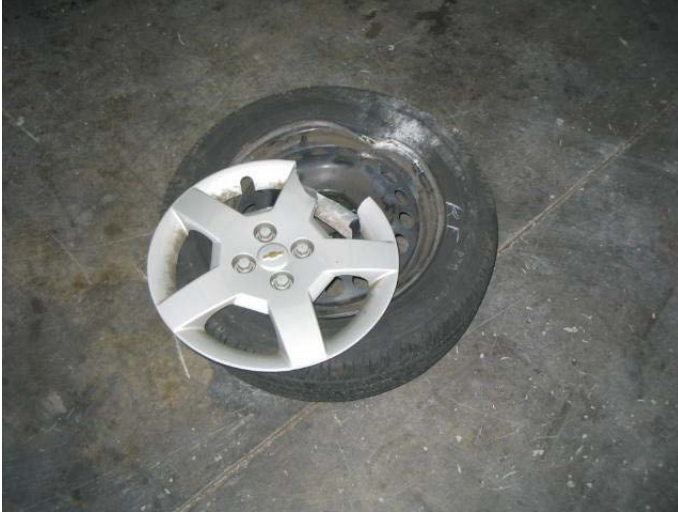
- 012 Right rear wheel, tire and wheel cover damage – Wheel, tire and wheel cover had been removed from right rear and moved to right front by claimant after incident to allow for compact spare to be installed on right rear of vehicle – Damage to wheel, tire and wheel cover observable

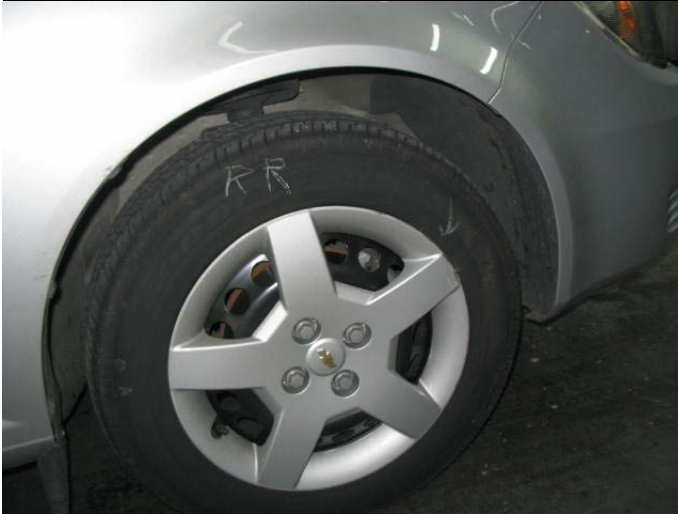
- 013 Same as 12 above
