Cards For Redemption

**GM World Card**

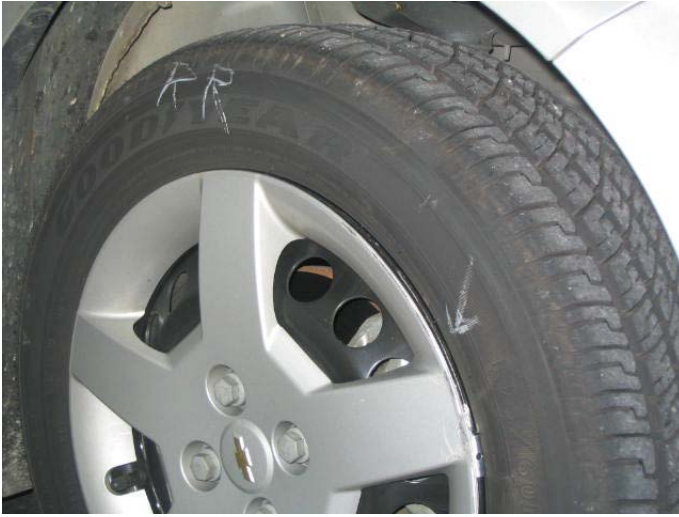
- 014 Engine compartment front top view – Plastic cover removed to allow view of engine controls – No observable damage – No observable missing parts or after-market items

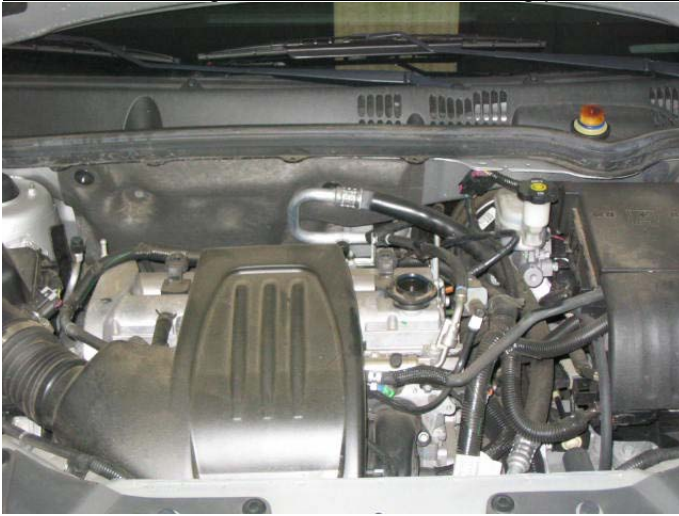
- 015 Deleted – Poor quality photo
016 Deleted – Poor quality photo
017 Instrument panel driver information center – Service tire monitor message viewable

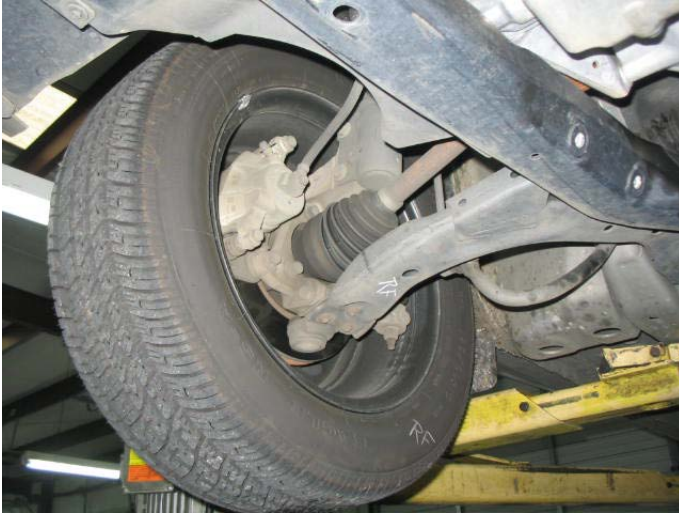
023 Right front suspension from front – No observable damage

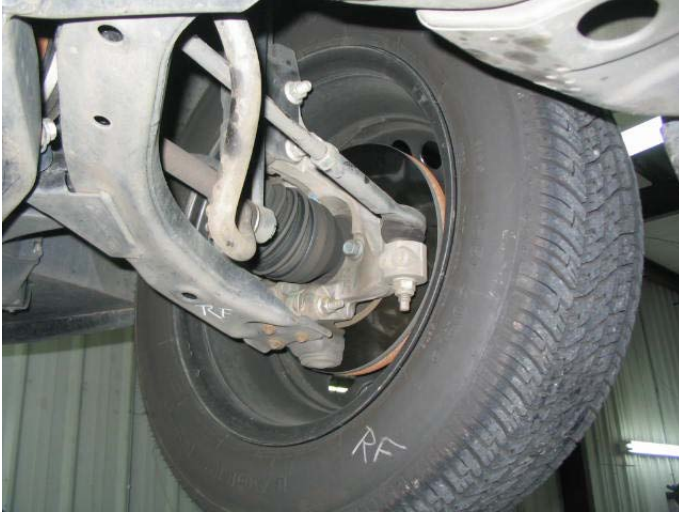
024 Left front suspension from rear – No observable damage

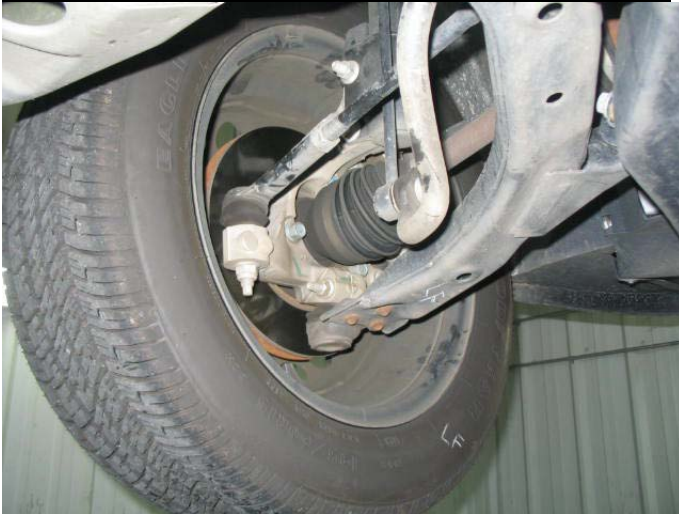
025 Left front suspension from front – No observable damage

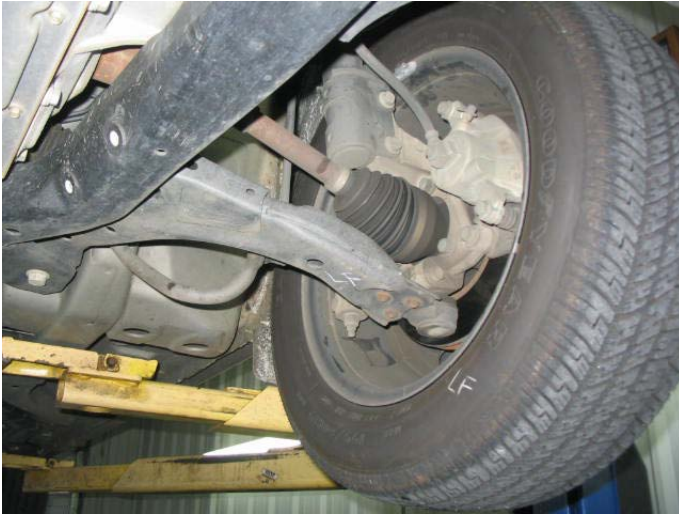
026 Right rear suspension from rear – No observable damage

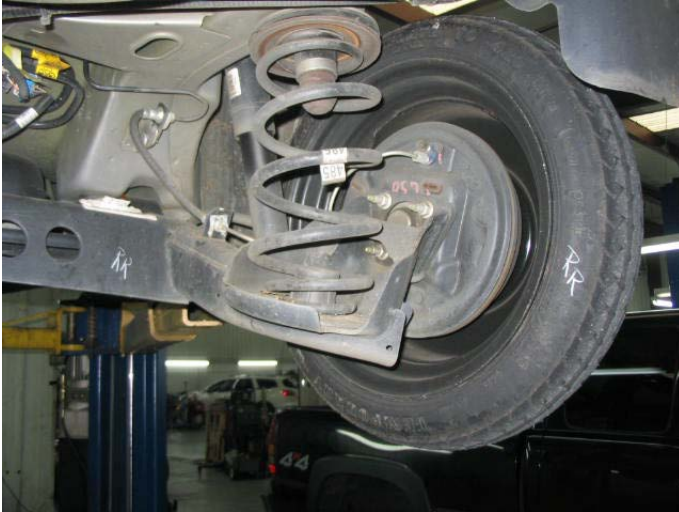
027 Right rear suspension from front – No observable damage

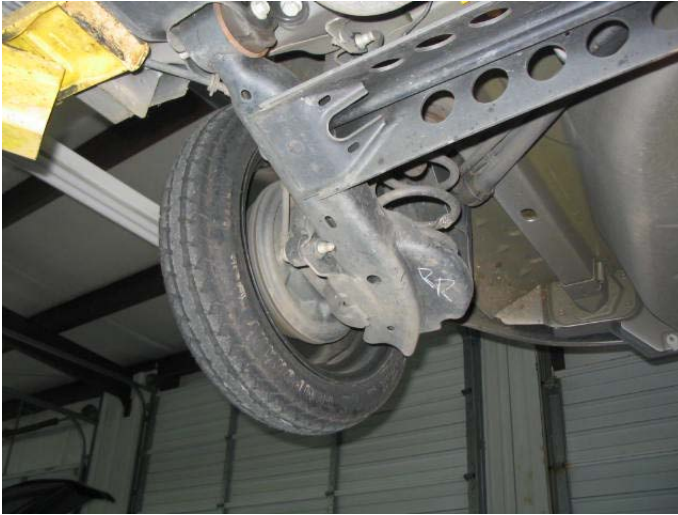
028 Left rear suspension from rear – No observable damage

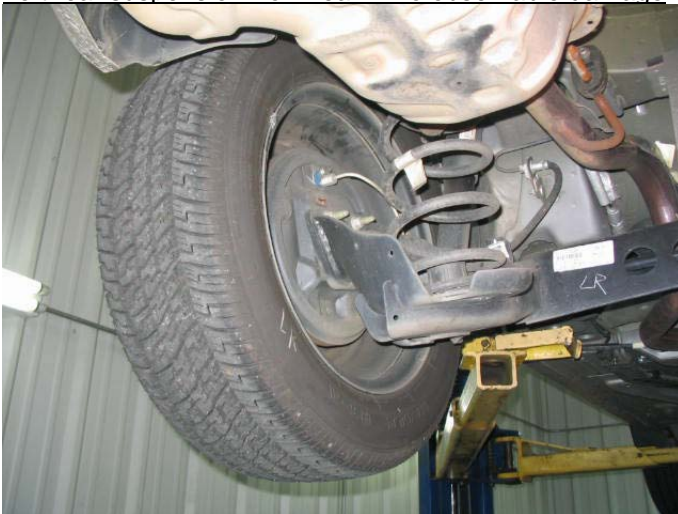
029 Left rear suspension from front – No observable damage

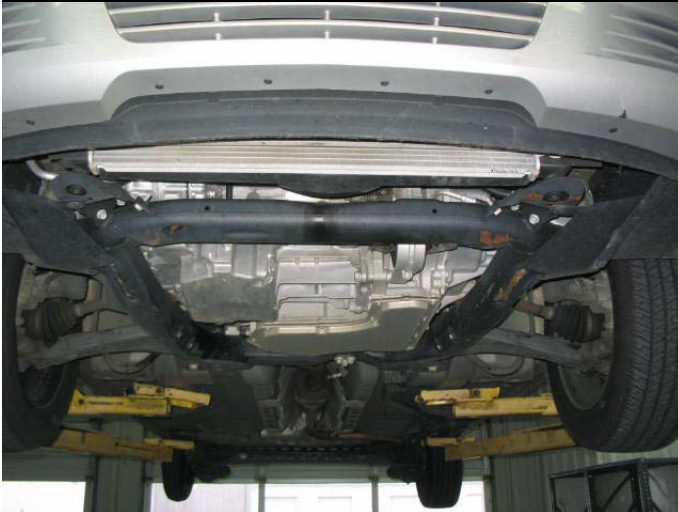
031 Undercarriage and floor pan from front – No observable damage

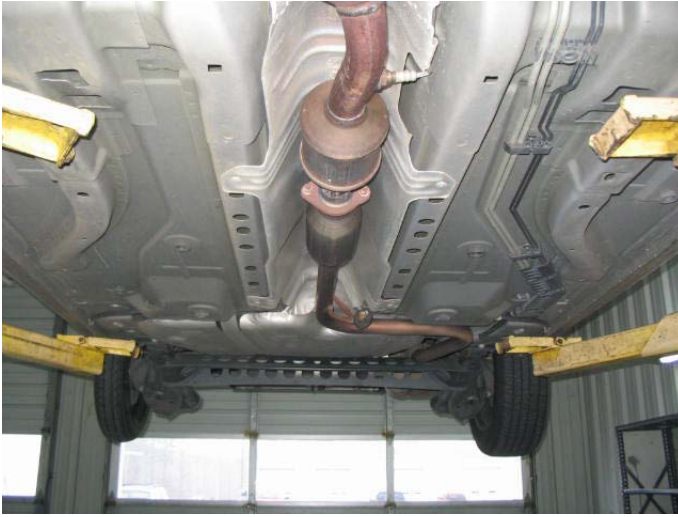
032 Undercarriage and rear cross-member and suspension from rear – No observable damage

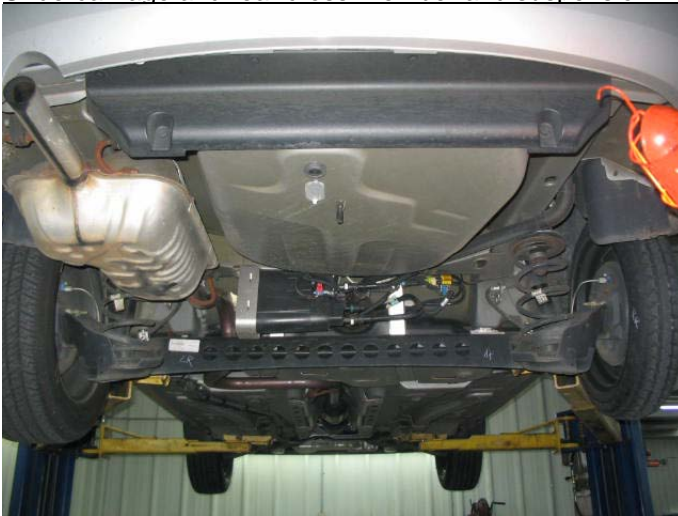
033 Undercarriage and floor pan from rear – No observable damage

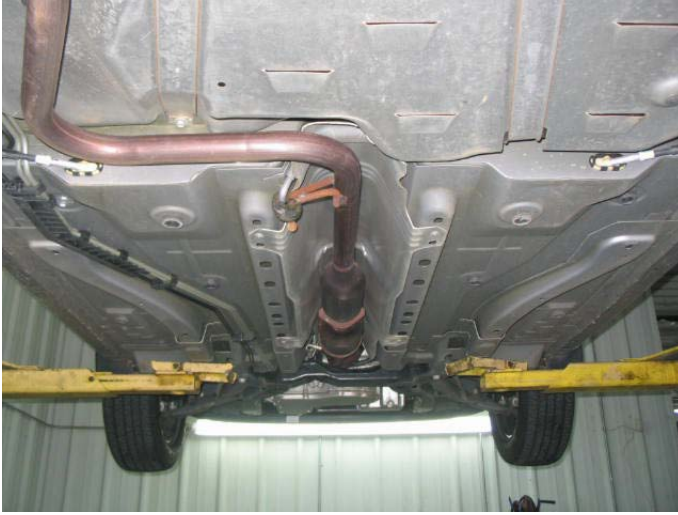
034 Engine cradle and R/L suspension from rear – No observable damage

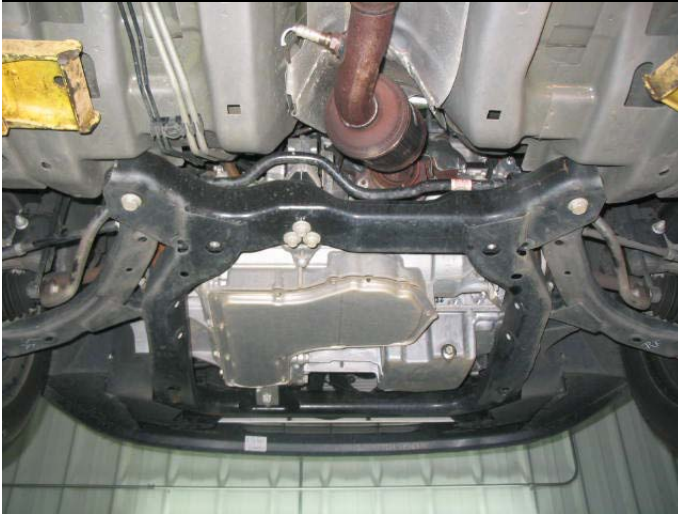
035 Close-up of damage to wheel, tire and wheel cover on right rear that was moved to right front by claimant after accident

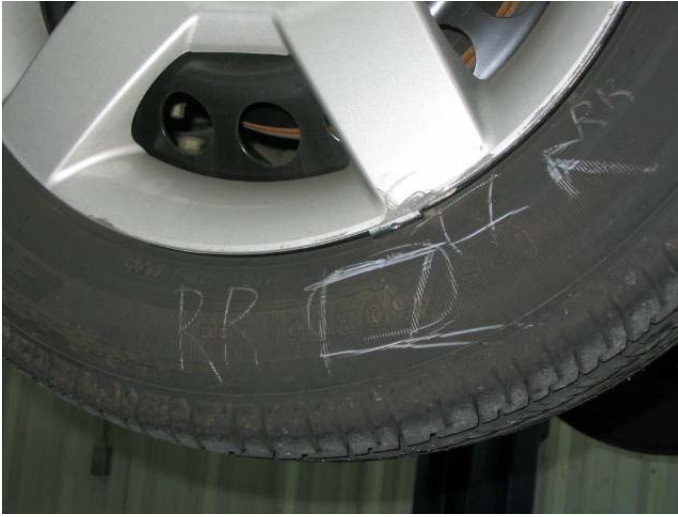
036 Left rear wheel, tire and wheel cover – No observable damage

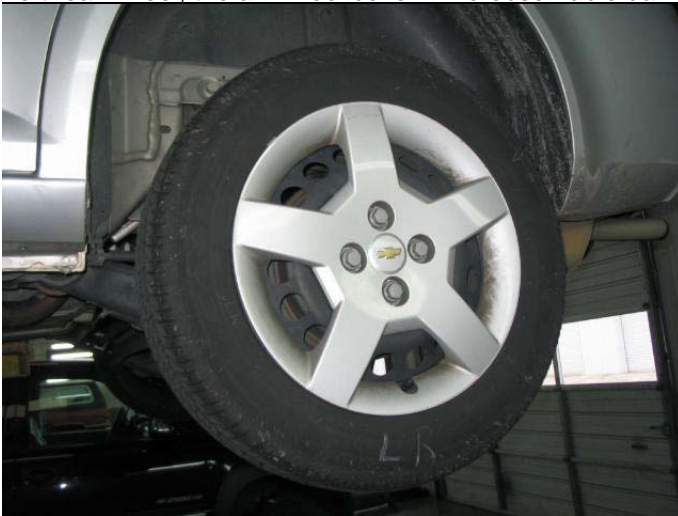
037 Left front wheel, tire and wheel cover – No observable damage

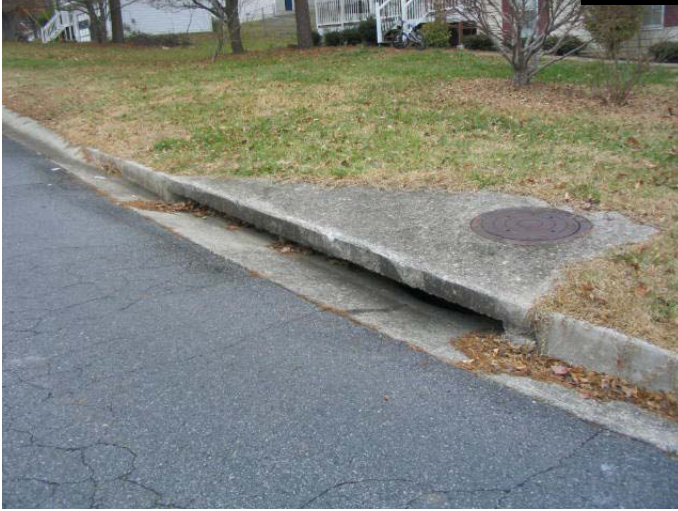
047 Damage to cement culvert located on Hampton lane – Culvert in photo is the impact area described by claimant as impact point that resulted in wheel and tire damage to vehicle

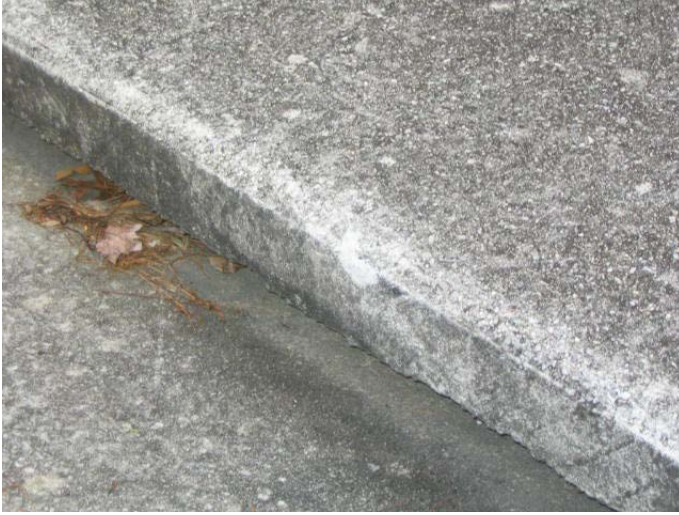
048 Side view of damage to culvert at [REDACTED]

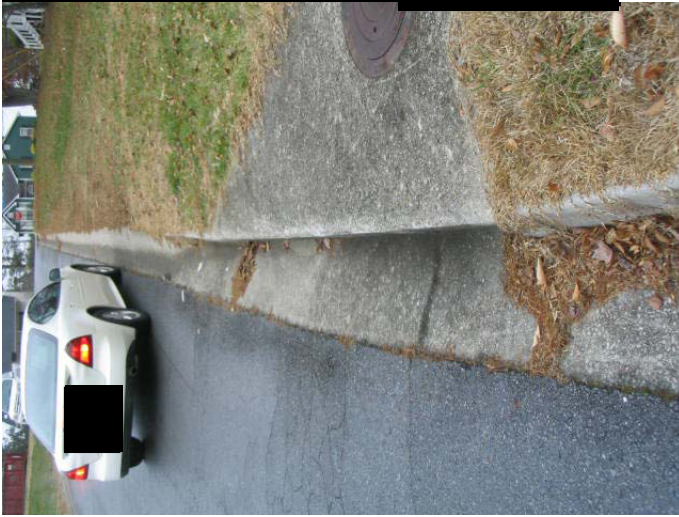
049 Corner of Hampton lane and Brookside drive looking south east – Stop sign in photo is located on Brookside drive and per claimant statement is where she indicated she came to a complete stop before proceeding into a right turn that ended up impacting cement culver. Impact area measured from stop sign to damage observed on culvert was less than 45 feet

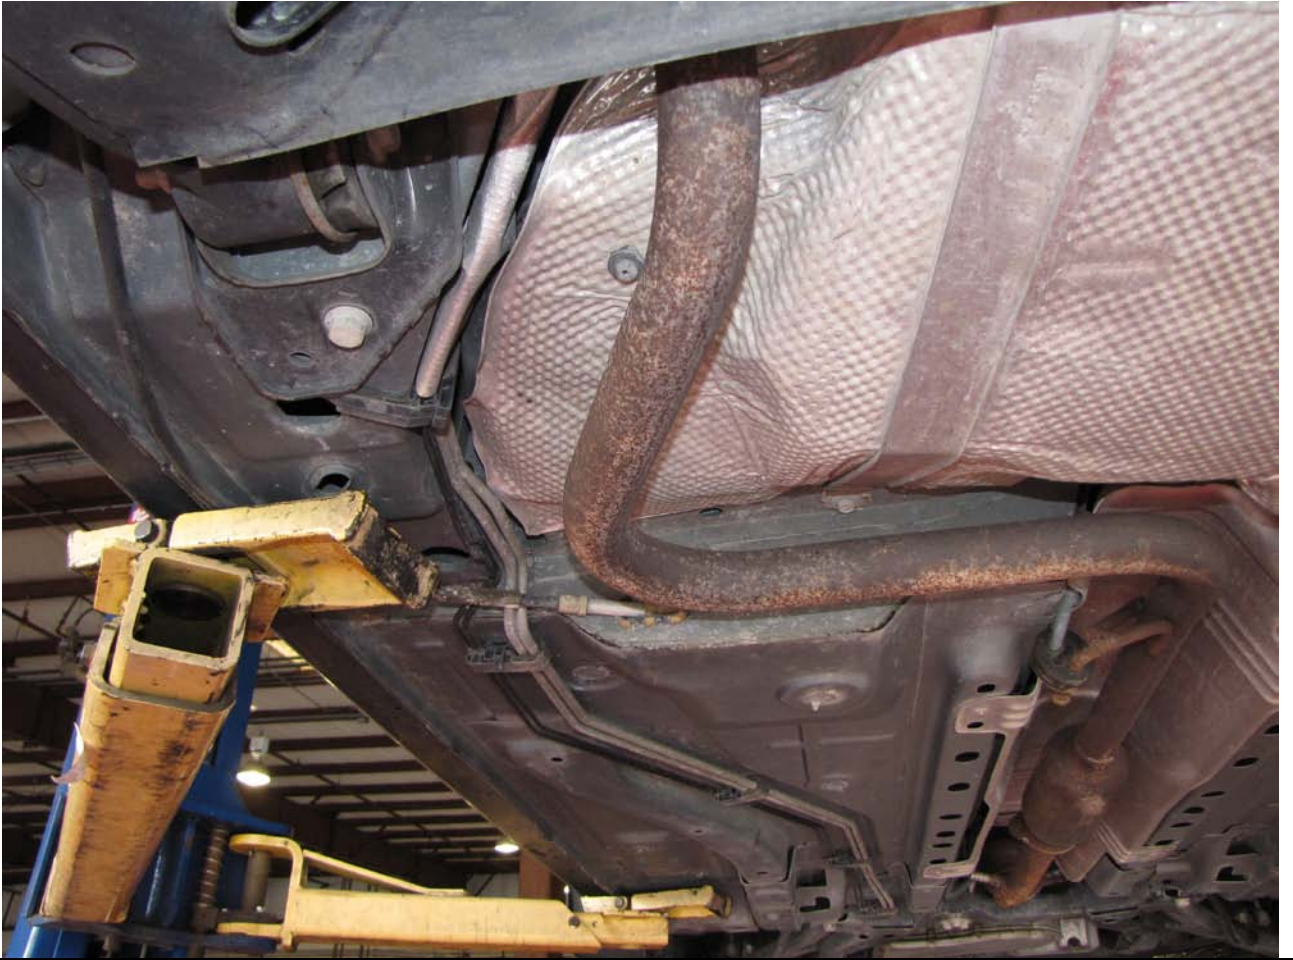
0061	VIEW OF IMPACT DAMAGE ON LF HUB CAP

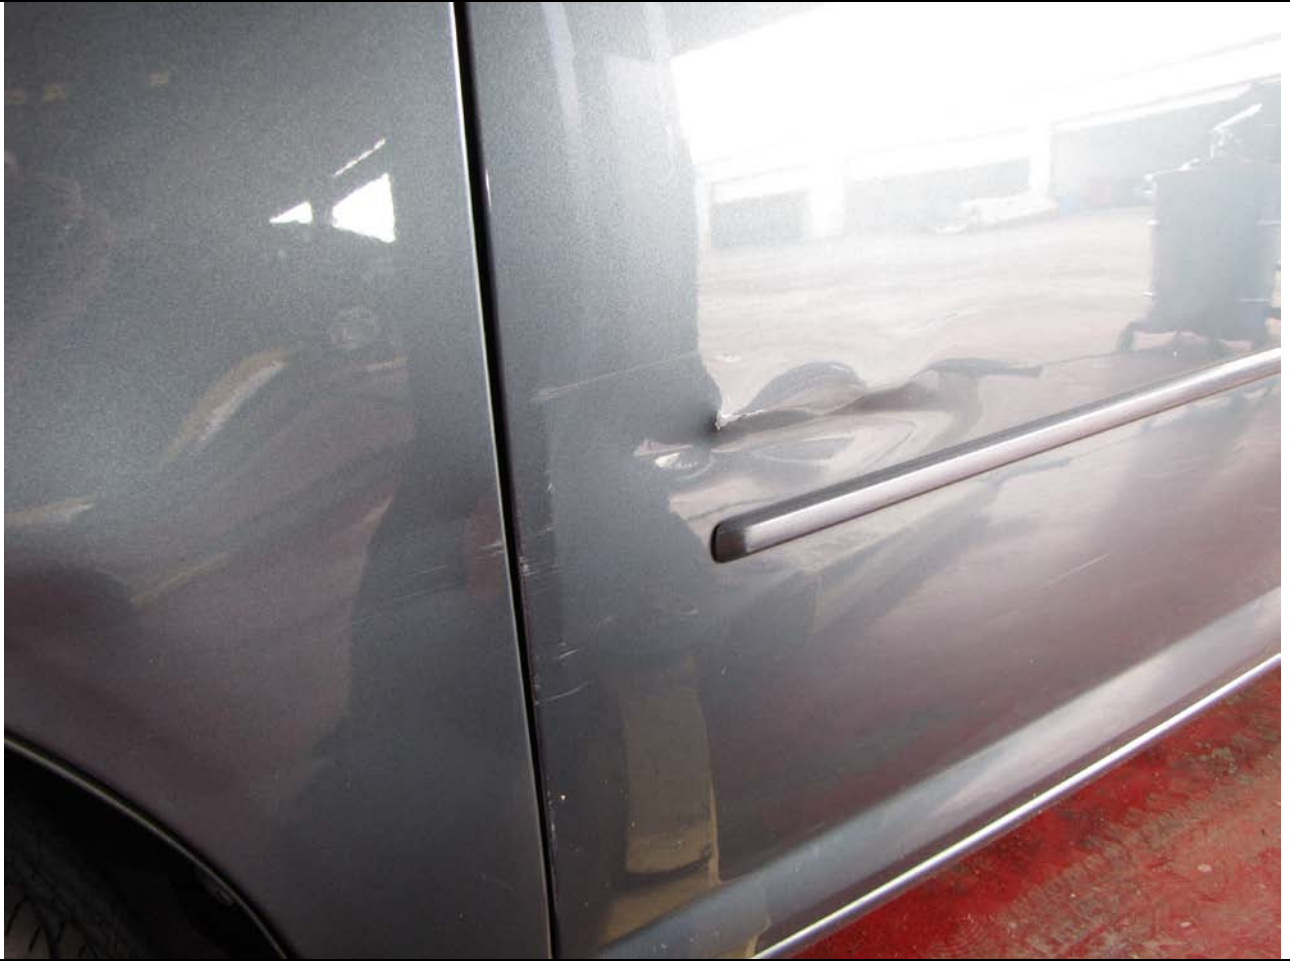
0072 VIEW OF IMPACT DAMAGE ON LEFT QUARTER PANEL

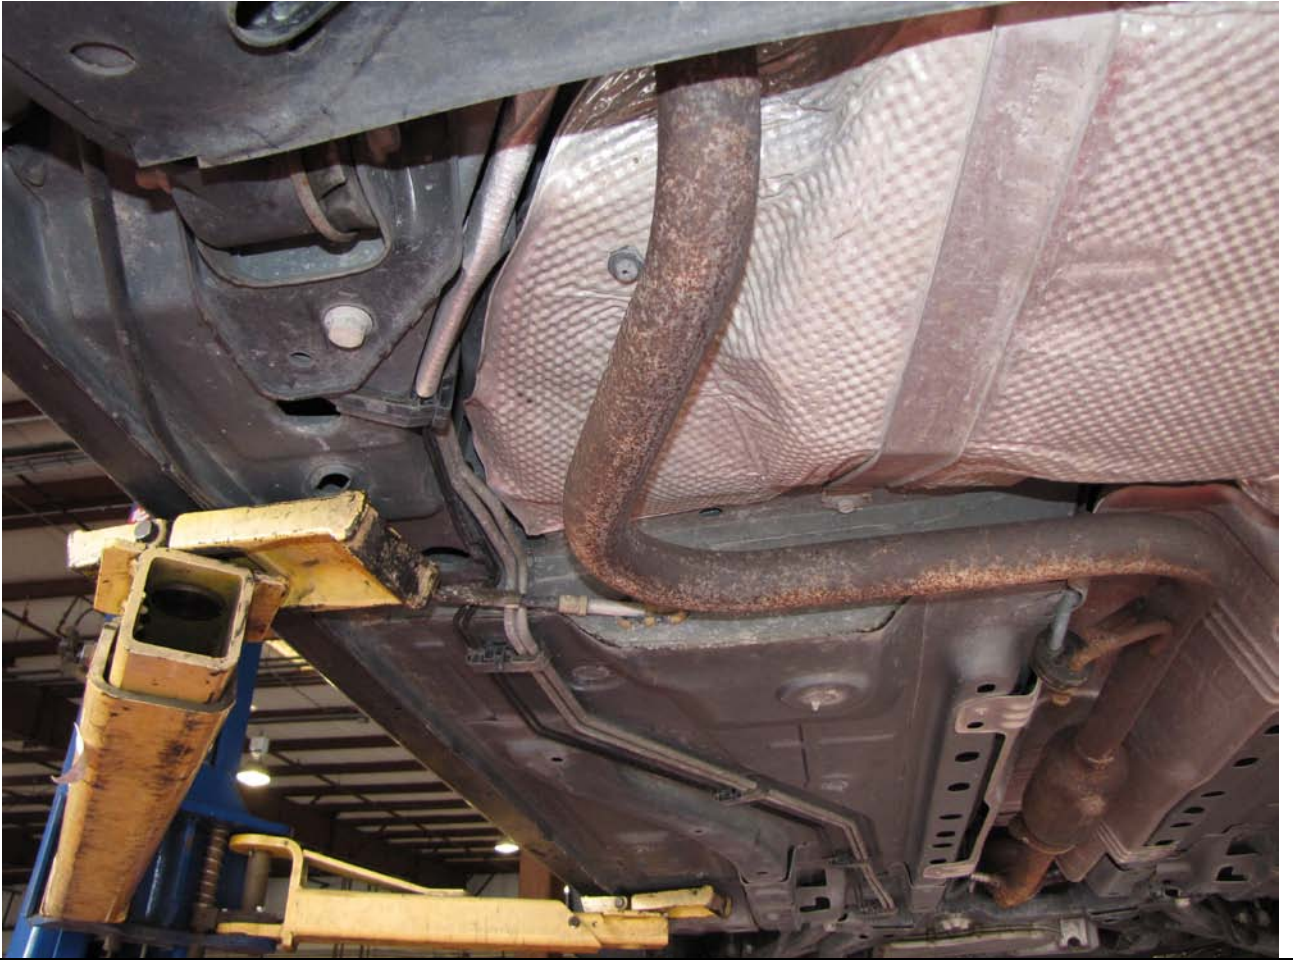
0061	VIEW OF IMPACT DAMAGE ON LF HUB CAP

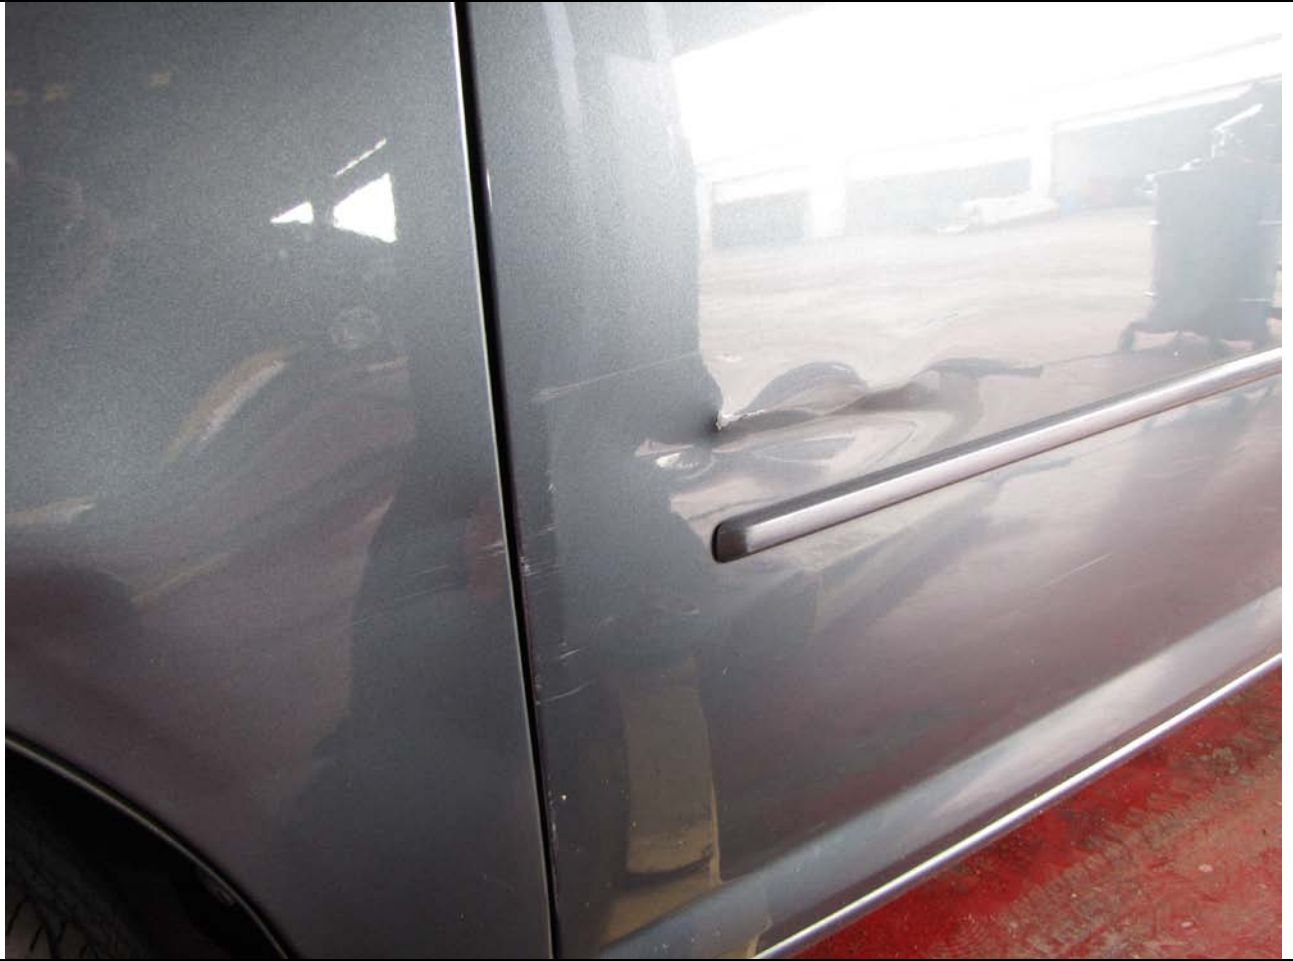
0072 VIEW OF IMPACT DAMAGE ON LEFT QUARTER PANEL
