Vibration in steering wheel at highway speeds

TQCN DOC# Affiliate		Dept.	Source	Location	Ref	Date			
TQCN_FTR-08114	TQCN_FTR-081140037 TMS		QAChassis	FPE	TMS	81195092	04/29/2008		
Problem Area	Primary Model		Model Year	Production Date	Odometer VIN (confirm 17 characters):		ters):		
Base Vehicle Corolla		2009	2008-02-13	277	JTDBL40E299				
Condition Title

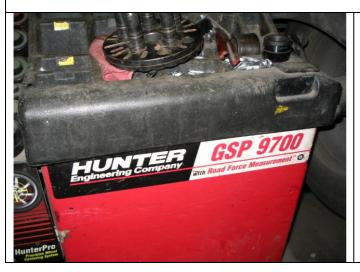
Hunter RFV Balance used

The technician replaced the left front tire, and rebalanced others to remedy condition. Part was shipped UPS for quality evaluation purposes to TMS

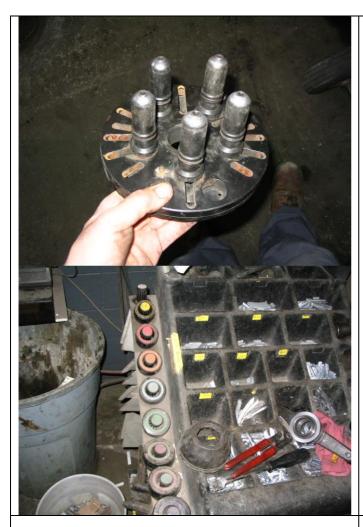
LEFT REAR WHEEL

Hunter fingers and cones used for RFV.

Original measurements: RFV – 7 lbs Balance 0

No adjustment required

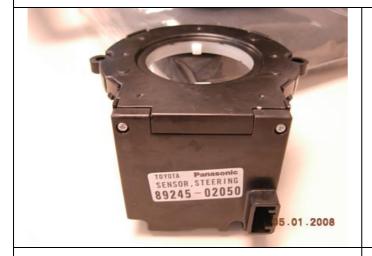
Steering Angle Sensor shorted-root cause undetermined

Replaced Steering Angle Sensor Part Number 89245-02050

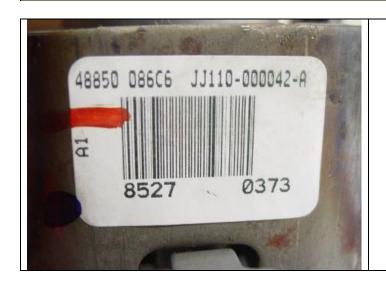
Additional tag found on EPS column.

Dealer replaced Electric Power Steering column assembly to correct condition.

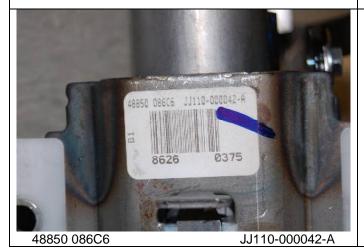
Noise was from inside marked area.

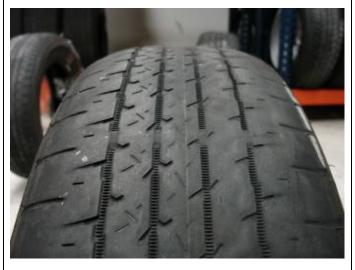
Left Front Tire	Tread Depth (mm)
-----------------	------------------

-1 - (,
nside	Groove	Groove	Groove	Groove	Outside
Shoulder	4	3	2	1	Shoulder
1.3	1.4	1.2	0.7	0.4	0.6

Dealer replaced (4) Firestone Affinity Touring S4 tires with Toyo to address the customer's concern.

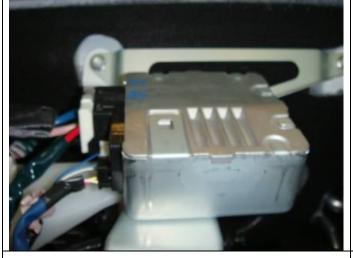
EPS ECU (above) was checked for B+, IG+, and GND by backprobing and all voltage checks appeared OK.

EPS ECU was replaced to correct the concern. Post-repair test drive revealed normal EPS operation and assist.

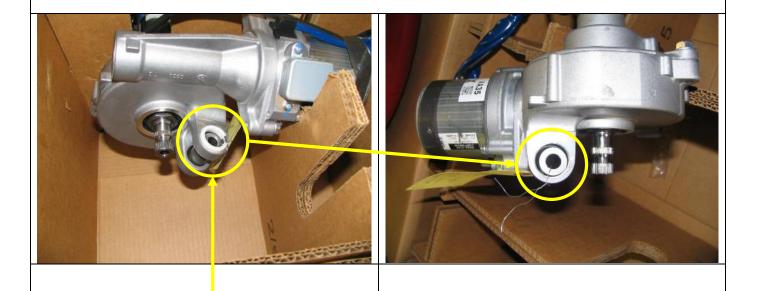
View showing correctly installed Bushing

View from opposite side - missing bushing

• Replaced Electric Steering Column Assembly PN 45250-02620 as plastic bushing not available separately.

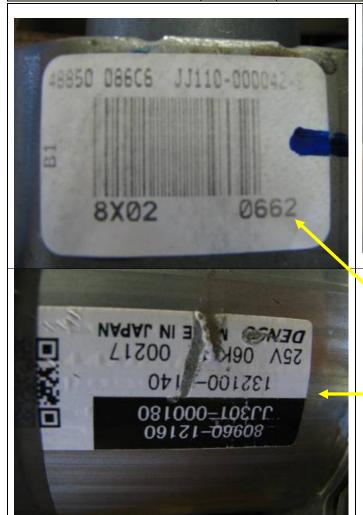
Markings on motor and column

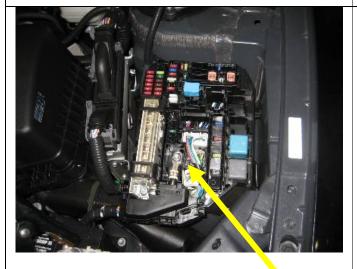
Location of terminal Q1

The threaded stud was damaged.

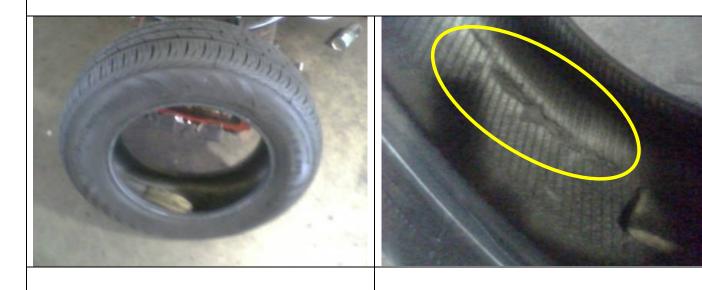
Left Front Tire With Piece of Wood Inside

Picture Of Damage Caused By Piece Of Wood

Wood was removed and tire was replaced to repair vehicle.

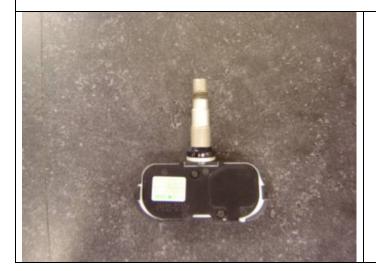
• Tire Pressure Sensor not transmitting data.

Replacement of Left/front Tire Pressure Sensor Assembly corrected complaint condition and customer is satisfied with repairs.

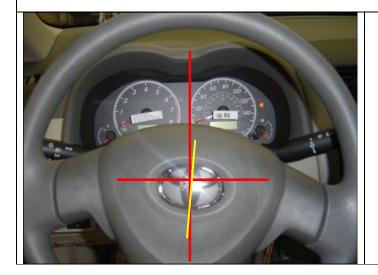
Steering wheel off center

Adjust tie rod ends to set steering wheel center.

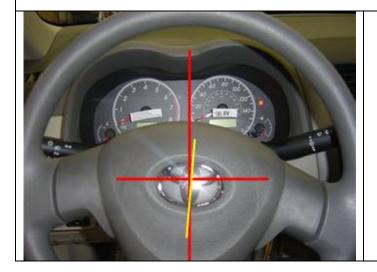
Steering wheel off center

Set steering wheel center by adjusting tie rods.

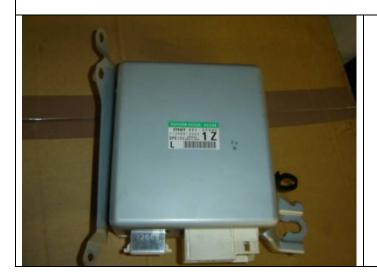
Power Steering Computer Assembly internal malfunction.

Replacement of Power Steering Computer Assembly and initializing Angle Sensor and Torque Sensor zero
point calibration corrected complaint conditions and customer is satisfied with repairs.

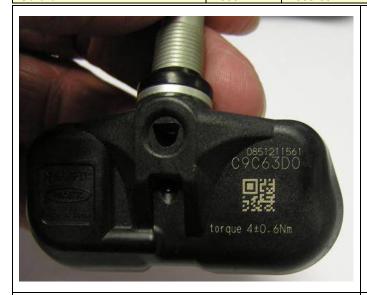
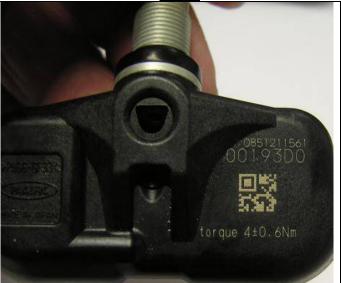
Tire Pressure Sensor Information: 0851211561 C9C63D0

Tire Pressure Sensor Information: 0851211561 00193D0

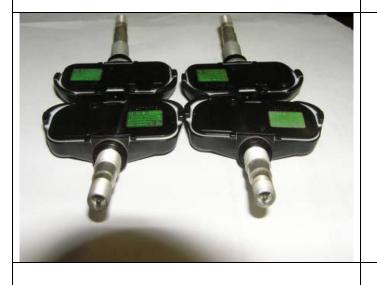
Back side of tire pressure sensors

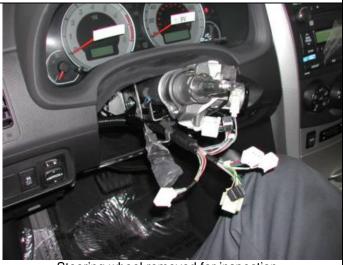
Steering wheel removed for inspection.

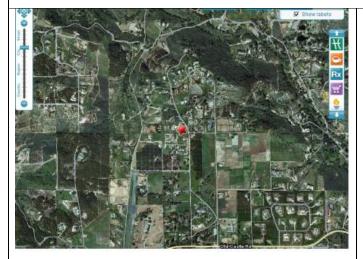
Red star shows approximate home location. Customer drives dirt/gravel road to "Old Castle Rd" (shown in yellow at bottom of photo). Note that a long section of each drive is North or South along a straight dirt road.

Repair Process

Technician replaced Power Steering Column assembly to correct complaint condition.
