**Memorandum Report  
RQ10-004  
Electric Power Steering Study  
2007 Saturn Ion**

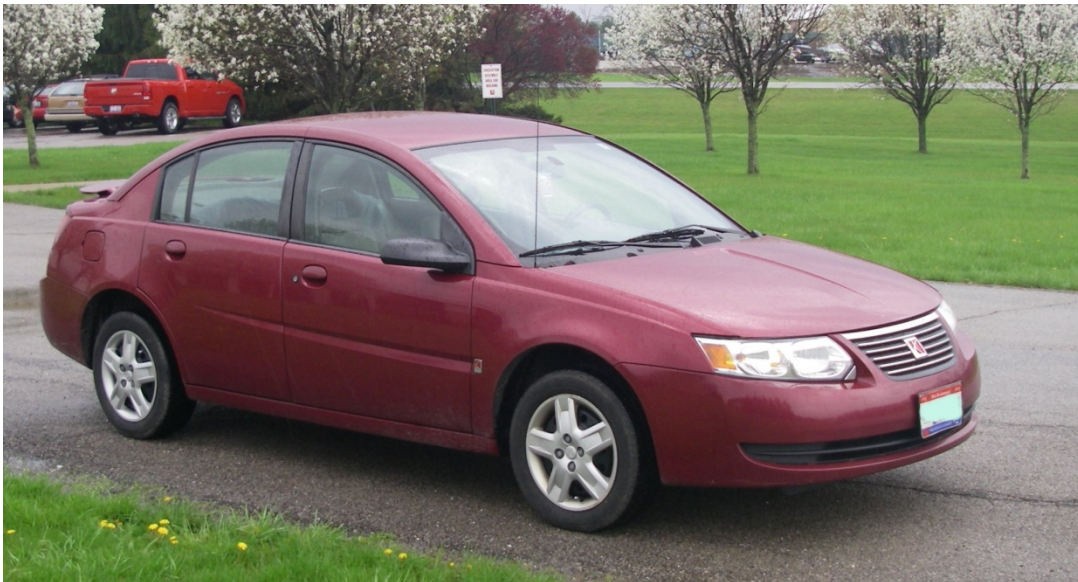
**Figure 1  
Subject Test Vehicle**

The test vehicle was a 2007 Saturn Ion (VIN: 1G8AJ55F97Z161XXX) that was leased from an owner who had submitted a Vehicle Owner's Questionnaire (VOQ) regarding loss of power steering assist. Each time the vehicle was driven following an engine start, the EPS was functional for between approximately 100 and 300 yards. After that, the EPS warning light came on, a warning chime sounded, and the EPS became nonfunctional. Stopping and restarting the engine caused the cycle to repeat. If the engine was started, but the vehicle was not driven, the EPS remained functional without experiencing drop-out of the EPS. Figure 1 shows the test vehicle used for this program.

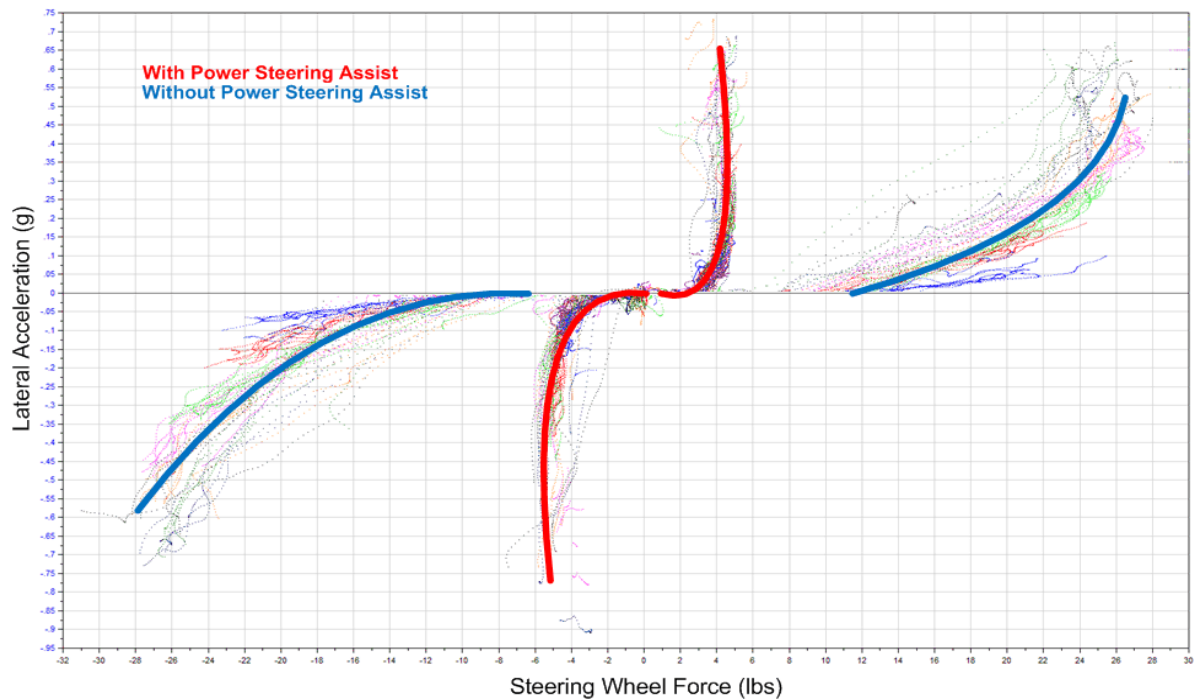
**Figure 3**  
**Lateral Acceleration vs. Steering Wheel Force - Assisted and Unassisted**

Figure 3 shows the lateral acceleration vs. steering wheel force for all testing and highlights the difference in required force between assisted and non-assisted steering effort. The blue line represents average unassisted steering effort while the red line represents average assisted steering effort.
