**From:** david.stanley@daimler.com  
**Sent:** Friday, January 27, 2012 2:08 PM  
**To:** Willard, Richard (NHTSA)  
**Subject:** RE: Proposed CNG owner letter  
**Attachments:** CNG Owner Letter.doc; Inspection Instructions (customer) - HDX CNG Tank Clearance.pdf

# INSPECTION INSTRUCTIONS

**Subject: Saf-T-Liner HDX CNG Tank Clearance Inspection**

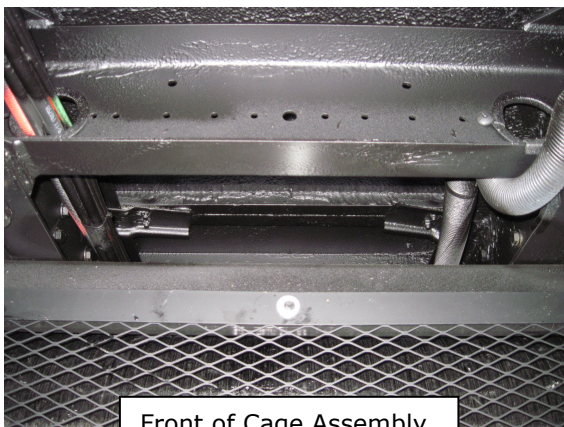
Front of Cage Assembly

1. Make sure the ignition is in the "Off" position. Chock the tires.
2. The following inspection was made from the front and/or rear of the CNG tank cage assemblies beneath the bus. The inspector was positioned between the frame rails.

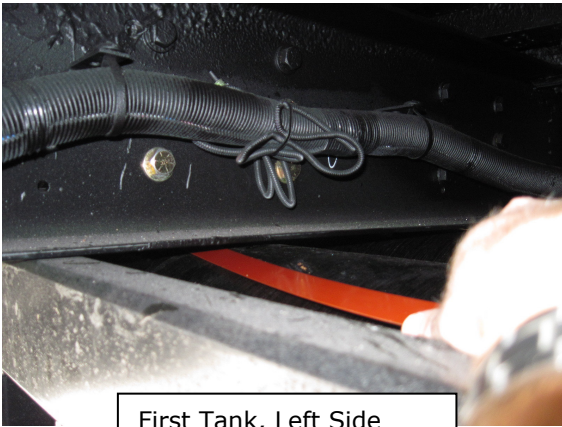
First Tank, Left Side  
(Inside Frame Rails)

Note: The no-contact test gauge shown in the following steps was made from 1/32" thick banding material and painted red for visibility in pictures.

4. From between the chassis frame rails, sweep the test gauge over each CNG tank and under the frame rail / tank cage. The gauge should move between the frame rail / tank cage and the CNG tank easily.
