Agenda

1. Configuration CP4 bearing

Status problems/measures CP 4
crack in oil seal

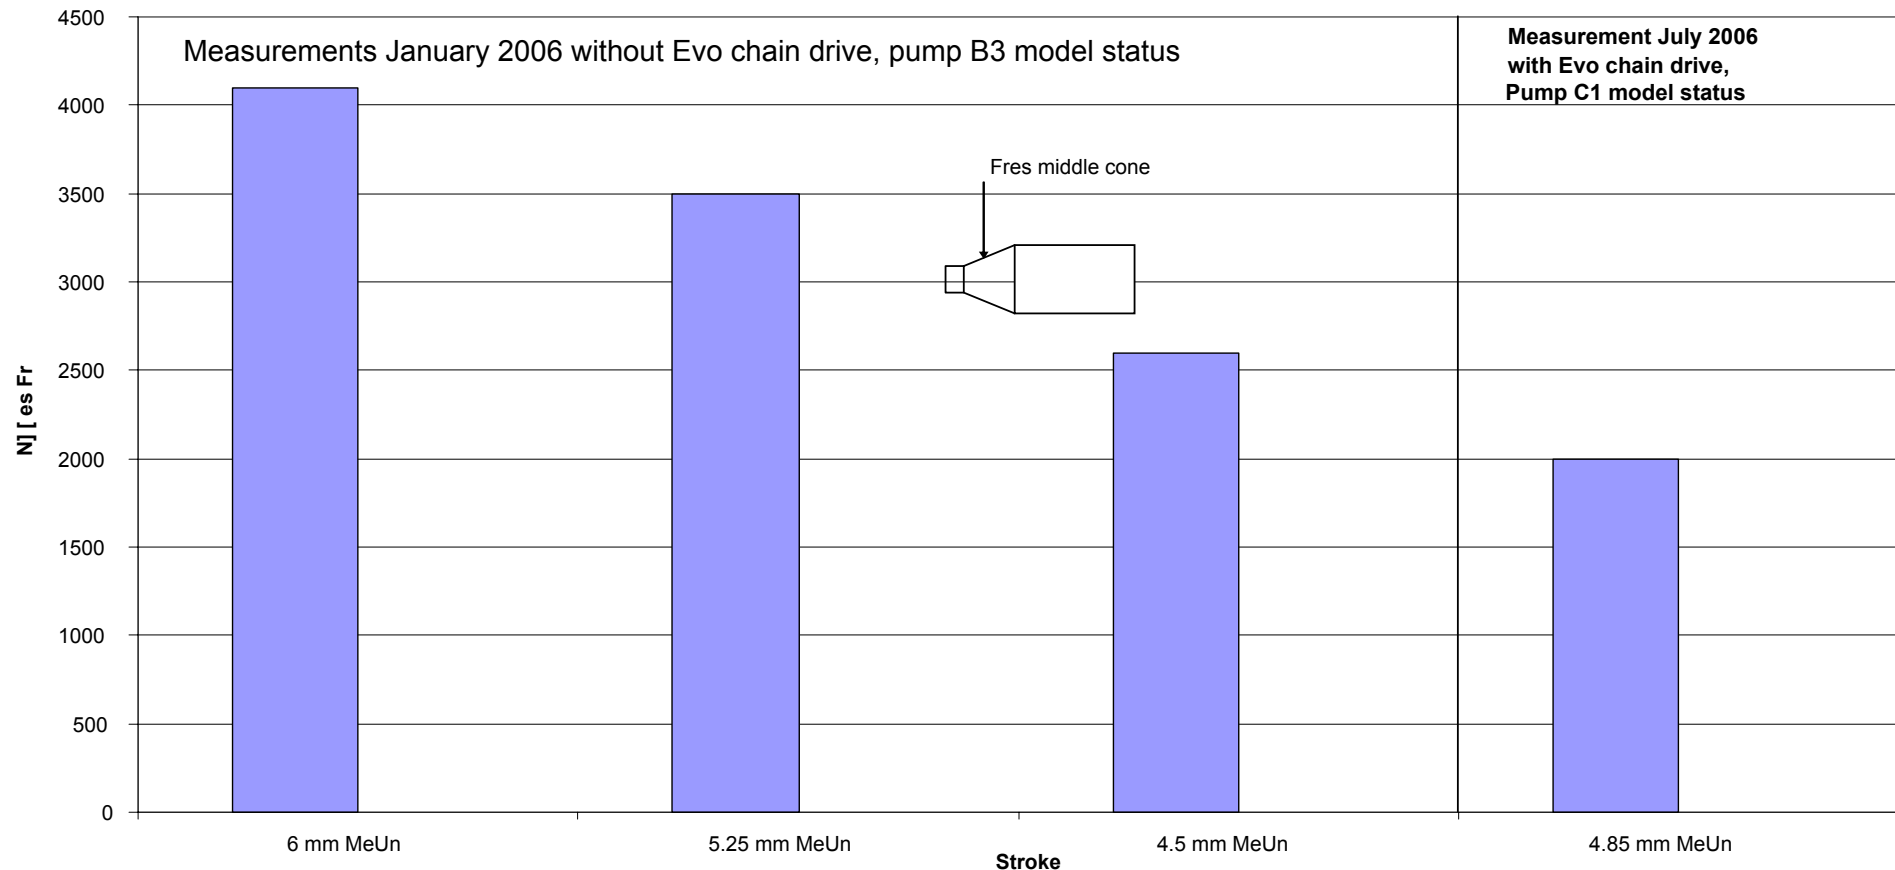
Comparison with current measurement (July 06):

Amounts of the resulting transverse force output from belt tension in relation to middle of cone CP4 are the maximum measured values in MeUn operation

- Internal pump forces due to 4.85 mm stroke lower than 6 mm stroke
- Measured external forces lower due to Evo chain drive
- ➔ Lower bearing load expected (calculation performed with current values)

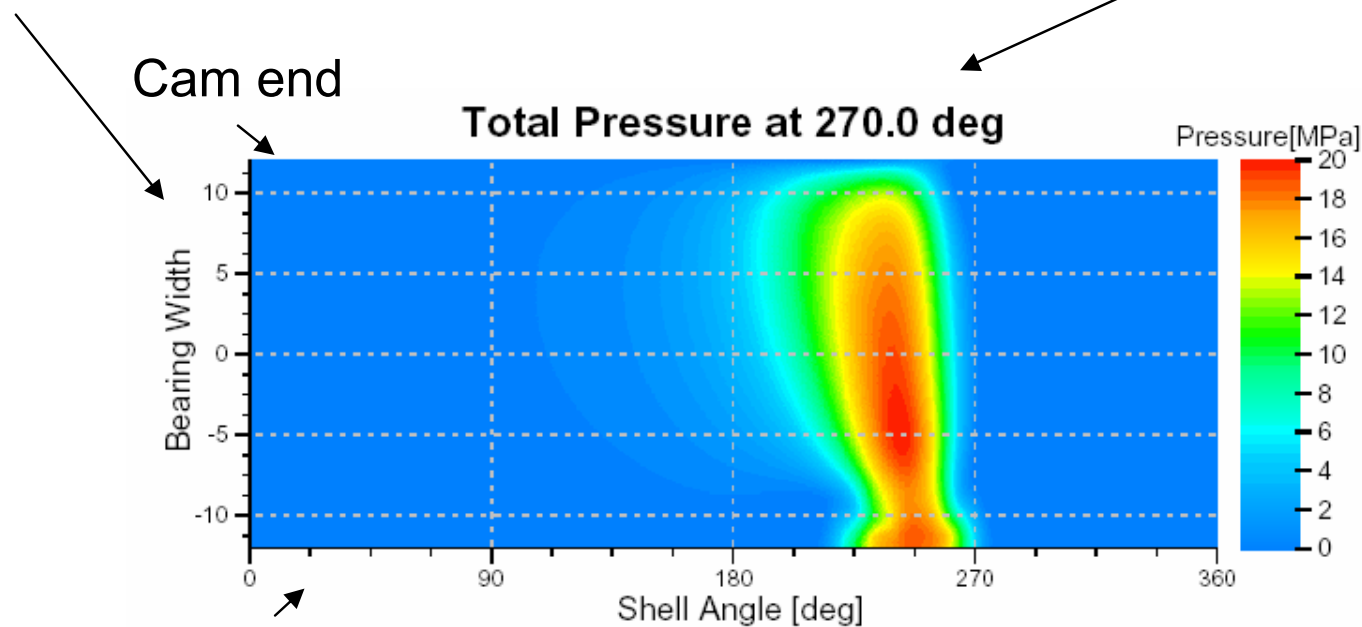
Results EHD: 2D pressure distribution in flange bearing

Definitions

Axial coordinates (Z-direction)

Cam angle

Circumferential φ

0° = metering unit direction

- Pressure distribution in the bearing provides information about zones with high localized loadings
- Basis for parameter variation such as crowned bearing, for example

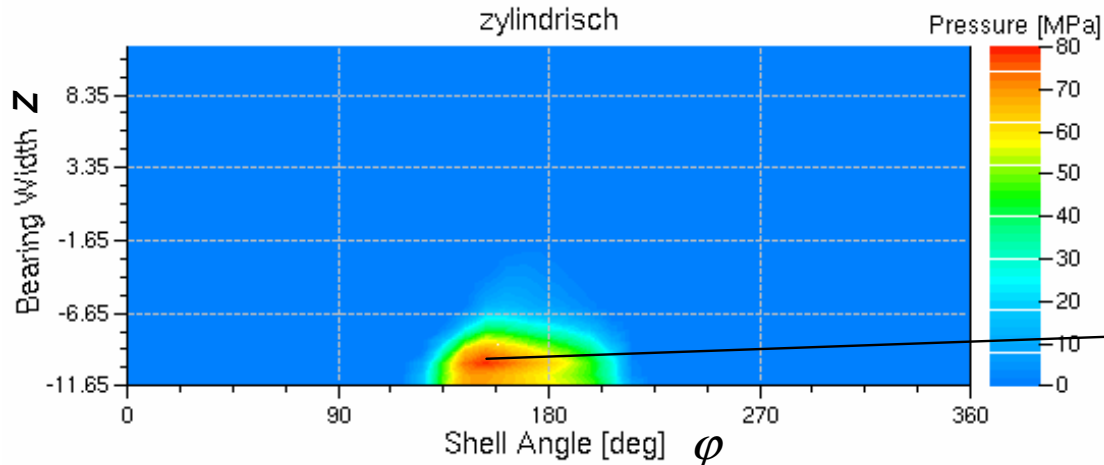
Cylindrical bearing

Example of contact pressure in the flange bearing

Asperity Contact Pressure at 264.0 deg $\rho_k(z, \varphi)$

zylindrisch

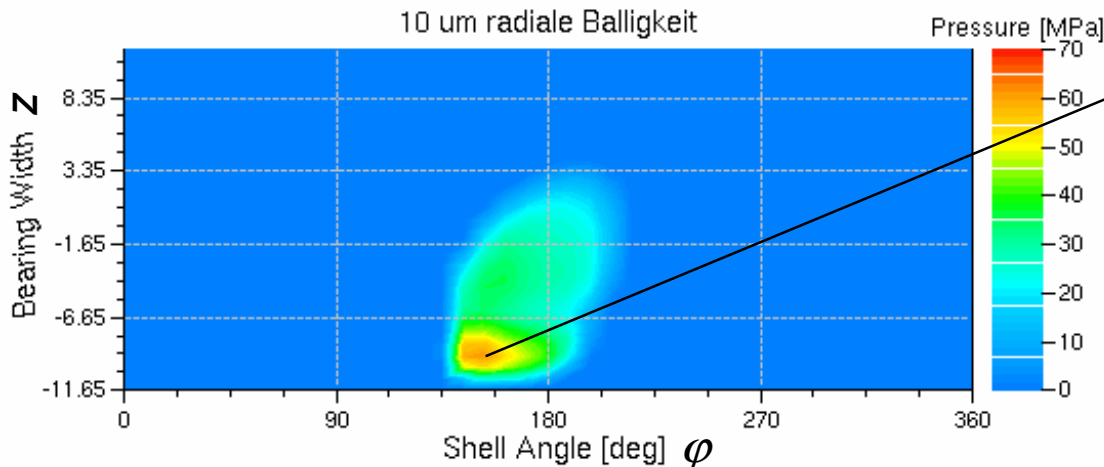
Crowned bearings

Asperity Contact Pressure at 248.0 deg $\rho_k(z, \varphi)$

10 um radiale Balligkeit

The values for the contact pressure are comparative values, not absolute values

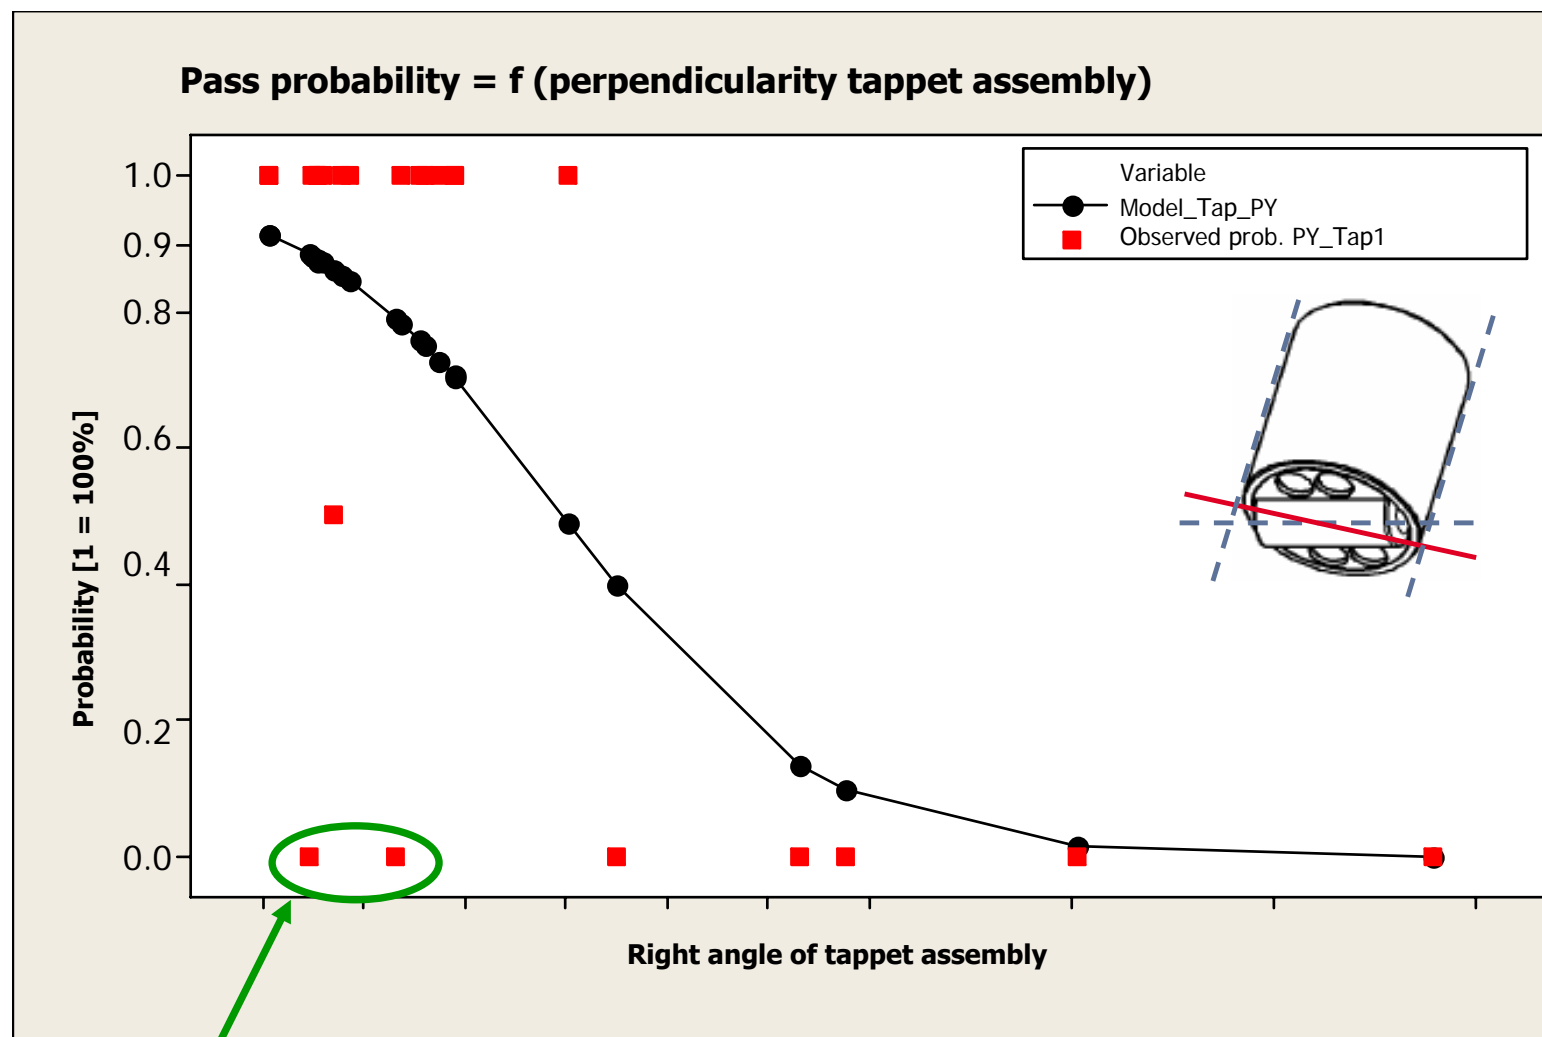
Probability for ER end – perpendicularity

Perpendicularity values of the pump #683-4337

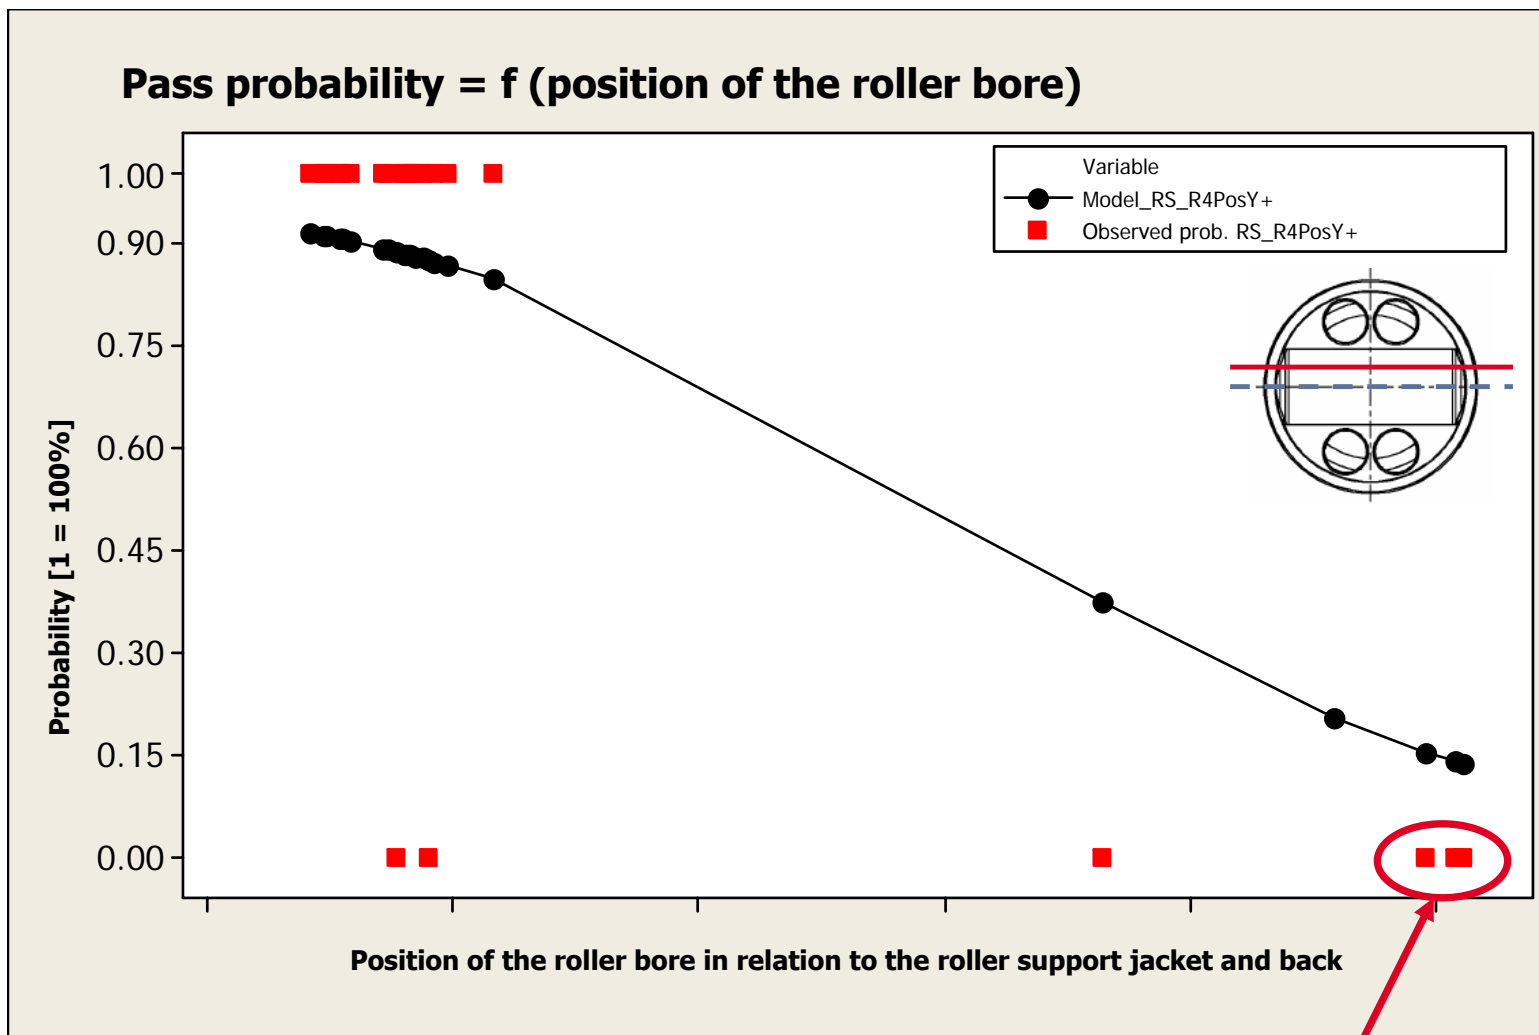
Probability for ER end – position

Position values of the pump #683-4337

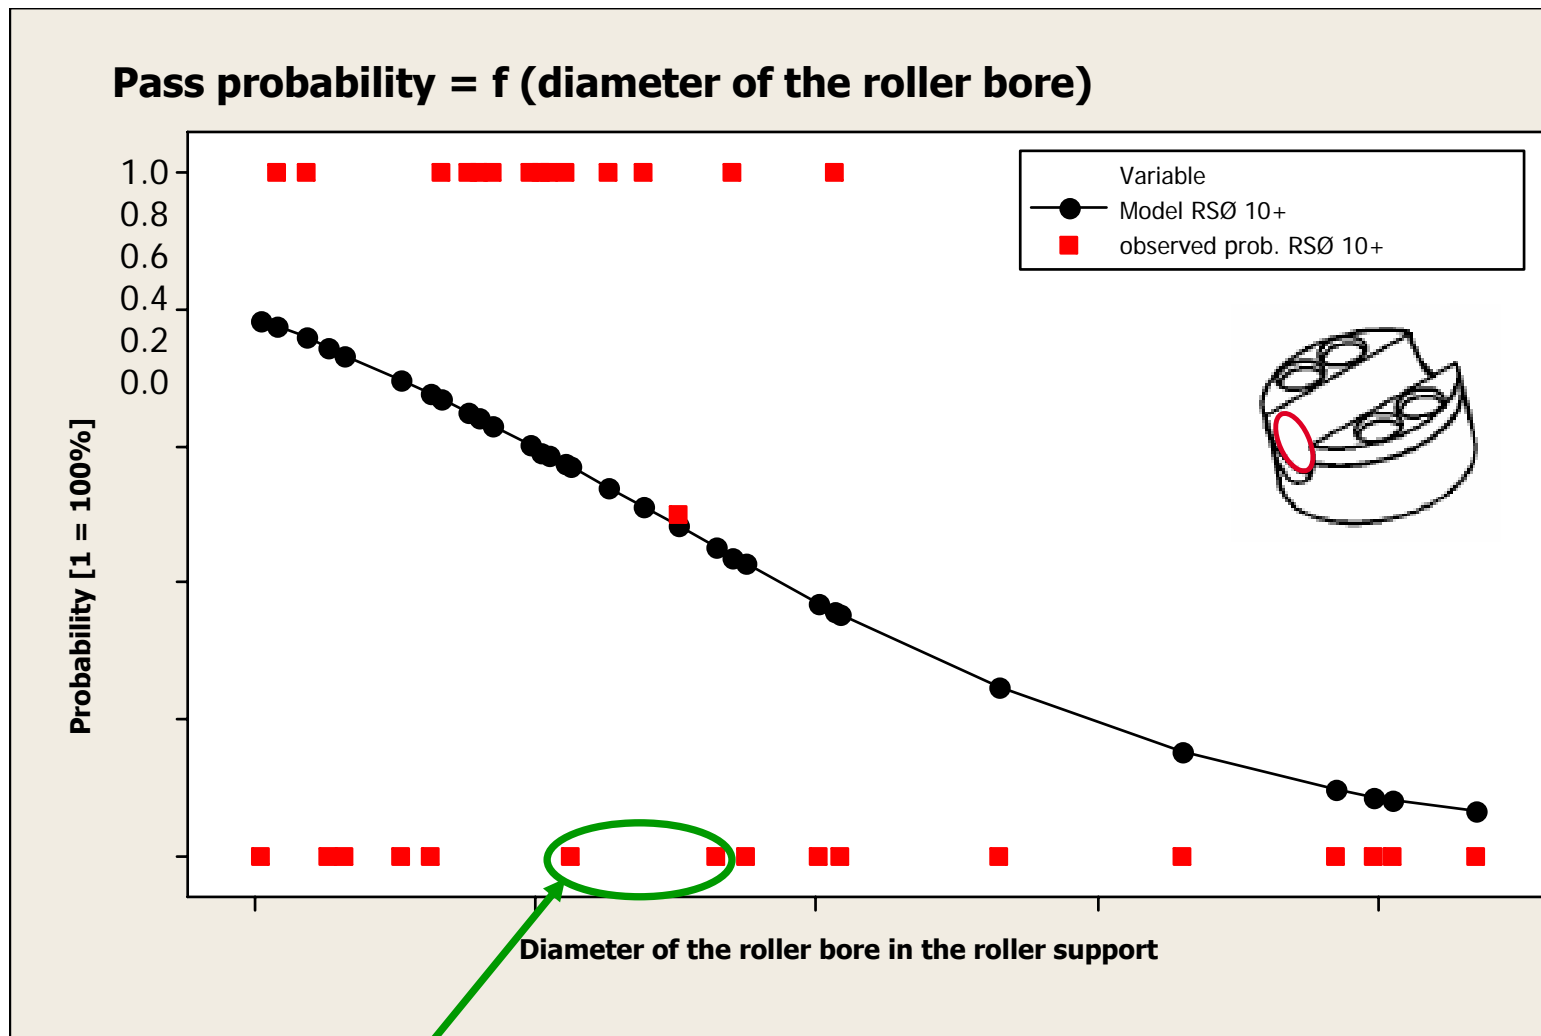
Probability for ER end – diameter

Diameter values of the pump #683-4337
