VOLKSWAGEN

Part no.: 03L.130.755.D

Intake valve and HP piston from CP4.1, run in hent removed

V6TDI Gen1 - status HPFP failures in the Touareg Bin5 MY11

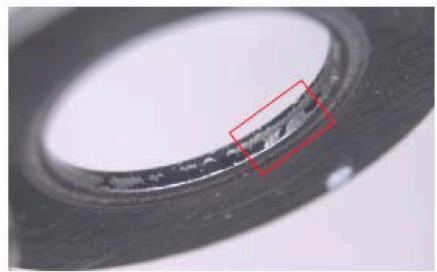
The probable damage inside the intake valve disk involves shear-marks from the stamping process.

Intake valve disk with shear-marks on the interior surface from the stamping process
