**From:** Non-responsive content removed  
**Sent:** Thursday, March 26, 2009, 3:24 PM  
**To:** Non-responsive content removed  
**Cc:** [Redacted]  
**Subject:** Subject: CP4 pre-filling / first start-up at the belt in Neckarsulm

# 1) Hypothesis of damage profile of drivetrain

**Outline of possible damage profile during drivetrain wear CP4.2 and the influencing variables**

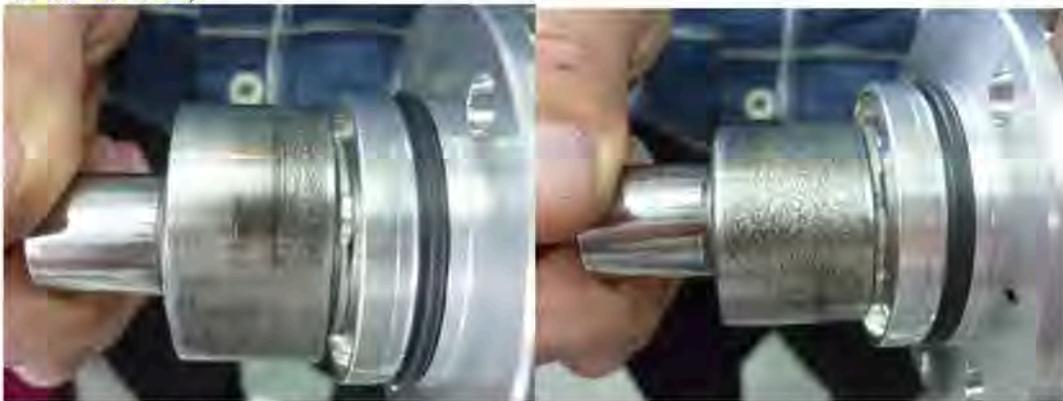
- Approach:
  - First start-up OK
  - Roller test OK
  - The vehicle failed during internal test drive
- Fuel pump seized, solid run mark and adhesive wear on the surface of the shaft (we believe that the pump has not run with sufficient or high-quality fuel - **Bosch, Audi** as on 08.10.2010)

- HP pump filled with chips
  - We could not inspect the roller towing levers that were in the laboratory
- Analysis results are provided as hard copy, it is distributed on 08.16.2010. (by Non-responsive content removed)

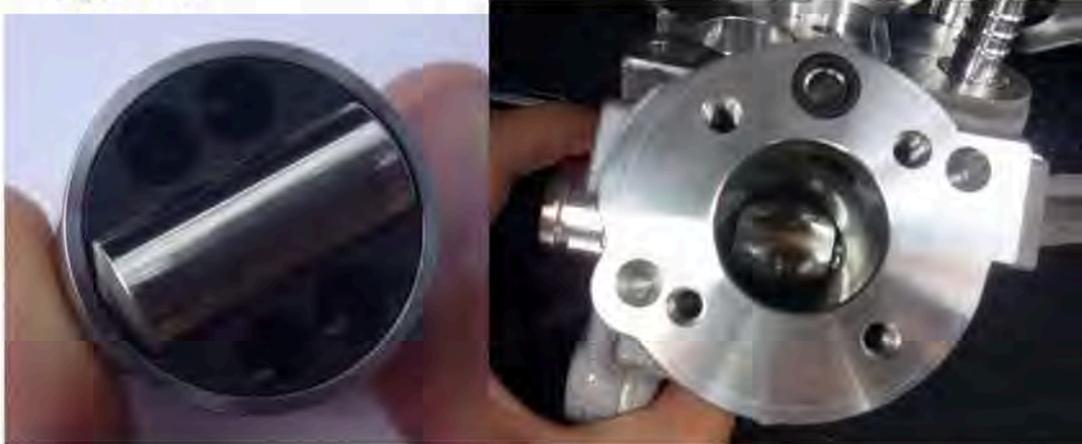
- There is brown discoloration on the surface (**overheating or deposition**) and coaxial running marks that originate most likely from machining
- Likewise, the surface of the shaft shows brown discoloration (**overheating or deposition**)

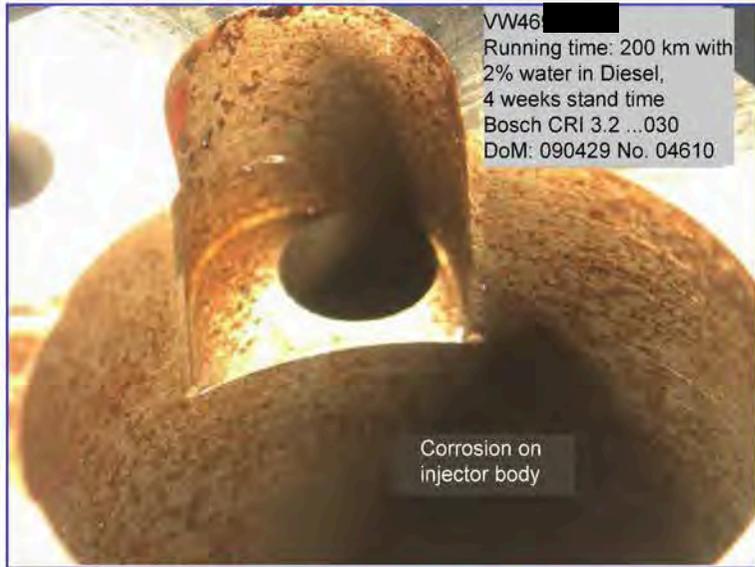
Damage to injector CRI3-2, Vehicle\_2 (VW469-8-0141, CEC +RME + 2% water)

Damage determined by [redacted] Non-responsive content removed

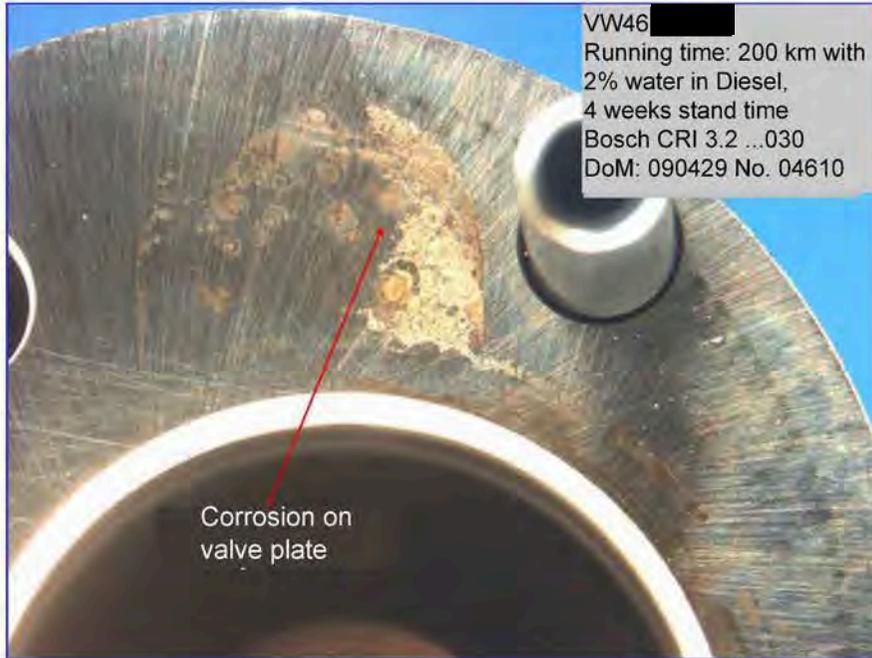
Damage to injector CRI3-2, Vehicle\_2 (VW469-8-0141, CEC +RME + 2% water)

Damage determined by [redacted] Non-responsive content removed

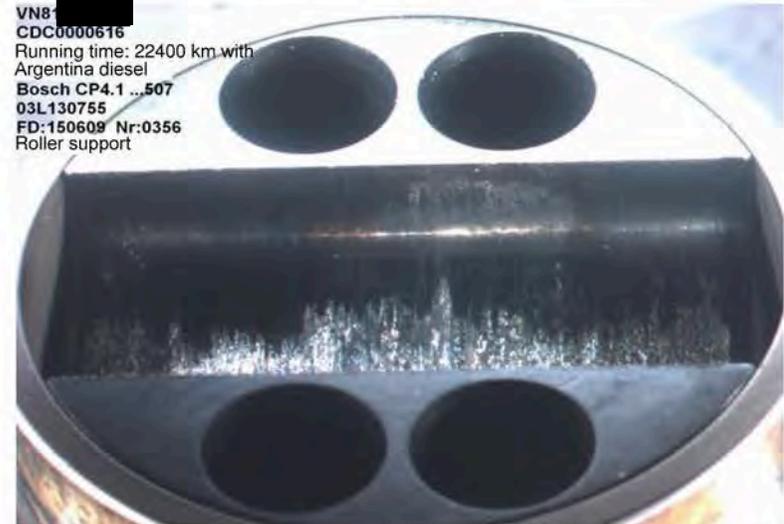
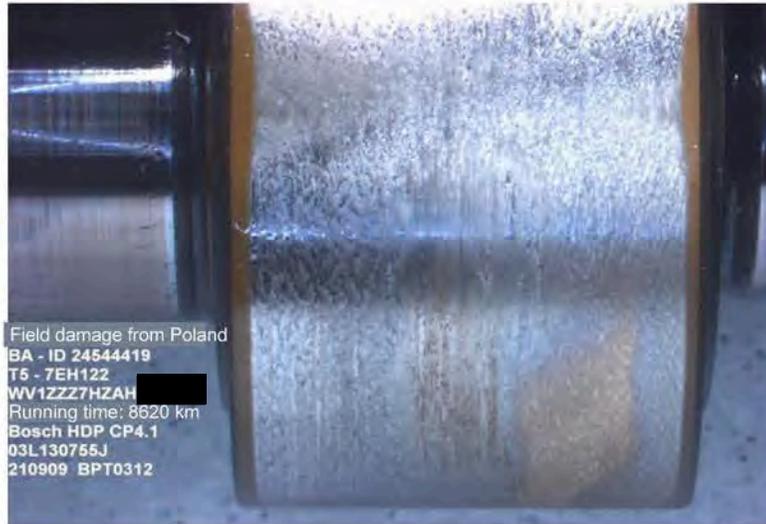
- Shavings created in high-pressure fuel pump drivetrain
  - Shavings distributed through entire fuel system
  - Malfunctions of HPP, PCV, RDS, injectors, DHV
- ⇒ Breakdowns
