# Types of friction in the high-pressure fuel pump

### CP4 Diesel high-pressure fuel pump in CR injection systems from 1800 bar (EU5)

## Actual context for drivetrain damage CP4

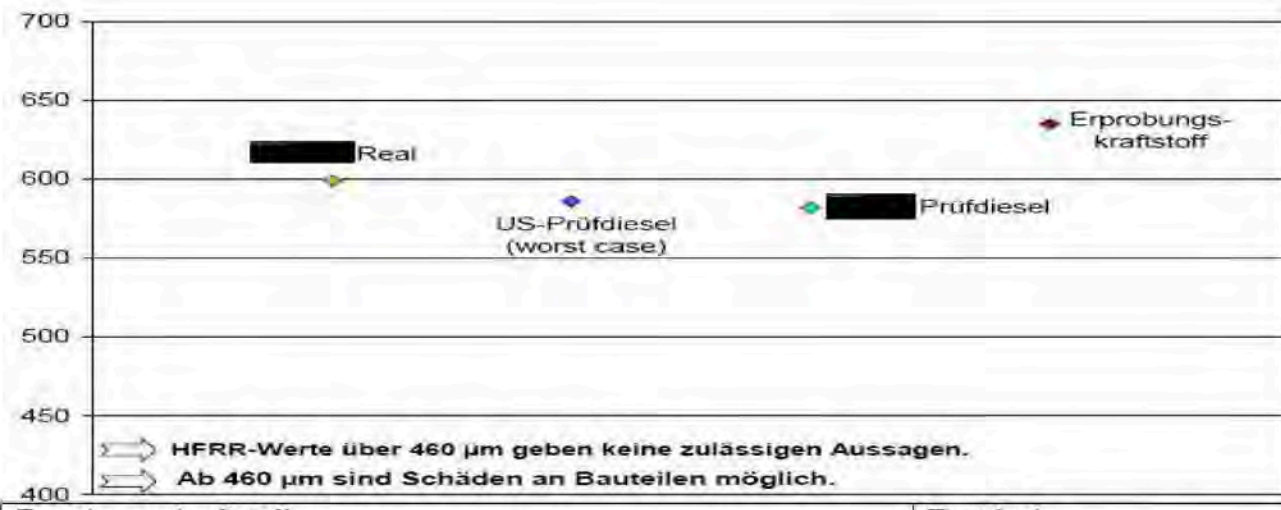
# HFRR values of various diesel fuels

Erprobungs-kraftstoff	Test fuel
US-Prüfdiesel (worst case)	Test diesel from US (worst case)
Prüfdiesel	Test diesel from
HFRR-Werte über 460 μm geben keine zulässigen Aussagen.	HFRR values over 460 μm are not meaningful
Ab 460 μm sind Schäden an Bauteilen möglich	Damage can be caused to components from 460 μm
HFRR [μm]	HFRR [μm]

- The biggest problems were encountered with test diesel from [REDACTED]
- HFRR value lower in comparison with other test fuels.
- HFRR value along does not provide reliable information about possible wear problems.
- Only a general tendency can be identified (wear is more likely for HFRR greater than 460  $\mu\text{m}$ )
- Lubricating film thicknesses can provide support.
- Better correlation between observed damage symptoms and lubrication film thickness.

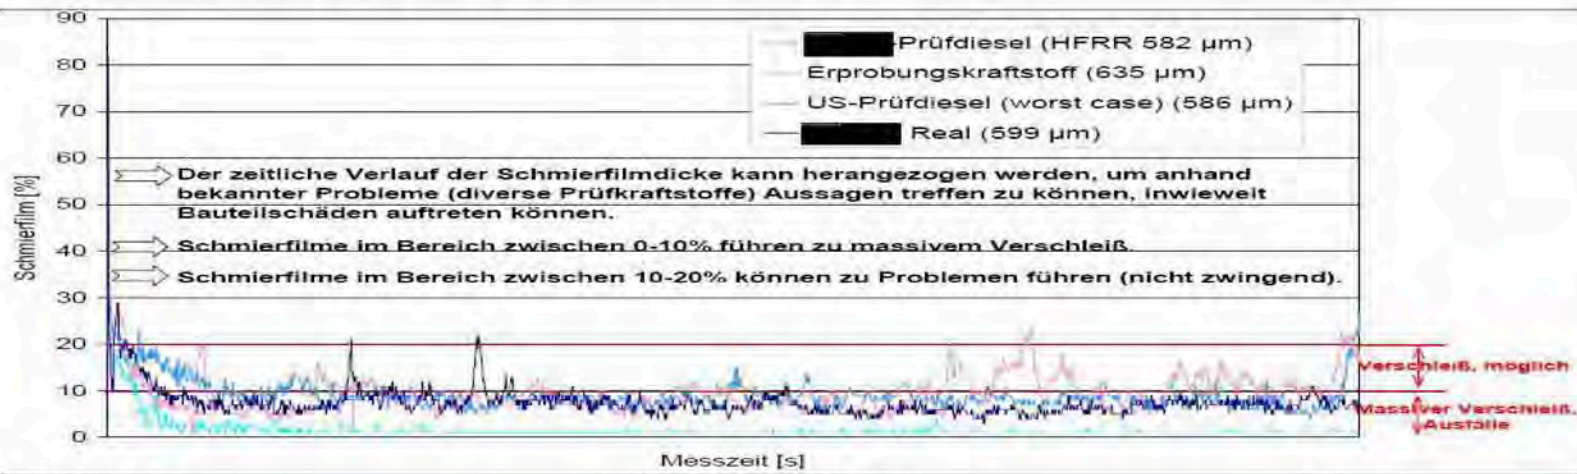
## Proposed test program for friction/wear

Indien-Prüfdiesel (HFRR 582 µm)	India test diesel (HFRR 582 µm)
Erprobungskraftstoff (635 µm)	Test fuel (635 µm)
US-Prüfdiesel (worst case) (586 µm)	US test diesel (worst case) (586 µm)
Mexico Real (599 µm)	Mexico Real (599 µm)
Der zeitliche Verlauf der Schmierfilmdicke kann herangezogen werden, um anhand bekannter Probleme (diverse Prüfkraftstoffe) Aussagen treffen zu können, inwieweit Bauteilschäden auftreten können.	The temporal development of the lubricating film can be used to offer information based on existing problems (various test fuels) indicating the extent to which component damage can occur.
Schmierfilme im Bereich zwischen 0-10% führen zu massivem Verschleiß.	Lubricating films in the 0-10% range lead to massive wear.
Schmierfilme im Bereich zwischen 10-20% können zu Problemen führen (nicht zwingend).	Lubricating films between 10-20% can lead to problems (though this not necessarily the case)

Schmierfilm [%]	Lubricating film [%]
Verschleiß, möglich	Wear, possible
Massiver verschleiß, Ausfälle	Massive wear, failures
Messzeit [S]	Measurement period

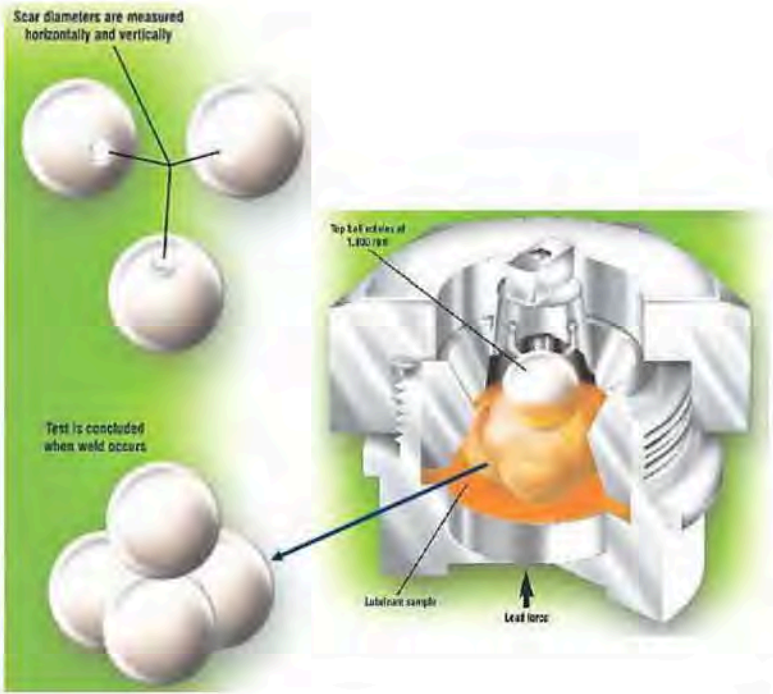
# Four Ball Bearing Device (FBBD)

The diagram illustrates the Four Ball Bearing Device (FBBD) test. It shows a central rotating shaft with four balls in contact. A lead force is applied to the top ball, and a lubricant sample is introduced. The top ball rotates at 1,800 RPM. The test is concluded when a weld occurs. Scar diameters are measured horizontally and vertically on the balls.

- Standard test method for oils
- Precision data comparable with HFR|R data
- Correlation with damage symptoms unknown (hardly any measurements with diesel)
- Method must first be adapted for diesel fuel:
  - Constant temperature required (to prevent fuel vaporization) (not currently in existence in oil method)
  - Load variation leads to vaporization (conditioning required)
  - Humidity has to be set (not the case at present)

- **Four Ball Bearing Device (FBBD):**
- Mapping of elastohydrodynamic friction (roller/camshaft)
- Boundary and mixed friction, as well as hydrodynamic friction (roller/roll shoe) ignored
- No standardized method for fuels (modification required)
- No consideration of conditions in start-stop mode (boundary and mixed friction)
- Implementation under different temperatures ( $-30 \pm 150^{\circ}\text{C}$ )
- Variable rotation of the ball bearings (10 - 5800 rpm)
- Ambient pressure

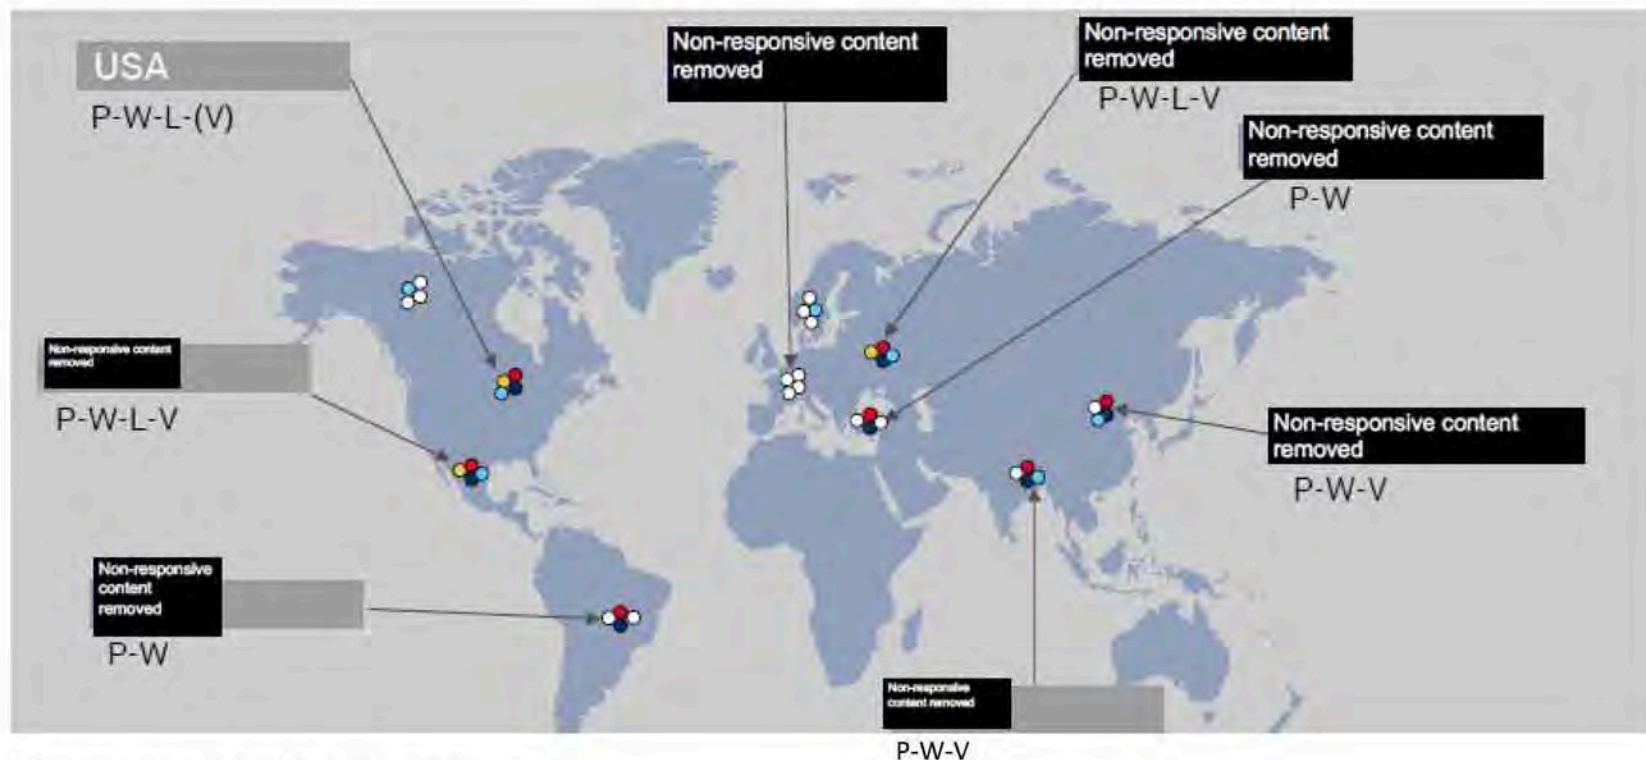
EA 1003EN-00024[5]

Water influences viscosity and lubricity

**P:** particle •    
 **W:** water •    
 **L:** lubricity •    
 **V:** viscosity •    
 nonspecific market focus •

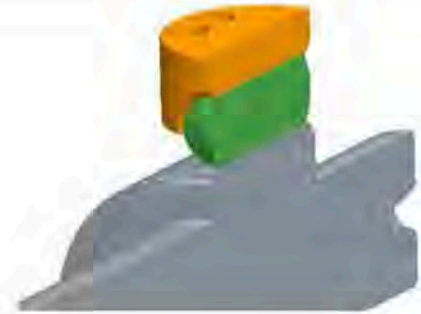
### Low lubricity (kerosene, water,...)

- causes greater wear in the roller/roller shoe combination ( up to 200 [1/min]) at start (mixed friction period)

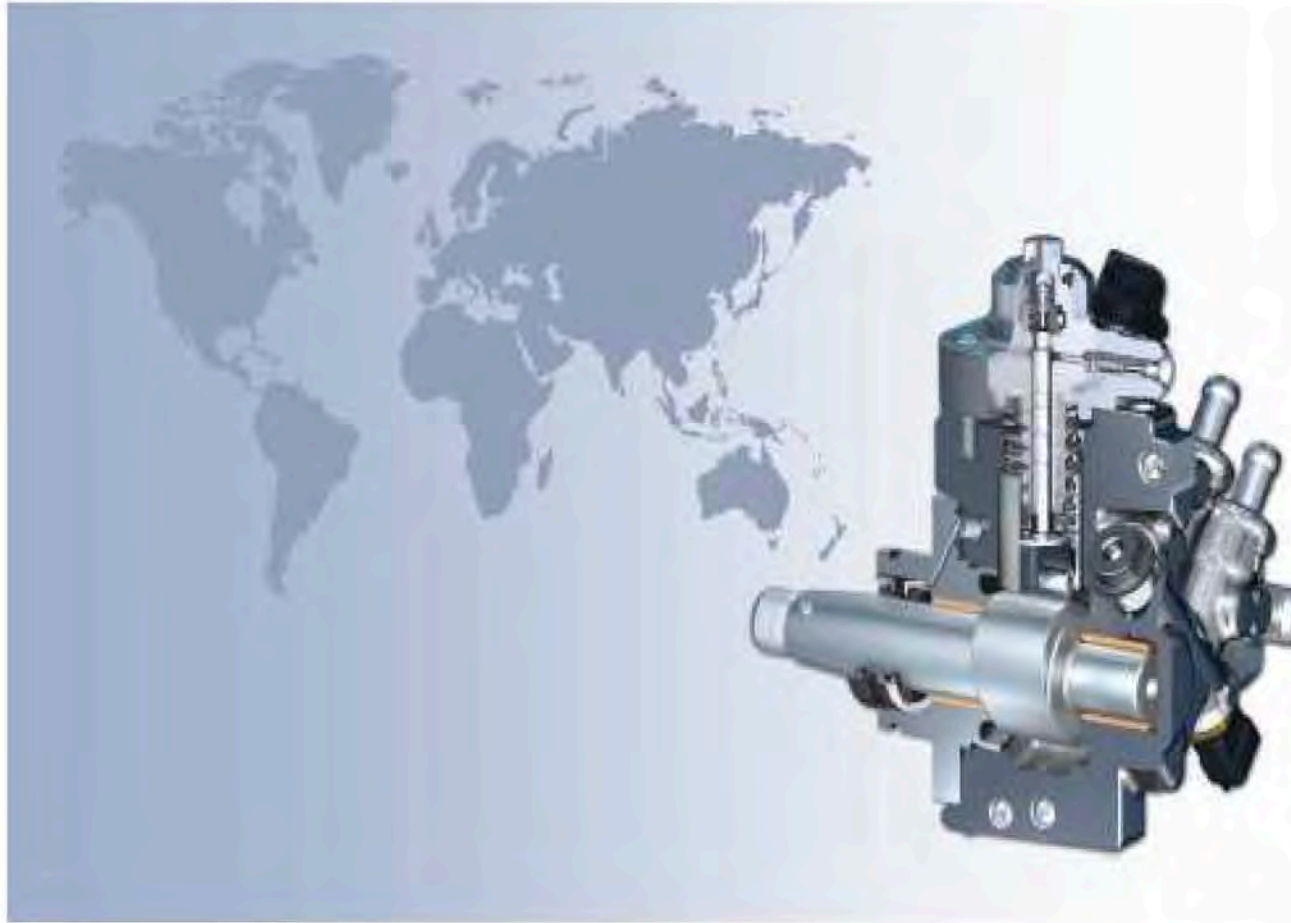
EA11003EN-00025[0]

CP4 Field situation worldwide

Differences between CP4.1 and CP4.2.

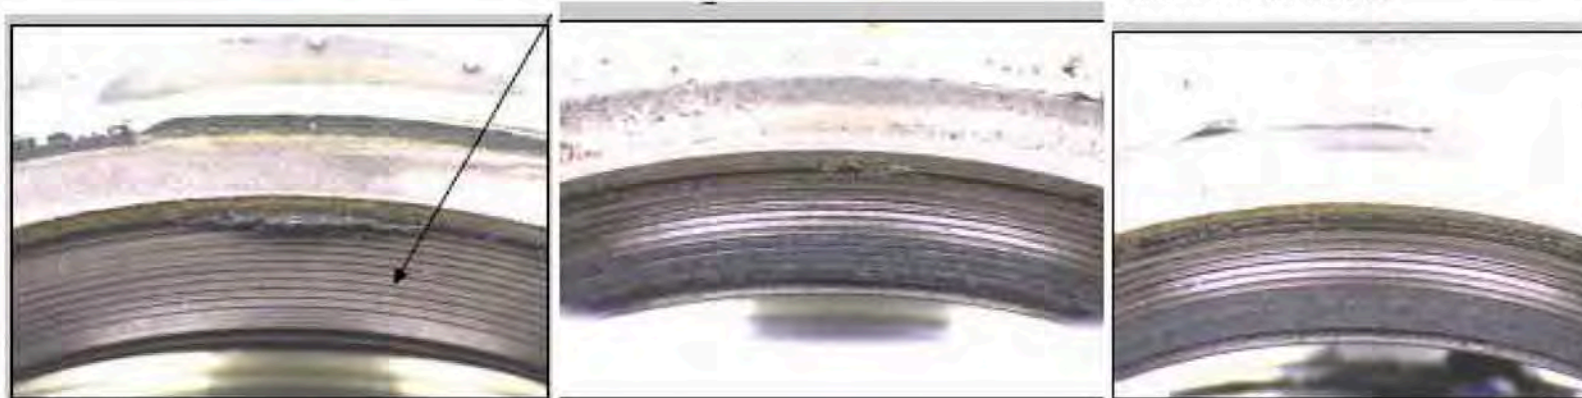
### Dependence of shaft seal wear on fuel and runtime

EN590: Viscosity 40°C = 2.5 mm<sup>2</sup>/s, HFRR<sub>60°C</sub> = 420 μm

- Depth of wear on shaft seal in the case of Audi [REDACTED] much greater than usual
- Clear indicator of poor quality fuel

Verschleißentwicklung WDR Bruss in Abhängigkeit von Kraftstoff und Laufzeit für PDL, 70 + 80°C	Development of wear on Bruss shaft seal depending on fuel and runtime for PDL, 70 + 80°C
Verschleißtiefe WDR in μm	Depth of wear on shaft seal in μm
Laufzeit in h	Runtime in hours

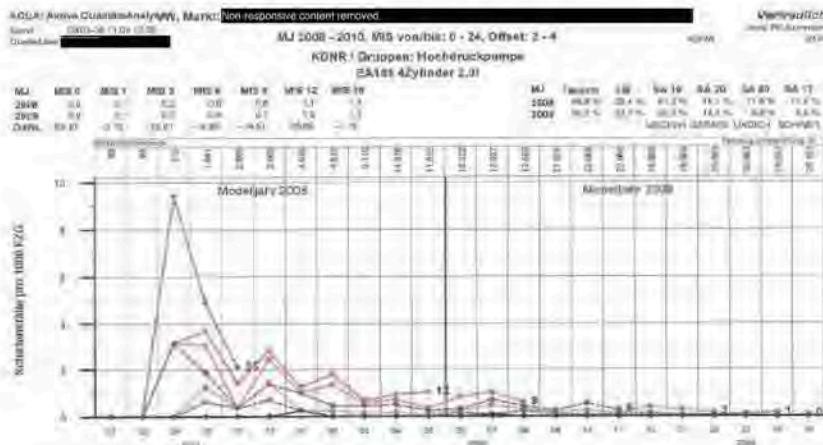
EA11003EN-00025[7]

# CP4 field situation in Italy for VW 4-cylinder TDI

- Package of measures 1**
- 1 Straightedge inspection of cam roller
  - 2 Visual check Cam roller after C coating
  - 3 Optimized C coating
  - 4 Improved cam roller texture (new second supplier)

- Package of measures 2**
5. Optimized C coating process, roller shoe
  6. Camera system for inspecting surface of cam roller
  7. C2 layer for roller instead of C3 layer

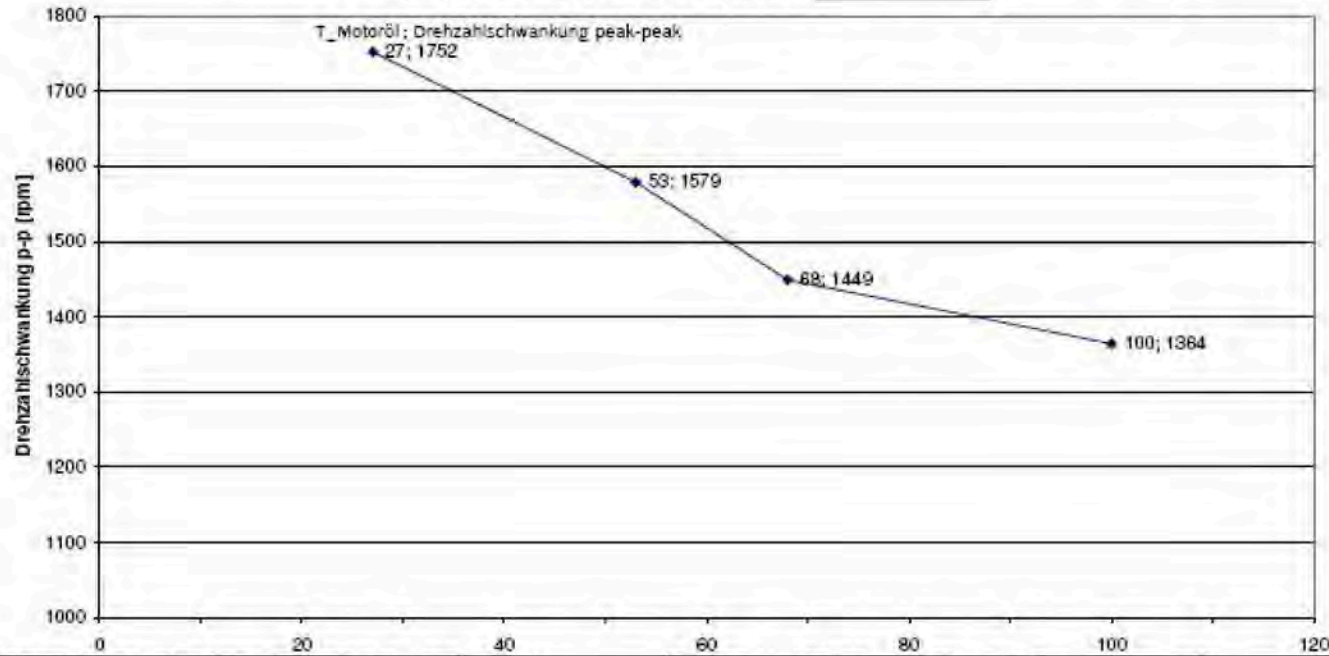
**CP4 speed variation on vehicle = f (engine oil temperature)**  
 Measurement of Q7 full load acceleration, @ 3250 rpm engine (2440 rpm pump) / 1800 bar  
 Phasing 0; roller EU5P original part Q7

T_Motoröl ; Drehzahlschwankung peak-peak	T_engine oil ; speed variation peak-peak
Motoröltemperatur [°C]	Engine oil temperature [°C]
Drehzahlschwankung p-p [rpm]	Speed variation p-p [rpm]

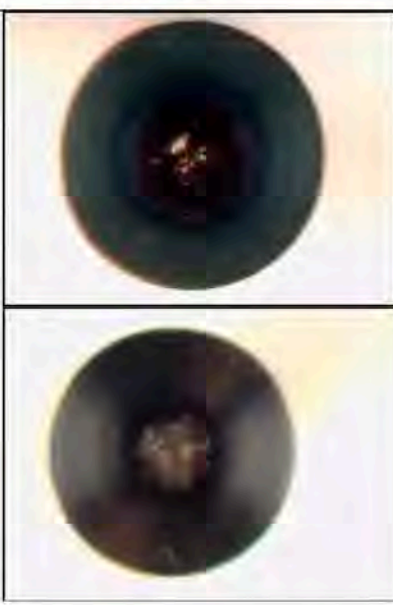
Rating	Photos	Description
6

<ul style="list-style-type: none"><li>→ several particle impacts</li><li>→ C-coating slightly worn in the middle</li></ul>

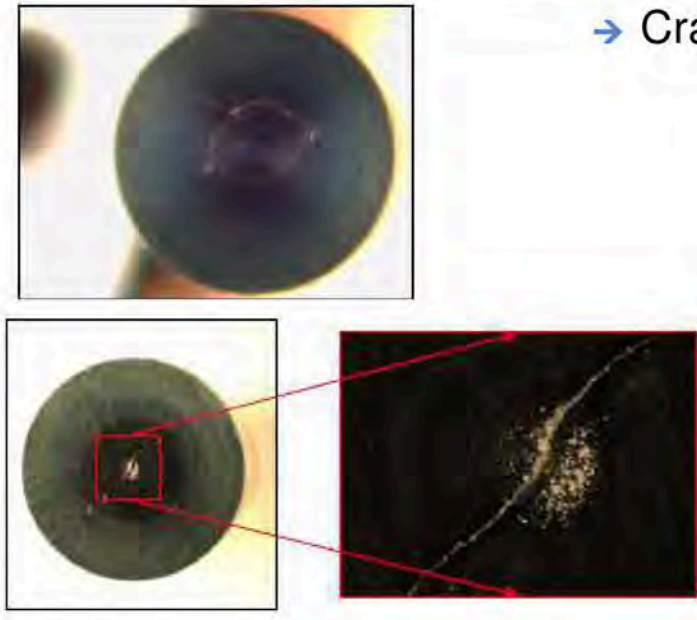
Rating	Photos	Description
7

→ Crack on piston foot

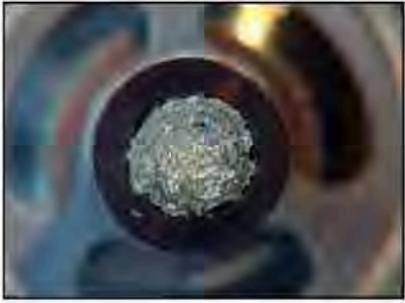
Rating	Photos	Description
7

<ul style="list-style-type: none"><li>→ Massive particle impact</li><li>→ Massive wear</li><li>→ Clear signs of seizing</li><li>→ C coating worn away on entire contact area</li></ul> <b>Breakage</b>

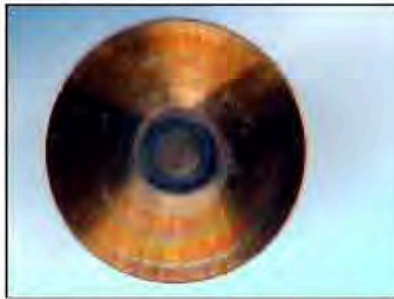
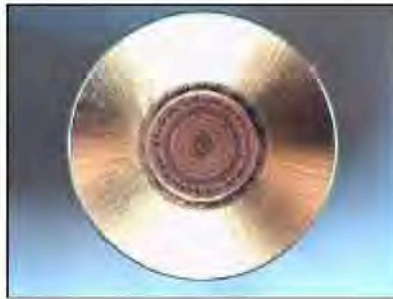
- ➔ As new
- ➔ Hardly used
- ➔ Smoothing
- ➔ Slight signs of cavitation

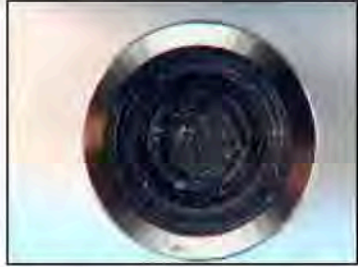
Rot  
7

- ➔ Particles extremely impacted
- ➔ Massive wear as far as the edge of the piston

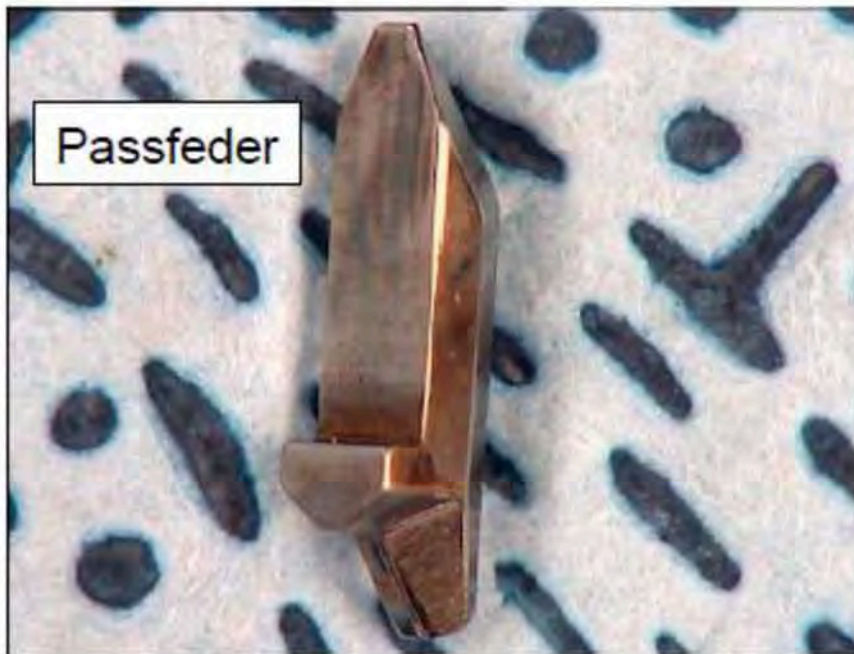
## CP4, turned tappet protection status 09.17.07

- Test status:
  - 2 pumps opened after about 500 h endurance run
  - Visual findings does not show any critical anomalies.  
Solution has the potential for start of production.

Passfeder

Feather key

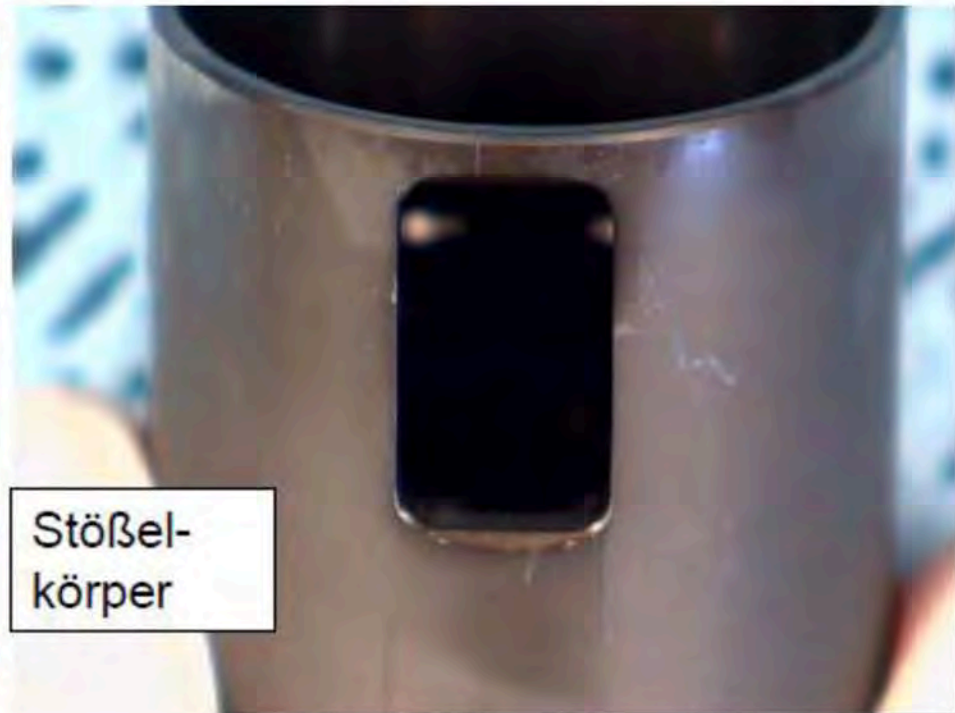
Stößel-  
körper

Tappet body

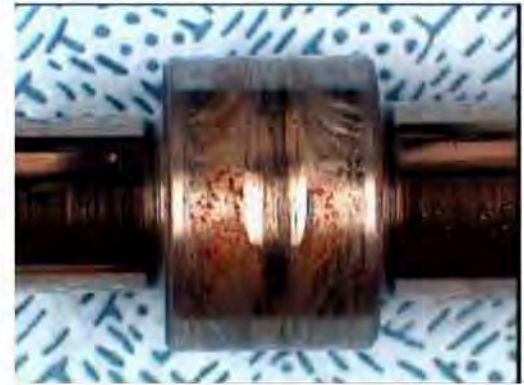
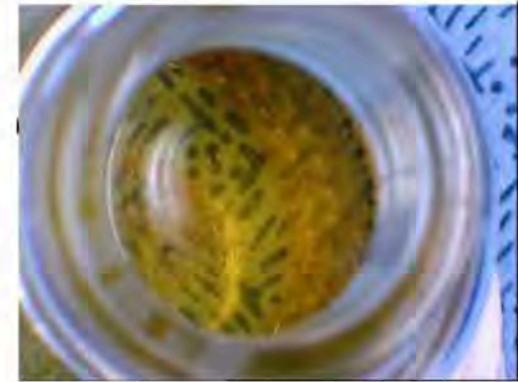
- Pump no.: 081206 0049
  - TT no.: 0045 B21 058
  - DS-PC/EDI receipt: 10/12/2007
  - VW complaint: Chips in the high-pressure pump
  - Testing conditions are not known yet
- 
- First results
    - Drivetrain damage with a 90° turned roller
    - Corrosion on running surface
    - Free water in the pump!
