Bulletin No.: 12106B Date: January 2013

PRODUCT SAFETY RECALL

SUBJECT: Shift Lever Indicator May Not Display Correct Gear

MODELS: 2008-2010 Chevrolet Malibu

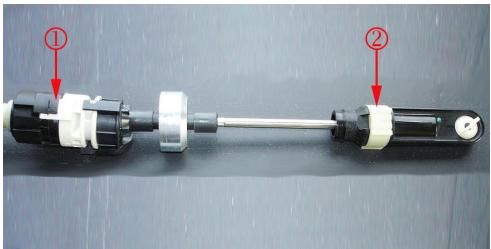
2269489

Note: Perform the service repair procedure in this bulletin on second design transmission shift cables only. First design transmission shift cables do NOT require a repair. Refer to the illustration to view a first design shift cable. Refer to *Transmission Shift Cable Kit Installation Procedure* in this bulletin to view the second design transmission shift cable.

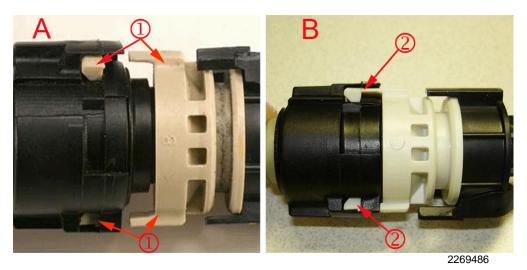
2. Determine if the transmission shift cable locking tabs are fractured and separated.

- If the transmission shift cable locking tabs (1) are fractured and separated (A), remove the transmission shift cable and replace it with a new one. Refer to Floor Shift Control Cable Replacement or Range Selector Lever Cable Replacement in SI. Also install a transmission shift cable kit with the new shift cable.
- If the transmission shift-cable locking tabs (2) are NOT fractured and separated (B), install the transmission shift cable kit. Proceed to Step 3.

Dealers are to install a retainer over the transmission shift cable end fitting. If the end fitting tabs are fractured, the shift cable must be replaced.

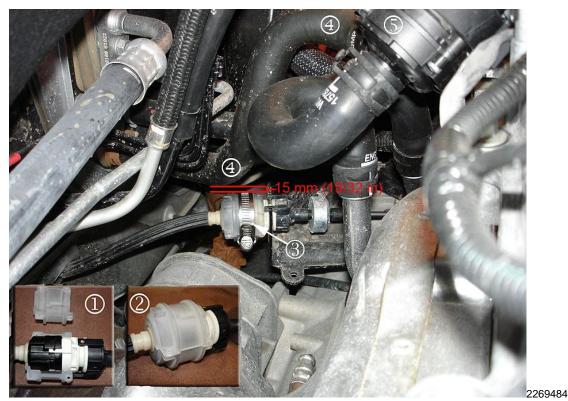
Hybrid vehicle shown. Combustion engine vehicle is similar.

Caution: Do not kink or damage the inlet coolant hose (4) when repositioning the hose to obtain the 15 mm (19/32 in) clearance. To avoid damaging the hose clamp, use J-38185 or equivalent hose clamp pliers to loosen the hose clamp.

- 5.1. Using J-38185 or equivalent hose clamp pliers, loosen the inlet coolant hose (4) connected to the heater cooler pump (5). Note the location of the clamp on the inlet coolant hose (4).
- 5.2. Rotate the inlet coolant hose (4) clockwise until 15 mm (19/32 in) of clearance between the inlet coolant hose (4) and clam shell (3) is achieved.
- 5.3. Ensure that the inlet coolant hose clamp is secure on the inlet coolant hose (4) in the production location.
- 5.4. Install the generator control module cover. Refer to Generator Control Module Cover Replacement in SI.
- 6. Close the hood.

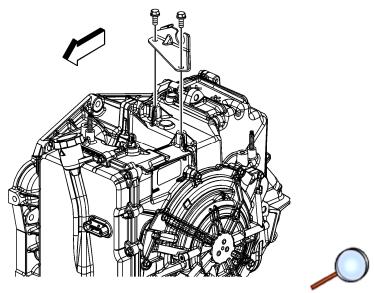
- 5. Remove the shift control cable bracket bolts.
- 6. Remove the shift control cable bracket.

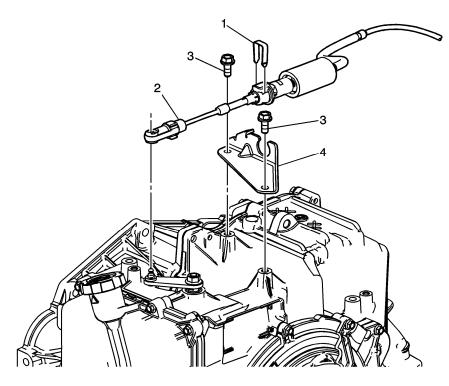
Range Selector Lever Cable Bracket Replacement

range corector zover easie zracket resplacement							
Callout	Component Name						
Preliminary Procedures							
 Set the park brake and chock the wheels. Remove the battery tray. Refer to <u>Battery Tray Replacement</u>. 							
1	Transmission Range Selector Lever Cable Retainer						
2	Transmission Range Selector Lever Cable						
3	Transmission Range Selector Lever Cable Bracket Bolt Notice: Refer to Fastener Notice. Tighten 25 Y (18 lb ft)						
4	Transmission Range Selector Lever Cable Bracket

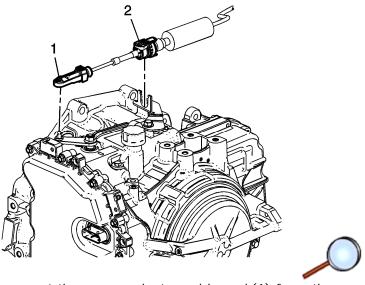
- 2. Disconnect the range selector cable end (1) from the range selector lever.
- 3. Disconnect the range selector cable (2) from the range selector cable bracket.

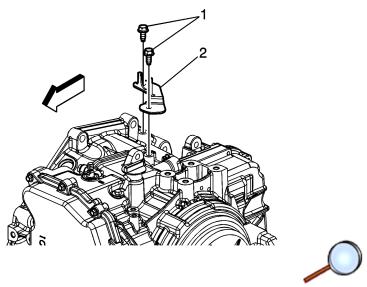
1. Install the transmission range selector cable bracket (2).

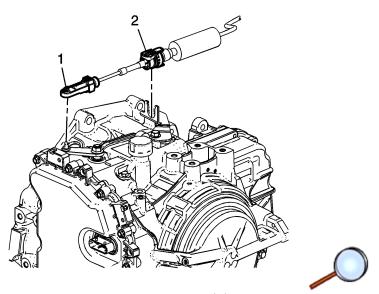
- 3. Connect the range selector cable (2) to the range selector cable bracket.
- 4. Connect the range selector cable end (1) to the range selector lever.
- 5. Check the range selector cable adjustment. Refer to <u>Range Selector Lever Cable Adjustment</u>.

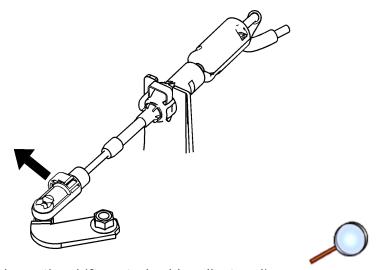
4. Release the shift control cable adjuster clip.

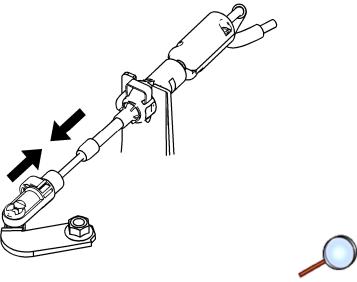
5. Slide the two halves of the shift control cable together until all free play is removed.

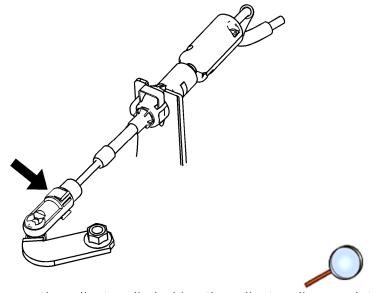
- 6. Depress the adjuster clip locking the adjuster clip completely.
- 7. Pull both halves of the cable in opposite directions to verify the cable adjuster is secured.
- 8. Check the transaxle shift control lever in all gear selections for proper operation.

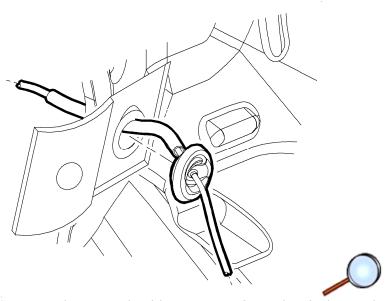
- 5. Remove the control cable grommet from the dash panel.
- 6. Remove the control cable from the vehicle.

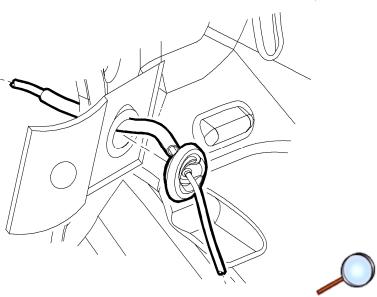
- 1. Guide the control cable through the pass-through in the dash panel.
- 2. Secure the control cable grommet by pressing the cable into the pass-through hole in the dash panel.

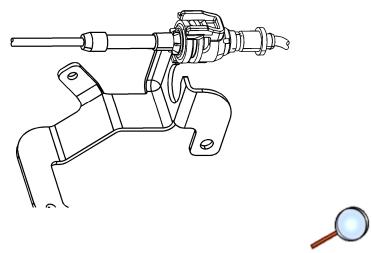
3. Install the control cable into the transmission bracket, push down until the tabs lock the cable to the bracket.

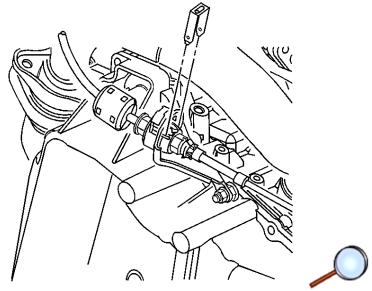
2. Fully lift the retainer from the transaxle range selector cable mechanism.

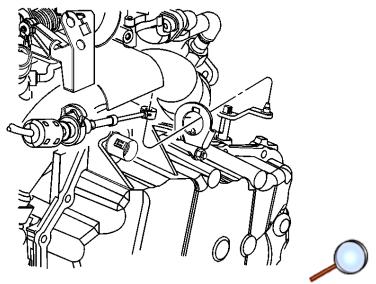
- 3. Disconnect the transaxle range selector cable terminal from the transaxle manual shift lever pin.
- 4. Press the locking tabs inward in order to release the transaxle range selector cable from the bracket.
- 5. Remove the console. Refer to Console Replacement.

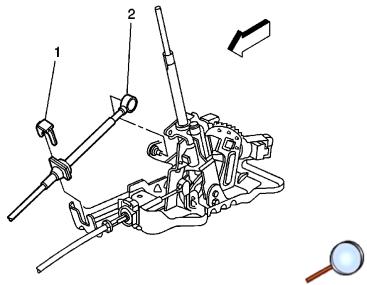
- 6. Disconnect the transaxle range selector cable terminal from the shift lever pin.
- 7. Pull the lock release (1) and remove the transaxle range selector cable (2) from the console.

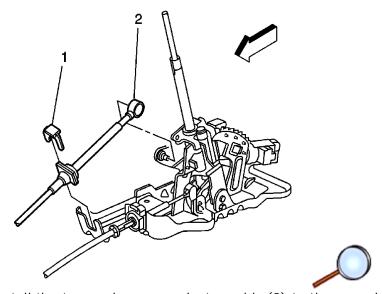
- 2. Install the transaxle range selector cable (2) to the console.
- 3. Install the lock release (1) to the range selector cable.
- 4. Connect the transaxle range selector cable terminal to the shift lever pin.
- 5. Install the console. Refer to Console Replacement.

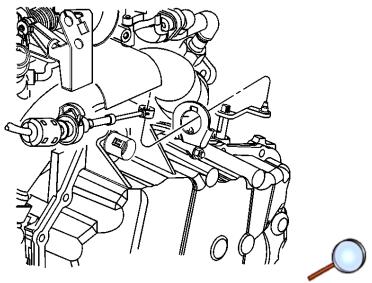
- 6. Install the transaxle range selector cable into the bracket.
- 7. Connect the transaxle range selector cable terminal to the transaxle manual shift lever pin.

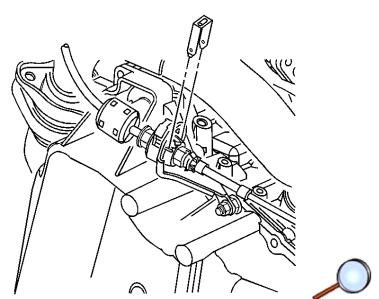
- 8. Insert the retainer to the transaxle range selector cable mechanism.
- 9. Adjust the automatic transmission range selector cable. Refer to <u>Range Selector Lever Cable Adjustment</u>.

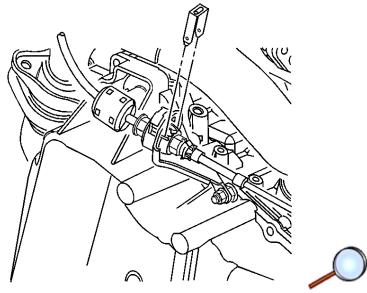
2. Remove the retainer from the transaxle range selector cable mechanism.

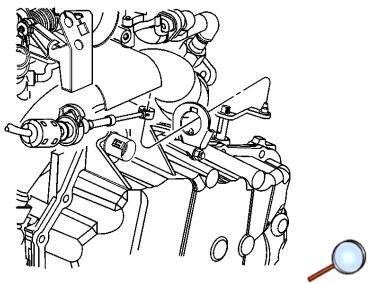
- 3. Disconnect the transaxle range selector cable terminal from the transaxle manual shift lever pin.
- 4. Press the locking tabs inward in order to release the transaxle range selector cable from the bracket.
- 5. Remove the console. Refer to Console Replacement.
- 6. Remove the Body Control Module. Refer to <u>Body Control Module Replacement</u>.
- 7. Remove the BCM mounting beacket Motors. All rights reserved.

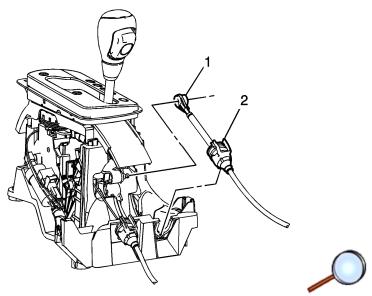
- 9. Disconnect the transaxle shift control cable terminal (1) from the shift lever pin.
- 10. Release the transaxle shift control cable retainer (2) and remove the transaxle range selector cable from the transaxle control lever base.

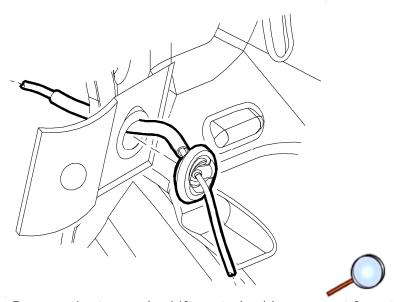
- 11. Remove the transaxle shift control cable grommet from the cowl panel.
- 12. Remove the transaxle shift control cable from the vehicle.

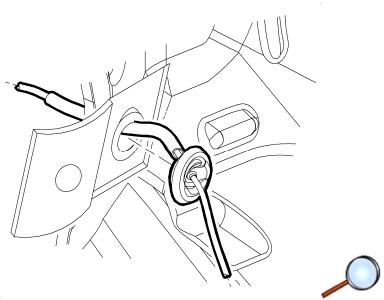
- 1. Guide the transaxle shift control cable through the pass-through in the cowl panel.
- 2. Secure the transaxle shift control cable grommet by pressing the grommet into the pass-through hole in the cowl panel.

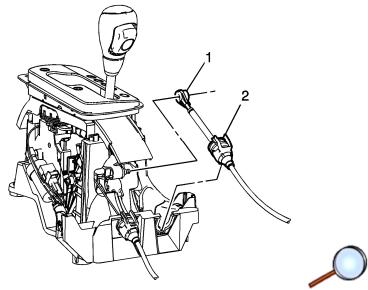
- 3. Install the transaxle shift control cable to the transaxle control lever base. Insure the cable retainer (2) is fully secured to the transaxle control lever base.
- 4. Connect the transaxle shift control cable terminal (1) to the shift lever pin.
- 5. Connect shift cable to floor retaining clips.
- 6. Install the BCM mounting bracket.
- 7. Install the Body Control Module. Refer to Body Control Module Replacement.
- 8. Install the console. Refer to Console Replacement.

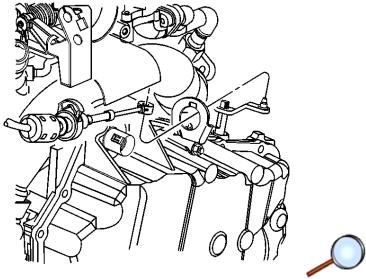
- 9. Install the transaxle range selector cable into the bracket.
- 10. Connect the transaxle range selector cable terminal to the transaxle manual shift lever pin.

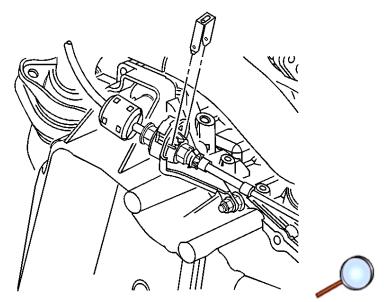
- 11. Install the retainer to the transaxle range selector cable.
- 12. Adjust the automatic transmission range selector cable. Refer to <u>Range Selector Lever Cable Adjustment</u>.

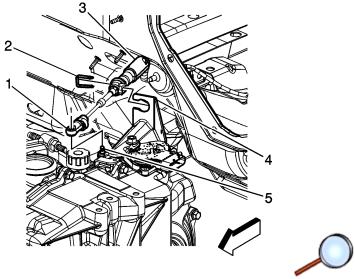
- 2. Disconnect the transaxle shift control cable terminal (1) from the transaxle manual shift lever pin (5).
- 3. Remove the retainer (2) from the transaxle shift control cable.
- 4. Press the locking tabs inward in order to release the transaxle shift control cable (3) from the cable bracket (4).
- 5. Remove the console. Refer to Console Replacement.

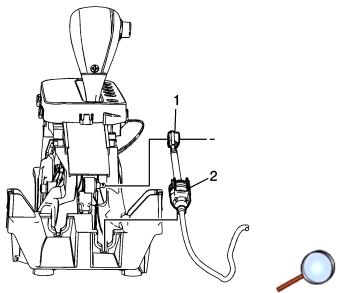
6. Disconnect the transaxle shift control cable terminal (1) from the shift lever pin. © 2013 General Motors. All rights reserved.

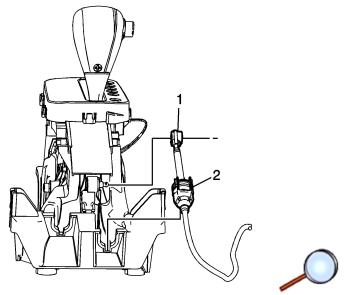
- 7. Install the transaxle shift control cable to the transaxle control lever base. Insure the cable retainer (2) is fully secured to the transaxle control lever base.
- 8. Connect the transaxle shift control cable terminal (1) to the shift lever pin.
- 9. Install the console. Refer to Console Replacement.

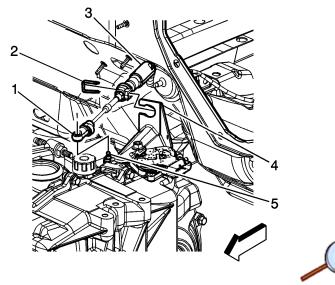
- 10. Install the transaxle shift control cable (3) to the cable bracket (4).
- 11. Install the retainer (2) to the transaxle shift control cable.

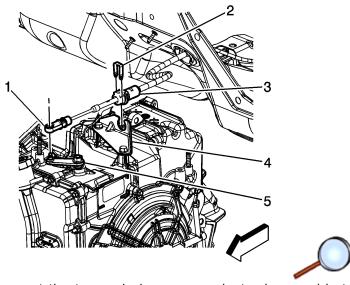
- 3. Disconnect the transmission range selector lever cable terminal (1) from the transmission manual shift lever pin (5).
- 4. Remove the retainer (2) from the transmission range selector lever cable.
- 5. Press the locking tabs inward in order to release the transmission range selector lever cable (3) from the cable bracket (4).
- 6. Remove the console. Refer to Console Replacement.

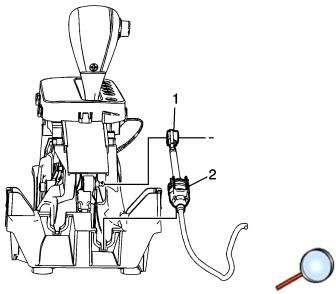
- 3. Install the transmission range selector lever cable to the transmission control lever base. Insure the cable retainer (2) is fully secured to the transmission control lever base.
- 4. Connect the transmission range selector lever cable terminal (1) to the shift lever pin.
- 5. Install the console. Refer to Console Replacement.

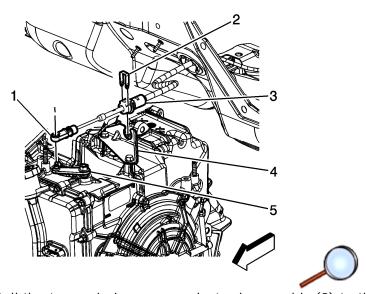
- 6. Install the transmission range selector lever cable (3) to the cable bracket (4).
- 7. Install the retainer (2) to the transmission range selector lever cable.
- 8. Connect the transmission range selector lever cable terminal (1) to the transmission manual shift lever pin (5).
- 9. Install the radiator surge tank to the original position.
- 10. Adjust the automatic transmission range selector lever cable. Refer to <u>Range Selector</u> <u>Lever Cable Adjustment</u>.

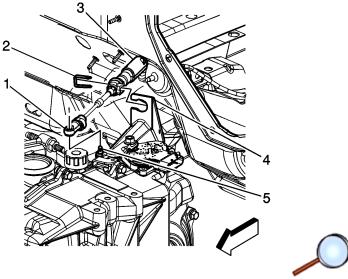
- 2. Disconnect the transaxle shift control cable terminal (1) from the transaxle manual shift lever pin (5).
- 3. Remove the retainer (2) from the transaxle shift control cable.
- 4. Press the locking tabs inward in order to release the transaxle shift control cable (3) from the cable bracket (4).
- 5. Remove the console. Refer to Console Replacement.

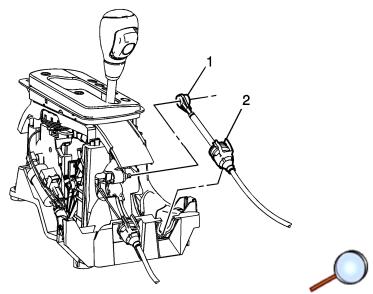
6. Disconnect the transaxle shift control cable terminal (1) from the shift lever pin. © 2013 General Motors. All rights reserved.

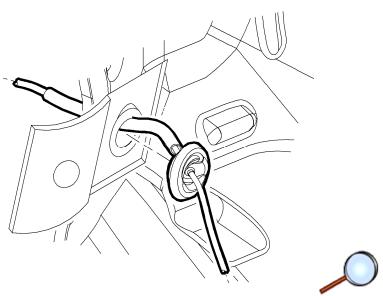
- 8. Remove the transaxle shift control cable grommet from the cowl panel.
- 9. Remove the transaxle shift control cable from the vehicle.

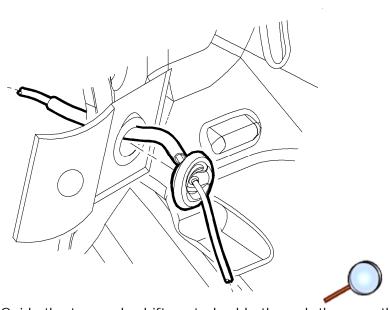
- 1. Guide the transaxle shift control cable through the pass-through in the cowl panel.
- 2. Secure the transaxle shift control cable grommet by pressing the grommet into the pass-through hole in the cowl panel.

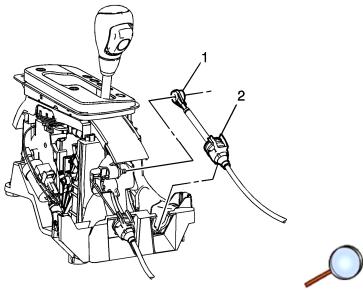
- 3. Install the transaxle shift control cable to the transaxle control lever base. Insure the cable retainer (2) is fully secured to the transaxle control lever base.
- 4. Connect the transaxle shift control cable terminal (1) to the shift lever pin.
- 5. Install the console. Refer to Console Replacement.

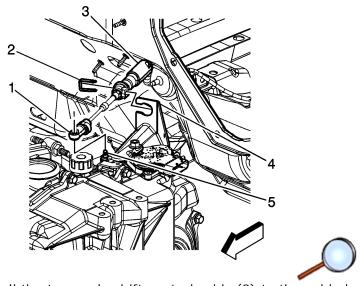
- 6. Install the transaxle shift control cable (3) to the cable bracket (4).
- 7. Install the retainer (2) to the transaxle shift control cable.
- 8. Connect the transaxle shift control cable terminal (1) to the transaxle manual shift lever pin (5).
- 9. Adjust the control cable assembly. Refer to Shift Control Cable Adjustment.

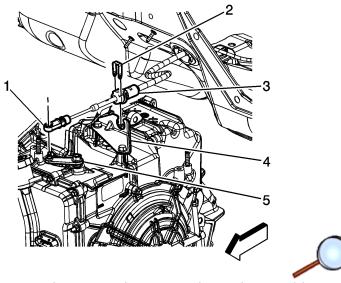
- 2. Disconnect the transaxle range selector lever cable terminal (1) from the transaxle manual shift lever pin (5).
- 3. Remove the retainer (2) from the transaxle range selector lever cable.
- 4. Press the locking tabs inward in order to release the transaxle range selector lever cable (3) from the cable bracket (4).
- 5. Remove the console. Refer to Console Replacement.

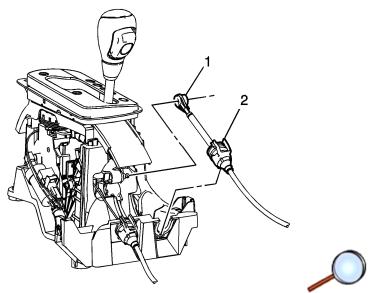
6. Disconnect the transaxle range selector lever cable terminal (1) from the shift lever pin. © 2013 General Motors. All rights reserved.

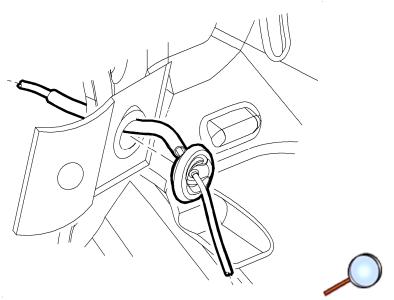
- 8. Remove the transaxle range selector lever cable grommet from the cowl panel.
- 9. Remove the transaxle range selector lever cable from the vehicle.

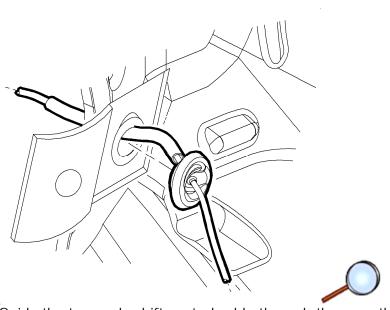
- 1. Guide the transaxle shift control cable through the pass-through in the cowl panel.
- 2. Secure the transaxle shift control cable grommet by pressing the grommet into the pass-through hole in the cowl panel.

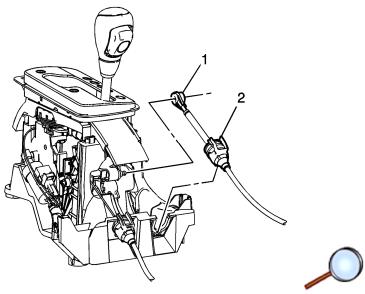
- 3. Install the transaxle range selector lever cable to the transaxle control lever base. Ensure the cable retainer (2) is fully secured to the transaxle control lever base.
- 4. Connect the transaxle range selector lever cable terminal (1) to the shift lever pin.
- 5. Install the console. Refer to Console Replacement.

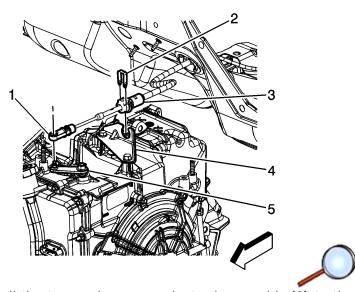
- 6. Install the transaxle range selector lever cable (3) to the cable bracket (4).
- 7. Install the retainer (2) to the transaxle range selector lever cable.
- 8. Connect the transaxle range selector lever cable terminal (1) to the transaxle manual shift lever pin (5).
- 9. Adjust the automatic transmission range selector lever cable. Refer to <u>Range Selector Lever Cable Adjustment</u>.

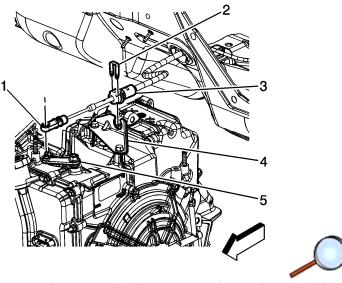
- 2. Disconnect the transmission range selector lever cable terminal (1) from the transmission manual shift lever pin (5).
- 3. Remove the retainer (2) from the transmission range selector lever cable.
- 4. Press the locking tabs inward in order to release the transmission range selector lever cable (3) from the cable bracket (4).
- 5. Remove the console. Refer to Front Floor Console Replacement.

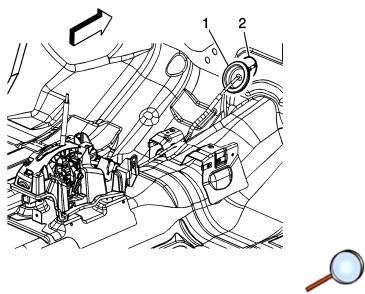
- 1. Install the transmission range selector lever cable to the vehicle.
- 2. Install the transmission range selector lever cable grommet (1) to the cowl panel.

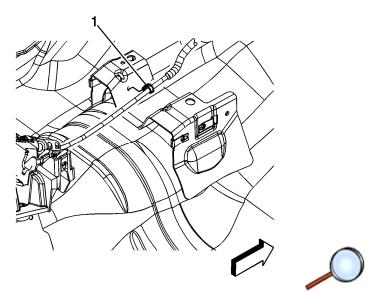
3. Attach the transmission range selector lever cable retainer.

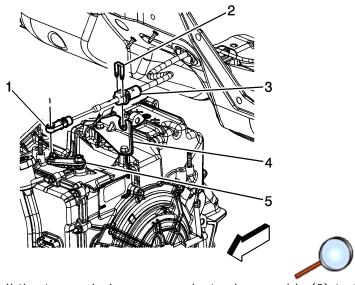
- 7. Install the transmission range selector lever cable (3) to the cable bracket (4).
- 8. Install the retainer (2) to the transmission range selector lever cable.
- 9. Connect the transmission range selector lever cable terminal (1) to the transmission manual shift lever pin (5).
- 10. Adjust the automatic transmission range selector lever cable. Refer to <u>Range Selector Lever Cable Adjustment</u>.

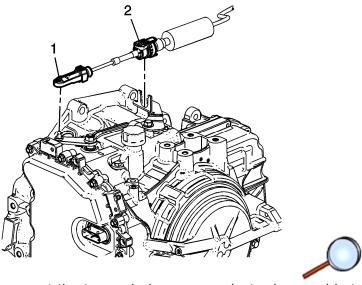
- 2. Disconnect the transmission range selector lever cable terminal (1) from the transmission manual shift lever pin.
- 3. Press the locking tabs inward in order to release the transmission range selector lever cable (2) from the cable bracket.
- 4. Remove the console. Refer to <u>Front Floor Console Replacement</u>.

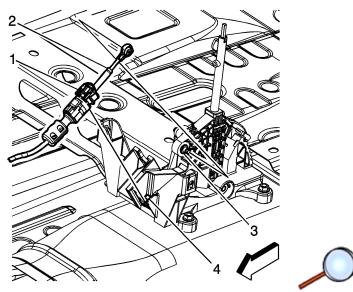
5. Disconnect the transmission range selector lever cable terminal (2) from the shift lever pin.

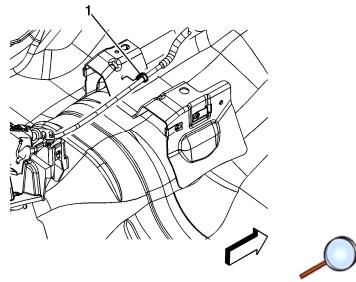
7. Release the transmission range selector lever cable retainer (1).

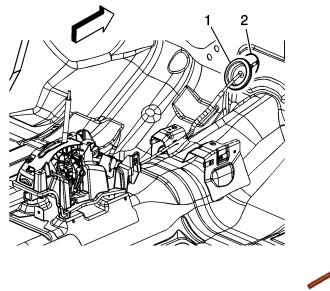
- 8. Remove the transmission range selector lever cable grommet (1) from the cowl panel (2).
- 9. Remove the transmission range selector lever cable from the vehicle.

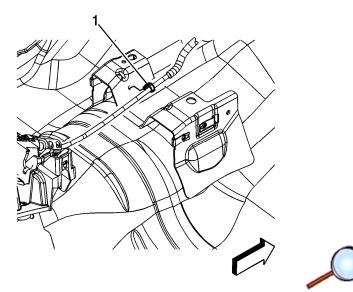
3. Attach the transmission range selector lever cable retainer (1).

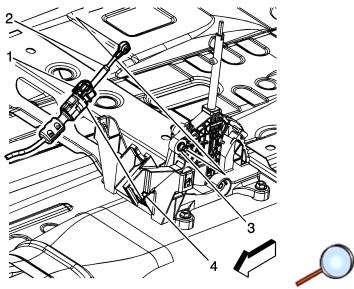
- 4. Install the transmission range selector lever cable to the transmission control lever base. Insure the cable retainer (1) is fully secured to the transmission control lever base.
- 5. Connect the transmission range selector lever cable terminal (2) to the shift lever pin.
- 6. Install the console. Refer to Front Floor Console Replacement.

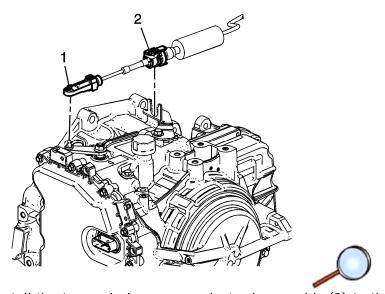
- 7. Install the transmission range selector lever cable (2) to the cable bracket.
- 8. Connect the transmission range selector lever cable terminal (1) to the transmission manual shift lever pin.
- 9. Adjust the automatic transmission range selector lever cable. Refer to <u>Range Selector</u> <u>Lever Cable Adjustment</u>.

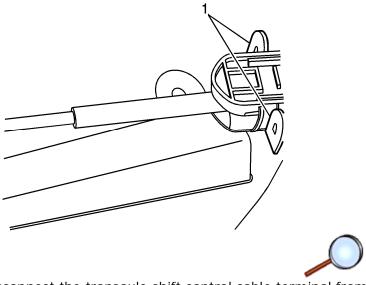
- 2. Disconnect the transaxle shift control cable terminal from the transaxle manual shift lever pin.
- 3. Press the locking tabs (1) inward in order to release the transaxle shift control cable from the cable bracket.
- 4. Remove the center floor air outlet. Refer to Rear Floor Air Duct Replacement.

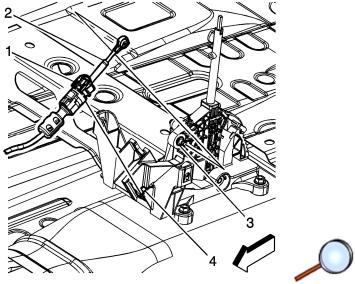
5. Disconnect the transmission range selector lever cable terminal (2) from the shift lever pin.

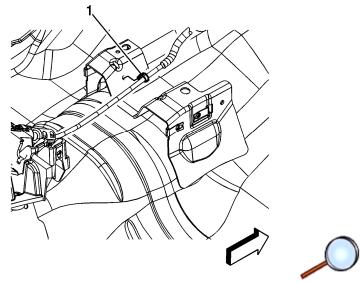
7. Release the transmission range selector lever cable retainer (1).

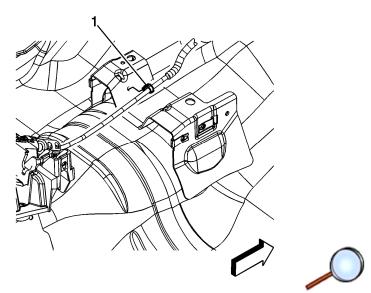
3. Attach the transmission range selector lever cable retainer (1).

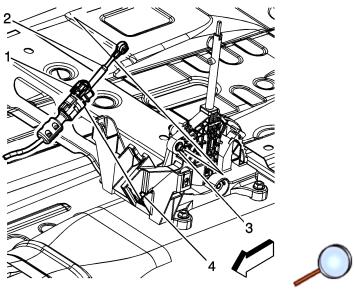
- 4. Install the transmission range selector lever cable to the transmission control lever base.
- 5. Connect the transmission range selector lever cable terminal (2) to the shift lever pin.
- 6. Install the center floor air outlet. Refer to Rear Floor Air Duct Replacement.

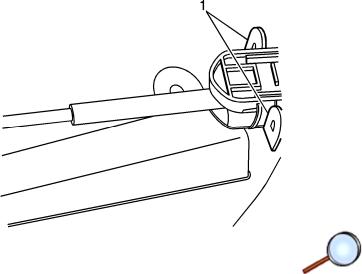
- 7. Install the transaxle shift control cable to the cable bracket. Ensure the cable retainer (1) is fully secured to the transmission bracket.
- 8. Connect the transaxle shift control cable terminal to the transaxle manual shift lever pin.
- 9. Adjust the automatic transmission range selector lever cable. Refer to <u>Range Selector</u> <u>Lever Cable Adjustment</u>.
