PE11-005

TOYOTA

ATTACHMENT 2,

ATTACHMENT 5,
Arbitration

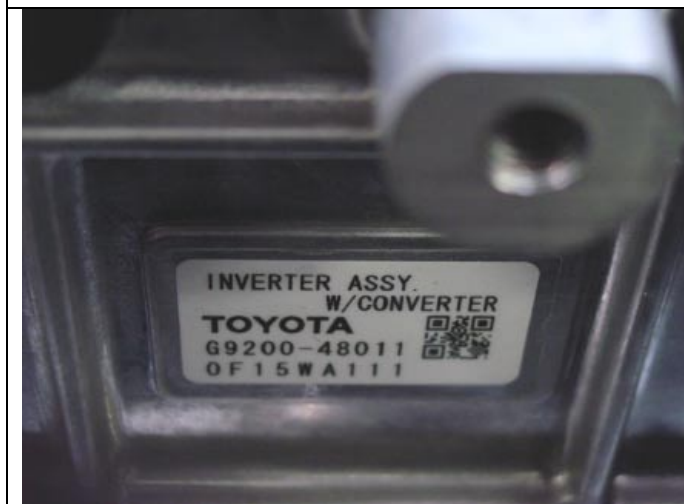
Close-up photo of manufactures label on malfunctioning '06 Highlander Inverter assembly.

- Top symbol sequence was: **G9200-48011.**
- Bottom symbol sequence was: **0F15WA111.**

Inverter Assembly (“Inverter Assy, W/Converter” PN G9200-48011) was replaced.

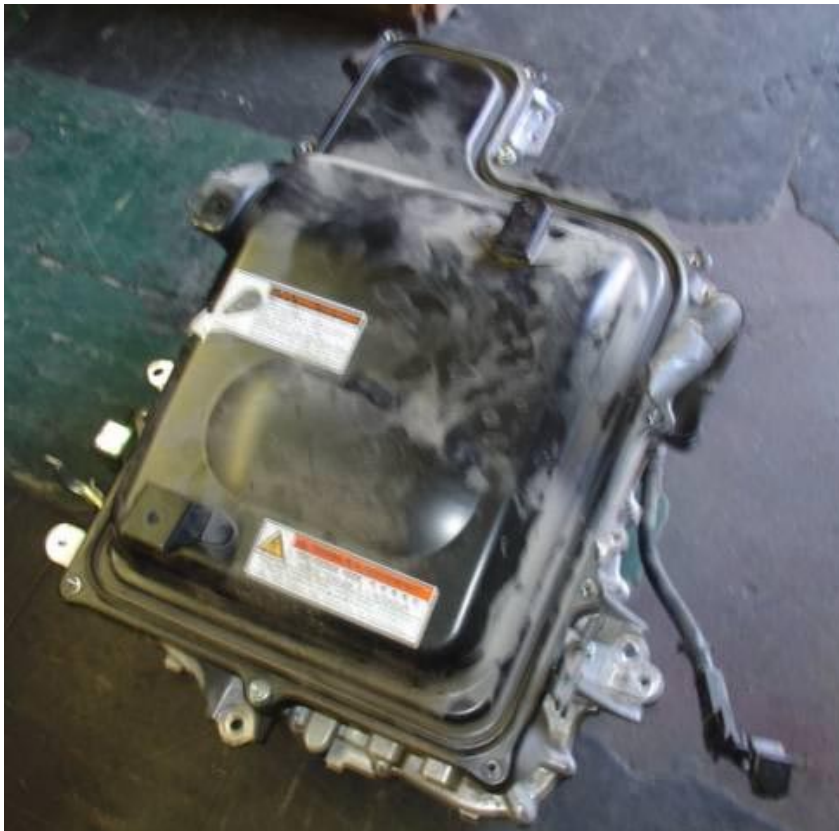
Above: Inverter assembly removed from vehicle.

Replace inverter assembly, recheck for any DTC's, and test drive to confirm repair effectiveness.

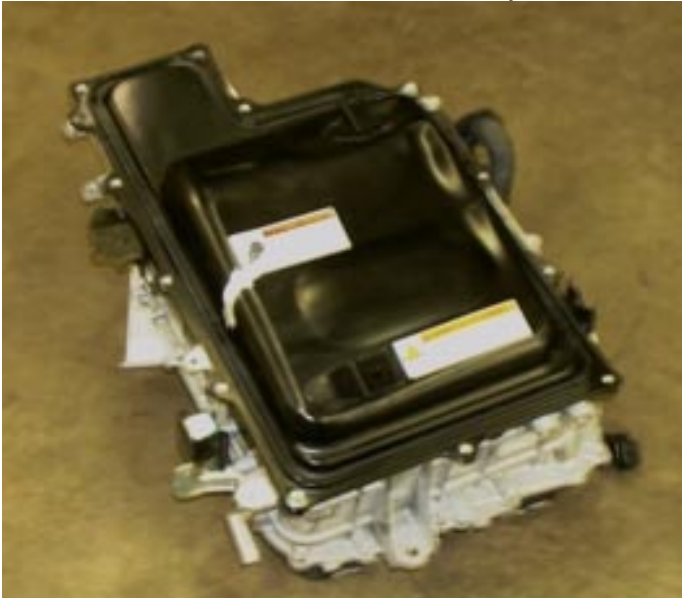
<p>Photo of Inverter Assembly</p>

<p>Inverter Serial Number OE18YA047</p>

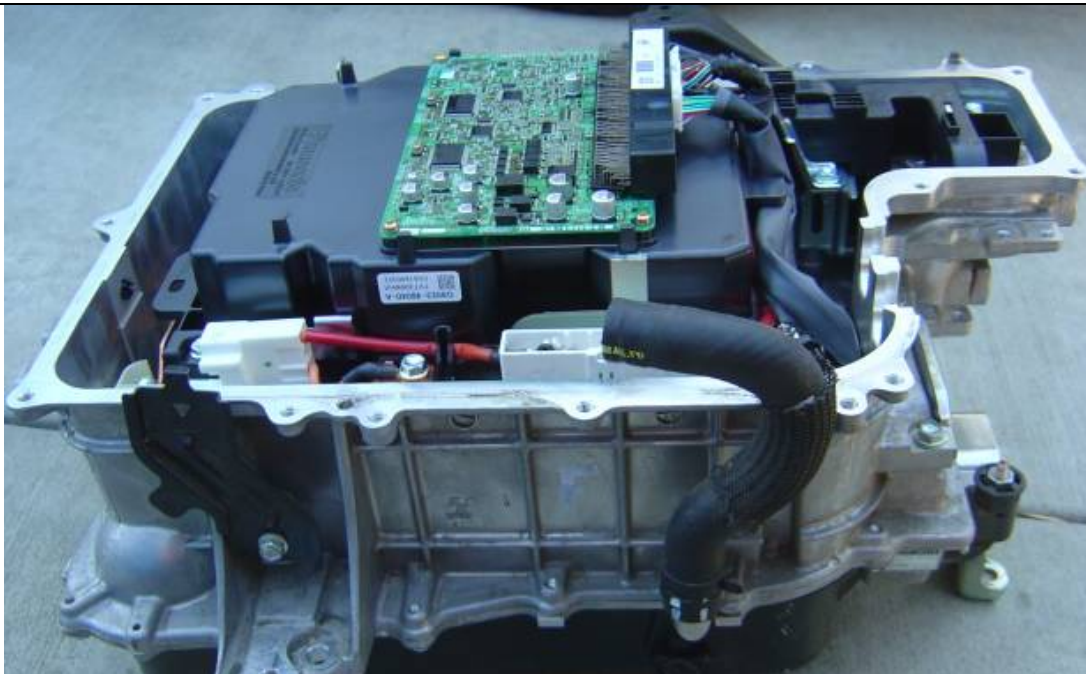
Right: Calibrations in vehicle at time of DTC check:

Hybrid Control Calibration 899834807000
 Hybrid Control Calibration 898824802201
 Hybrid Control Calibration 898824802202
 Engine ECT Control Calibration 3482700

Replace HV Inverter w Converter assembly. Road test vehicle and confirm no further DTC's were output.

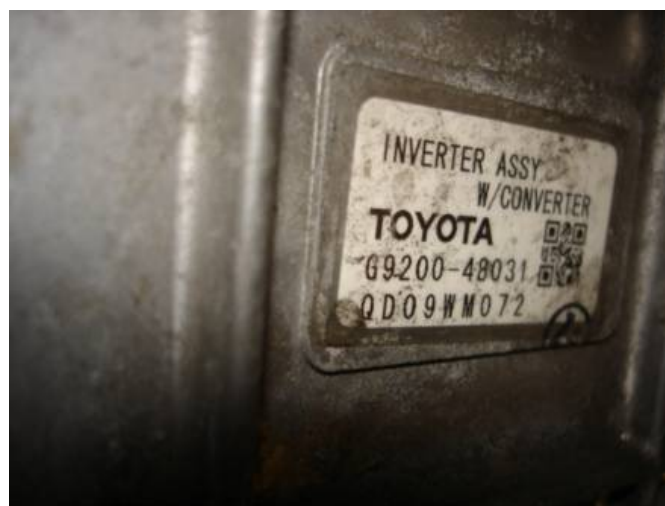
Inverter assembly

Inverter serial # QD09WM072

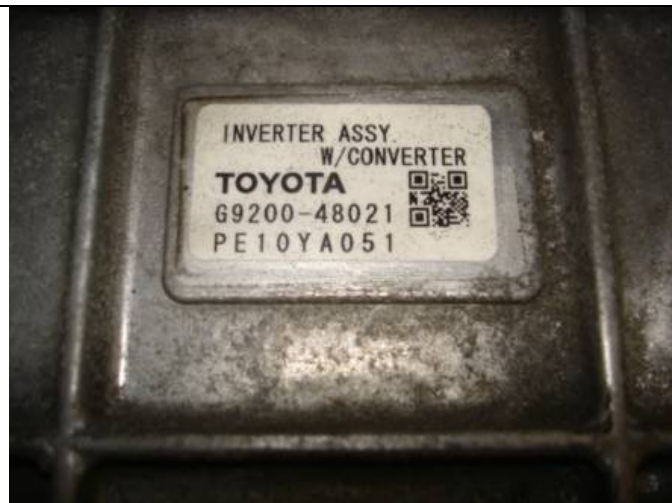
Inverter assembly

Inverter serial # PE10YA051

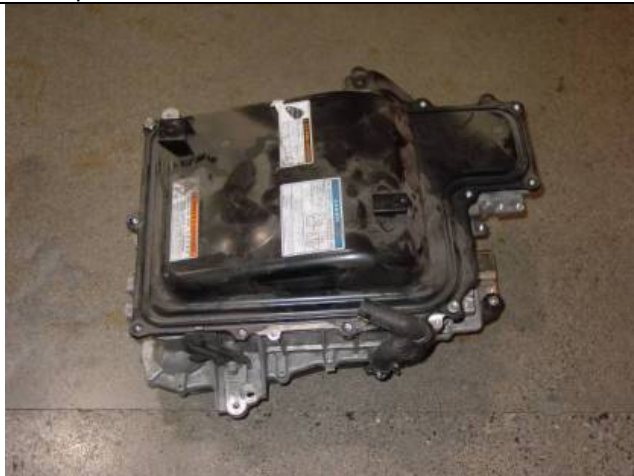
2006 Highlander HV Inverter assembly that set DTC P0A7A, illuminated MIL and rendered Vehicle inoperative.

- Actual repair cost charged to Customer was \$4,817.07 (Part Cost/\$4,091.14, Labor/\$277.50, CA Sales Tax/\$378.43).
- Customer was grateful for assistance from Toyota, but still concerned that 4 year old vehicle required a \$4,817.00 repair.

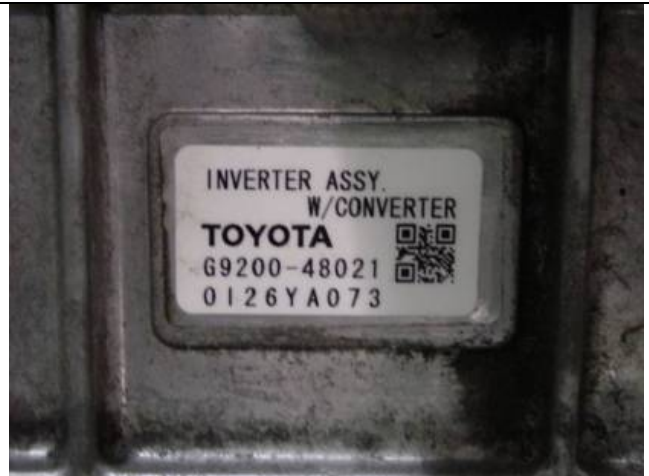
**Close-up photo showing manufactures markings on malfunctioning Inverter assembly. Markings were:
G9200 – 48021
0126YA073**

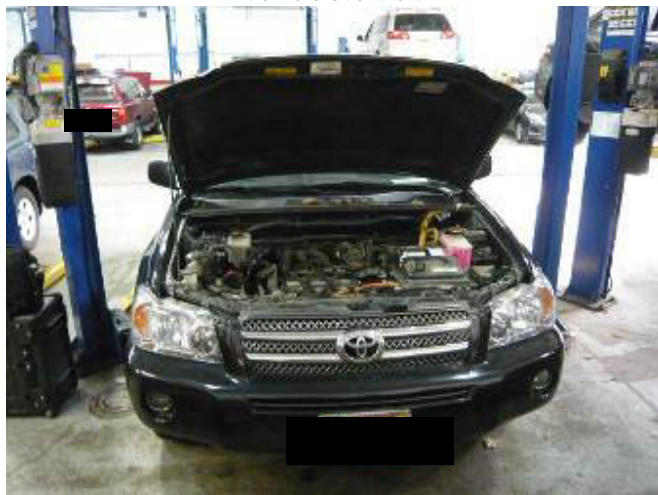
Picture 1

There are NO arc marks.

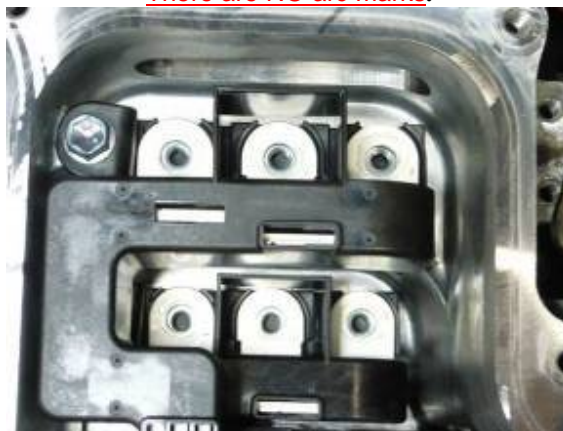
- Tech and PQFO-NE members inspected the vehicle as per the Repair Manual.
 - Confirmed the HV ECU connection condition is Good.
 - Confirmed the MG ECU connection condition of inside Inverter is Good.
 - Confirmed the three-phase AC cables connection condition is Good. And there are NO arc marks. (Please refer the Picture 1.)
 - Confirmed the resistance of MG by milliohm meter.

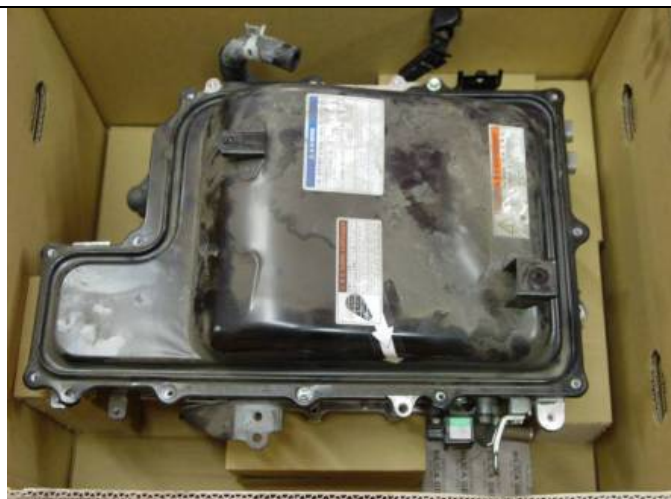
2006 Highlander HV Inverter assembly that set DTC P0A78, illuminated MIL and rendered Vehicle inoperative.

Inverter assembly was replaced, correcting condition.

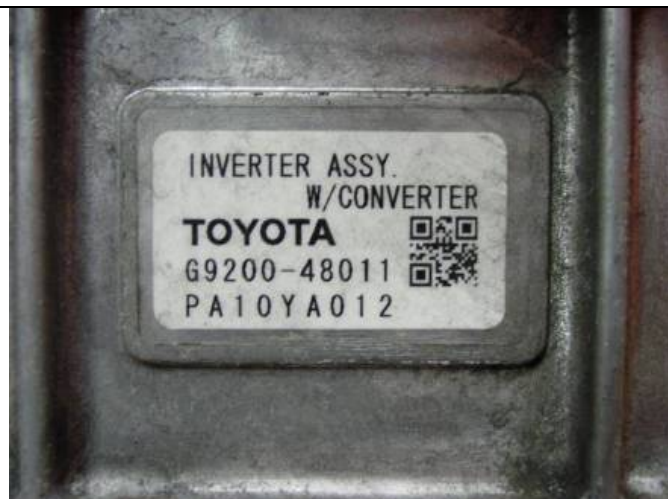
Close-up photo showing manufactures markings on Inverter assembly. Markings were:
G9200 – 48011
PA10YA012

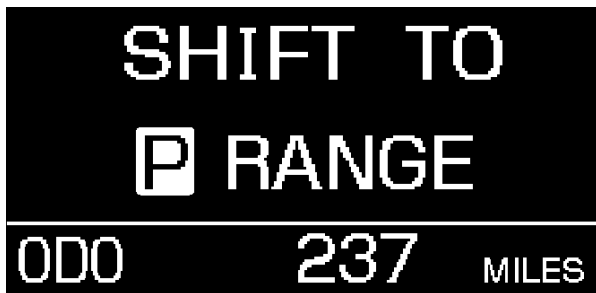
Multi-Information Display

- When the condition described below is present, the message prompt as shown appears in the multi-information display and multi display (only on models with multi display), accompanied by the illumination of the master warning light and the continuous sounding of the buzzer.
 - ◆ The READY light is illuminated, the shift position is in the N position, and the HV battery is discharged.
