PE11-040

2003-2004 G-Van – Fuel Filler Neck Corrosion

6 VOQs: 2003-2004 G-Van – Fuel Filler Neck Corrosion

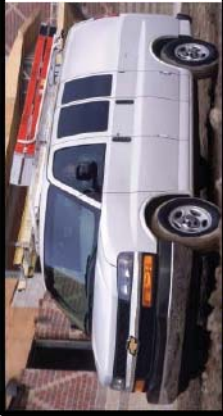
2003-2004MY G-van (Express/Savana) w/left cargo door, E26

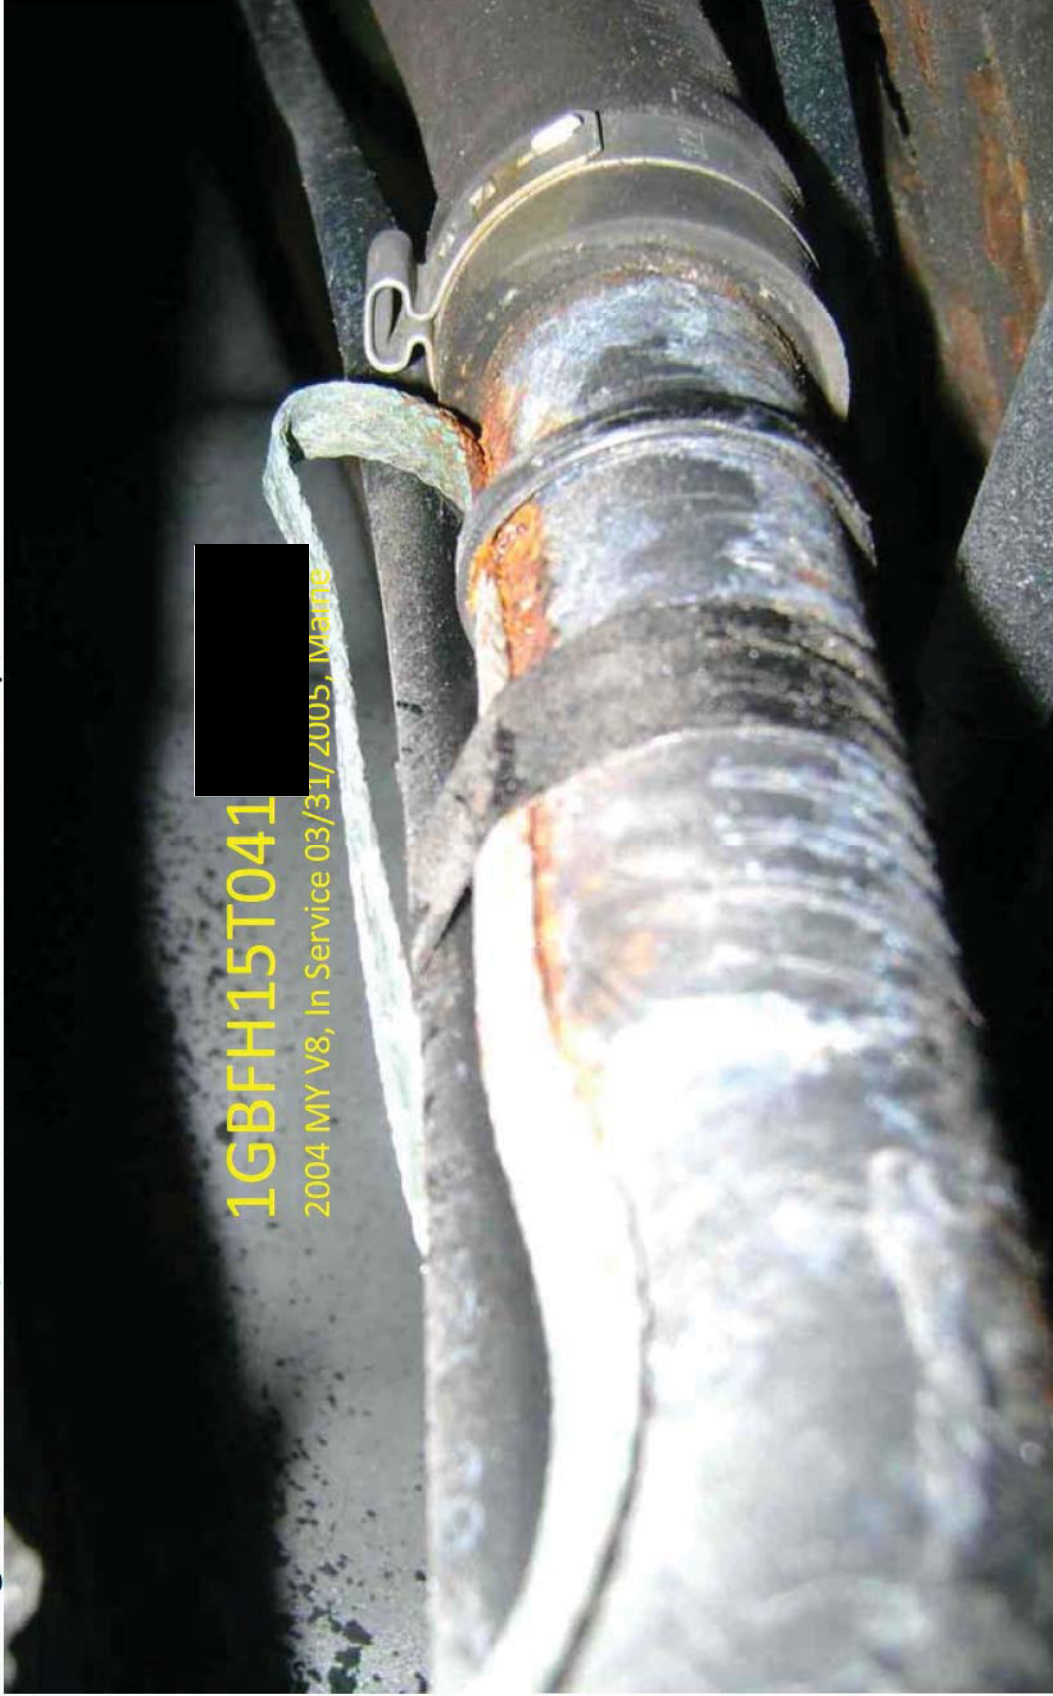
Arbogast Buick GMC, 2004-2005 MY G-Van field inspection

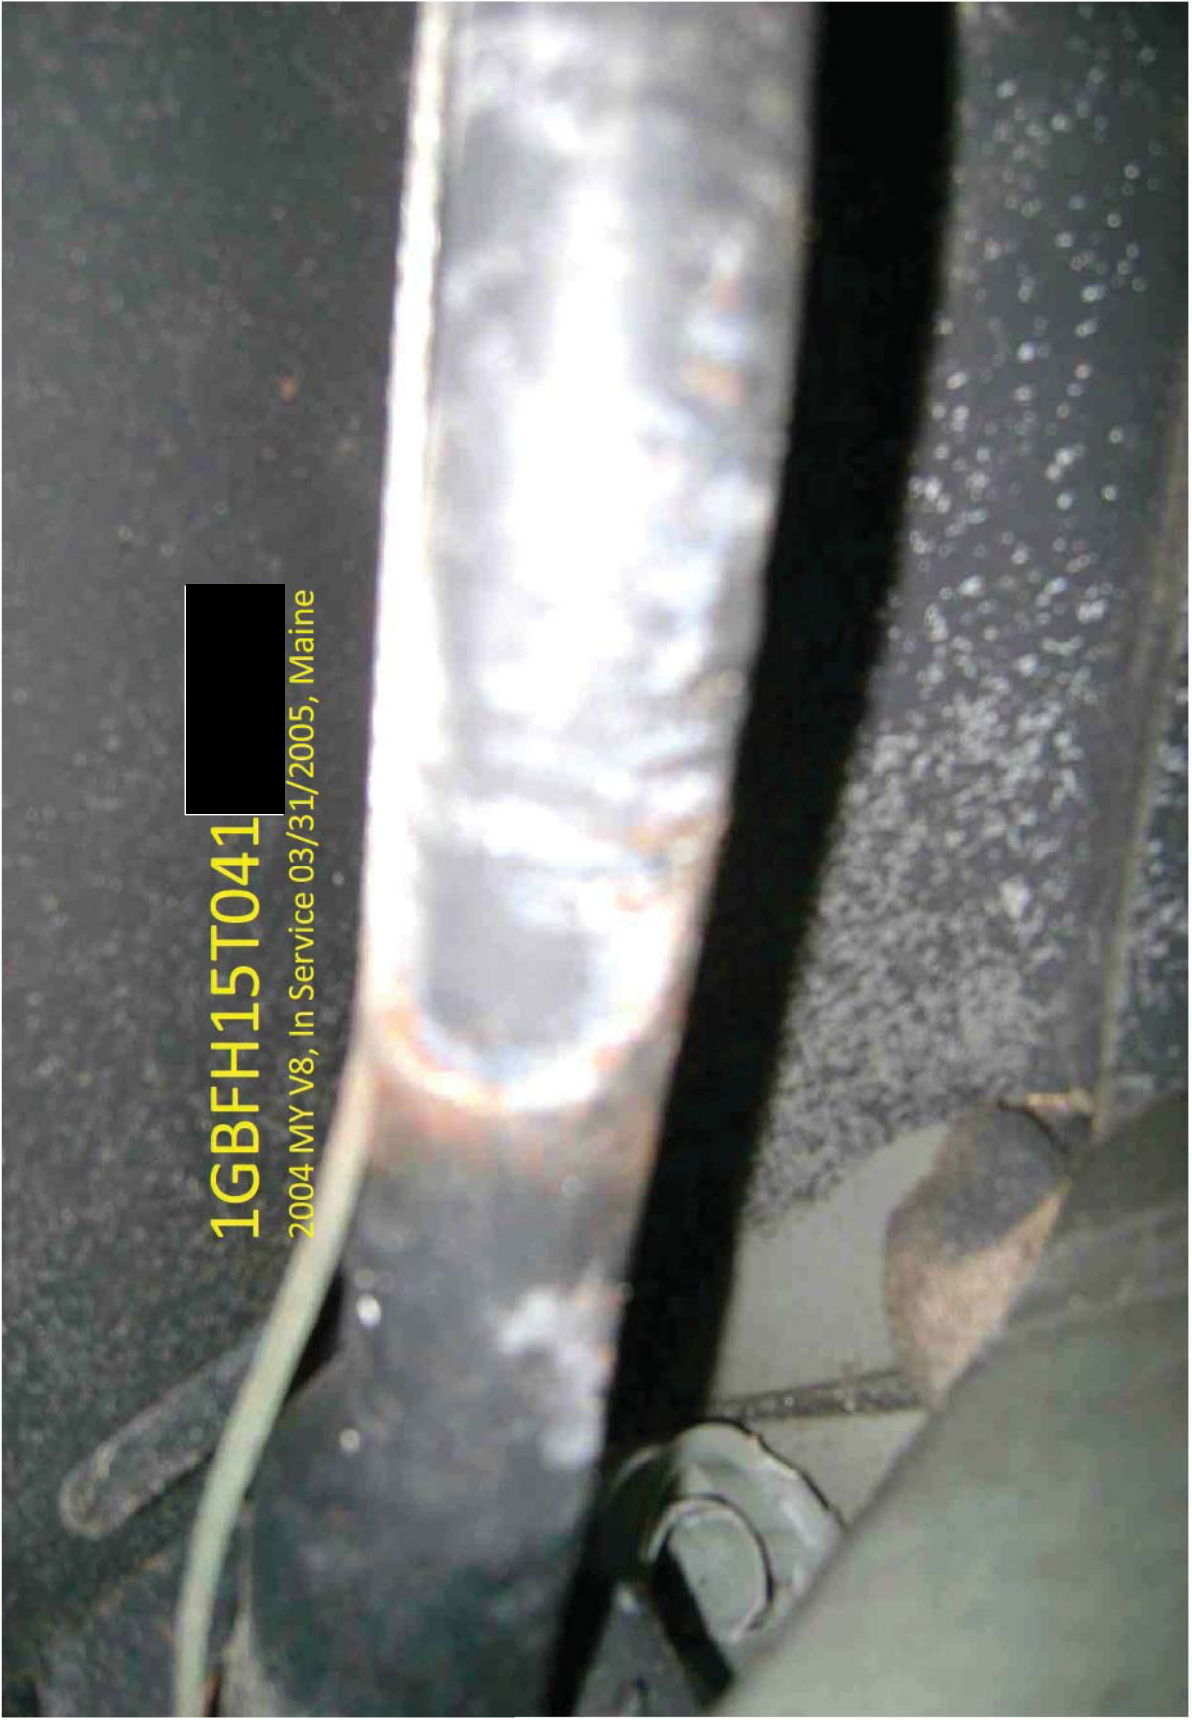
1GBFH15T041

Arbogast Buick GMC, 2004-2005 MY G-Van field inspection

2004 MY V8, In Service 03/31/2005, Maine

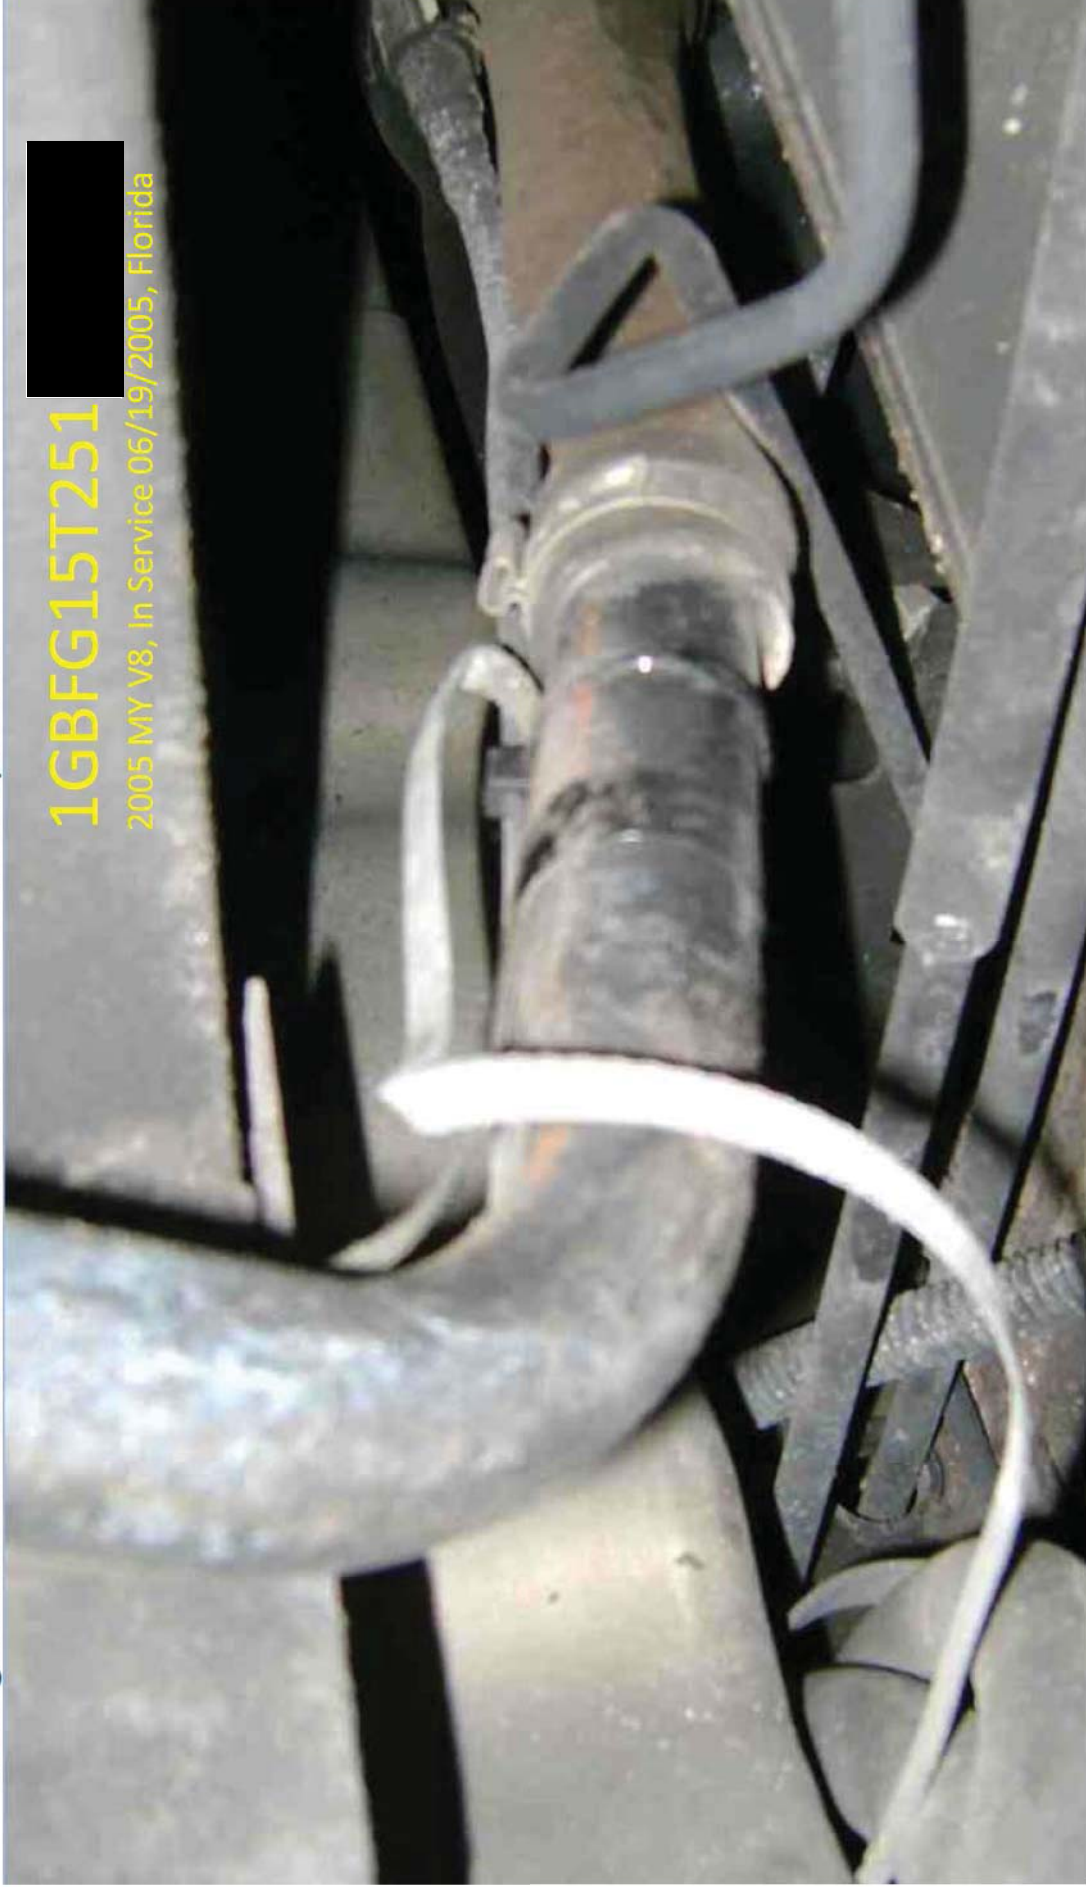
1GBFG15T251

Arbogast Buick GMC, 2004-2005 MY G-Van field inspection

2005 MY V8, In Service 06/19/2005, Florida

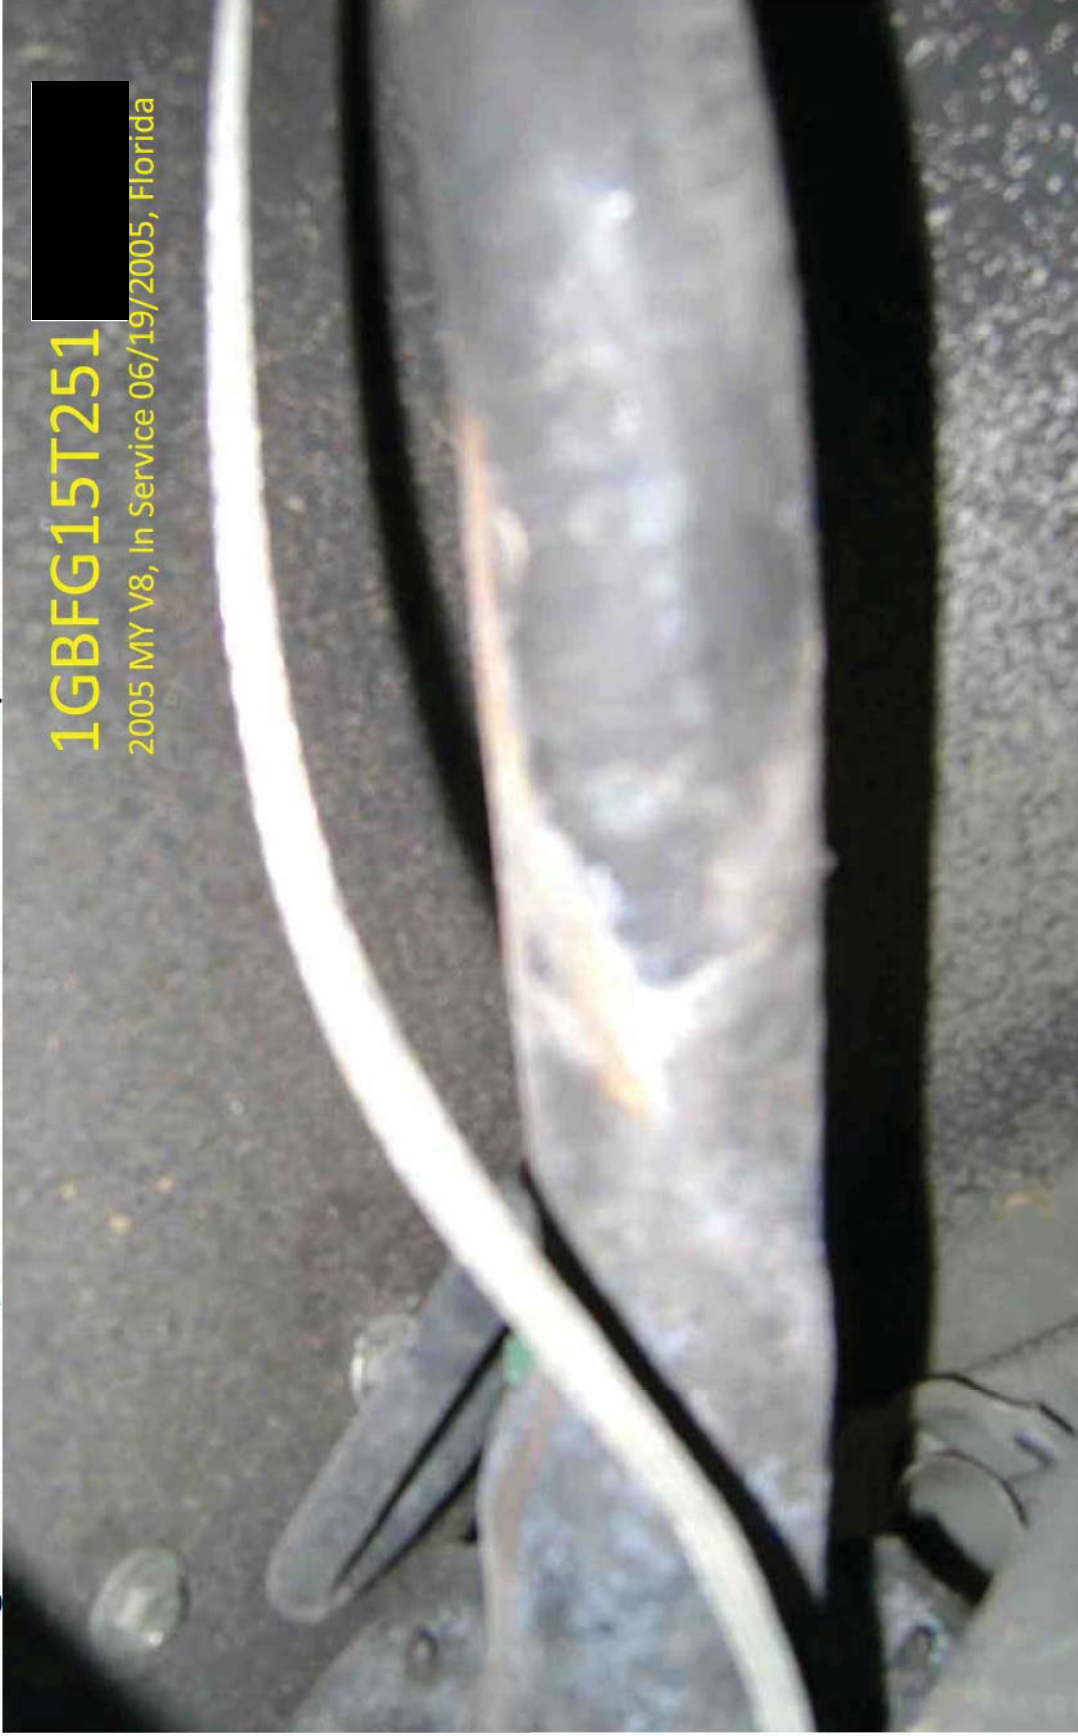
1GBFG15T251

2005 MY V8, In Service 06/19/2005, Florida

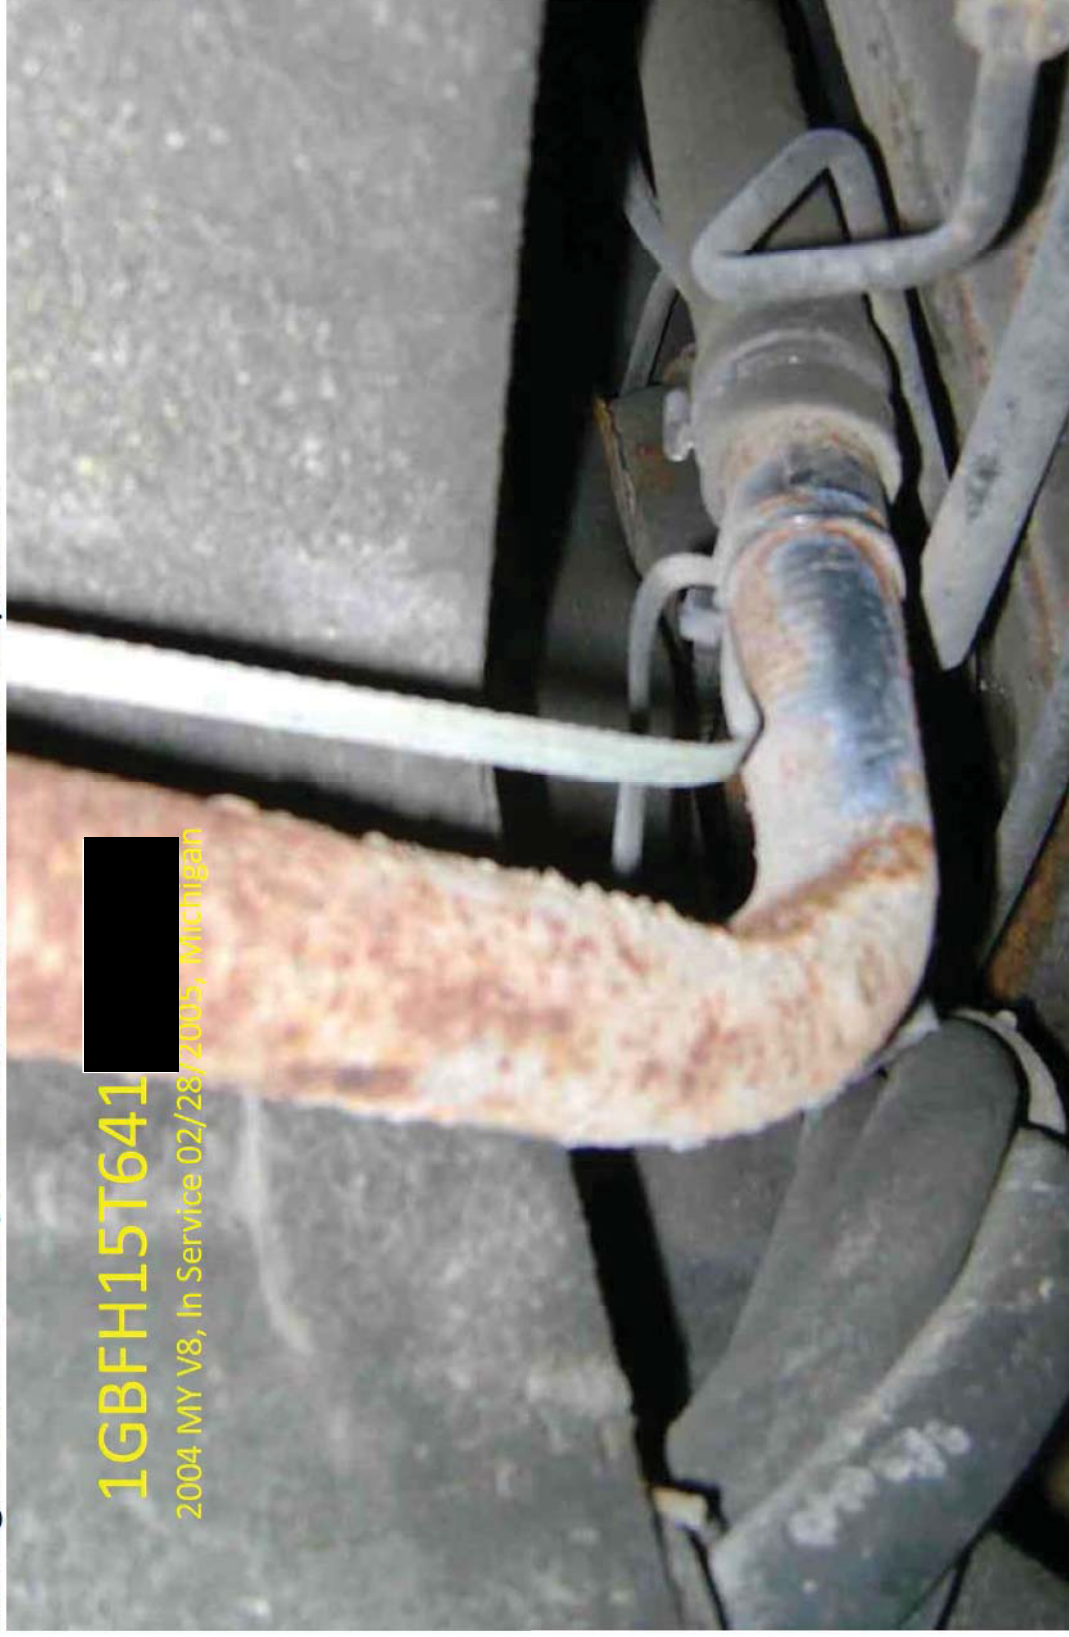
1GBFH15T641

Arbogast Buick GMC, 2004-2005 MY G-Van field inspection

2004 MY V8, In Service 02/28/2005, Michigan

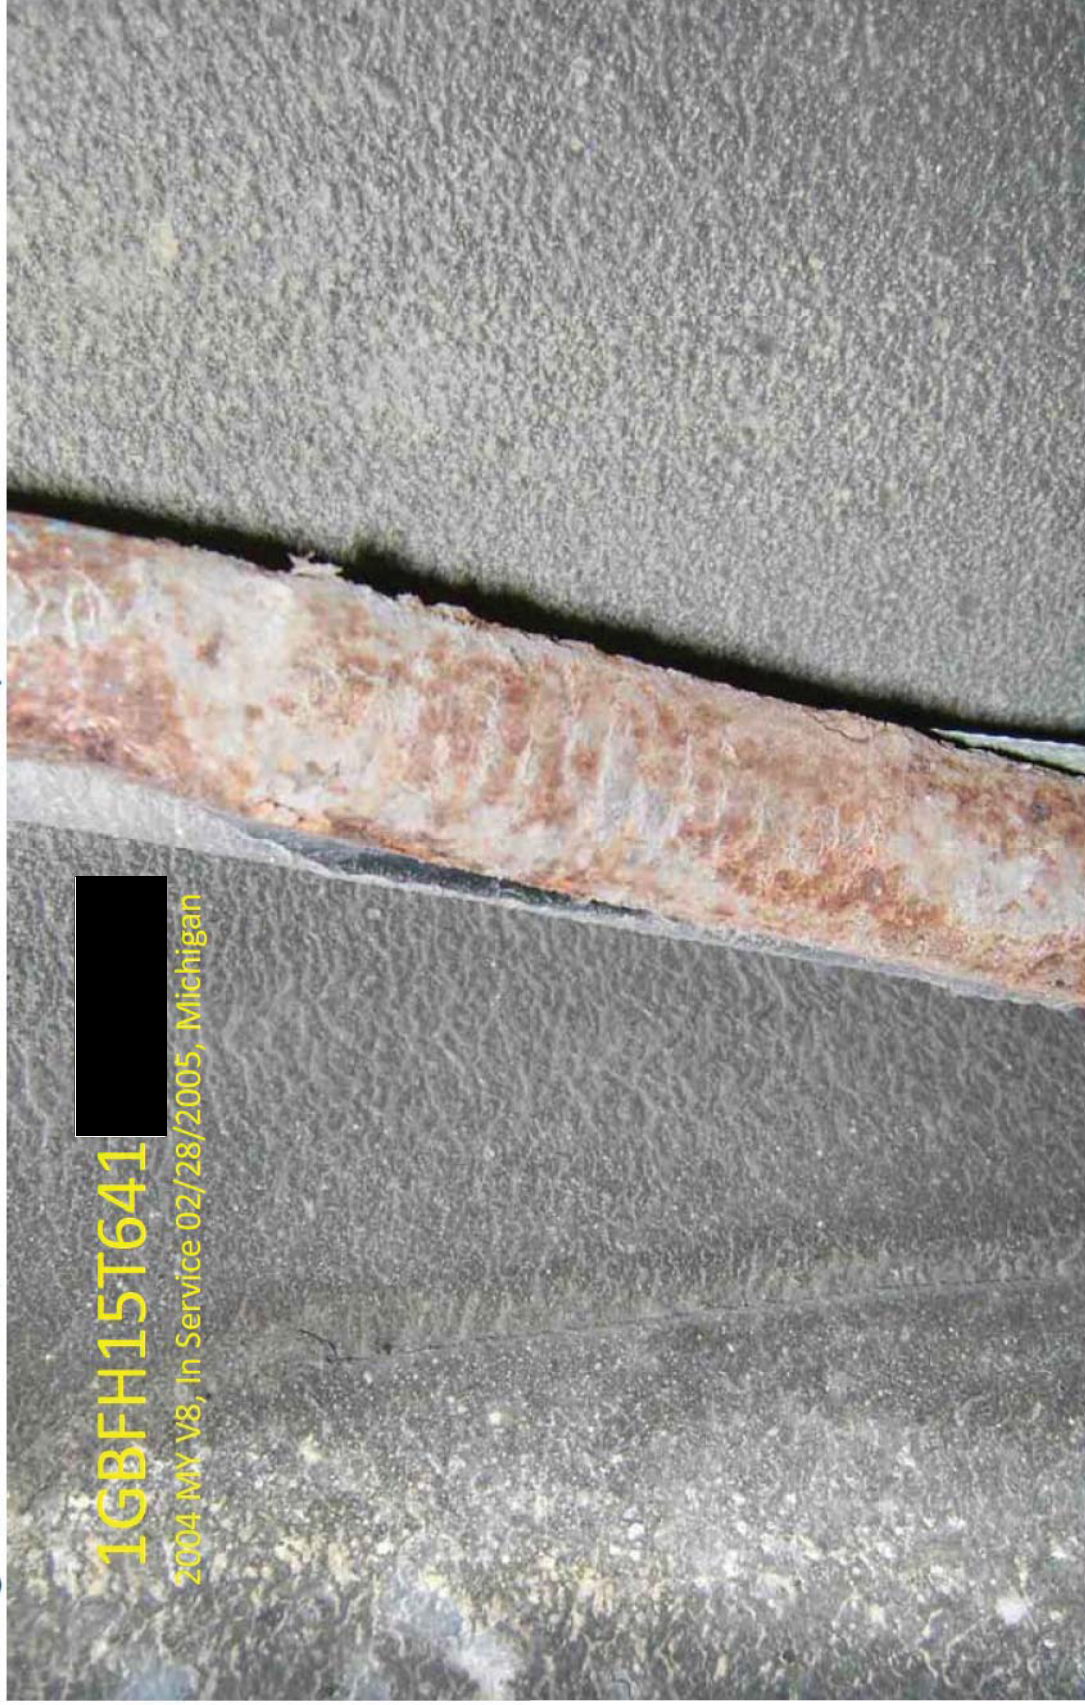
1GBFH15T641

2004 MY V8, In Service 02/28/2005, Michigan
