EA12-001

ATTACHMENT 4 PART 2  
CONSUMER COMPLAINT  
PART 2

Case # : 1106150977 Case Type : ACCIDENT Owner's Group : Field  
 Brand : Toyota Case/Activity Last Updated : 6/16/2011 03:34:21 PM  
 Case Title : PRODUCT ; FCRP ; AIR BAGS- FRONT ; DEPLOY

TQCN DOC# TQCN_FTR-112440050		Affiliate SET	Dept. QAElectrical		Ref	Date
Primary Model Corolla	Model Year 2003	Production Date 2002-08-30	Odometer 103169	VIN 1NXBR32E03Z [REDACTED]	Repair Date 8/31/2011	
Source FTS	Location REG-SET	Problem Area Base Vehicle	Parts Destination CQE	DTC B0103,B0108,B1100,B1183,B1186		
Part # 1 8917002190	Part # 1 Serial/Date Code 229203819A		Part # 2	Part # 2 Serial/Date Code		Parts Available No Part(s) Available
Condition Title SRS Deployment With No Signs of Frontal Collision

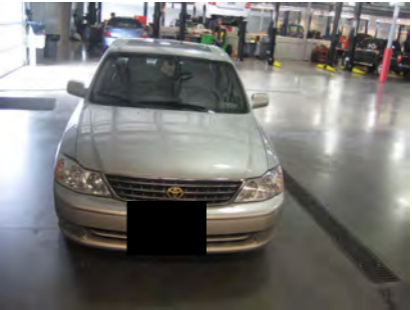
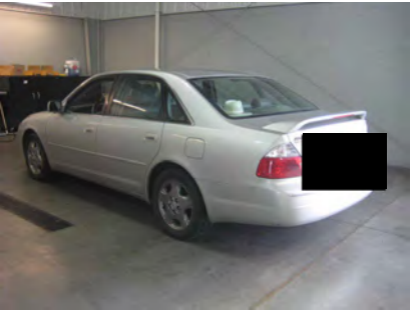
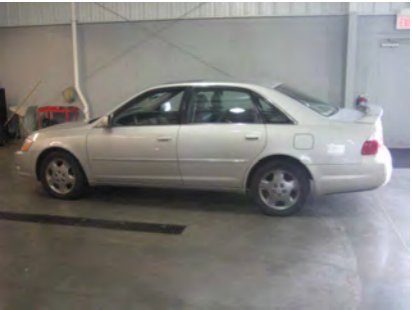
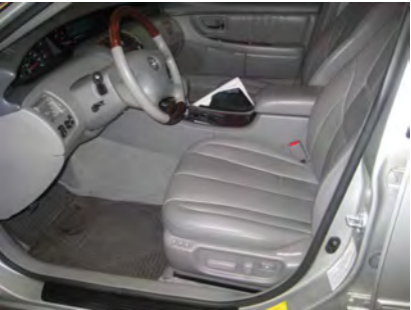
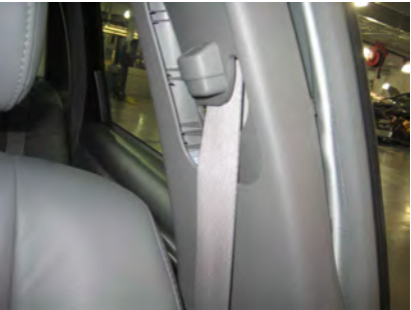
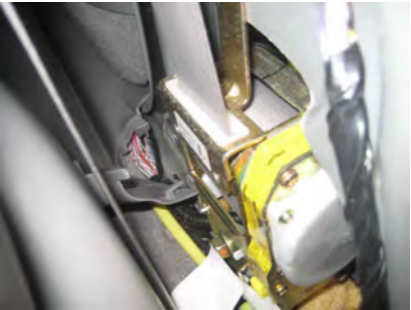
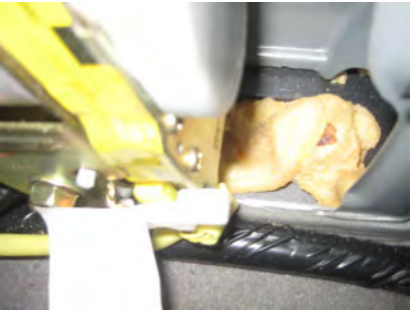
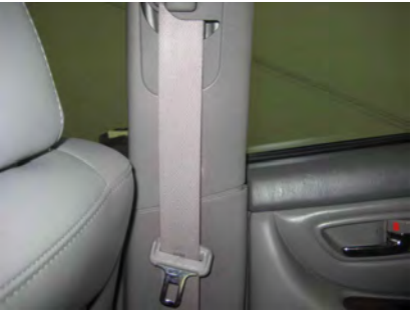
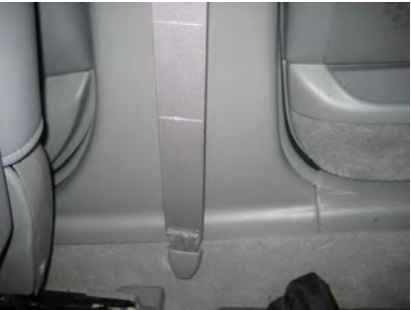
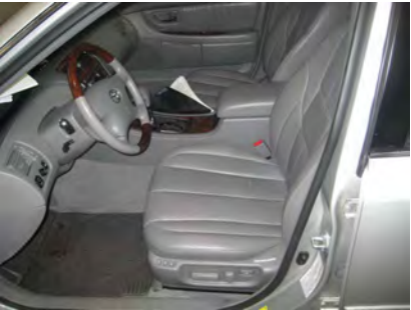
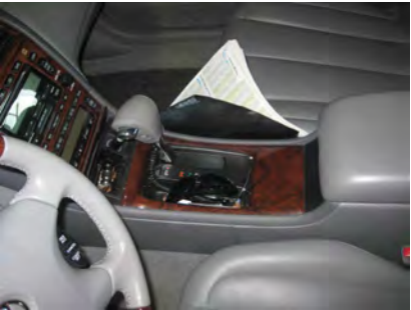
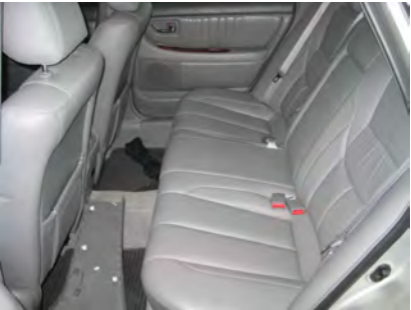
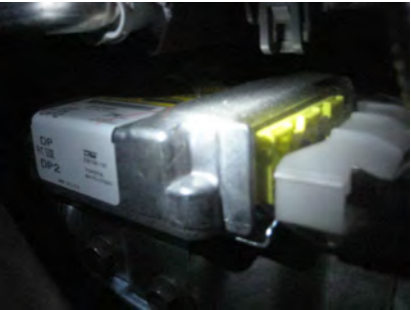
<u><b>CONTACT SUMMARY:</b></u>
<p>On June 21, 2010 I inspected a 2003 model year Corolla VIN# 2T1BR32E73C [REDACTED] belonging to Ms. [REDACTED] at Hammer Collision. At the time of my inspection the vehicle's odometer displayed 138,382 miles. Approaching the vehicle I noted that the vehicle had several areas of prior body repair and these areas were not of the best quality. I found that both front air bags had been deployed along with both front seatbelt pretensioners. I had been informed that both front seats had been occupied at the time of the incident. The windshield was cracked by the passenger's side air bag deployment. I found that the tires were in good condition but were muddy. I opened the hood and found that both front sensors were securely mounted and the wiring connectors were fully plugged in. There was no visible damage to either sensor or to the wiring. I inspected the center air bag sensor and found that it was also securely mounted. I also checked the wiring connectors and terminals. I found that there was no corrosion or liquid intrusion present in the connector. I connected the Toyota scan tool to the DLC3 connector and found that I could communicate with the ECU's. I found codes B0102, B0107, B0132, B0137, and B1100 present in the airbag system. I attempted to recover the event data information but found that the vehicle did not support this. I requested that the vehicle be moved and placed on a lift. With the vehicle in this condition I inspected the under side of the vehicle. I found that the front splash shields were held on with wire. I also found that the left side of the radiator support was not welded in place. I found that the left side rocker panel cover was hanging loose. Examining the underside of the vehicle I found that there was a fresh dent and scrape in the passenger's side front frame rail. I followed this path and found a fresh scrape on the passenger's side rear frame. I also found that the rear axle beam was scraped clean in an area approximately a foot wide, and inline with the other two impact points. The forward impact point is within 18" of the center air bag sensor. There were several areas of old damage under the vehicle, but the items listed were the only fresh areas.</p> <p>After inspecting the vehicle I found no evidence that the incident was caused by a defect in the vehicle. I believe that the deployment was caused by the shock of impact to the right front floor structure.</p>

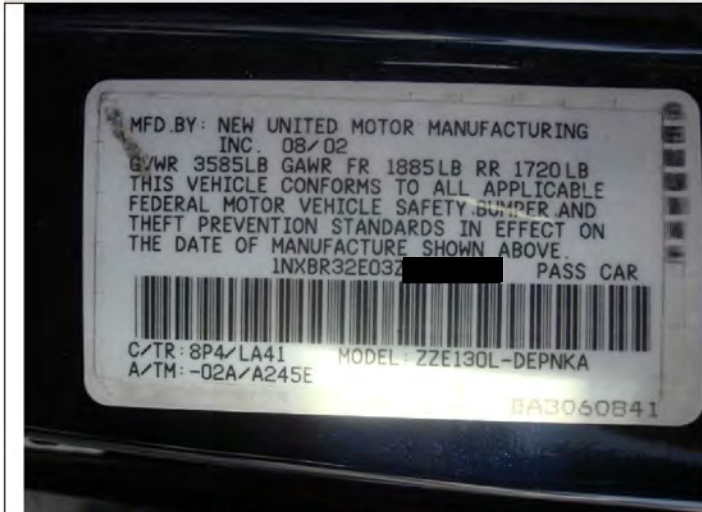
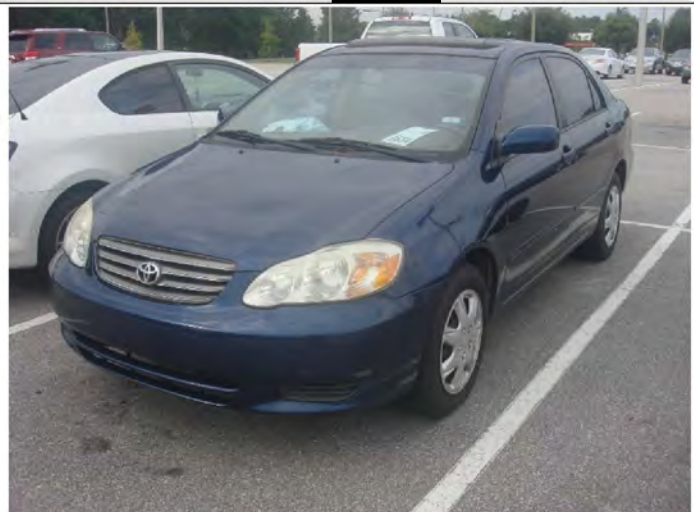
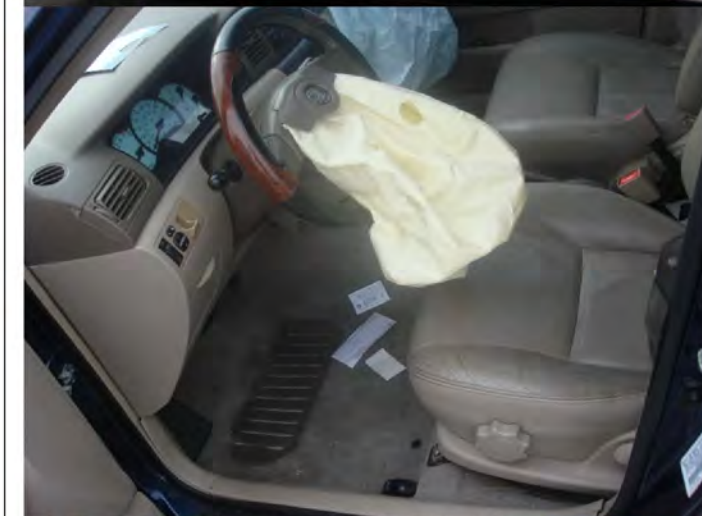
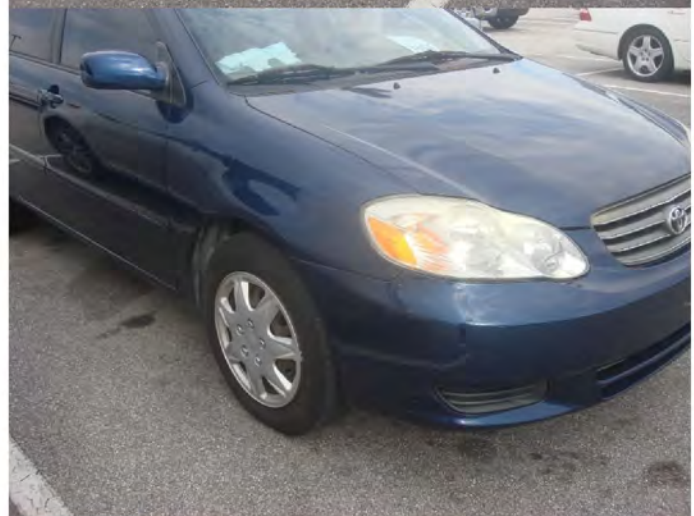
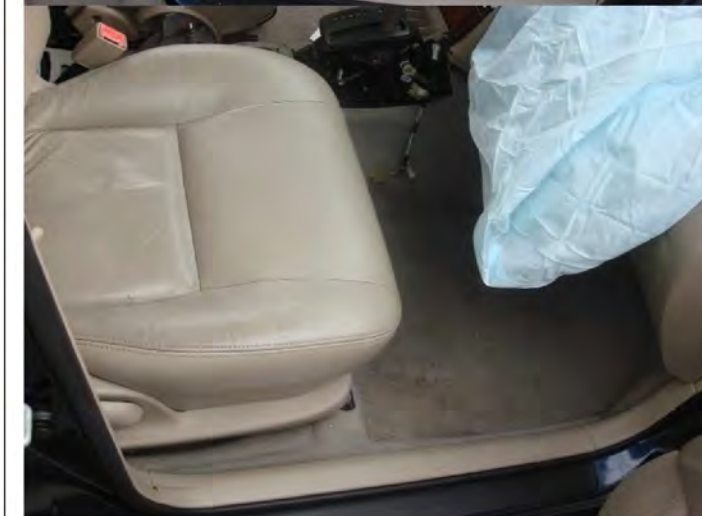
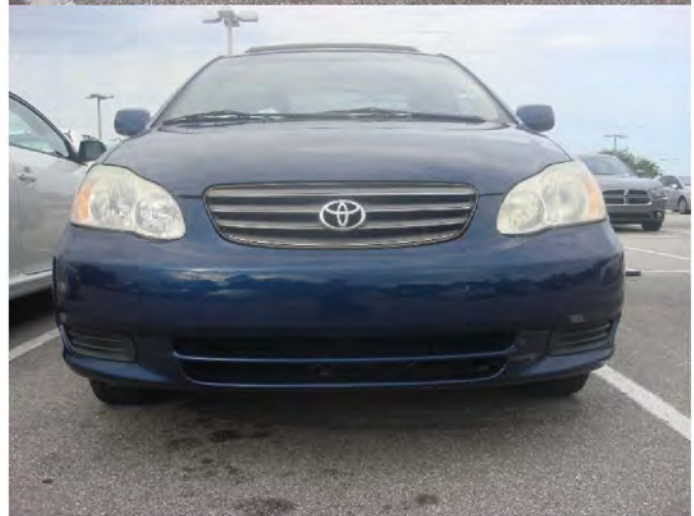
TQCN DOC# TQCN_FTR-112440050		Condition Title SRS Deployment With No Signs of Frontal Collision			Date
Primary Model Corolla	Model Year 2003	Production Date 2002-08-30	Odometer 103169	VIN (confirm 17 characters): 1NXBR32E03Z [REDACTED]

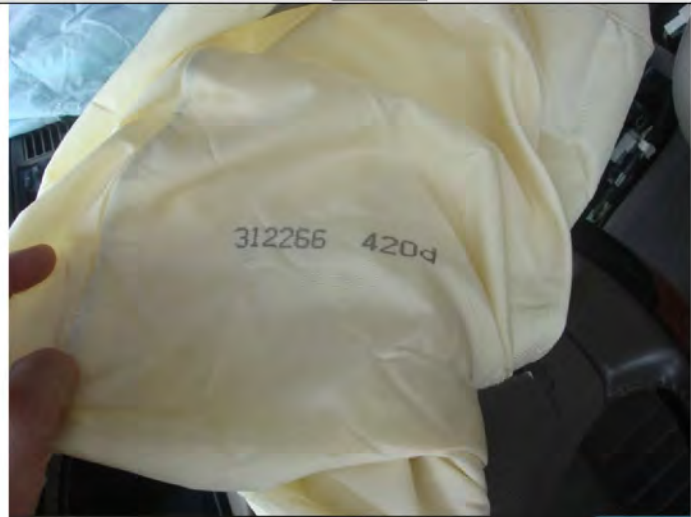
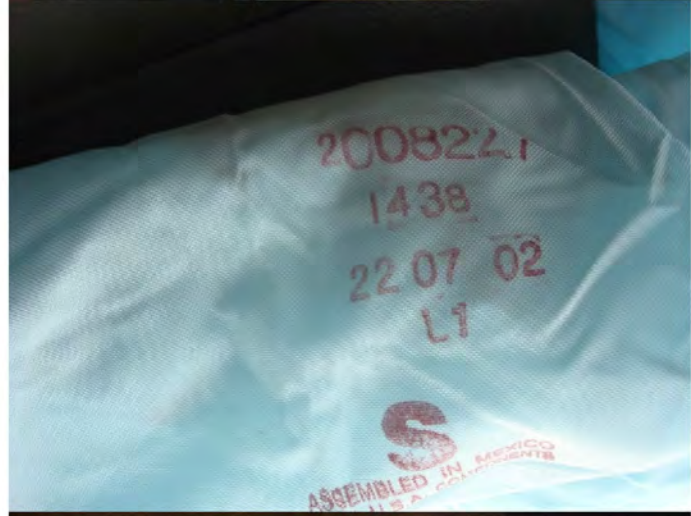
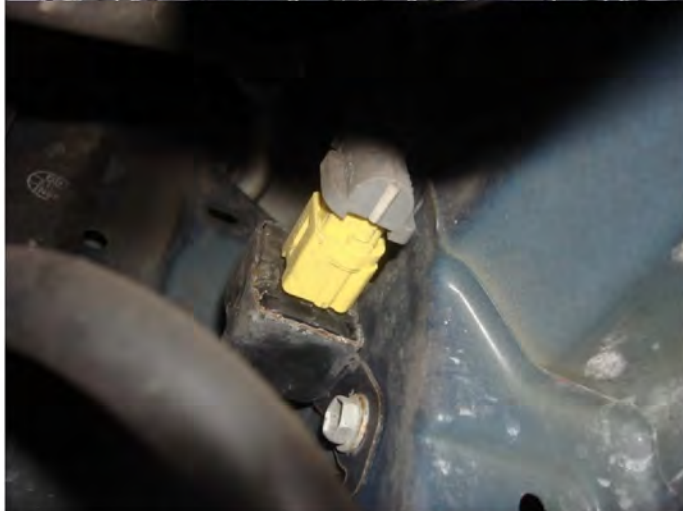
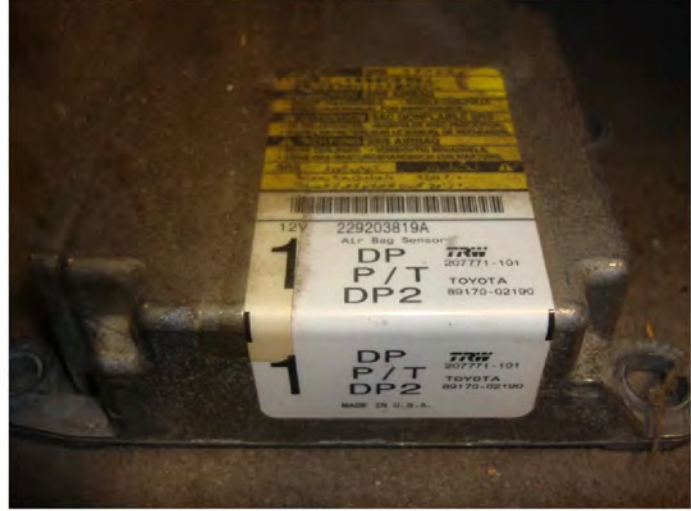
Monitor Status	DTC	Curr	Pend	Hist	Perm	Calibration
Inc						30002300
	B0103	X		X		
	B0108	X		X		
	B1100	X		X		
	B1183	X		X		
	B1186	X		X

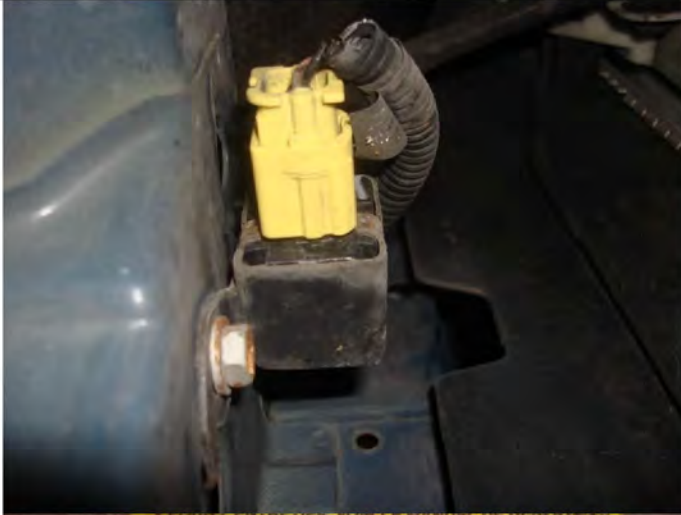
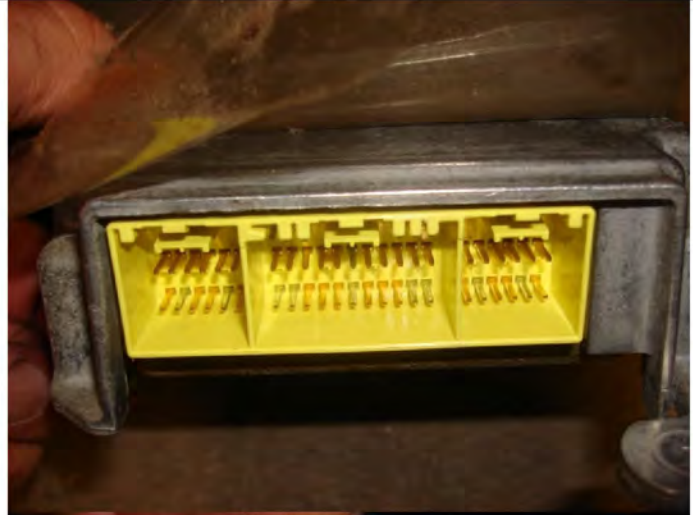
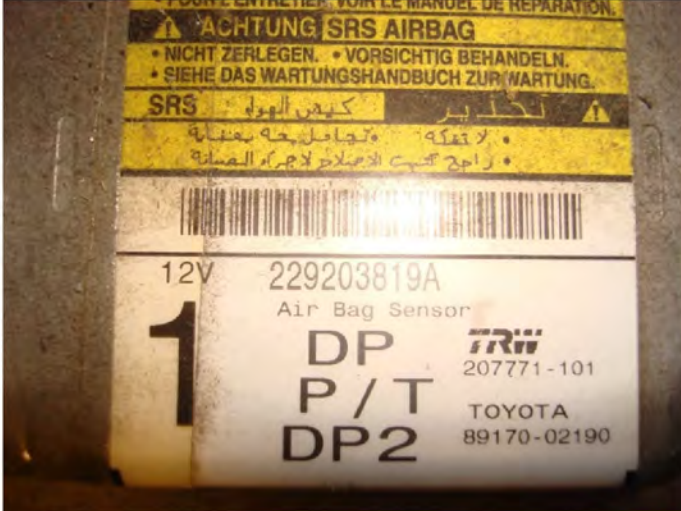
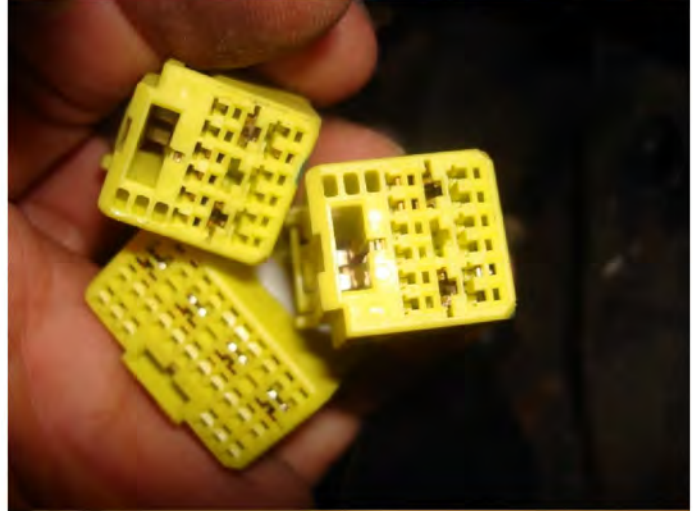
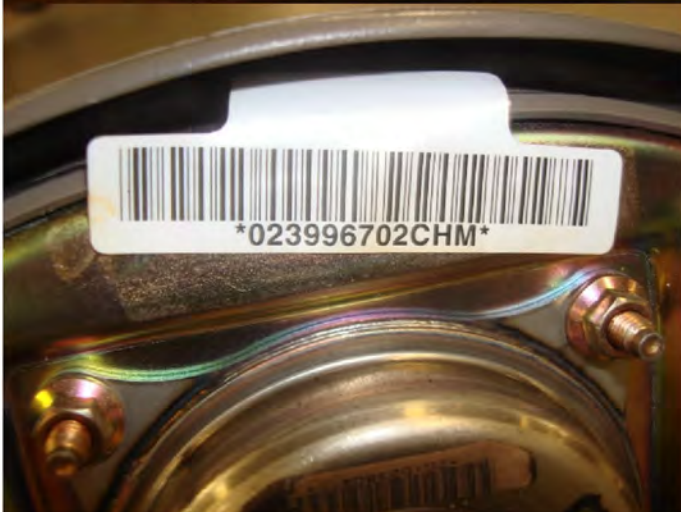
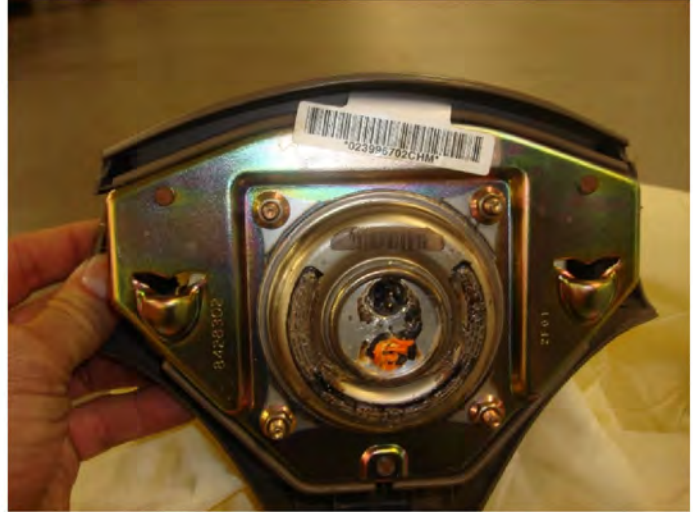
TQCN DOC# TQCN_FTR-112440050		Condition Title SRS Deployment With No Signs of Frontal Collision			Date
Primary Model Corolla	Model Year 2003	Production Date 2002-08-30	Odometer 103169	VIN (confirm 17 characters): 1NXBR32E03Z [REDACTED]
