EA12-001

# ATTACHMENT 4 PART 2 CONSUMER COMPLAINT PART 2

PRODUCT; FCRP; AIR BAGS-FRONT; DEPLOY

TQCN\_FTR-112440038 Condition Title SMART Investigation SRS Deployment With No Visable

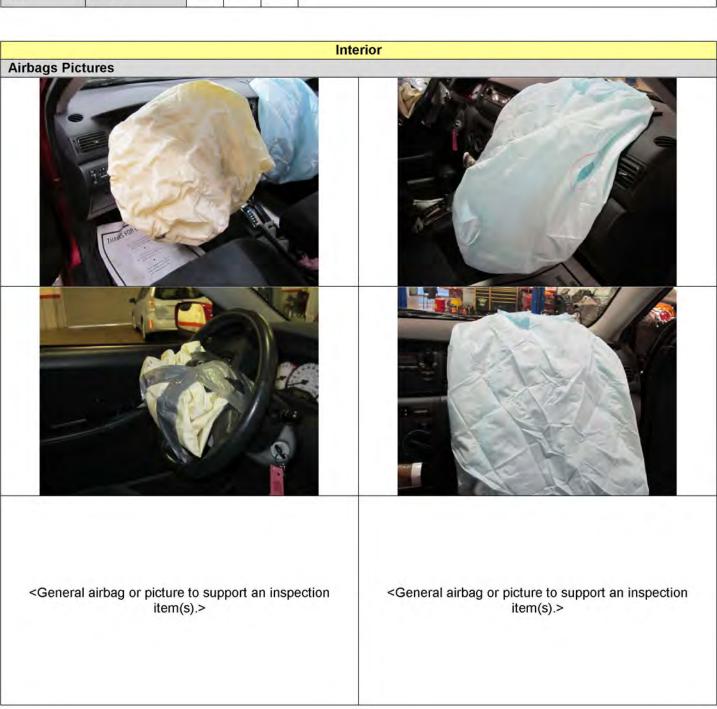
TQCN_FTR-120830133			Condition	Title ntional Airba	Date 03/27/2012			
Primary Model Corolla		20	del Year 03	1000	002-09-26	Odometer 55710	VIN (confirm 17 characters): 1NXBR32E33Z	
	Rear Window Curtain SRS			X				
Driver's Side	Curtain Side SRS			X				
Passenger Side	Curtain Side SRS			X

FTS found no signs of impact, or collision damage to vehicle at time of inspection. Air bag light was on at time of inspection, and the following air bag DTC's were stored in memory: B0103, B0108, B0138, B1100. The driver and passenger side air bags were deployed at time of vehicle inspection.

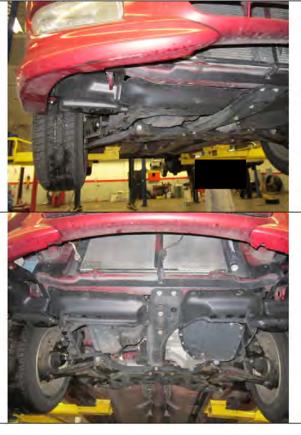
**Undercar Pictures**

Corolla		2003	2002-09-20	33710	INABROZESSZ	
	fail.		Unde	ercar		
Inspection A	Area	Notes & Obse	ervations			
	Left Front	No signs of co	llision damage.			
Suspensio	Right Front	No signs of co	llision damage.			
n	Left Rear	No signs of co	llision damage.			
	Right Rear	No signs of co	llision damage.			
Steering Gea	ar and	No signs of co	llision damage.			
Drive axle / I	Driveshaft	No signs of co	llision damage.			
Transmissio Transaxle	on /	No signs of co	Ilision damage.			
Differential/r assembly	rear axle	No signs of co	llision damage.			
Exhaust Sys	stem	No signs of co	llision damage.			
Fuel Tank a	nd Lines	No signs of co	llision damage.			
Hadassas Di		1
