EA12-001

TOYOTA

Attachment-Response 4

Field Report

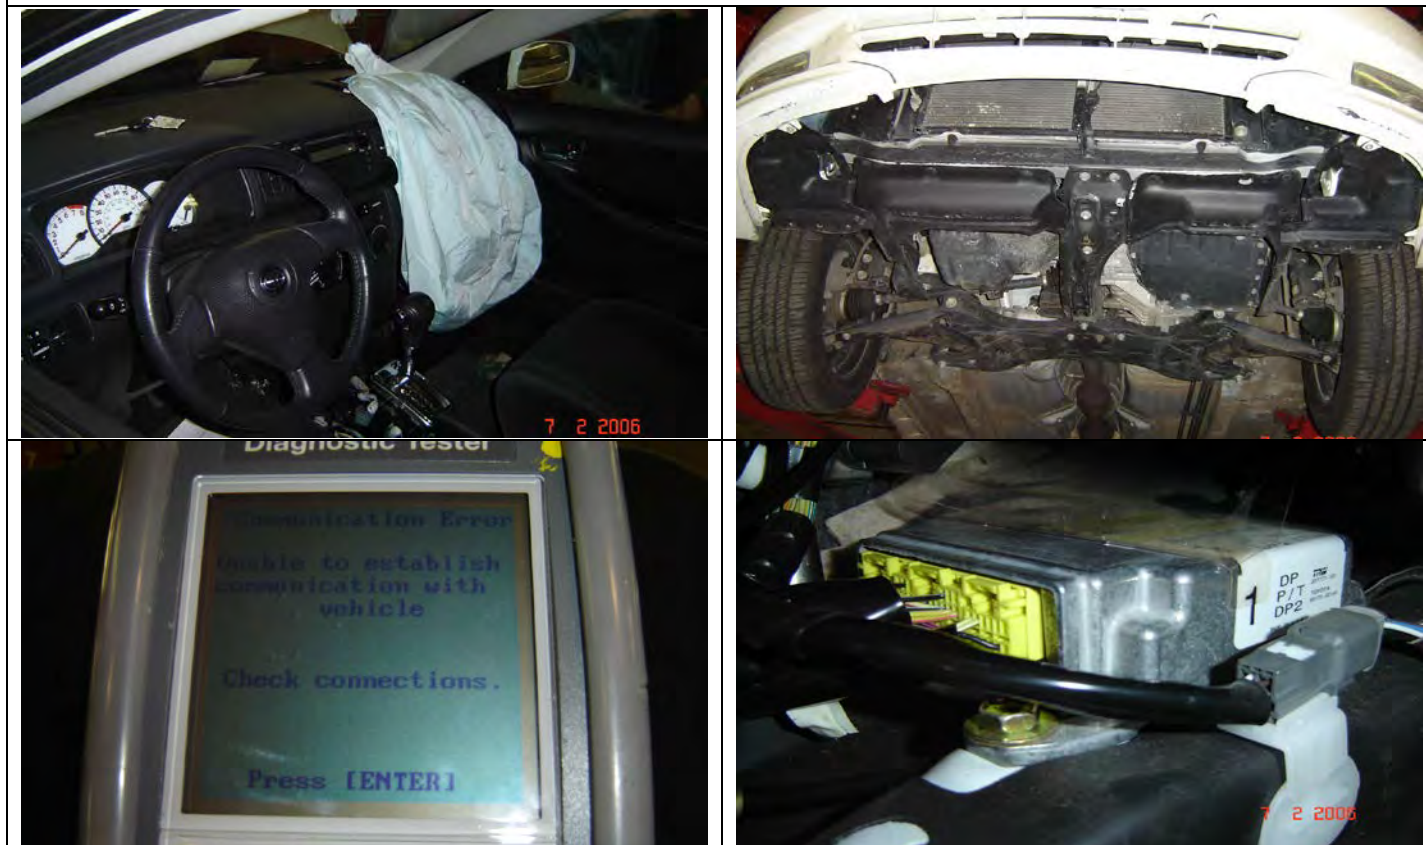
Confirm no damage to front and undercarriage of vehicle. Using Toyota diagnostic scan tool there was no communication to center sensor. Shorting TC to CG at DLC3 did not get system to show codes with flashing warning lamp. Center sensor was not sending voltage to driver's bag for circuit confirmation. Center sensor was not functioning. Center sensor was fastened to floor of vehicle properly. Center sensor had a strange sulfur type smell.

Center sensor had an internal failure.

Replace center sensor and all necessary components to repair customer vehicle.

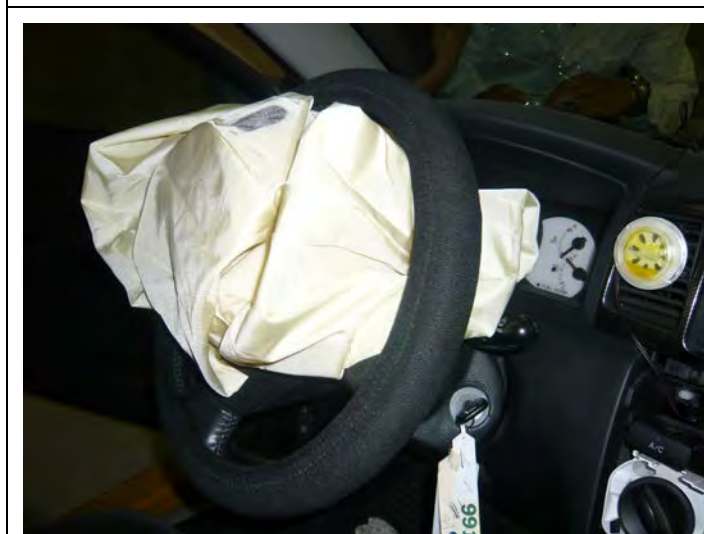
- Inspected vehicle for damage – none found
- Checked for codes – could not communicate with SRS ECU
- Inspected wiring harness between Airbag Center Sensor Assembly and the front driver and passenger airbags and the LH and RH seat belt pretensioner – ok

Techstream cannot communicate with SRS ECU

Replaced airbag center sensor assembly. Part was recovered for additional investigation.

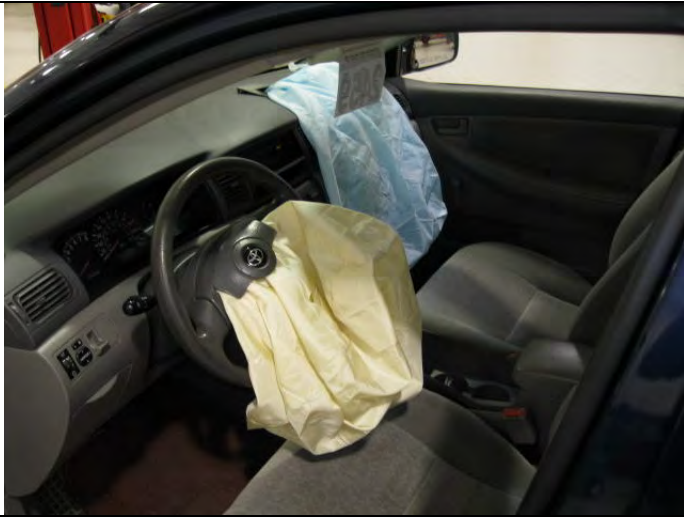
Front Airbags

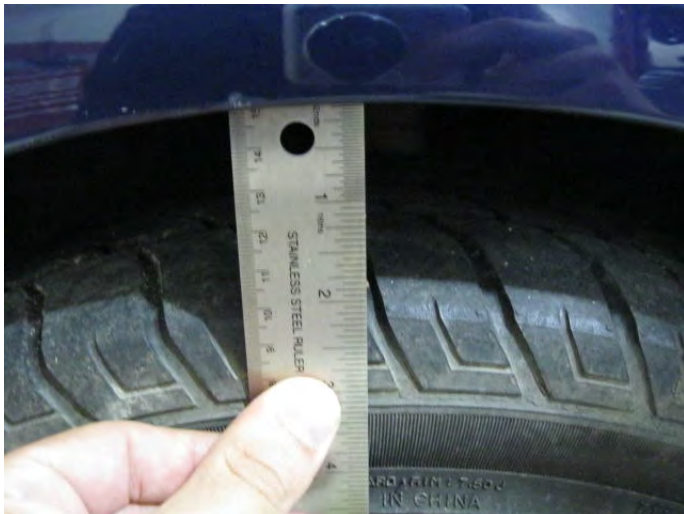
Vehicle Lowered

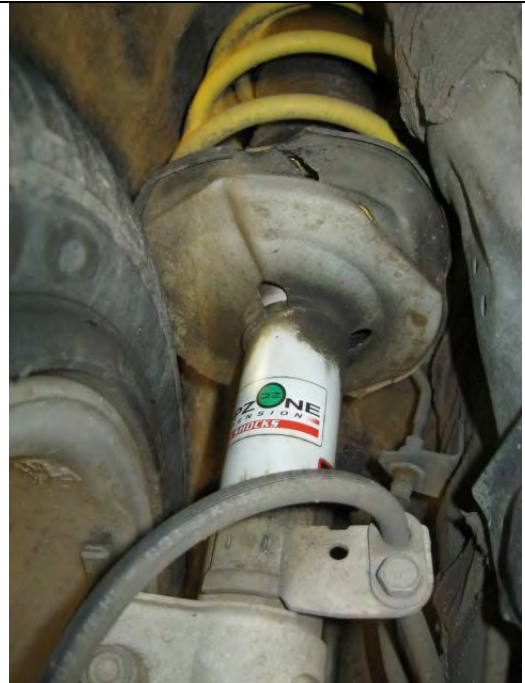
<p>Probable Cause</p> <ul style="list-style-type: none"> Unknown Vehicle condition (SRS system) before reported incident unknown Possible harsh impact from road surface exaggerated by damaged right front strut
<p>Repair Process</p> <ul style="list-style-type: none"> Customer currently consulting with insurance company for repairs

Damaged RF Strut

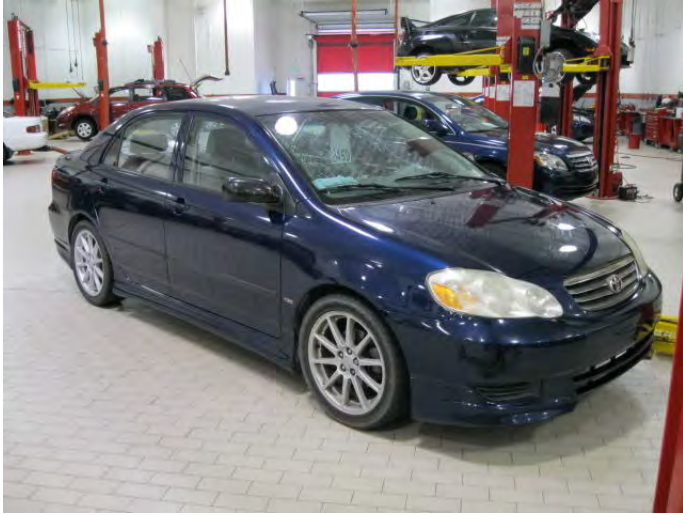
Vehicle Exterior

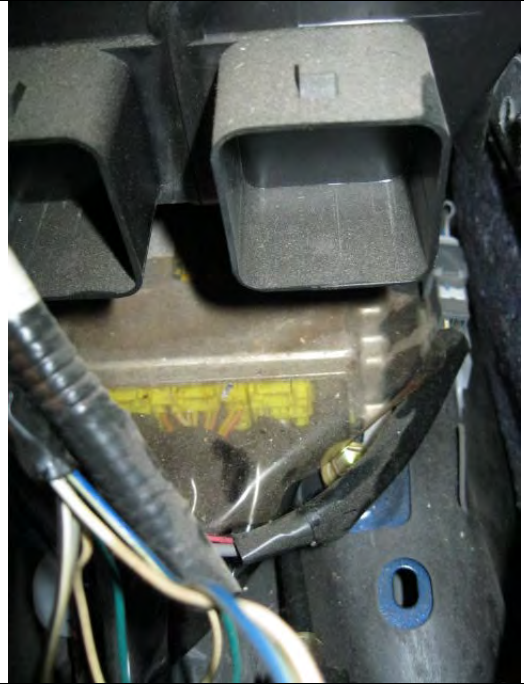
Center Sensor

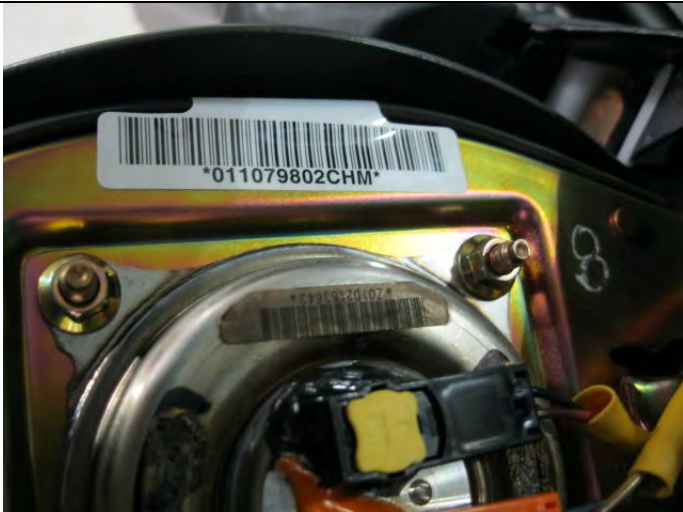
Driver's Airbag Serial

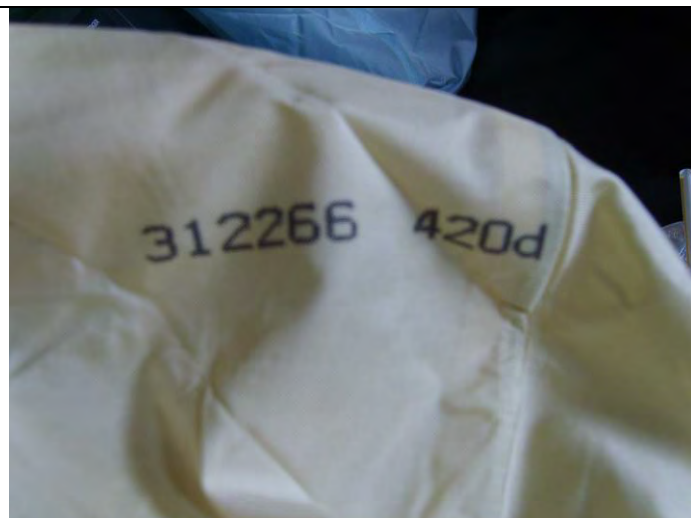
Number on the driver's air bag
312266 420d

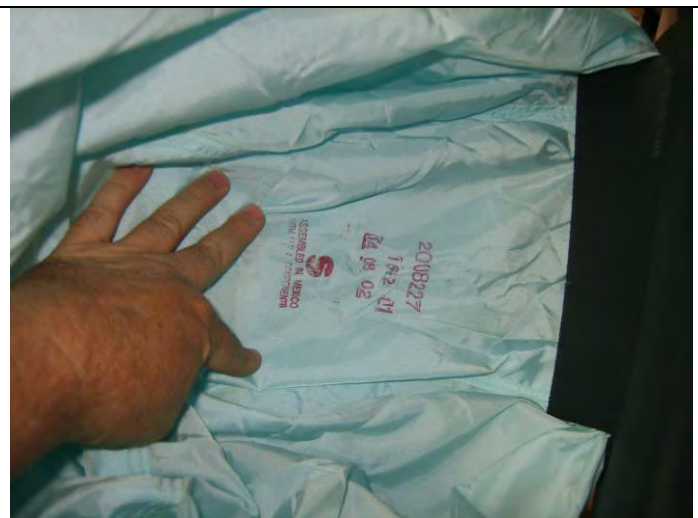
Number on the passenger's air bag

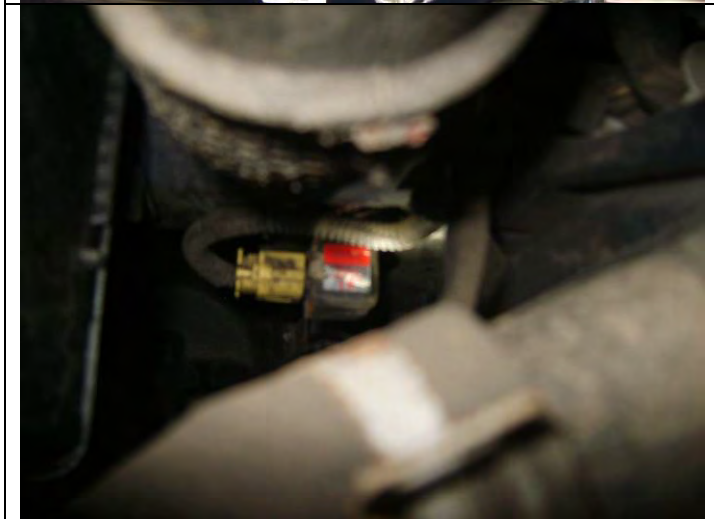
Left front sensor

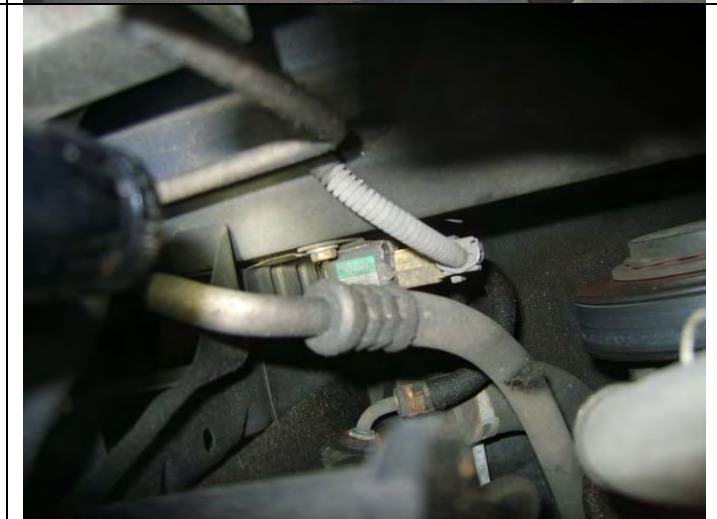
Right front sensor

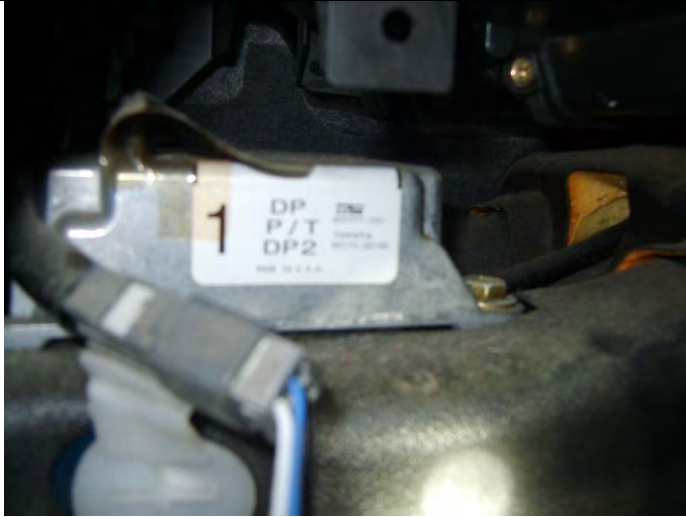
Center sensor

1 DP TRW
P/T 207771-101
DP2
89170-02190

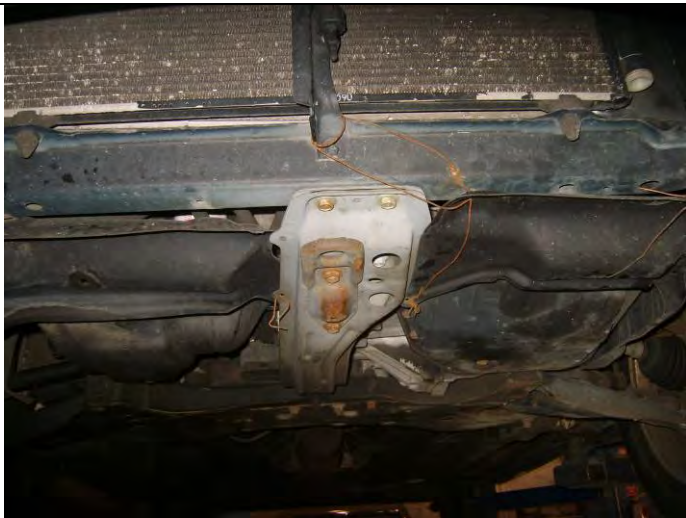
Splash shields held on with wire

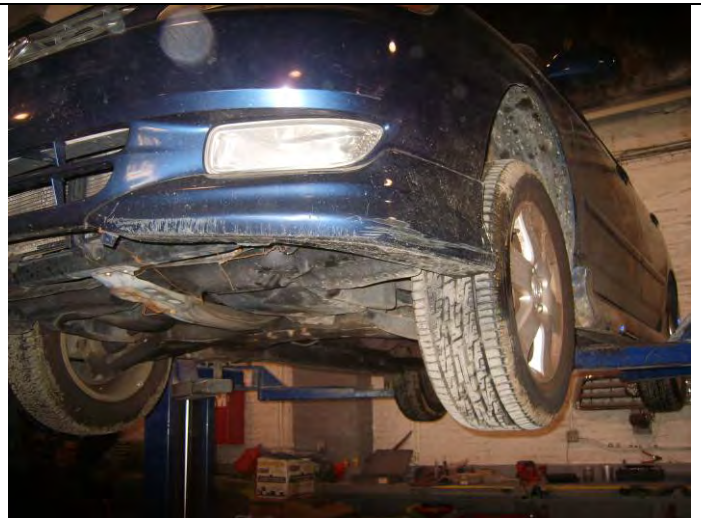
Old impact to sub frame

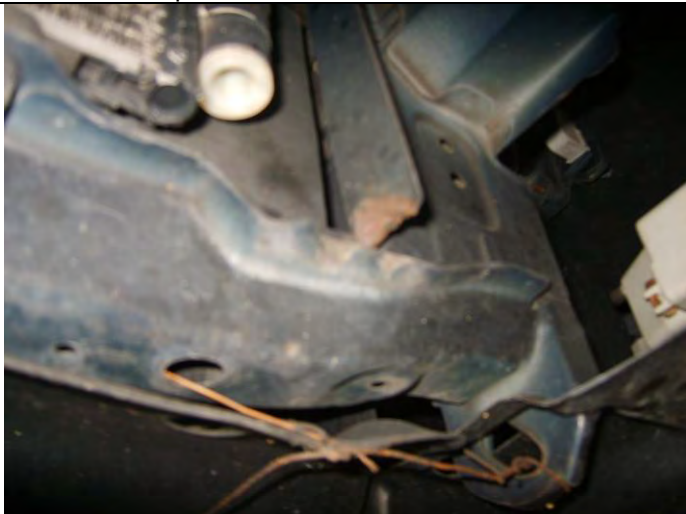
Left side of the radiator support not attached and old damage

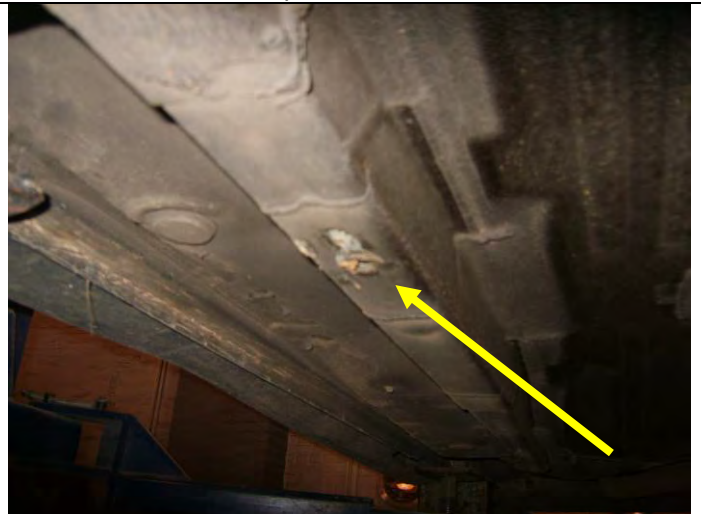
I requested that the vehicle be placed on a lift.
 With the vehicle on the lift I found more old substandard body work.
 I also found an impact mark on the reinforcement of the floor pan, this is within 18" of the center sensor.
 There was another impact mark on the rear of the reinforcement and the rear axle beam was wiped clean on the bottom in this area.

I suspect that the vehicle ran over an object approximately the size of a curb stop and the impact with the front of the floor pan caused the air bags to deploy.

Fresh impact to floor pan on the passenger's side behind the front wheel

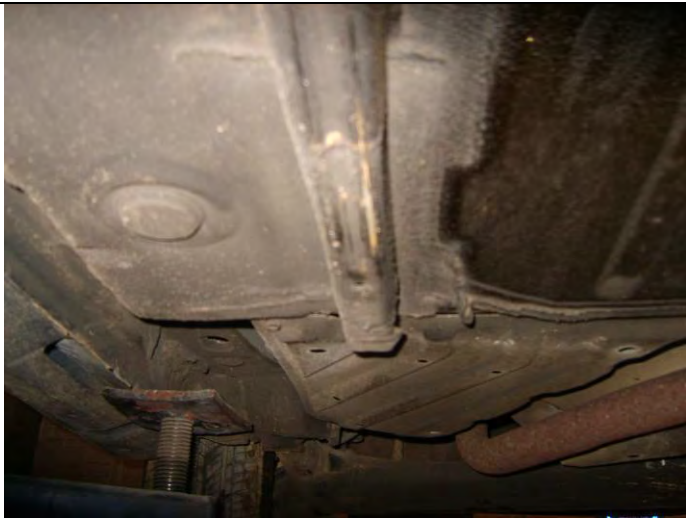
Right rear floor pan

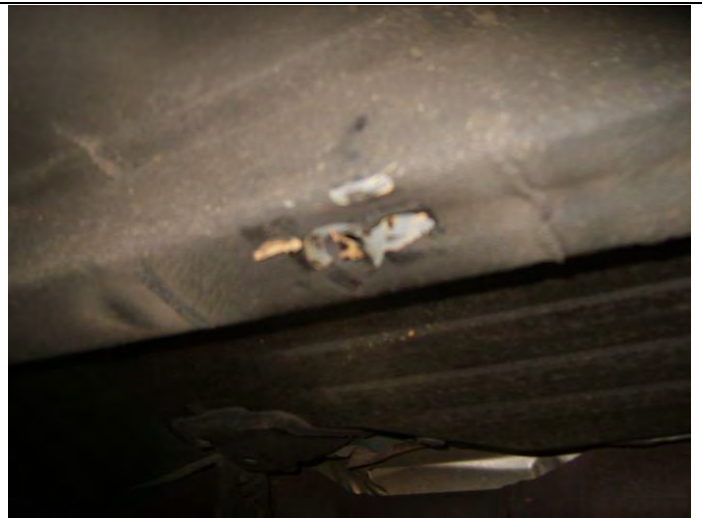
Same area as above

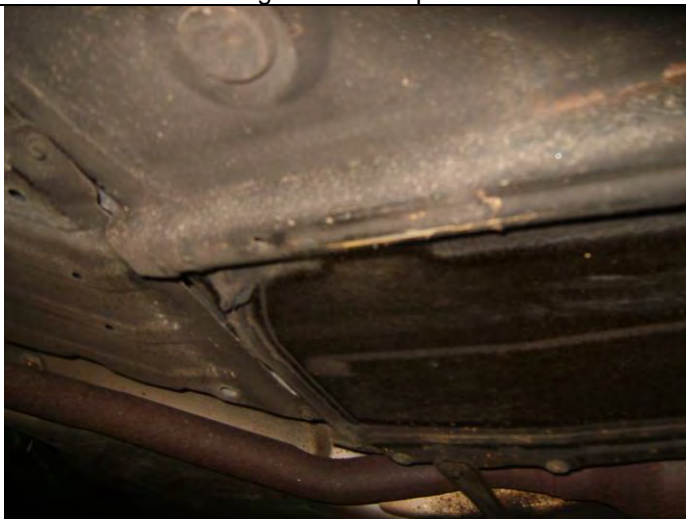
Same area as above

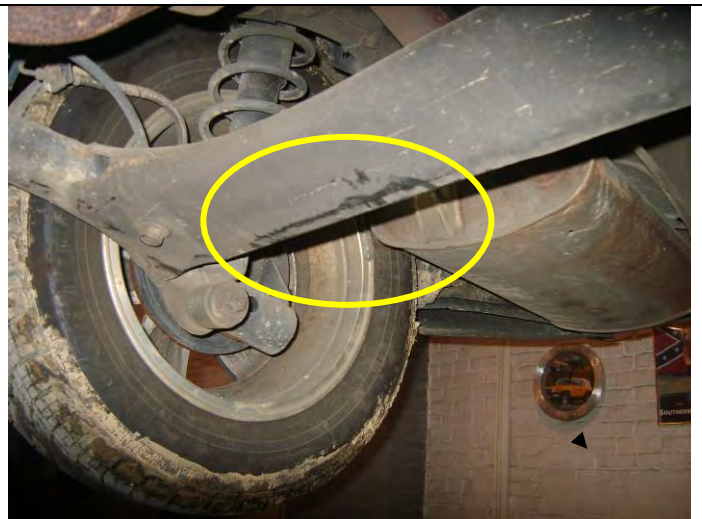
Right side of the rear axle beam

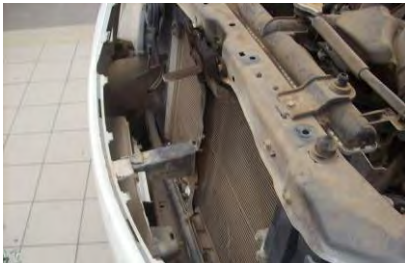
Front of vehicle with not damage

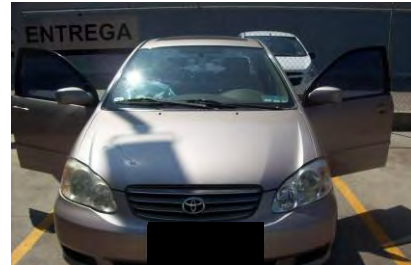
Front of vehicle witout damage

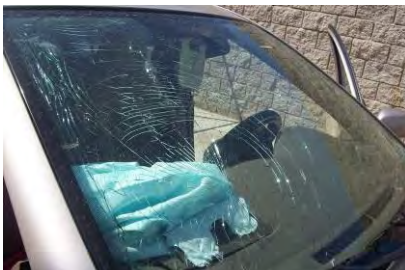
Stone hit the front windshield (customer states that the front air bags deployed as the stone hit the window)

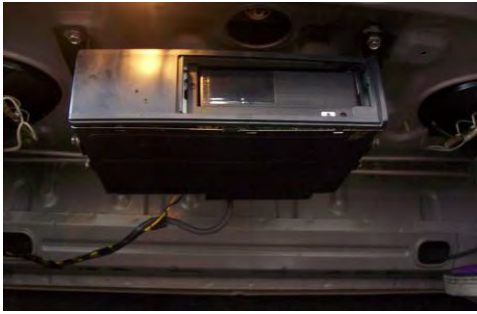
Aftermarket CD box installed in trunk area

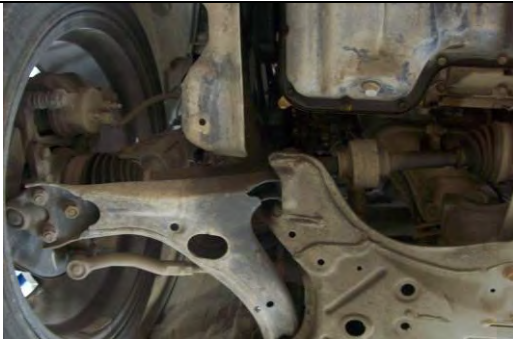
Front and rear under vehicle visual inspection (No damage was noticed)

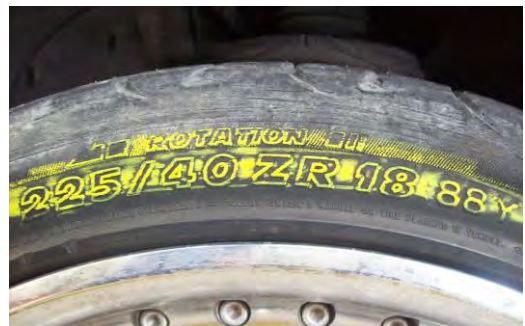
225/40/R18 tires

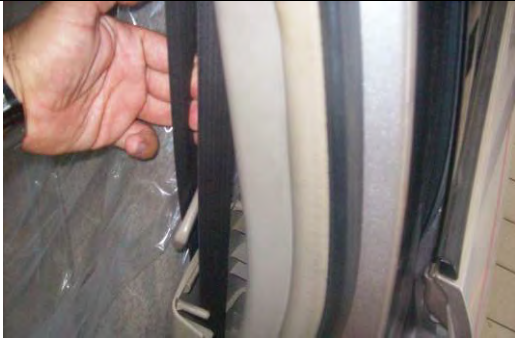
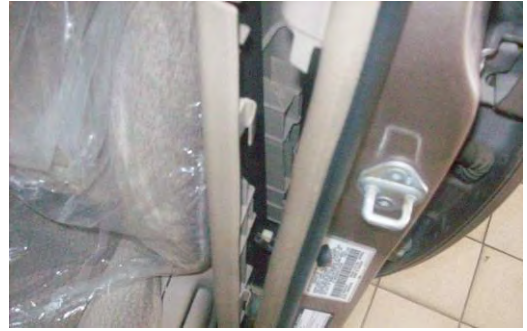
Seat belt retracted when air bags activated, customer was not wearing seat belts. (front right and left)

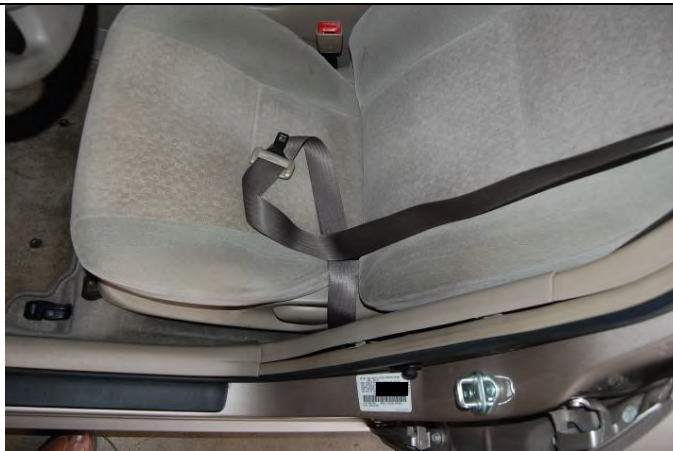
Driver side pretensioner deployed

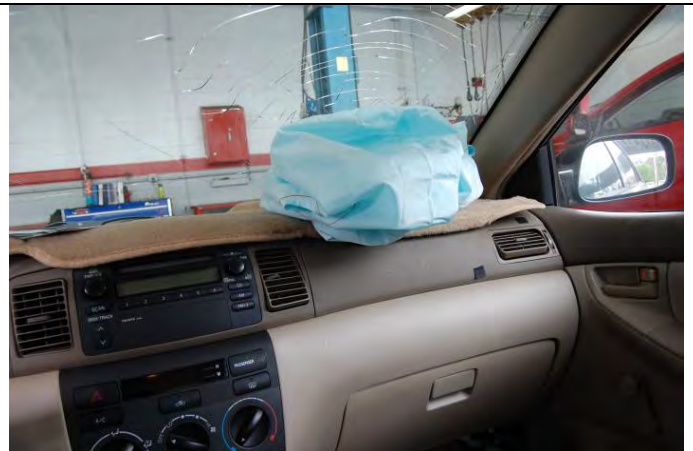
Passenger bag deployed – windshield broken

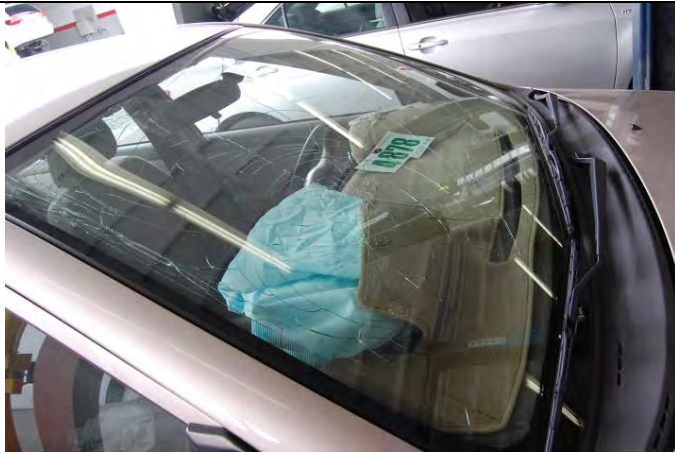
Windshield broken

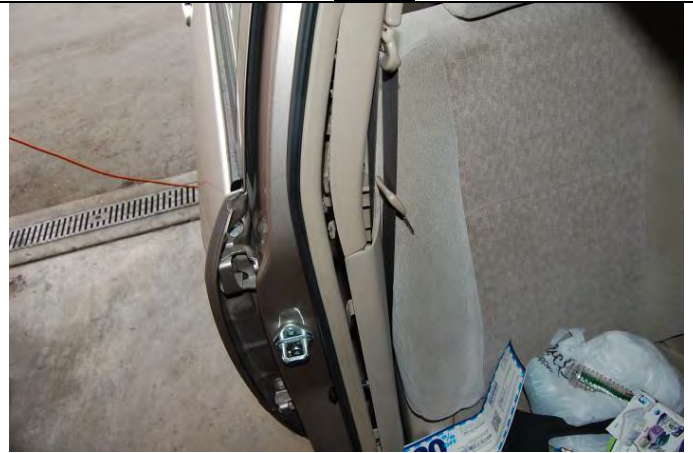
Passenger side seat belt pretensioner deployed

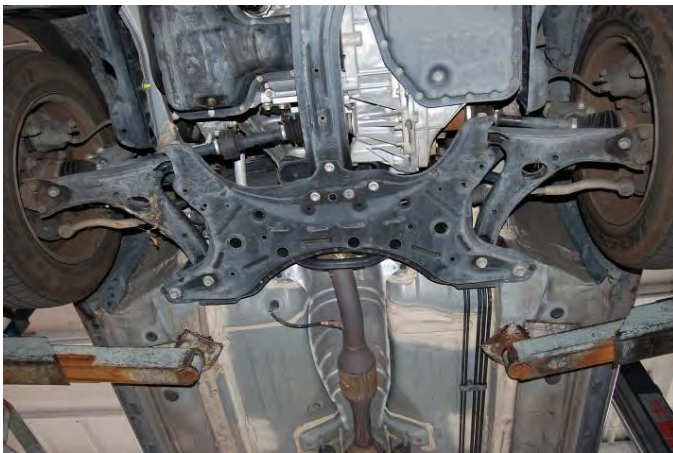
No visible undercarriage damage

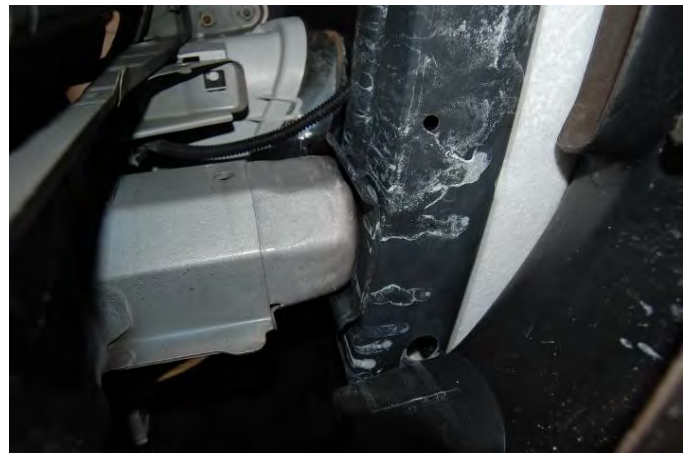
Left frame rail and bumper support – no damage

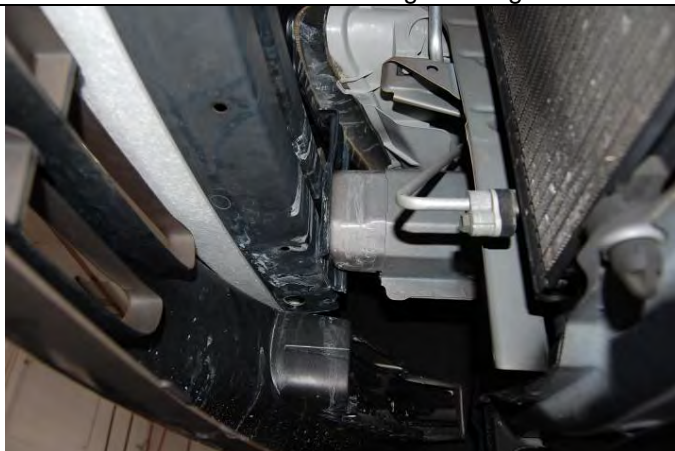
Right frame rail and bumper support – no damage

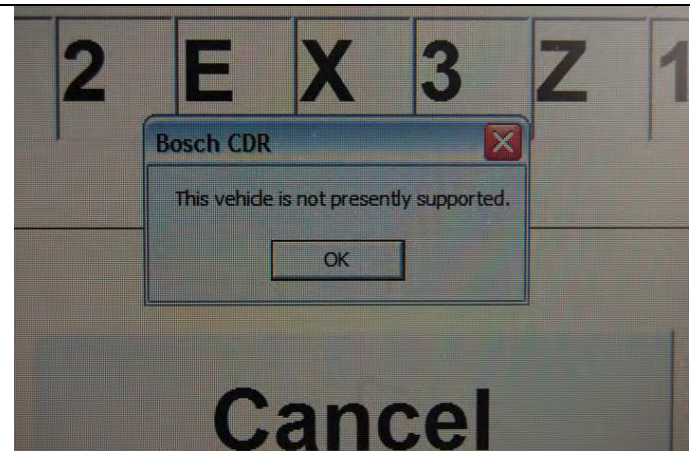
Bosch CDR readout

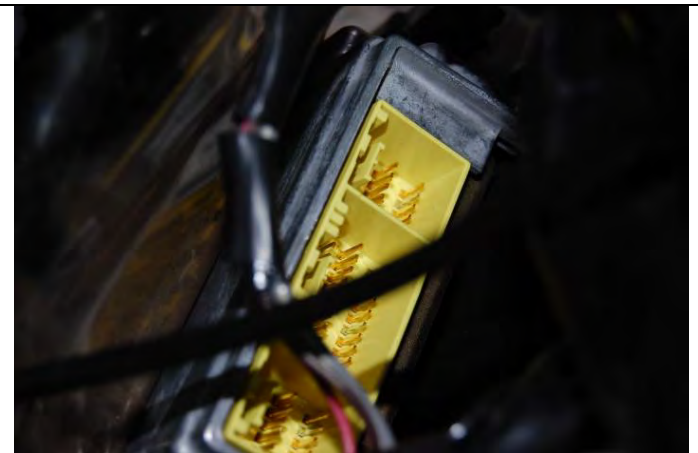
SRS ECU free from corrosion

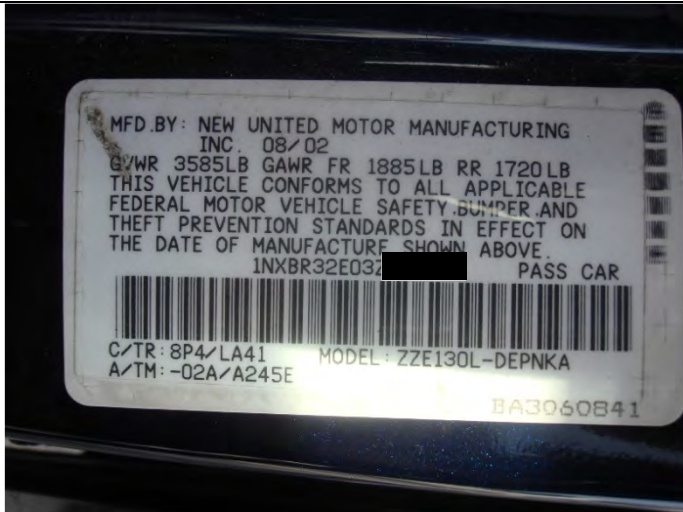
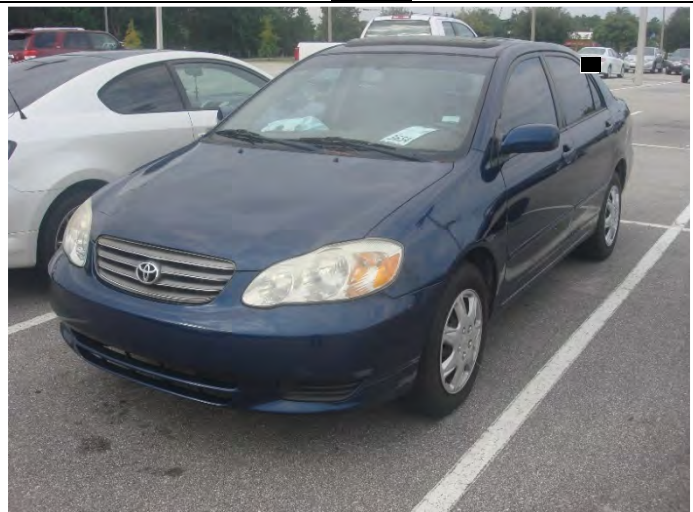
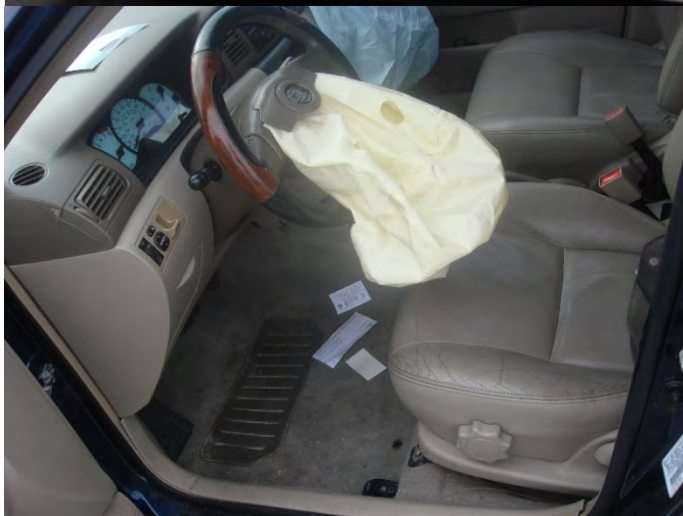
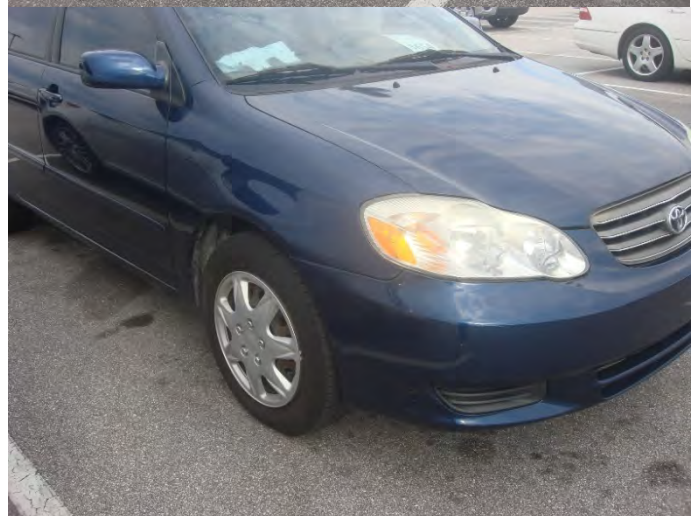
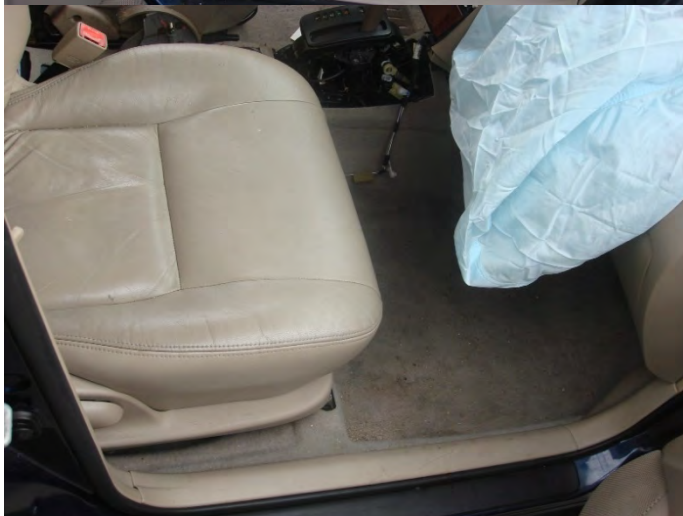
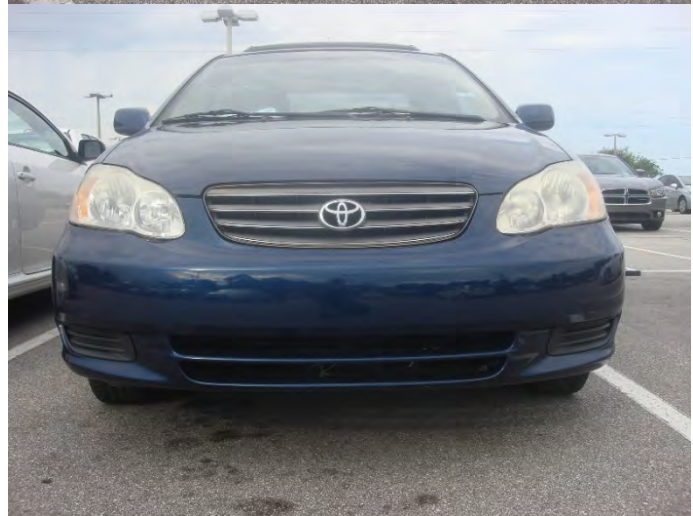
TQCN DOC# TQCN_FTR-112440050		Condition Title SRS Deployment With No Signs of Frontal Collision			Date 09/05/2011
Primary Model Corolla	Model Year 2003	Production Date 2002-08-30	Odometer 103169	VIN (confirm 17 characters): 1NXBR32E03Z [REDACTED]

No repairs performed pending legal review.

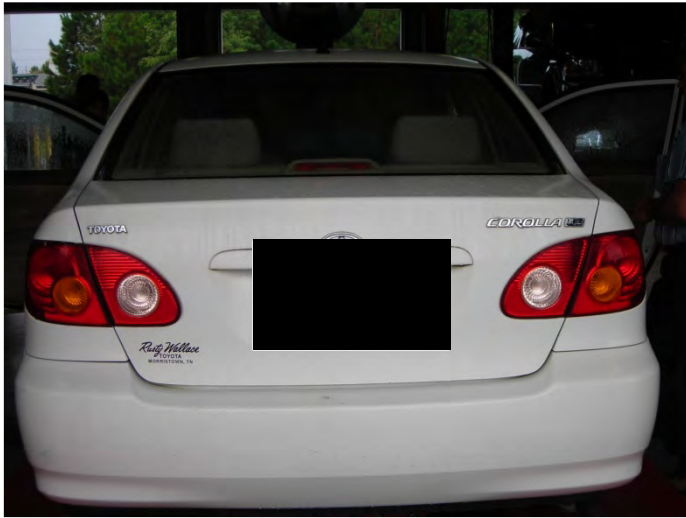
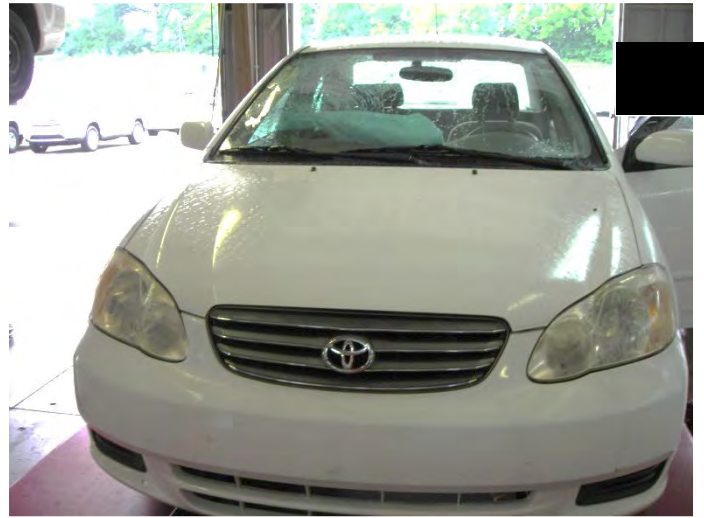
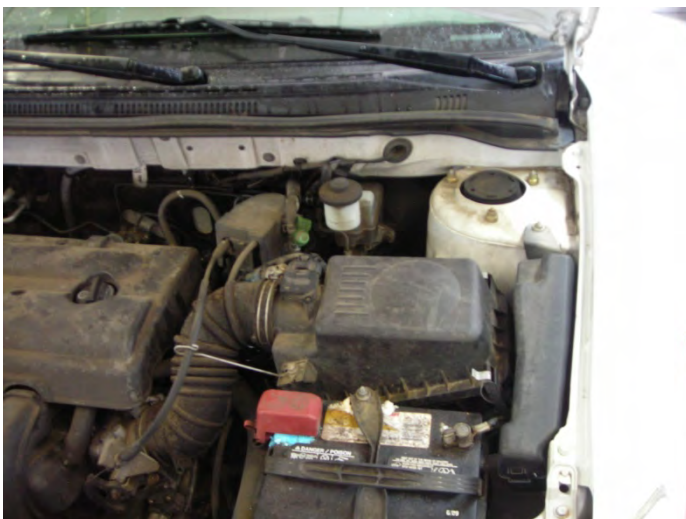
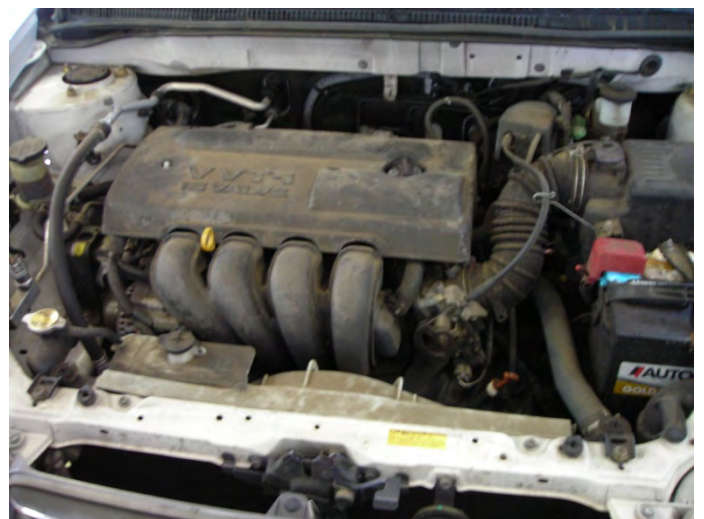
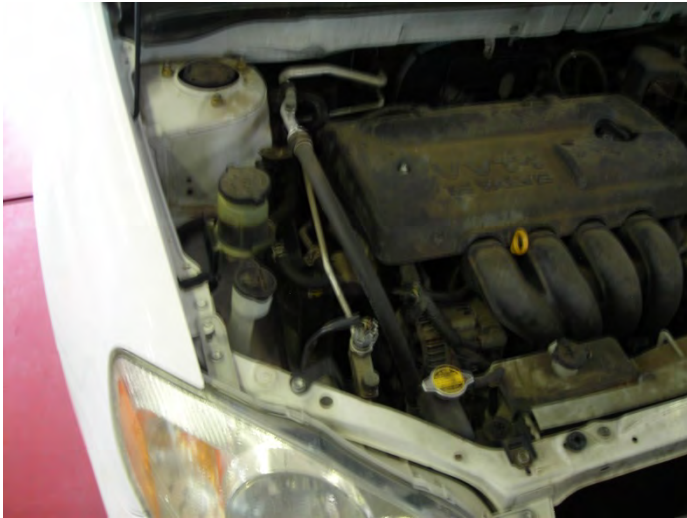
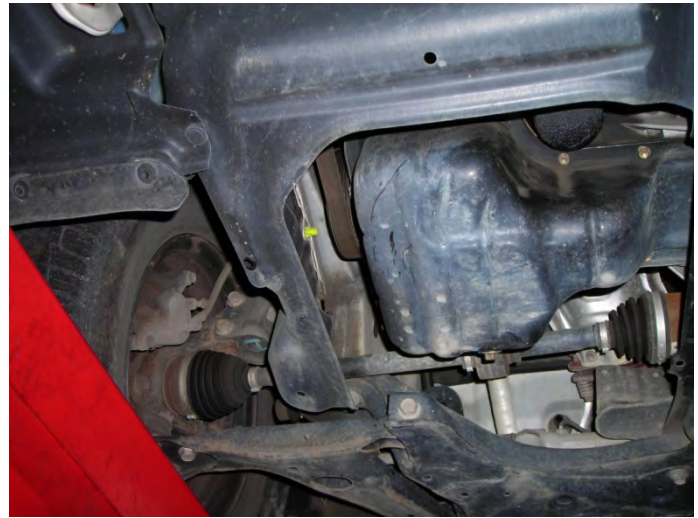
The vehicle was inspected at dealer 41052 on June 23, 2008 for a SRS MIL on. The dealership retrieved SRS code B0103 Short in D Squib Circuit (to B+). Dealer diagnosed as a spiral cable issue. Customer declined repairs at that time.

No damage found on or under vehicle

No repairs at this time

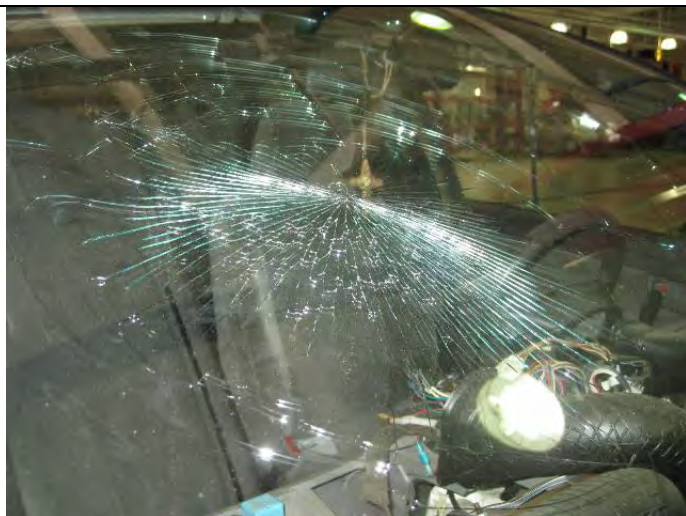
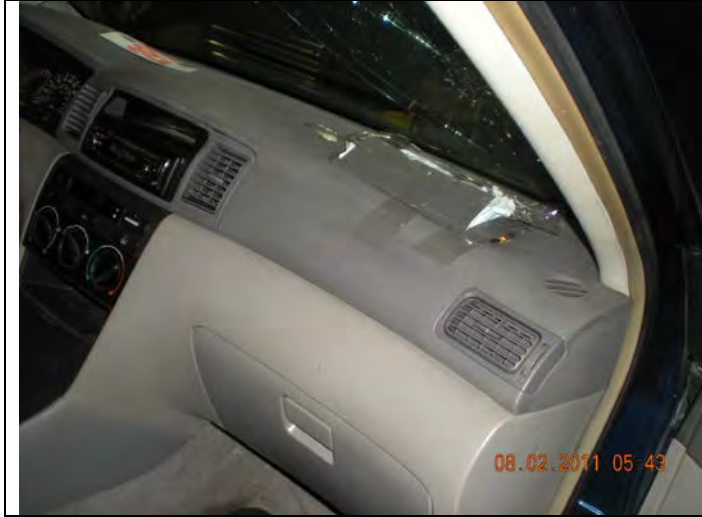
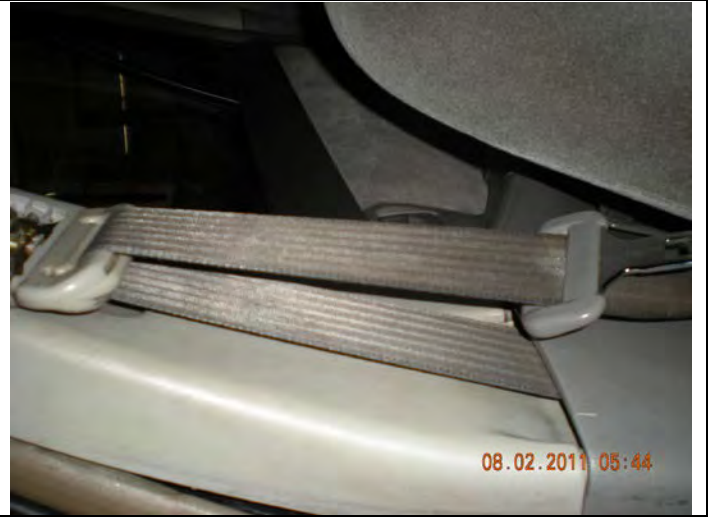
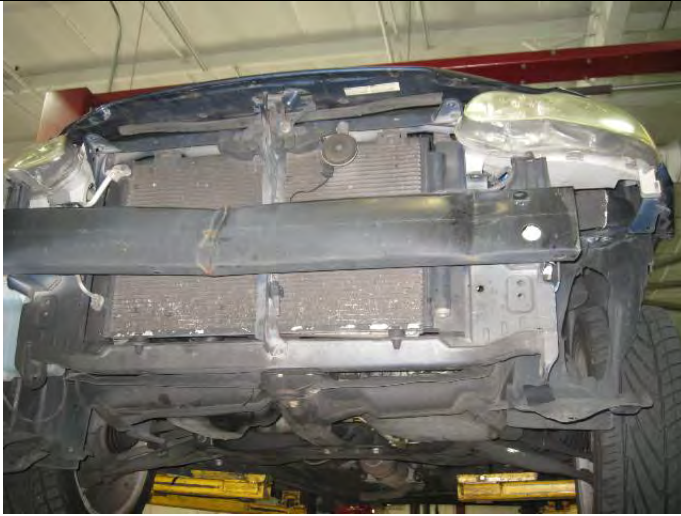
- B0101 Open in D squib circuit
- B0103 Short in D squib circuit (to B+)
- B0107 Short in P squib circuit (to ground)
- B0108 Short in P squib circuit (to B+)
- B1100 Airbag sensor assy malfunction
- Front seat belt pretensioners deployed
- Passenger side airbag deployed
- Drivers airbag not deployed
- Drivers squib/ clock spring is shorted
- Retrieved EDR data sent to legal
- Removed bumper cover for picture of damage from minor accident. 2years prior according to customer

- Defective center air bag sensor and shorted clock spring.

- Center airbag sensor needs replaced
- Windshield needs replaced
- Drivers and passenger seat belts need replaced
- Clock spring needs replaced
- Passenger air bag needs replaced

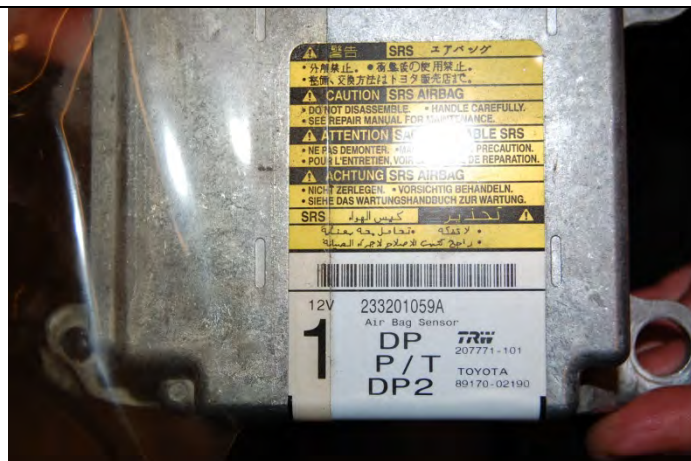
Inspected Vehicle and confirmed: Vehicle has had prior body damage to the left rear qtr. panel/bumper and was repainted (not recently). CARFAX report called out no prior accidents. Noted both front airbags and pre tensioners had deployed and broke front windshield glass, above the passenger side. Driver seatbelt locked loose/passenger seatbelt locked tight. Retrieved the following DTCs w/ Tech Stream: B0103, B0105, B0106, B0131, B0136 & B1100. Visually inspected interior, exterior and undercarriage of vehicle and was unable to confirm root cause for airbag deployment. Attempted to recover EDR Data, but was unable to retrieve. TMS PQSS-CQE & SMART Team recovered SRS Center sensor for further analysis.

Center Sensor Pictured above

No repairs at this time.

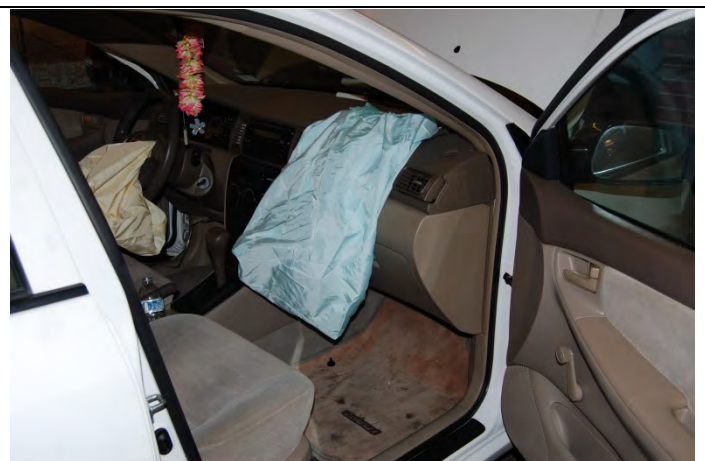
Airbag deployment pictured above

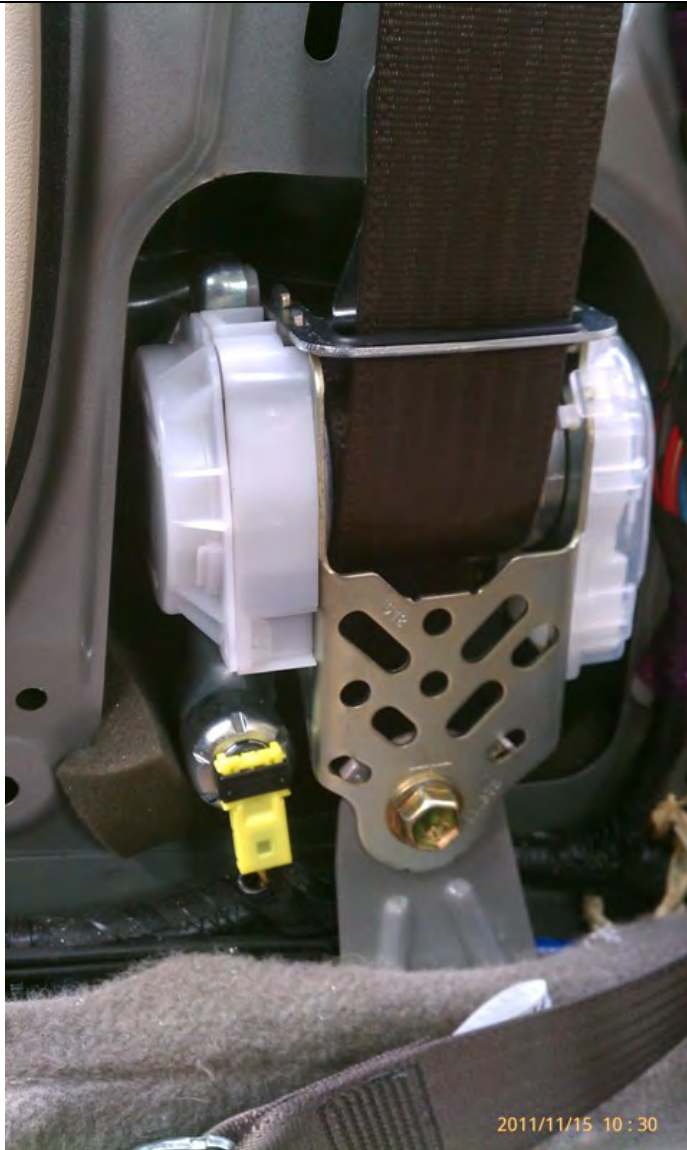
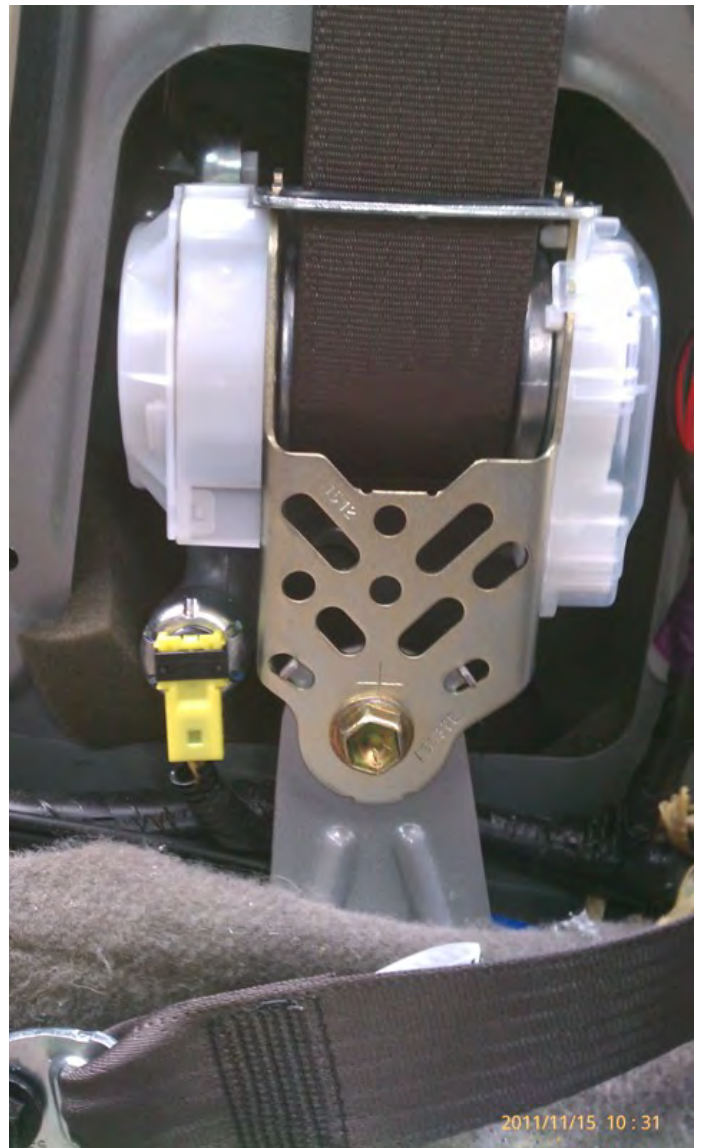
Driver side pretensioner deployed while driving. SRS MIL light on solid. Vehicle is in great condition. No damage to vehicle noted.

No repairs performed pending possible inspection.
Note - pretensioner was replaced previously on 9/27/2011 due to SRS MIL light on.
