EA12-001

TOYOTA

Attachment-Response 4

Field Report

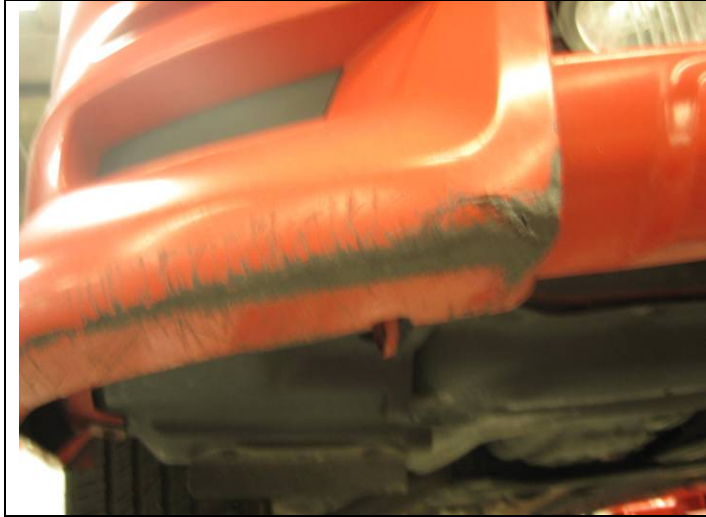
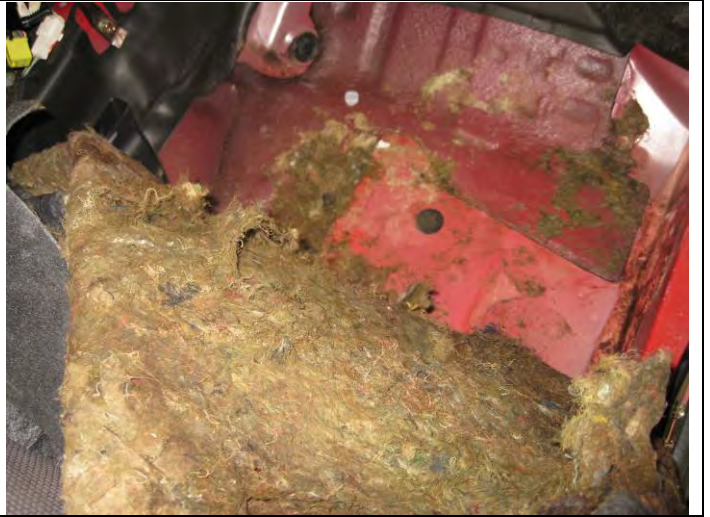
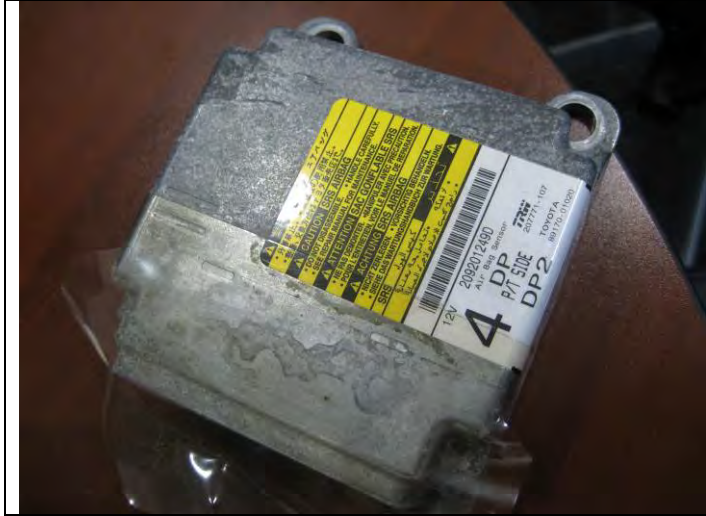
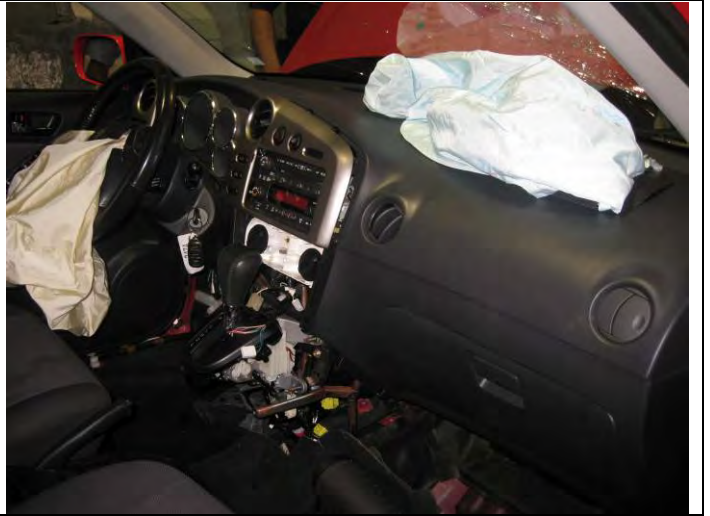
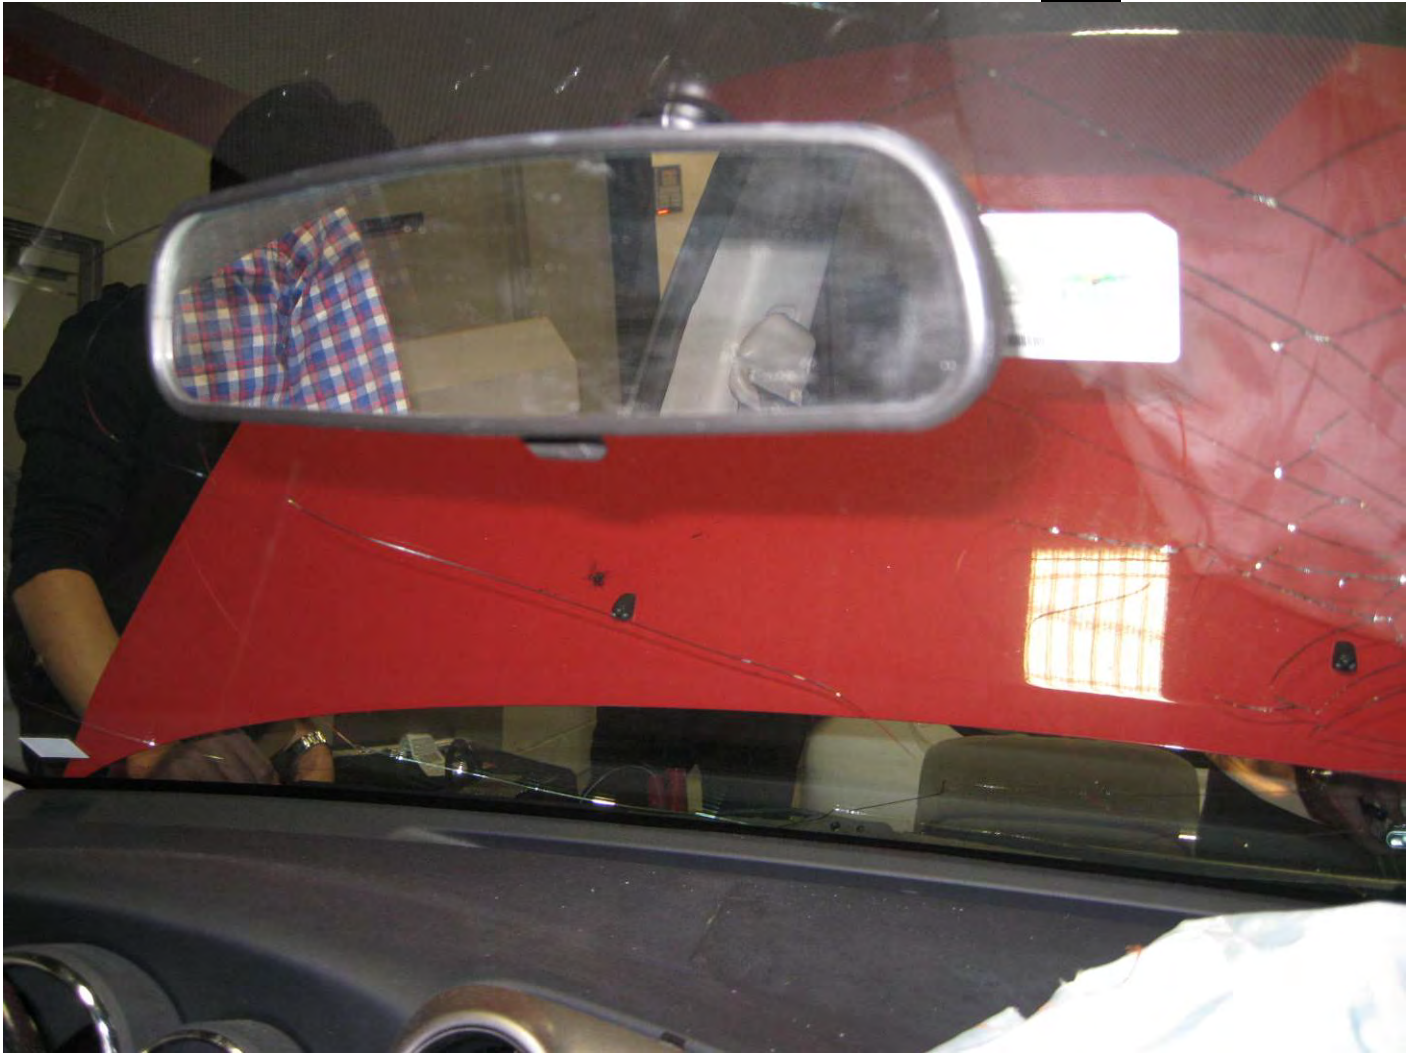
- Vehicle was inspected for the customers stated concern.
- The driver's front and the passenger front airbags were deployed at time of inspection.
- The front windshield was cracked

No repairs have been made
FCRP inspection

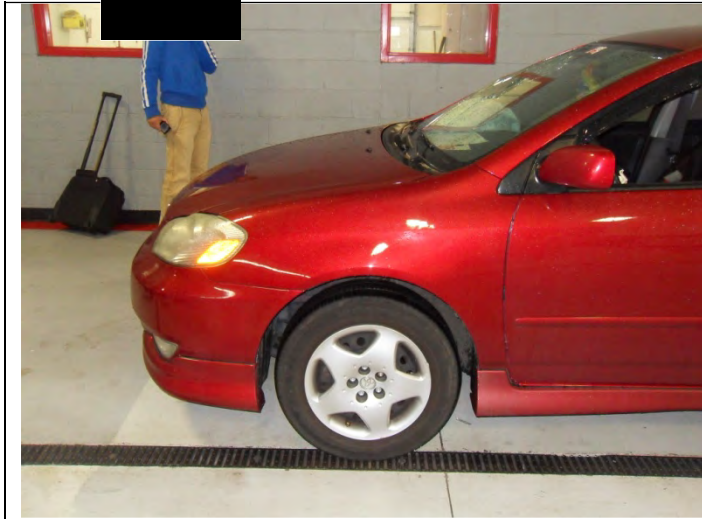
Factory steel on LF only

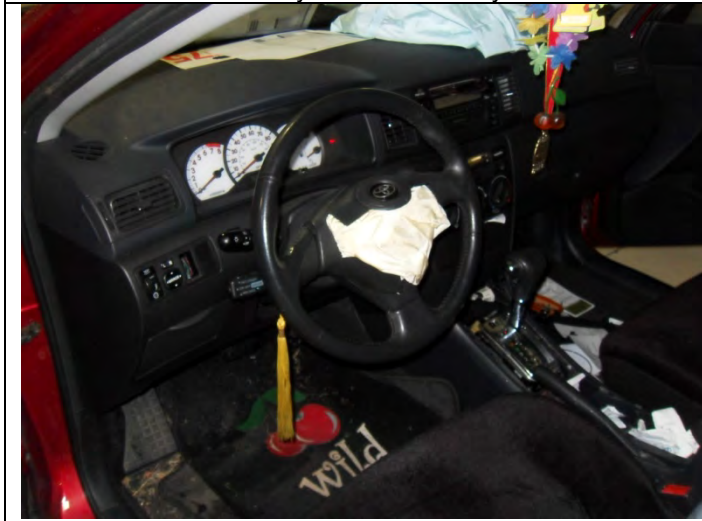
Both Front Air Bags Deployed

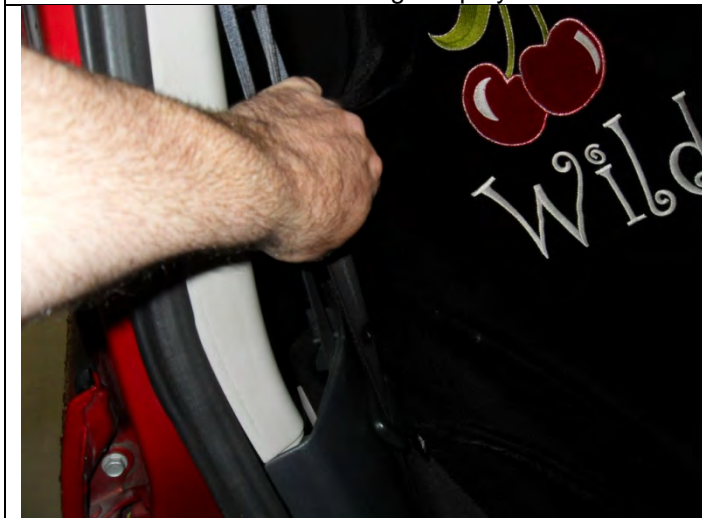
RF Seat Belt Locked In Idle Position

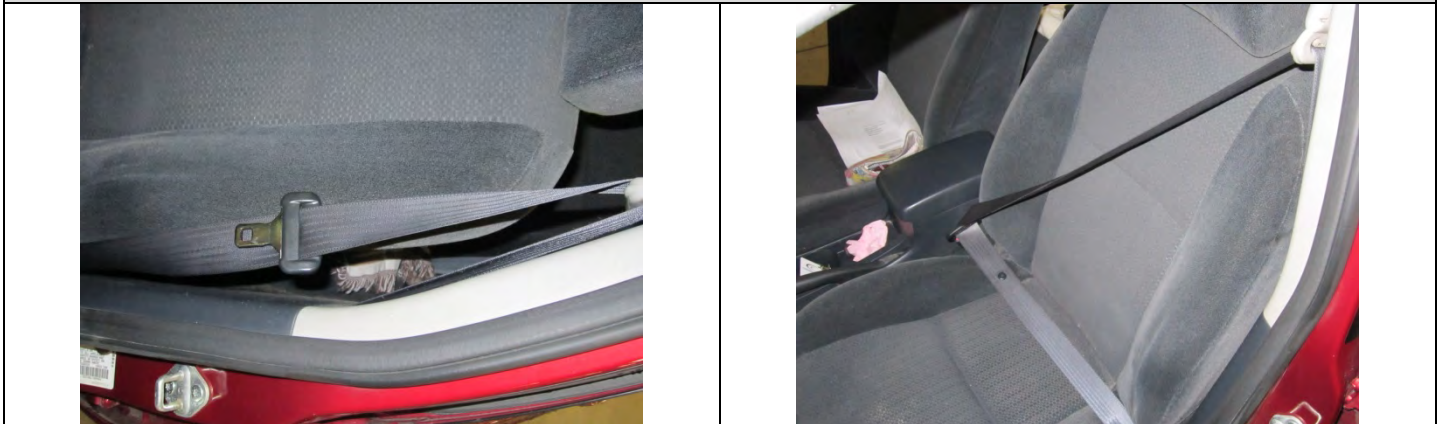
Seat Belt Pictures / Videos

Interior		
Inspection Area	Notes & Observations	
Left Front Position	Seat	
	Seatbelt	Seat belt operating normally at time of FTS inspection.
Right Front Position	Seat	
	Seatbelt	Seat belt operating normally at time of FTS inspection.
Left Rear Position	Seat	
	Seatbelt	Seat belt operating normally at time of FTS inspection.
Center Rear Position N/A: <input type="checkbox"/>	Seat	
	Seatbelt	Seat belt operating normally at time of FTS inspection.
Right Rear Position	Seat	
	Seatbelt	Seat belt operating normally at time of FTS inspection.
Third Row N/A: <input checked="" type="checkbox"/>	Seat	
	Seatbelt

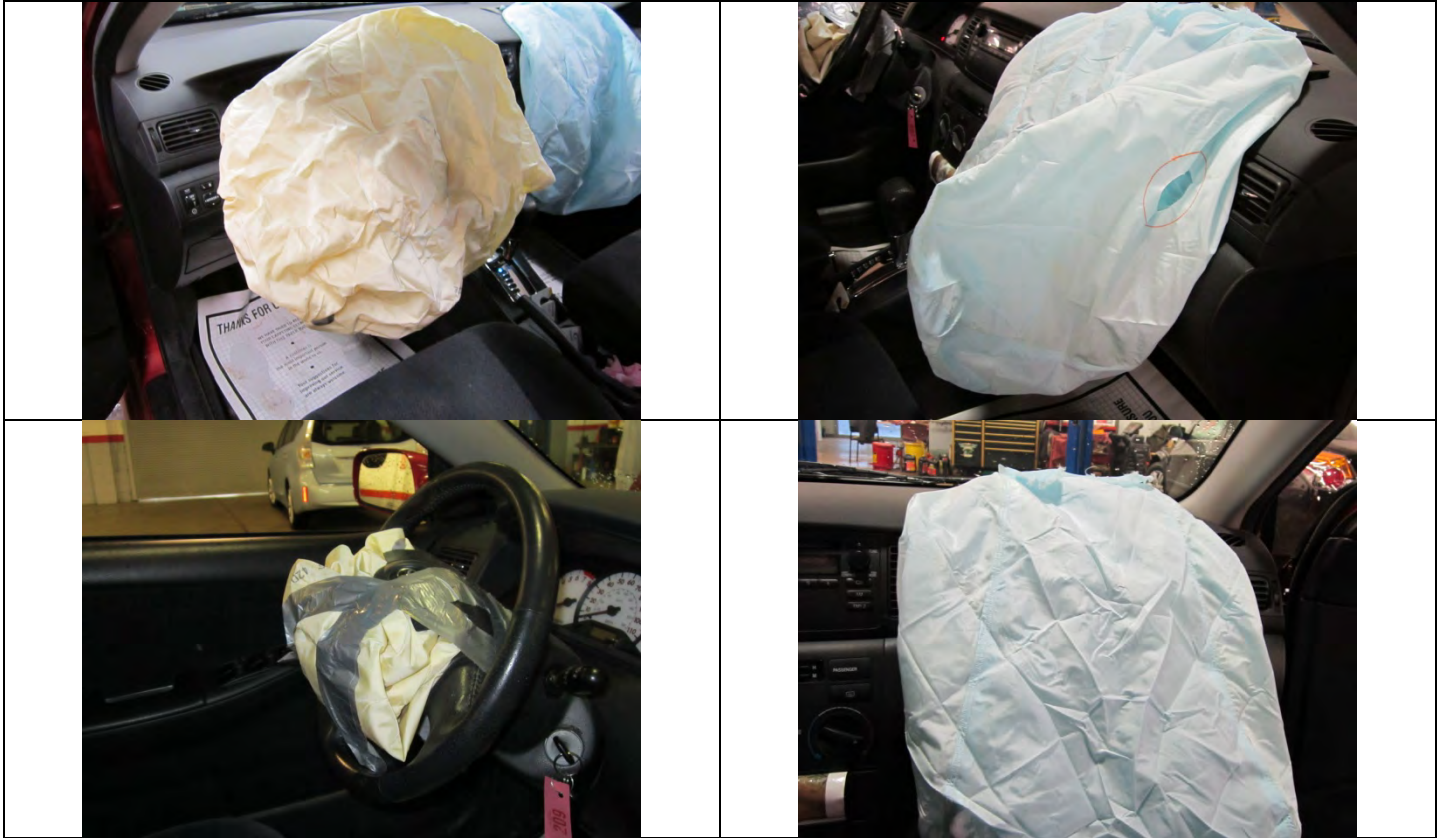
Airbags Pictures

FTS found no signs of impact, or collision damage to vehicle at time of inspection. Air bag light was on at time of inspection, and the following air bag DTC's were stored in memory: B0103, B0108, B0138, B1100. The driver and passenger side air bags were deployed at time of vehicle inspection.

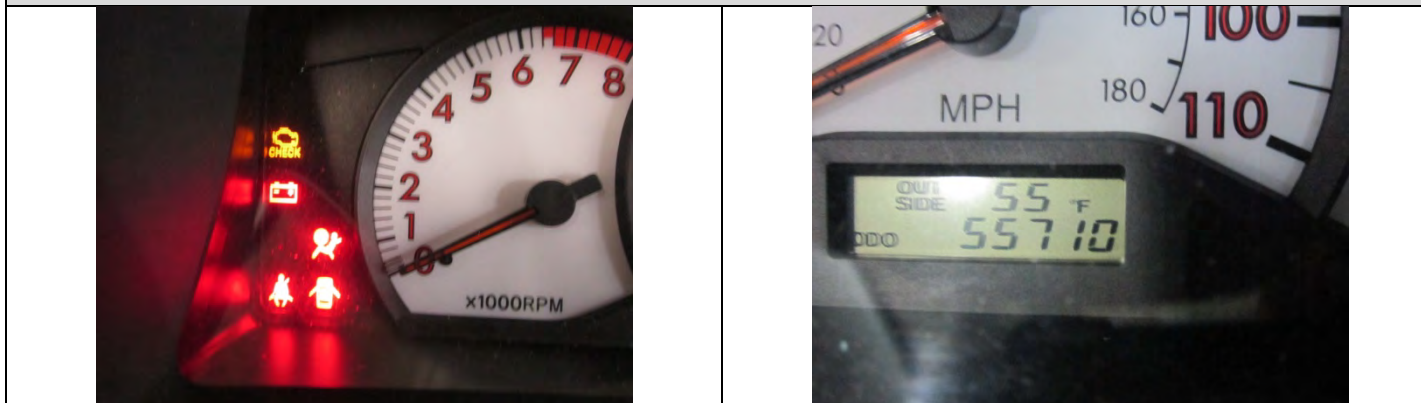
Interior Other Pictures

Inspection Area	Notes & Observations
Warning Light Status	<input type="checkbox"/> Unable to check, vehicle will not start / Ready ON <input type="checkbox"/> Equipped with Safety Connect, note system status here:
	Air Bag Light – on
Instrument Cluster	
Steering Wheel & Column	Air bag deployed.
Shift Lever & Linkage	
Pedal Assembly	Accelerator
	Brake
	Clutch N/A: <input type="checkbox"/>
Floormat & Floorpan	Left Front
	Right Front

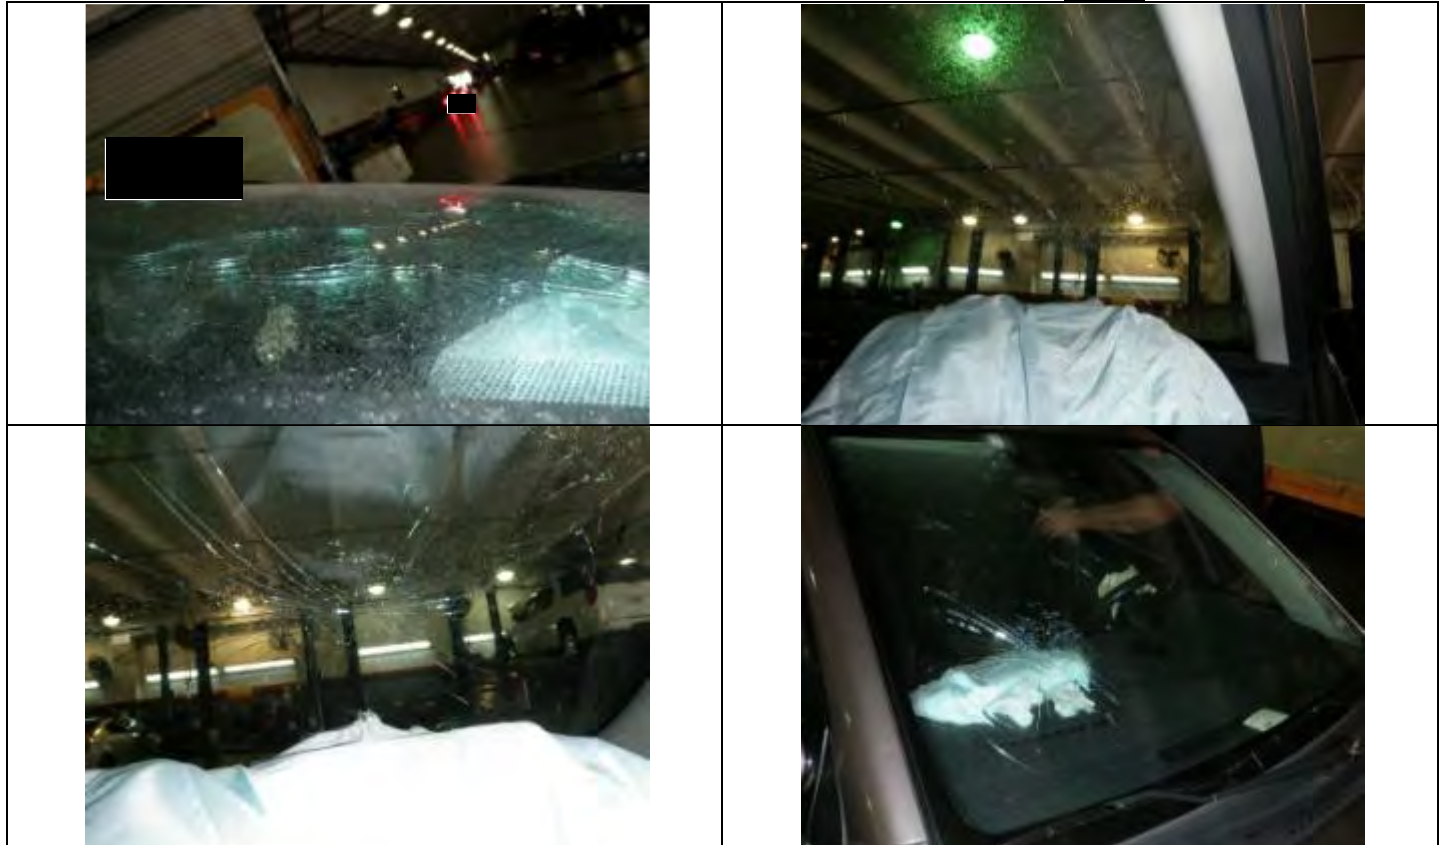
Interior		
Inspection Area	Notes & Observations	
Left Front Position	Seat	No abnormalities
	Seatbelt	Seat belt tensioner had deployed. The seat belt was loose and would not retract to its original condition against the driver's side b-pillar. This indicated that the seat belt was buckled into the receiver at the time of the incident.
Right Front Position	Seat	No abnormalities
	Seatbelt	Seat belt tensioner had deployed. Seatbelt was held tight against the passenger side B-pillar indicating that the seat belt was not buckled into the receiver at the time of incident.
Left Rear Position	Seat	No abnormalities
	Seatbelt	Normal operation, seat belt buckle had to be retrieved from under the rear seat, was not visible initially.
Center Rear Position	Seat	No abnormalities
	N/A: <input type="checkbox"/> Seatbelt	Normal operation
Right Rear Position	Seat	No abnormalities
	Seatbelt	Normal operation
Third Row	Seat	n/a

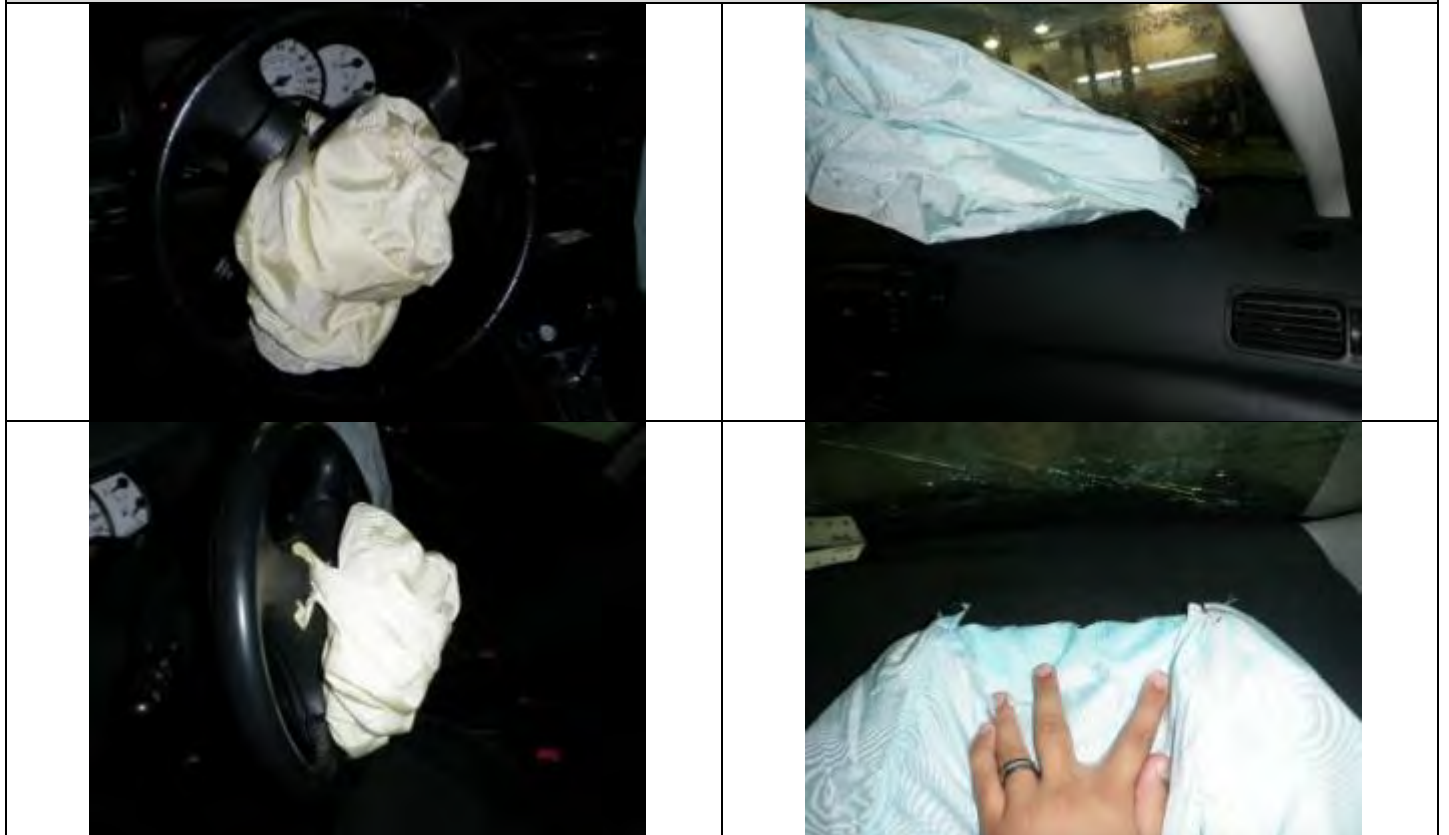
Airbags Pictures

Interior					
Supplemental Restraints Inspection		Deployed		N/A	Notes & Observations
		Yes	No		
Driver	Front SRS	<input checked="" type="checkbox"/>	<input type="checkbox"/>	<input type="checkbox"/>	Deployed as designed
	Knee SRS	<input type="checkbox"/>	<input type="checkbox"/>	<input checked="" type="checkbox"/>	
	Seat Side SRS	<input type="checkbox"/>	<input type="checkbox"/>	<input checked="" type="checkbox"/>	
	Seat Belt SRS	<input checked="" type="checkbox"/>	<input type="checkbox"/>	<input type="checkbox"/>	The seat belt was loose and would not retract to its original condition against the driver's side b-pillar. This indicated that the seat belt was buckled into the receiver at the time of the incident.
	Seat Cushion SRS	<input type="checkbox"/>	<input type="checkbox"/>	<input checked="" type="checkbox"/>	
Front Passenger	Front SRS	<input checked="" type="checkbox"/>	<input type="checkbox"/>	<input type="checkbox"/>	Deployed as designed.

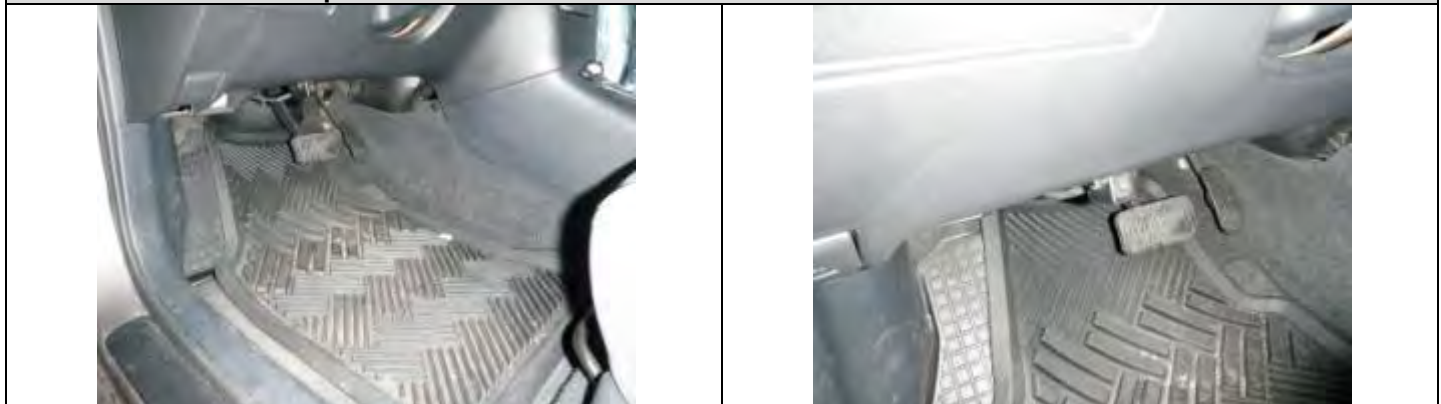
Floormat / Interior Floorpan Pictures

Warning Light Status	<input type="checkbox"/>	Unable to check, vehicle will not start / Ready ON
	<input type="checkbox"/>	Equipped with Safety Connect, note system status here:
Airbag light was on. No other warning indication lights were illuminated with the vehicle running.		
Instrument Cluster	No abnormalities	
Steering Wheel & Column	No abnormalities	
Shift Lever & Linkage	No abnormalities	
Pedal Assembly	Accelerator	No abnormalities
	Brake	No abnormalities
	Clutch N/A: <input checked="" type="checkbox"/>	
Floormat & Floorpan	Left Front	Unsecured aftermarket all weather floor mat installed. The factory floor mat was found underneath secured properly by the factory clips.
	Right Front	Aftermarket all weather floor mat.

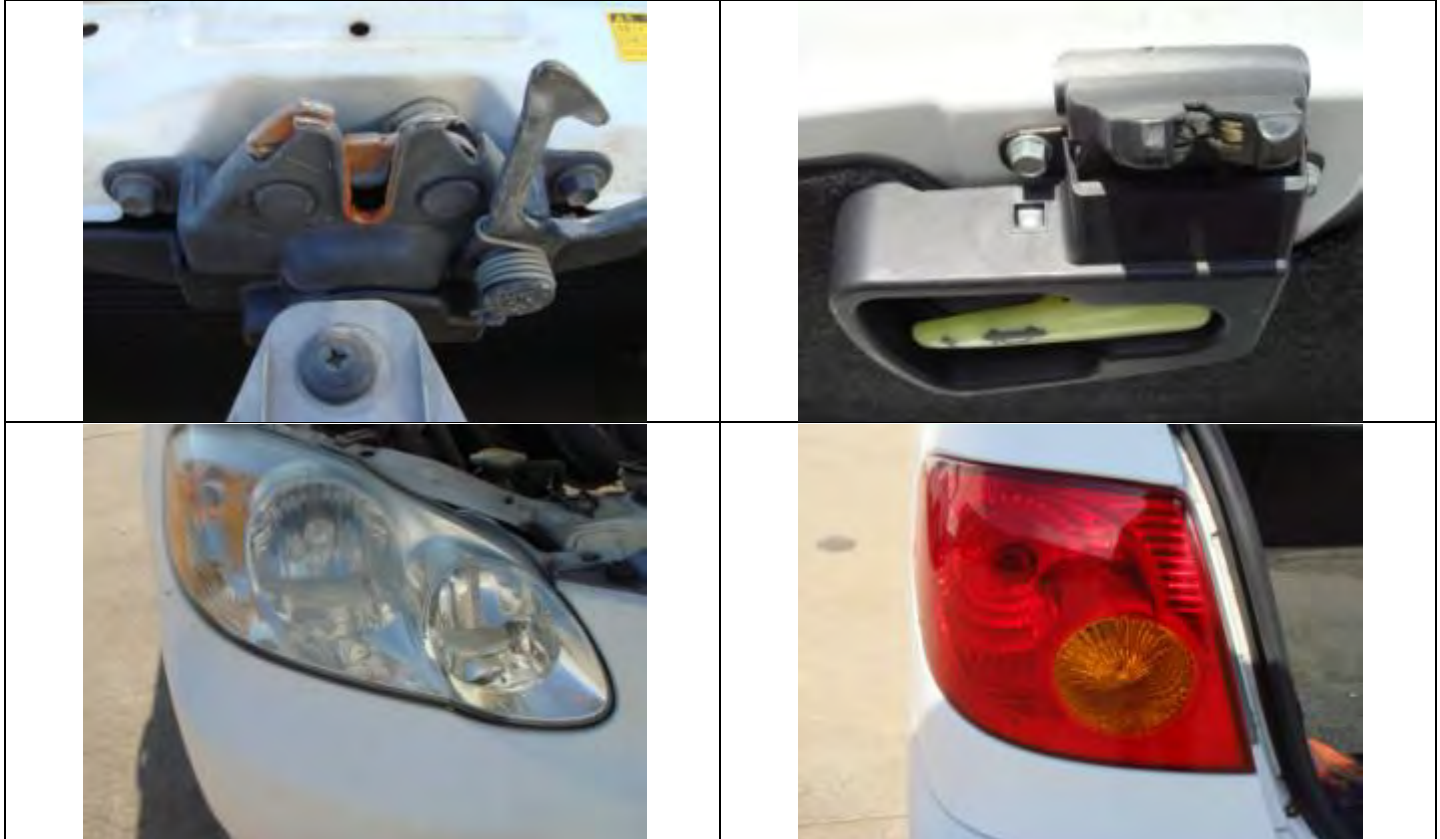
Exterior Other Pictures

Exterior Other	
Inspection Area	Notes & Observations
Headlights / Taillights	All operational
Brake Lights	Operational
Turn Signals	All operational
Glass & External Mirrors	No cracks or damage
Hood Latch	Operational
Hatch / Trunk Latch	Operational
Door Latch & Lock	Operational

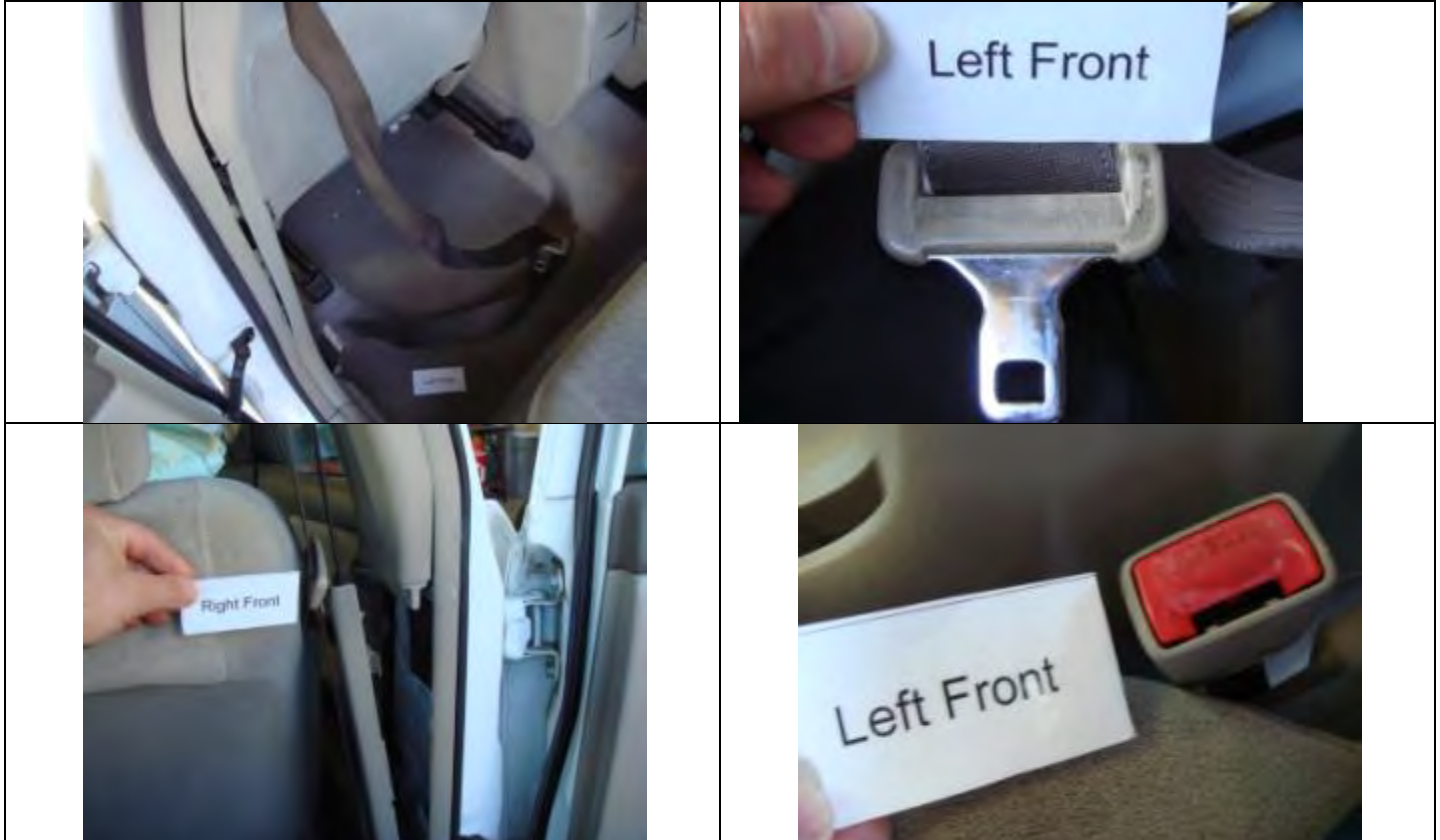
Seat Belt Pictures / Videos

Interior		
Inspection Area	Notes & Observations	
Left Front Position	Seat	Rearward, approximately 14.25 inches from leading edge of seat to lower dash trim panel
	Seatbelt	Pretensioner deployed with seatbelt in extended position, approximately 63 inches of exposed seatbelt webbing, latch is operational
Right Front Position	Seat	Rearward, approximately 14 inches from leading edge of seat to glove compartment
	Seatbelt	Pretensioner is deployed, belt is tight against b-pillar, approximately 33 inches of exposed seatbelt webbing
Left Rear Position	Seat	OK
	Seatbelt	Operational
Center Rear Position	Seat	OK
	N/A: <input type="checkbox"/> Seatbelt	Seatbelt webbing is cut, approximately 33.5 inches of seatbelt webbing intact
Right Rear Position	Seat	OK
	Seatbelt	Operational, upper seatbelt guide is missing
Third Row	Seat	
	N/A: <input checked="" type="checkbox"/> Seatbelt

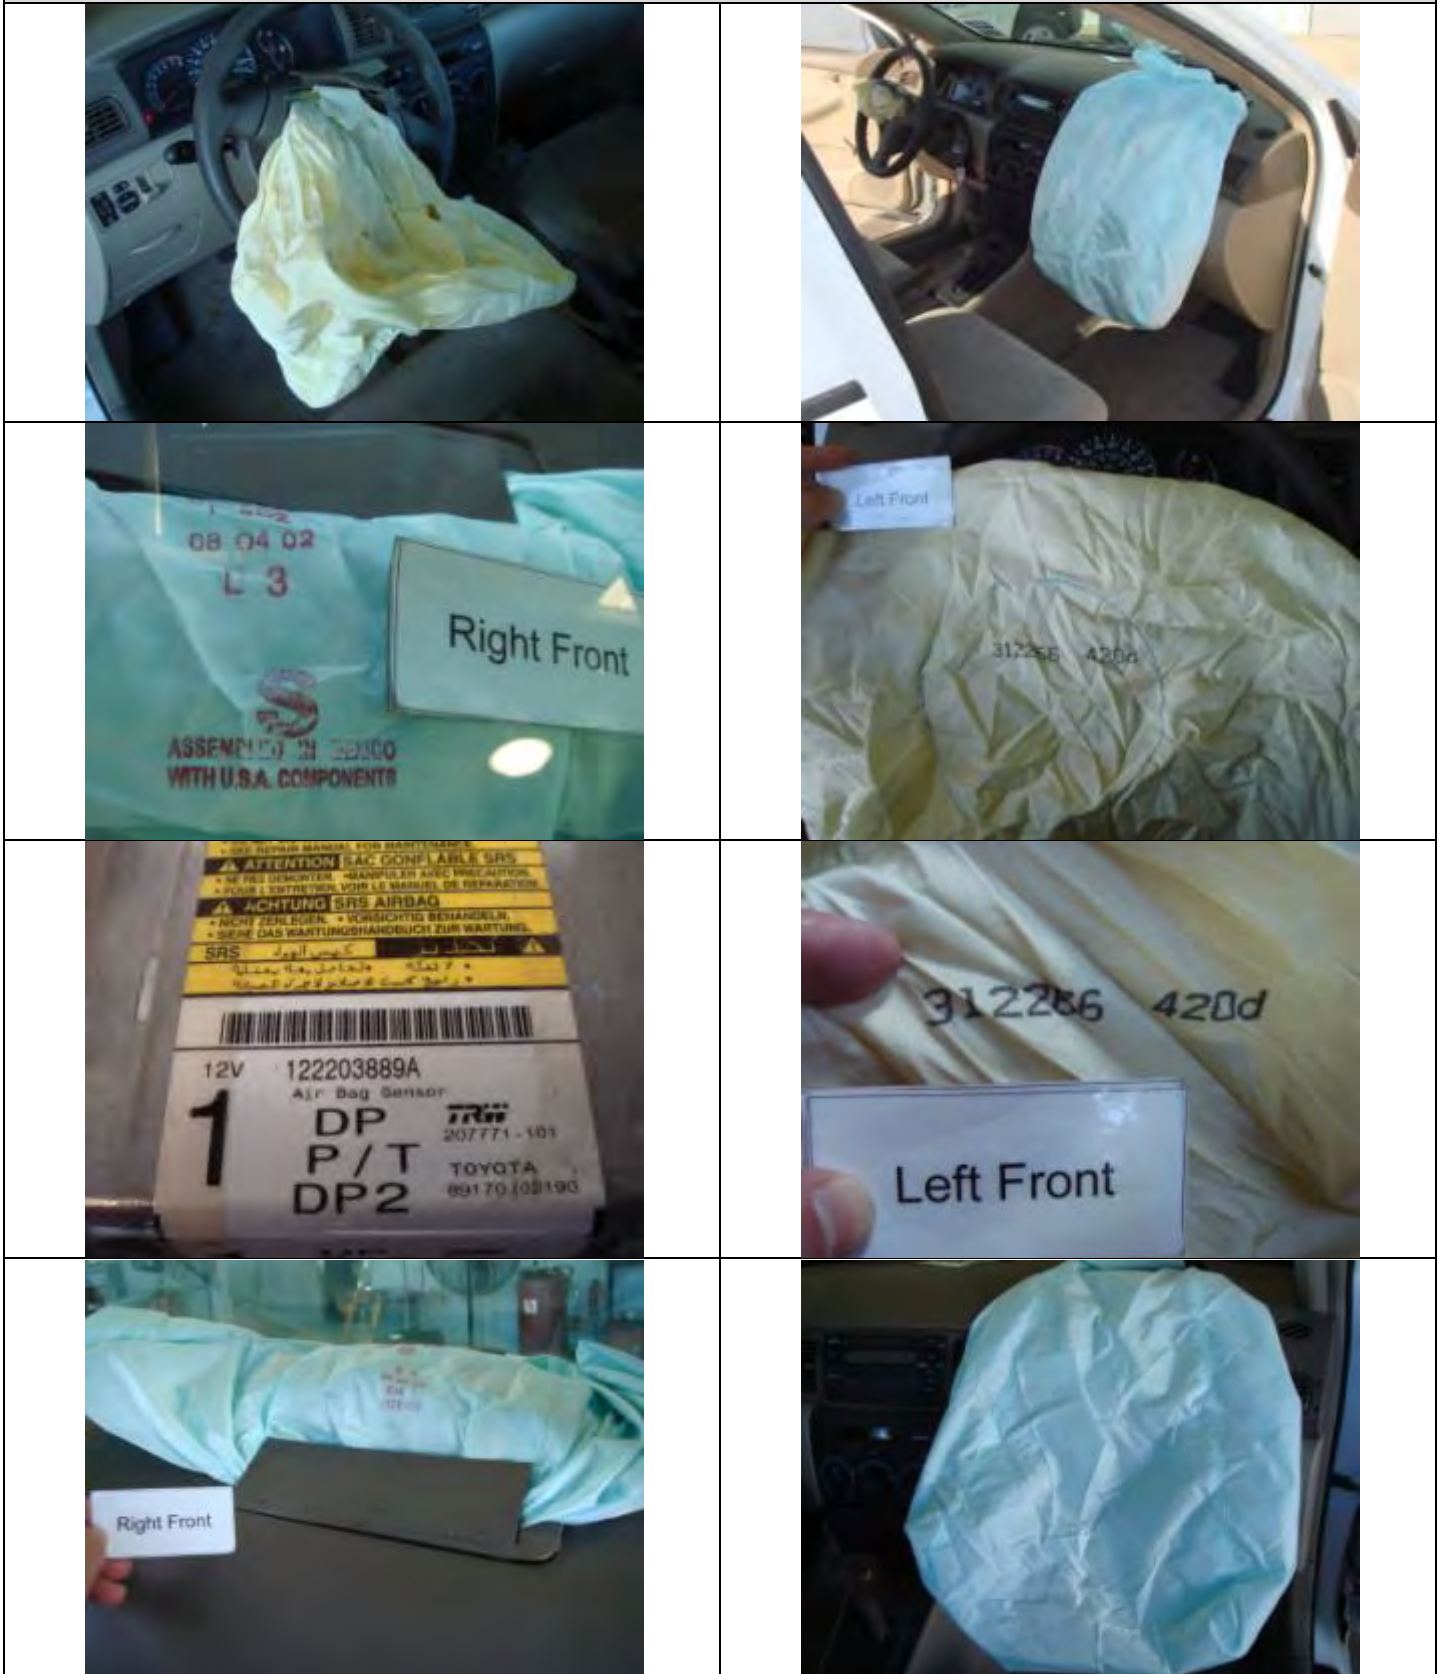
Airbag Pictures

Interior					
Supplemental Restraints Airbag Inspection		Deployed		N/A	Notes & Observations
		Yes	No		
Driver	Front SRS	<input checked="" type="checkbox"/>	<input type="checkbox"/>	<input type="checkbox"/>	
	Knee SRS	<input type="checkbox"/>	<input type="checkbox"/>	<input checked="" type="checkbox"/>	
	Seat Side SRS	<input type="checkbox"/>	<input type="checkbox"/>	<input checked="" type="checkbox"/>	
	Seat Belt SRS	<input checked="" type="checkbox"/>	<input type="checkbox"/>	<input type="checkbox"/>	
	Seat Cushion SRS	<input type="checkbox"/>	<input type="checkbox"/>	<input checked="" type="checkbox"/>	
Front Passenger	Front SRS	<input checked="" type="checkbox"/>	<input type="checkbox"/>	<input type="checkbox"/>	
	Knee SRS	<input type="checkbox"/>	<input type="checkbox"/>	<input checked="" type="checkbox"/>	
	Seat Side SRS	<input type="checkbox"/>	<input type="checkbox"/>	<input checked="" type="checkbox"/>

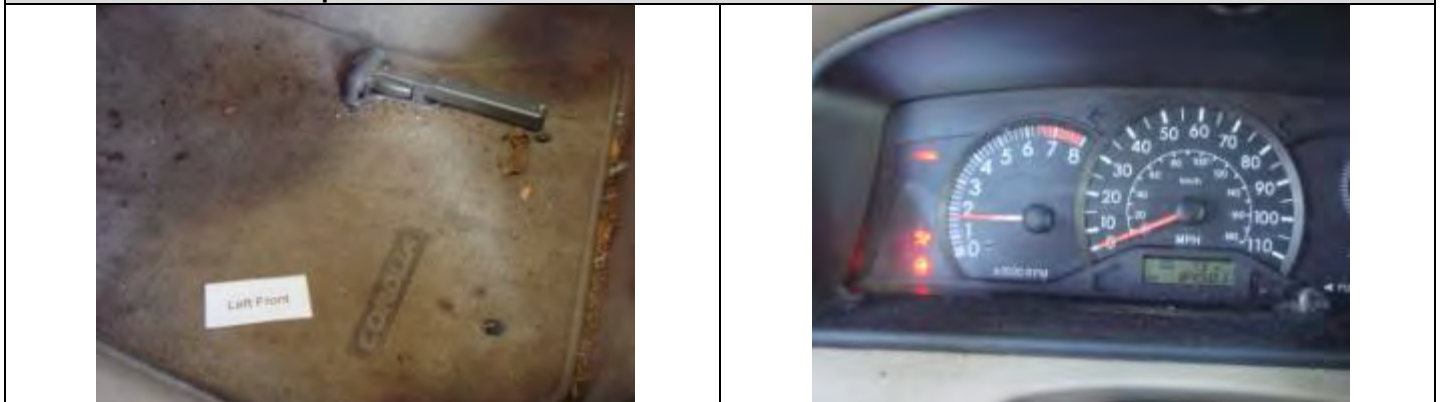
Floorpan / Interior Floorpan Pictures

Interior - Other	
Inspection Area	Notes & Observations
Warning Light Status	<input type="checkbox"/> Unable to check, vehicle will not start / Ready ON <input type="checkbox"/> Equipped with Safety Connect, note system status here:
	Operational, SRS light is on
Instrument Cluster	Operational
Steering Wheel & Column	Operational, tilt is operational
Shift Lever & Linkage	Operational
Pedal Assembly	Accelerator Smooth movement, no binding or obstructions
	Brake Operational
	Clutch N/A: <input checked="" type="checkbox"/>
Floorpan & Floorpan	Left Front OE carpeted mat, inboard retainer not installed, outboard retainer is installed
	Right Front 2 aftermarket carpeted mats stacked

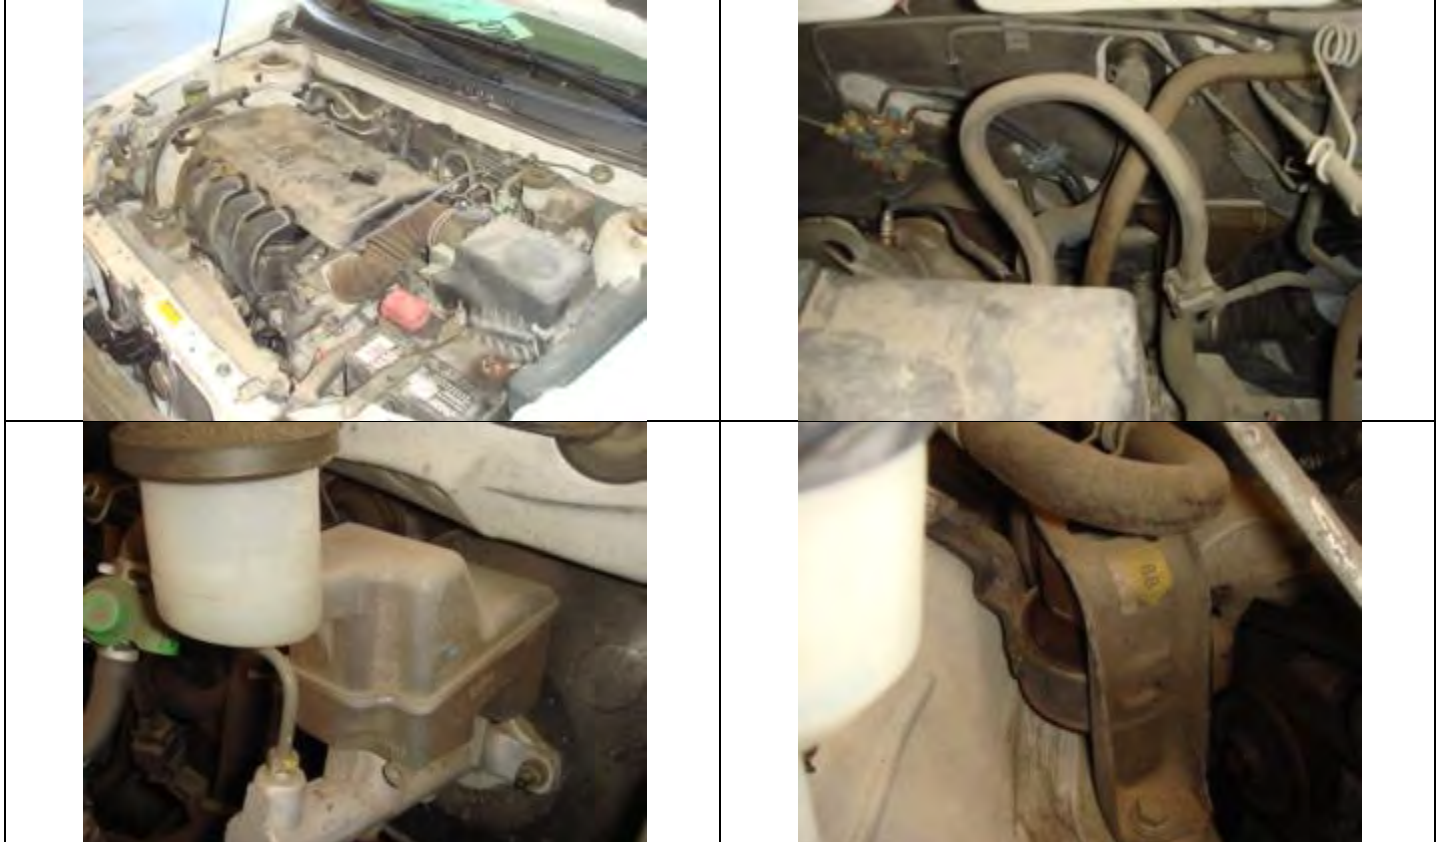
Underhood Pictures

Inspection Area		Notes & Observations				
Engine Oil	Level	<input type="checkbox"/> High	<input checked="" type="checkbox"/> Normal	<input type="checkbox"/> Low	<input type="checkbox"/> N/A	
	Condition	OK				
Trans Oil	Level	<input type="checkbox"/> High	<input checked="" type="checkbox"/> Normal	<input type="checkbox"/> Low	<input type="checkbox"/> N/A	For vehicles equipped with a dipstick
	Condition	OK				
Brake Fluid	Level	<input type="checkbox"/> High	<input checked="" type="checkbox"/> Normal	<input type="checkbox"/> Low	<input type="checkbox"/> N/A	
	Condition	OK				
Clutch Fluid	Level	<input type="checkbox"/> High	<input type="checkbox"/> Normal	<input type="checkbox"/> Low	<input checked="" type="checkbox"/> N/A	
	Condition					
Steering Fluid	Level	<input type="checkbox"/> High	<input checked="" type="checkbox"/> Normal	<input type="checkbox"/> Low	<input type="checkbox"/> N/A	
	Condition	OK

Coolant	Level	<input type="checkbox"/> High	<input checked="" type="checkbox"/> Normal	<input type="checkbox"/> Low	<input type="checkbox"/> N/A	
	Condition	OK				
12V Battery	SOC	<input checked="" type="checkbox"/> Pass	<input type="checkbox"/> Fail	<input type="checkbox"/> N/A	Using Midtronics tester or open circuit voltage / failure code or OC voltage	
	Condition	Operational				
Radiator, Radiator Hoses & Condenser		No leaks or damage observed				
Engine Compartment Wire Harness		Operational, no damage				
Engine Compartment Fuel Lines		No leaks or damage observed				
Engine / Transmission Mounts		OK

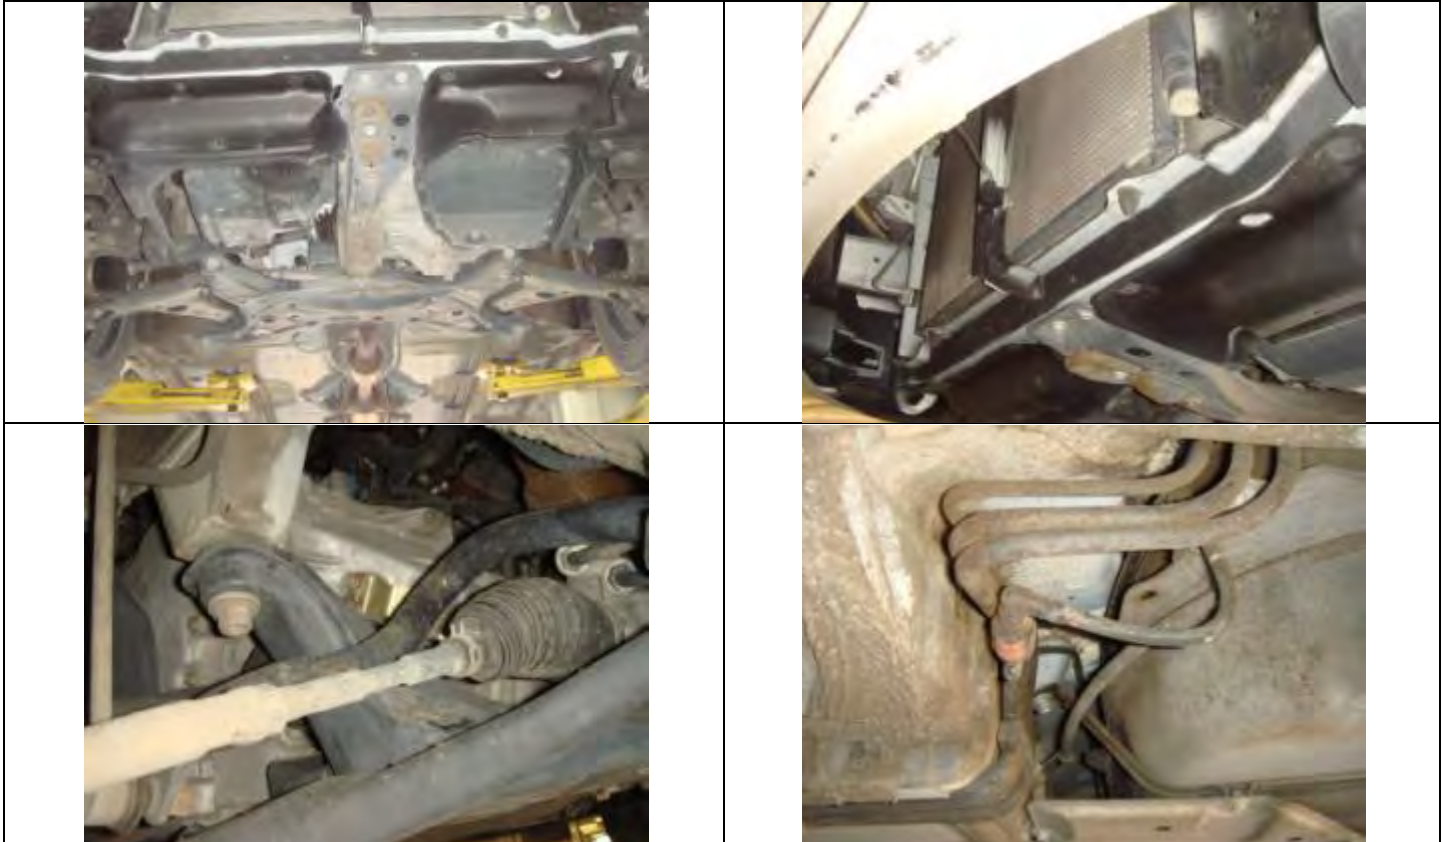
Undercar Pictures

Undercar		
Inspection Area	Notes & Observations	
Suspension	Left Front	Operational, no damage observed
	Right Front	Operational, no damage observed
	Left Rear	Operational, no damage observed
	Right Rear	Operational, no damage observed
Steering Gear and Linkage	Operational, no leaks or damage observed	
Drive axle / Driveshaft	Operational no damage observed	
Transmission / Transaxle	Operational no damage observed	
Differential/rear axle assembly	Operational no damage observed	
Exhaust System	OK	
Fuel Tank and Lines	OK

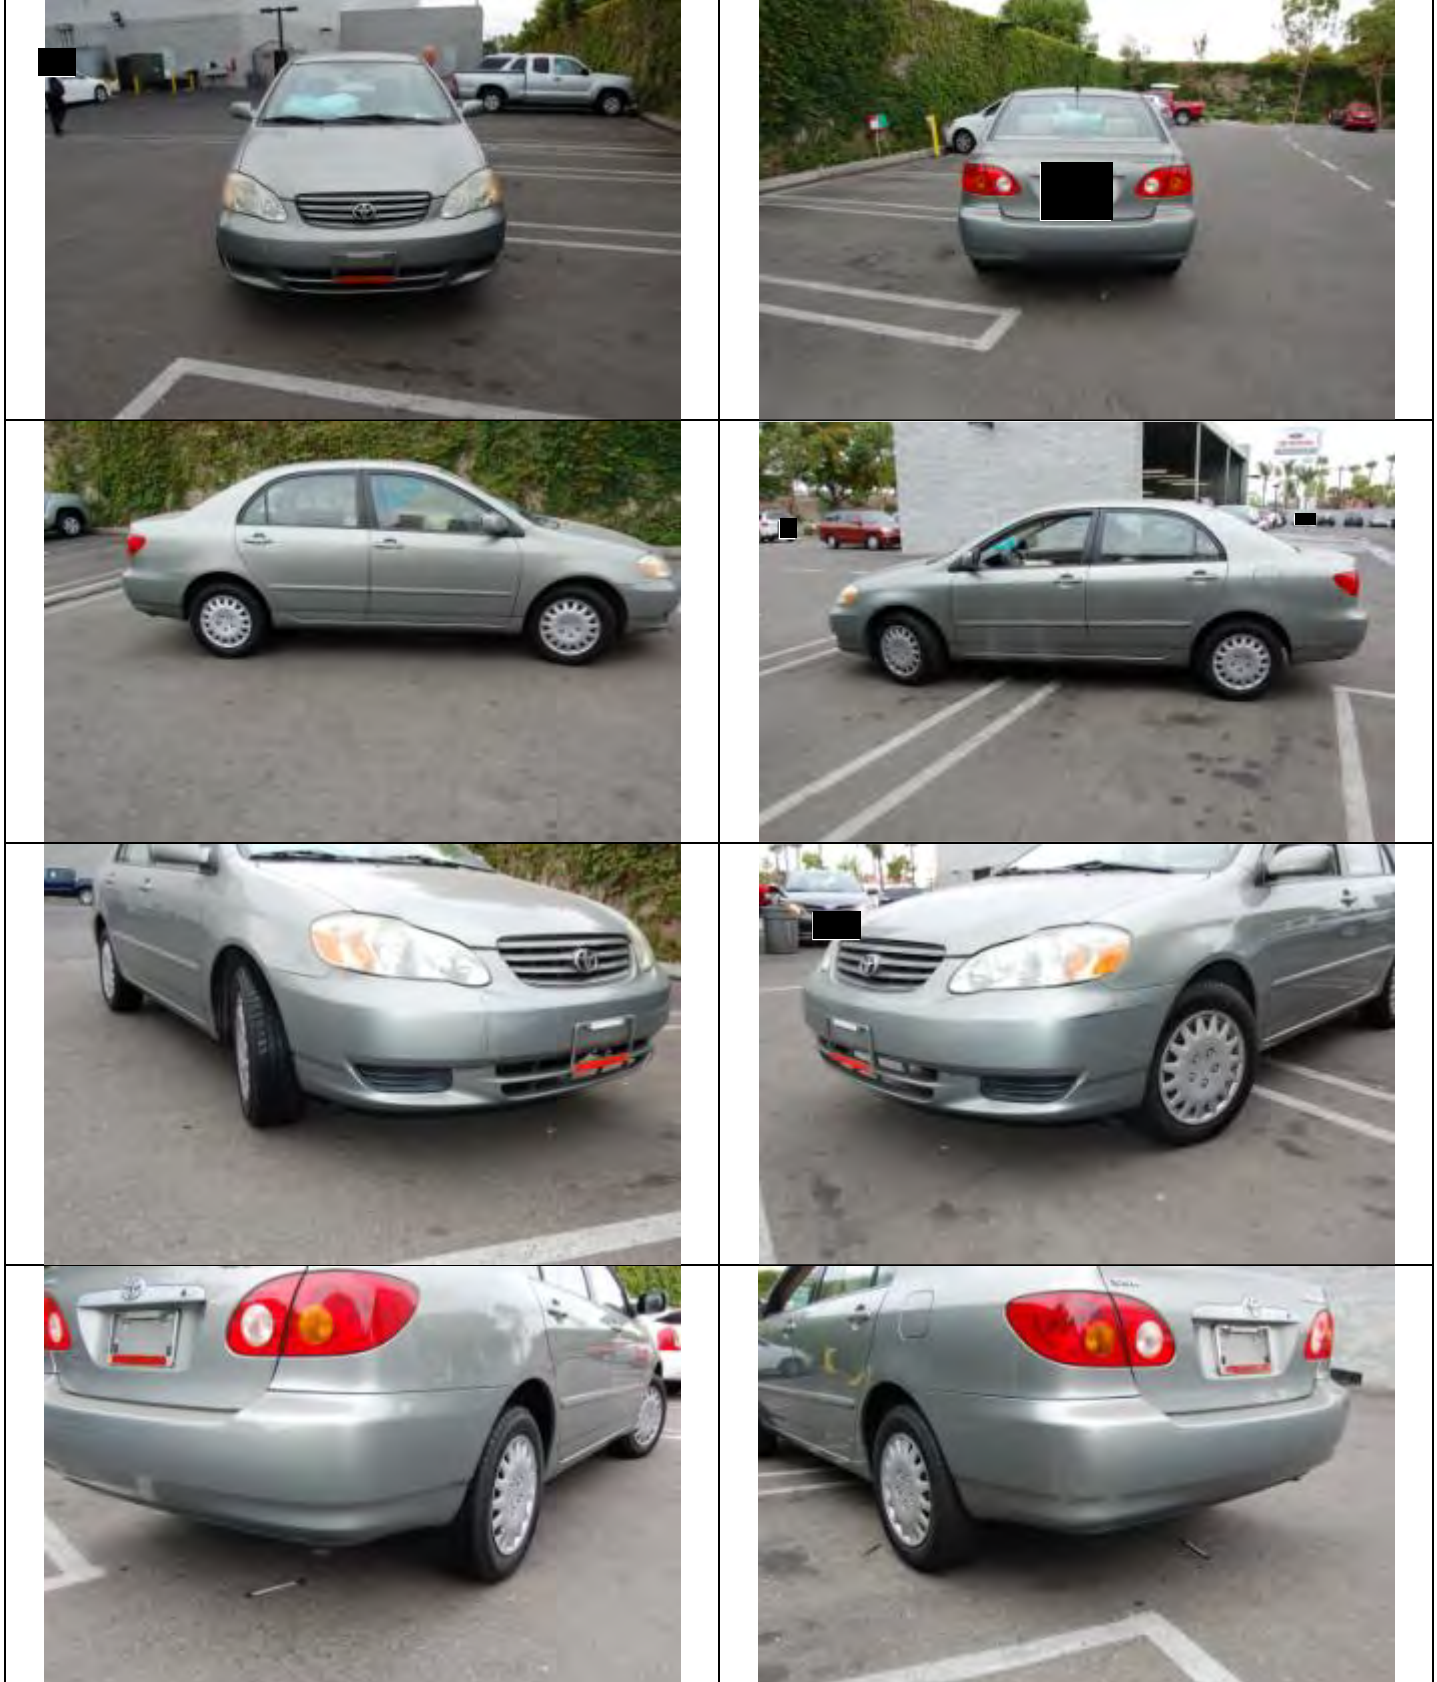
Incident/Impact Area Pictures

- Driver's side reverse light is out – inoperative
- Left front fender area has paint overspray – See pictures
- Vehicle did not have license plates (front or rear) – See pictures
- Front bumper has deep scratches on the bottom portion.
- Front bumper has damage to the right side (passenger side) – See pictures
- Left rear door has dents and scratches – See pictures
- Driver's window run (molding) is twisted and deformed – See pictures
- Performed health check, but was unable to connect with SRS ecu – See files
- Test drove vehicle for about one mile in and around dealership.
