EA12-001

TOYOTA

Attachment-Response 4

Field Report

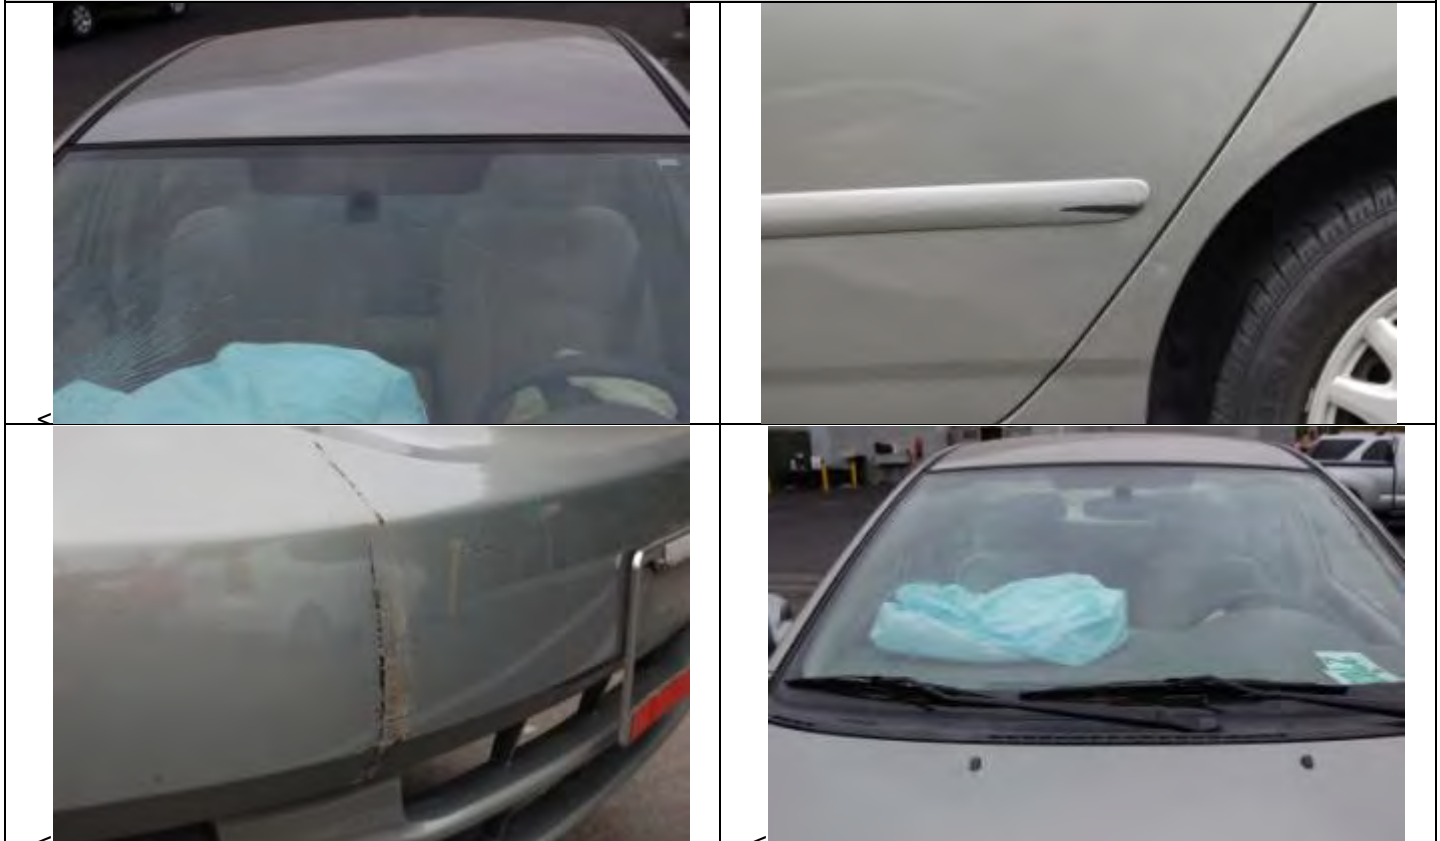
Exterior Other Pictures

Exterior Other	
Inspection Area	Notes & Observations
Headlights / Taillights	Operating as designed
Brake Lights	Operating as designed
Turn Signals	Operating as designed
Glass & External Mirrors	Operating as designed – aftermarket rear view mirror
Hood Latch	Operating as designed
Hatch / Trunk Latch	Operating as designed
Door Latch & Lock	Operating as designed

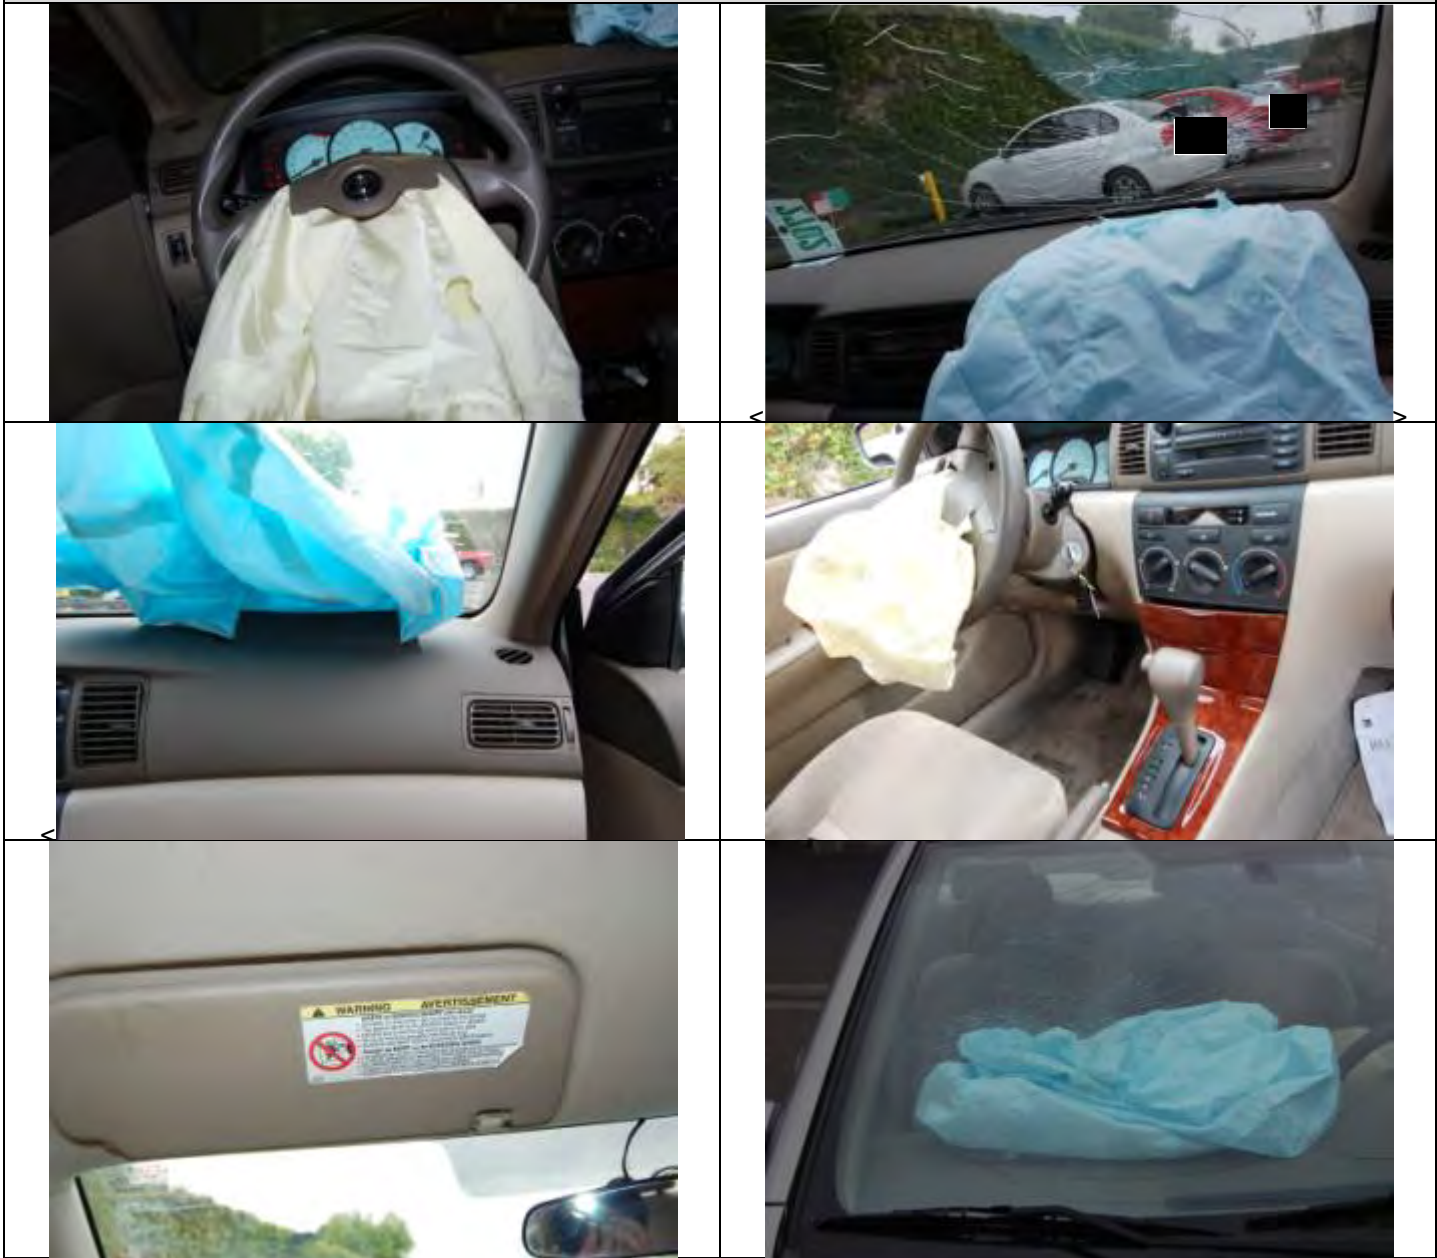
Airbag Pictures

Interior		
Inspection Area	Notes & Observations	
Left Front Position	Seat	Normal operation
	Seatbelt	Locked due to pre-tensioner – See pictures
Right Front Position	Seat	Normal operation
	Seatbelt	Locked due to pre-tensioner – See pictures
Left Rear Position	Seat	Normal operation
	Seatbelt	Normal operation
Center Rear Position N/A: <input type="checkbox"/>	Seat	
	Seatbelt	
Right Rear Position	Seat	Normal operation
	Seatbelt	Normal operation
Third Row N/A: <input checked="" type="checkbox"/>	Seat	
	Seatbelt

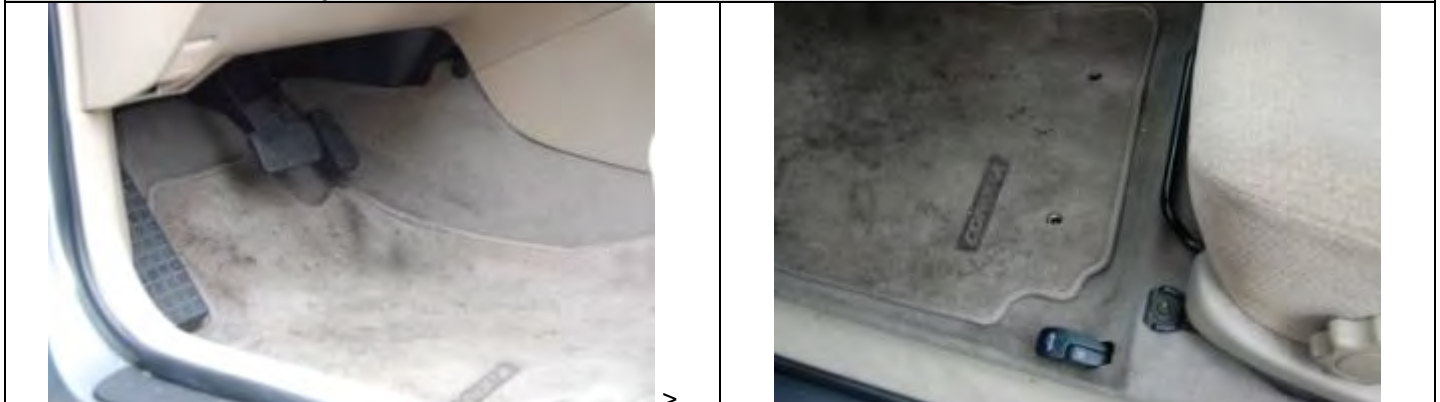
Floormat / Interior Floorpan Pictures

Interior - Other	
Inspection Area	Notes & Observations
Warning Light Status	<input type="checkbox"/> Unable to check, vehicle will not start / Ready ON <input type="checkbox"/> Equipped with Safety Connect, note system status here:
	Normal operation – SRS light on
Instrument Cluster	Normal operation
Steering Wheel & Column	Normal operation
Shift Lever & Linkage	Normal operation
Pedal Assembly	Accelerator Normal operation
	Brake Normal operation
	Clutch N/A: <input checked="" type="checkbox"/>
Floormat & Floorpan	Left Front Normal – factory floor mats, but not tethered.
	Right Front Normal – factory floor mats; installed properly

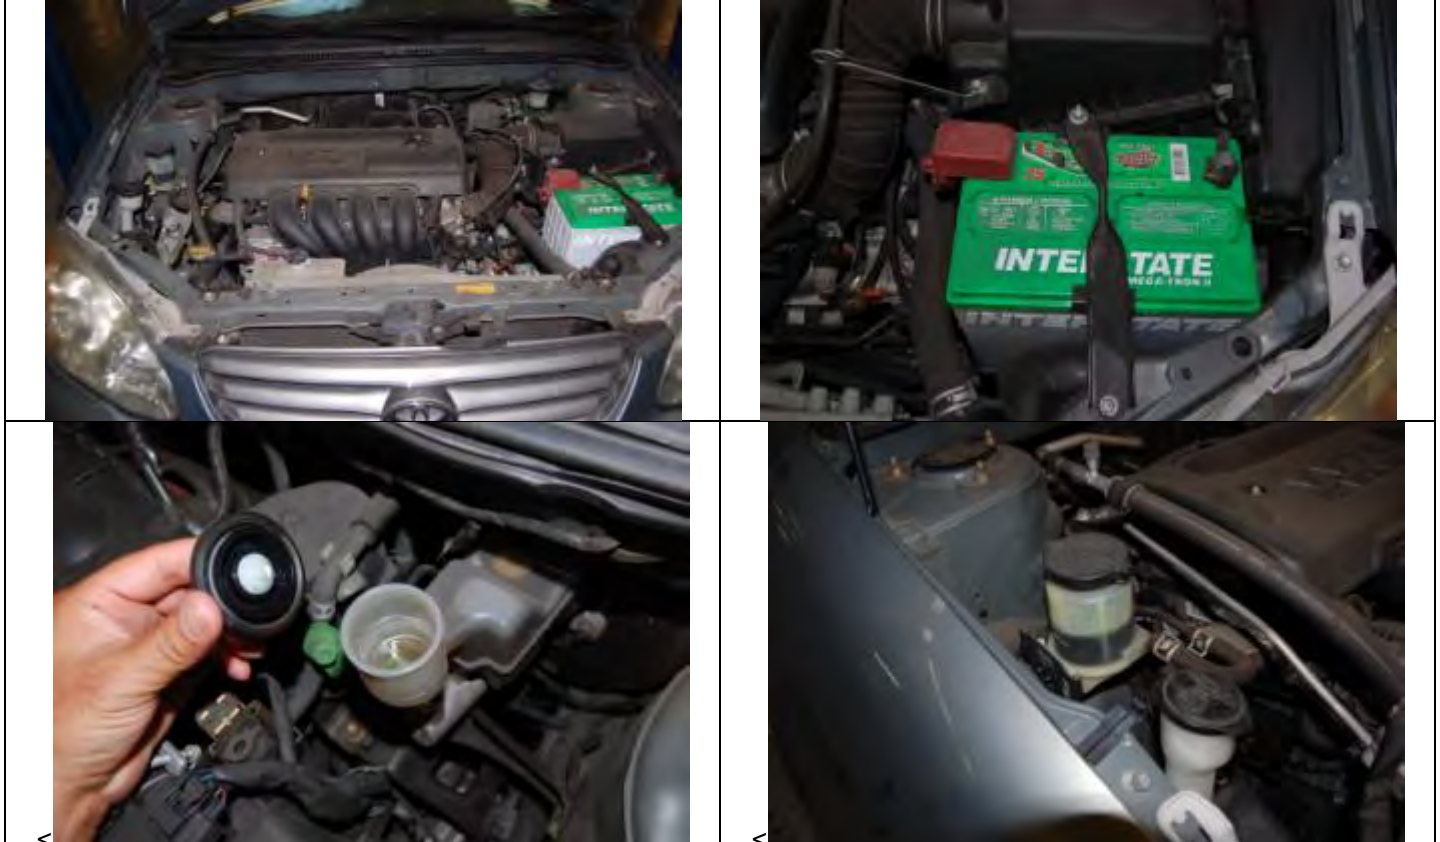
Underhood Pictures

Inspection Area		Notes & Observations				
Engine Oil	Level	<input type="checkbox"/> High	<input checked="" type="checkbox"/> Normal	<input type="checkbox"/> Low	<input type="checkbox"/> N/A	
	Condition	Normal				
Trans Oil	Level	<input type="checkbox"/> High	<input checked="" type="checkbox"/> Normal	<input type="checkbox"/> Low	<input type="checkbox"/> N/A	For vehicles equipped with a dipstick
	Condition	Normal				
Brake Fluid	Level	<input type="checkbox"/> High	<input checked="" type="checkbox"/> Normal	<input type="checkbox"/> Low	<input type="checkbox"/> N/A	
	Condition	Normal				
Clutch Fluid	Level	<input type="checkbox"/> High	<input type="checkbox"/> Normal	<input type="checkbox"/> Low	<input checked="" type="checkbox"/> N/A	
	Condition					
Steering Fluid	Level	<input type="checkbox"/> High	<input checked="" type="checkbox"/> Normal	<input type="checkbox"/> Low	<input type="checkbox"/> N/A

Condition	Normal				
Coolant	Level	<input type="checkbox"/> High	<input checked="" type="checkbox"/> Normal	<input type="checkbox"/> Low	<input type="checkbox"/> N/A	
	Condition	Normal				
12V Battery	SOC	<input checked="" type="checkbox"/> Pass	<input type="checkbox"/> Fail	<input checked="" type="checkbox"/> N/A	Using Midtronics tester or open circuit voltage / failure code or OC voltage	
	Condition	Normal – Aftermarket battery				
Radiator, Radiator Hoses & Condenser		Normal				
Engine Compartment Wire Harness		Normal				
Engine Compartment Fuel Lines		Normal				
Engine / Transmission Mounts		Normal

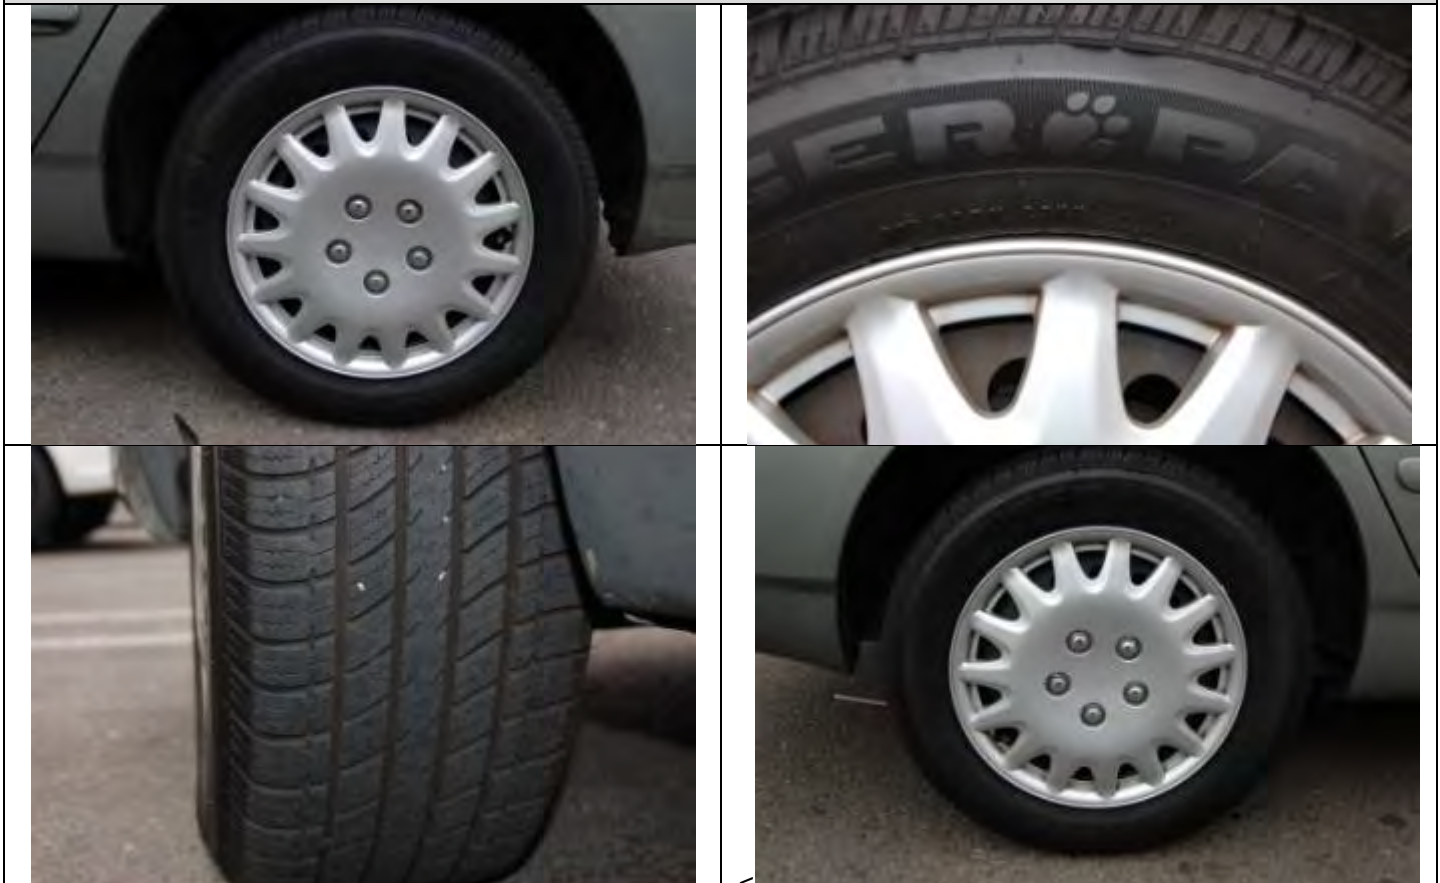
Tire & Wheel Pictures

Tires & Wheels												
Inspection Area	Left Front			Right Front			Left Rear			Right Rear		
Tire Brand / Model	Uniroyal			Uniroyal			Uniroyal			Uniroyal		
Tire Model Name - Code	Tiger Paw			Tiger Paw			Tiger Paw			Tiger Paw		
Tire Size	205/60/15			205/60/15			205/60/15			205/60/15		
Tire DOT #	Y9TMC9UU4210			Y9TMC9UU4210			Y9TMC9UU4210			Y9TMC9UU4210		
Cold Tire Pressure (psi)	37			37			36			38		
Tread Depth (Measured in 32 nd of an inch)	I	C	O	I	C	O	I	C	O	I	C	O
	9/32	9/32	9/32	9/32	9/32	9/32	8/32	8/32	8/32	8/32	8/32	8/32
Tire Wear Condition	Normal											
Wheel Condition	Normal

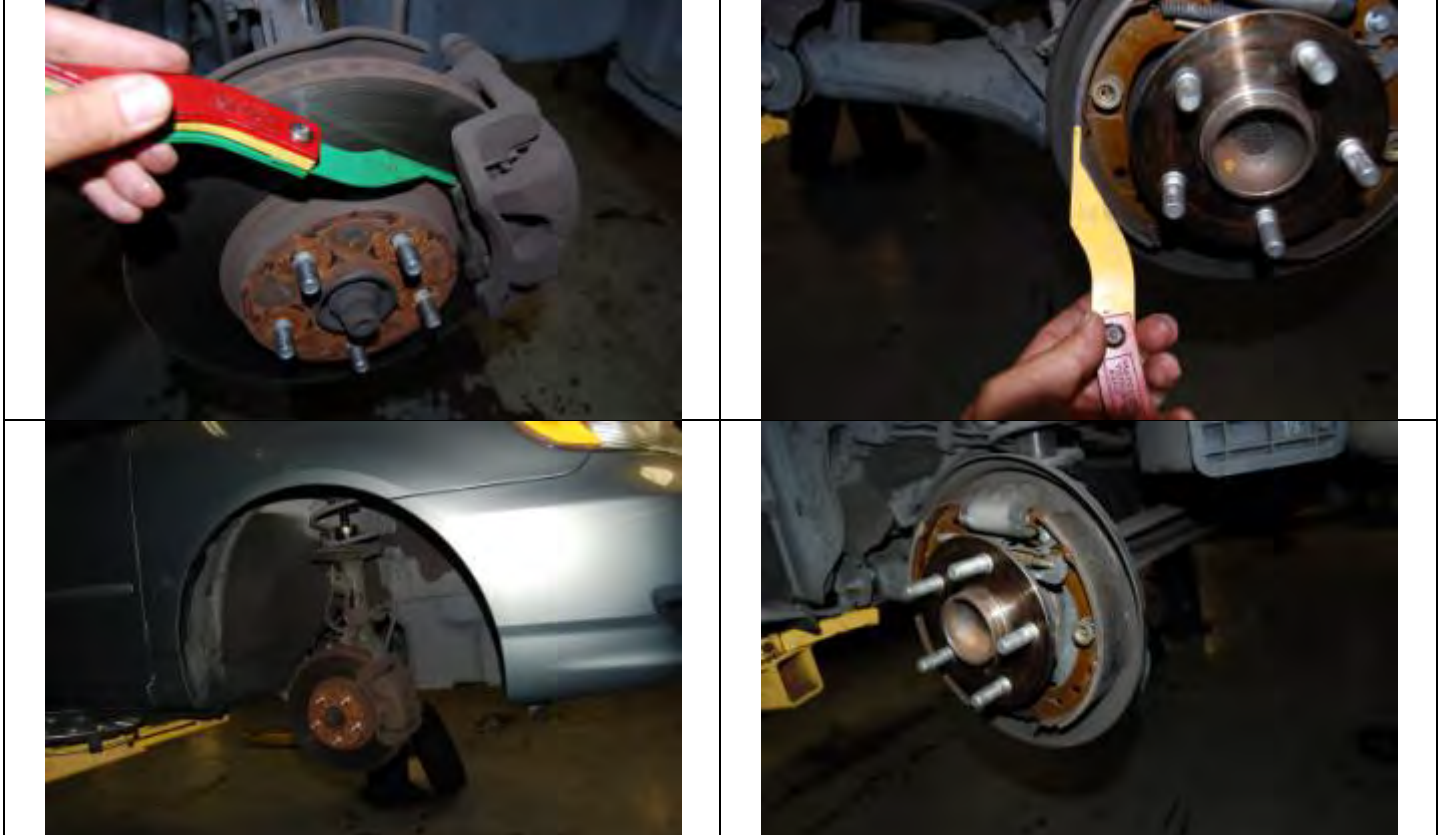
Brake Pictures

Brake System				
Inspection Area	Left Front (LF)	Right Front (RF)	Left Rear (LR)	Right Rear (RR)
Pad / Shoe Thickness (mm)	8mm	8mm	5mm	5mm
Calipers / Wheel Cylinders	Normal			
Pad / Shoe Condition	Normal			
Caliper Slide Pins & Other Hardware	Normal			
Rotor / Drum Condition	Normal			
Wheel Speed Sensor & Wiring Condition	Normal			
Master Cylinder	Normal			
ABS Actuator	N/A			
Brake Lines & Hoses	Normal			
LSPV - Load Sensing Proportioning Valve	N/A			
Parking Brake Operation	Normal

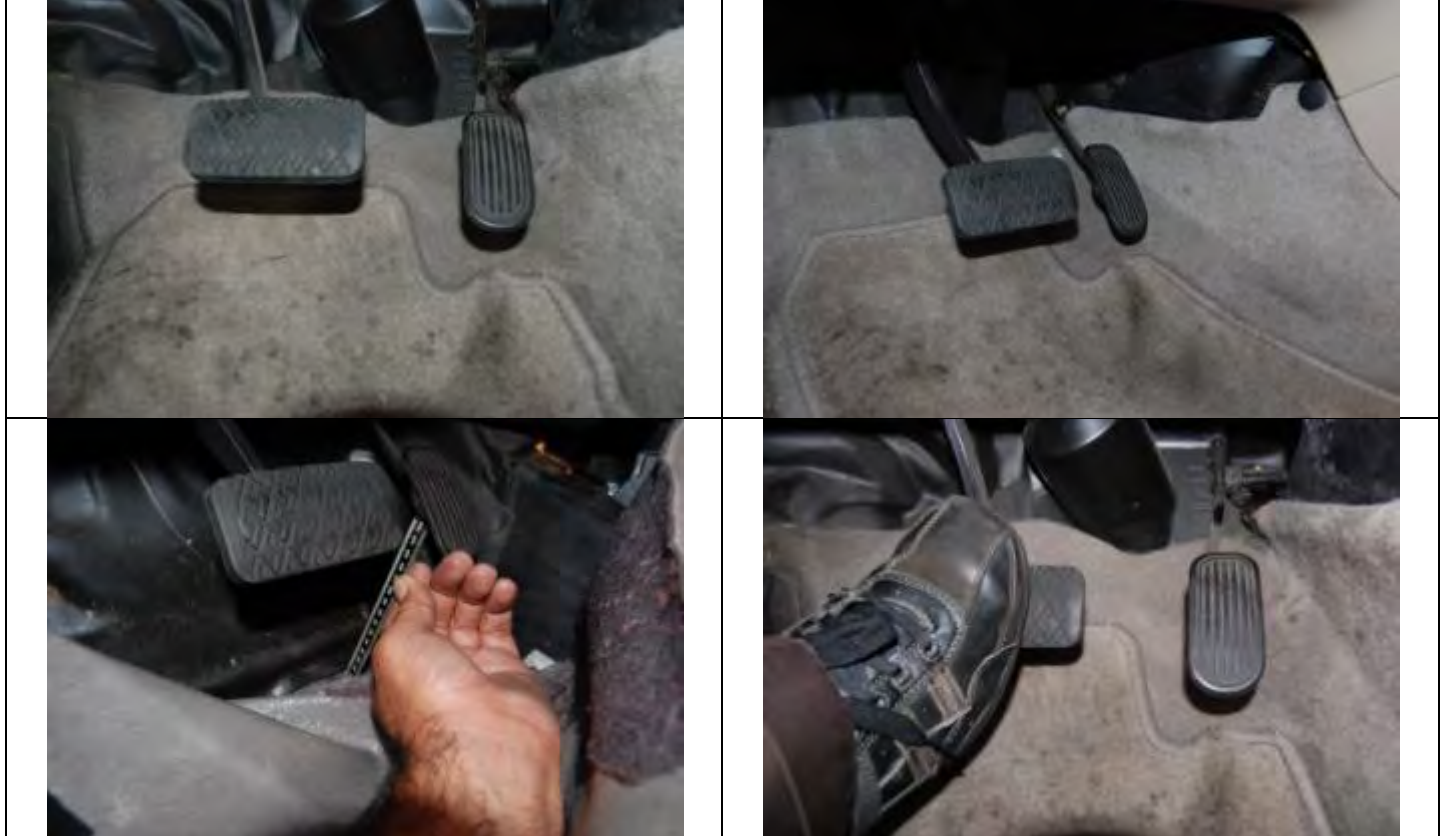
Brake System - Pedal Pictures

Measurement: 20mm

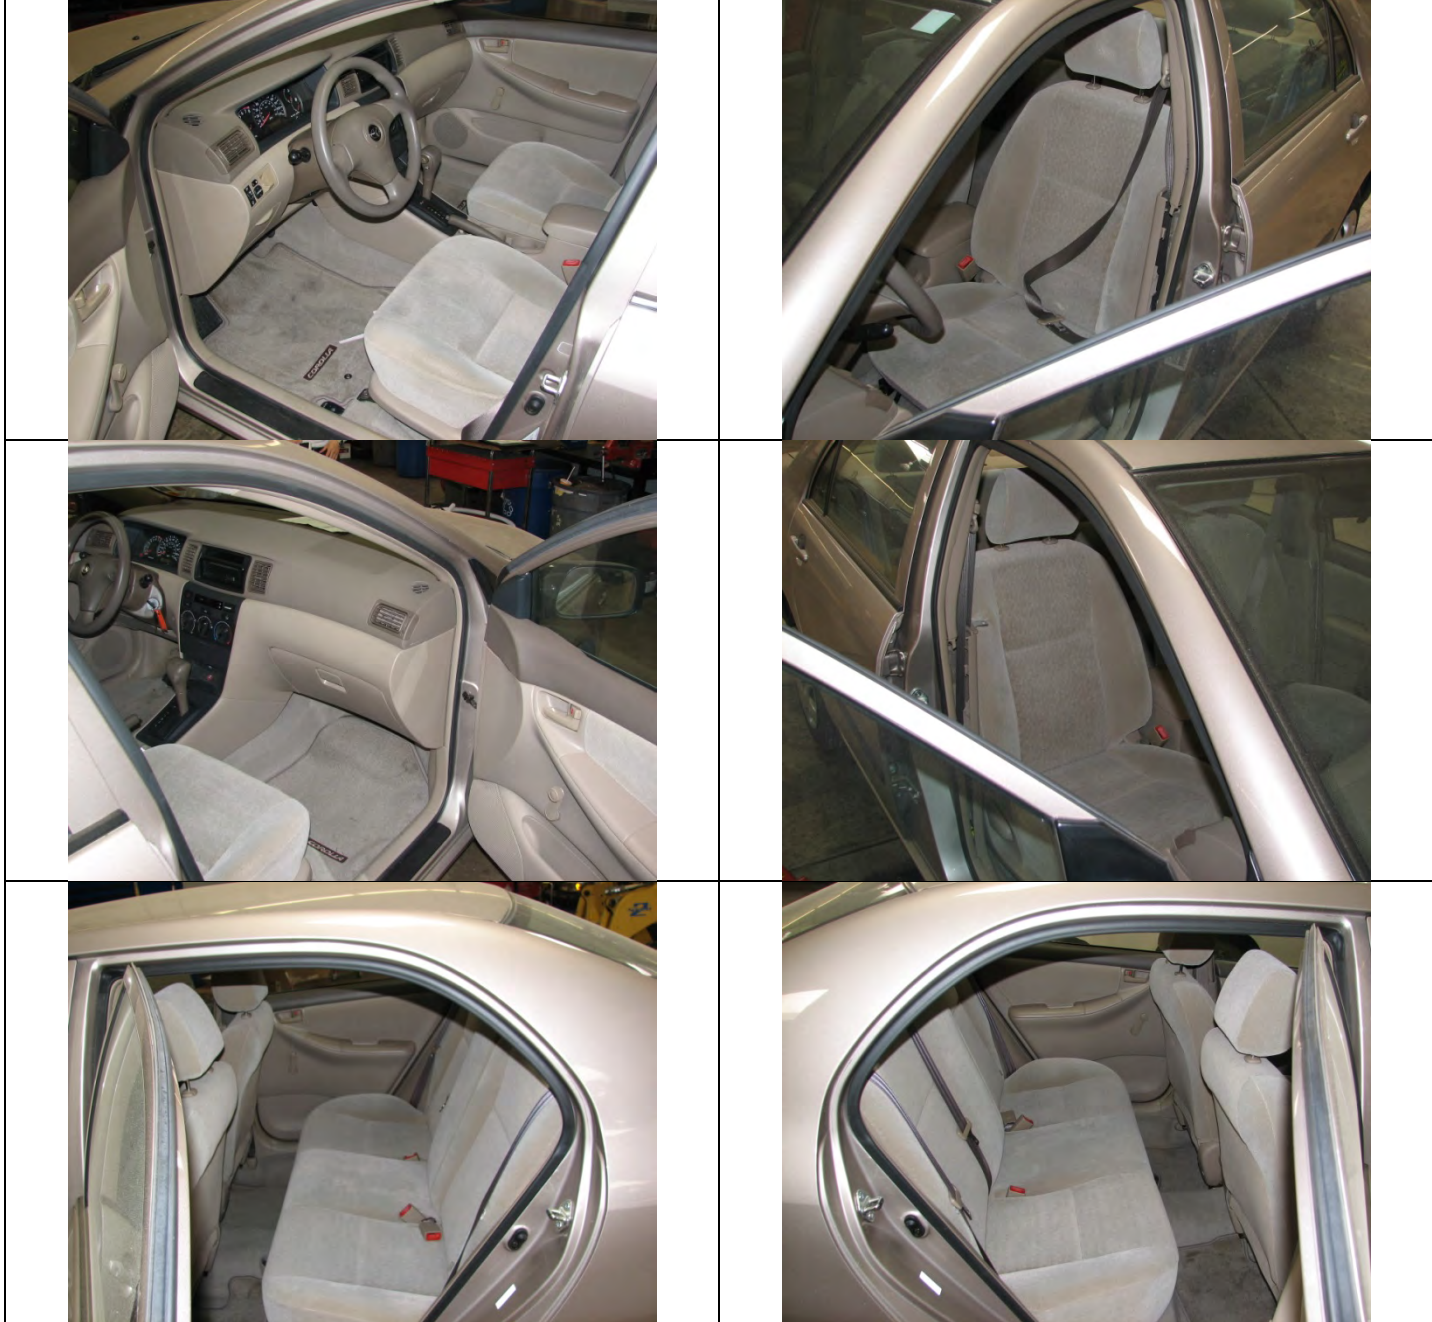
Interior Pictures

Incident Date:	5/21/12	Incident Time:	Unknown	<input type="checkbox"/> AM	<input type="checkbox"/> PM
<p>Customer stated that she was sitting at a stop light on 5/21/12, not sure of exact time of day. Stated that she had not hit anything and there was no impact to vehicle. Stated both the driver and passenger seatbelts tightened and locked up. Stated that she smelled something burning like a firecracker. Stated that there were no airbag warning lights on before the incident.</p>					
Incident Location: Unknown					
Incident Description Provided By:	<input checked="" type="checkbox"/> Owner/Driver <input type="checkbox"/> Driver <input type="checkbox"/> Other:				
Injuries?	<input checked="" type="checkbox"/> No <input type="checkbox"/> Yes*	*If yes, provide description of injuries.			
Police Report Provided?	<input checked="" type="checkbox"/> No <input type="checkbox"/> Yes*	*If yes, attach report as described in section "5. Contact Details & Related Files". Agency: Number:

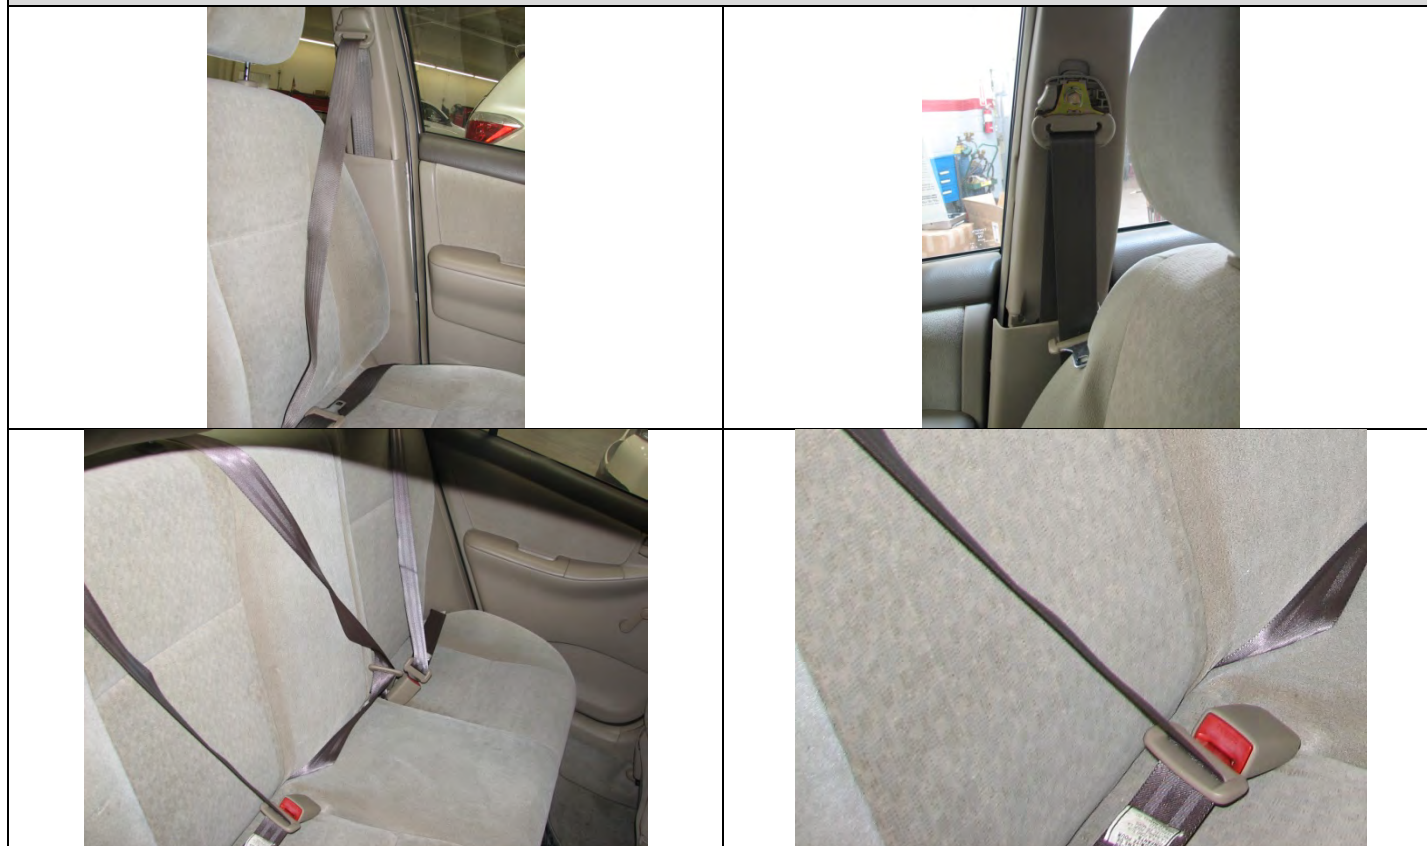
Seat Belt Pictures / Videos

Interior					
Supplemental Restraints Airbag Inspection		Deployed		N/A	Notes & Observations
		Yes	No		
Driver	Front SRS	<input type="checkbox"/>	<input checked="" type="checkbox"/>	<input type="checkbox"/>	
	Knee SRS	<input type="checkbox"/>	<input type="checkbox"/>	<input checked="" type="checkbox"/>	N/A
	Seat Side SRS	<input type="checkbox"/>	<input type="checkbox"/>	<input checked="" type="checkbox"/>	N/A
	Seat Belt SRS	<input checked="" type="checkbox"/>	<input type="checkbox"/>	<input type="checkbox"/>	Pre-tensioner deployed, seat belt extended.
	Seat Cushion SRS	<input type="checkbox"/>	<input type="checkbox"/>	<input checked="" type="checkbox"/>	N/A
Front Passenger	Front SRS	<input type="checkbox"/>	<input checked="" type="checkbox"/>	<input type="checkbox"/>	
	Knee SRS	<input type="checkbox"/>	<input type="checkbox"/>	<input checked="" type="checkbox"/>	N/A
	Seat Side SRS	<input type="checkbox"/>	<input type="checkbox"/>	<input checked="" type="checkbox"/>	N/A

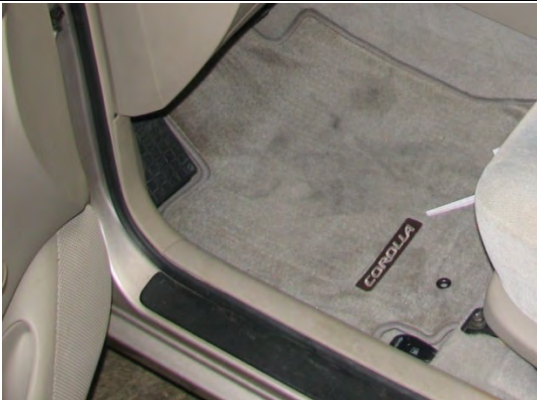
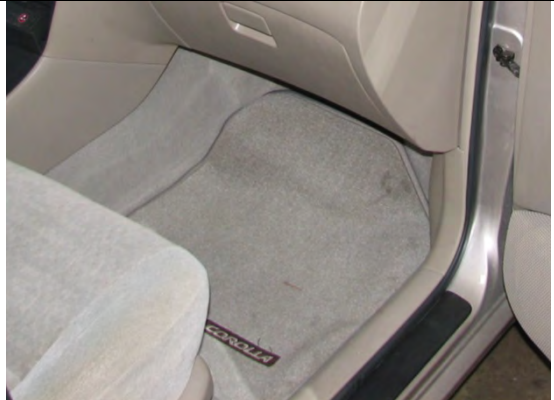
Floormat / Interior Floorpan Pictures

Interior - Other		
Inspection Area	Notes & Observations	
Warning Light Status	<input type="checkbox"/> Unable to check, vehicle will not start / Ready ON <input type="checkbox"/> Equipped with Safety Connect, note system status here:	
	SRS warning lamp on, All other warning lamps were found to be operational in the combination meter when the ignition was turned on. All of these lamps extinguished once the engine was started.	
Instrument Cluster	Normal operation.	
Steering Wheel & Column	Normal operation.	
Shift Lever & Linkage	Normal operation.	
Pedal Assembly	Accelerator	Normal operation.
	Brake	Normal operation.
	Clutch N/A: <input checked="" type="checkbox"/>	N/A
Floormat & Floorpan	Left Front	OEM floor mat, Not hooked into place, hooks missing
	Right Front	OEM floor mat.

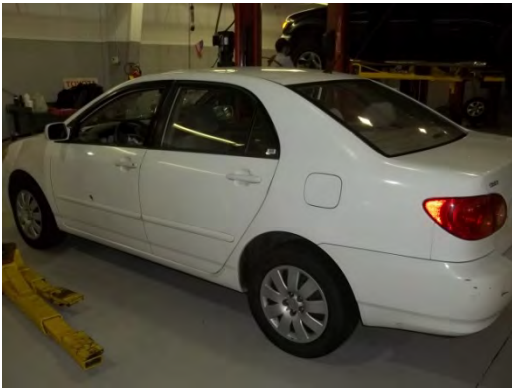
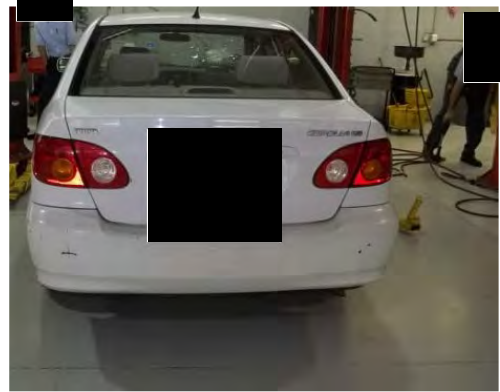
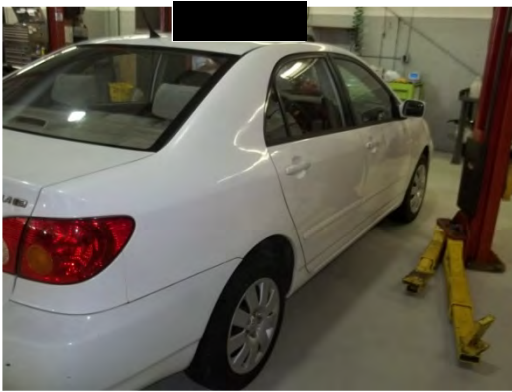
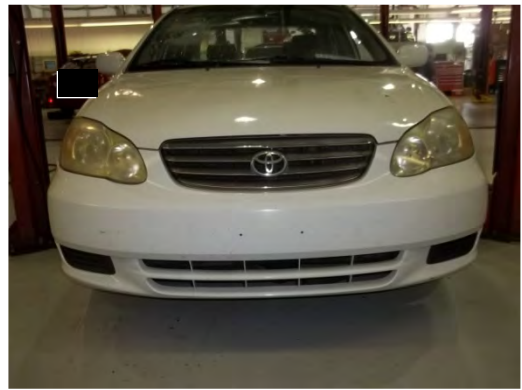
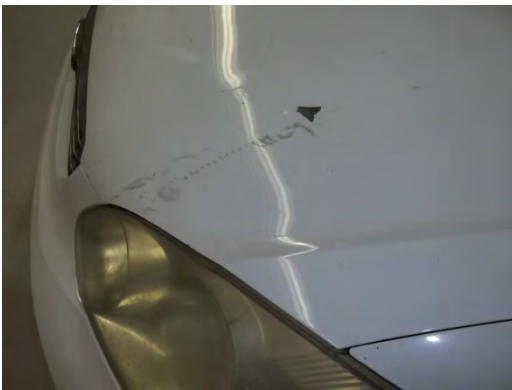
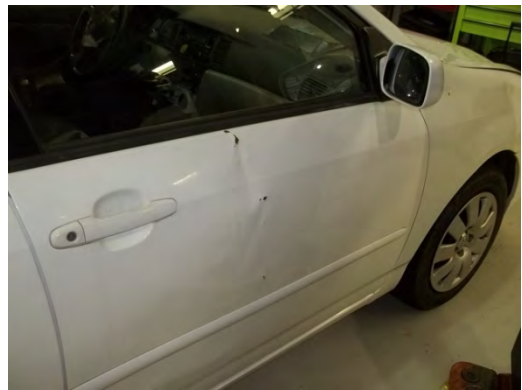
Incident/Impact Area Pictures

Incident Date:	6/22/2012	Incident Time:	4:00	<input type="checkbox"/> AM	<input checked="" type="checkbox"/> PM
<p>Customer stated her daughter was driving the vehicle alone at approximately 25-30 mph Southbound on NC Hwy 16 at 4819 in Conover NC when her seat belt latched up & got tight. She heard a loud pop noise and the driver side front airbag deployed hitting the driver in the chest resulting in a bruised chest, sore neck and broken windshield. The driver was able to release the seat belt and exit the vehicle. The customer advised the driver stated that the brakes locked up, was still moving after two seconds then the brakes unlocked or released. The driver stopped the vehicle in the middle of the road and turned it off. A person that was in the vehicle behind the Corolla pushed the vehicle to the side of the road. The North Carolina State Trooper and Conover Sheriff responded, but did not file an accident report because there was no accident.</p>

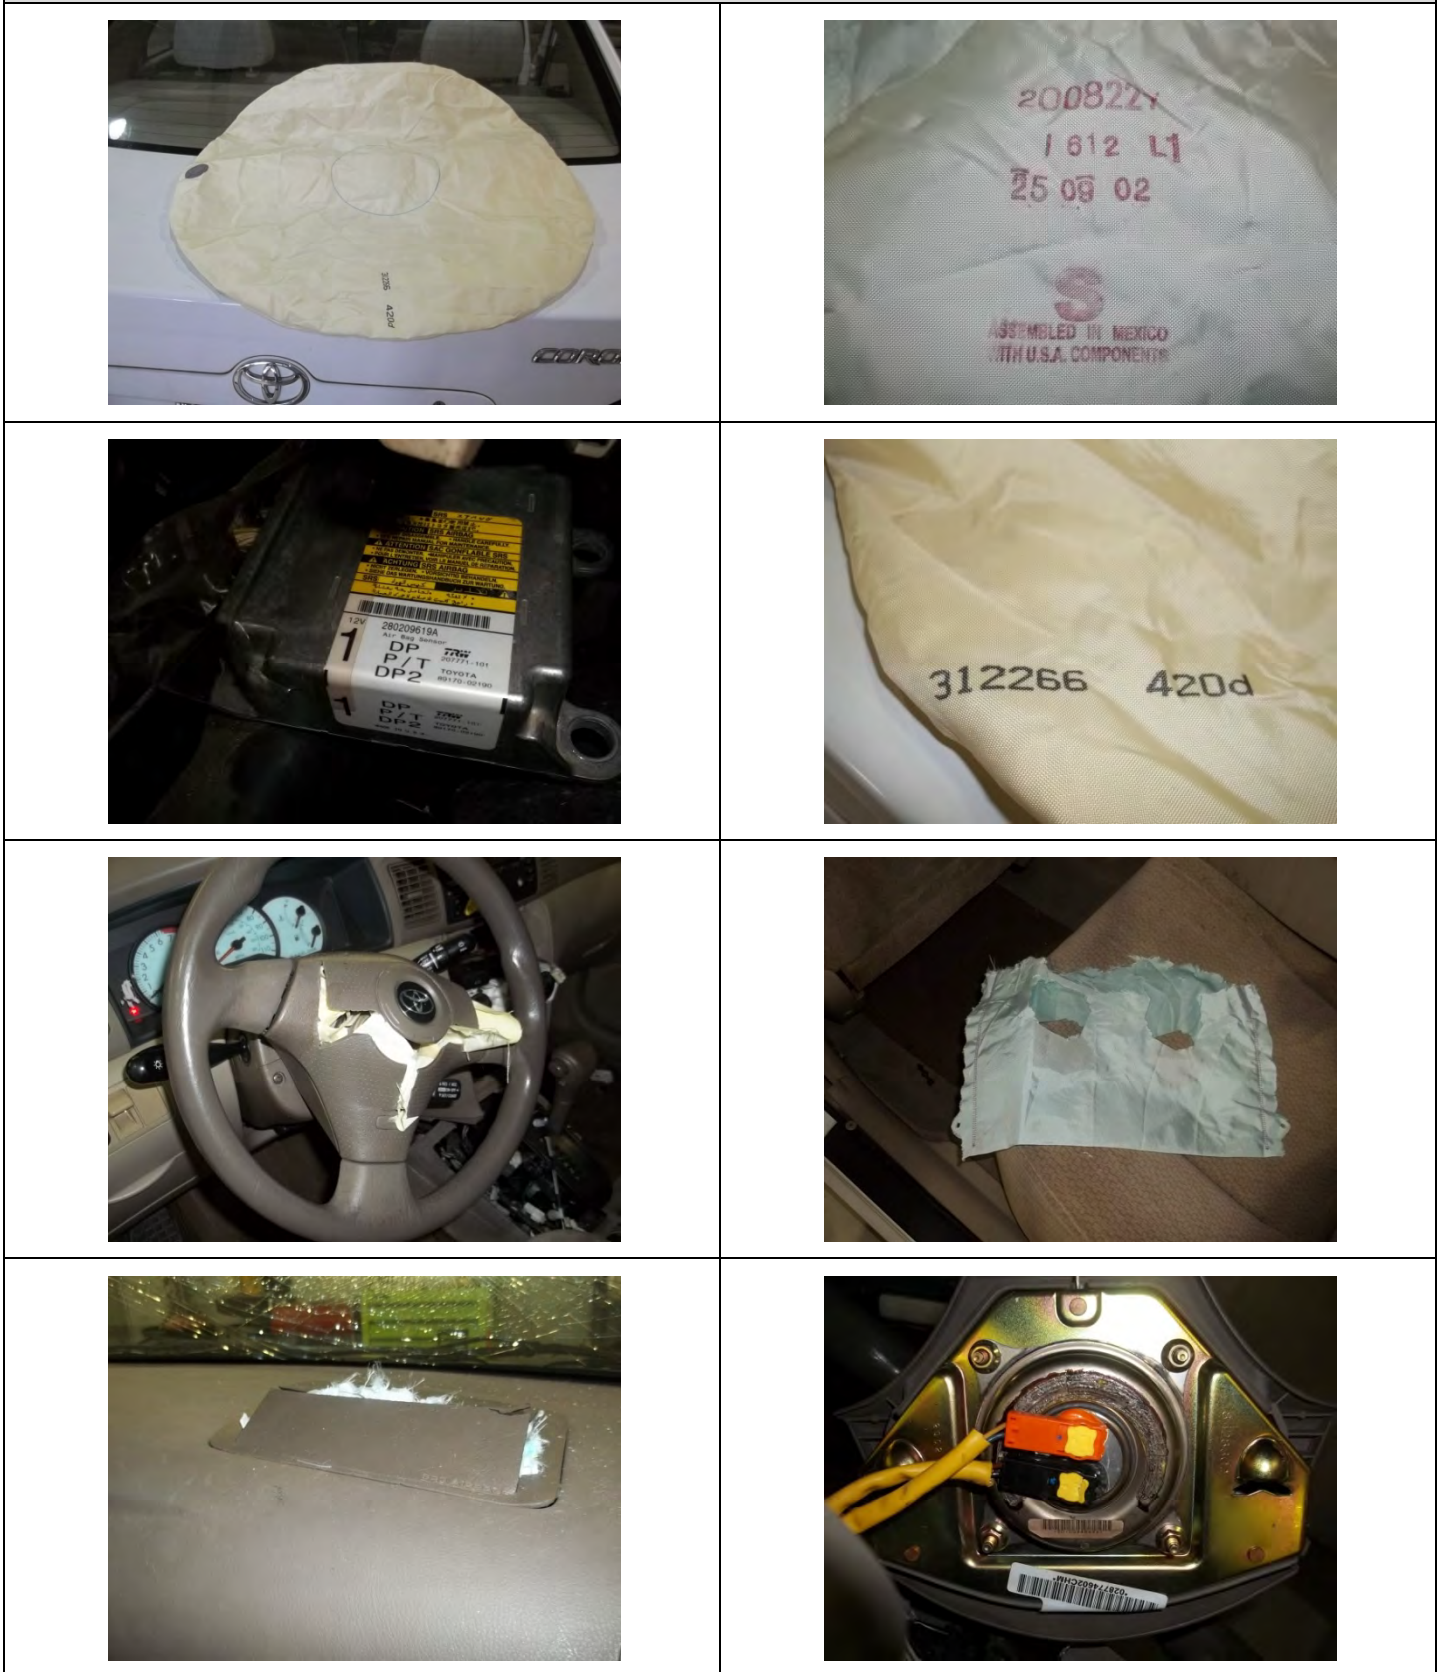
Airbag Pictures

Interior					
Supplemental Restraints Airbag Inspection		Deployed		N/A	Notes & Observations
		Yes	No		
Driver	Front SRS	<input checked="" type="checkbox"/>	<input type="checkbox"/>	<input type="checkbox"/>	
	Knee SRS	<input type="checkbox"/>	<input type="checkbox"/>	<input checked="" type="checkbox"/>	
	Seat Side SRS	<input type="checkbox"/>	<input type="checkbox"/>	<input checked="" type="checkbox"/>	
	Seat Belt SRS	<input type="checkbox"/>	<input type="checkbox"/>	<input checked="" type="checkbox"/>	
	Seat Cushion SRS	<input type="checkbox"/>	<input type="checkbox"/>	<input checked="" type="checkbox"/>	
Front Passenger	Front SRS	<input checked="" type="checkbox"/>	<input type="checkbox"/>	<input type="checkbox"/>	
	Knee SRS	<input type="checkbox"/>	<input type="checkbox"/>	<input checked="" type="checkbox"/>	
	Seat Side SRS	<input type="checkbox"/>	<input type="checkbox"/>	<input checked="" type="checkbox"/>

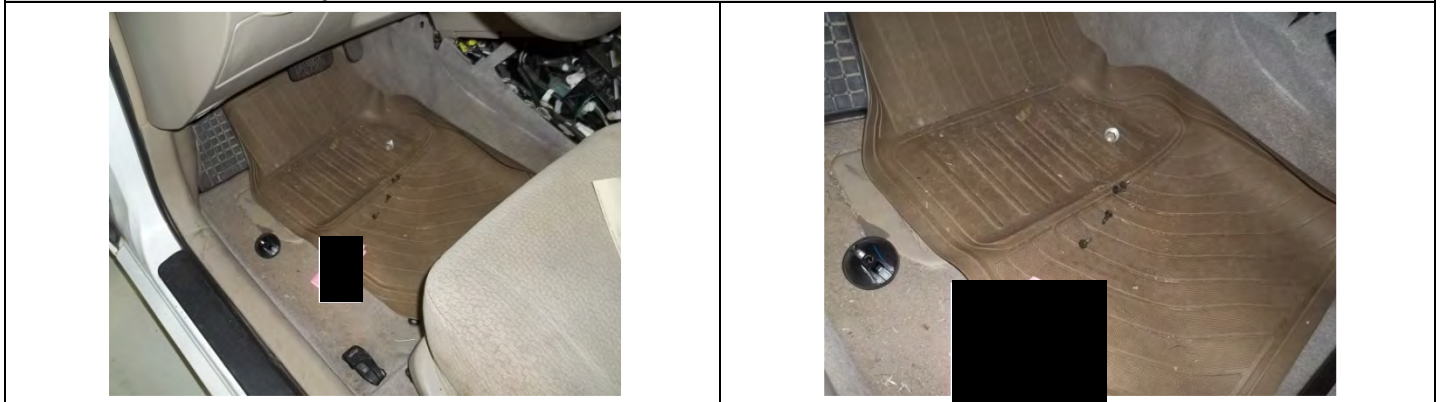
Floormat / Interior Floorpan Pictures

Inspection Area	Notes & Observations	
Warning Light Status	<input type="checkbox"/>	Unable to check, vehicle will not start / Ready ON
	<input type="checkbox"/>	Equipped with Safety Connect, note system status here:
Instrument Cluster		
Steering Wheel & Column		
Shift Lever & Linkage		
Pedal Assembly	Accelerator	
	Brake	
	Clutch N/A: <input type="checkbox"/>	
Floormat & Floorpan	Left Front	Generic rubber mat not secured to floor
	Right Front

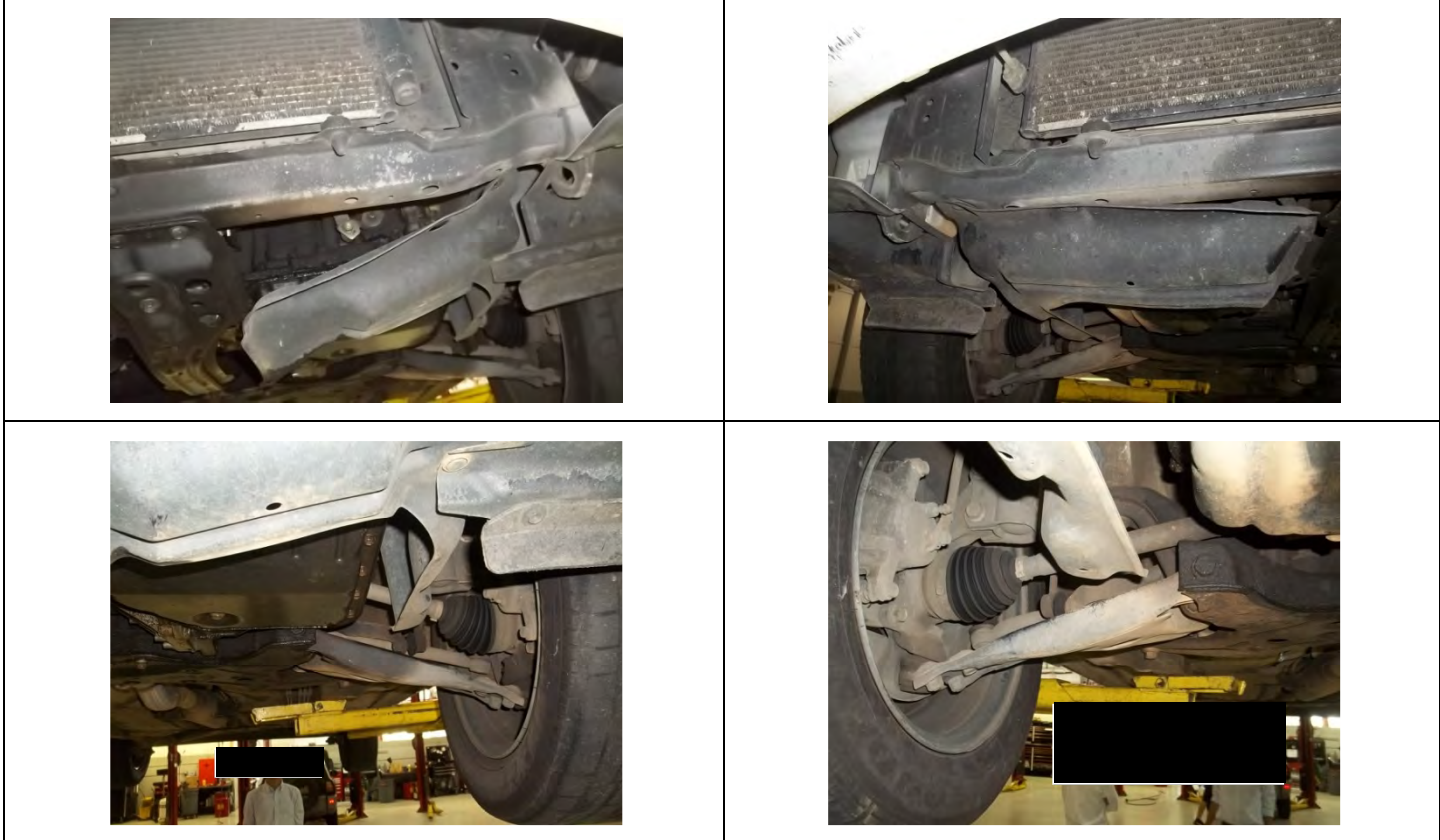
Undercar Pictures

Undercar		
Inspection Area		Notes & Observations
Suspension	Left Front	NORMAL
	Right Front	NORMAL
	Left Rear	NORMAL
	Right Rear	NORMAL
Steering Gear and Linkage		NORMAL
Drive axle / Driveshaft		NORMAL
Transmission / Transaxle		Oil leaking
Differential/rear axle assembly		Oil leaking
Exhaust System		normal
Fuel Tank and Lines		normal

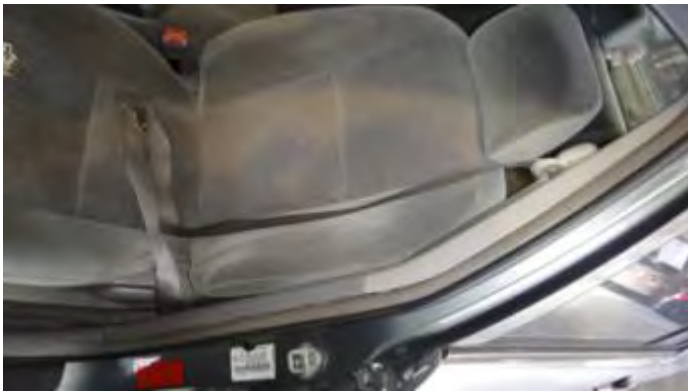
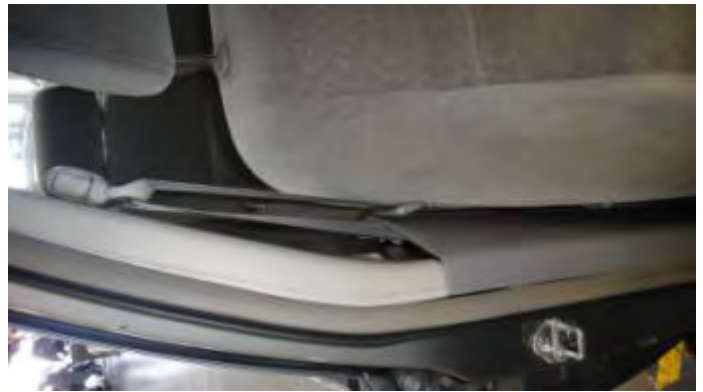
Seat Belt Pictures / Videos

Interior		
Inspection Area	Notes & Observations	
Left Front Position	Seat	
	Seatbelt	Pre-tensioner deployed with belt in use. Latch functions normally
Right Front Position	Seat	
	Seatbelt	Pre-tensioner deployed with belt out of use. Latch functions normally
Left Rear Position	Seat	
	Seatbelt	
Center Rear Position	Seat	
	N/A: <input type="checkbox"/> Seatbelt	
Right Rear Position	Seat	
	Seatbelt	
Third Row	Seat	
	N/A: <input type="checkbox"/> Seatbelt

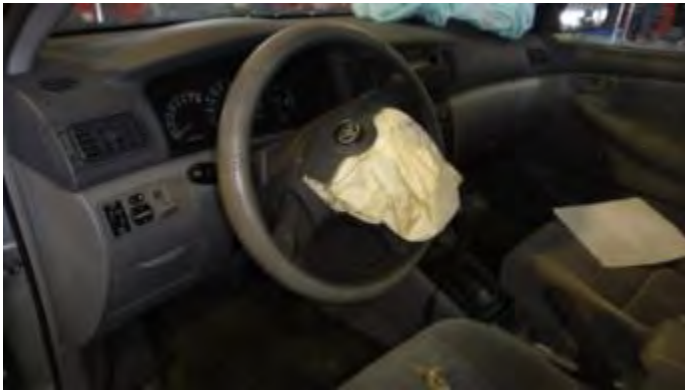
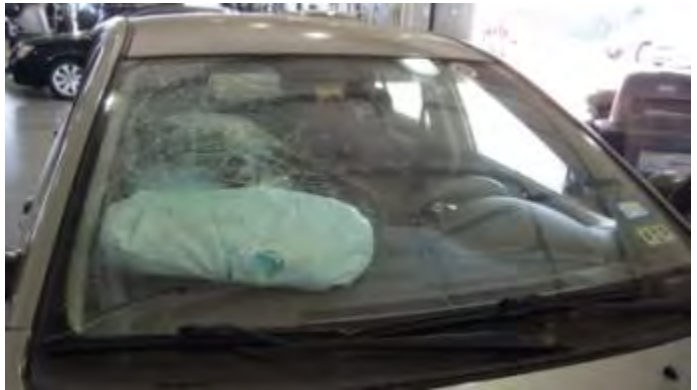
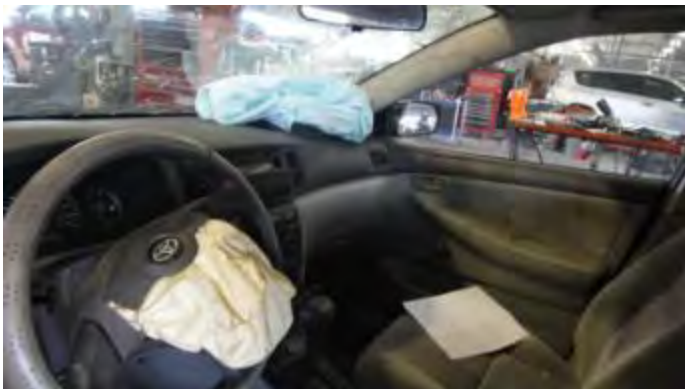
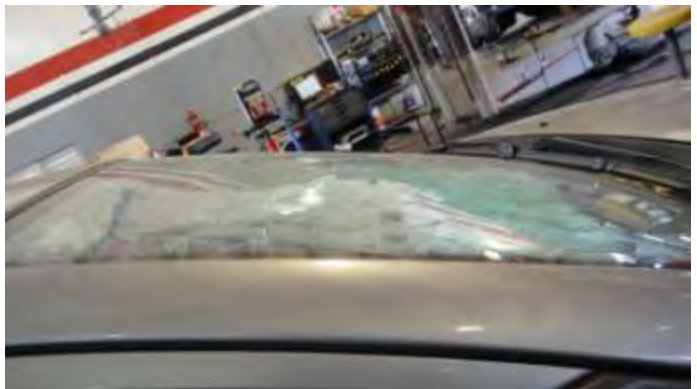
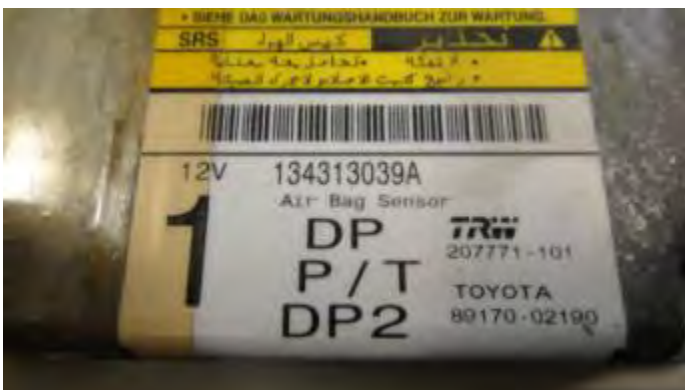
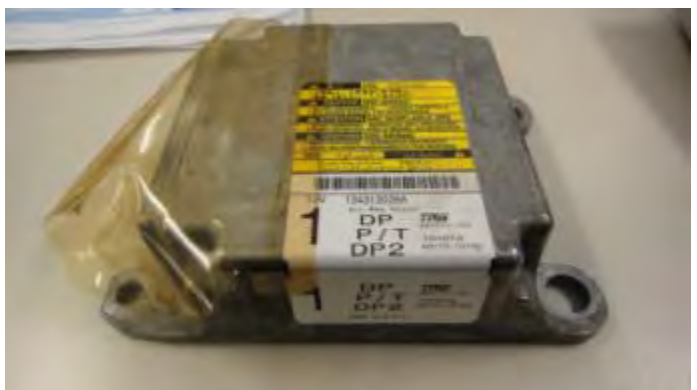
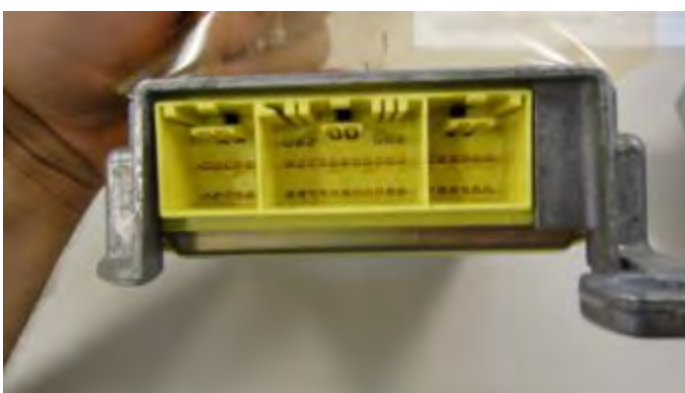
Airbag Pictures

Interior					
Supplemental Restraints Airbag Inspection		Deployed		N/A	Notes & Observations
		Yes	No		
Driver	Front SRS	<input checked="" type="checkbox"/>	<input type="checkbox"/>	<input type="checkbox"/>	
	Knee SRS	<input type="checkbox"/>	<input type="checkbox"/>	<input checked="" type="checkbox"/>	
	Seat Side SRS	<input type="checkbox"/>	<input type="checkbox"/>	<input checked="" type="checkbox"/>	
	Seat Belt SRS	<input checked="" type="checkbox"/>	<input type="checkbox"/>	<input type="checkbox"/>	
	Seat Cushion SRS	<input type="checkbox"/>	<input type="checkbox"/>	<input checked="" type="checkbox"/>	
Front Passenger	Front SRS	<input checked="" type="checkbox"/>	<input type="checkbox"/>	<input type="checkbox"/>	
	Knee SRS	<input type="checkbox"/>	<input type="checkbox"/>	<input checked="" type="checkbox"/>	
	Seat Side SRS	<input type="checkbox"/>	<input type="checkbox"/>	<input checked="" type="checkbox"/>
