EA12-001

TOYOTA

Attachment-Response 4

Field Report

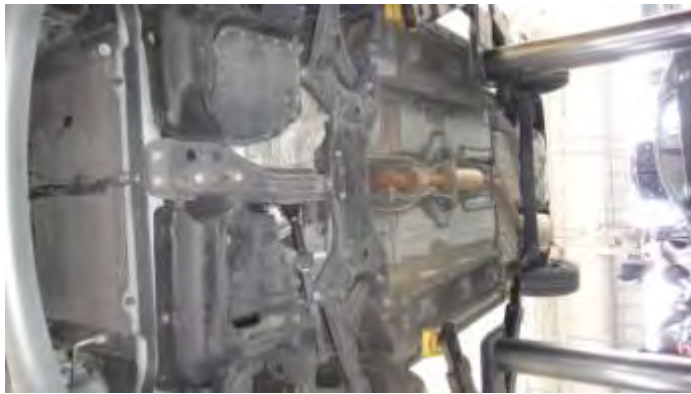
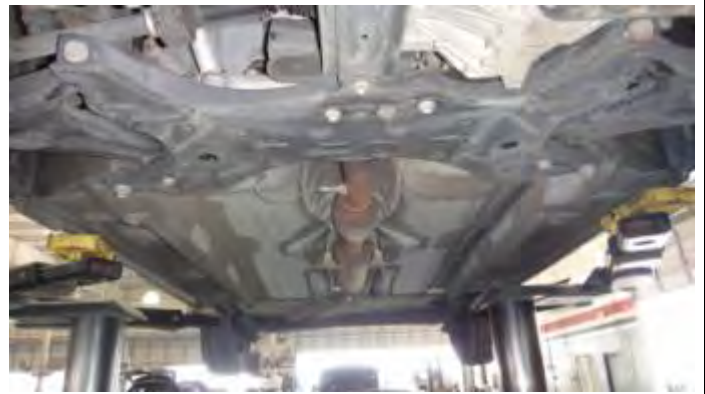
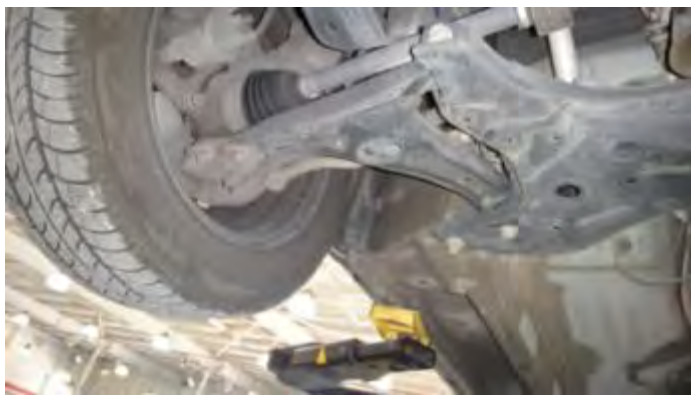
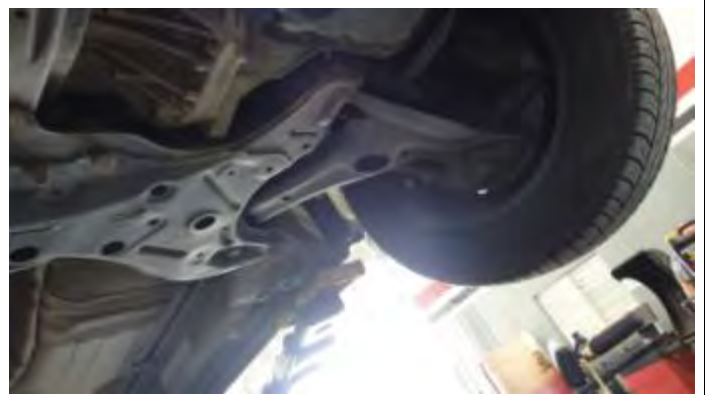
Undercar Pictures

Inspection Area		Notes & Observations
Suspension	Left Front	Undamaged
	Right Front	Undamaged
	Left Rear	Undamaged
	Right Rear	Undamaged
Steering Gear and Linkage		Undamaged
Drive axle / Driveshaft		Undamaged
Transmission / Transaxle		Undamaged
Differential/rear axle assembly		Undamaged
Exhaust System		Undamaged
Fuel Tank and Lines		Undamaged
