EA12-001

Attachment-Response 4

PRODUCT: ACCIDENT/FLOOD DAMAGE: AIR BAGS-FRONT: DEPLOY

TQCN DOC#	Co	ondition Title			Date
TQCN_FTR-121700145	U	nintentional Airba	g Deployment		06/21/2012
Primary Model	Model Year	Production Date	Odometer	VIN (confirm 17 characters):	
Corolla	2003	2002-09-24	117477	JTDBR32E730

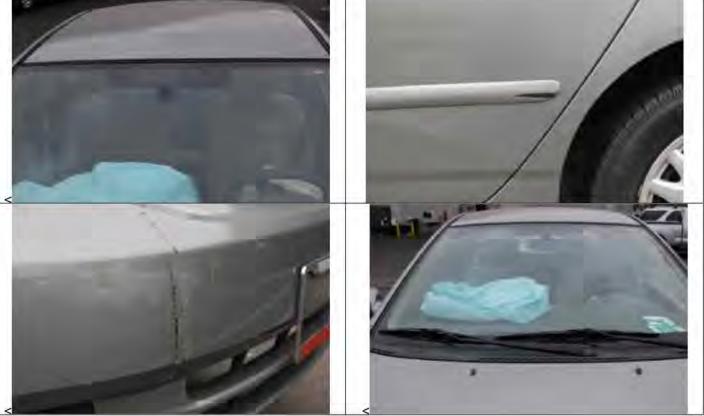
Exterior Other	
Inspection Area	Notes & Observations	
Headlights / Taillights	Operating as designed	
Brake Lights	Operating as designed	
Turn Signals	Operating as designed	
Glass & External Mirrors	Operating as designed – aftermarket rear view mirror	
Hood Latch	Operating as designed	
Hatch / Trunk Latch	Operating as designed	
Door Latch & Lock	Operating as designed

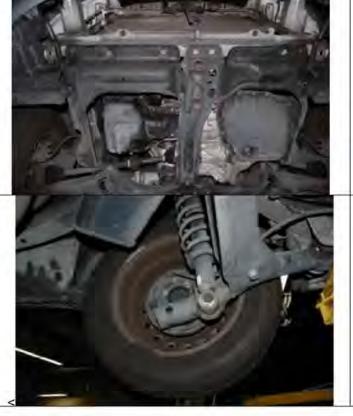
Undercar Pictures

Undercar
Inspection A	rea	Notes & Observations
Left Front		Normal
Suspension	Right Front	Normal
ouspension	Left Rear	Normal
	Right Rear	Normal
Steering Gea Linkage	r and	Normal
Drive axle / D	riveshaft	Normal
Transmissior Transaxle	1/	Normal
Differential/reassembly	ear axle	Normal
Exhaust System		Normal
Fuel Tank an	d Lines	Normal
Undercar Dic		1557.5.7

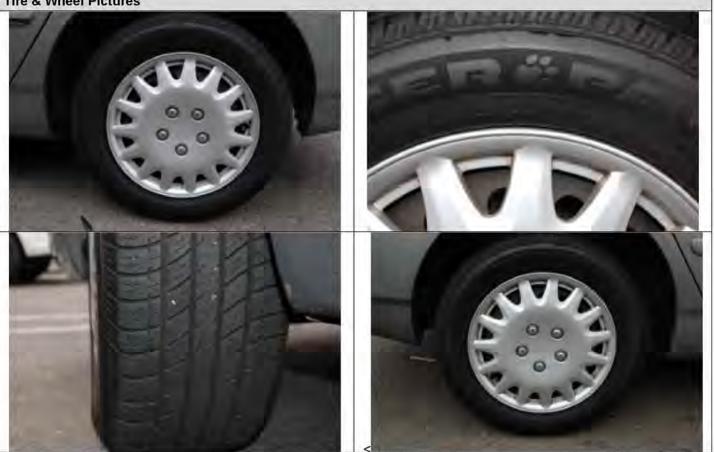
Tire & Wheel Pictures

Tires &	Wheel	S						
Inspection Area	Left F	Left Front		Right	Right Front		Left Rear			Right Rear		
Tire Brand / Model	Uniroy	ral		Uniroy	al		Uniroy	/al		Uniroy	/al	
Tire Model Name - Code			Tiger I	Paw		Tiger	Paw		Tiger	Paw		
Tire Size	205/60			205/60	0/15		205/60	0/15		205/60	0/15	
Tire DOT #	Y9TM			Y9TM	C9UU4	210	Y9TMC9UU4210			Y9TMC9UU4210		
Cold Tire Pressure (psi)	37	37		37		36			38			
Tread Depth (Measured	1	С	0	1	С	0	1	С	0	1	C	0
in 32 nd of an inch)	9/32	9/32	9/32	9/32	9/32	9/32	8/32	8/32	8/32	8/32	8/32	8/32
Tire Wear Condition	Norma	al										
Wheel Condition	Norma	al	- 11

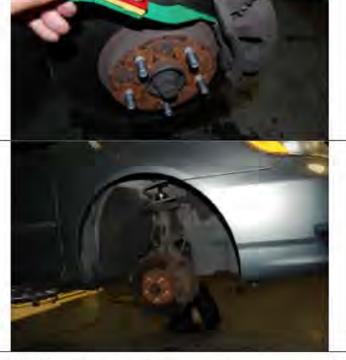
Brake System						
Inspection Area	Left Front (LF)	Right Front (RF)	Left Rear (LR)	Right Rear (RR)				
Pad / Shoe Thickness (mm)	8mm	8mm	5mm	5mm				
Calipers / Wheel Cylinders	Normal			,				
Pad / Shoe Condition	Normal							
Caliper Slide Pins & Other Hardware	Normal	lormal						
Rotor / Drum Condition	Normal	Normal						
Wheel Speed Sensor & Wiring Condition	Normal	Normal						
Master Cylinder	Normal							
ABS Actuator	N/A							
Brake Lines & Hoses	Normal							
LSPV - Load Sensing Proportioning Valve	N/A	N/A						
Parking Brake Operation	Normal

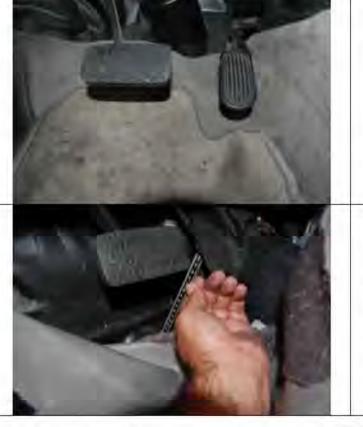
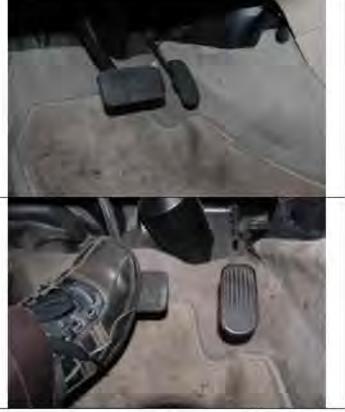
Brake System - Pedal Pictures

Measurement: 20mm
