EA12-001 CHRYSLER 10-4-2012 ENCLOSURE 4 PEER CAIRS Backup

Preliminary Vehicle Investigation Report(PVIR)

CAIR# 17749707											
YEAR BRAND			VEHICLE IDENTIFICATION NUMBER			N	MO/DY- HR	ODOMETER		N- ERVICE	
2004 JEEP GRAND CHEROKEE LAREDO 4X4 SPORT UTILITY 4-DR		Γ	1J4GW48SX4C		С			53590	0:	3/03/2003	
NAME OF OWNER	ADDRESS/LOCAT	TIO	N		CITY			STATE	C	COUNTRY	
					ADAH			PA	U	JSA	
ZIP COLOR		МО	DEL H	OME	PHONE		BU:	SINESS	PHON	1E	
Graphite Metallic Clear	· Coat	WJ.	J								
SELLING DEALER NAME	BUSINESS CENTE	R	DLR. C	ODE	CITY		STATE			NTRY	
GOLICK CHRYSLER-JEEP INC	35		23492		PITCAIRN		PA		USA		
INSPECTOR - NAME FIRST, LAS			ECTOR'S		IPANY		CTOR'S PH	ONE NO	).		
James Zumbo N	SP	PX/	EAA/PGI	1	_		55-1601				
DAMAGE ESTIMATE					REPAIR		TE				
MINOR MODERATE TO	TAL LOSS		\$ 1000.00								
INTERVIEW WITH:	ORIVER		INTER		OTHER 🅶 [	ORIVER/	OWNER				
NAME: LAST,FIRST, MIDDLE	ectroniques de seguina que entre estre esta esta de la companie de la companie de la companie de la companie d	energy-sage s	es ecit-cut-arcicali desta cineiracion	entral de la constitución de la co	en de la reche	uli taka akai sahashashashi taka	in police and heavy and the desire and police and heavy and heavy

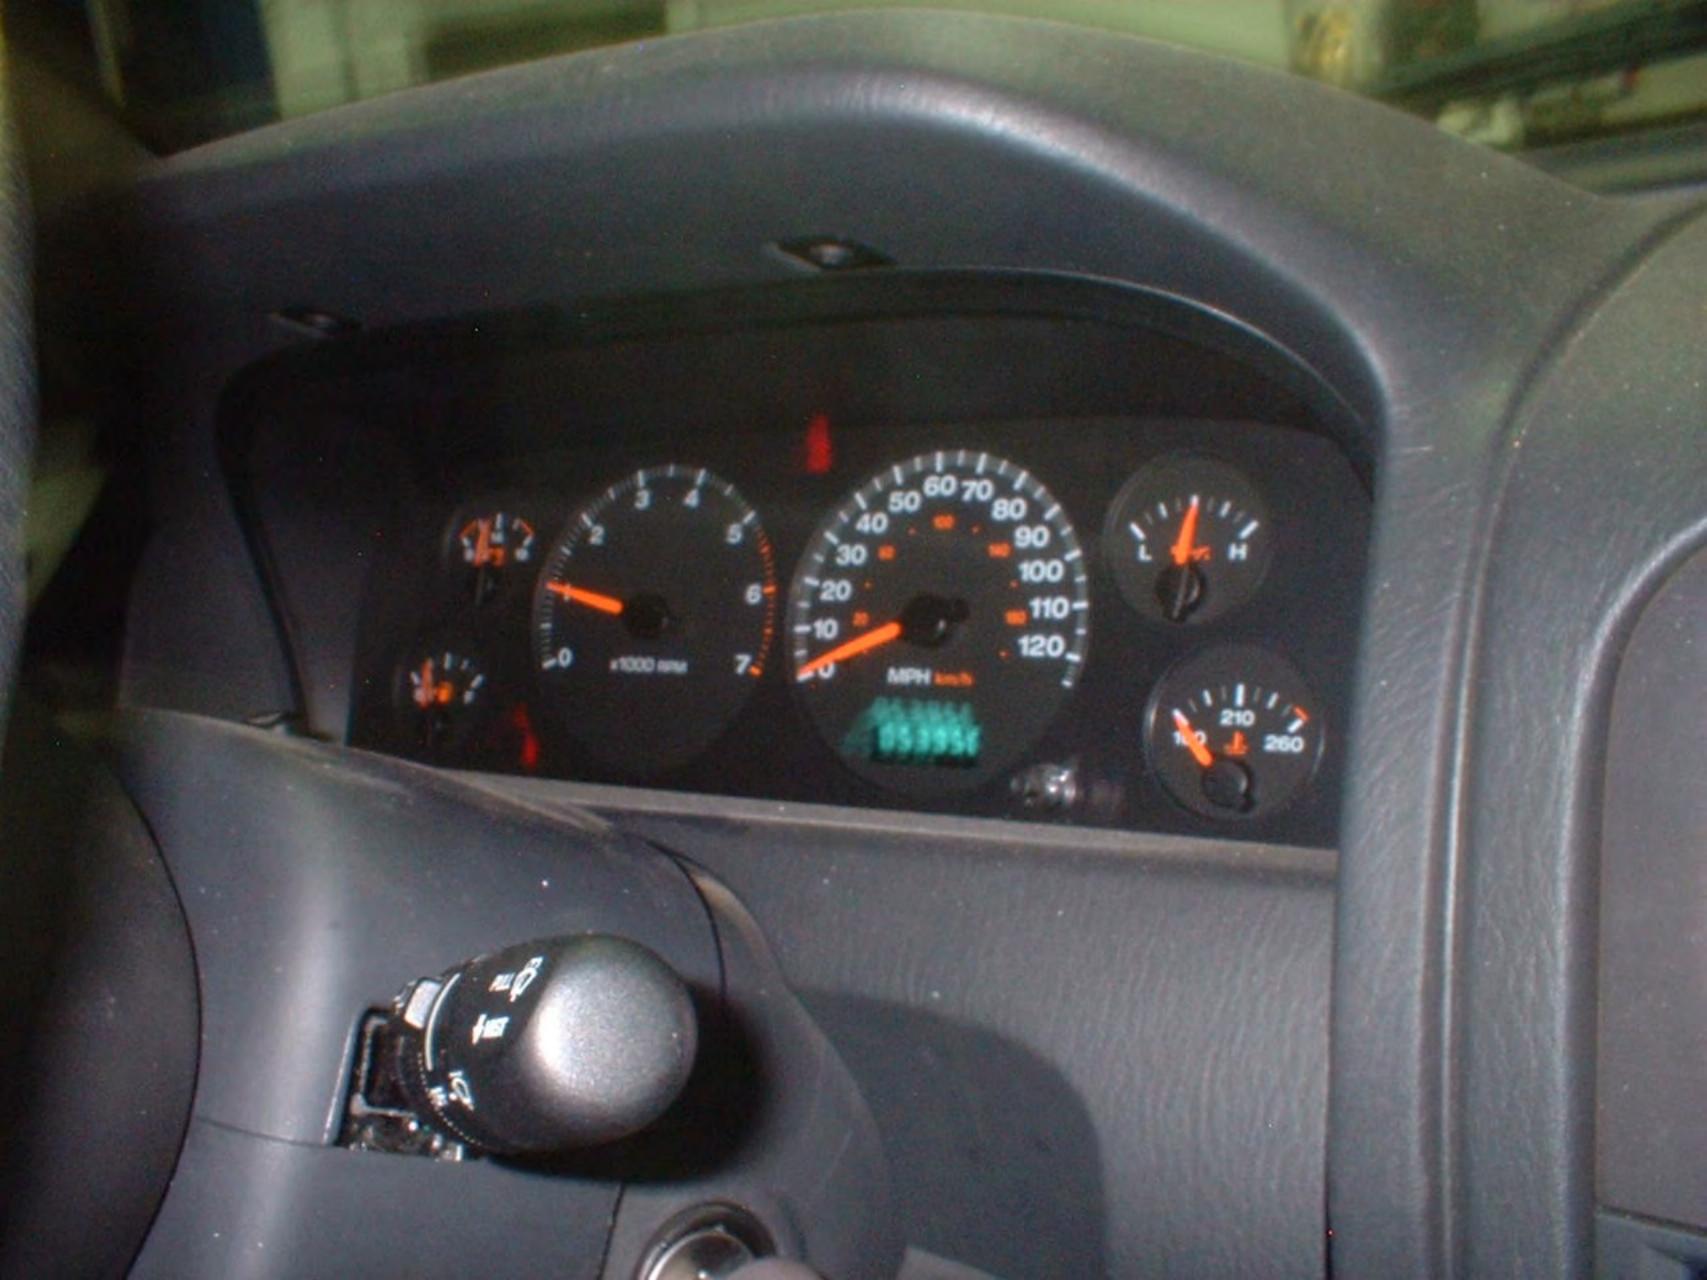
1) Ignifion 2) ORB III is connected connector
