EA12-001

CHRYSLER

ENCLOSURE 4

PEER CAIRS Backup

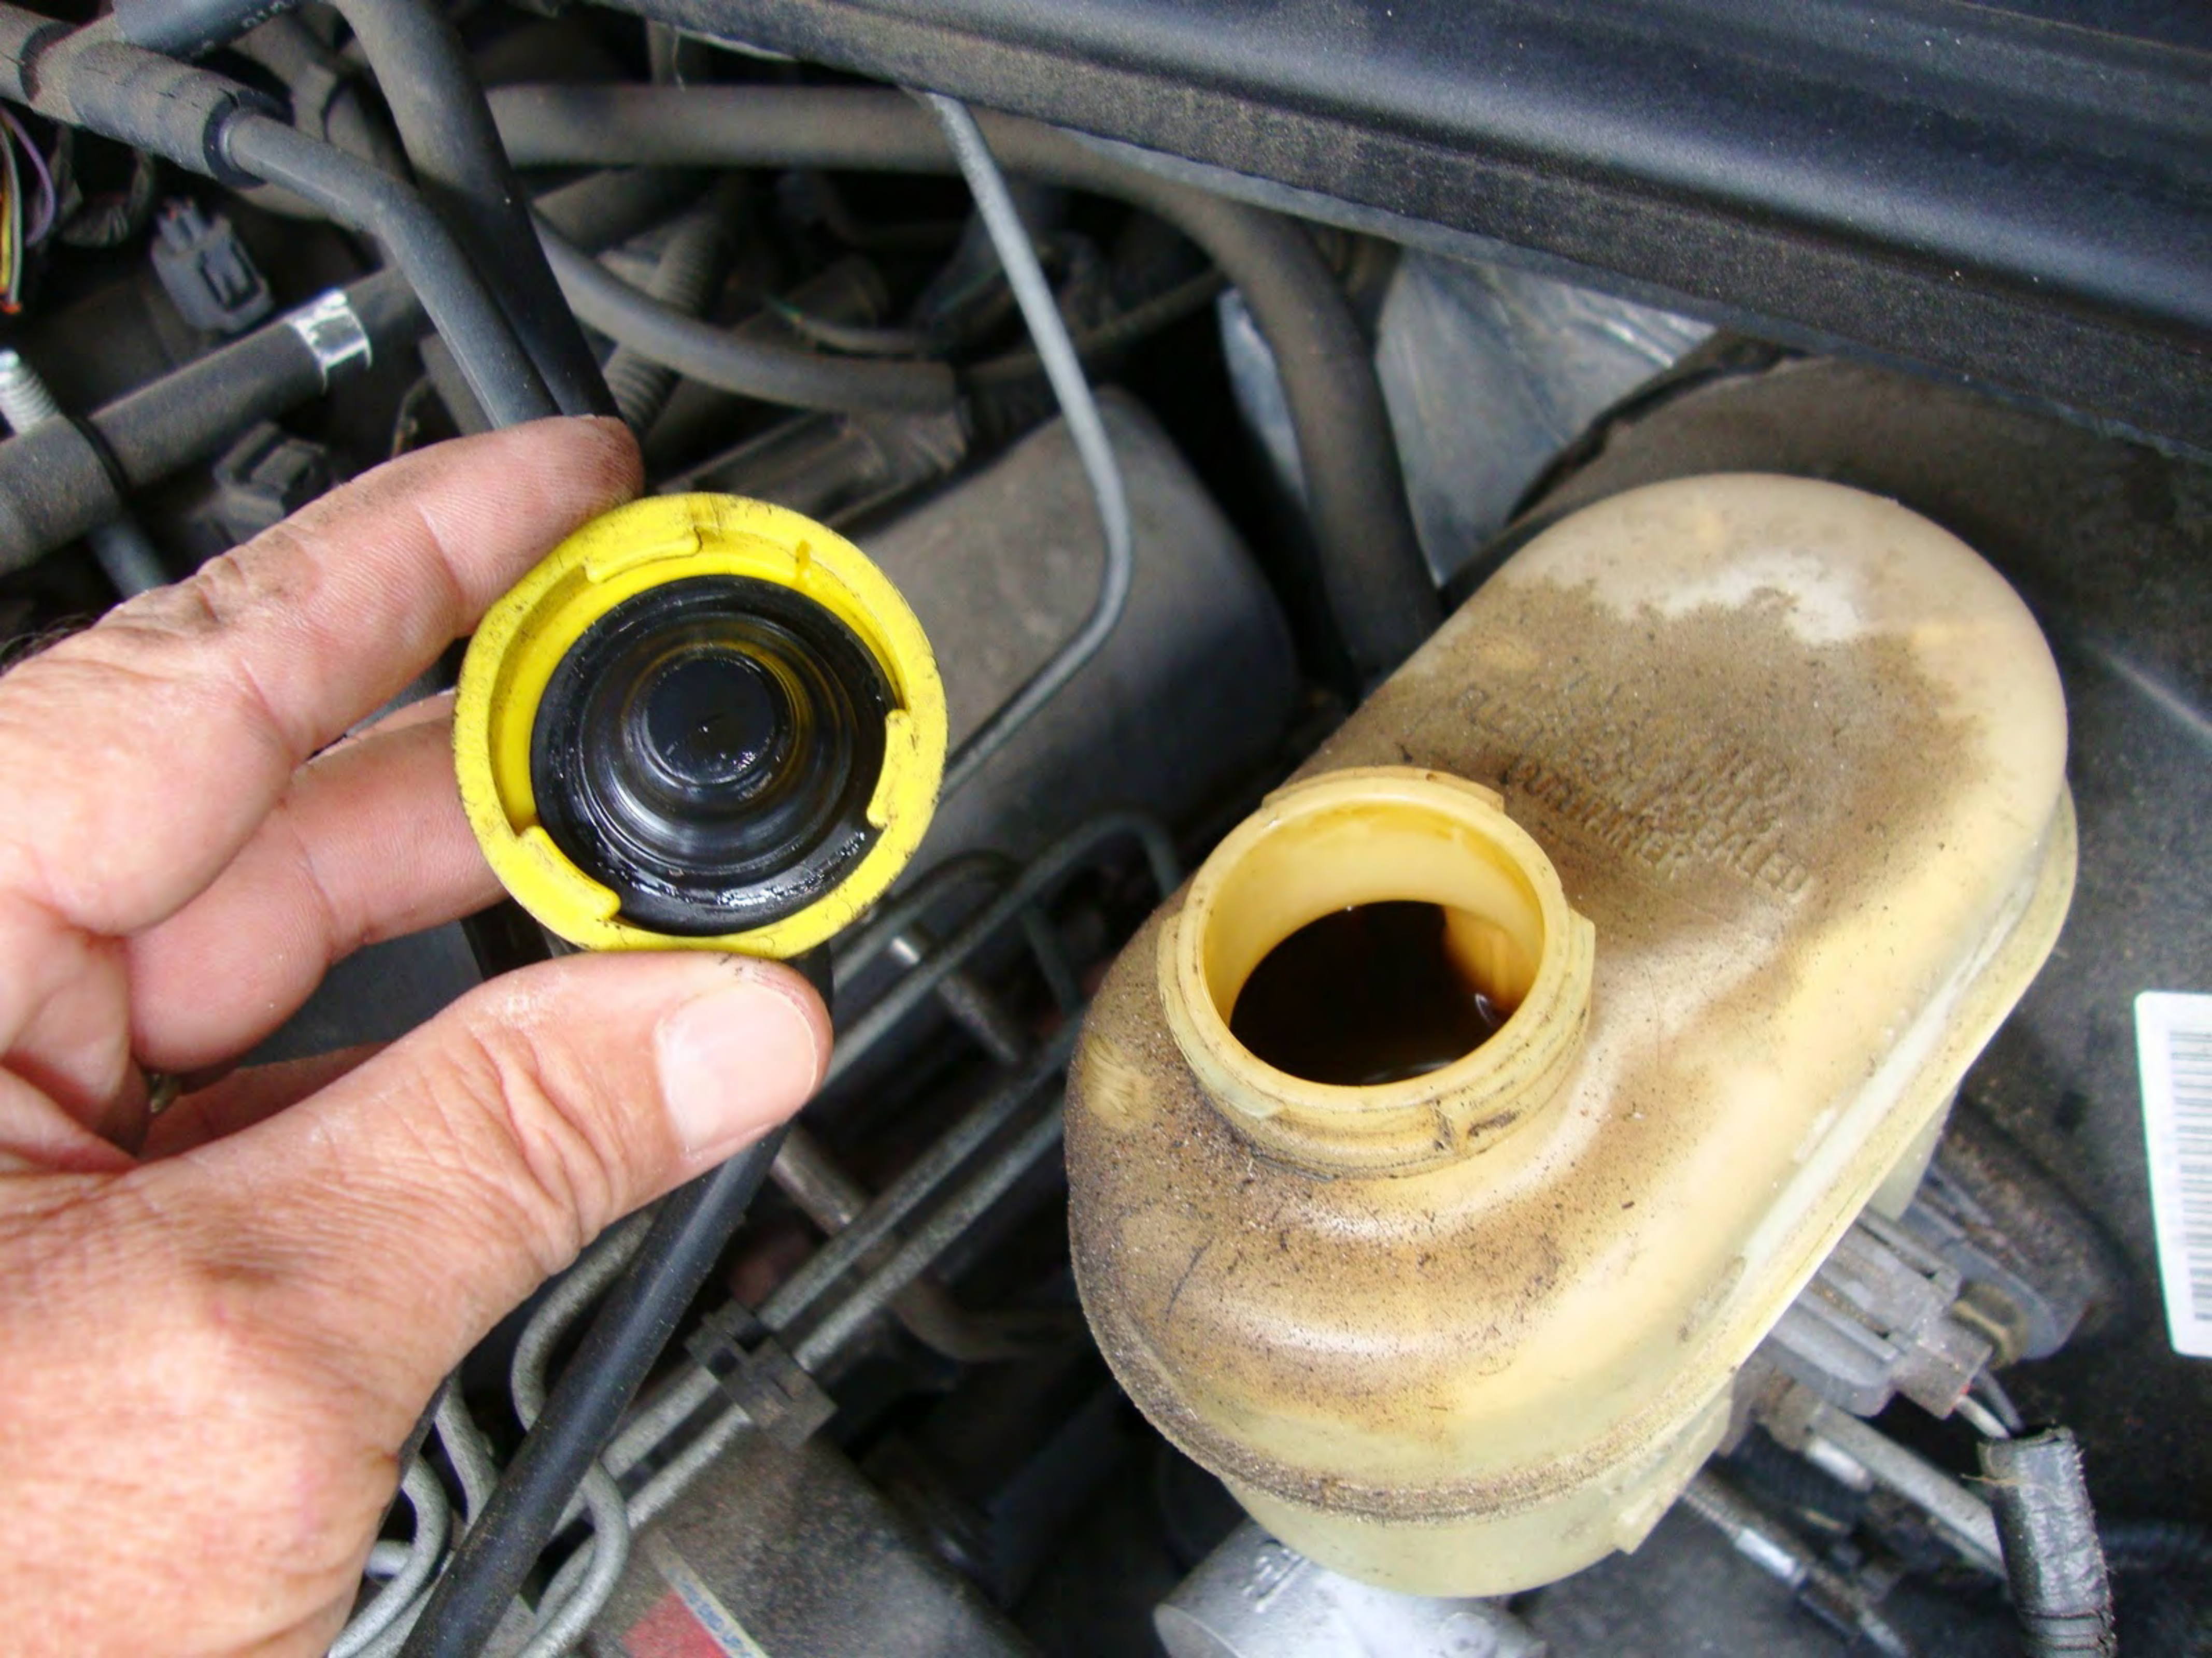
Yellow and blue labels on the battery.
