EA12-005

APPENDIX C2

LAWSUIT 1

FIRST AMENDED
COMPLAINT

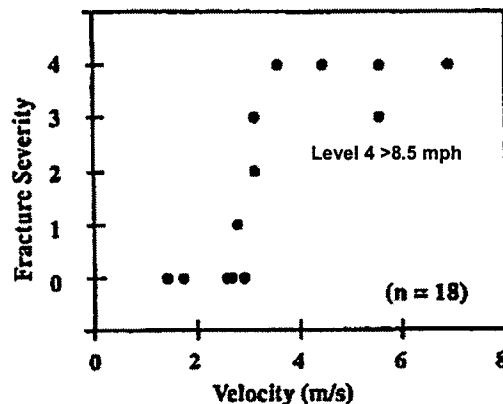
Ms. [REDACTED] sustained multiple LeFort II and III facial fractures. Figure 1 shows the facial fracture severity level based on impact velocity (Yoganandan et al. 1993). Clearly, Ms. [REDACTED] impact with the ground exceeded the level for LeFort III fractures.

Figure 1: Fracture severity versus impact velocity
(Level 0 = no fracture and Level 4 = most severe case - LeFort III)
(Yoganandan et al. 1993).

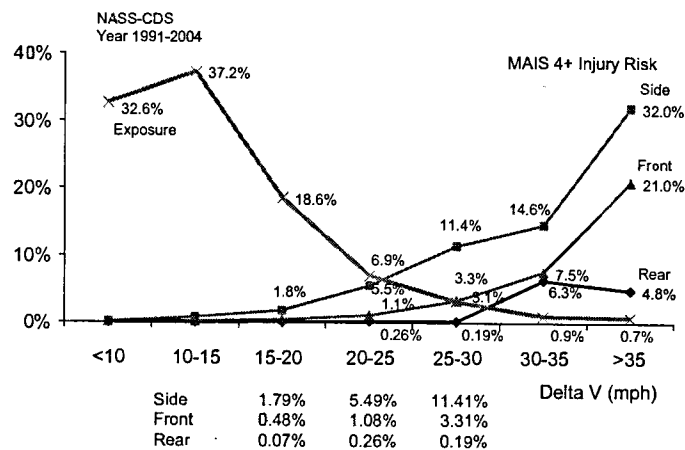
Figure 4: Risk of serious and severe injury (MAIS 3+ and MAIS 4+) to occupants in tow-away rear impacts.

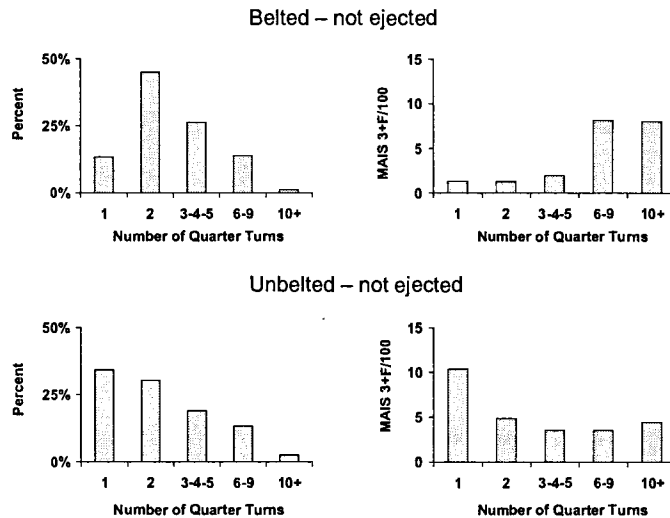
19) Mr. [REDACTED] was involved in a quarter-turn rollover arrested by a tree impact. Digges, Eigen (2003) investigated the risk of serious injury for non-ejected occupants in single vehicle rollovers by quarter turns. They found that more than 30% of seriously injured unbelted occupants were involved in quarter-turn rollovers where the injury rate was highest (Figure 6). They also discovered that most quarter-turn rollovers had impacts with fixed objects before or after the rollover. They reviewed individual cases of quarter-turn rollovers and found that 28% of serious injuries were from impacts with fixed objects prior to the rollover, and 66% were from impacts during or after the rollover, excluding ground impacts. Fixed object impacts during a rollover event are clearly injurious. Mr. [REDACTED] was belted but his skeletal injuries are consistent with the impact with the tree.

Figure 6: Distribution and risks serious injury (MAIS 3+F) by number of quarter turns (Digges, Eigen 2003).

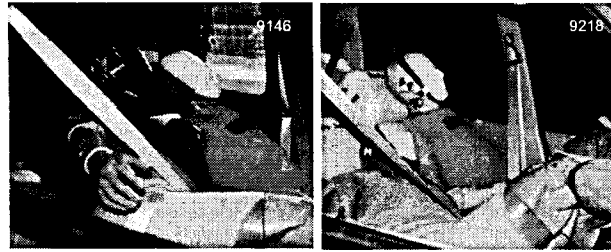
The revised FMVSS 301 standard uses 50th percentile male dummies in the driver and right-front passenger seats. Dummy instrumentation is not required and no biomechanical criteria are included. A 50th male Hybrid II dummy was placed in the driver and passenger seats in 3 of Ford's offset tests (9146, 9176 and 9218) and in the 2 NCAP tests. However, there were no photos or videos produced in test 9176 due to an error with the impact speed. Biomechanical responses in the Ford offset developmental tests were not measured. Occupant kinematics was assessed by reviewing videos and photos. Figures 1 shows the dummy position after the offset crash tests. The front, belted dummies remained in their seats after the crash.

Figure 1: Post-crash dummy position in test 9146 with 22.4 mph delta V and test 9218 with 22.2 mph delta V.

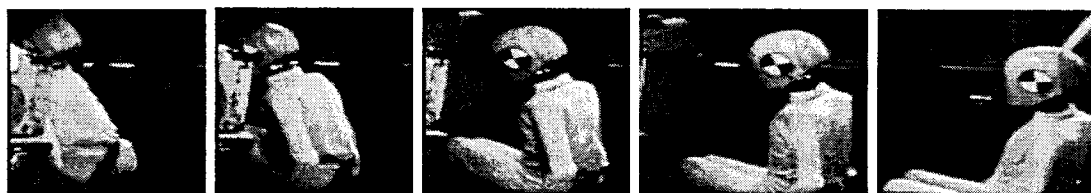
49) Exponent Failure Analysis (2002) carried out a 33.5 mph frontal sled test with an unbelted 6 year old child dummy seated behind a BMW ABTS seat. Figure 6 shows the head impact, which resulted in a head response (HIC = 5303) that was 733% above the IARV for the child. The HIC level is consistent with an extremely high risk of fatal head injury by contact with a stiff front seatback. The compression-flexion neck response was 256% above the IARV. Accident data and test findings suggest that more rigid front seats are not a reasonable approach to improving safety of 2nd row seated children in more frequent frontal crashes.

Figure 6: Unbelted 6 year old child dummy seated behind a BMW ABTS seat in a frontal impact.
