ISUZU ENGINEERING TEST REPORT

CERTIFICATION TEST REPORT

FMVSS 301

1998 ISUZU RODEO

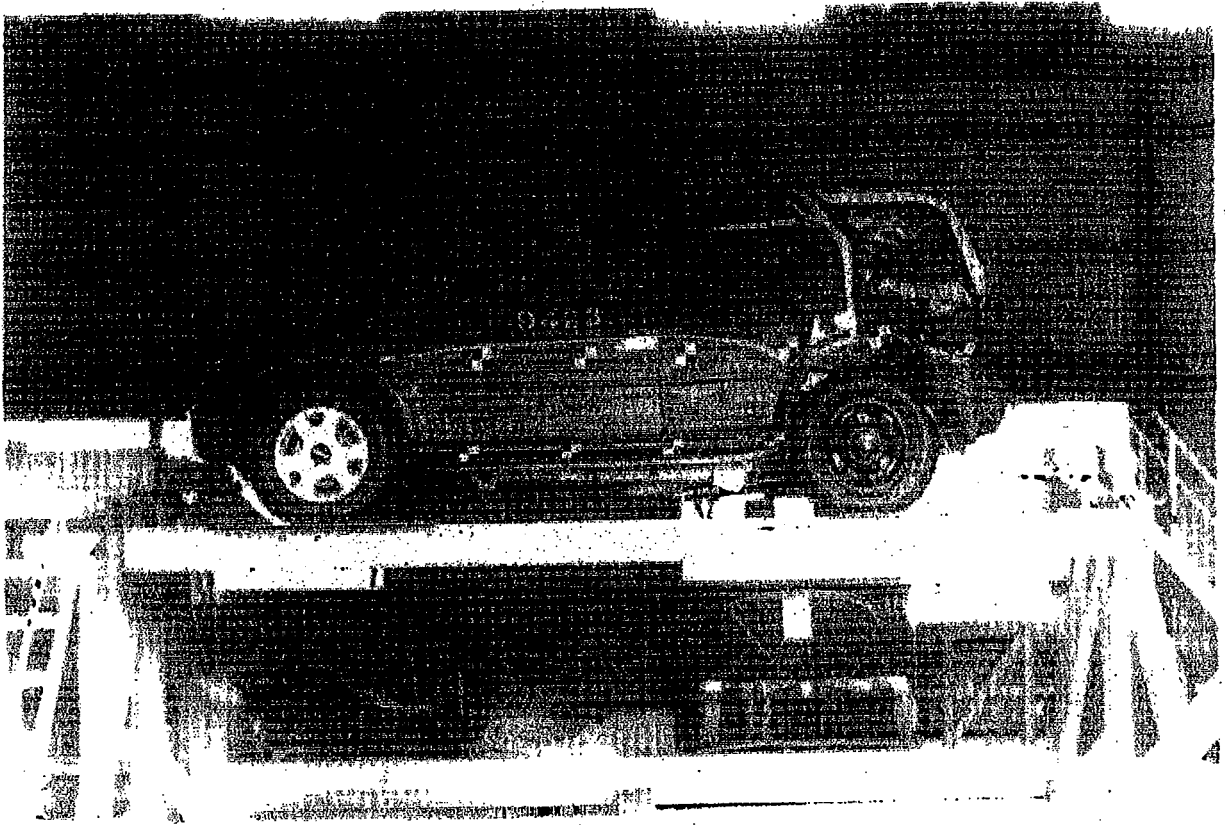
Photo. 7

STATIC ROLL OVER TEST
