ISUZU ENGINEERING TEST REPORT

CERTIFICATION TEST REPORT

FMVSS 301

2002 ISUZU TROOPER

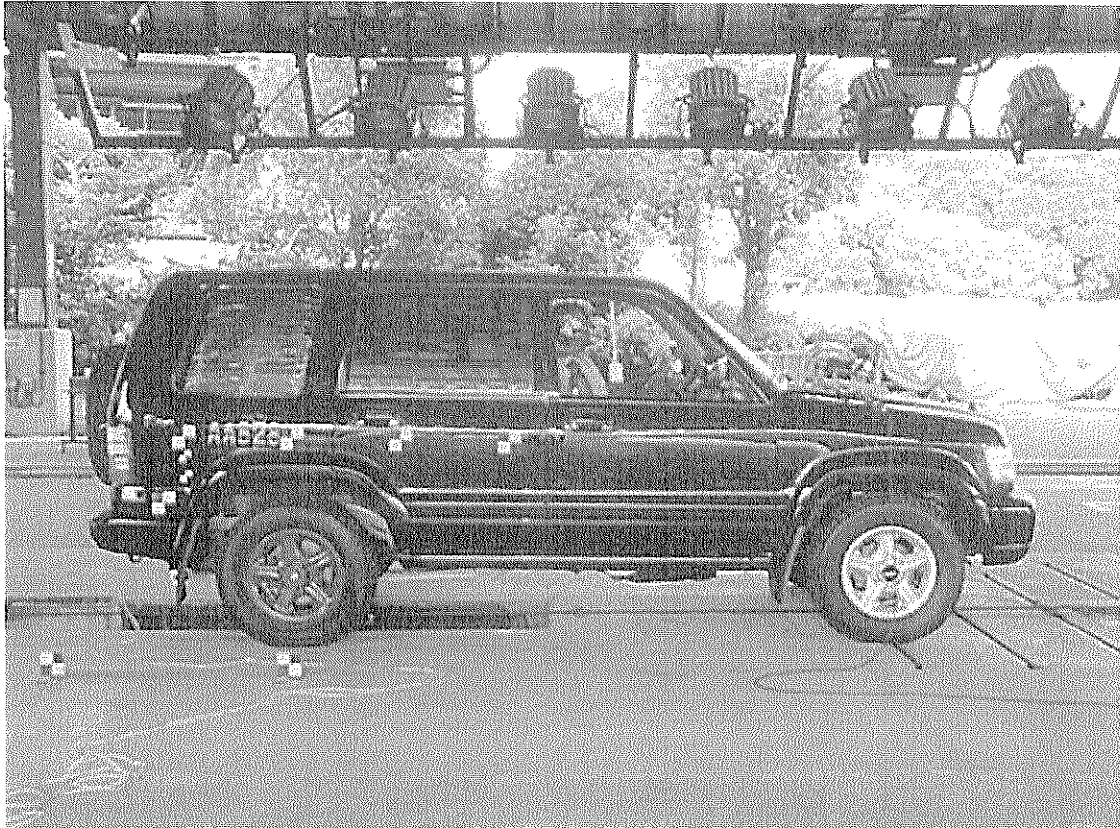
PRE-TEST

RIGHT SIDE VIEW

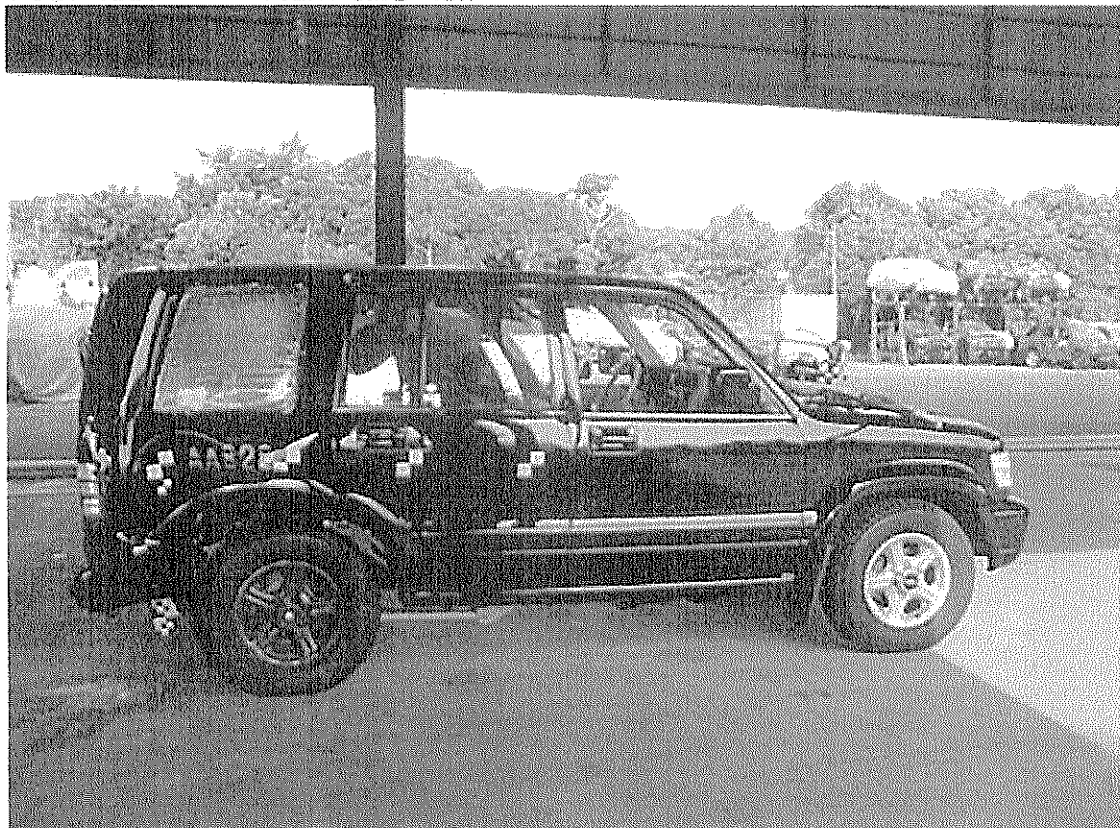
POST-TEST

RIGHT SIDE VIEW

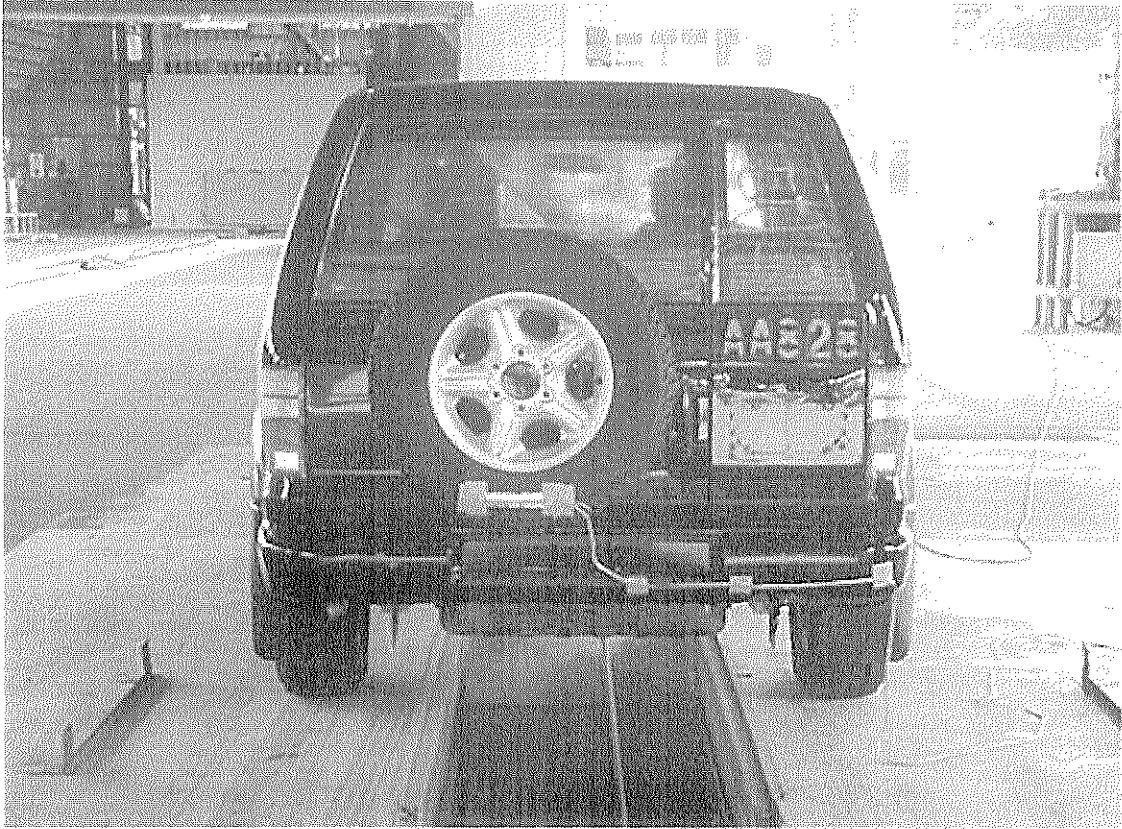
PRE-TEST

REAR VIEW

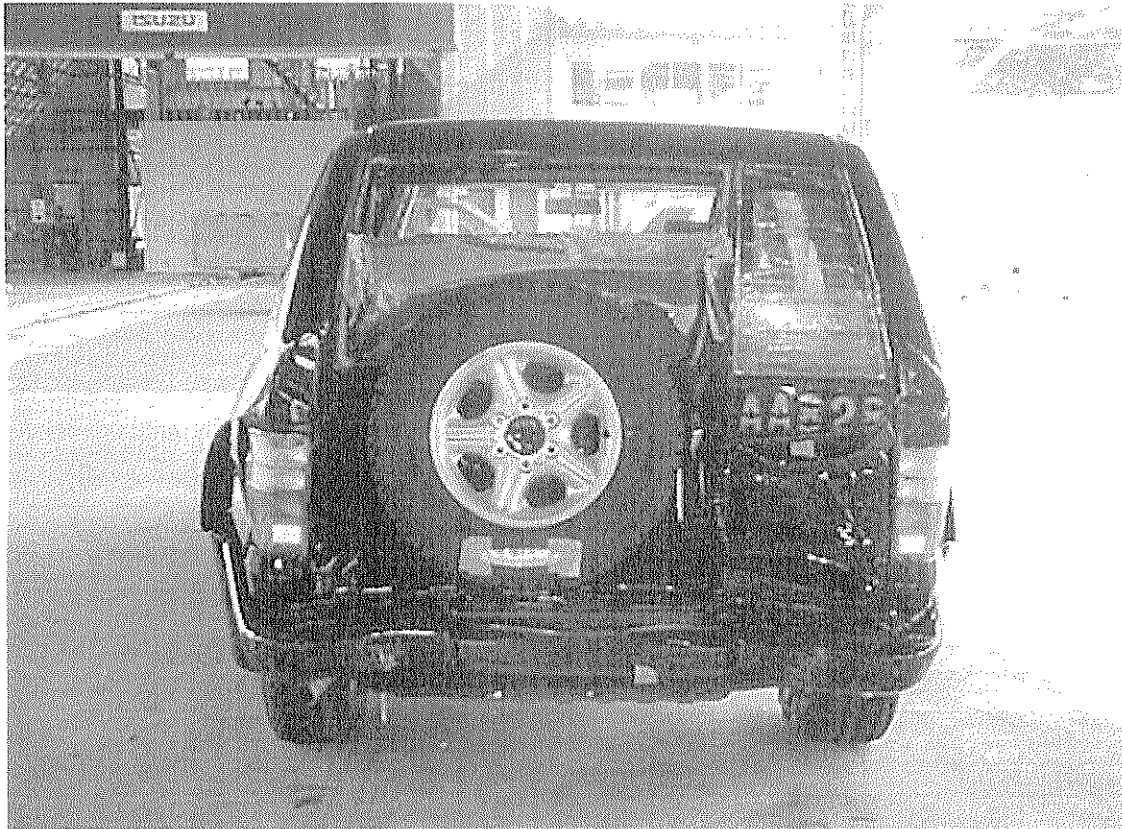
POST-TEST

REAR VIEW

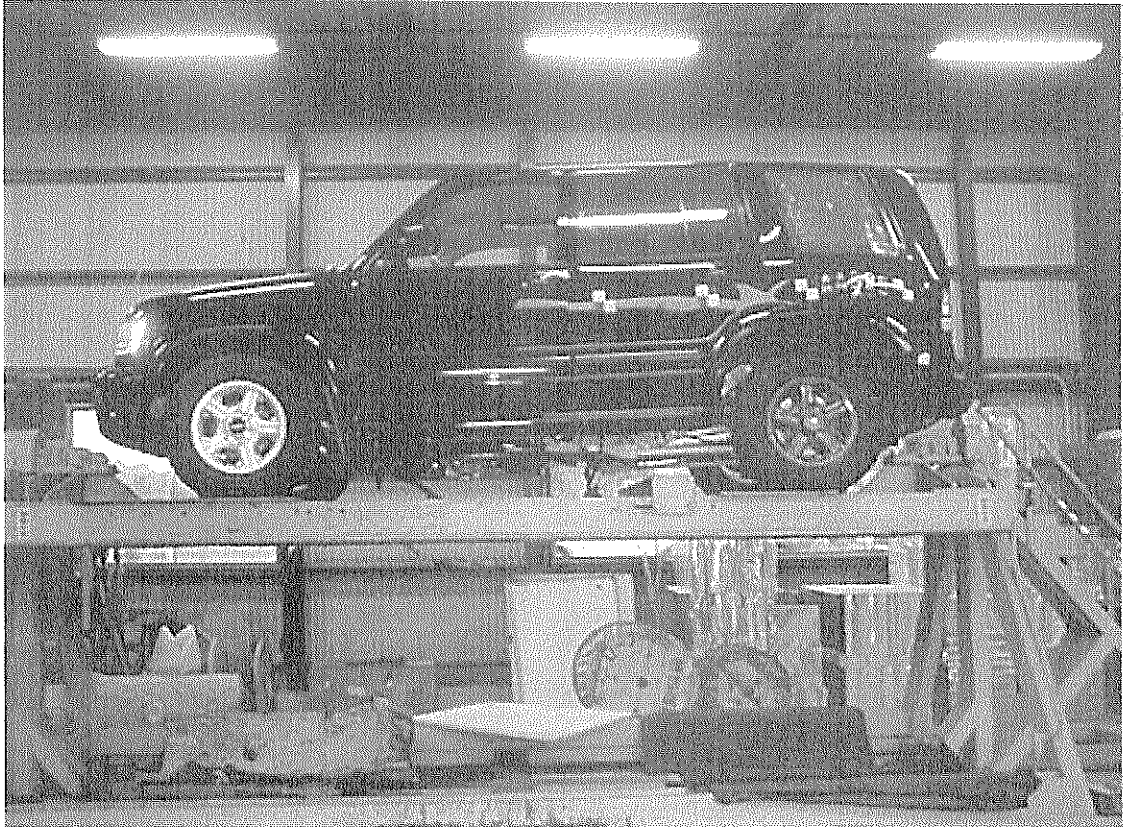
ROLLOVER TEST

STATIC ROLLOVER ( 1 st. Roll ;Clockwise )

STATIC ROLLOVER ( 2 nd. Roll ; Counterclockwise )

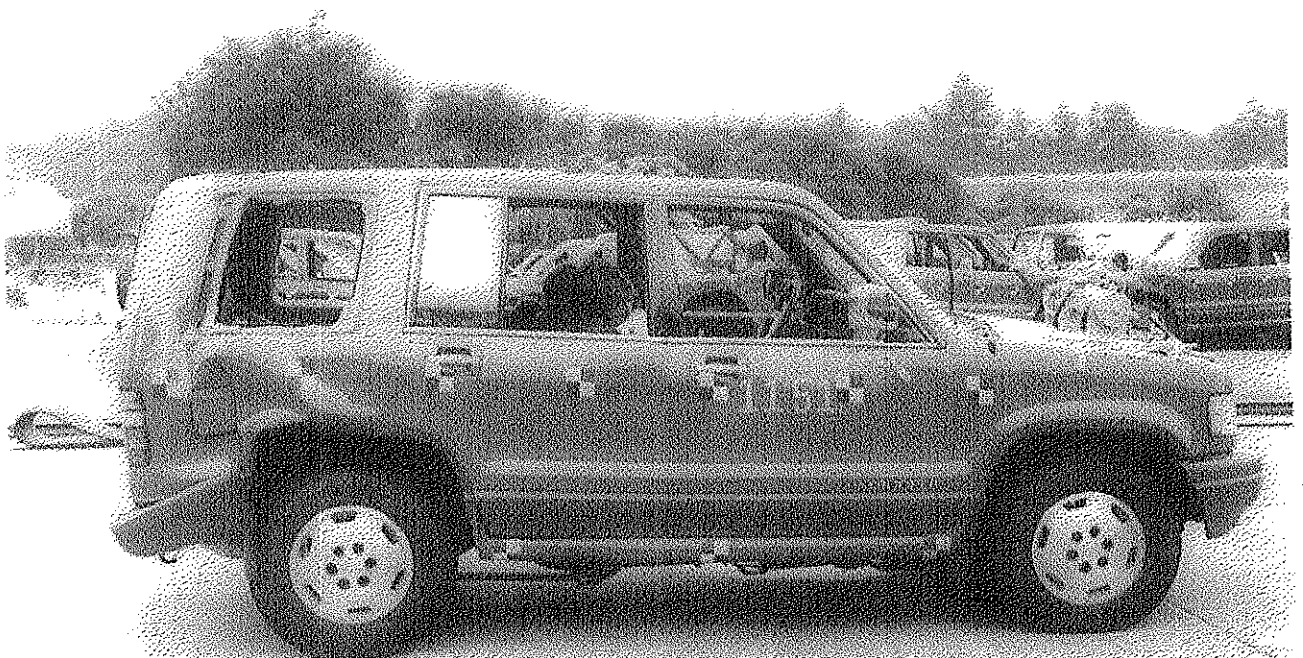
Photo. 4

POST-TEST

RIGHT SIDE VIEW

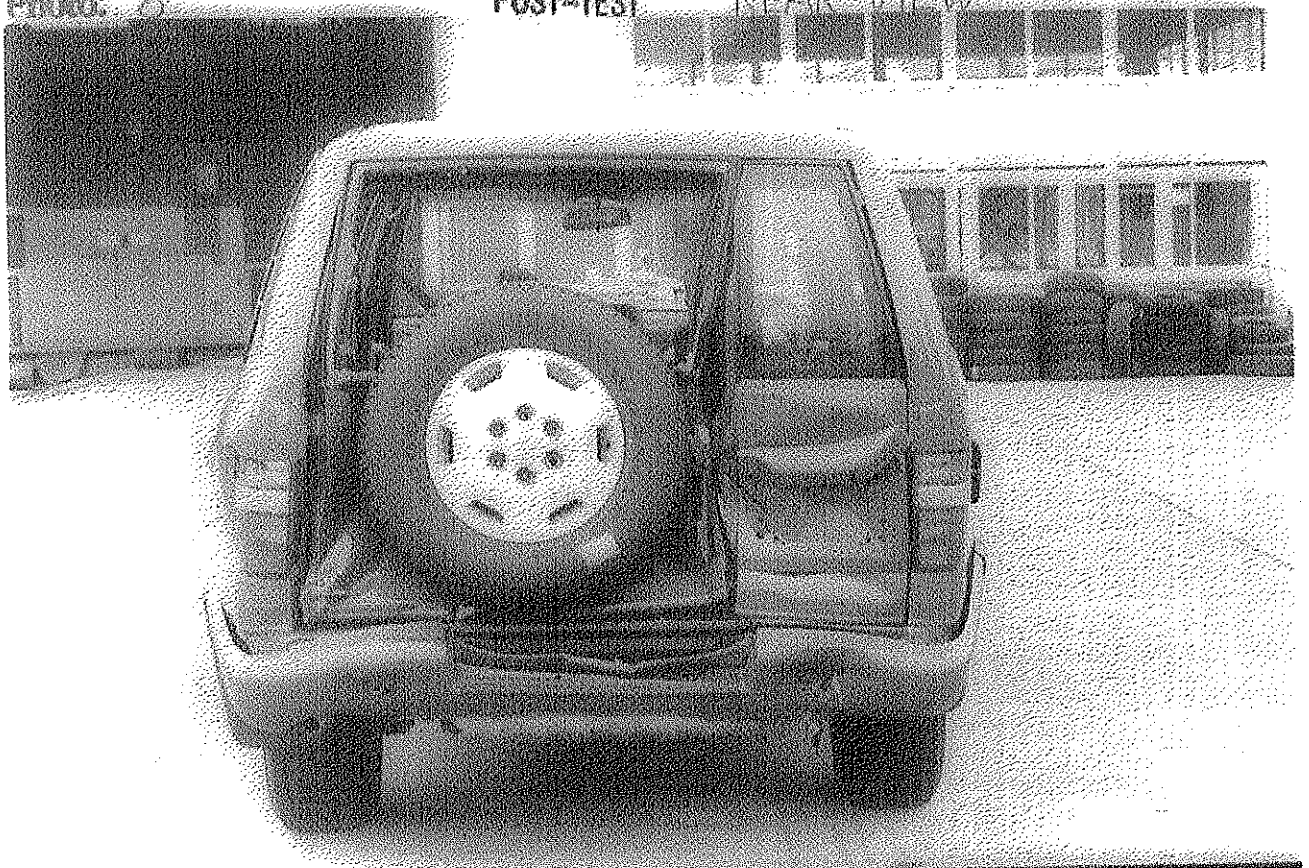
Photo: 8

POST-TEST REAR VIEW

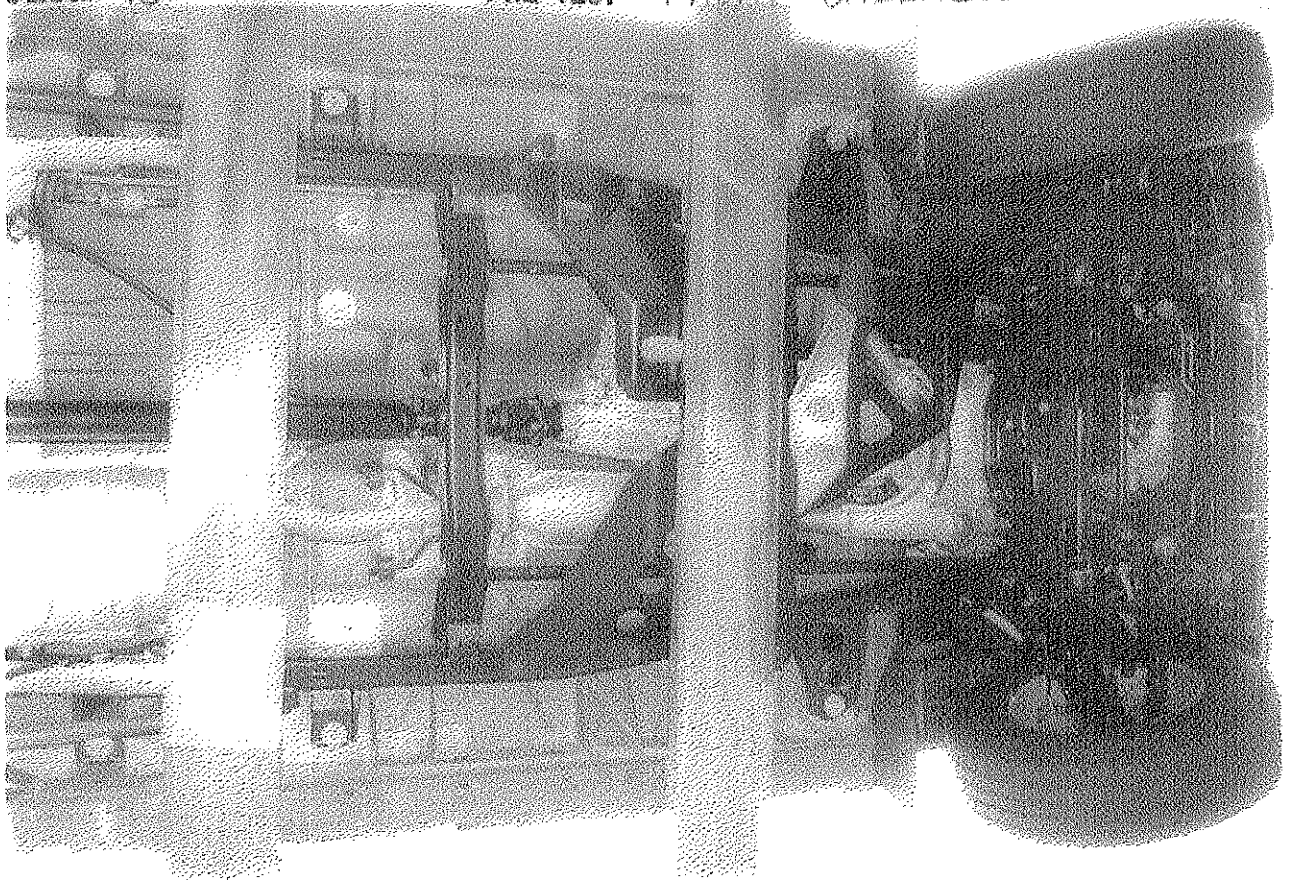
Photo 13

PRE-TEST FRONT UNDERBODY

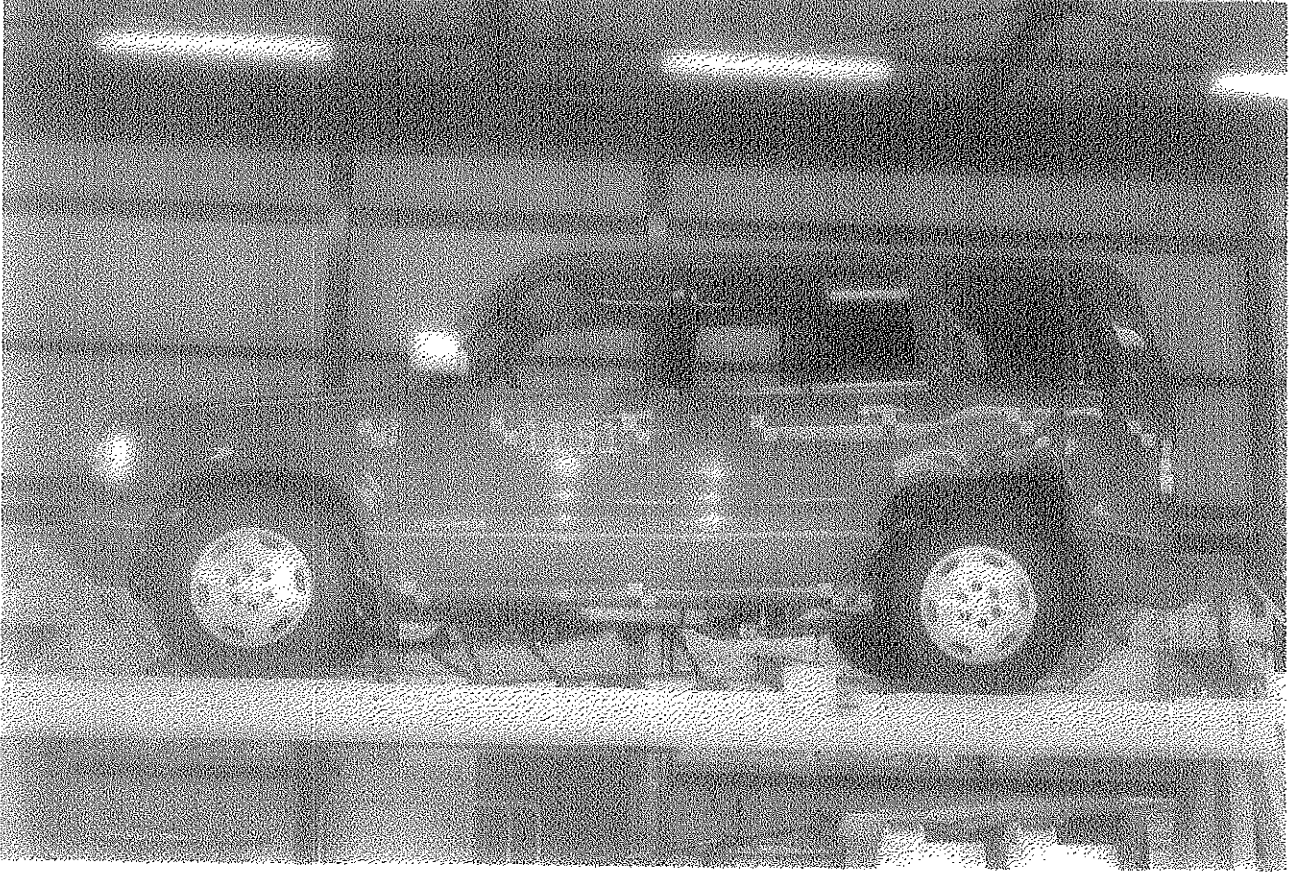
Photo 17

POST-TEST STATIC ROLL OVER

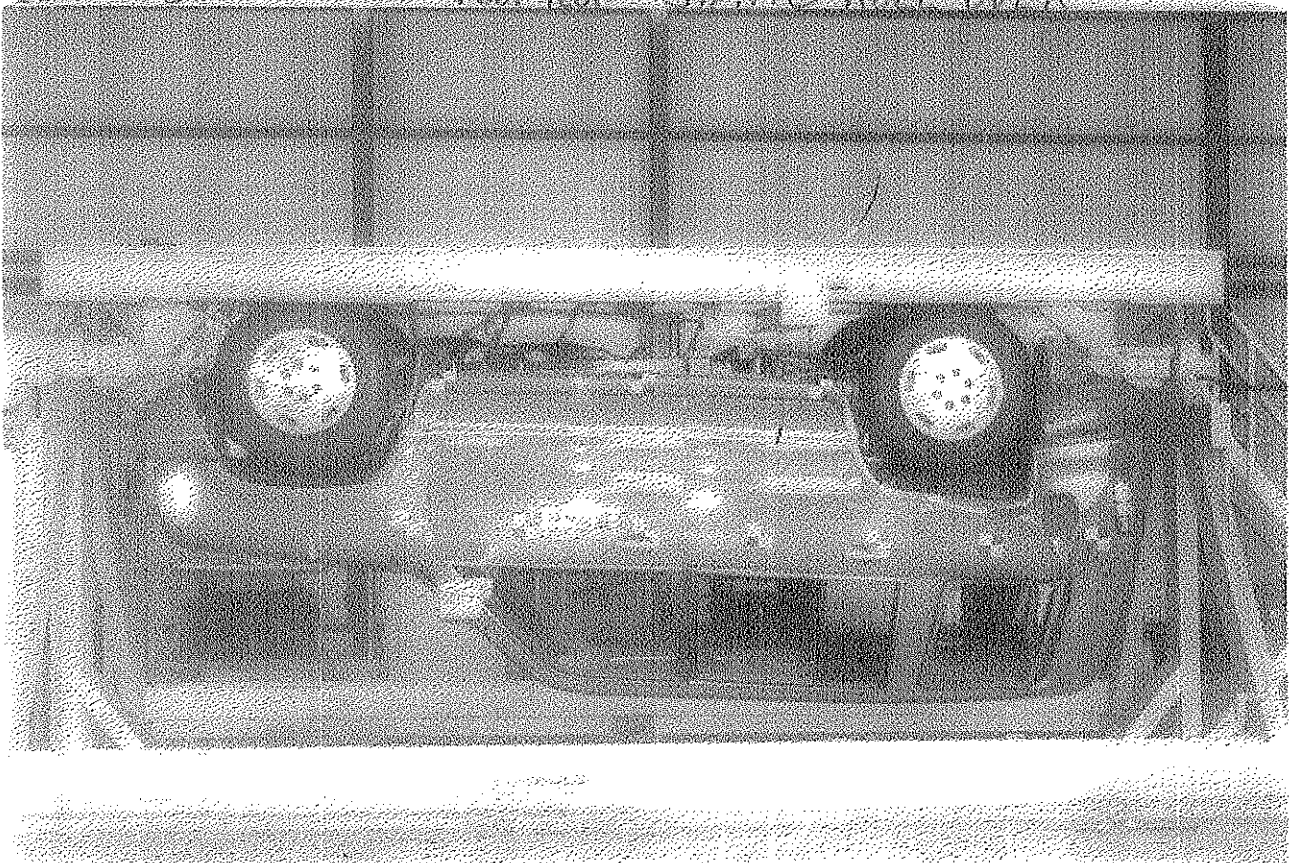
Photo 18

POST-TEST STATIC ROLL OVER
