ISUZU ENGINEERING TEST REPORT

CERTIFICATION TEST REPORT

FMVSS 301

1991 ISUZU RODEO

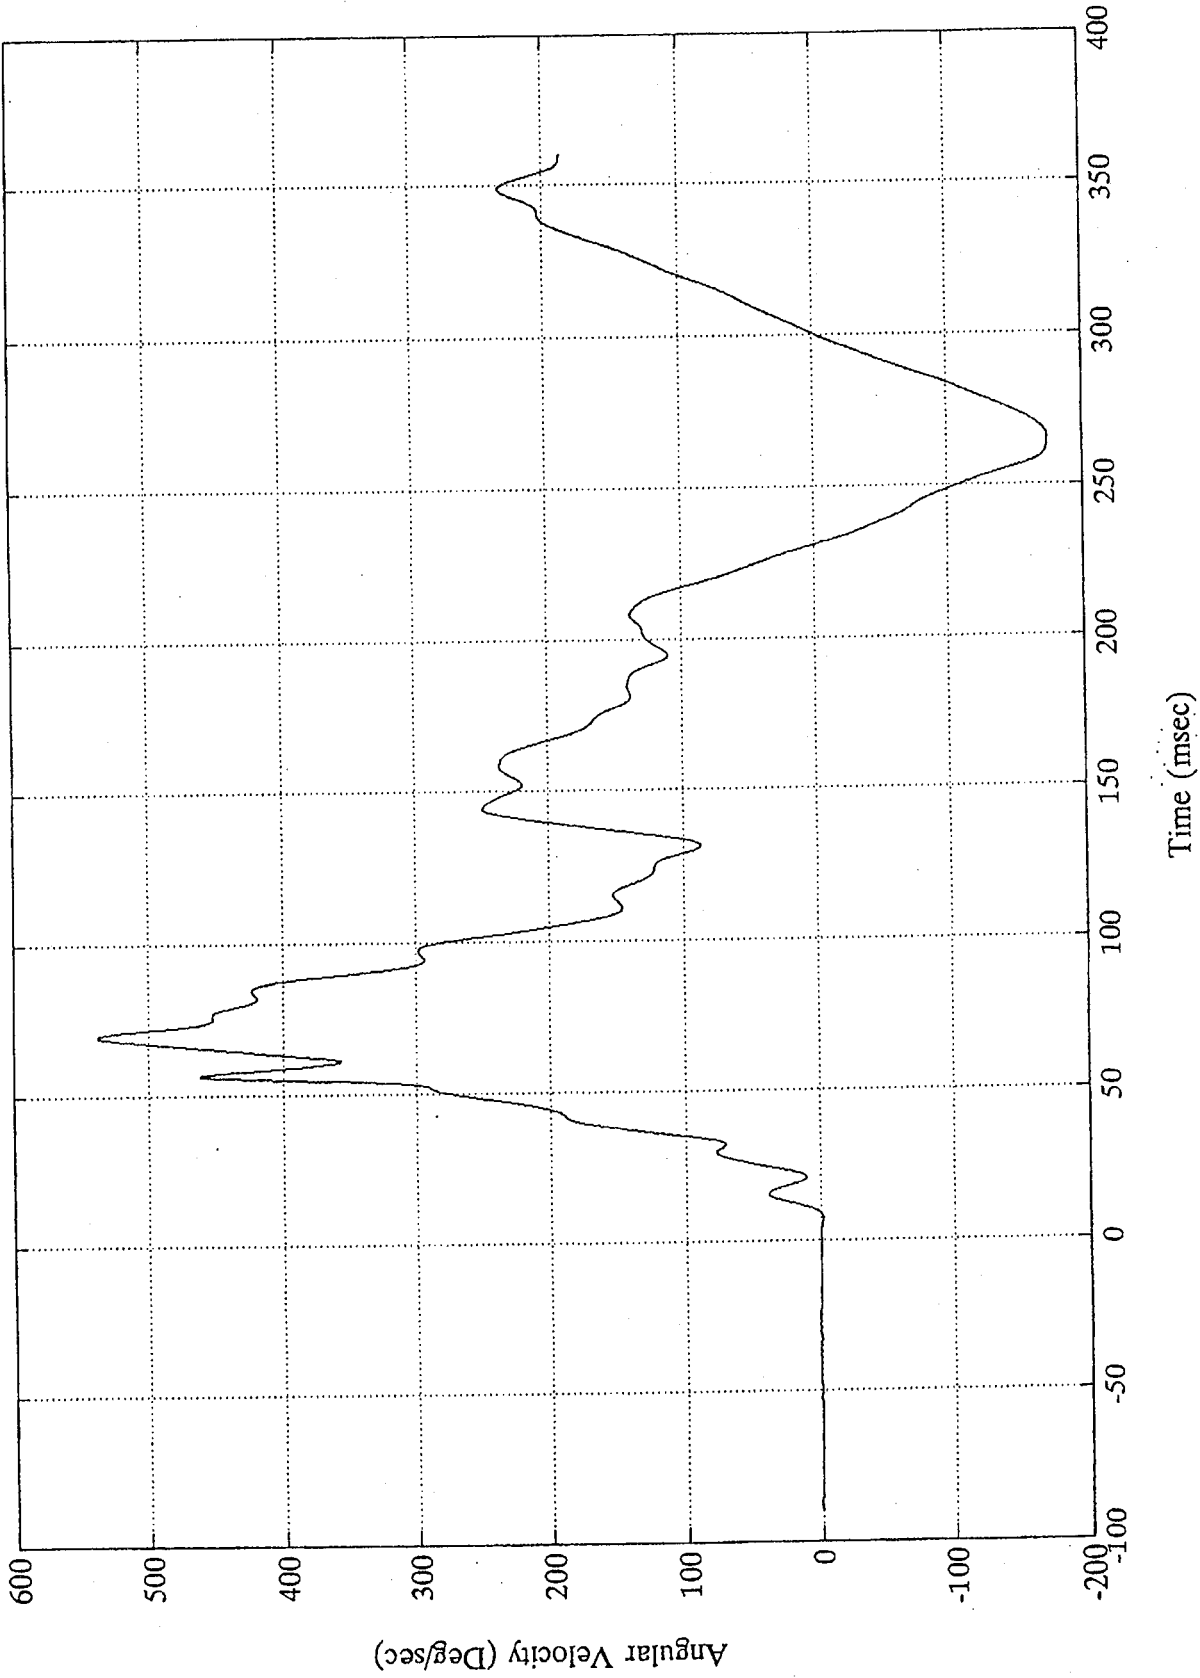
Max = 537.9 Deg/sec @ 69.6 msec  
Min = -174.3 Deg/sec @ 265.4 msec

Seatback Angular Velocity
