301-CAL-96-10

SAFETY COMPLIANCE TESTING FOR FMVSS 301 **FUEL SYSTEM INTEGRITY**

CAMI-AUTOMOTIVE INC. CANADA 1996 GEO TRACKER , 4-DOOR MPV

FINAL REPORT

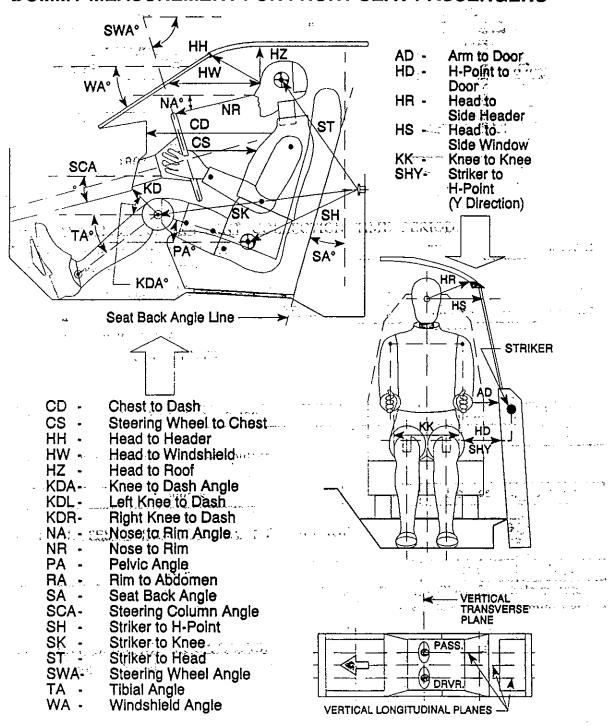
Figure 1

PART 572 DUMMY IN-VEHICLE POSITION (FOR REAR IMPACTS ONLY)

DUMMY MEASUREMENT FOR FRONT SEAT PASSENGERS

DRIVER (Serial #341)		
WA°	44 deg.		
SWA°	58 deg.		
SCA°	32 deg.		
SA°	18 deg.		
HZ	10.4		
НН	19.1		
HW	24.7		
HR	8.7		
NR ·	17.0 Angle 13.0 deg.		
CD	. 21.7		
CS	12.8		
RA	8.0		
KDL	6.1 Angle (KDA) 36 deg.		
KDR	5.8		
PA°	24 deg.		
TA°	41 deg.		
KK	11.1		
ST	22.1 Angle 10		
SK	22.0 Angle 93		
SH	7.3 Angle 127		
SHY	7.8		
HS	10.6		
HD	5.3		
AD	2.6

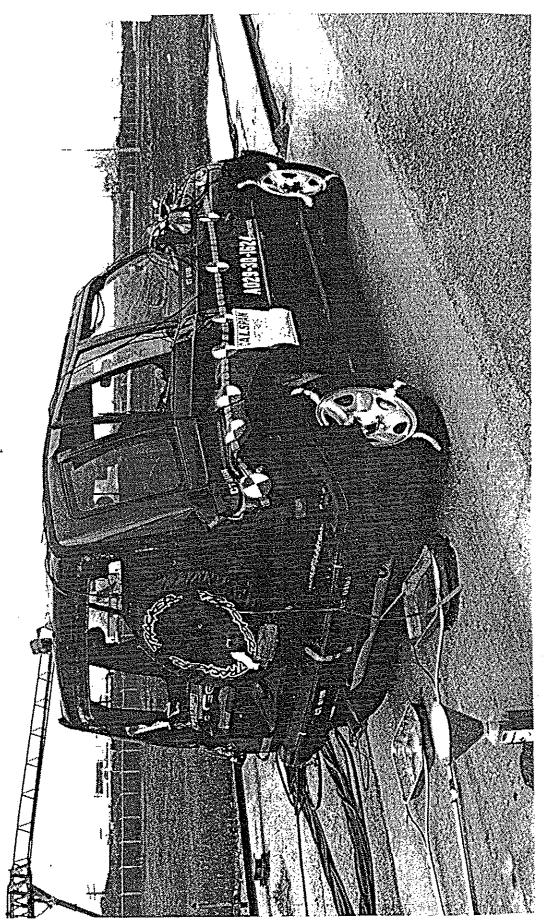
Figure A-12 POST-TEST RIGHT REAR THREE-QUARTER VIEW

Prior to the impact, the vehicle fuel tank contained 13.5 gallons of orange stoddard fluid (93% Usable Capacity). The vehicle spilled 19.7 oz. of stoddard by weight in the 5 minutes following the impact after the vehicle motion ceased and continued to leak at a rate of 1.5 oz./minute for the next 25 minutes. Both of these values exceeded the requirements of FMVSS No. 301 "Fuel System Integrity," therefore the rollover phase of the test was not conducted. Underbody high speed cameras documented stoddard leakage that occurred during the impact however this leakage was unable to be collected. Stoddard leakage seemed to occur from the right rear portion of the fuel tank near its vehicle attachment point. Section 3 of this report presents the compliance test data.

The vehicle fuel tank leaked stoddard during and following the impact. Stoddard appeared to exit the fuel tank at an area near or at the right rear tank and shield attachment bolt.

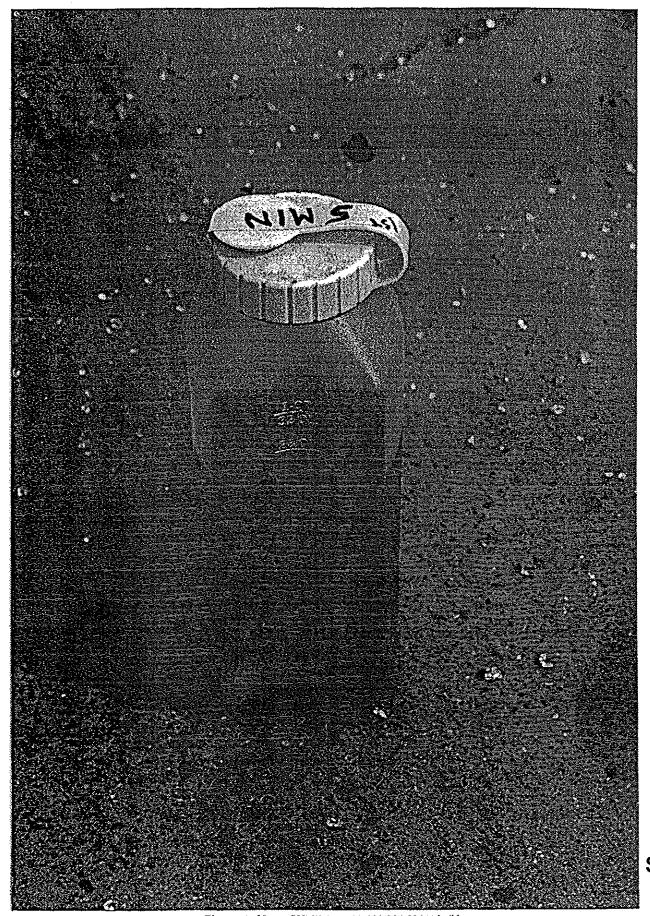
Figure A-22 SUPPLEMENTARY PHOTO #4
A-24

ACTUAL	MAX ALLOWED
*	1 oz.
19. 7 oz.	5 oz.
1.5 oz./1 min.	1 oz./1 min.
