Rear Impact Full-Scale Crash Testing  
for Upgrade of  
FMVSS 301 Test Procedure

Deformable Impactor into Rear of  
1996 Suzuki Sidekick  
at 80 kph with 70% Right Side Overlap  
TRC Test Number: 960314

Final Report

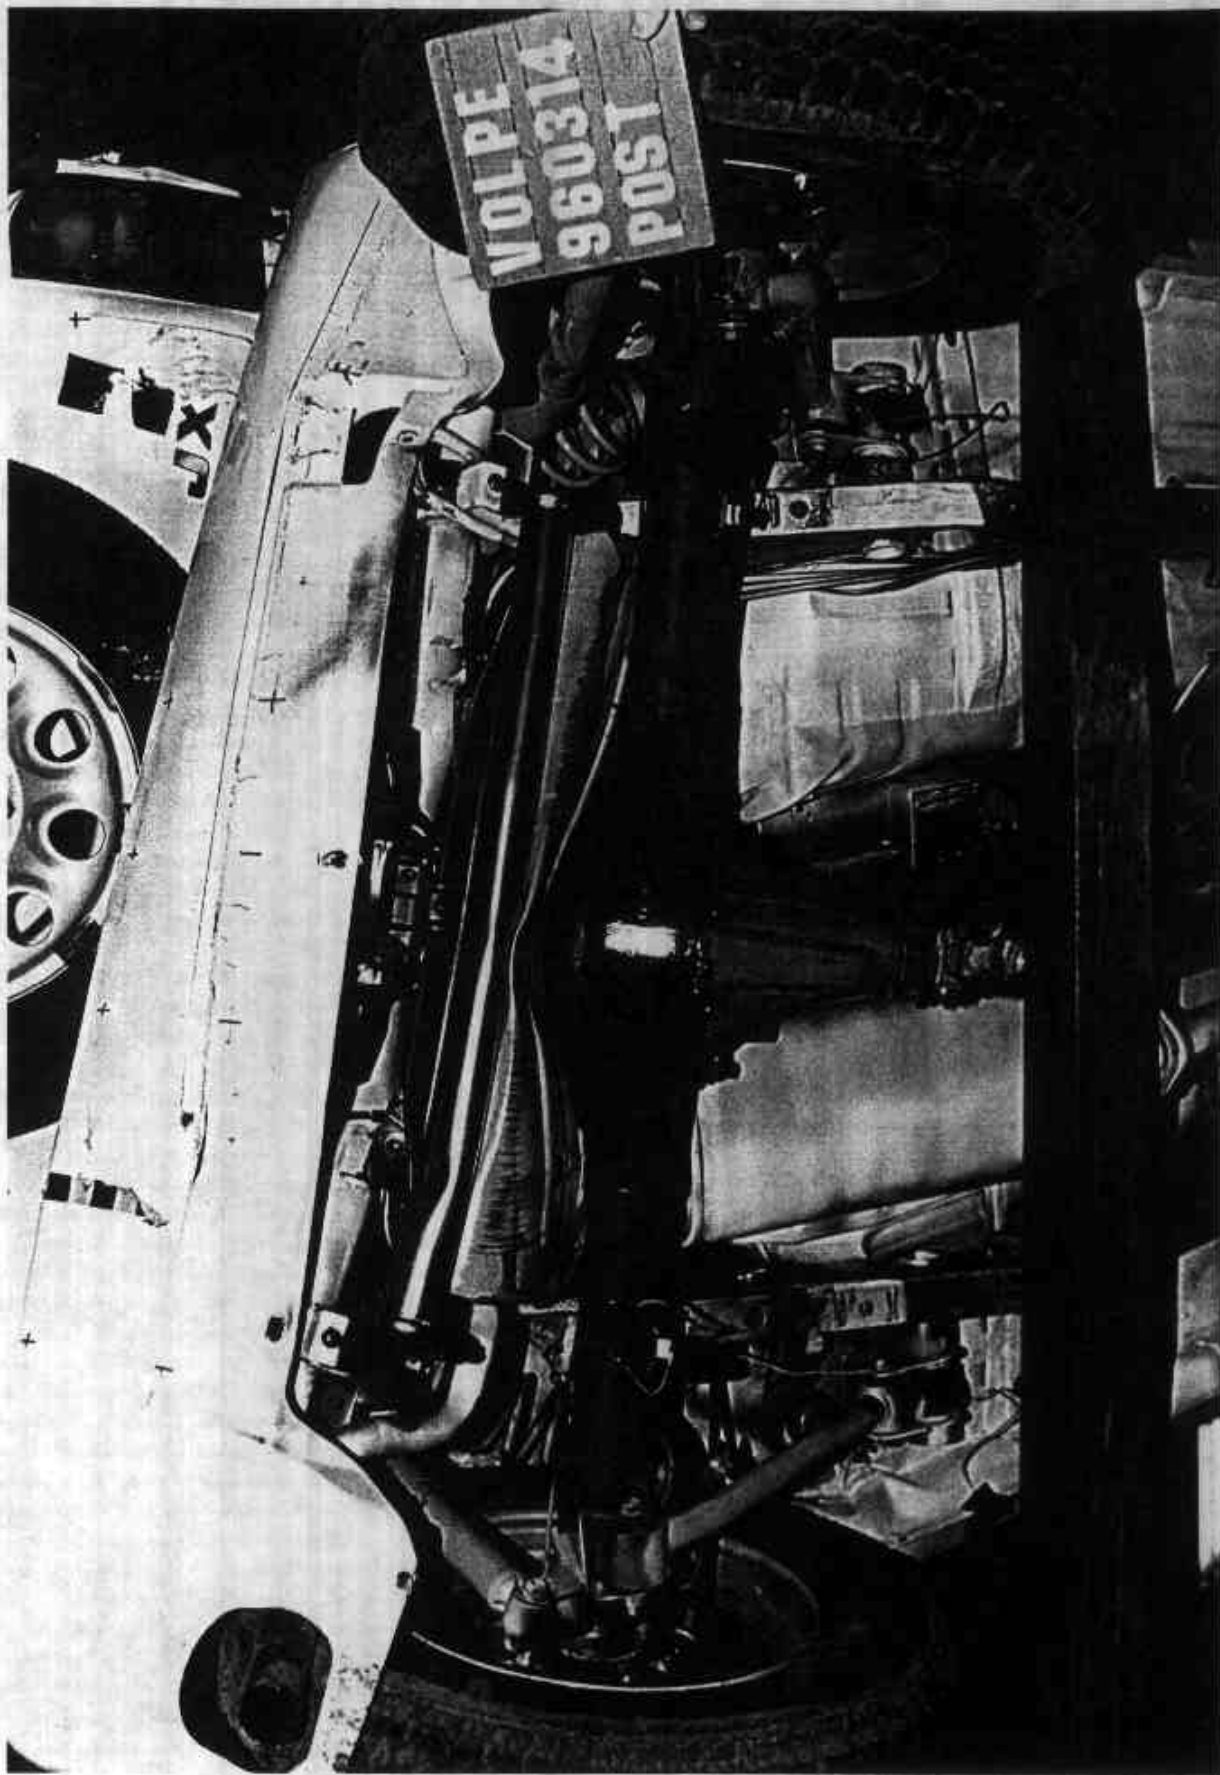
Figure A-21 Post-Test Rear Underbody View

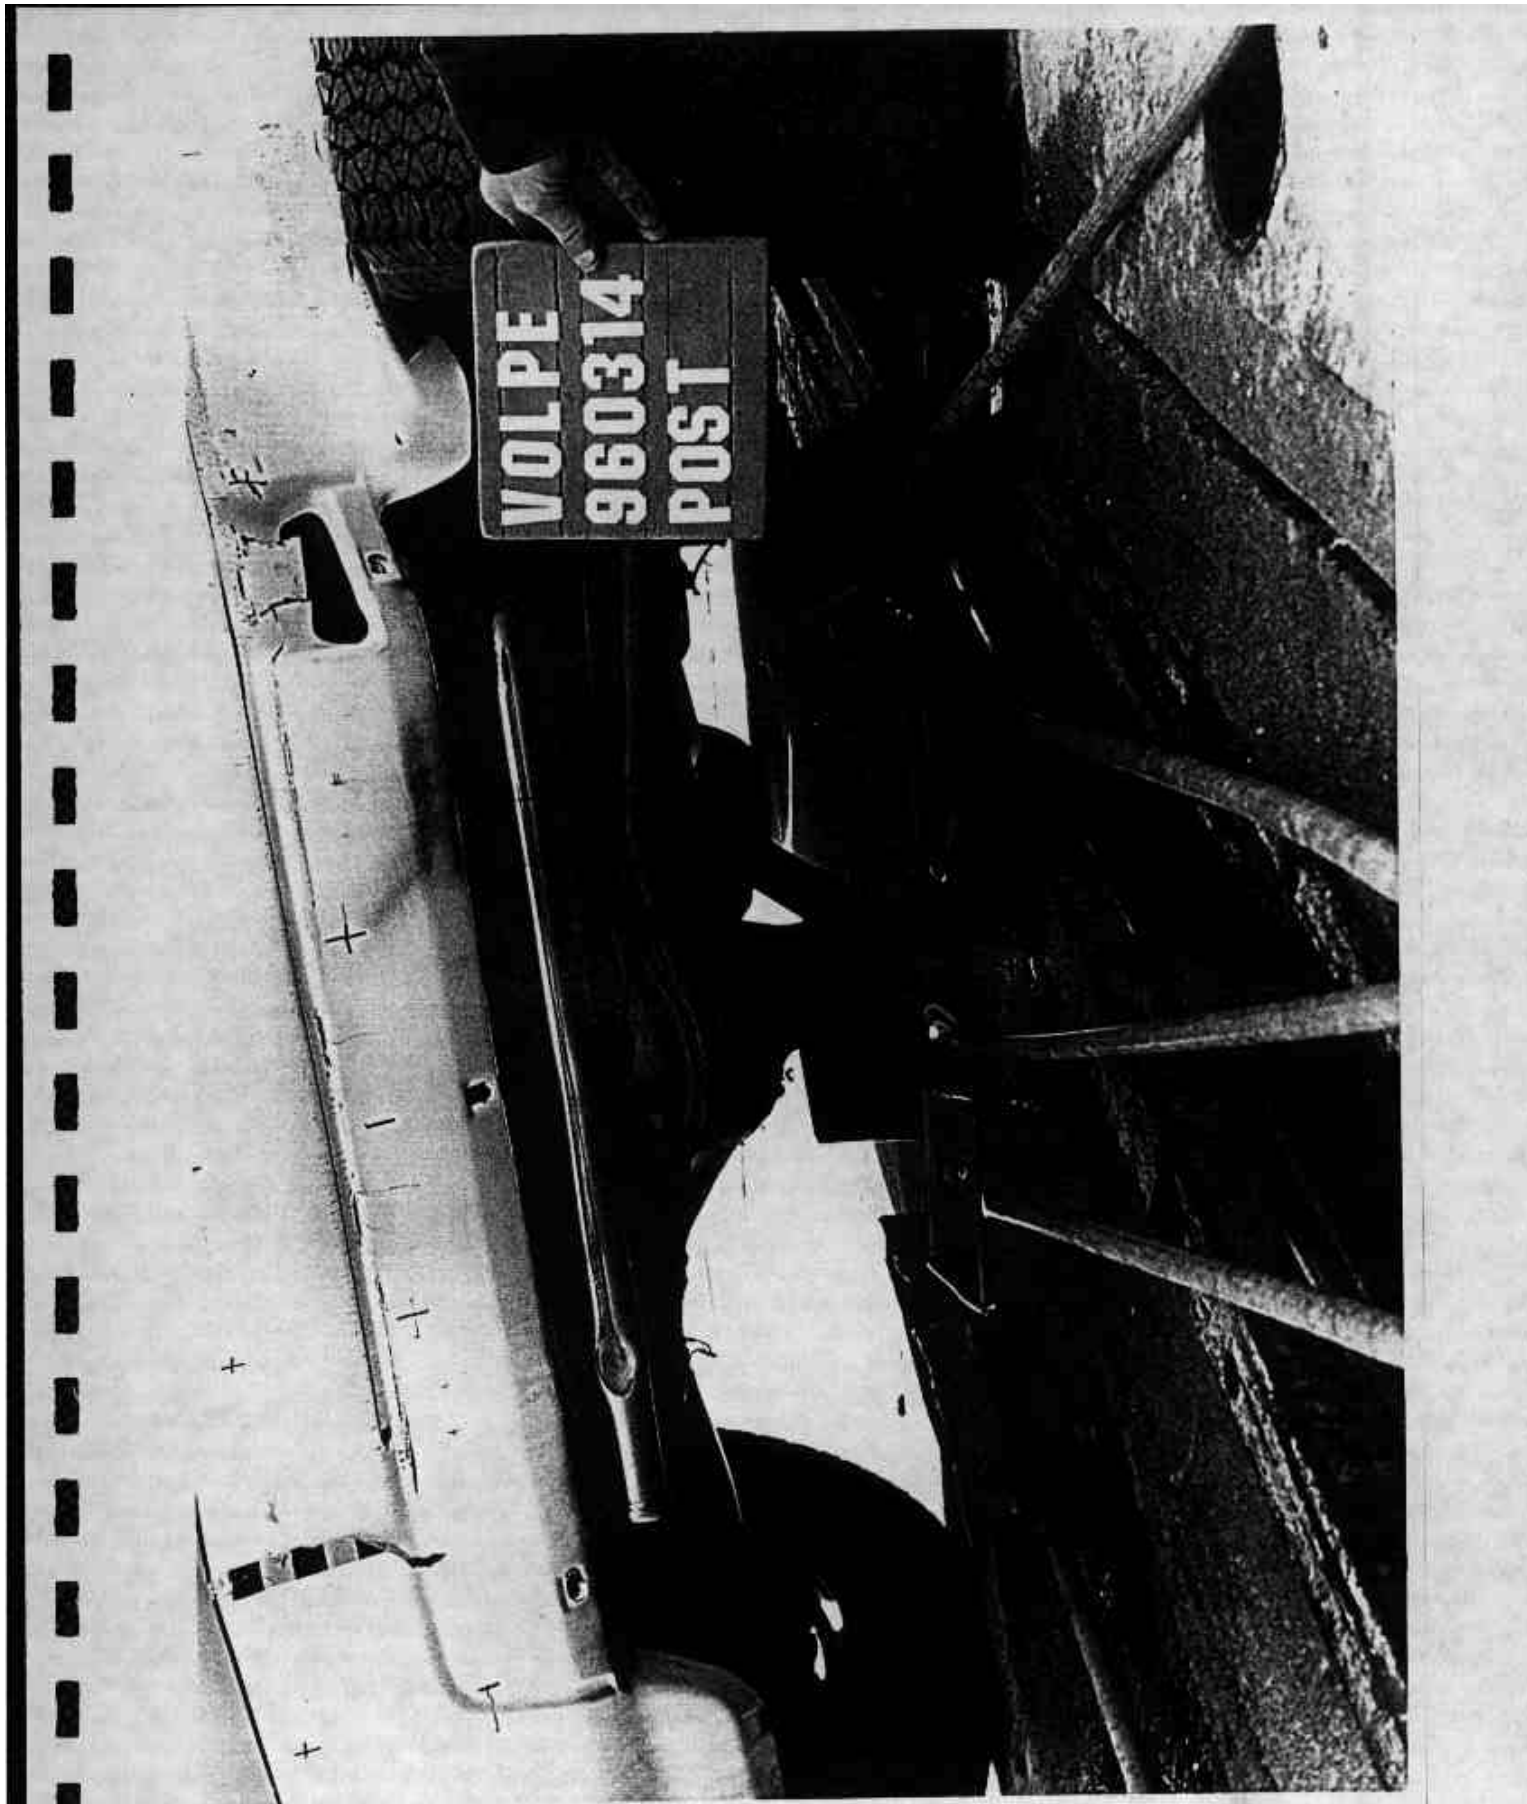
Figure A-44 Post-Test Vehicle Fuel System Fluid Spillage

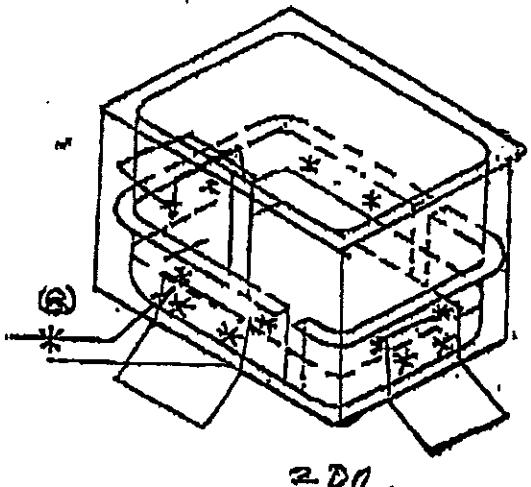
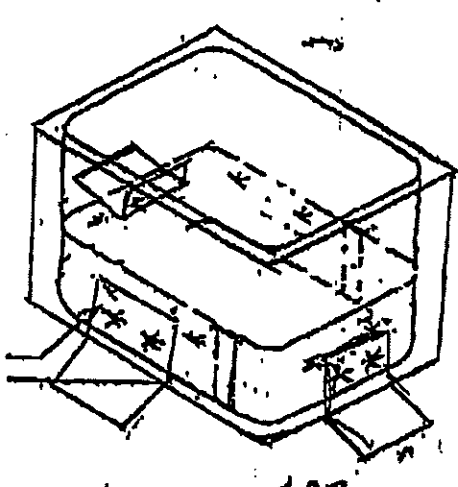
| <b>PRESENT CONDITION</b><br>6 INDIVIDUAL COMPONENTS. | | <b>PROPOSED CONDITION</b><br>5 INDIVIDUAL COMPONENTS | |
