# FUEL TANK STATIC TEST

The National Highway Traffic Safety Administration (NHTSA) tested a 1996 Geo Tracker 4-door sport utility vehicle to the rear impact requirements of Federal Motor Vehicle Safety Standard (FMVSS) No. 301, "Fuel System Integrity", at SRL Calspan Corporation in Buffalo, New York, on May 17, 1996. The vehicle spilled 19.7 oz. of stoddard solvent in the 5 minute period directly following the 29.5 mph rear impact by the moving barrier. It continued to leak at a rate of 1.5 oz/minute for the next 25 minutes. These test results indicate that the vehicle appears to be in noncompliance with the standard.

573.5(c)(5): General Motors has decided that certain 1996 Geo Tracker (4-Door Models Only) vehicles fail to conform to Federal Motor Vehicle Safety Standard (FMVSS) 301, "Fuel System Integrity". The fuel tank on these vehicles may become punctured by a fuel tank flange attachment reinforcement (gusset) during certain types of rear end collisions.

**SUBJECT: 96-C-38 - FUEL TANK LEAKAGE**

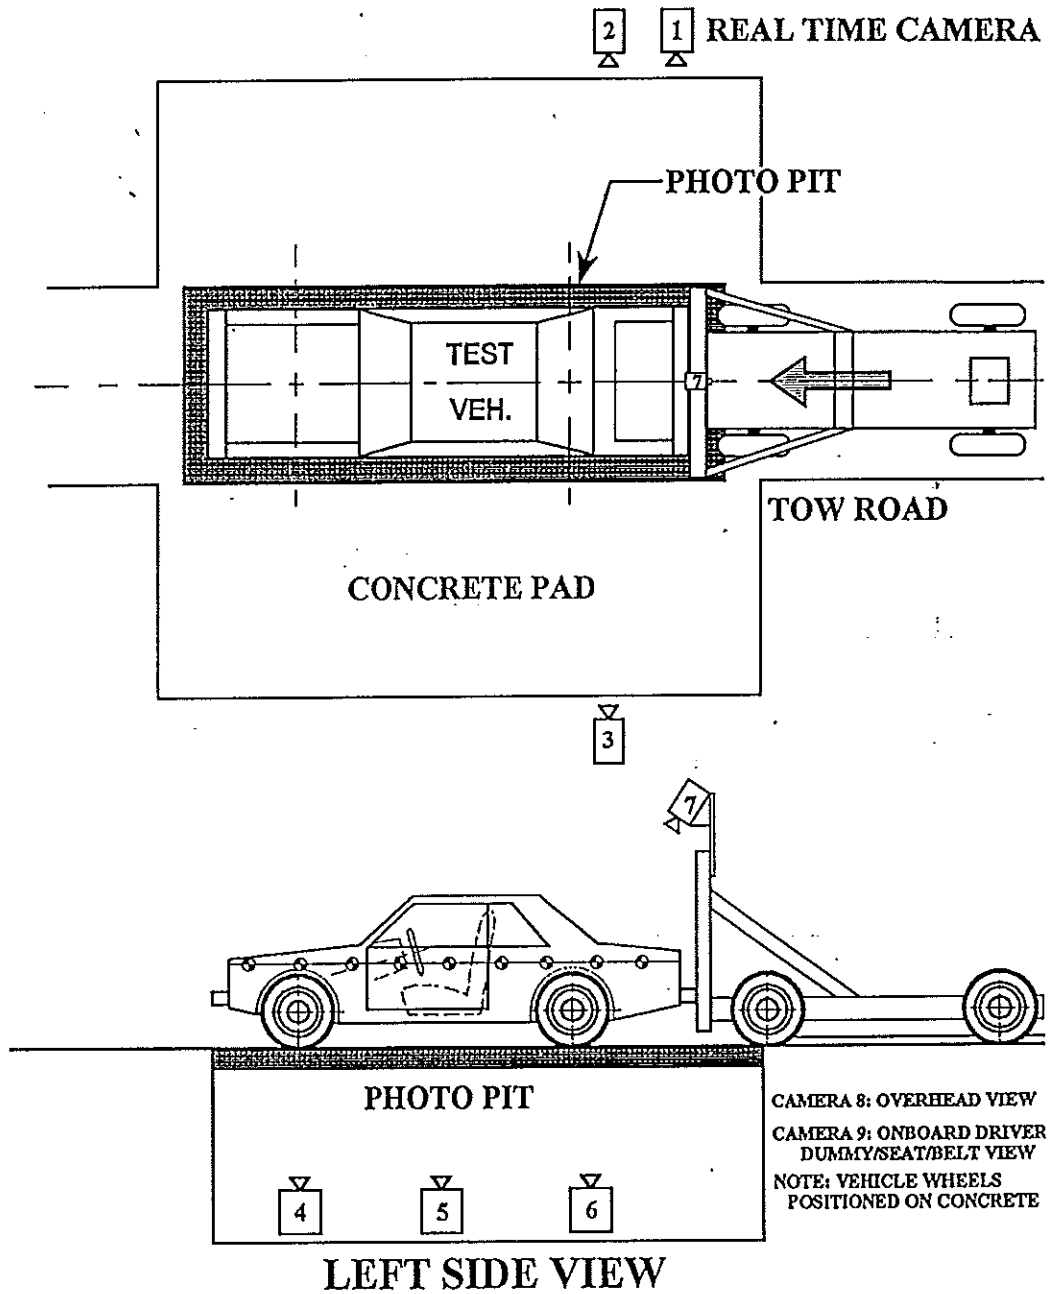
Figure 2

The crash event was recorded by one real-time and eight high-speed cameras. Camera locations and other pertinent camera information are found on pages 3-9 and 3-10 of this report.

CAMERA POSITIONS FOR REAR IMPACTS

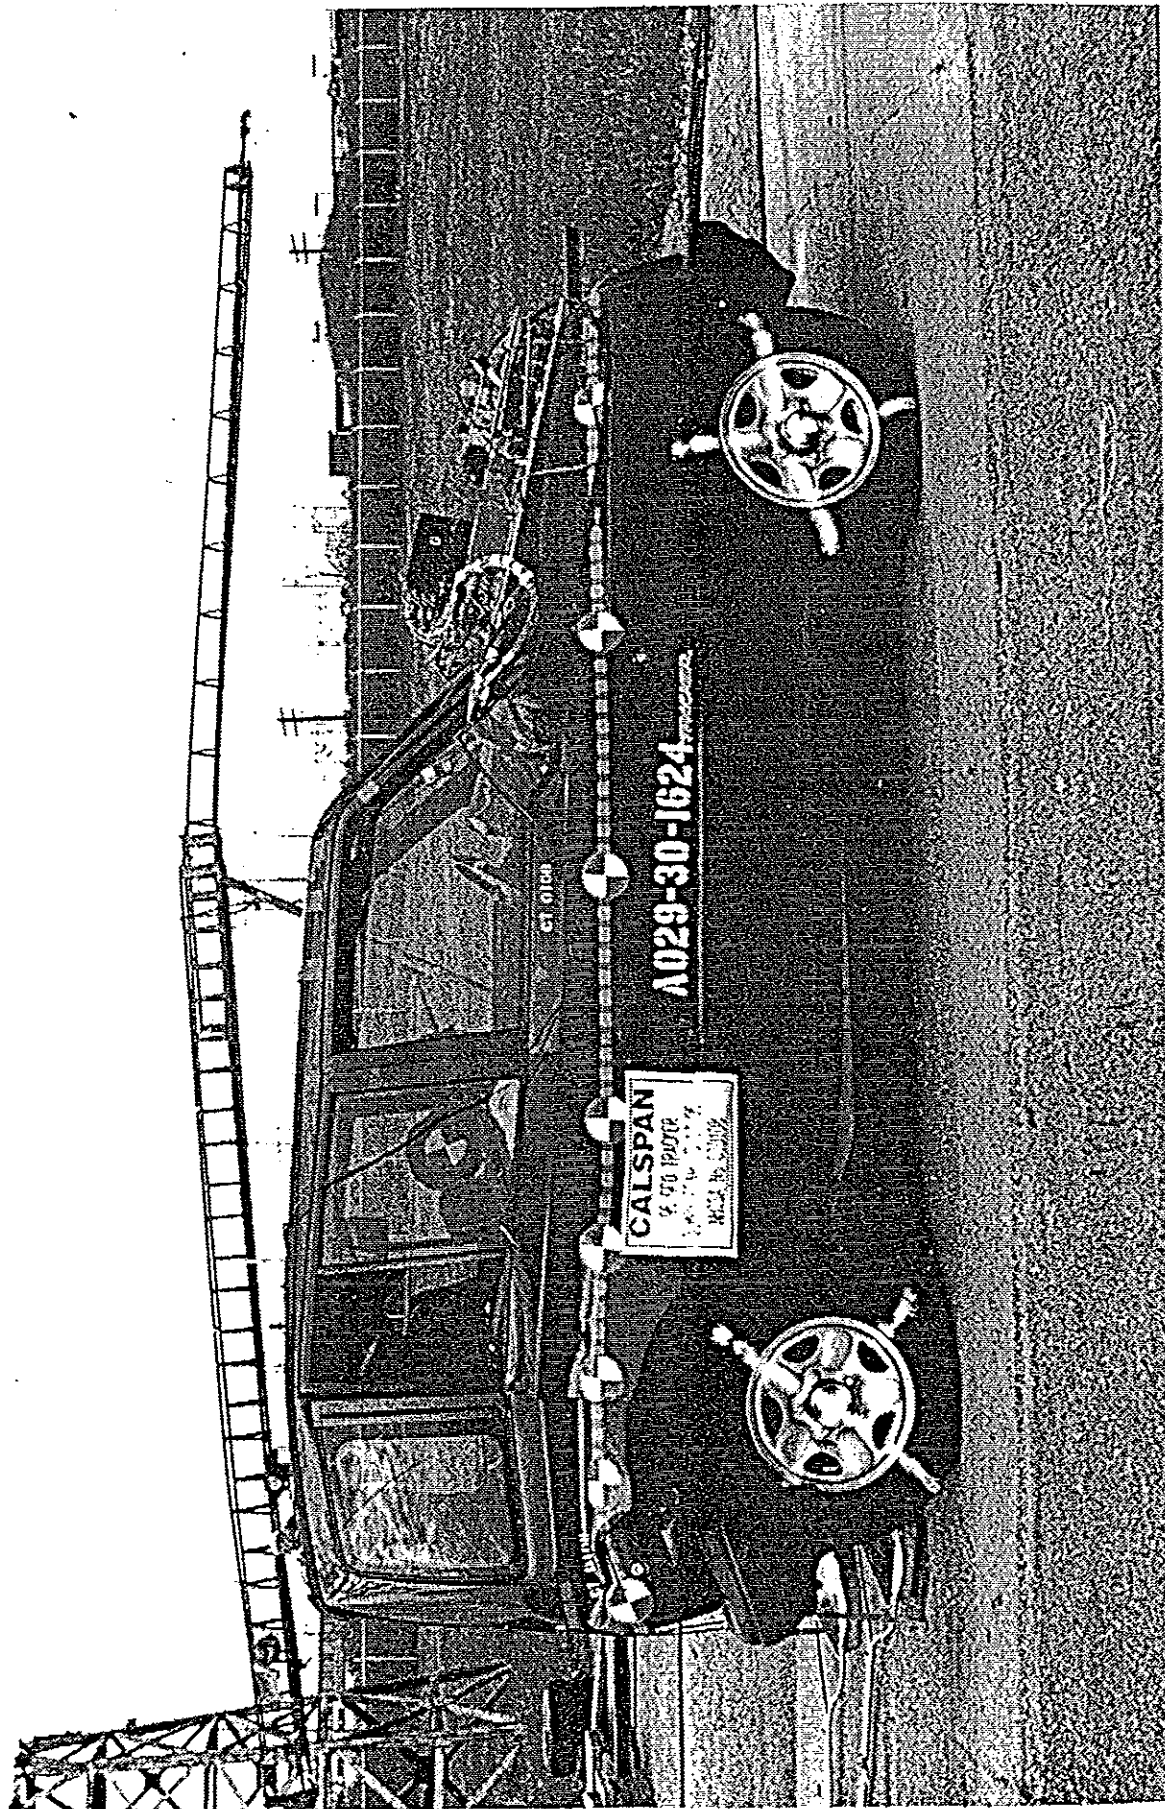
Figure A-6 POST-TEST RIGHT SIDE VIEW

The vehicle fuel tank leaked stoddard during and following the impact. Stoddard appeared to exit the fuel tank at an area near or at the right rear tank and shield attachment bolt.

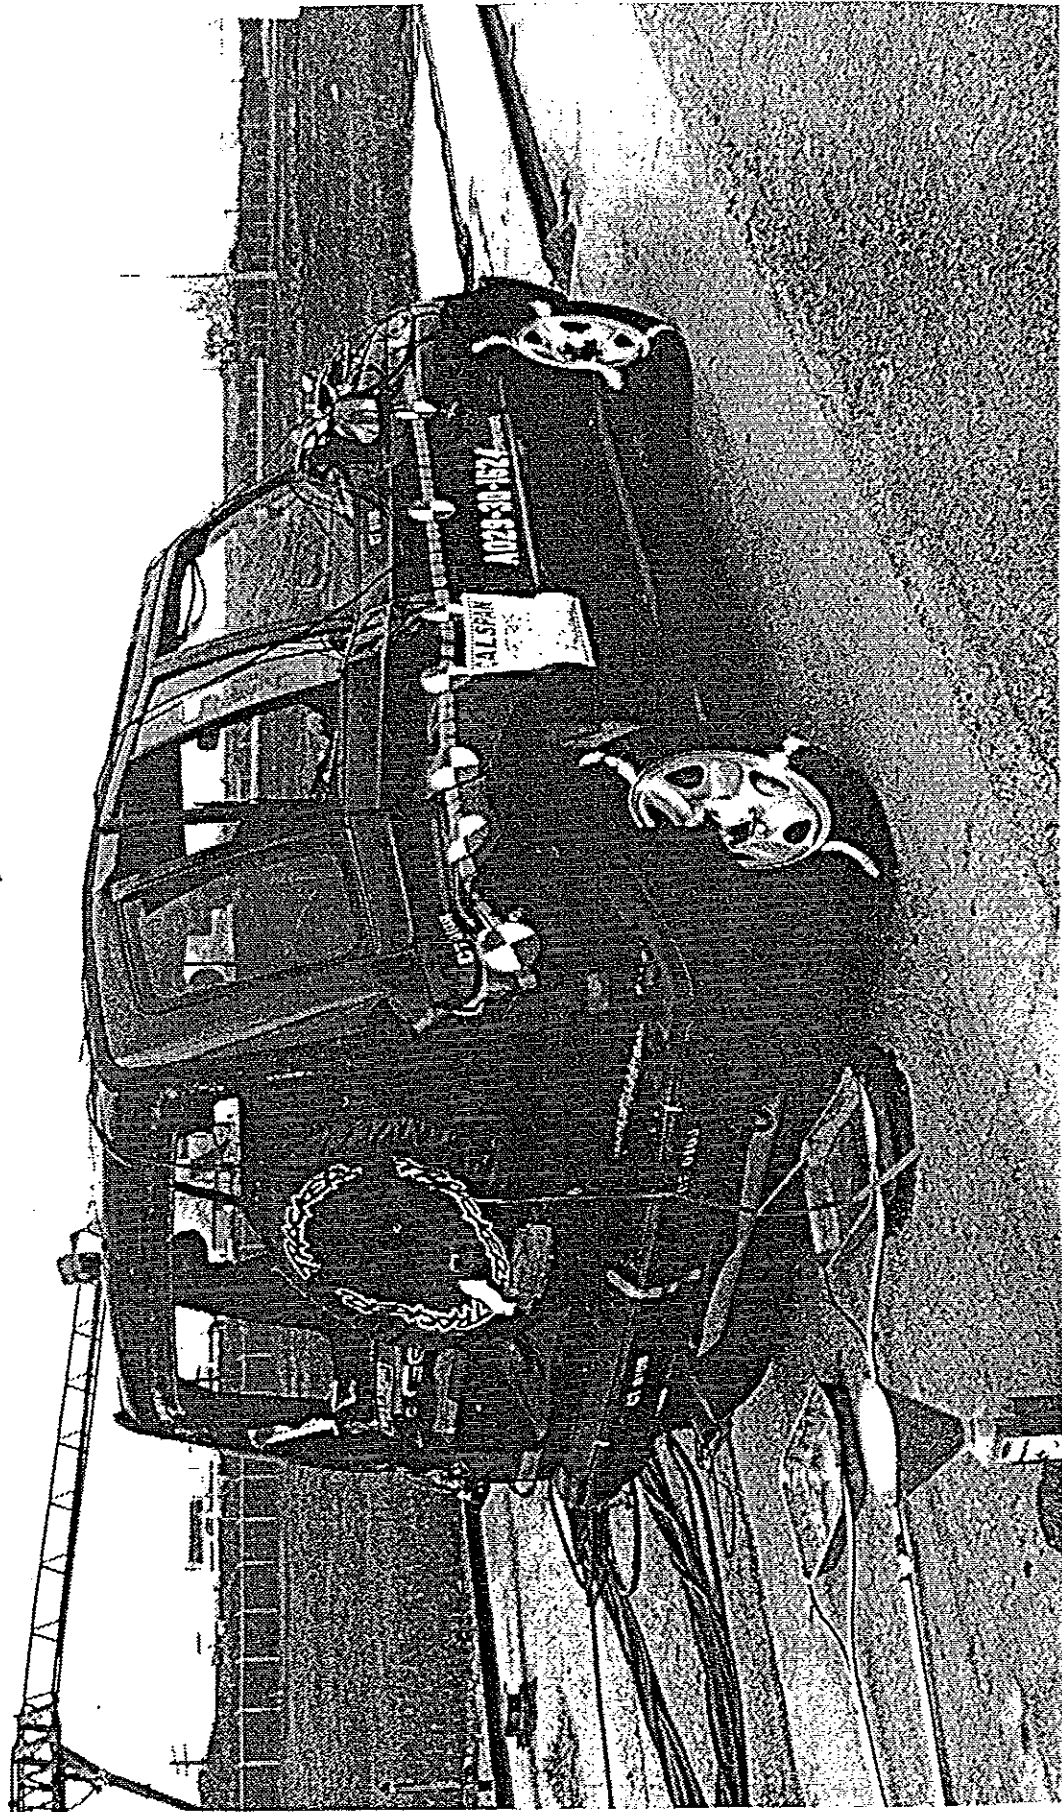
Figure A-12 POST-TEST RIGHT REAR THREE-QUARTER VIEW

Stoddard Solvent Spillage from Vehicle's Fuel System: Stoddard leaked from the right rear portion of the fuel tank during and immediately following impact. Stoddard leaked from this area in amounts that exceeded the requirements of FMVSS No. 301. Leakage measurements can be found in Section 3.

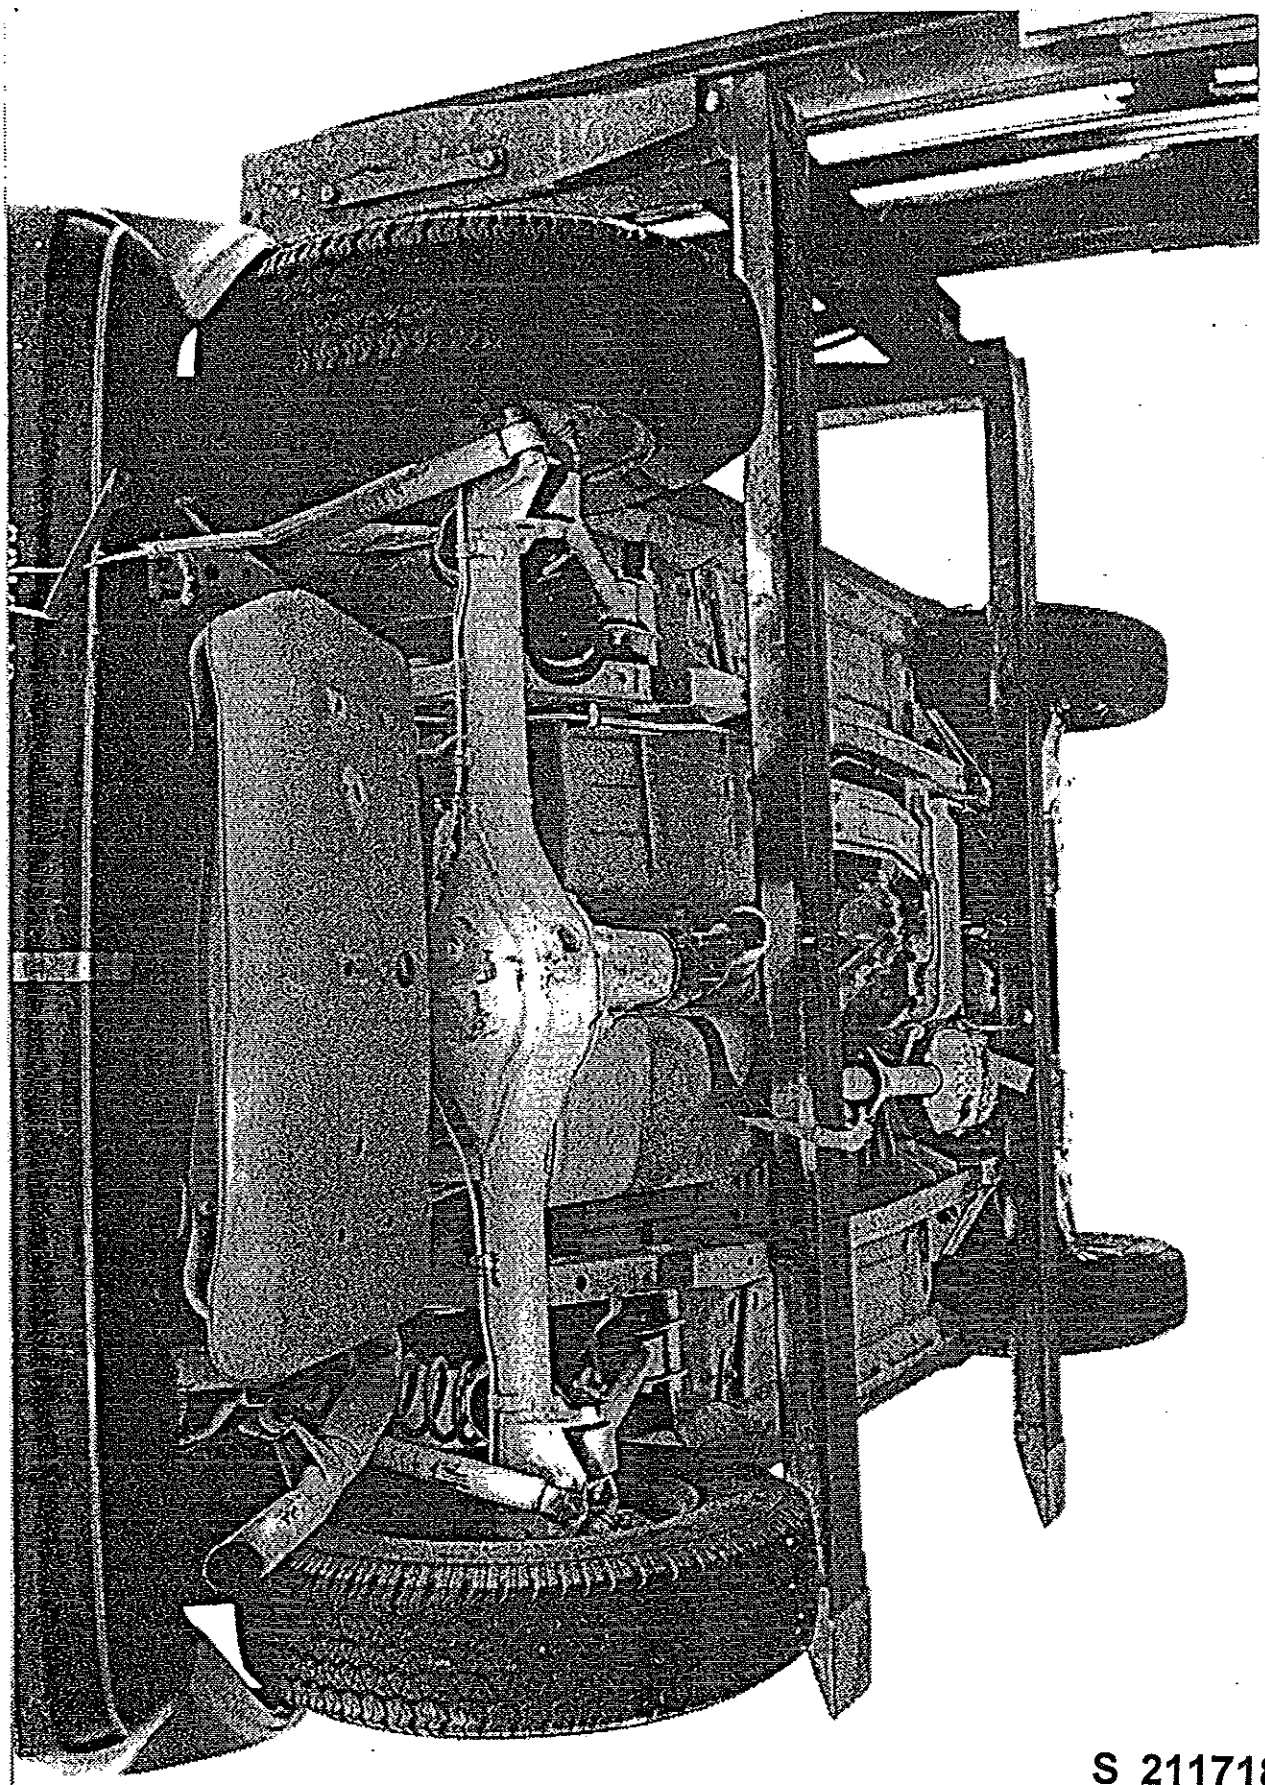
Figure A. 14 POST-TEST REAR UNDERBODY VIEW

Prior to the impact, the vehicle fuel tank contained 13.5 gallons of orange stoddard fluid (93% Usable Capacity). The vehicle spilled 19.7 oz. of stoddard by weight in the 5 minutes following the impact after the vehicle motion ceased and continued to leak at a rate of 1.5 oz./minute for the next 25 minutes. Both of these values exceeded the requirements of FMVSS No. 301 "Fuel System Integrity," therefore the rollover phase of the test was not conducted. Underbody high speed cameras documented stoddard leakage that occurred during the impact however this leakage was unable to be collected. Stoddard leakage seemed to occur from the right rear portion of the fuel tank near its vehicle attachment point. Section 3 of this report presents the compliance test data.

To correct this condition, dealers will install two new gussets between the fuel tank and attachment brackets to prevent the reinforcement from puncturing the fuel tank wall.

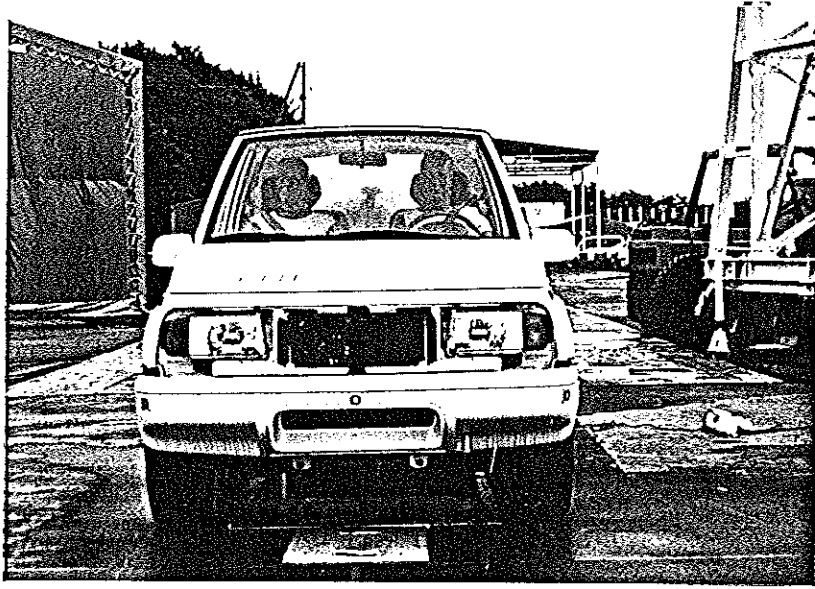
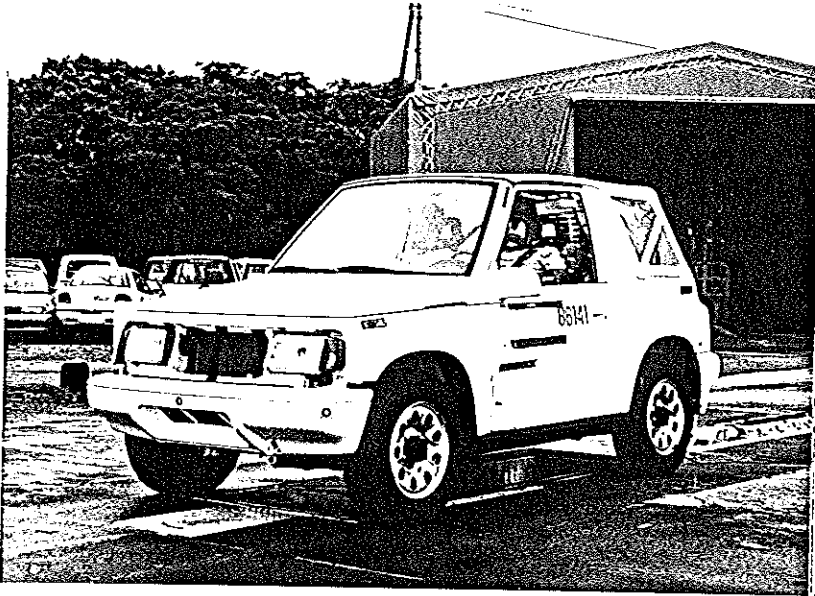
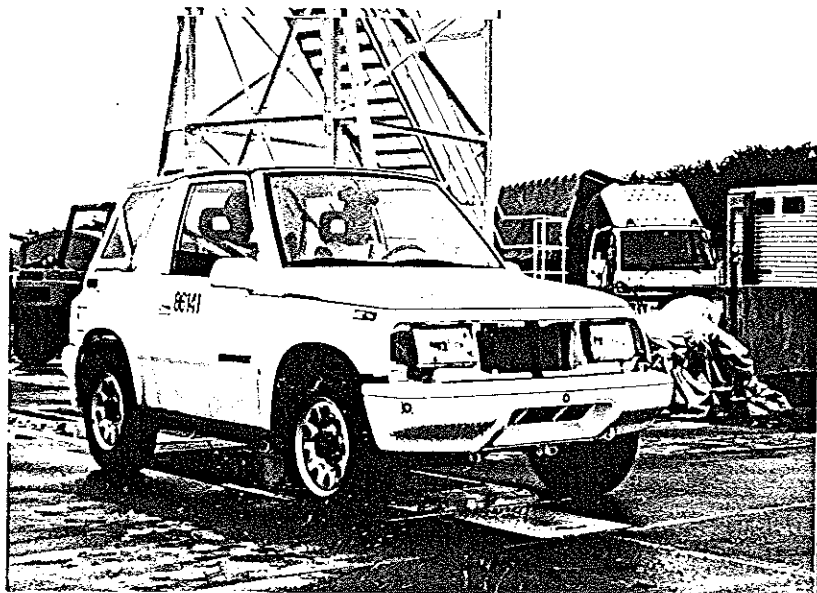
試験前 (Pre-Test)

TEST SPEED	54.4 km/h	
DEVIATION OF MOVING BARRIER	18mm Left	
VEHICLE DEFORMATION (MM)	LEFT	354
	CENTER	368
	RIGHT	296
PROPELLER SHAFT	Separated	
FUEL TANK DEFORMATION SPECIFY if there is any portion where may cause fuel leakage	None

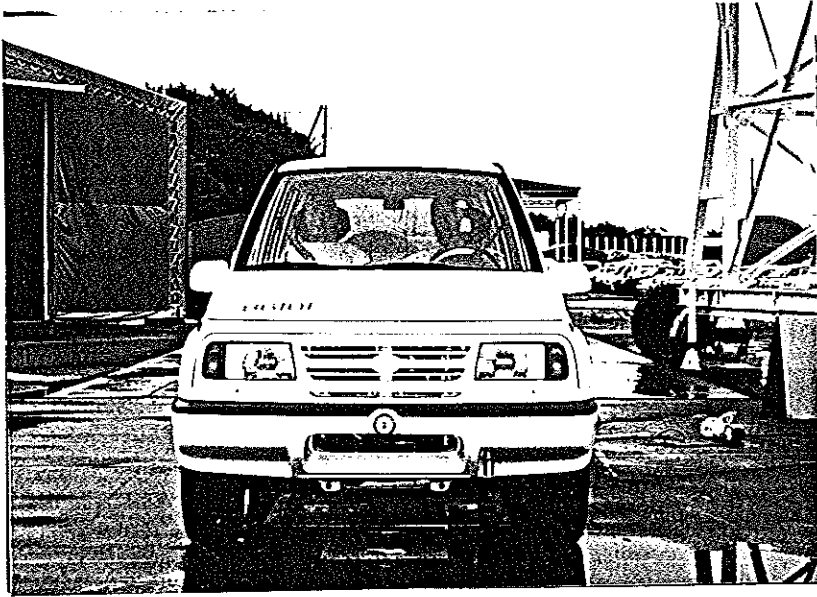
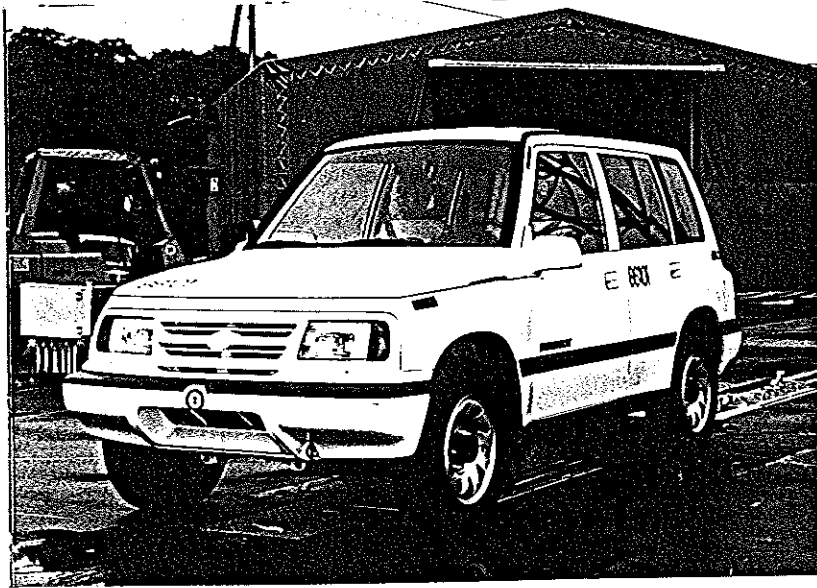
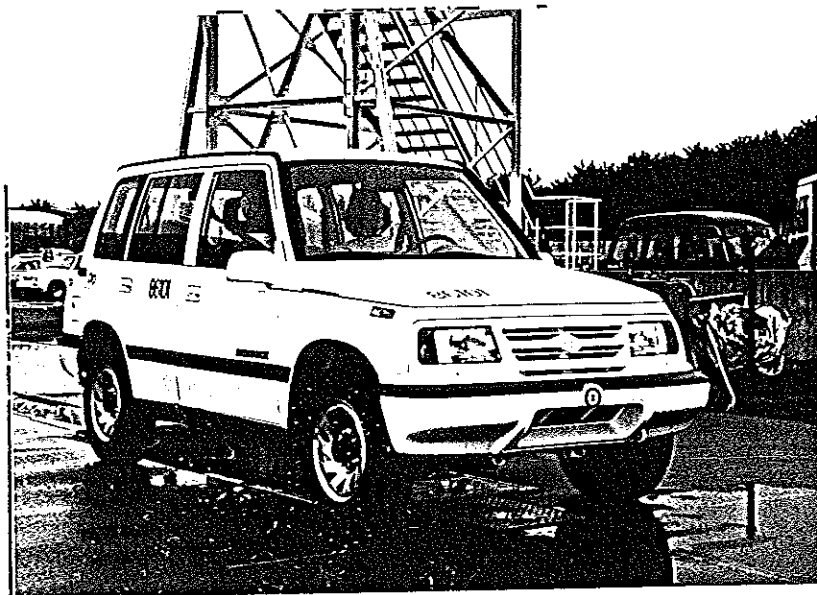
試験前 (Pre-Test)

TEST SPEED	<i>54.1 km/h</i>	
DEVIATION OF MOVING BARRIER	<i>21 mm Left</i>	
VEHICLE DEFORMATION (MM)	LEFT	<i>341</i>
	CENTER	<i>374</i>
	RIGHT	<i>380</i>
PROPELLER SHAFT	<i>Separated</i>	
FUEL TANK DEFORMATION <u>SPECIFY</u> if there is any portion where may cause fuel leakage	<i>None</i>
