Suzuki Test Standard No. G-8816  
FMVSS/CMVSS No. 301

TITLE : FUEL SYSTEM INTEGRITY

Test No. : 86-251  
Test Date : 06/25/96

Report on fuel leakage of YH9 in rear collision

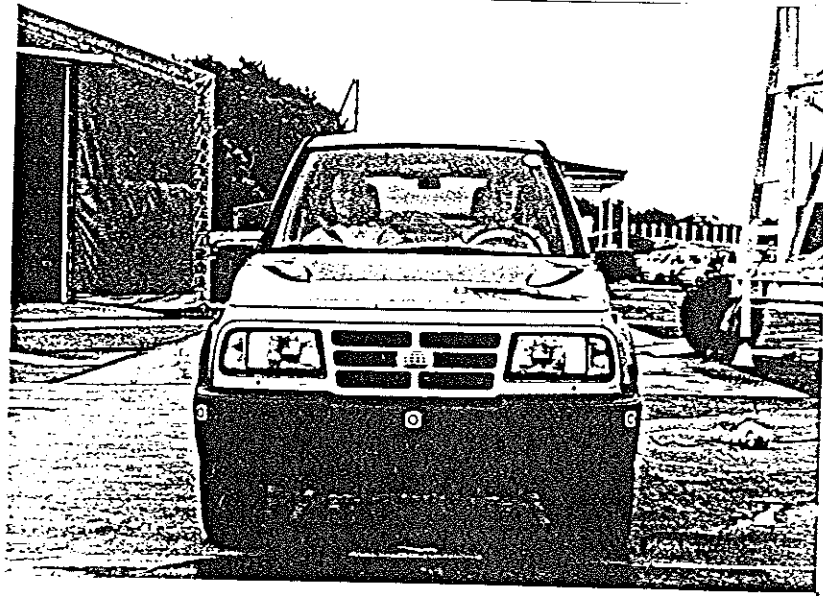
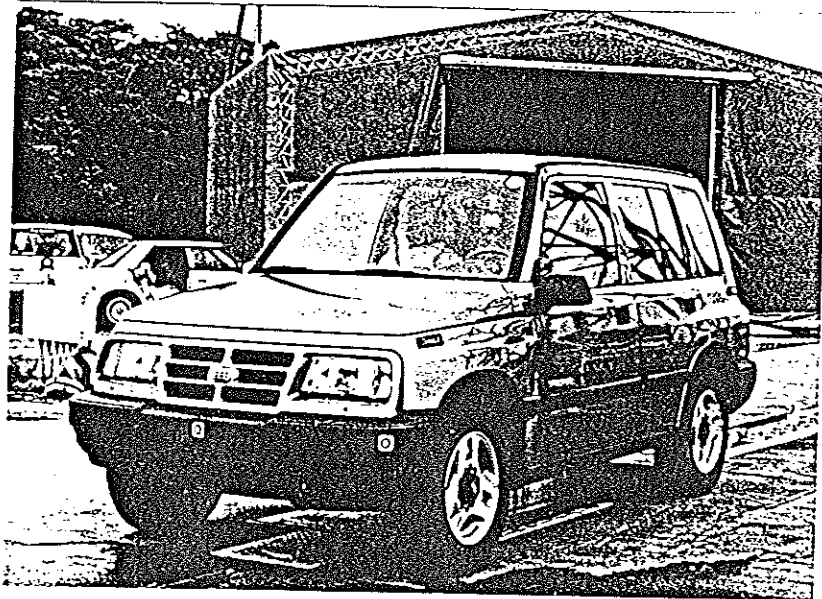
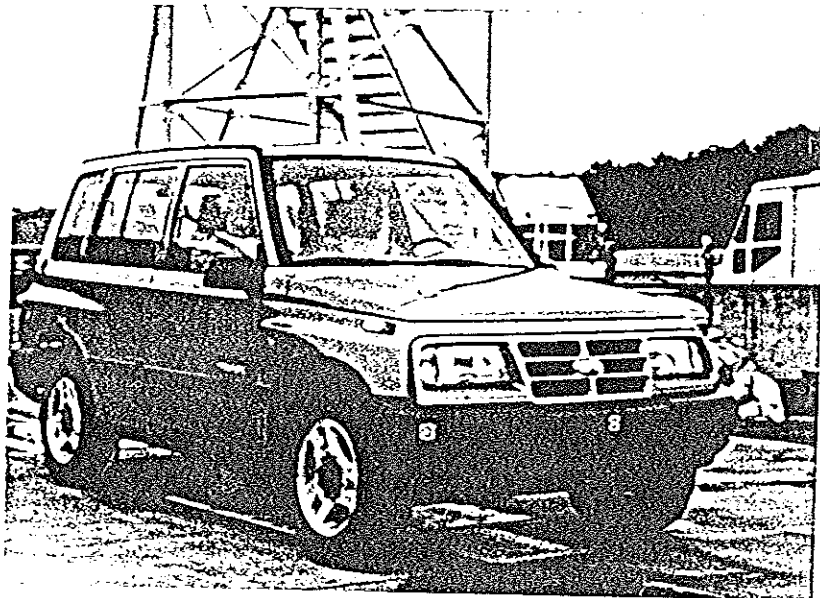
試験前 (Pre-Test)

TEST SPEED	48.3 km/h	
DEVIATION OF MOVING BARRIER	13mm Left	
VEHICLE DEFORMATION (MM)	LEFT	266
	CENTER	280
	RIGHT	268
PROPELLER SHAFT	Not Separated	
FUEL TANK DEFORMATION SPECIFY if there is any portion where may cause fuel leakage	None

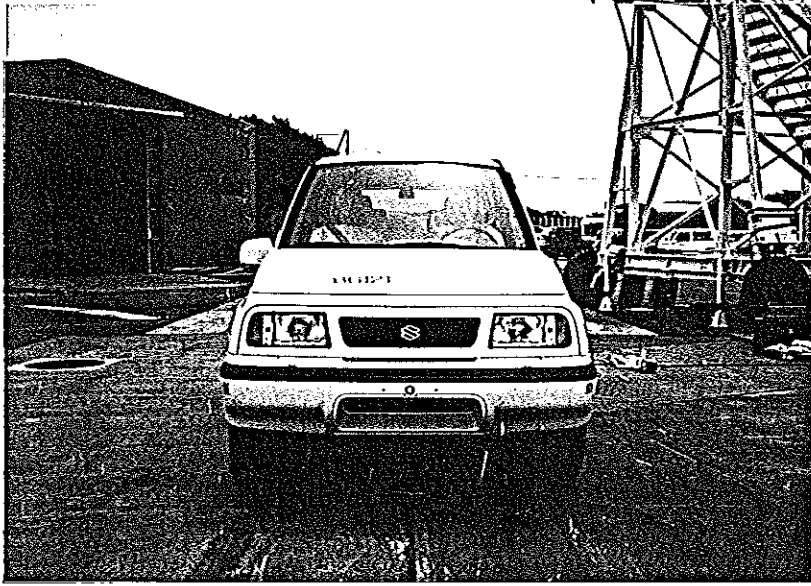
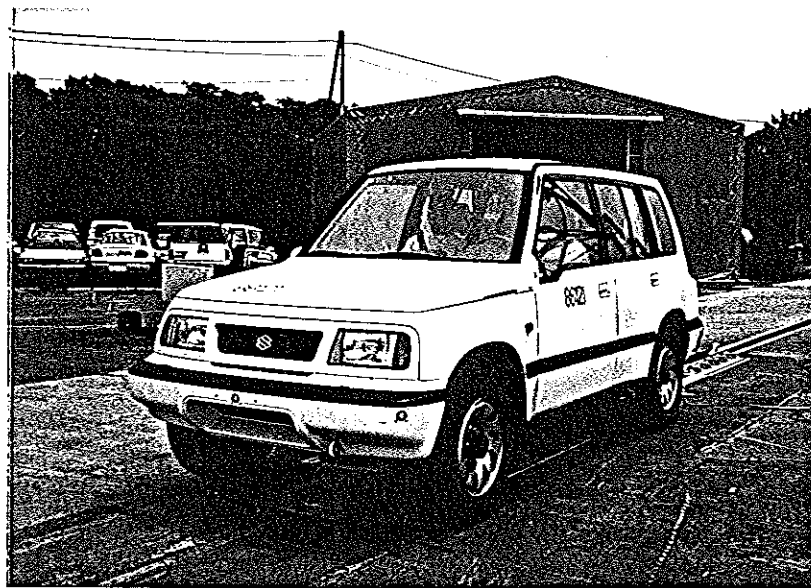
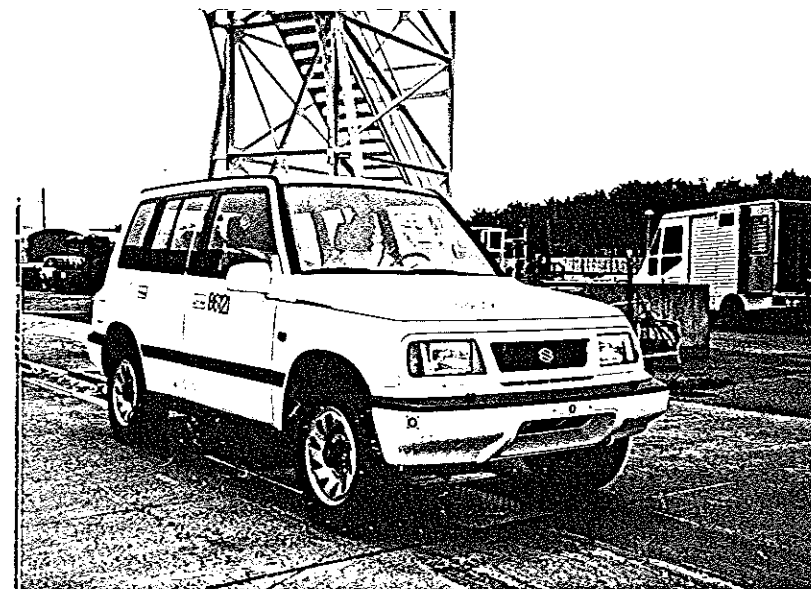
試験前 (Pre-Test)

TEST SPEED	54.0 km/h	
DEVIATION OF MOVING BARRIER	15 mm Left	
VEHICLE DEFORMATION (MM)	LEFT	309
	CENTER	354
	RIGHT	331
PROPELLER SHAFT	Separated	
FUEL TANK DEFORMATION SPECIFY if there is any portion where may cause fuel leakage	None

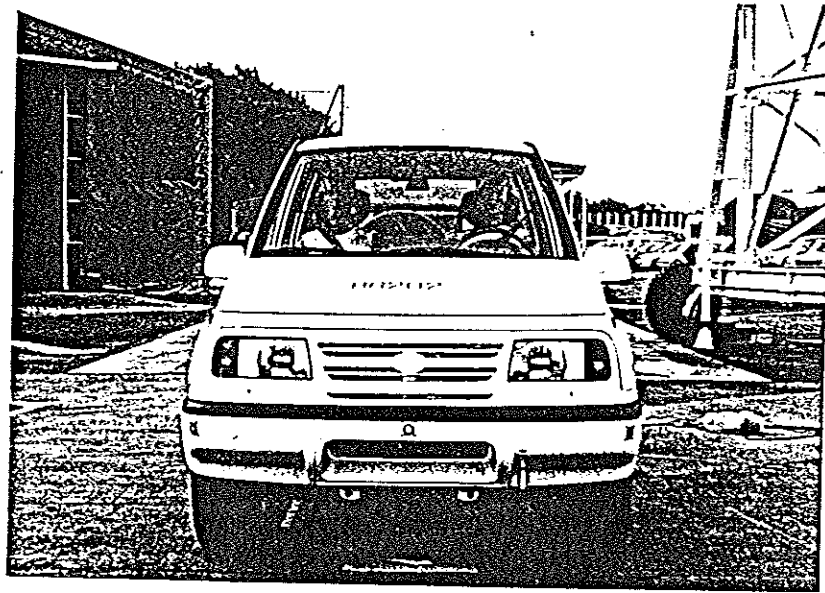
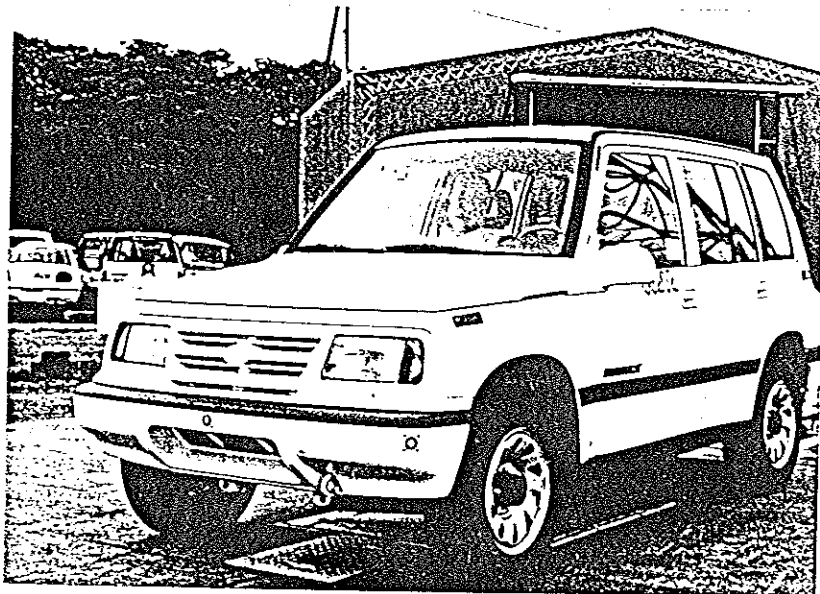
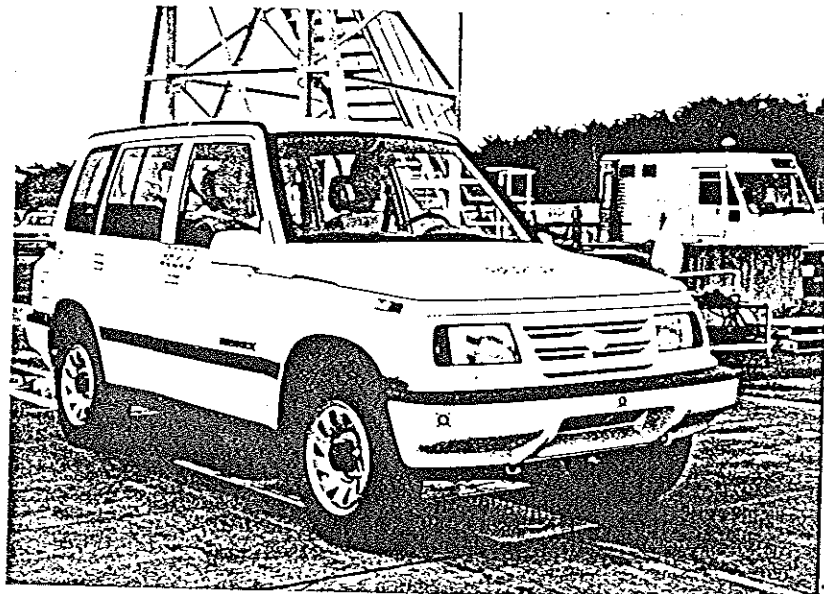
試験前 (Pre-Test)

TEST SPEED	78.6 km/h	
DEVIATION OF MOVING BARRIER	85mm Right	
VEHICLE DEFORMATION (MM)	LEFT	490
	CENTER	457
	RIGHT	507
PROPELLER SHAFT	Separated	
FUEL TANK DEFORMATION SPECIFY if there is any portion where may cause fuel leakage	None

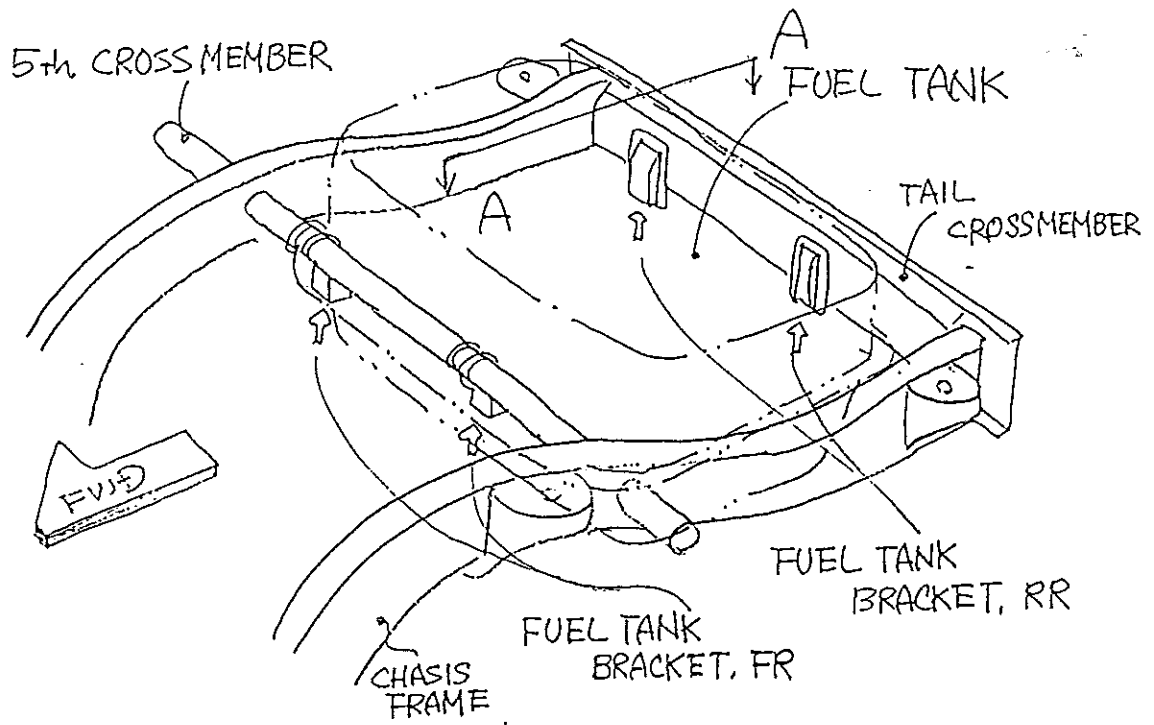
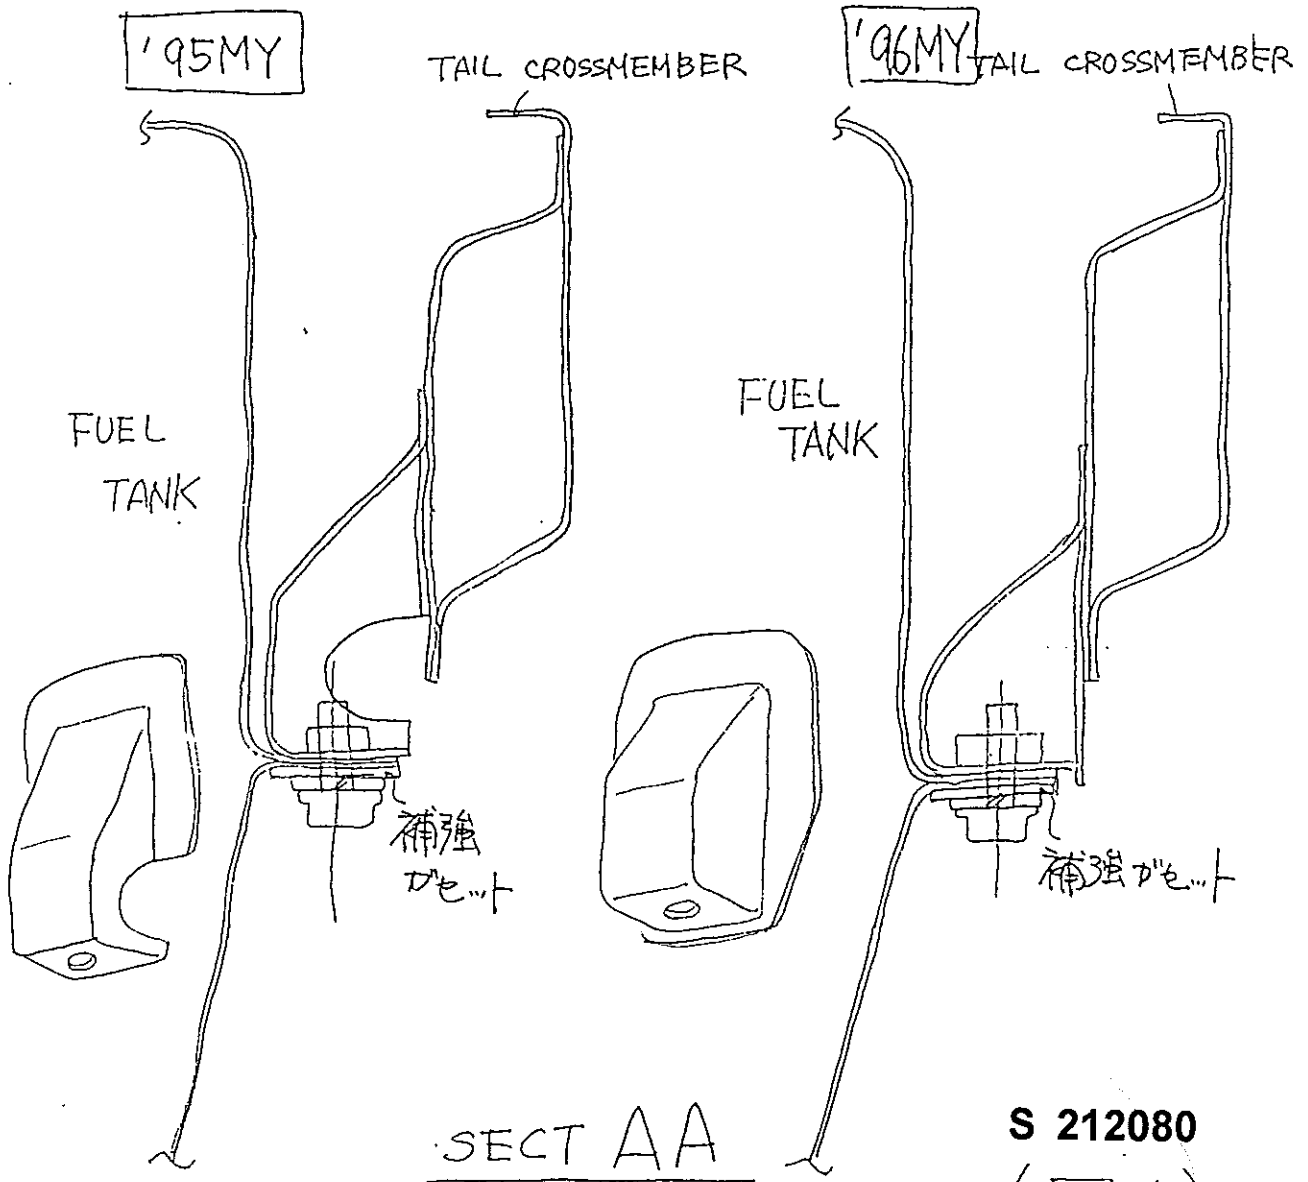
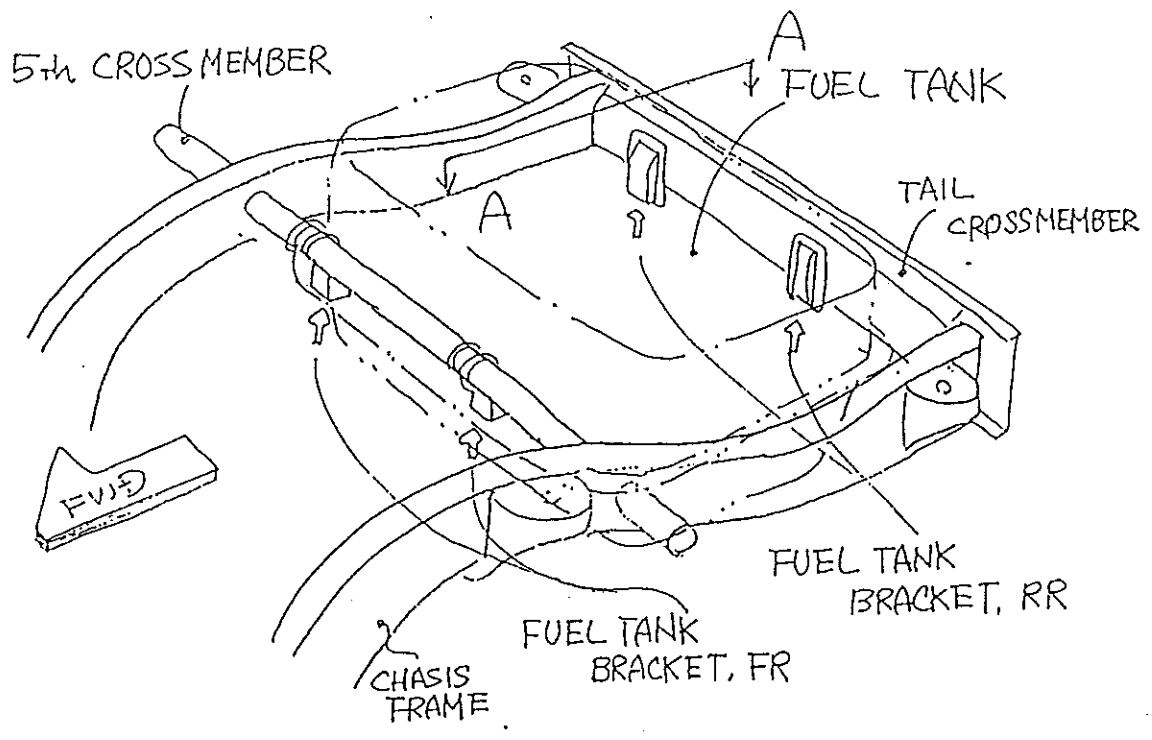
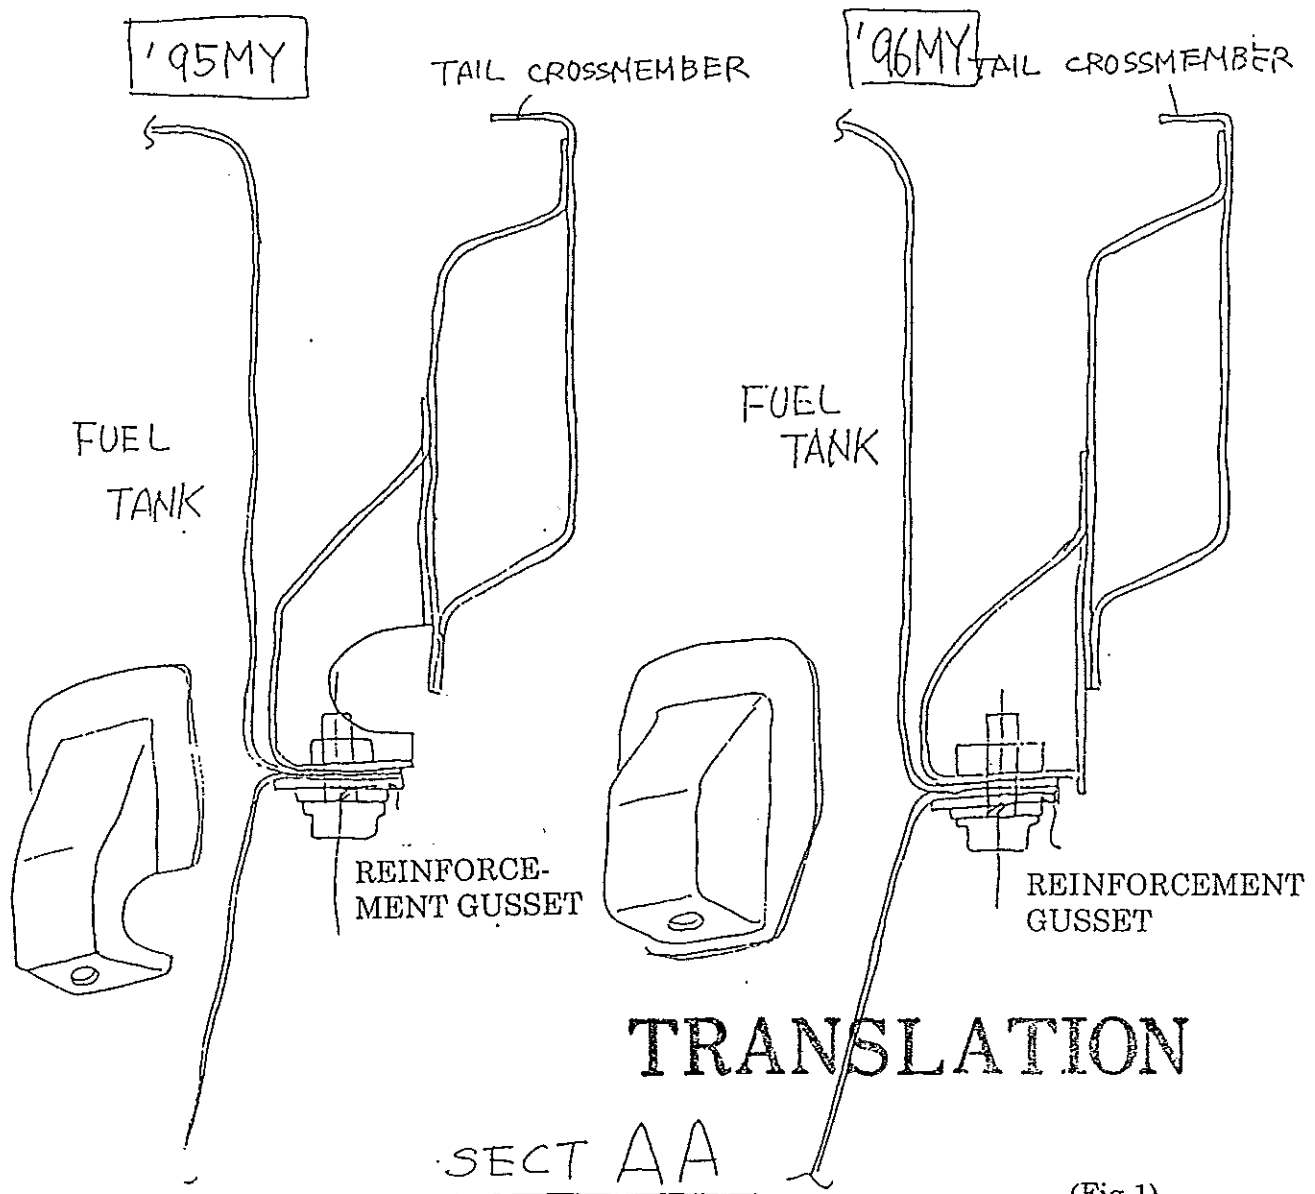
(Fig.1) S 212081

The tank is tightened both at the front and the rear. At a collision, the tank was deformed and due to this deformation, the outer edge of the gusset used as the tank reinforcement on the right side of the rear tightened part hit the rear face of the tank and the oil leaked there.

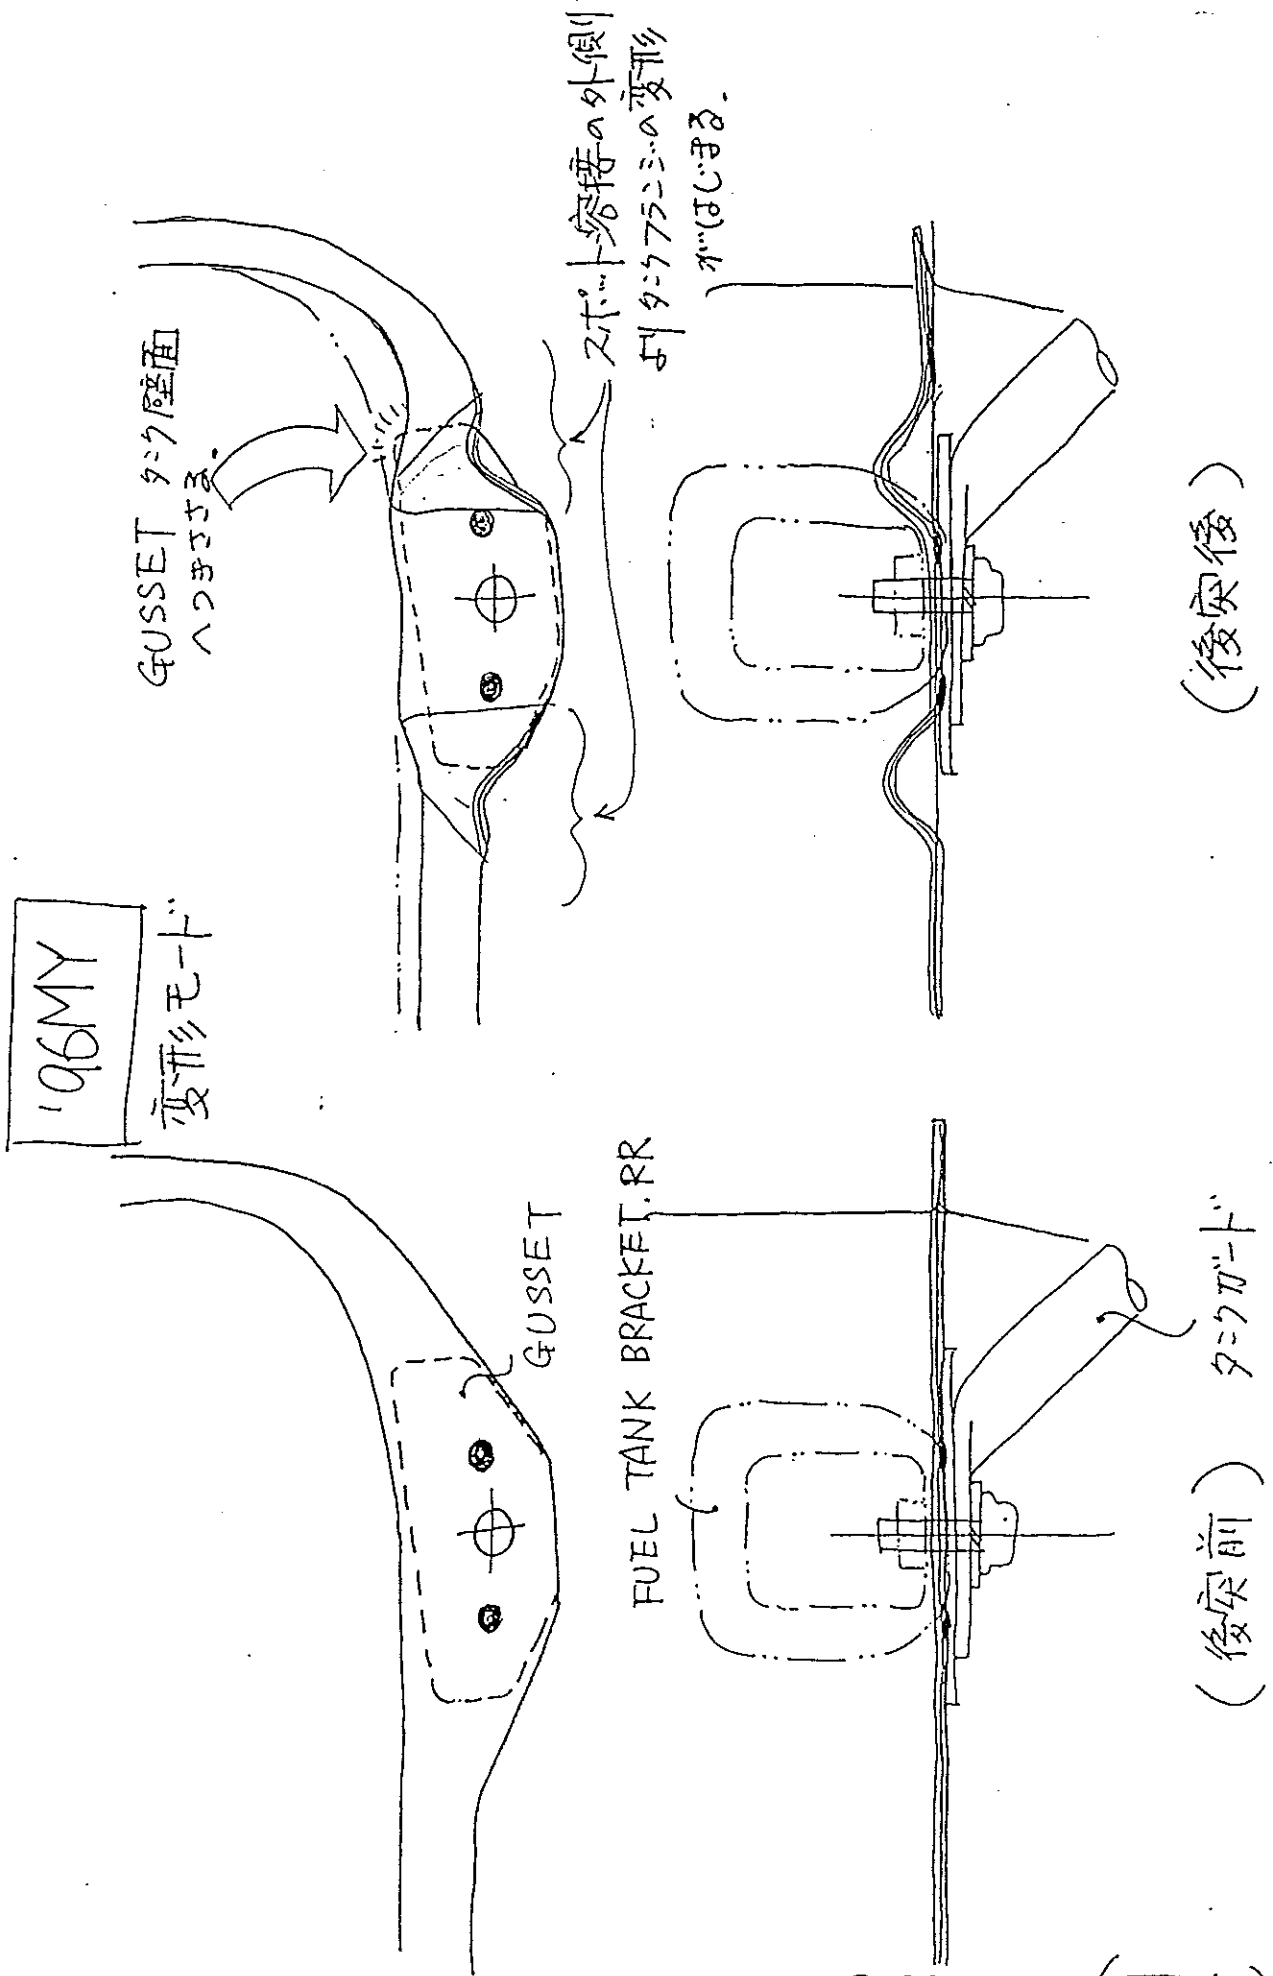
(Fig.3)

The simulation test by using actual vehicles was conducted again and it proved that combination of only two of the above factors does not cause fuel to leak. From this, the subject vehicle can be limited to the 4-door '96 MY vehicles made at CAMI. (Fig.3, Fig.4)

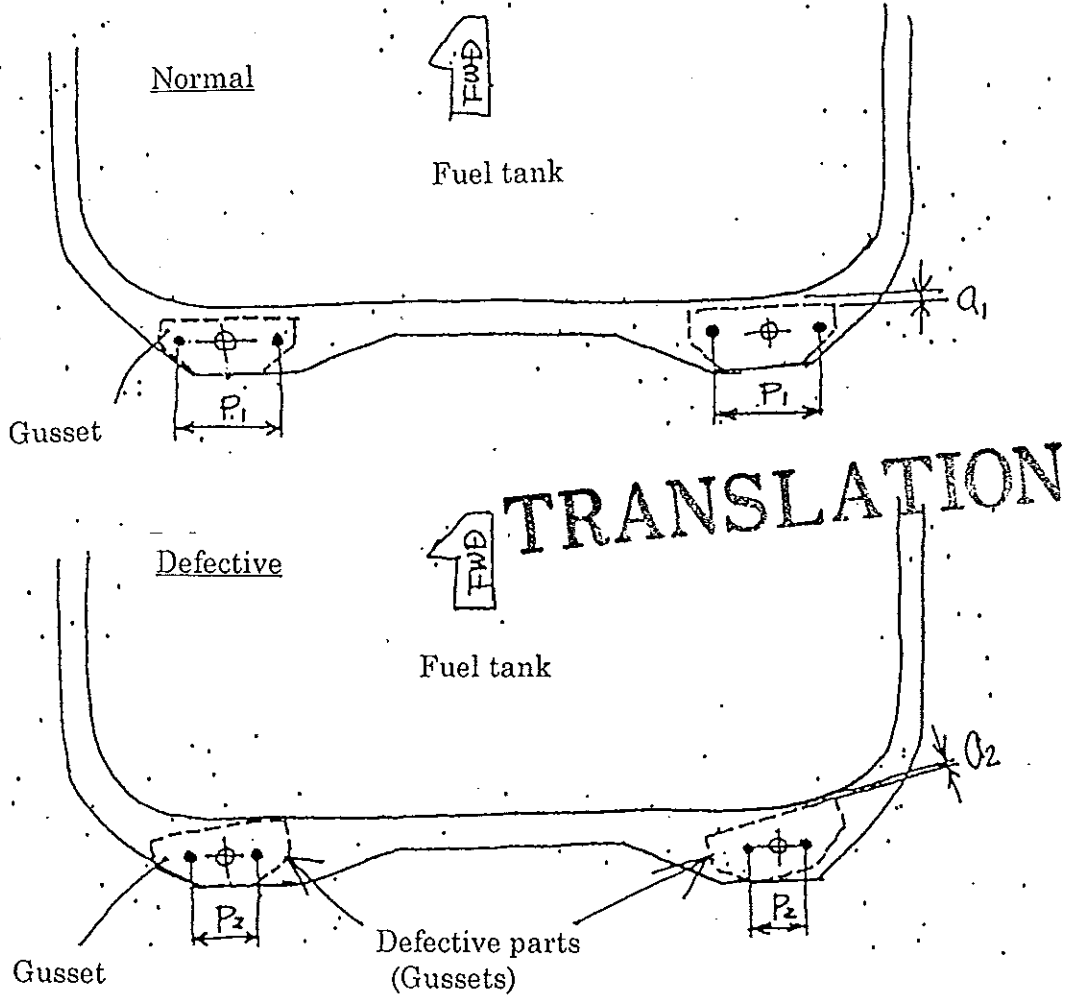
Schematic diagram of related parts

Starting with '96MY, the bracket to mount the tank for the J-car of 1.6 liter long body type has been reshaped. With the fuel tanks installed at CAMI, the width of its spot welding was narrow in some cases and the gusset itself was attached diagonally in some other cases. When these faulty conditions happened to coexist, such faulty condition resulted. (The gusset installation was done manually at CAMI while it was done with a jig and a welding robot at IWATA.) (Therefore, vehicles manufactured at IWATA, and those for the short body and wide body (YF0) types will not be subject to this recall.)

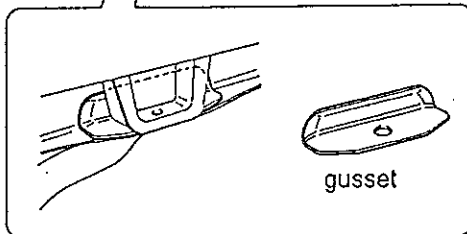
4. Install the gussets as illustrated.
5. Raise the fuel tank until the gusset contacts the bracket.
6. Tighten the installation bolts.  
Tightening torque: 40 lb-ft

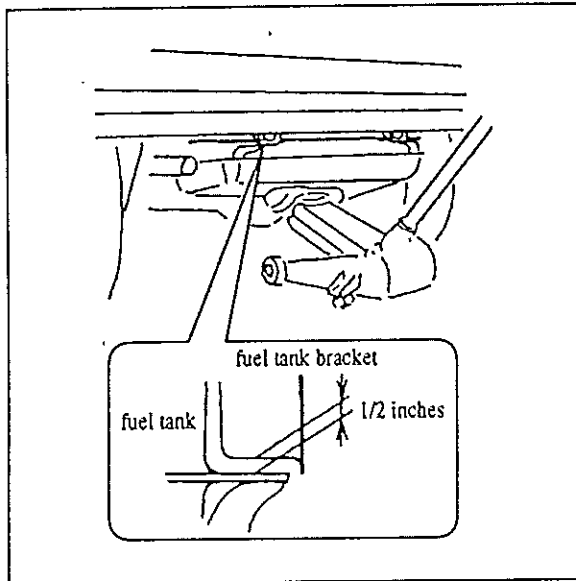
2. Remove two fuel tank bolts.

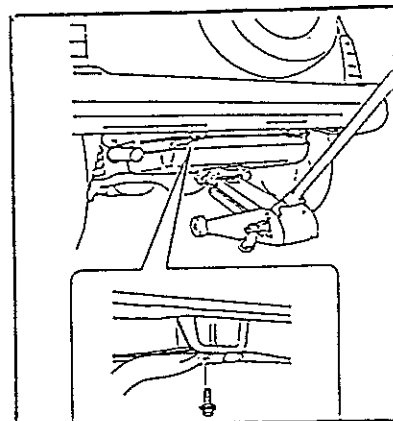
2. Remove the two 14 mm bolts supporting the rear of the fuel tank.

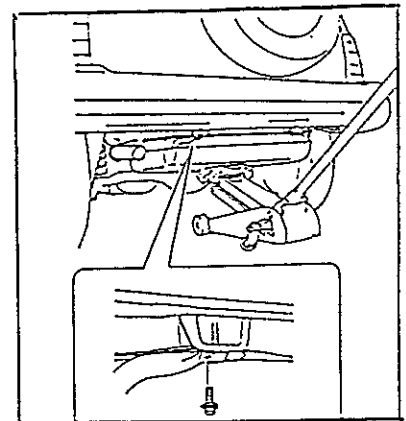
2. Remove the two 14 mm bolts supporting the rear of the fuel tank.

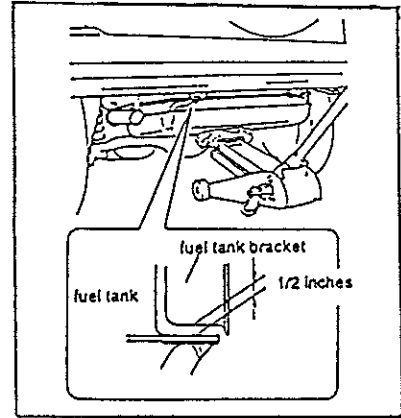
- 3. Lower the rear of the fuel tank ***SLOWLY*** approximately 13 mm (1/2 inch).  
\*Be sure not to lower the tank more than 26 mm (1 inch).

- 4. Install the gussets as illustrated.
- 5. Using the floor jack, gently raise the fuel tank until the gusset contacts the bracket.

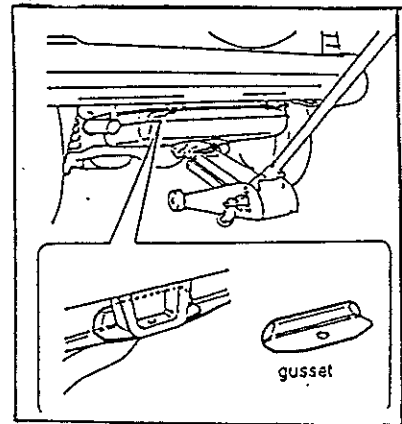
- 6. Install and tighten the two 14mm bolts previously removed. Torque these bolts to 40 lb-ft.
- 7. Clean the drivers side door post and affix an "S1" Campaign Decal to the pillar, just below the door striker.

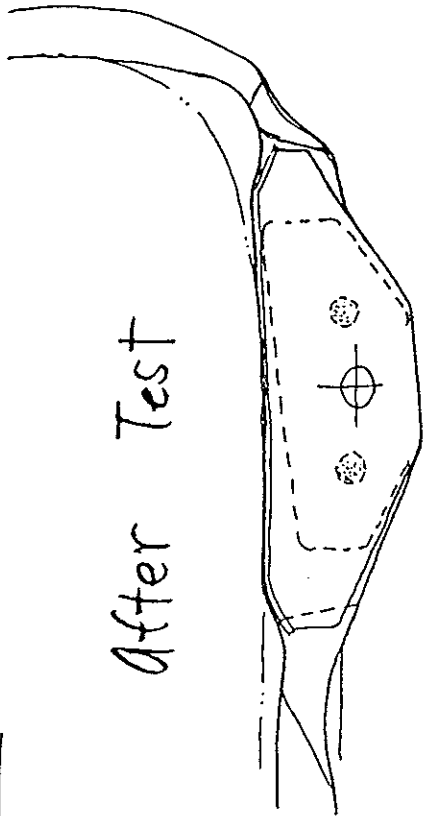
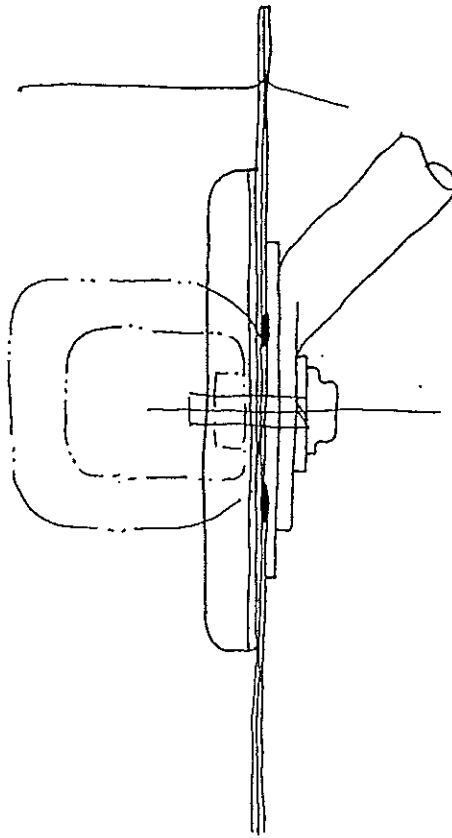
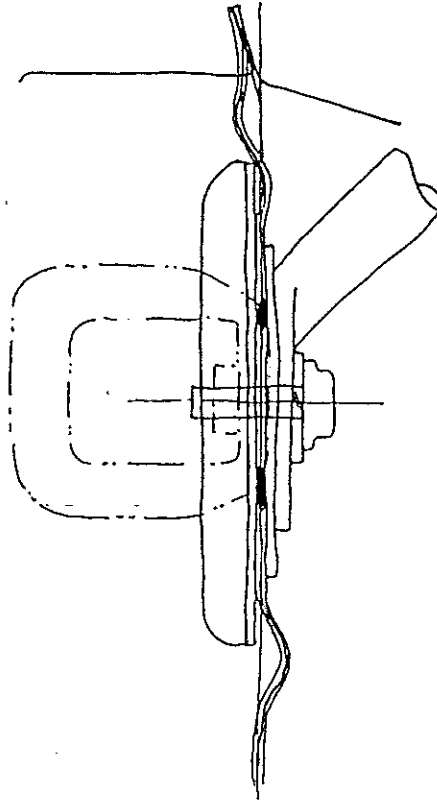
After Test

### Cause of Fuel Leakage

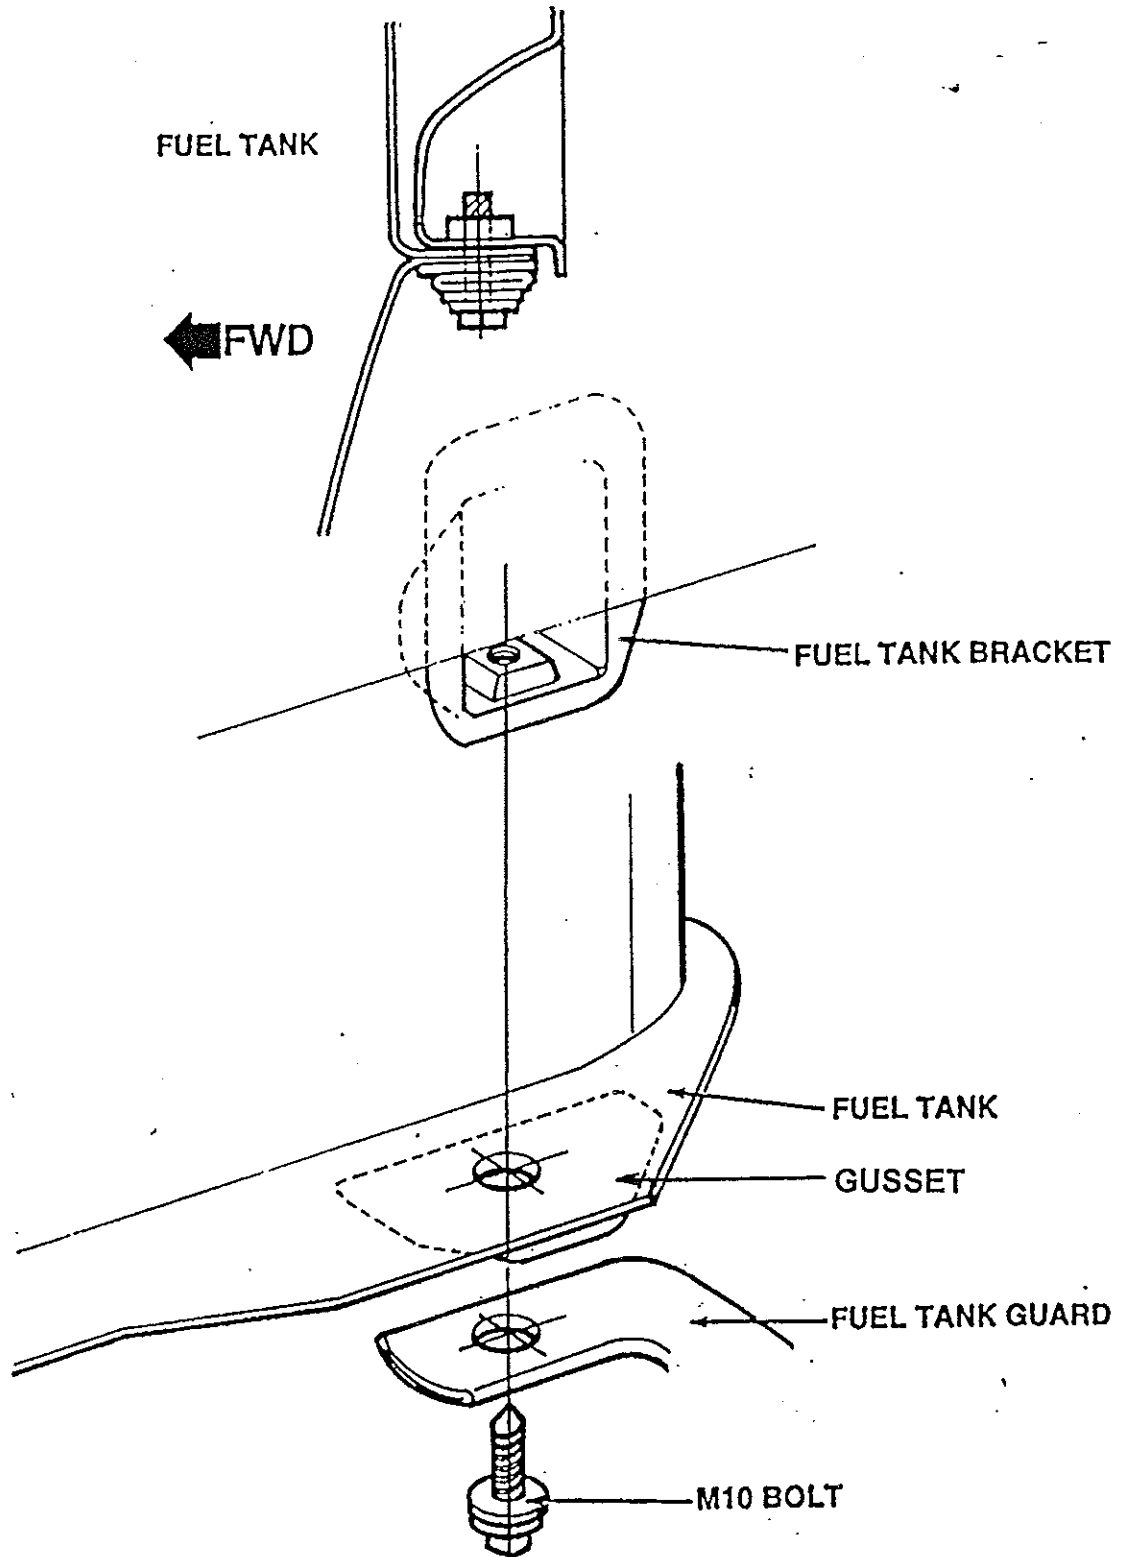
Illustration  
Rear Attachment of Fuel Tank to Vehicle  
1996 Geo Tracker 4-door  
(right rear attachment shown - left rear similar)

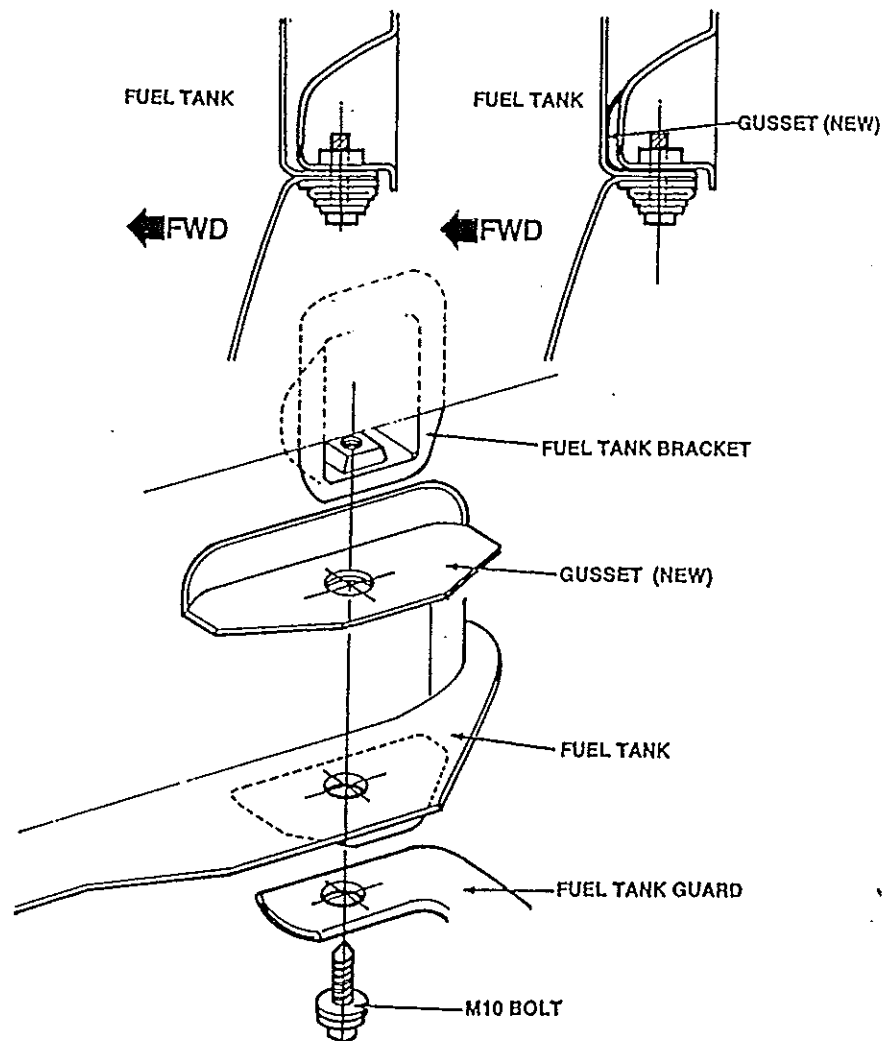
1. Raise and suitably support vehicle.
2. Support fuel tank with a suitable jack.
3. Slowly remove the two (2) rear fuel tank attachment bolts.
4. Install NEW gussets at each rear attachment locations as shown below.
5. Install rear fuel tank attachment bolts and torque to 35 Nm (26 lb. ft.).
6. Remove fuel tank support jack.
7. Lower vehicle.
8. Install the GM Campaign Identification Label.
