EA12-005

Attachment C

R51 FMVSS Test Report

**Nissan Technical Center, North America
2008 Nissan Pathfinder Vehicle Number 8WP122
into a Flat Frontal Barrier
TRC Inc. Test Number: 070216-1**

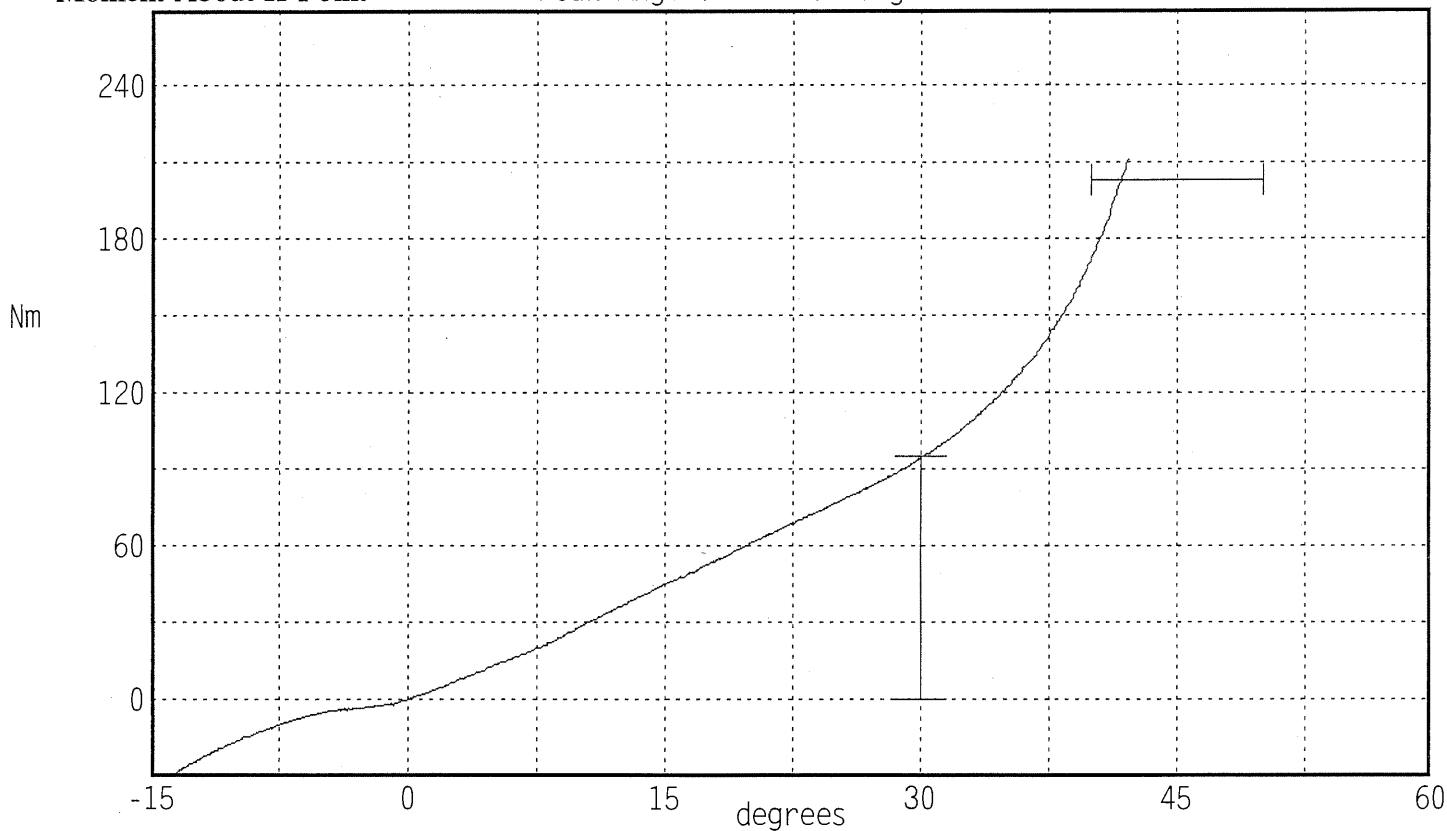
Moment About H-Point
Peak Moment: 210.8 Nm at 42.1 deg
Peak Angle: 42.1 deg at 210.8 Nm

Angular Velocity Max: 8.0 deg/sec Min: 6.9 deg/sec

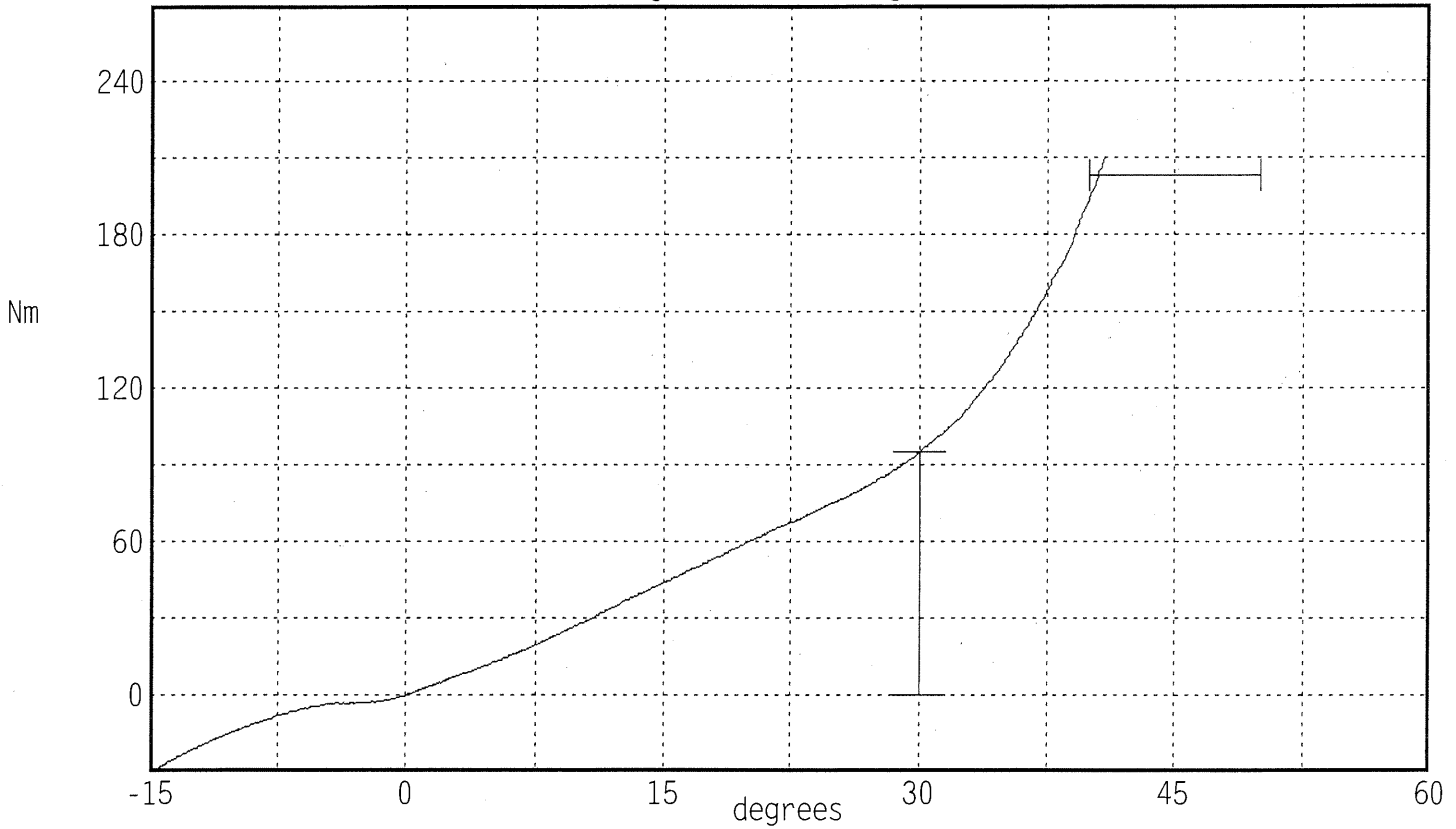
Moment About H-Point
Peak Moment: 210.2 Nm at 40.9 deg
Peak Angle: 40.9 deg at 210.2 Nm

Angular Velocity Max: 8.0 deg/sec Min: 7.0 deg/sec

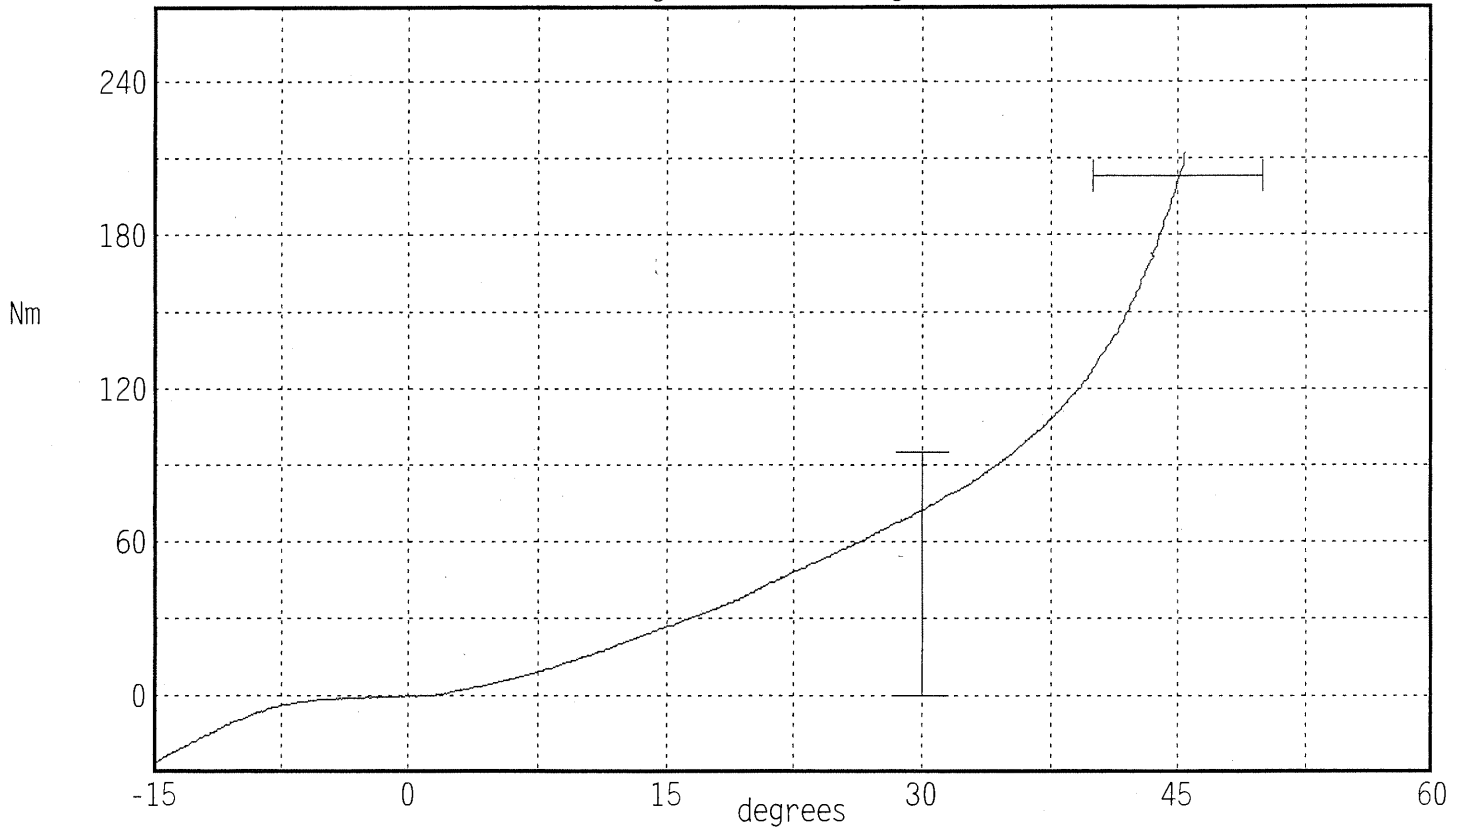
Moment About H-Point
Peak Moment: 211.8 Nm at 45.5 deg
Peak Angle: 45.5 deg at 211.8 Nm

Angular Velocity Max: 8.0 deg/sec Min: 6.9 deg/sec

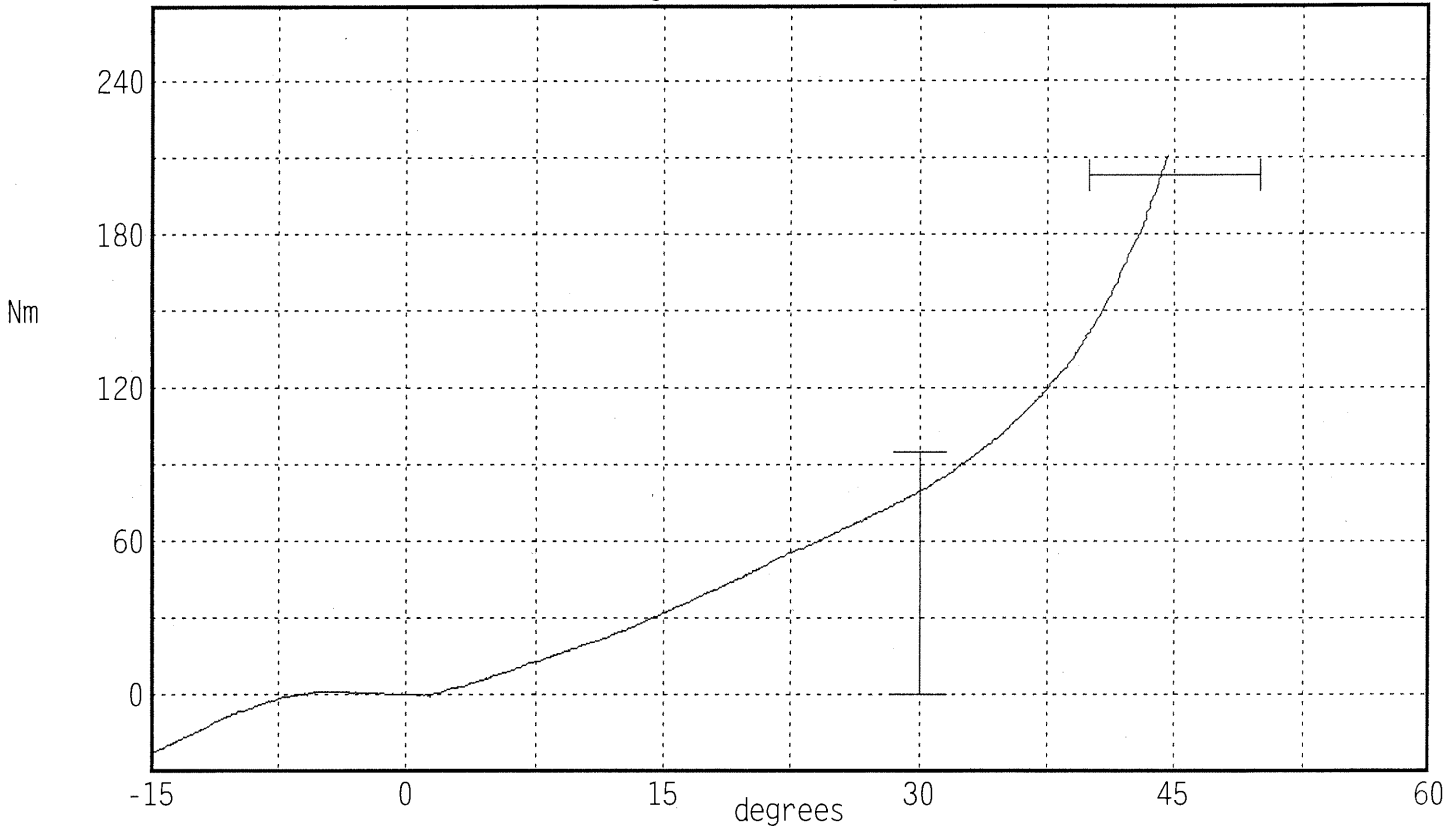
Moment About H-Point
Peak Moment: 210.4 Nm at 44.6 deg
Peak Angle: 44.6 deg at 210.4 Nm

Angular Velocity Max: 8.1 deg/sec Min: 6.9 deg/sec

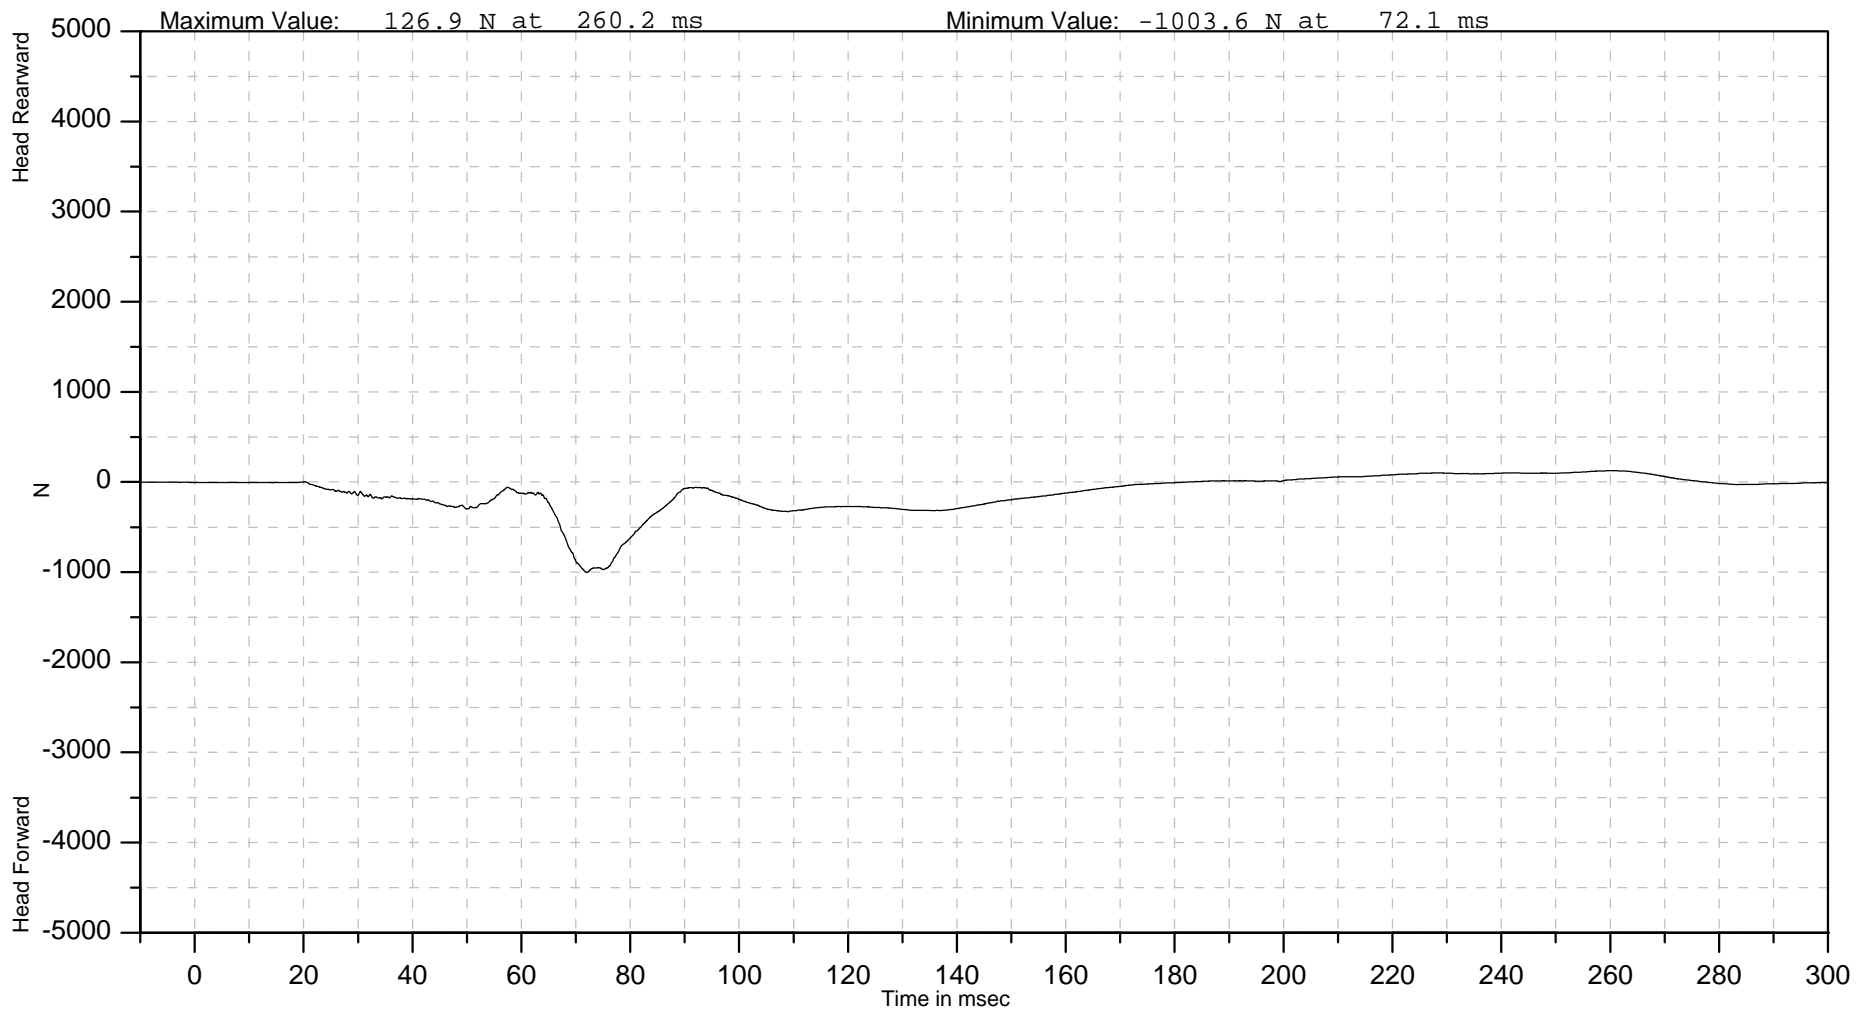
Filter: CFC 1000
Sign Convention: SAE J211

RFP Upper Neck X Force

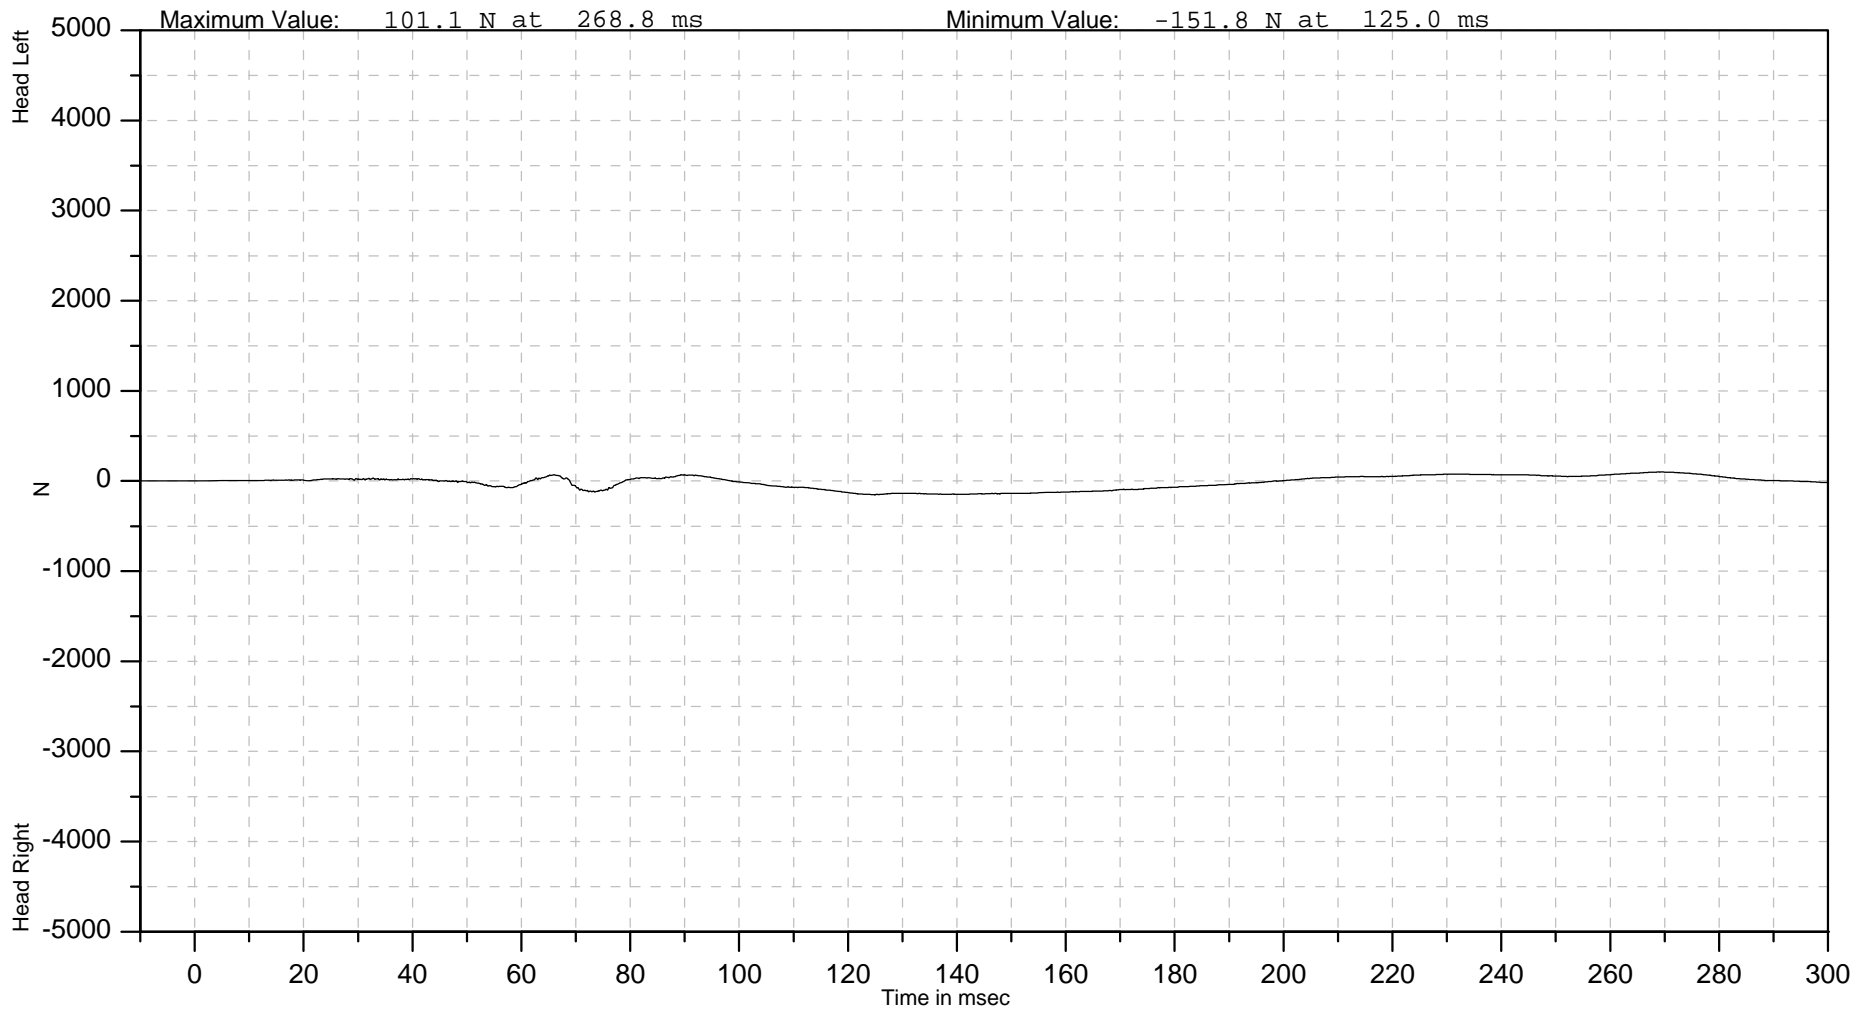
Filter: CFC 1000
Sign Convention: SAE J211

RFP Upper Neck Y Force

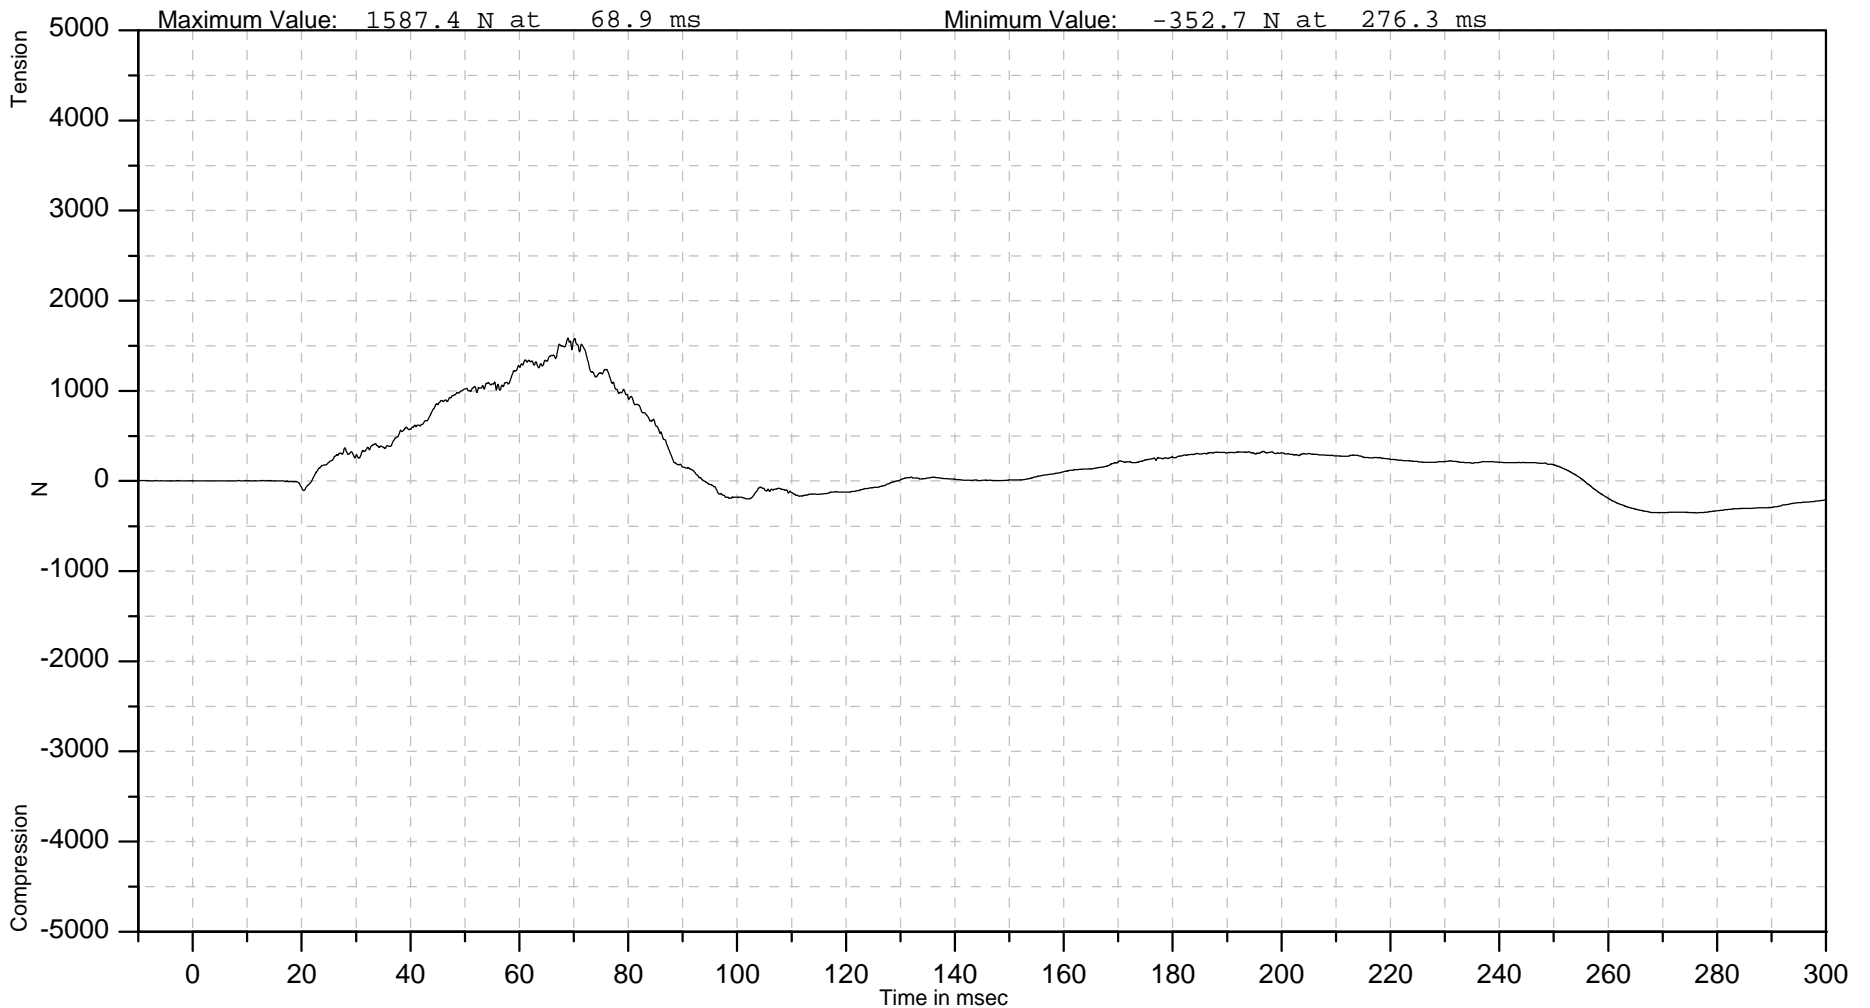
Filter: CFC 1000
Sign Convention: SAE J211

RFP Upper Neck Z Force

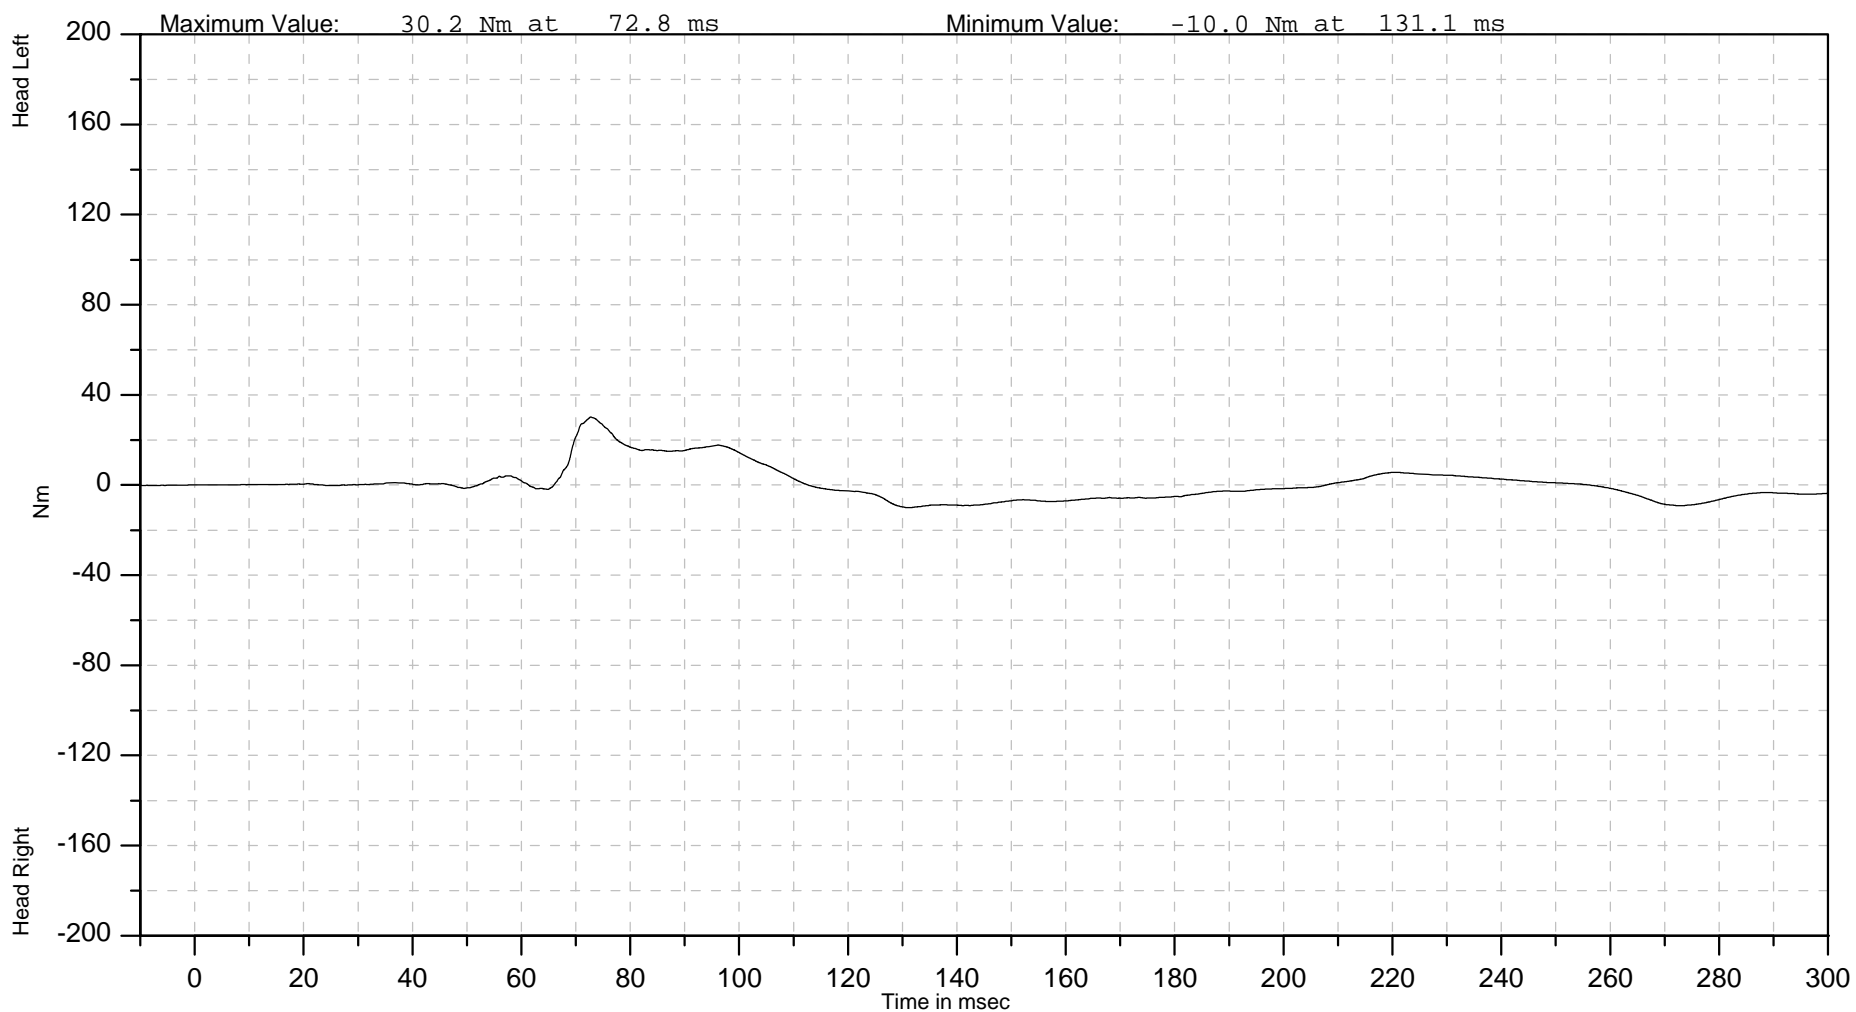
Filter: CFC 600
Sign Convention: SAE J211

RFP Upper Neck X Moment

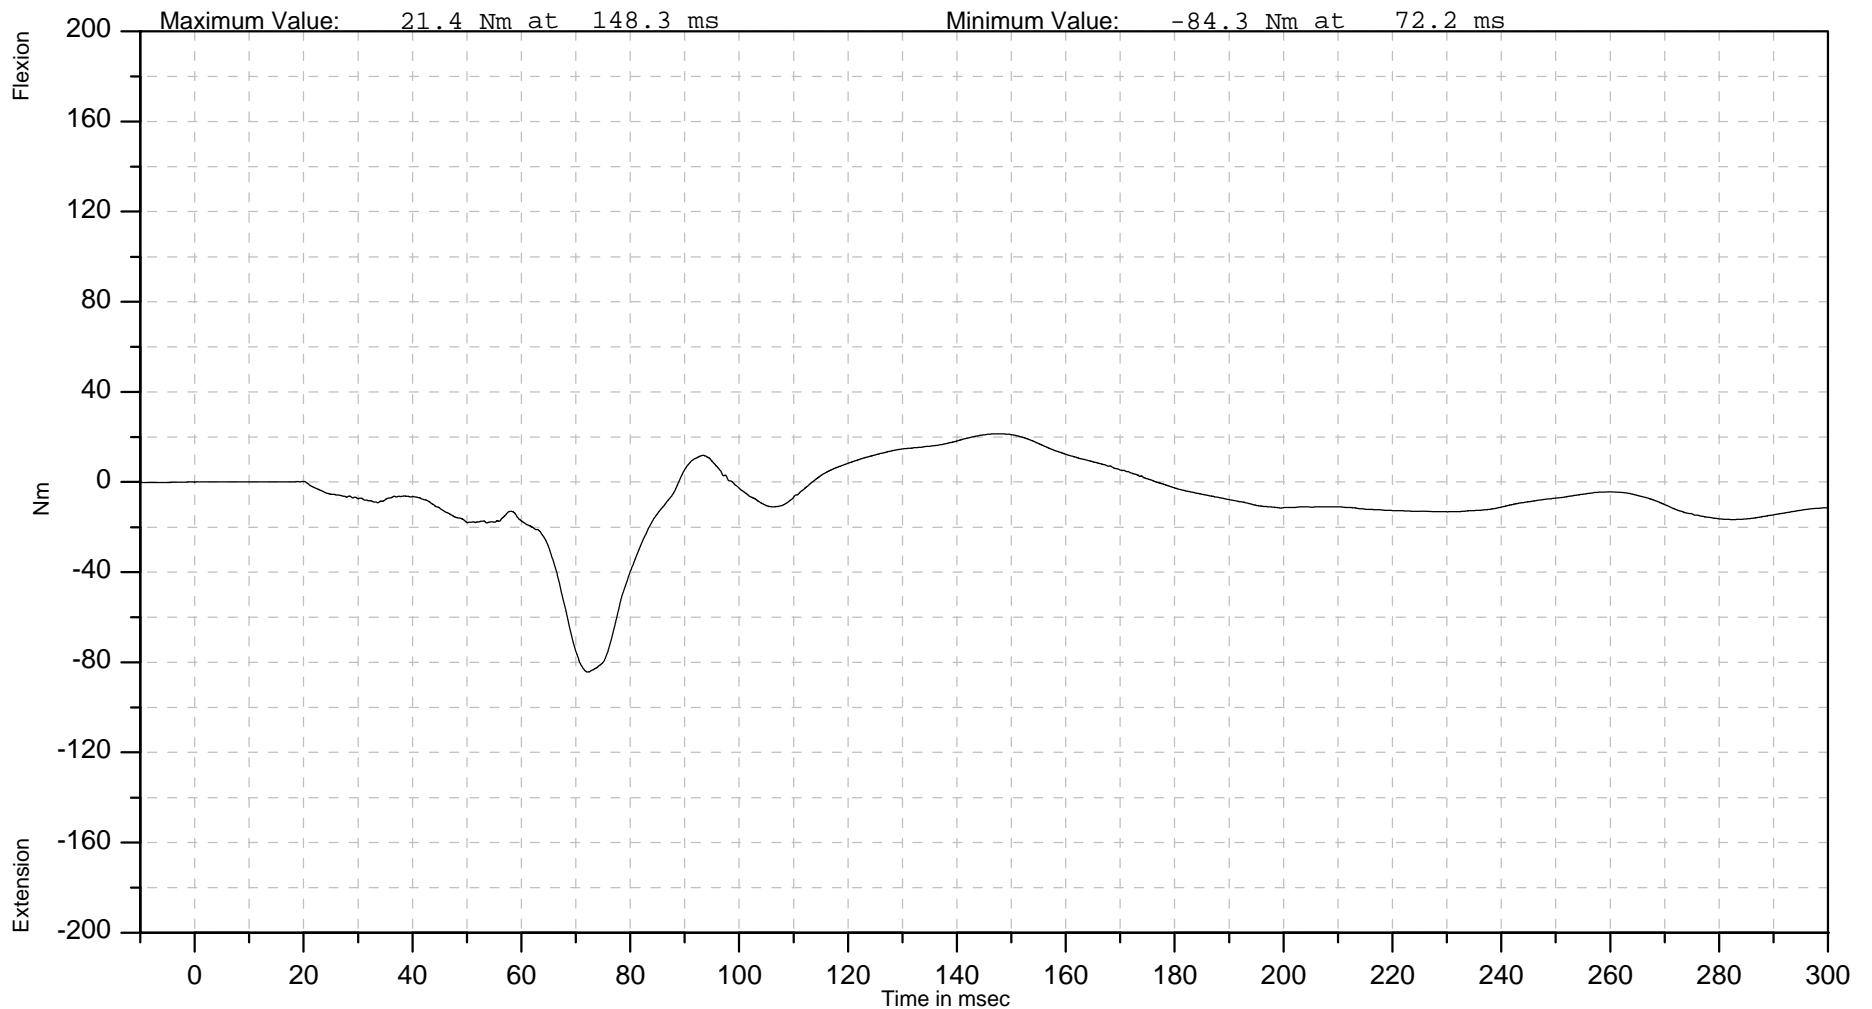
Filter: CFC 600
Sign Convention: SAE J211

RFP Upper Neck Y Moment

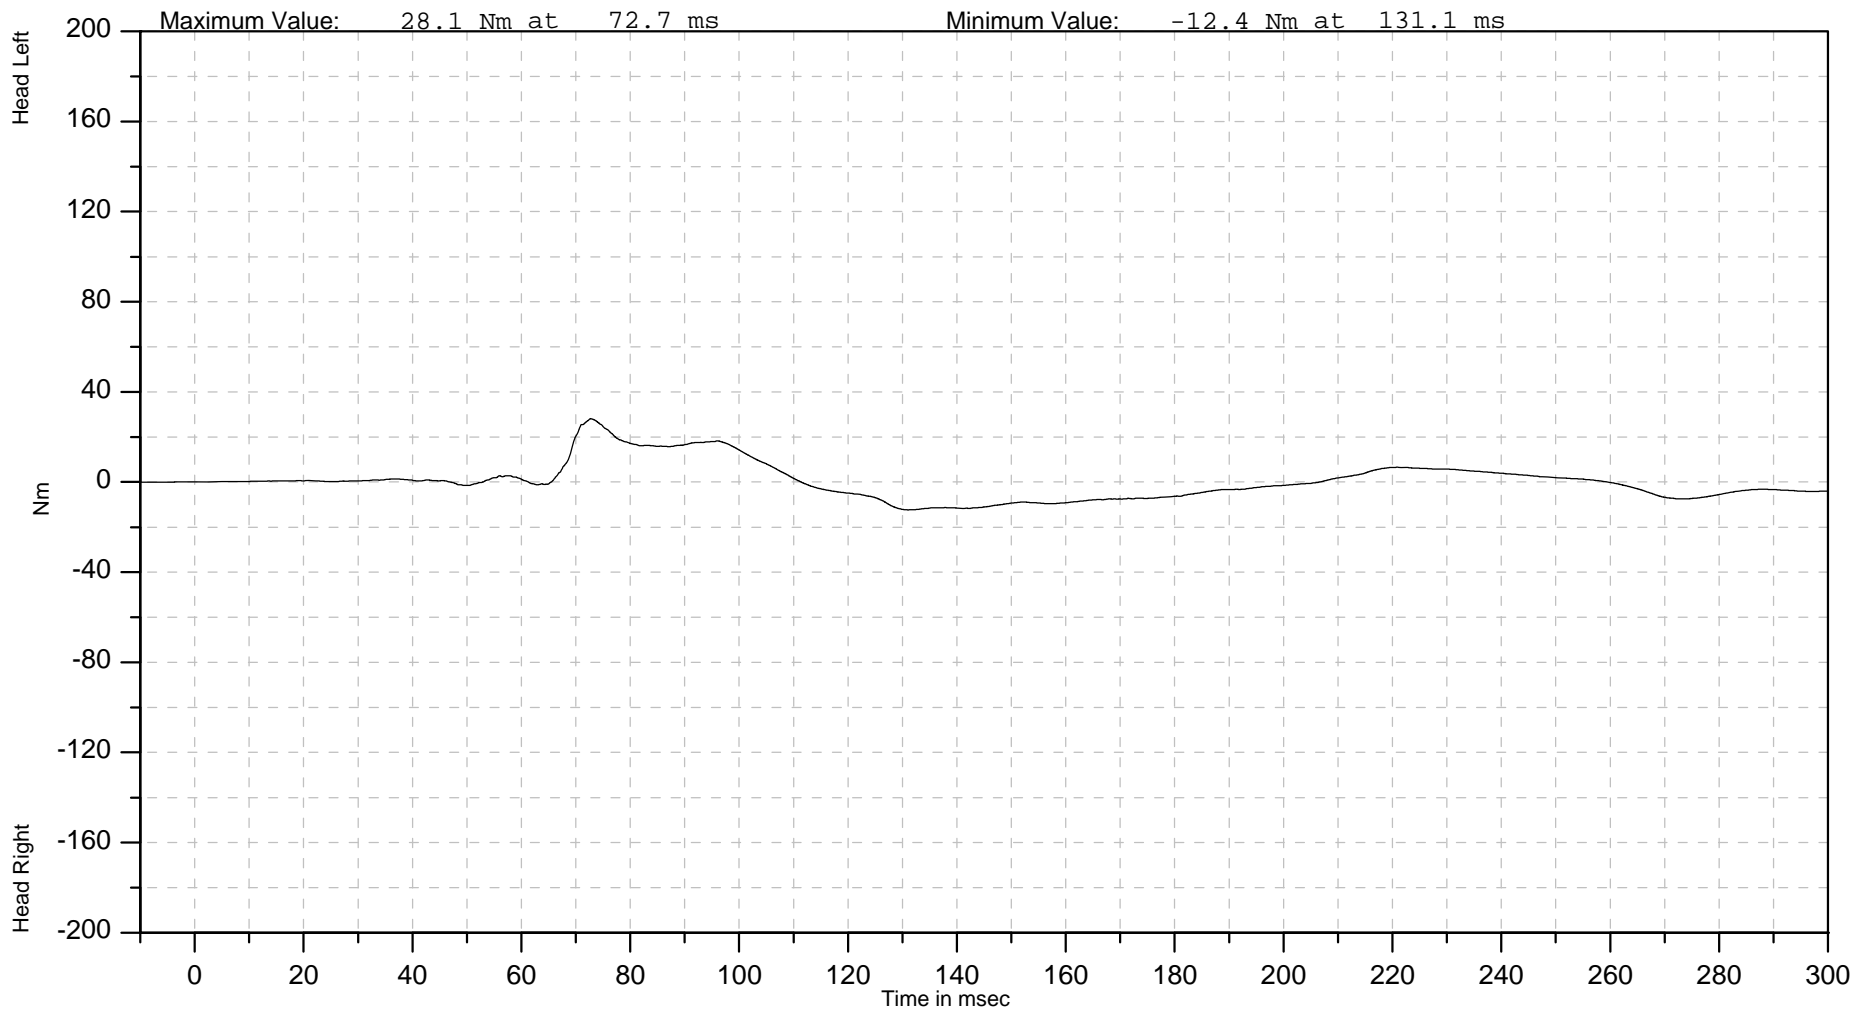
Filter: CFC 600
Sign Convention: SAE J211

RFP Occipital Condyle Neck X Moment

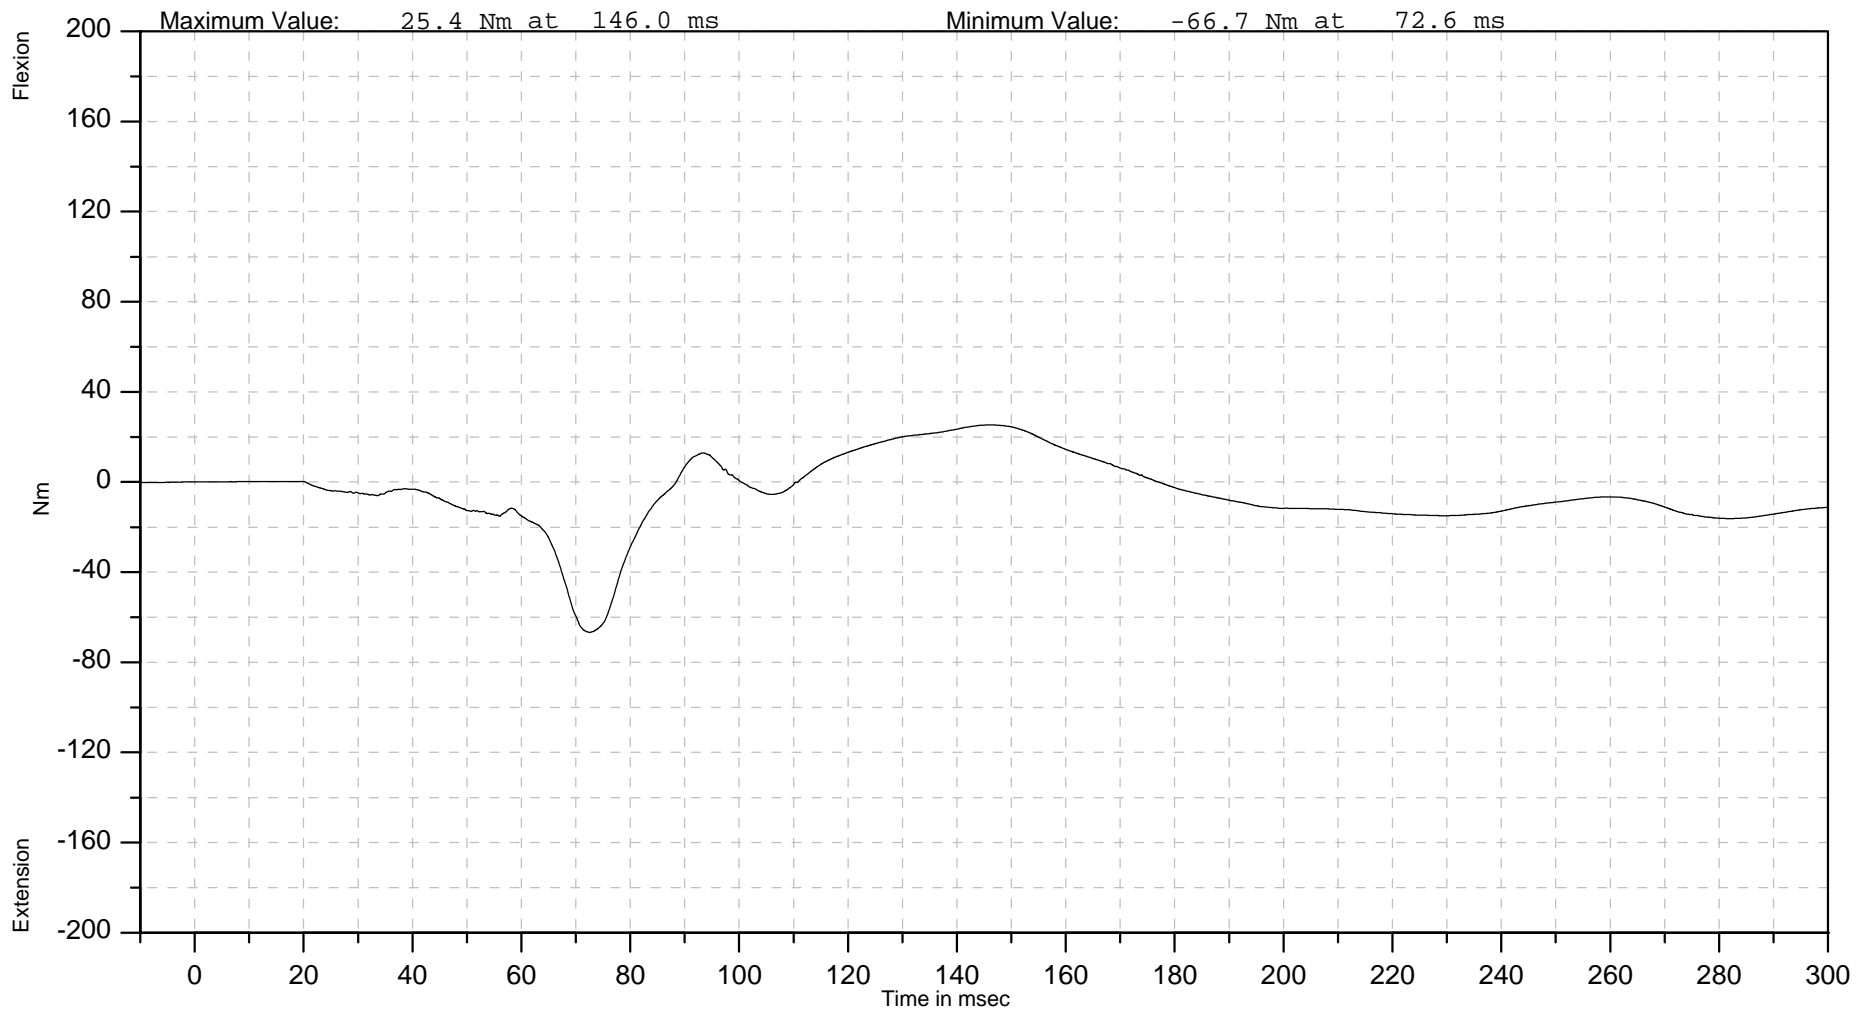
Filter: CFC 600
Sign Convention: SAE J211

RFP Occipital Condyle Neck Y Moment

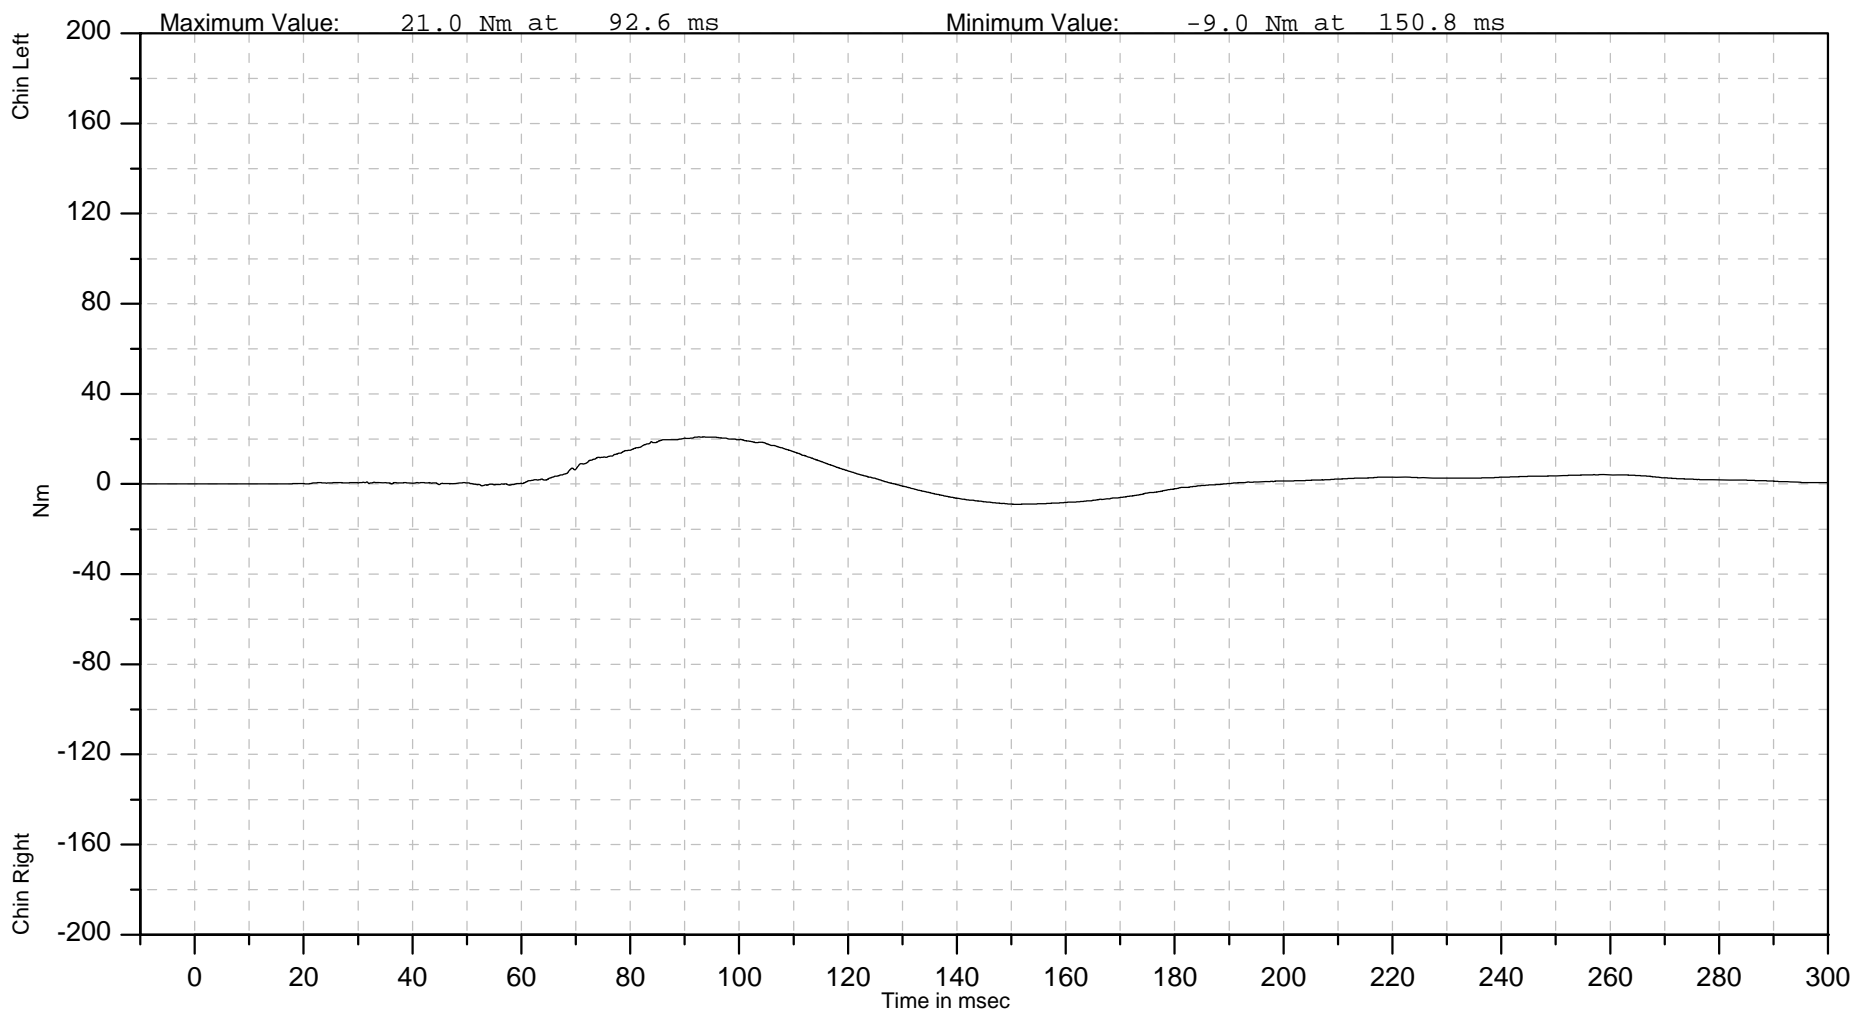
Filter: CFC 600
Sign Convention: SAE J211

RFP Upper Neck Z Moment

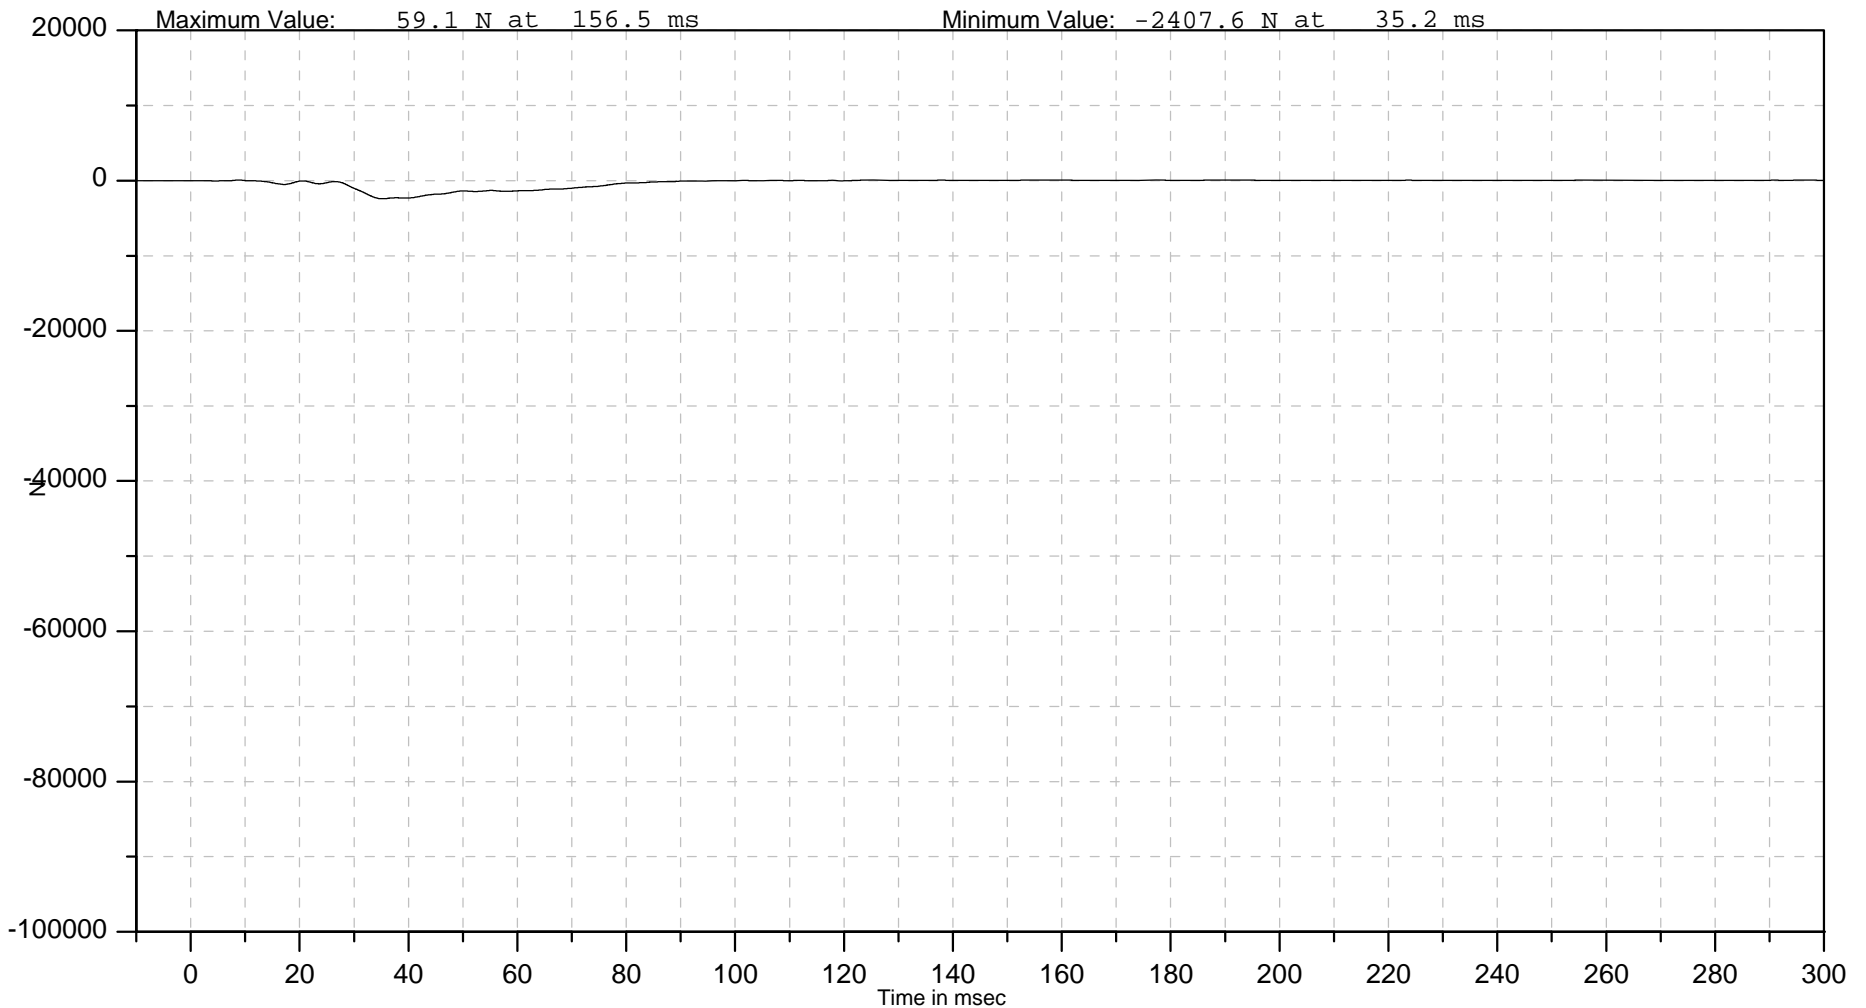
Filter: CFC 60
Sign Convention: SAE J211

3rd row up, 1st from left Fixed Barrier X Force

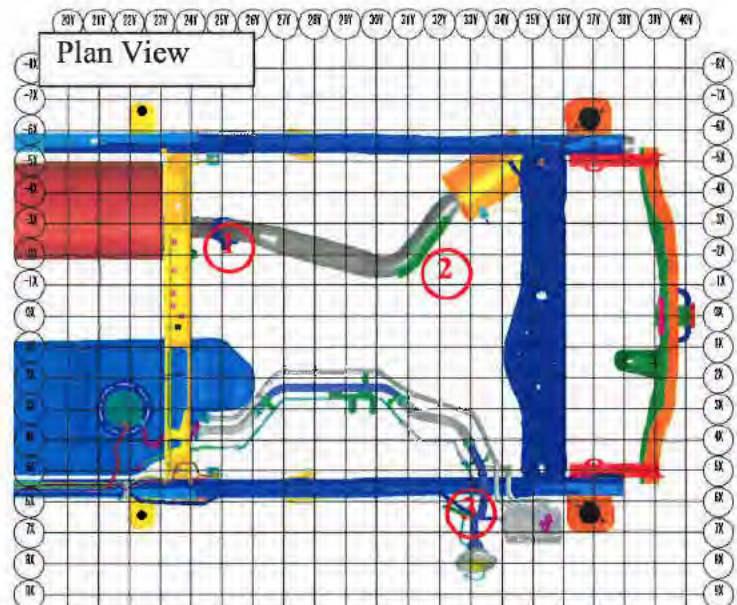
Drain hose position:
