EA12-005

CHRYSLER

ENCLOSURE 3

PEER VEHICLES – 1997 –

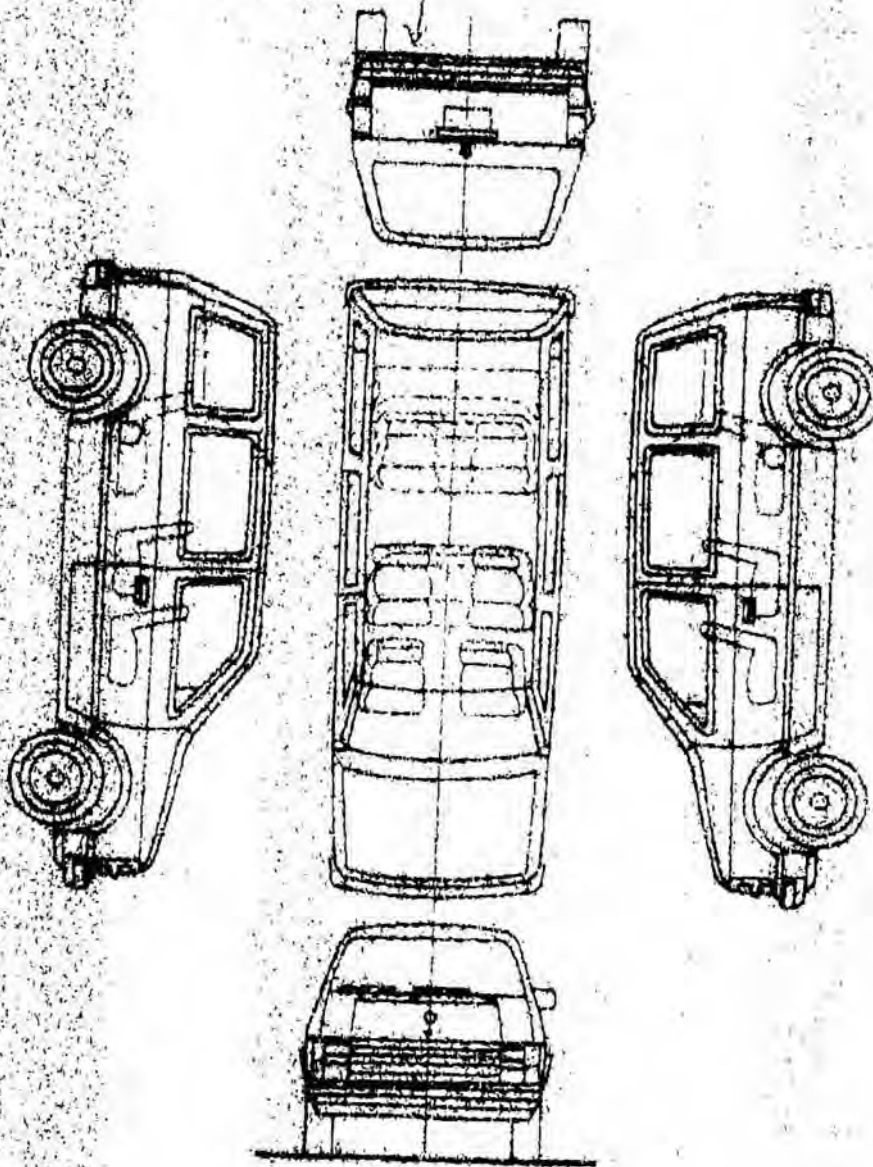
Exterior Damage Diagram and Measurements

IMPACT DAMAGE TO RIGHT LOWER FLOOR COINCIDENT OF FUEL TANK

NO EXTERIOR DAMAGE TO VEHICLE

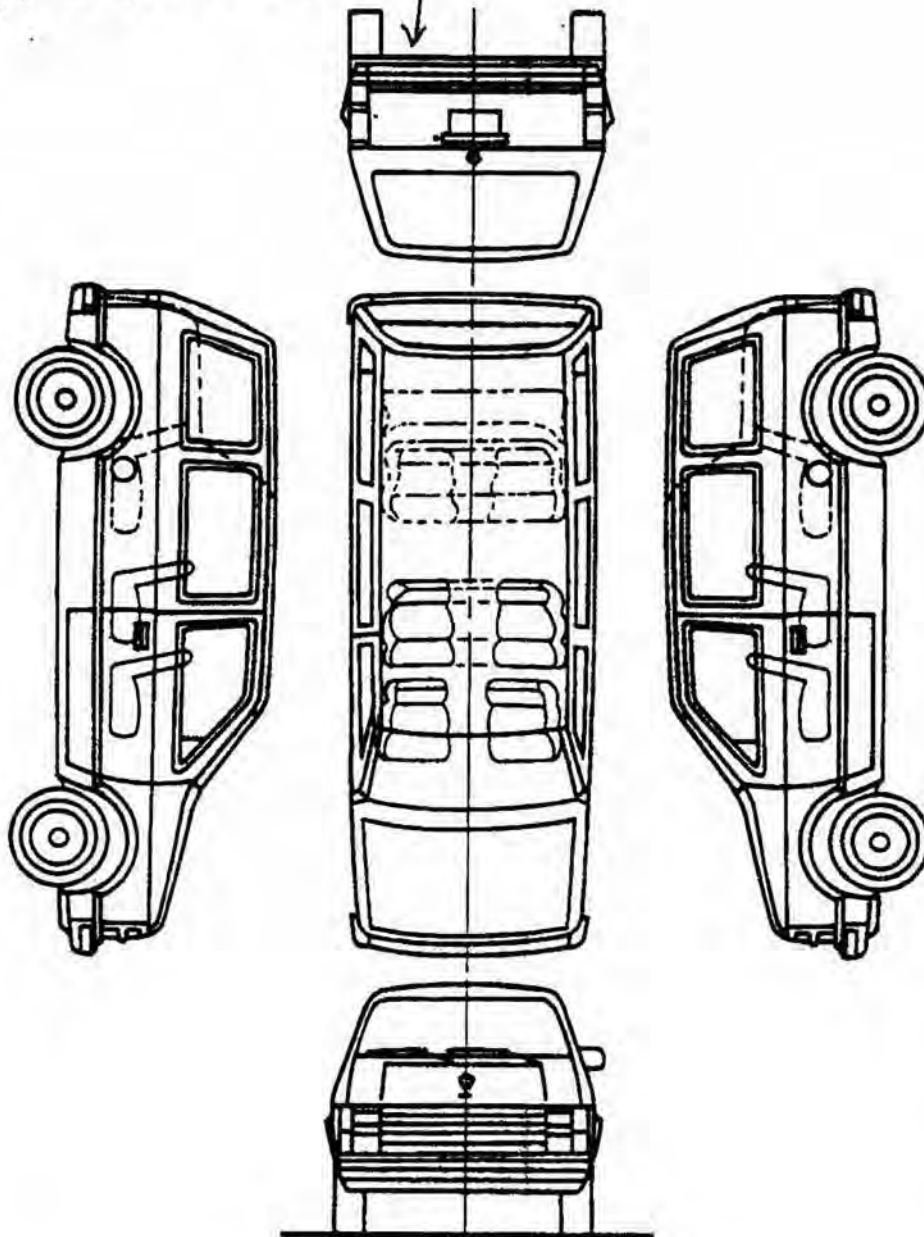
Exterior Damage Diagram and Measurements

VEHICLE HAD ALREADY BEEN REPAIRED ON DAY OF INSPECTION, SO THE GAS TANK HAD ALREADY BEEN REMOVED. THE TANK WAS THOROUGHLY EXAMINED OVER EVERY SQUARE INCH OF SURFACE. THE BOTTOM RIGHT REAR CORNER WAS PUNCTURED FROM IMPACT DAMAGE. NO OTHER DAMAGE WAS SEEN. ALL SEAMS, HOSE CONNECTIONS/FITTINGS AND SURFACES HAD NO VISIBLE DEFECTS NOTED. THE METAL SHIELD ENCASING THE GAS TANK WAS DAMAGED, ESPECIALLY THE SIDE SHIELD AT RIGHT SIDE OF TANK AT EXHAUST PIPE. IT WAS TORN LOOSE AND BENT. SEE PHOTOS # 13 AND 14. (SEE REPORT SUMMARY)

IMPACT DAMAGE TO RIGHT
LOWER REAR CORNER OF
GAS TANK

NO EXTERIOR DAMAGE TO VEHICLE

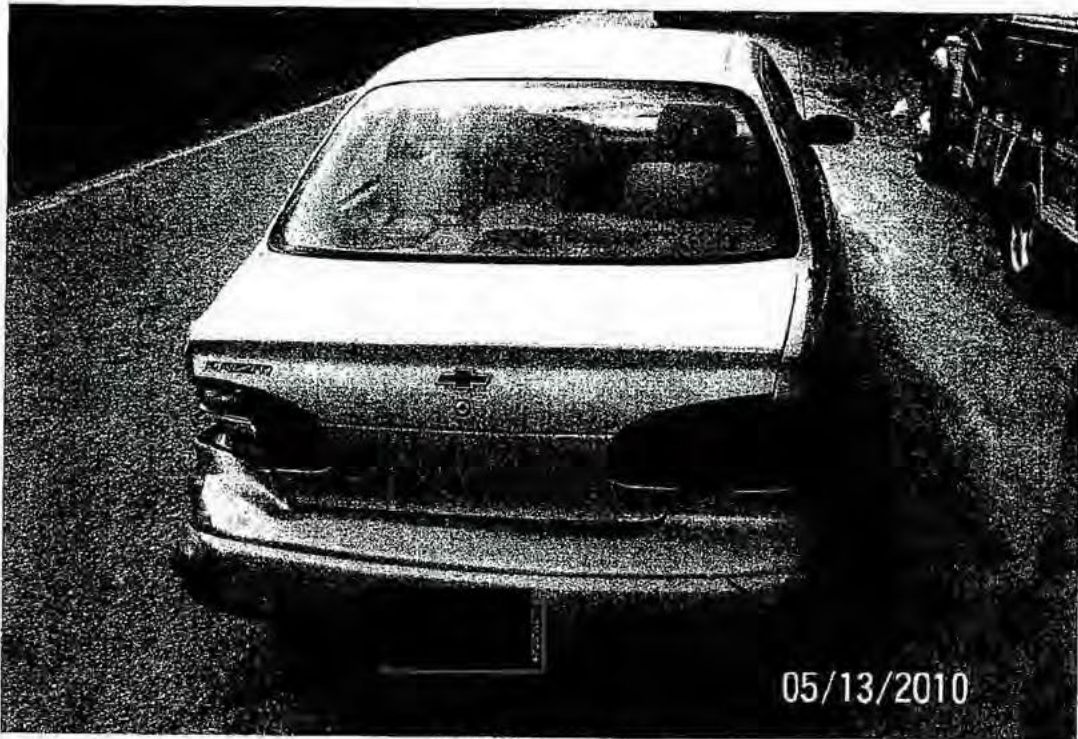
17. Unit 1 rear view

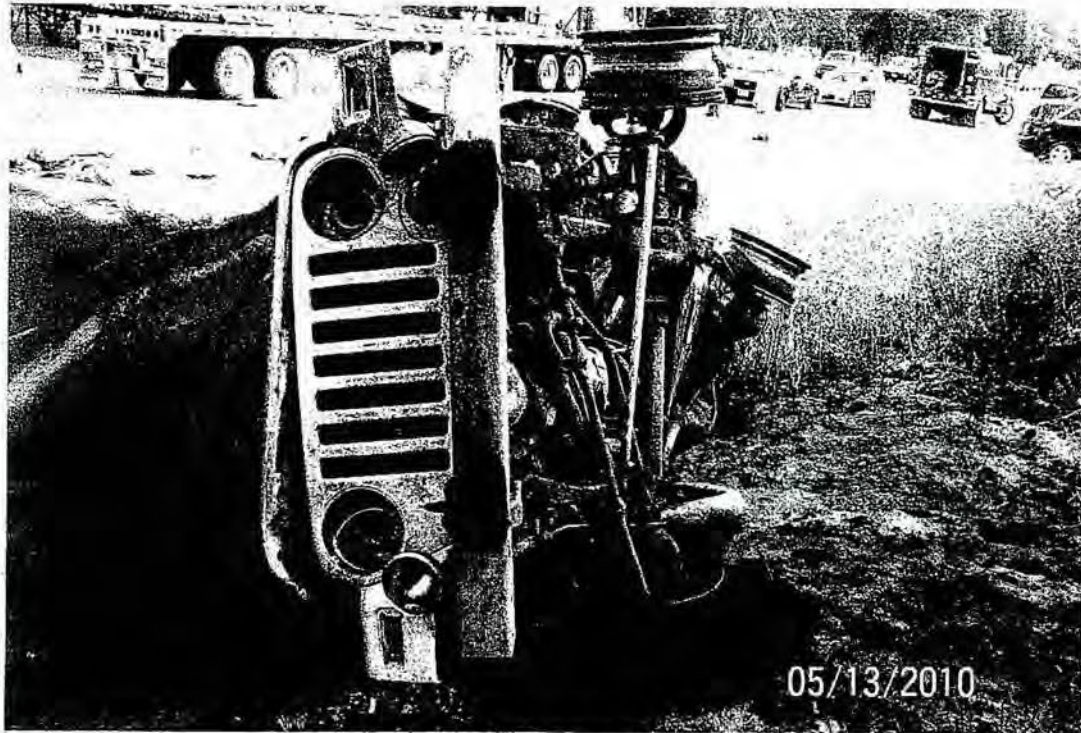
19. Unit 2 front view

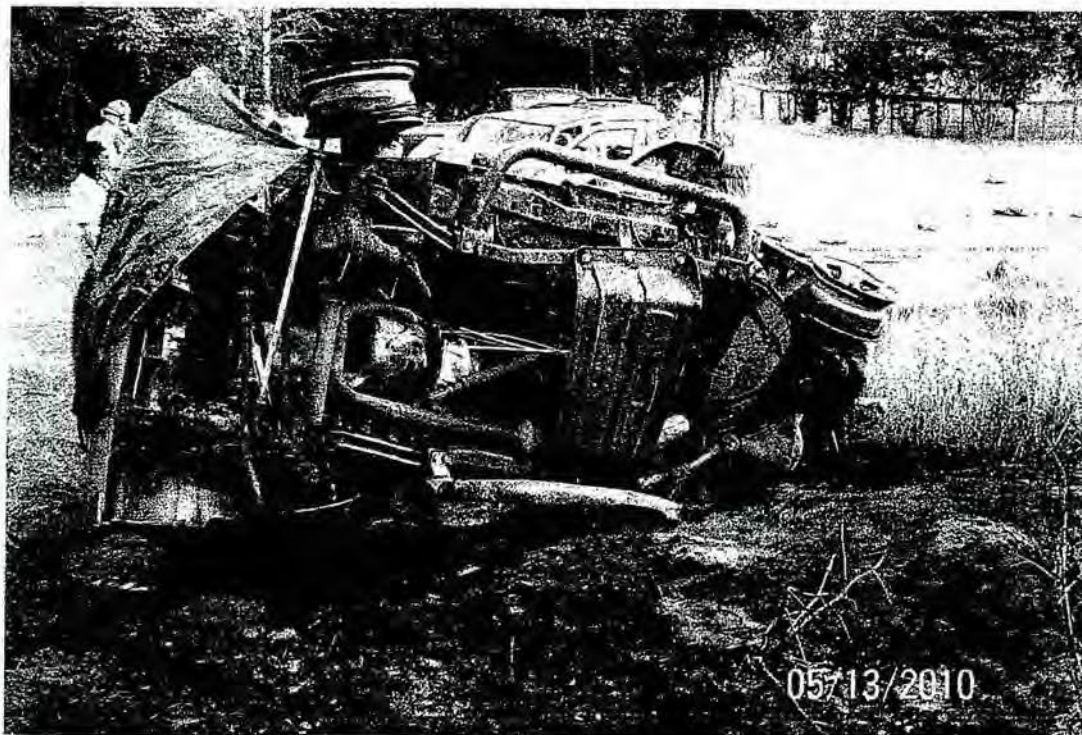
20. Unit 2 undercarriage

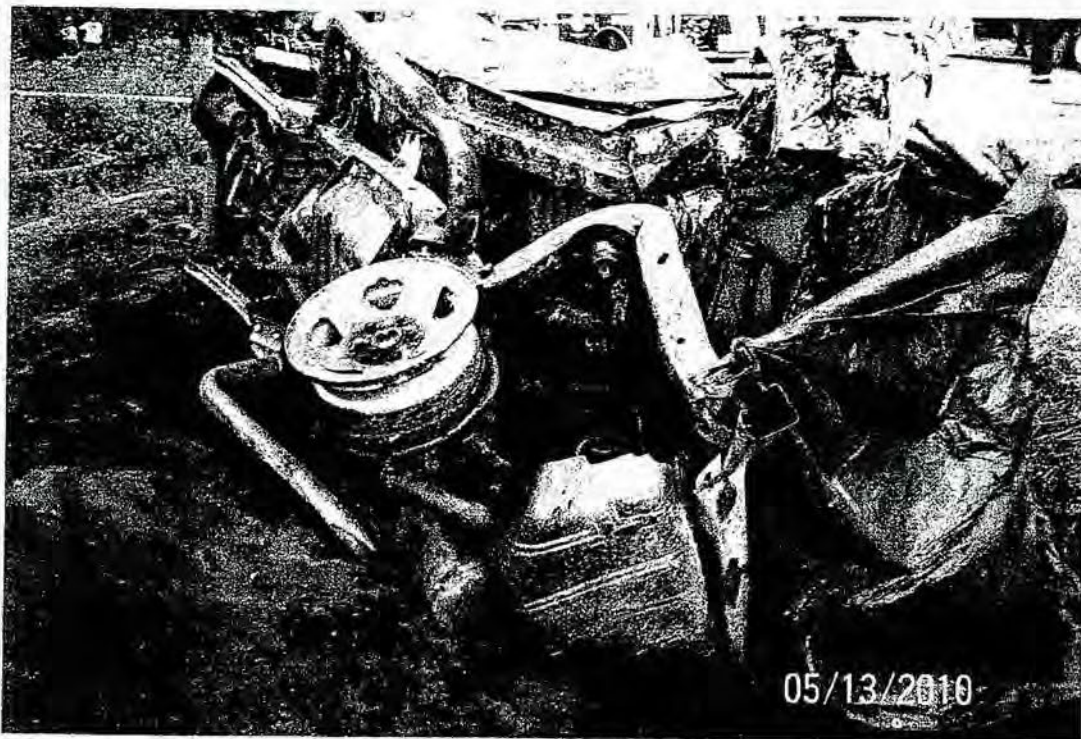
21. Unit 2 rear & undercarriage

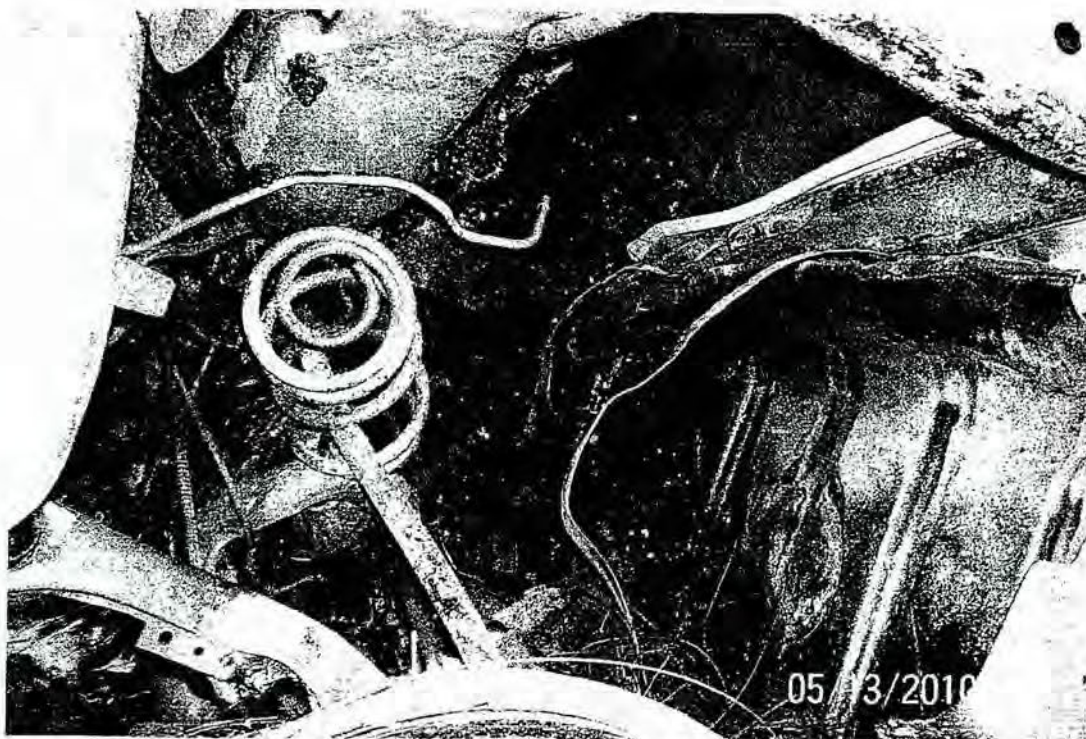
22. Unit 2 rear axle, fuel tank, suspension, etc.
