EA12-008

HYUNDAI-KIA

RESPONSE TO REQUEST 4

■ MDa accident vehicle' s present condition study details

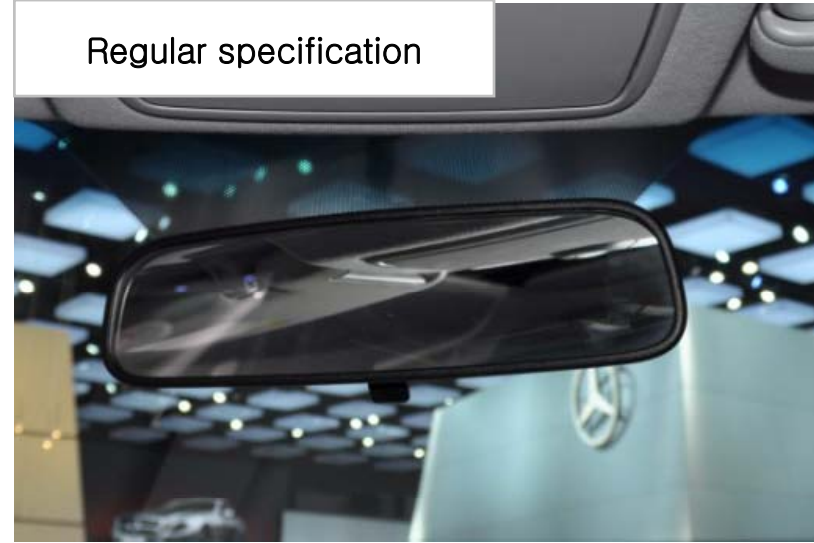
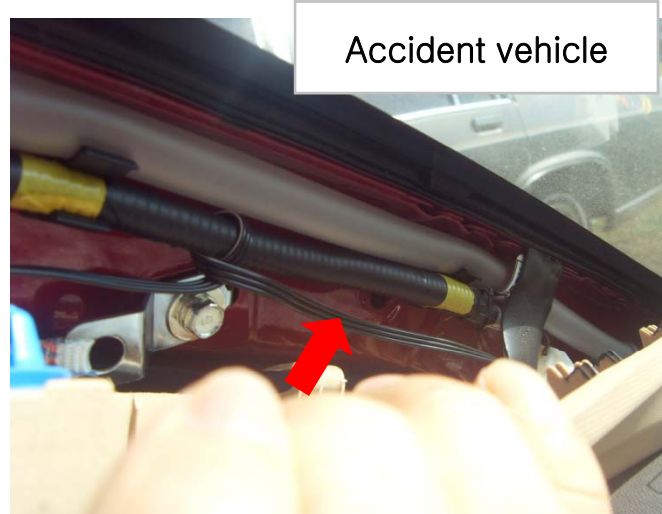
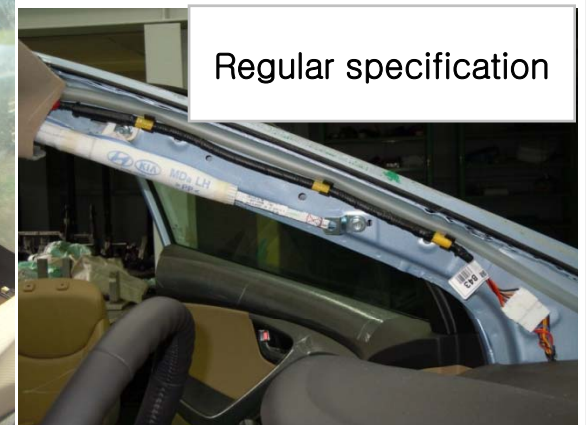
I/S MIRROR Specification Difference

- I/S MIRROR specification difference : Replacement work performed
 - WIR'G work from lower end part of A-PLR to H/LIN'G CTR part

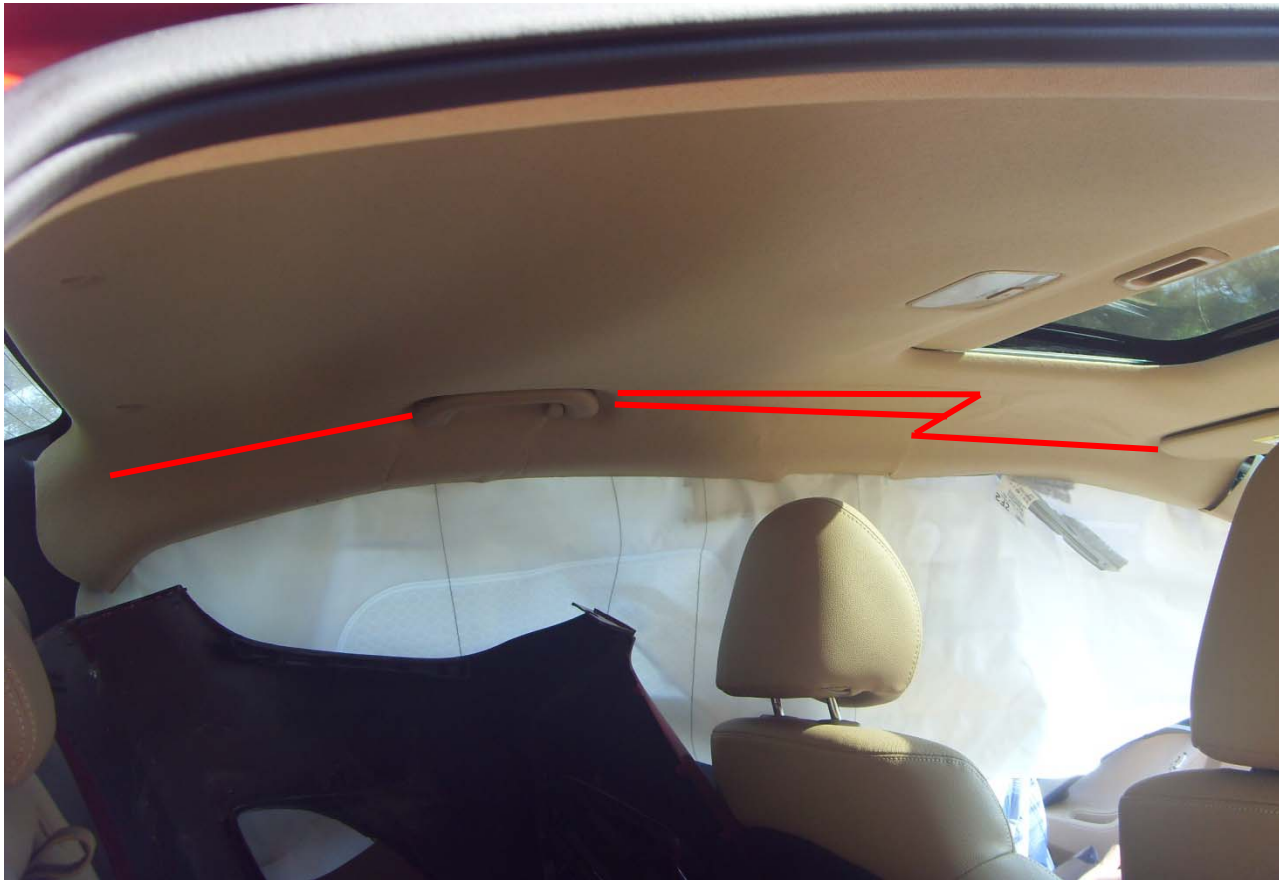
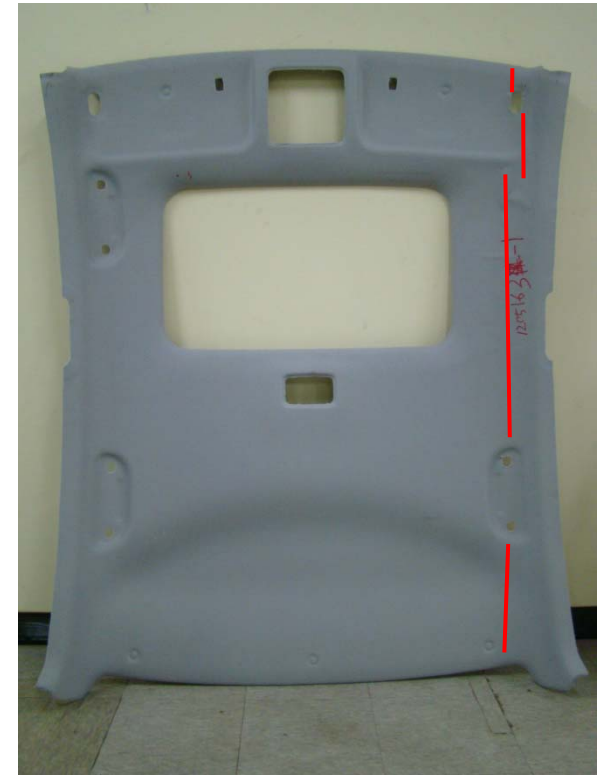
Actual vehicle H/LIN'G deployment line
- TEST : 5/15

- CTR part slightly different from actual vehicle TEST, but CAB deployment is normal

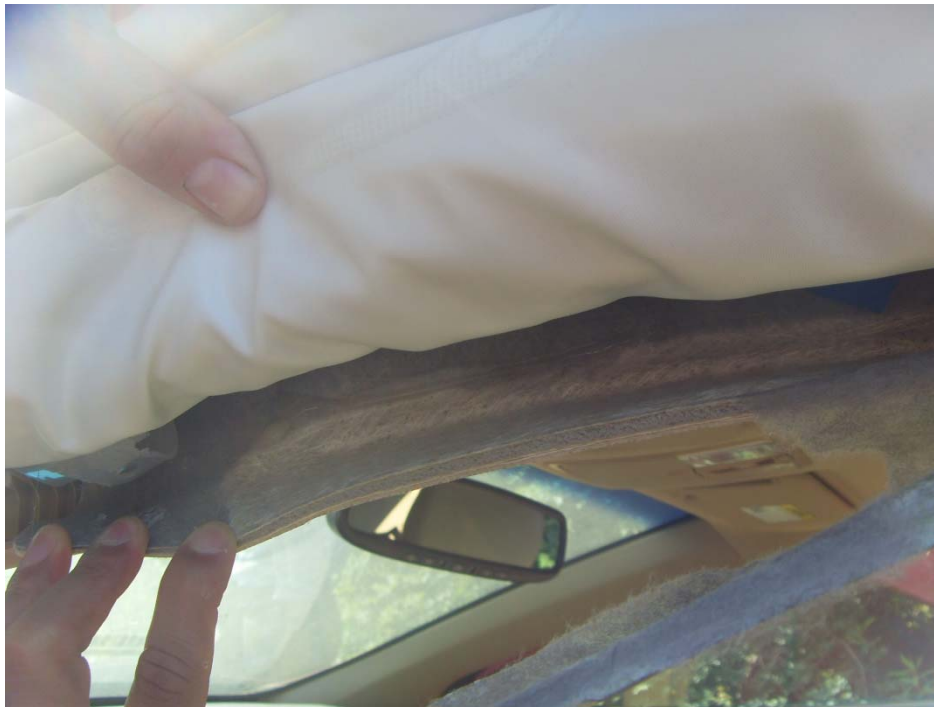
- Hot melt application volume is small and application condition is uneven
 - BRKT upper end part : Application volume is small and leans toward H/LIN'G part in application
 - BRKT lower end part : Application volume is small, but application is uniformly even with H/LIN'G

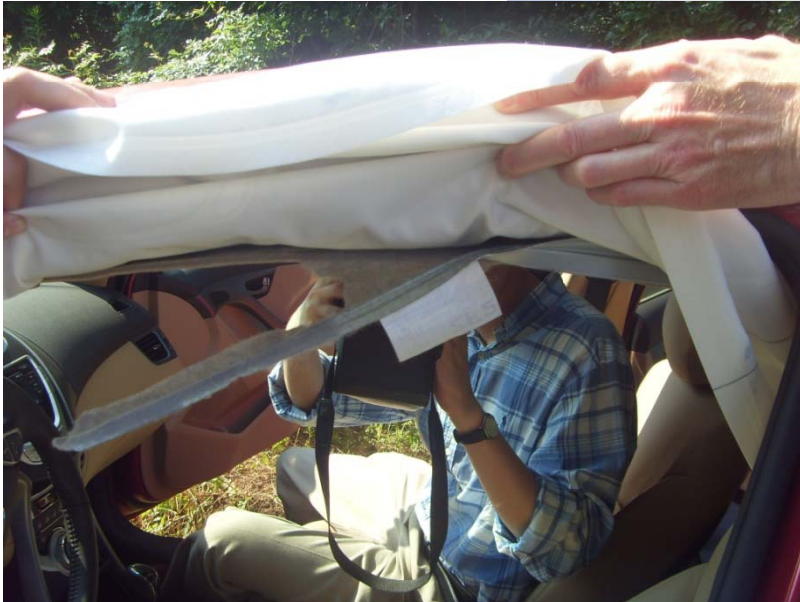
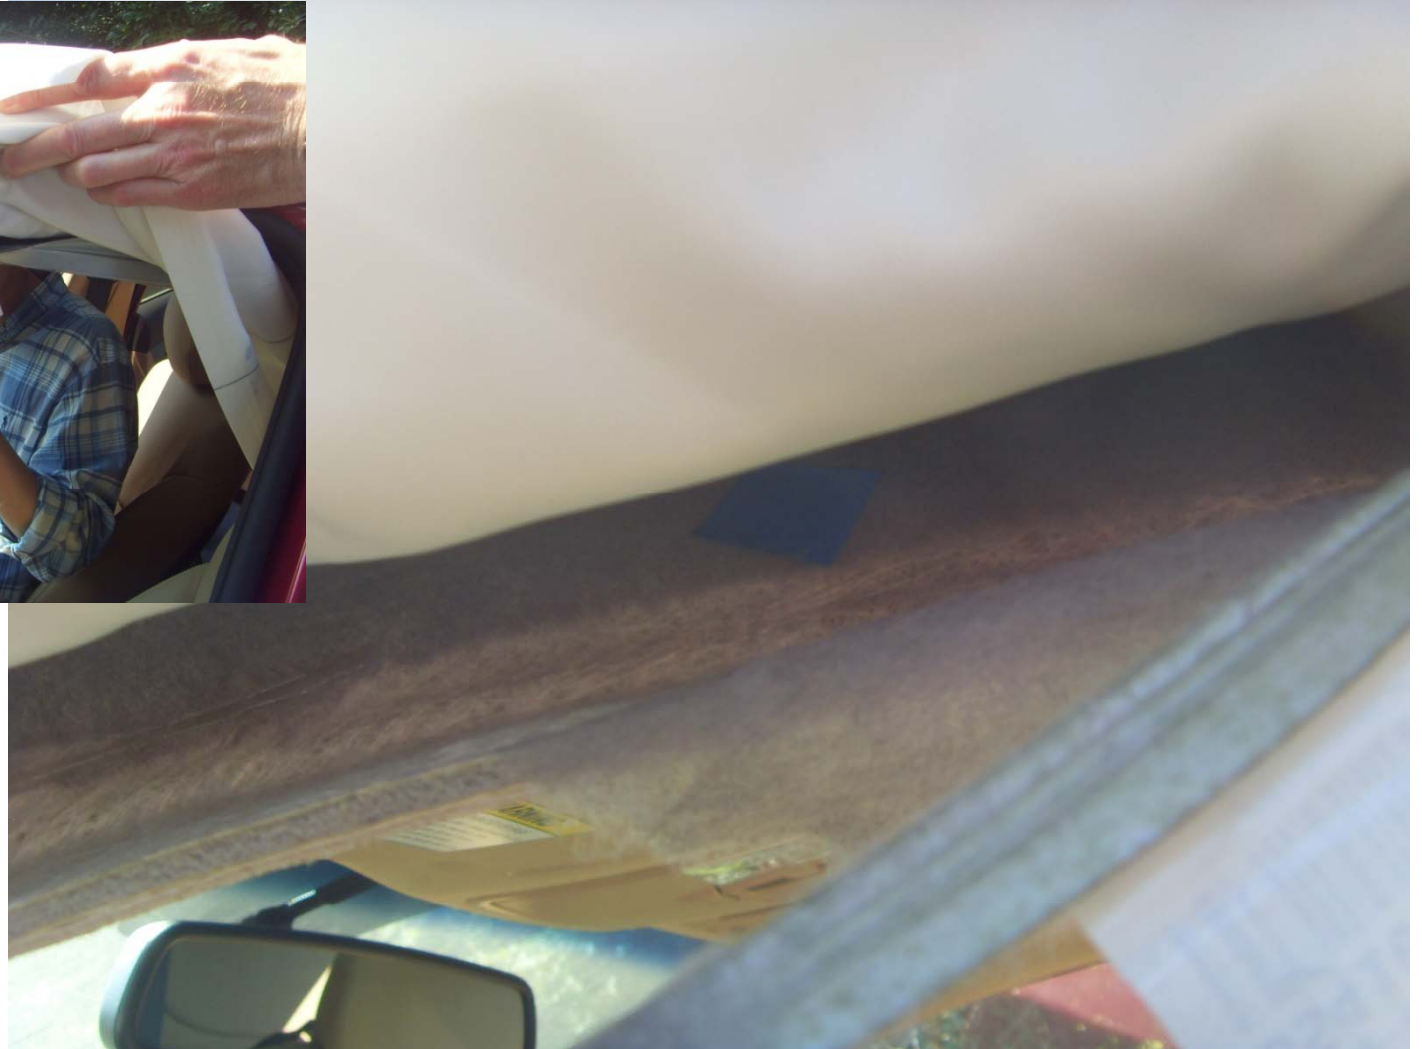
BRKT spray adhesion

- ▣ Spray adhesive application volume assumed as uneven
 - Non-woven fabric is stuck in BRKT lower end part and is raised, upper end part lacks adhesive (Blue color adhesive is light)

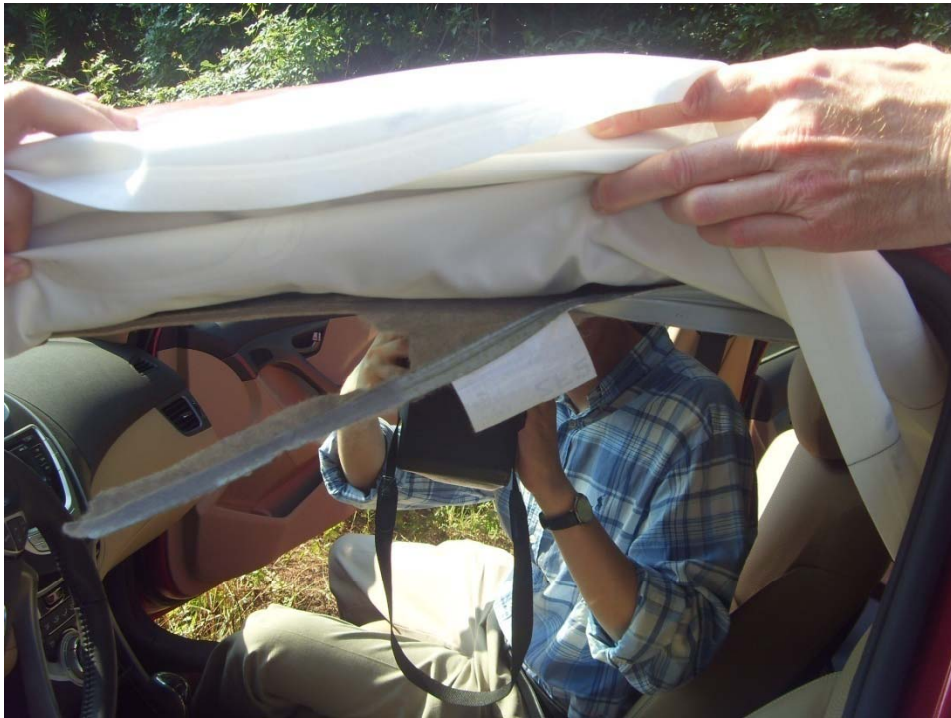
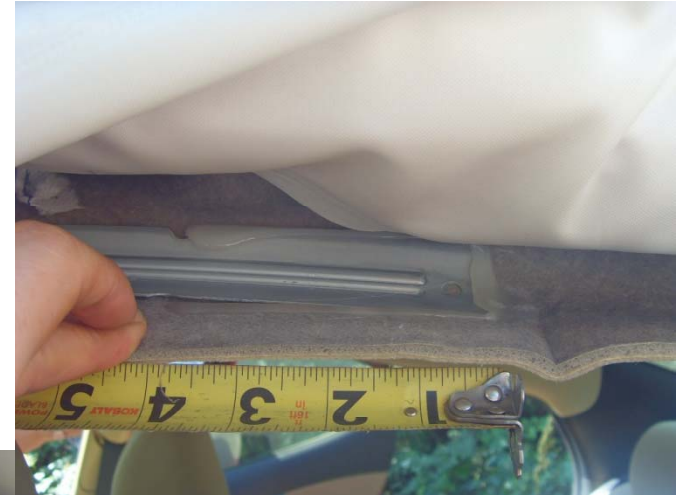
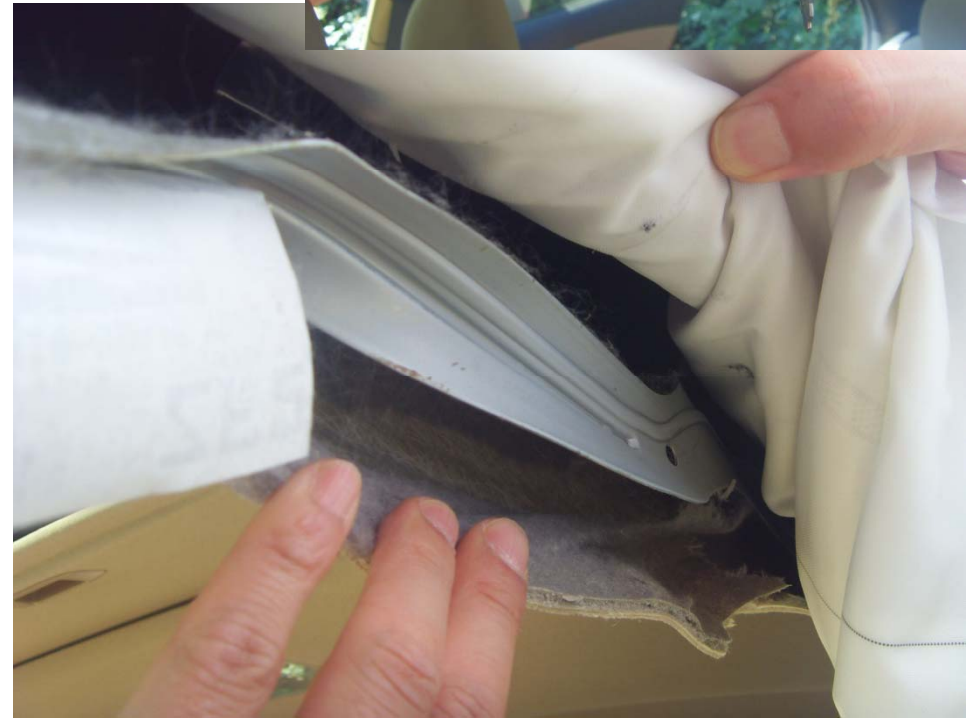
BRKT displacement form

- Excluding some rear side, overall displacement
→ CAB deployment anticipated in the condition of BRKT separated from H/LIN'G

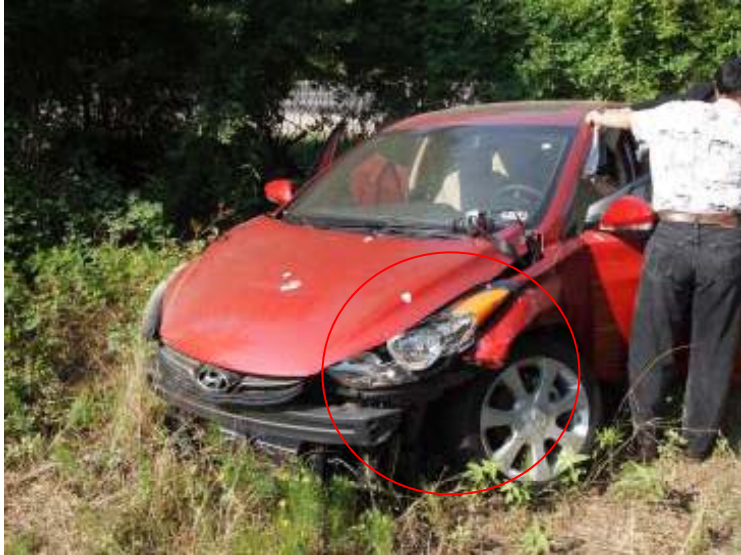
Vehicle deformation condition

→ Accident circumstance detail verification anticipation (with HMA)
From left side impact form, hood/fender/tire area deformation occurrence

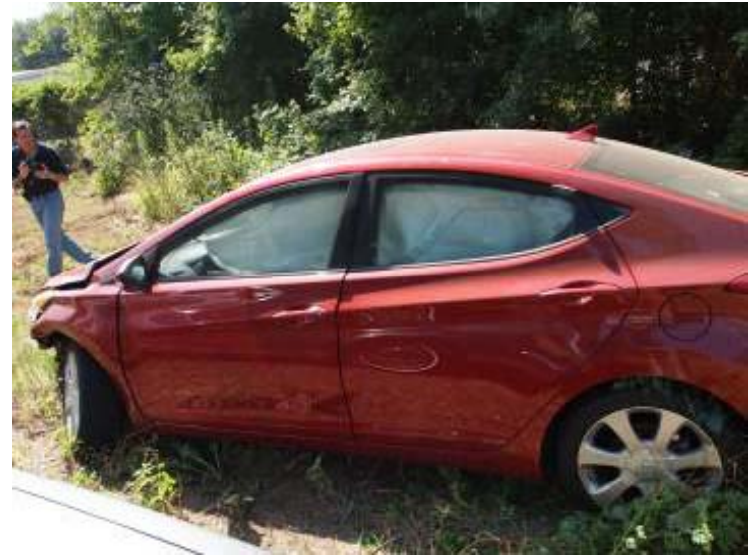
There is no LH SIDE door and left side body damage

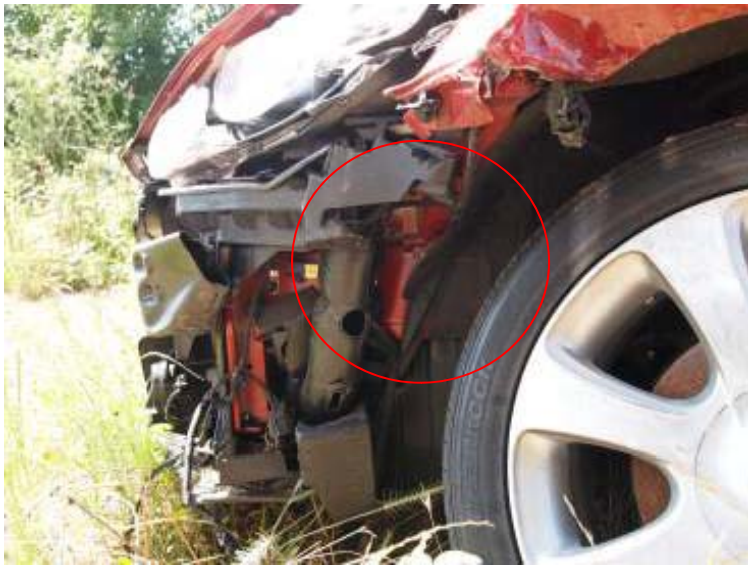
Body deformation area detailed photo-S/MBR mid part bending occurs
