Field Performance Report GM Aftersales

FPR Case No:	48392	Status: Saved
Type:	GMNA Truck	Transfer:
VIN:	1GNDT13S662 [REDACTED]	Country: United States of America
Make:	Chevrolet	Vehicle Status:
Model:	TrailBlazer	
Model Year:	2006	
Part Name:	Door Module	
Location:	Drivers	
Complaint:	Shorted	
Origination Point:	<input checked="" type="radio"/> Dealer <input type="radio"/> GM Internal	
Dealer Code	115086	
GM Rep ID No

- The review of 12 GMT360 DDM (Push Pull design) warranty returns since February 2006, have indicated that these modules were malfunctioning due to corroded B+ and ground traces on the control board. Of the 12 units, 6 showed evidence of excessive current draw resulting in open circuit traces (see attached Warranty Return Analysis report).

Root Cause Analysis

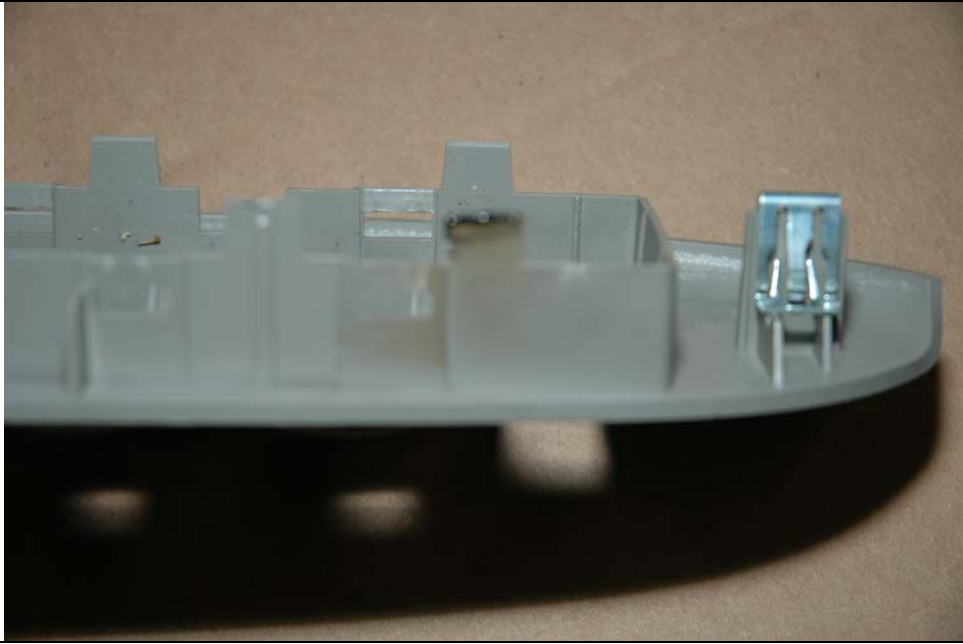
0016

L/F DOOR POWER WINDOW SWITCH DAMAGE (DIFFERENT VIEW).
