ISUZU
DET-13-035

Subject: NVS-212-pco/EA12-005

EA12-005
Isuzu Peer Vehicle Information Request Response
REQUEST NUMBER TWO DATA

MODEL INFORMATION

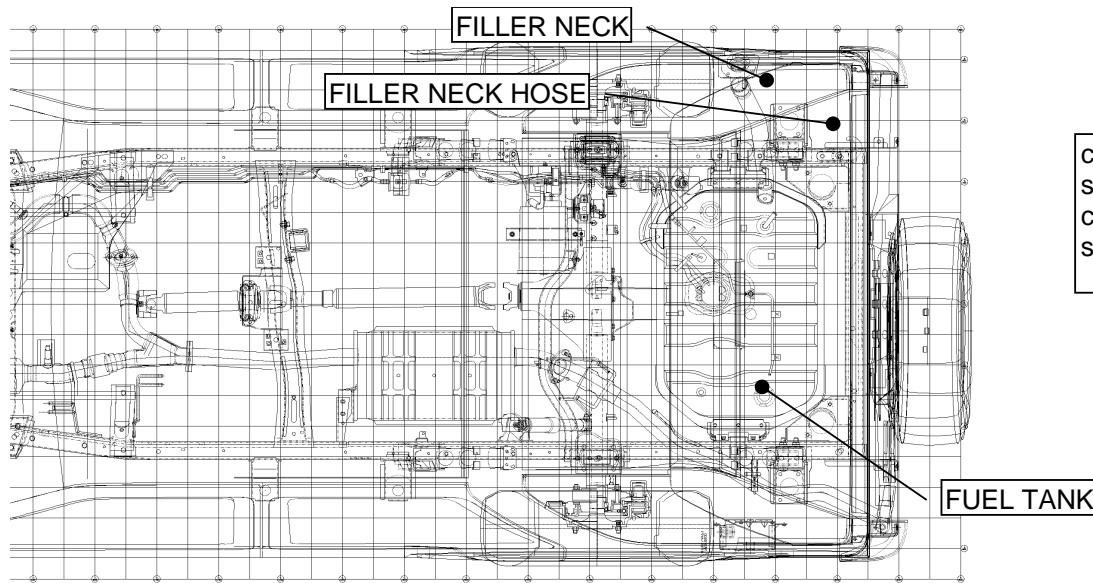
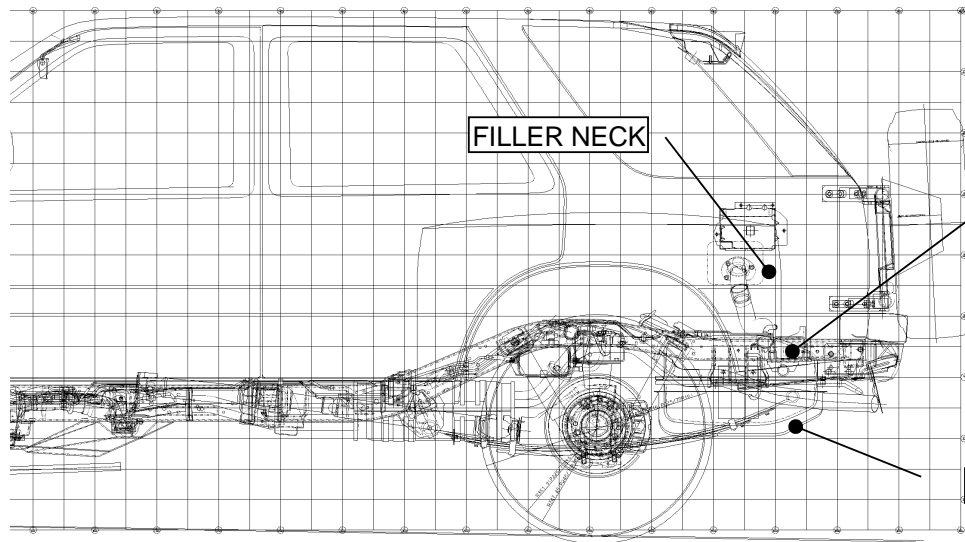
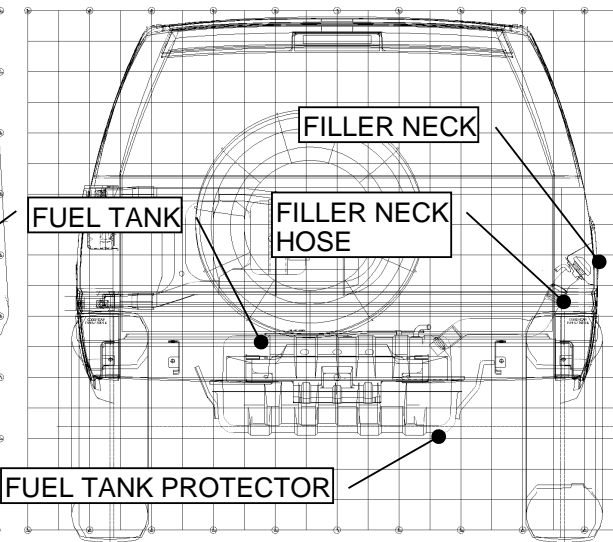
c. Side, rear, and top view drawings showing the placement of the subject components and related components that secure them in the vehicle;

| a. Model, model year, and platform designation; | Model | Rodeo | | Rodeo | | Rodeo | | Rodeo | | Rodeo | |
|--|---|---|---|---|---|---|---|---|---|---|---|
| c. Side, rear, and top view drawings | | See attached sheet "c UC drawing" | | <- | <- | <- | <- | <- | <- | <- | <- |

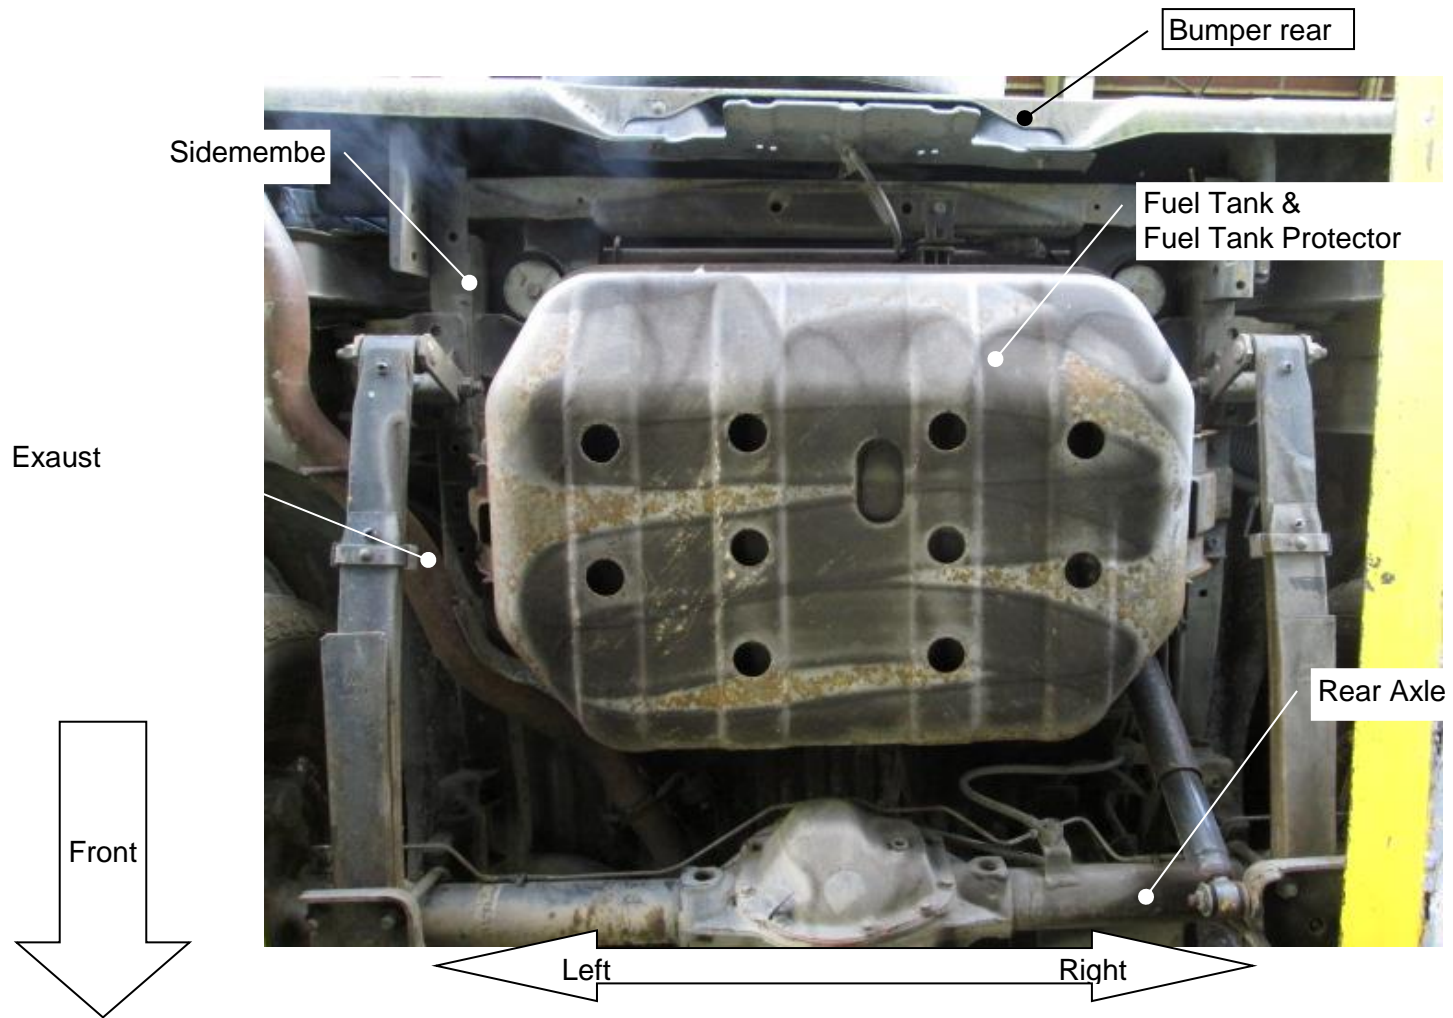
| a. Model, model year, and platform designation; | Model | Rodeo | | Rodeo | | Rodeo | | Rodeo | | Rodeo | |
|--|---|---|---|---|---|---|---|---|---|---|---|
| d. A bottom view drawing or photograph | | See attached sheet "d UC picture" | | <- | <- | <- | <- | <- | <- | <- | <- |

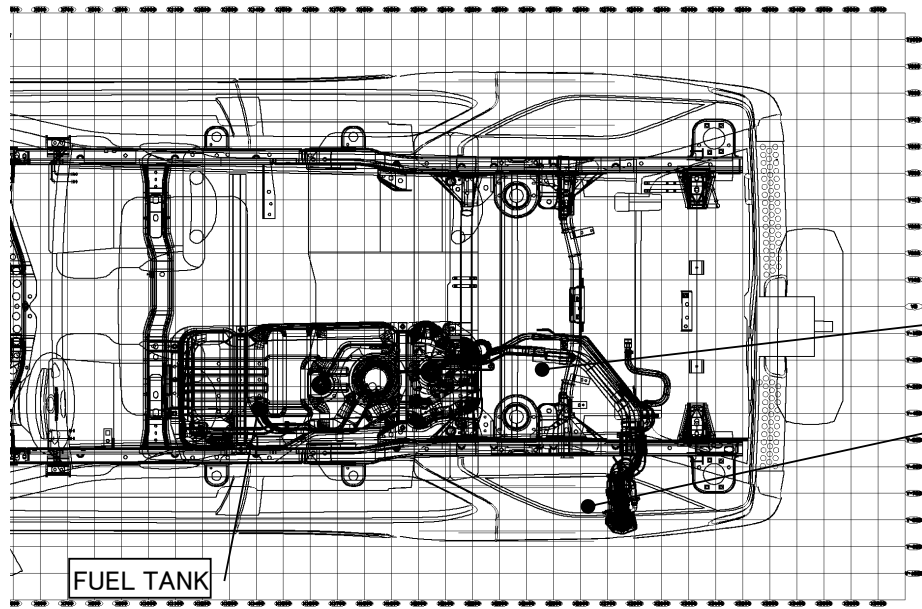
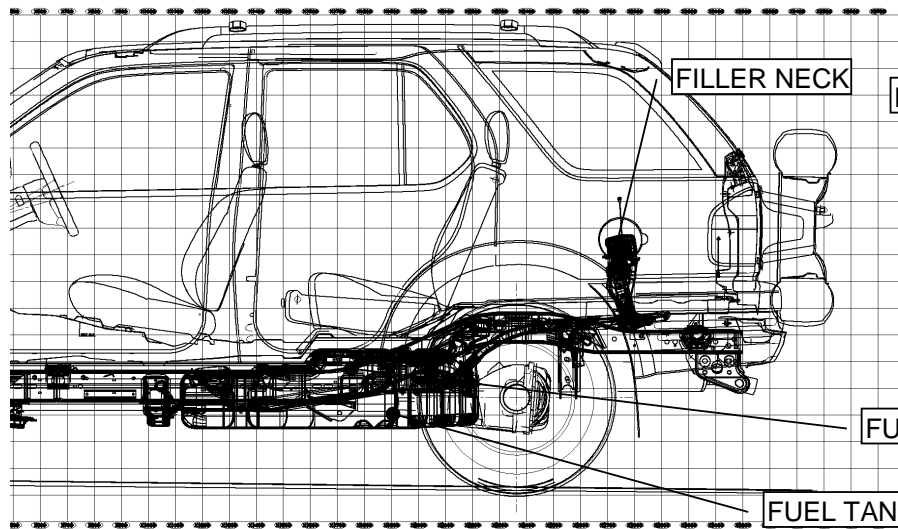
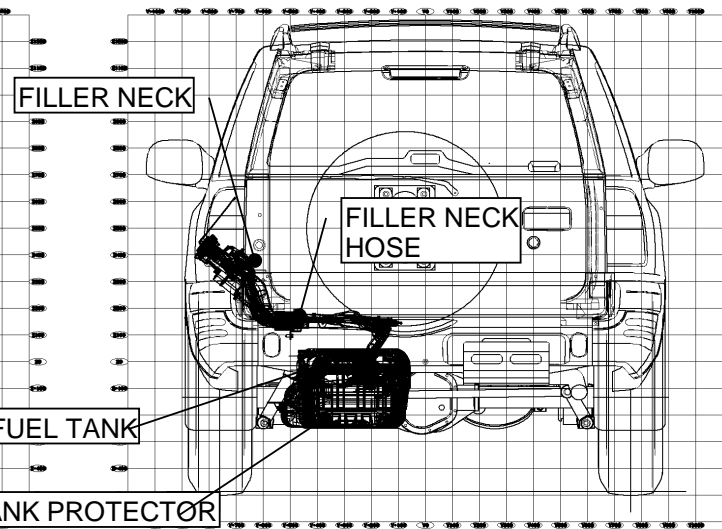
c. Side, rear, and top view drawings showing the placement of the subject components and related components that secure them in the vehicle;

FILLER NECK HOSE

FILLER NECK

FUEL TANK

FUEL TANK PROTECTOR

FILLER NECK
HOSE

| a. Model, model year, and platform designation; | Model | Rodeo | Rodeo | Rodeo | Rodeo | Rodeo | Rodeo | Rodeo |
|---|---|---|---|---|---|---|---|---|
| c. Side, rear, and top view drawings | | See attached sheet "c UE drawing" | <- | <- | <- | <- | <- | <- |

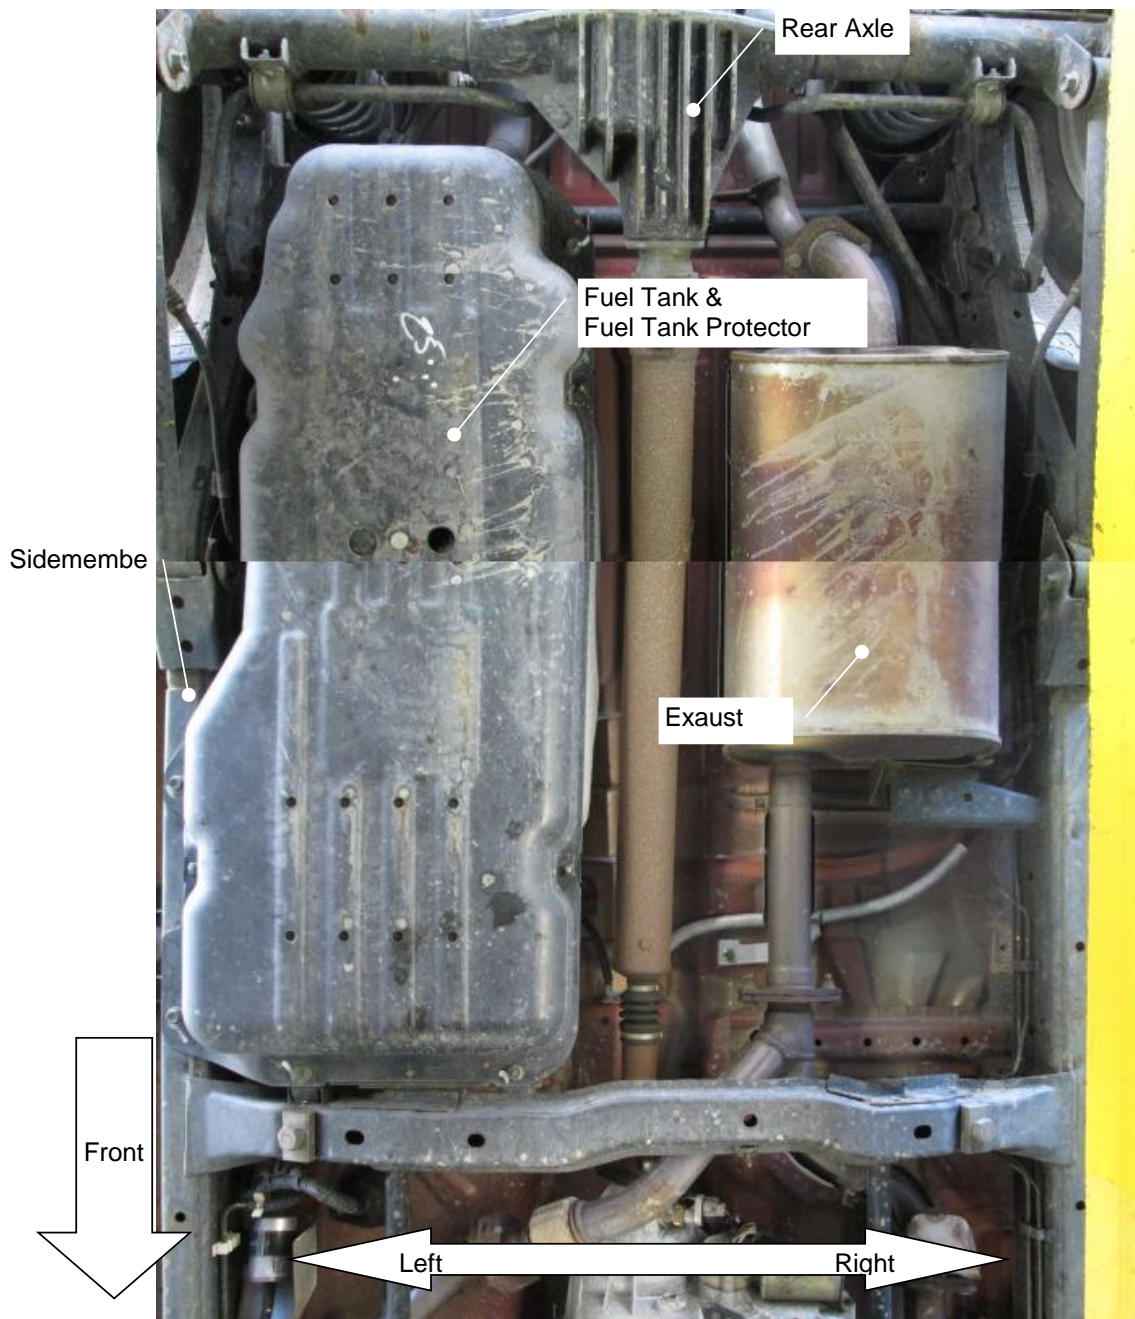
| a. Model, model year, and platform designation; | Model | Rodeo | Rodeo | Rodeo | Rodeo | Rodeo | Rodeo | Rodeo |
|---|---|---|---|---|---|---|---|---|
| d. A bottom view drawing or photograph | | See attached sheet "d UE picture" | <- | <- | <- | <- | <- | <- |

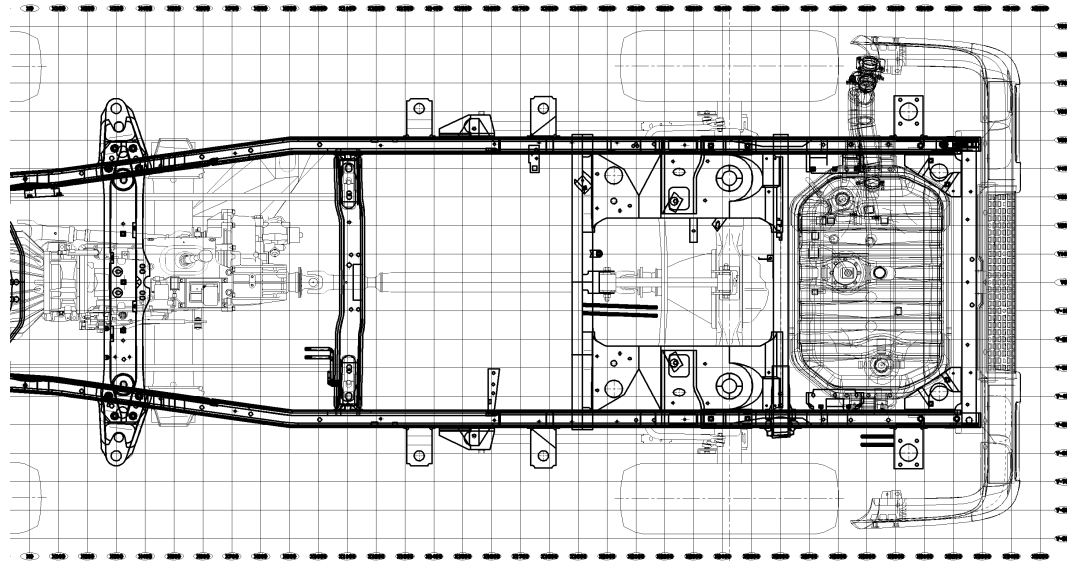
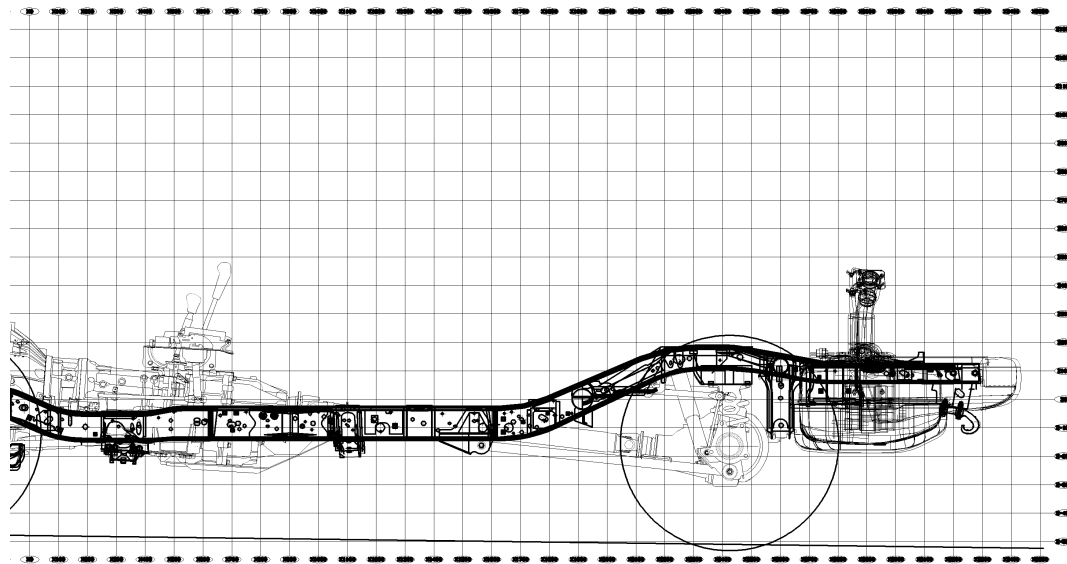
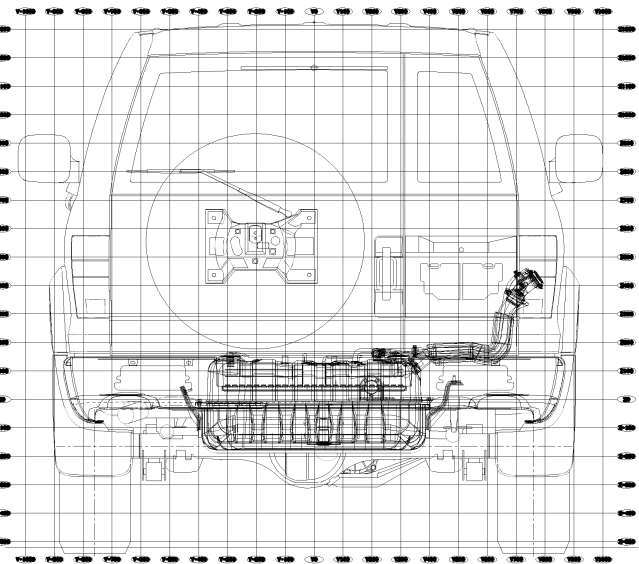
c. Side, rear, and top view drawings showing the placement of the subject components and related components that secure them in the

| a. Model, model year, and platform designation; | Model | Trooper | | Trooper | | Trooper | | Trooper | | Trooper | Trooper | Trooper | Trooper | Trooper | Trooper |
|--|---|---|---|---|---|---|---|---|---|---|---|---|---|---|---|
| c. Side, rear, and top view drawings | See attached sheet "c UX" | | < | | < | | < | | < | | < | < | < | < | < |

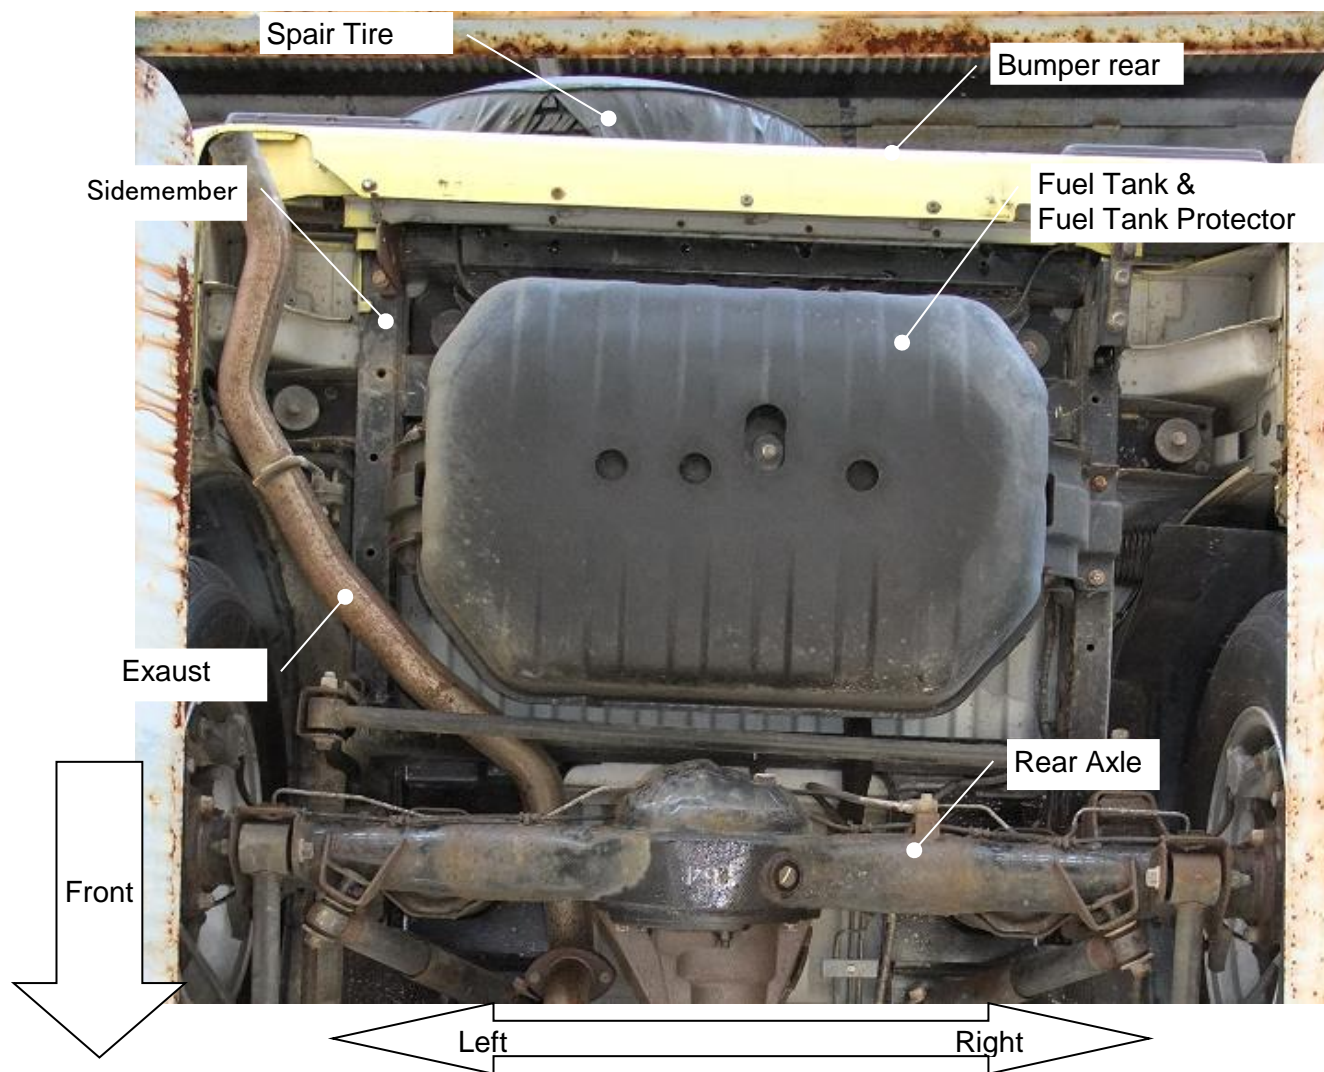
| a. Model, model year, and platform designation; | Model | Trooper | | Trooper | | Trooper | | Trooper | | Trooper | Trooper | Trooper | Trooper | Trooper | Trooper |
|--|---|---|---|---|---|---|---|---|---|---|---|---|---|---|---|
| d. A bottom view drawing or photograph | See attached sheet "d UX picture" | | < | | < | | < | | < | | < | < | < | < | < |
