**Toyota Motor Engineering &
Manufacturing North America, Inc.**

Re: NVS-212mjl; PE12-002

On behalf of Toyota Motor Corporation, this is a response to your February 17, 2012 information request (IR) regarding PE12-002. Please find the enclosed response to your inquiry and attachments (on CD-ROM) for the specific information requested. Additional information will be provided at a later time as noted in the response.

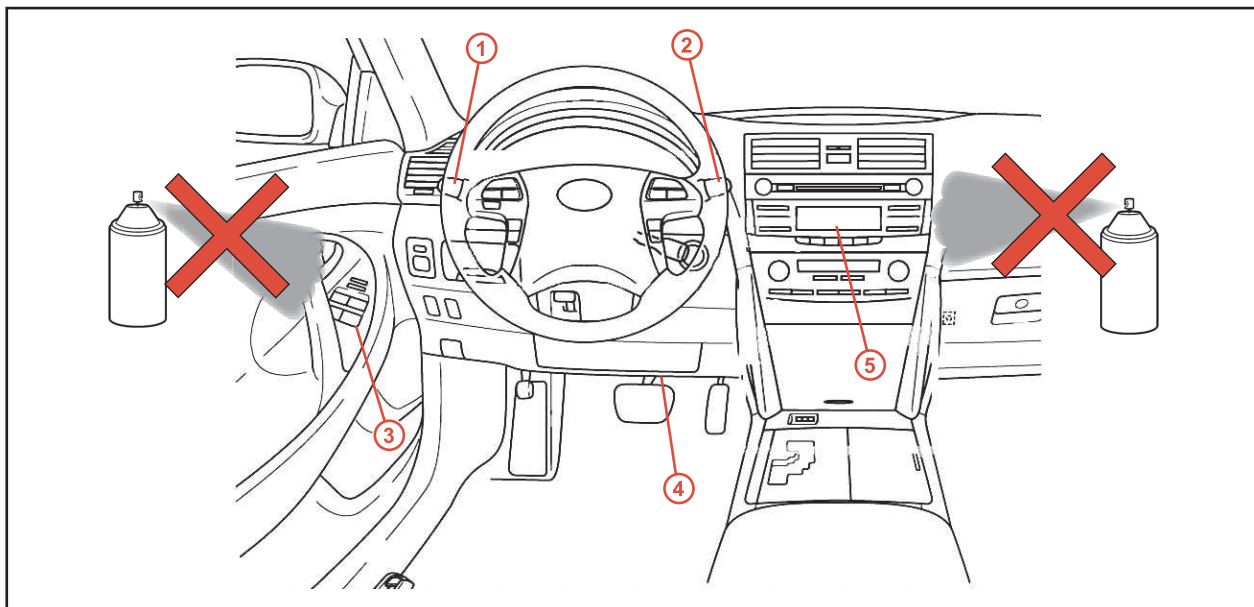
Figure 1.

- Brake lights
 - Cruise control
 - Shift interlock
- Care must be taken to **NOT** allow moisture to get into the switches when using upholstery steam cleaning equipment.

1	Headlight Dimmer Switch
2	Wiper Switch
3	Power Window Master Switch

4	Stop Light Switch
5	Audio
