PE13-002

VOLVO TRUCK

**Clutch Control Actuator Failure**

## Redundant Brake Pedal Micro Switch, Removal VN VHD

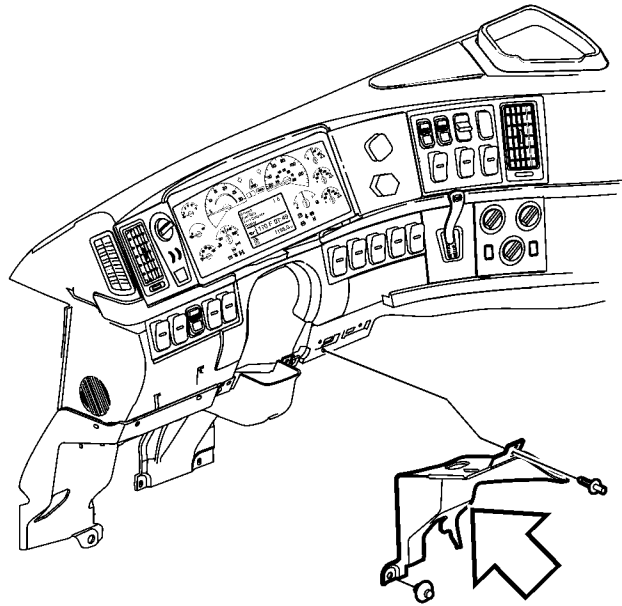
W8003940

- 1 Remove the drivers side lower right hand dash panel to gain access to the brake pedal switch.

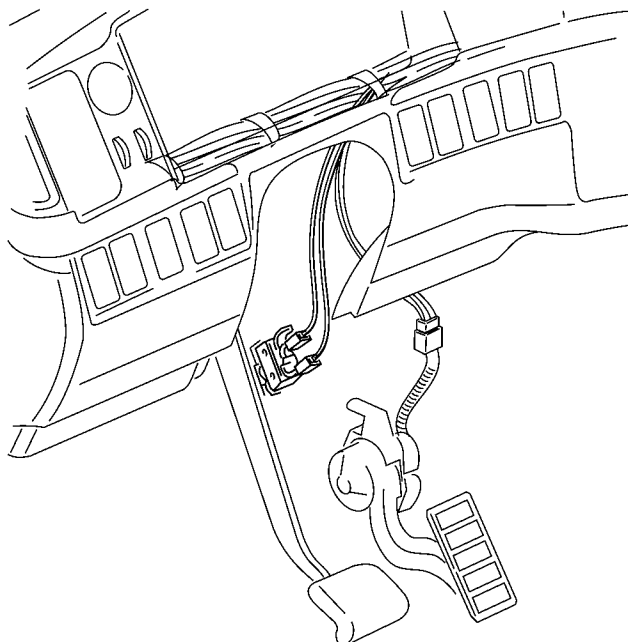
W3007823

- 2 Locate and remove the I-Shift brake pedal micro switch.

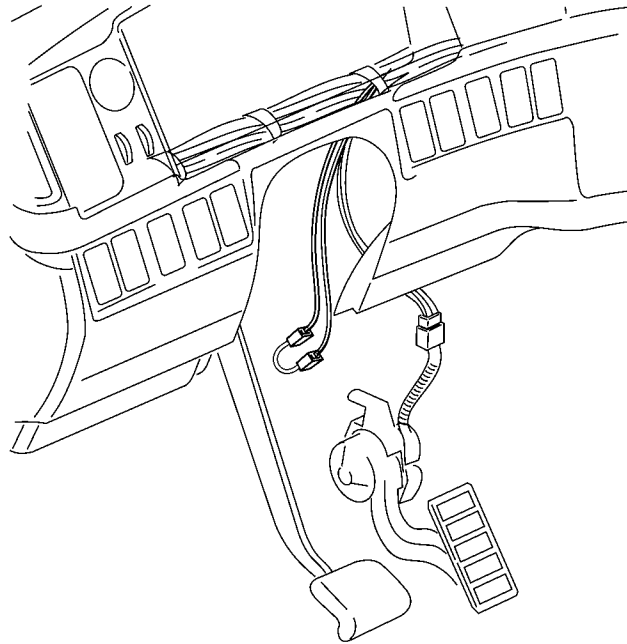
W3007822

- 3 Insert jumper wire (20913375) into the now vacant connector terminals.

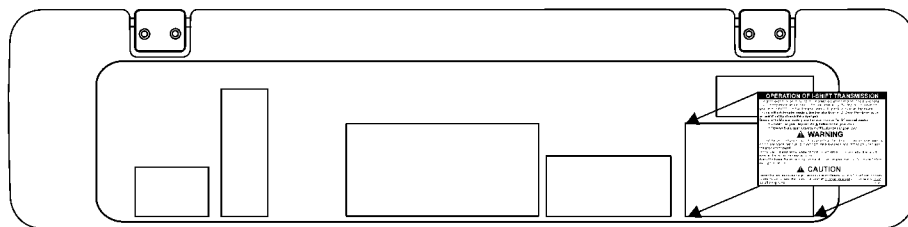
W8003941

- 4 Reinstall the drivers side lower right hand dash panel.
- 5 Lower the drivers side sun visor and install the new I-Shift instruction decal over the existing decal.

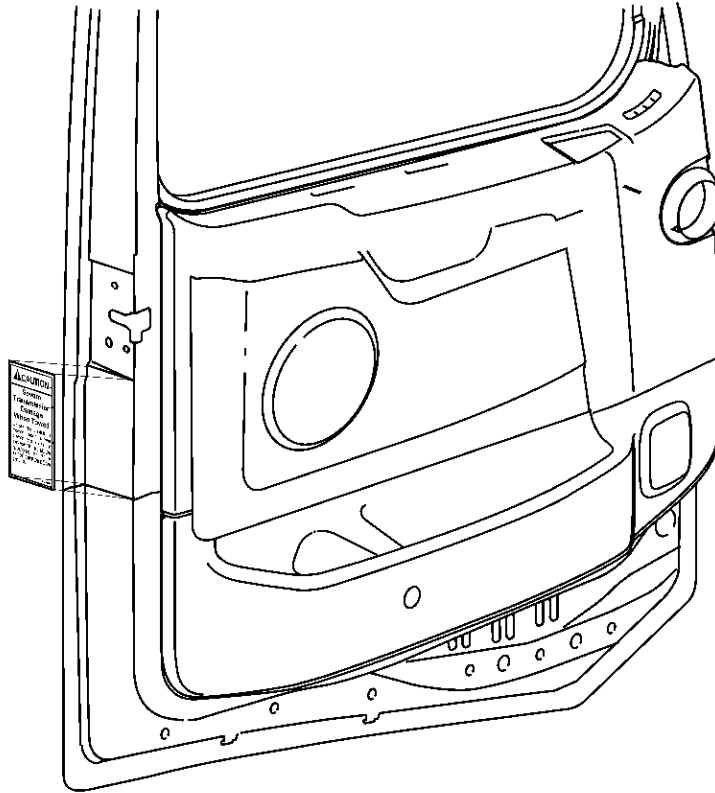
W8003942

- 6 Wipe clean the surface of the left hand door frame directly below the latch and install the I-Shift towing warning decal (21209123) as shown in below.

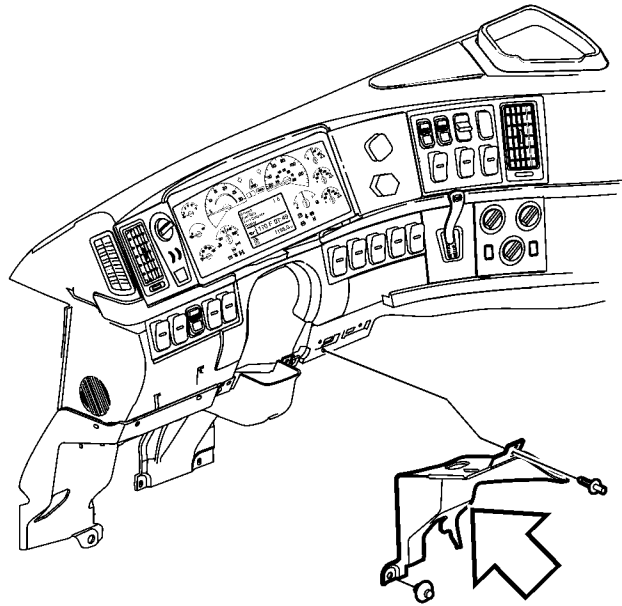
W8003940

- 1 Remove the drivers side lower right hand dash panel to gain access to the brake pedal switch.

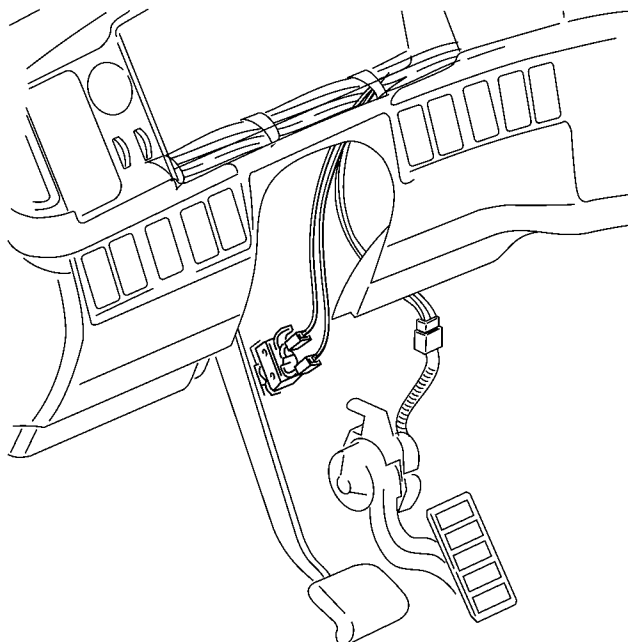
W3007823

- 2 Locate and remove the I-Shift brake pedal micro switch.

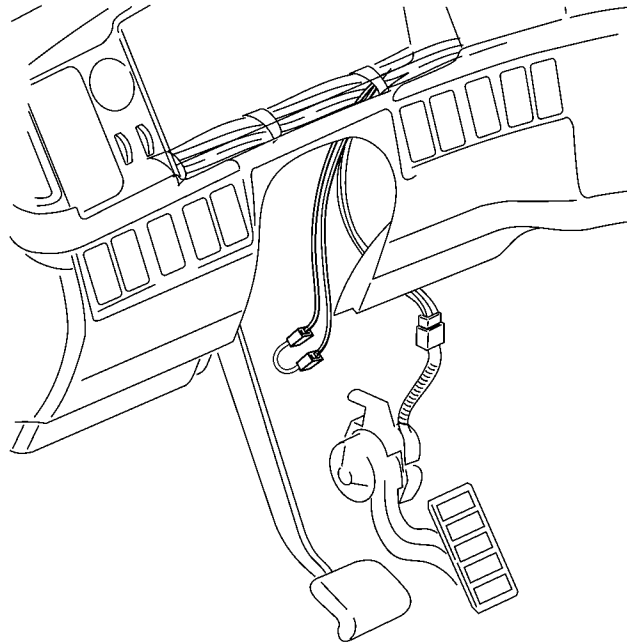
W3007822

- 3 Insert jumper wire (20913375) into the now vacant connector terminals.

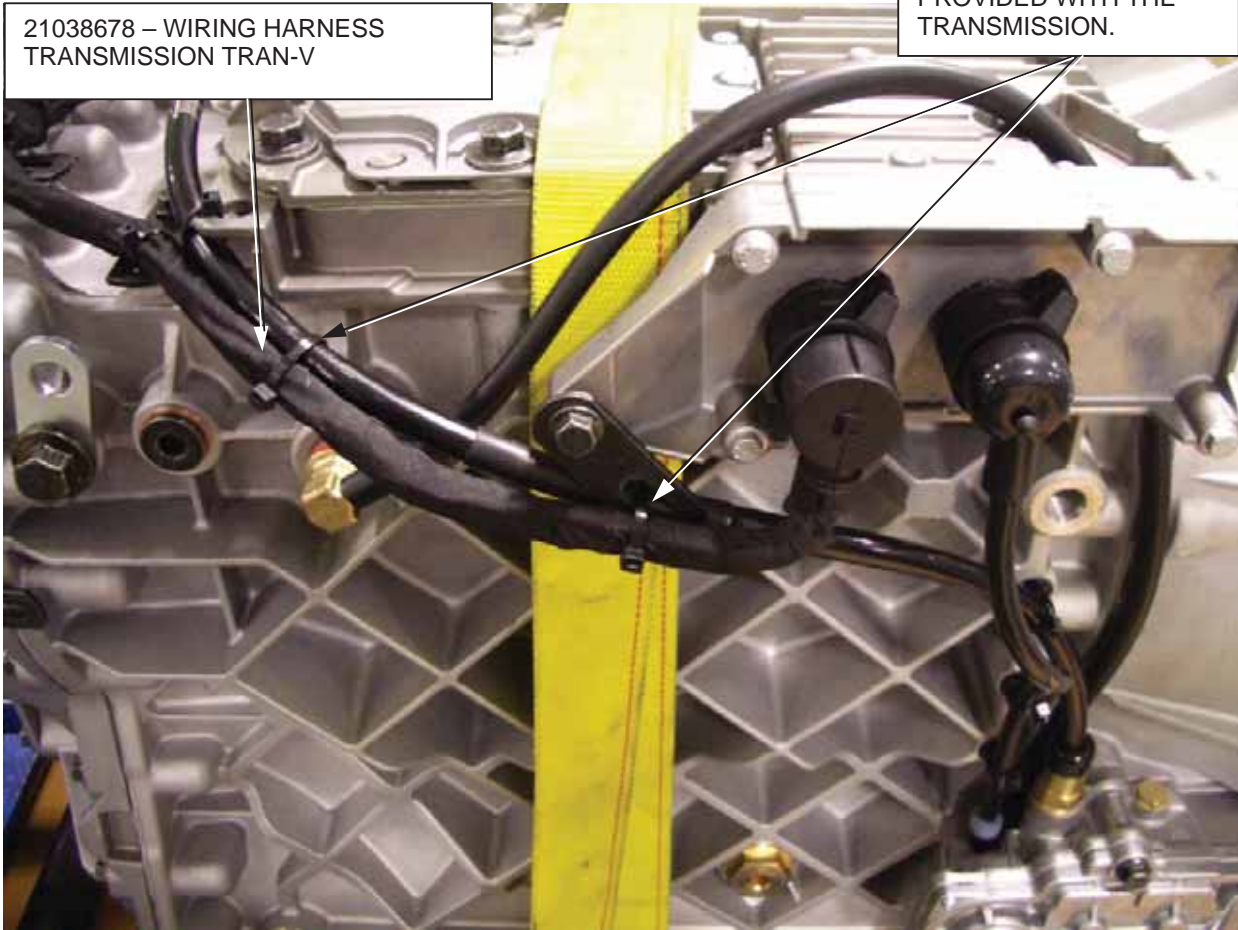
THIS VIEW SHOWS THE ROUTING AND CLIPPING OF THE I-SHIFT WIRING HARNESS FROM THE TCM ON THE RIGHT SIDE OF THE TRANSMISSION UP TO THE TOP BACK SIDE.

2x 948211 – CABLE TIE.  
CLIPPING BRACKET  
PROVIDED WITH THE  
TRANSMISSION.

21038678 – WIRING HARNESS  
TRANSMISSION TRAN-V

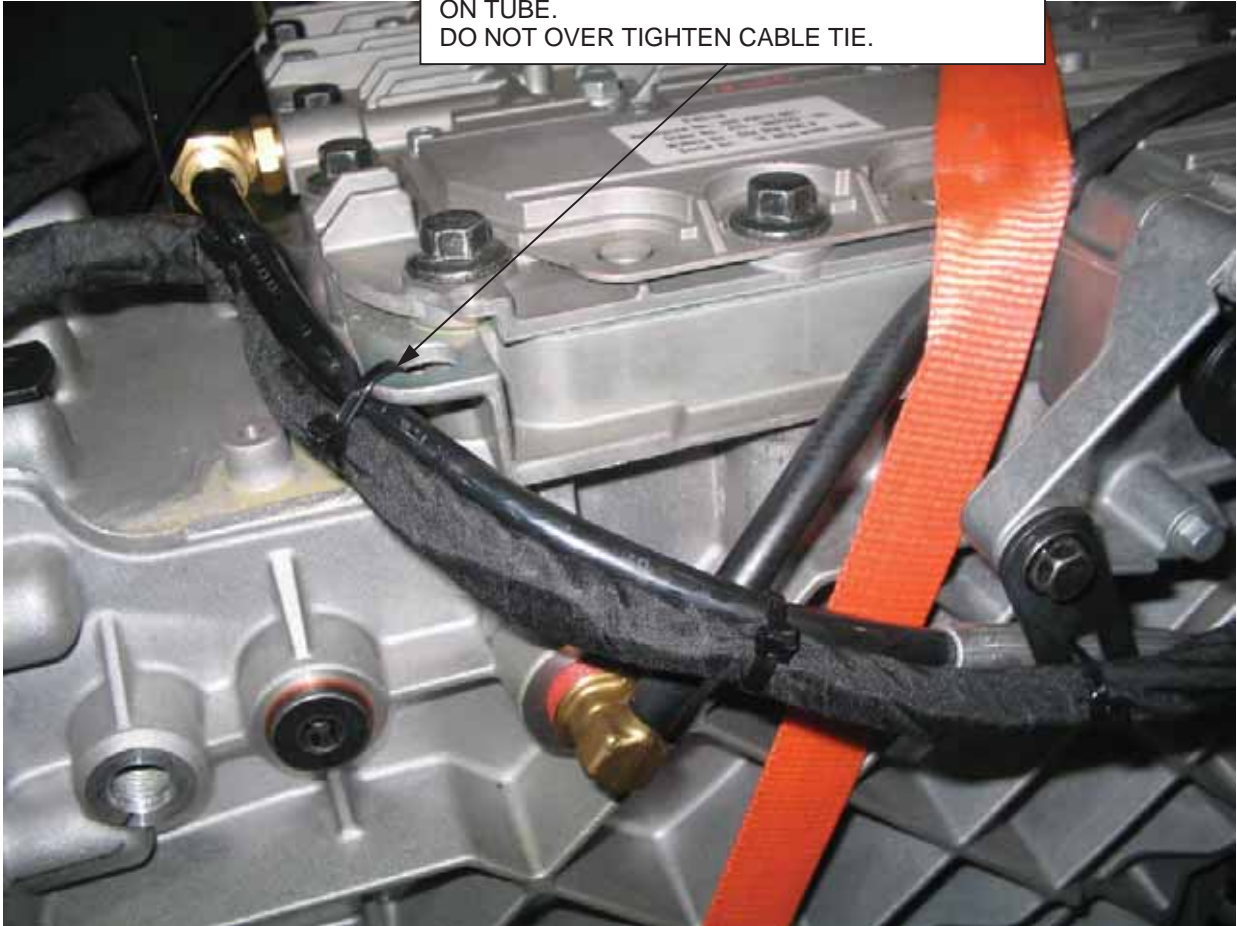
THIS VIEW SHOWS THE ROUTING AND CLIPPING OF THE WIRING HARNESS TO THE RIGHT REAR SIDE OF THE TRANSMISSION. NOTE: WIRING HARNESS IS TO BE TIED TO THE BOTTOM OF THE AIR LINE TO PREVENT ANY RUBBING OR CHAFFING.

948211 – CABLE TIE.  
NOT SHOWN IS A METAL SLEEVE AT TIE AREA ON TUBE.  
DO NOT OVER TIGHTEN CABLE TIE.

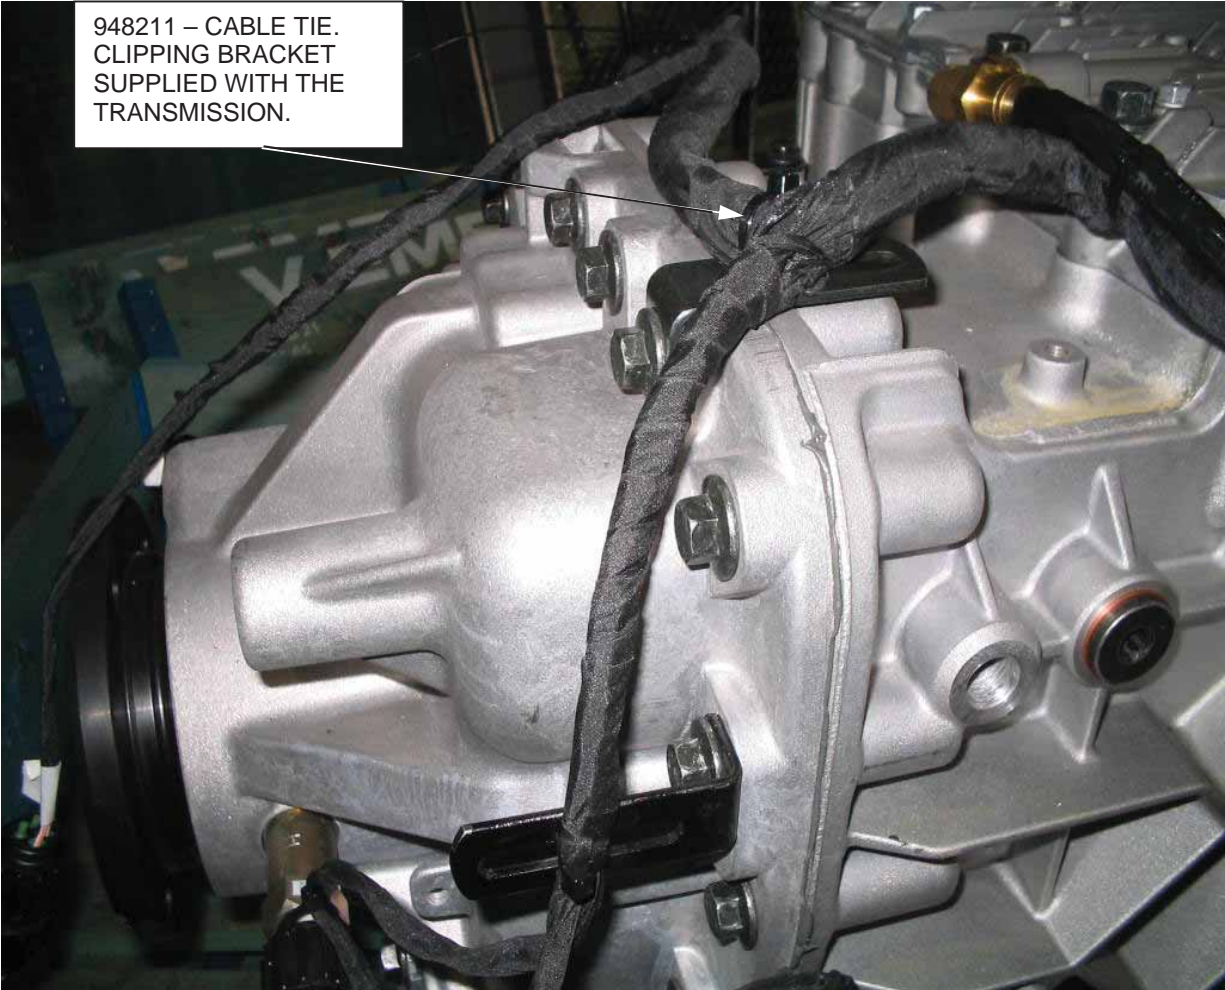
THIS VIEW SHOWS THE ROUTING AND CLIPPING OF THE WIRING HARNESS AT THE TOP RIGHT REAR CORNER OF THE TRANS AND ROUTING DOWN TO THE SPEEDO SENSOR CONNECTION.

948211 – CABLE TIE. CLIPPING BRACKET SUPPLIED WITH THE TRANSMISSION.

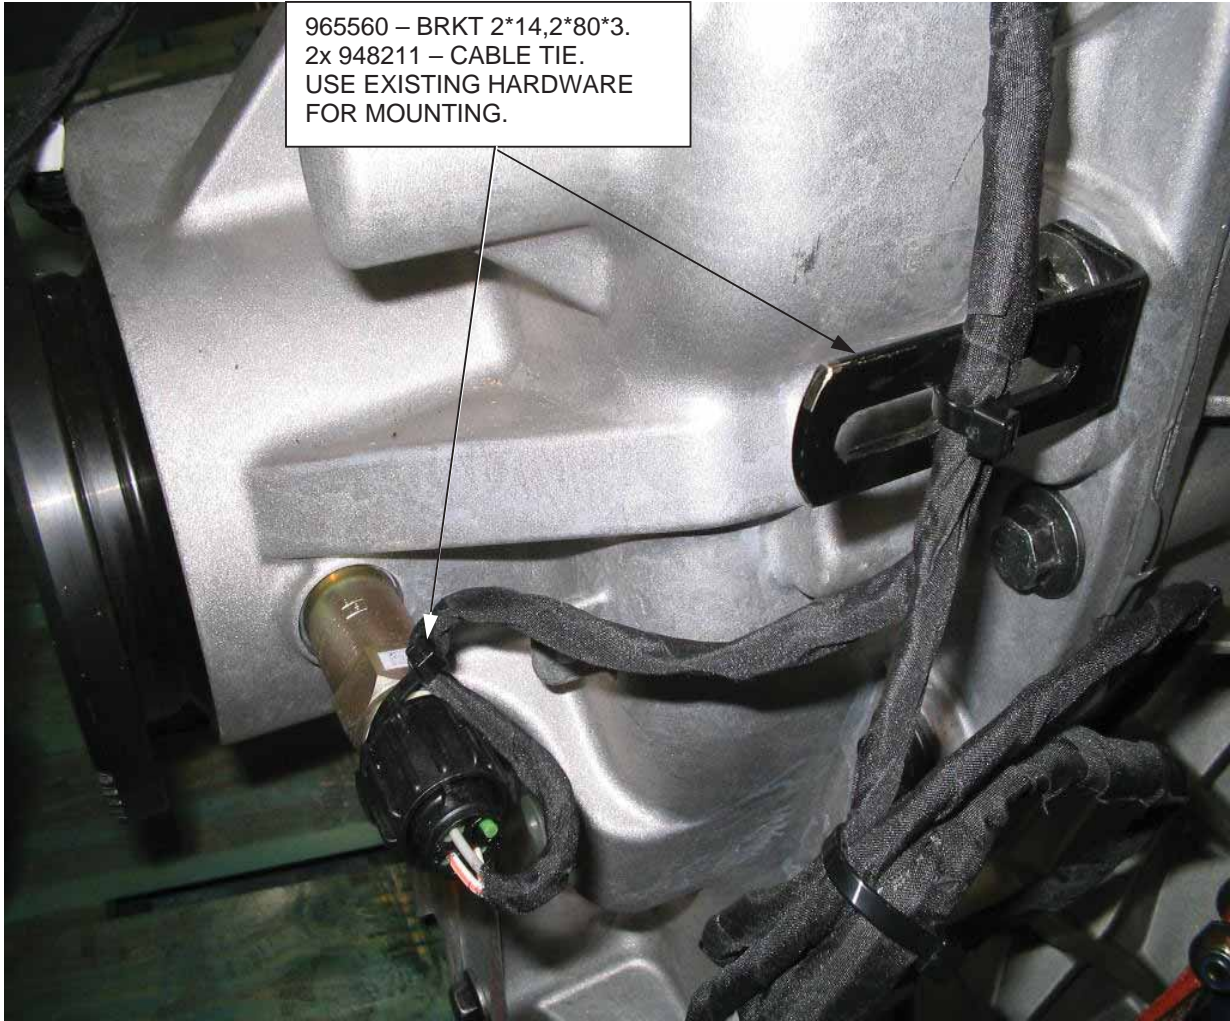
THIS VIEW SHOWS THE WIRING HARNESS ROUTED AND CLIPPED DOWN THE RIGHT REAR SIDE OF THE TRANSMISSION TO THE SPEEDO SENSOR.  
 NOTE: THE HARNESS IS TO BE TIED NEXT TO THE BRASS SPEEDO SENSOR INSERT NUT FOR STRAIN RELIEF CLIPPING.

965560 – BRKT 2\*14,2\*80\*3.  
 2x 948211 – CABLE TIE.  
 USE EXISTING HARDWARE FOR MOUNTING.

NOTE: HARNESS TO CHASSIS AND DPF CONNECTION ARE TO BE COILED AND TIED SECURELY TO TRANSMISSION FOR SHIPPING.

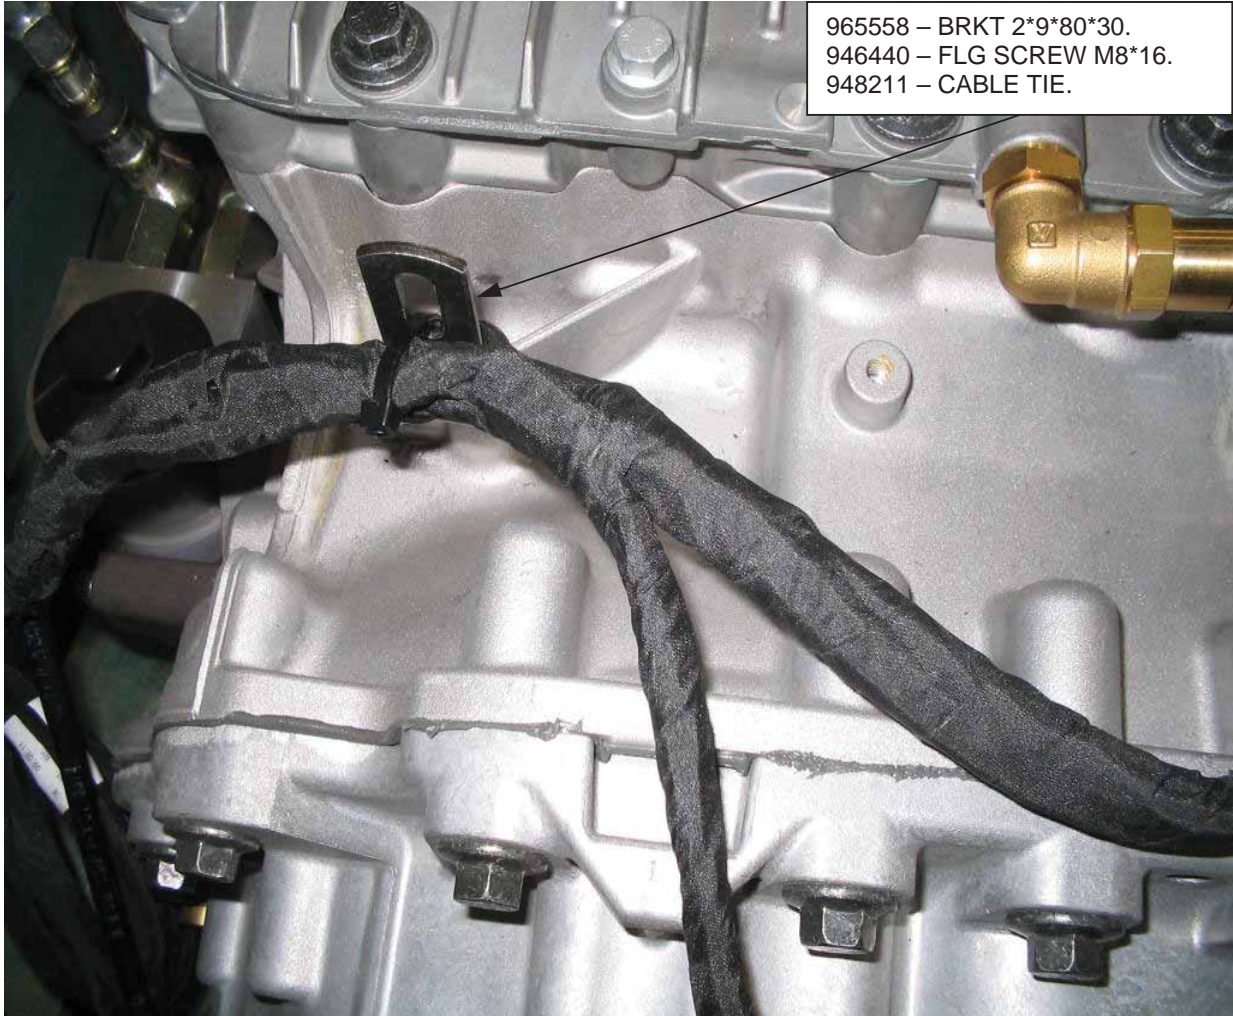
THIS VIEW SHOWS THE ROUTING AND CLIPPING OF THE WIRING HARNESS TO THE LEFT REAR TOP OF THE TRANSMISSION.  
 NOTE: PTO BREAKOUTS TO BE TEMPORARILY TIED BACK TO THE HARNESS AS RECEIVED FROM THE HARNESS MANUFACTURE AND WILL BE CUT LOOSE WHEN A PTO IS REQUIRED.

965558 – BRKT 2\*9\*80\*30.  
 946440 – FLG SCREW M8\*16.  
 948211 – CABLE TIE.

NOTE: HARNESS TO CAB AND GROUND CONNECTIONS ARE TO BE COILED AND TIED SECURELY TO THE TRANSMISSION FOR SHIPPING.

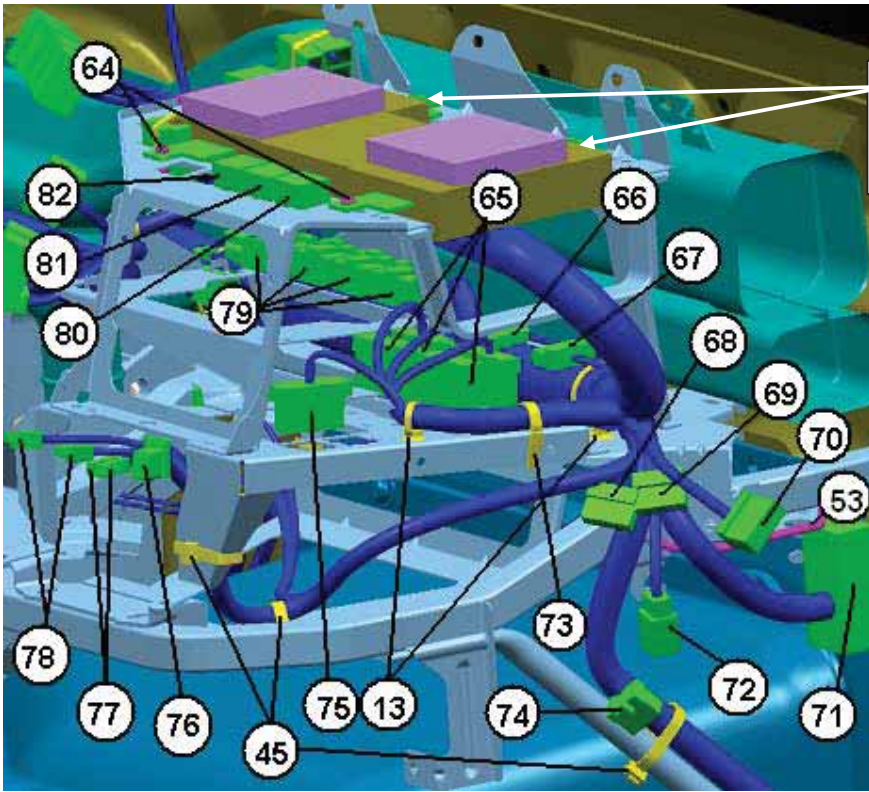
TECH CENTER PASS. SIDE

2 ADDITIONAL 971306 SCREWS (BALLOON 64) LOCATED BEHIND FRC UNIT

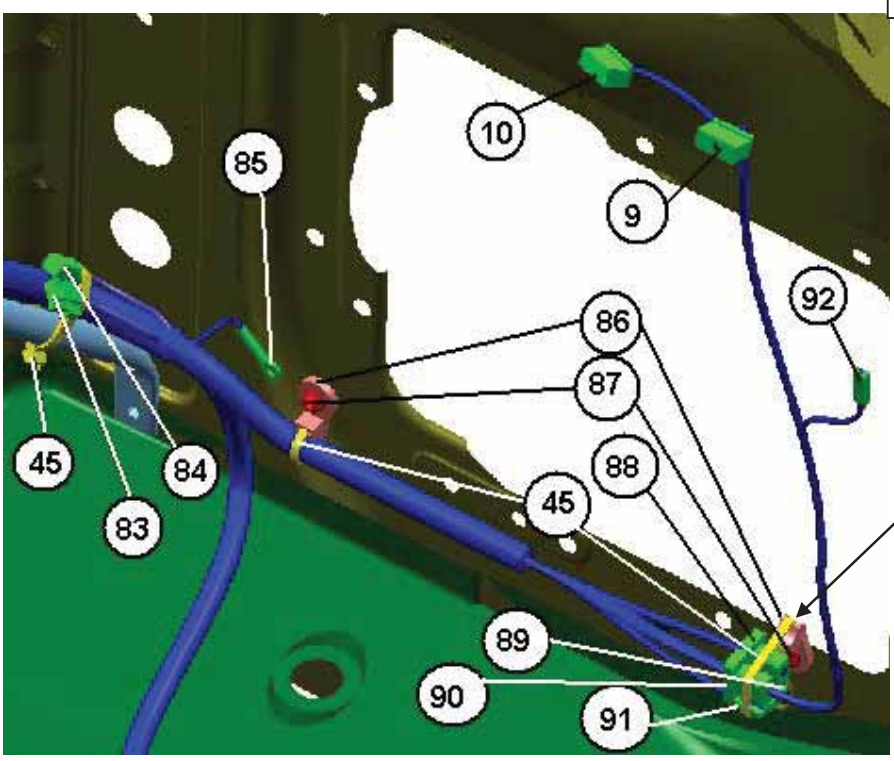
PASSENGER FLOOR AREA

NOTE: CABLE TIE CLIP (BALLOON 86) IS MOUNTED TO STUD POINTING UP AT THIS LOCATION. (CLIP POINTS DOWNWARD AT THE INBOARD STUD MOUNT LOCATION)

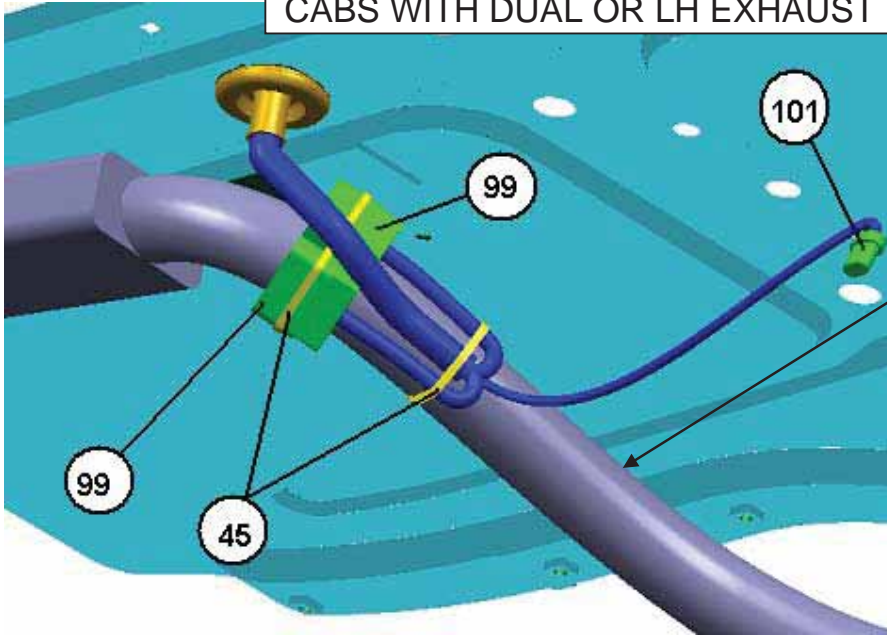
MAIN CAB TIES  
BACK TO AIR  
LINES AS SHOWN

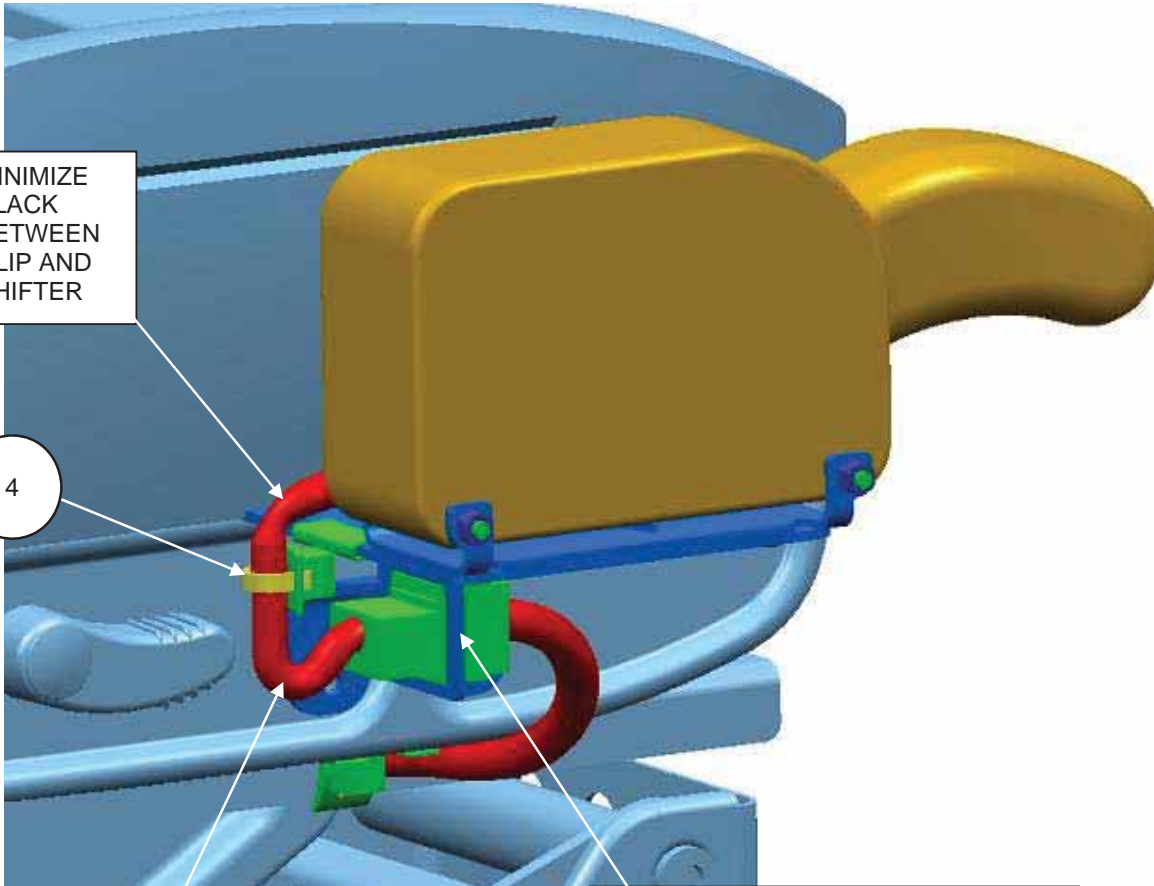
MINIMIZE SLACK BETWEEN CLIP AND SHIFTER

CREATE A DRIP LOOP FOR THE SHIFTER PIGTAIL WITH CABLE TIE (4) AS SHOWN.

CLIP SHIFTER PIGTAIL AND SEAT HARN CONNECTORS INTO SHIFTER BRACKET ASSEMBLY AS SHOWN

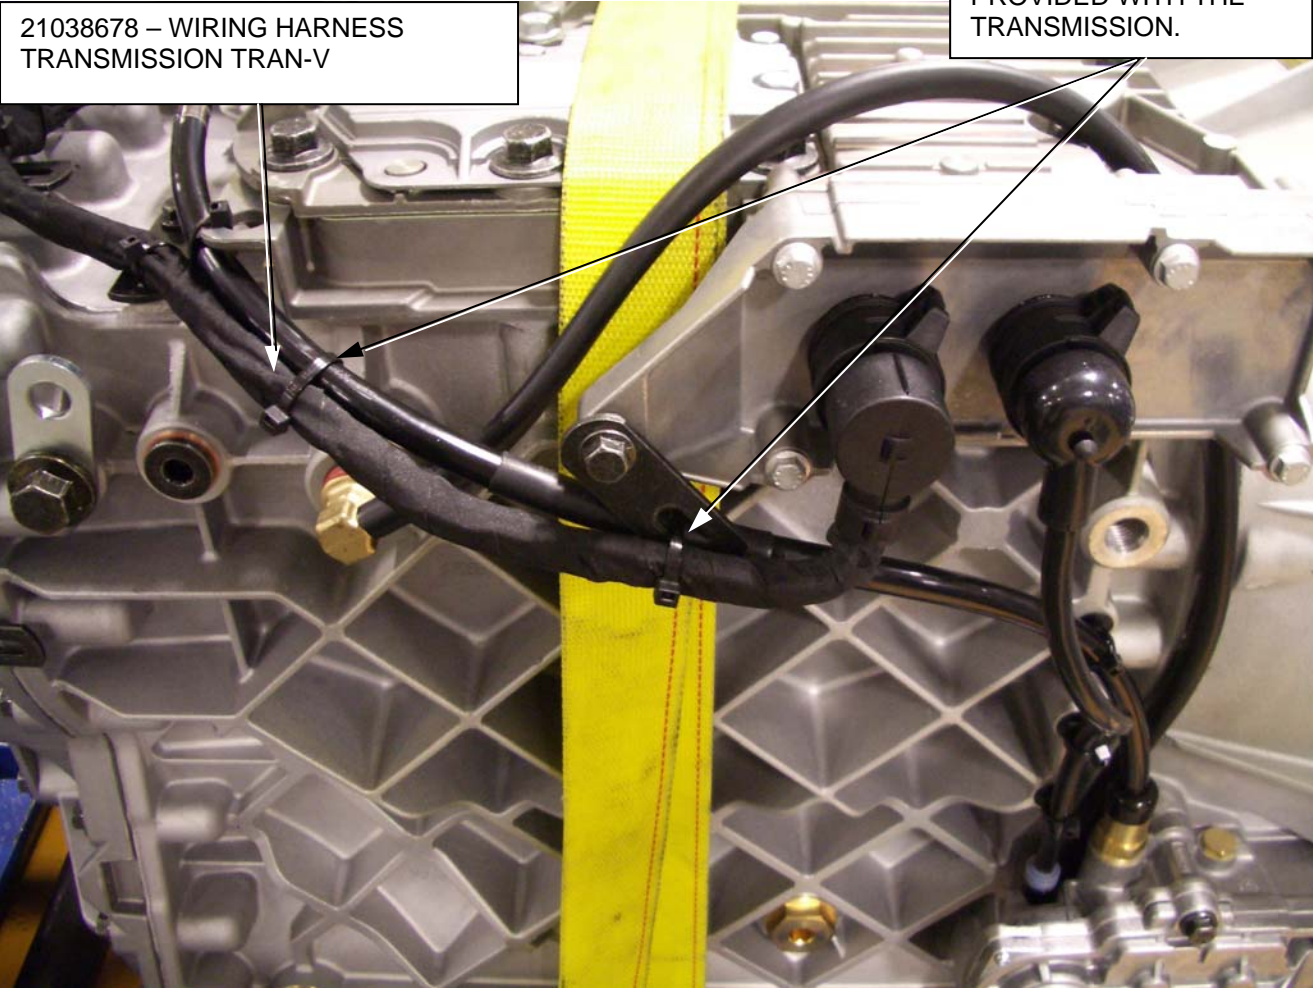
21038678 – WIRING HARNESS TRAN-V

2x 948211 – CABLE TIE. CLIPPING BRACKET PROVIDED WITH THE TRANSMISSION.

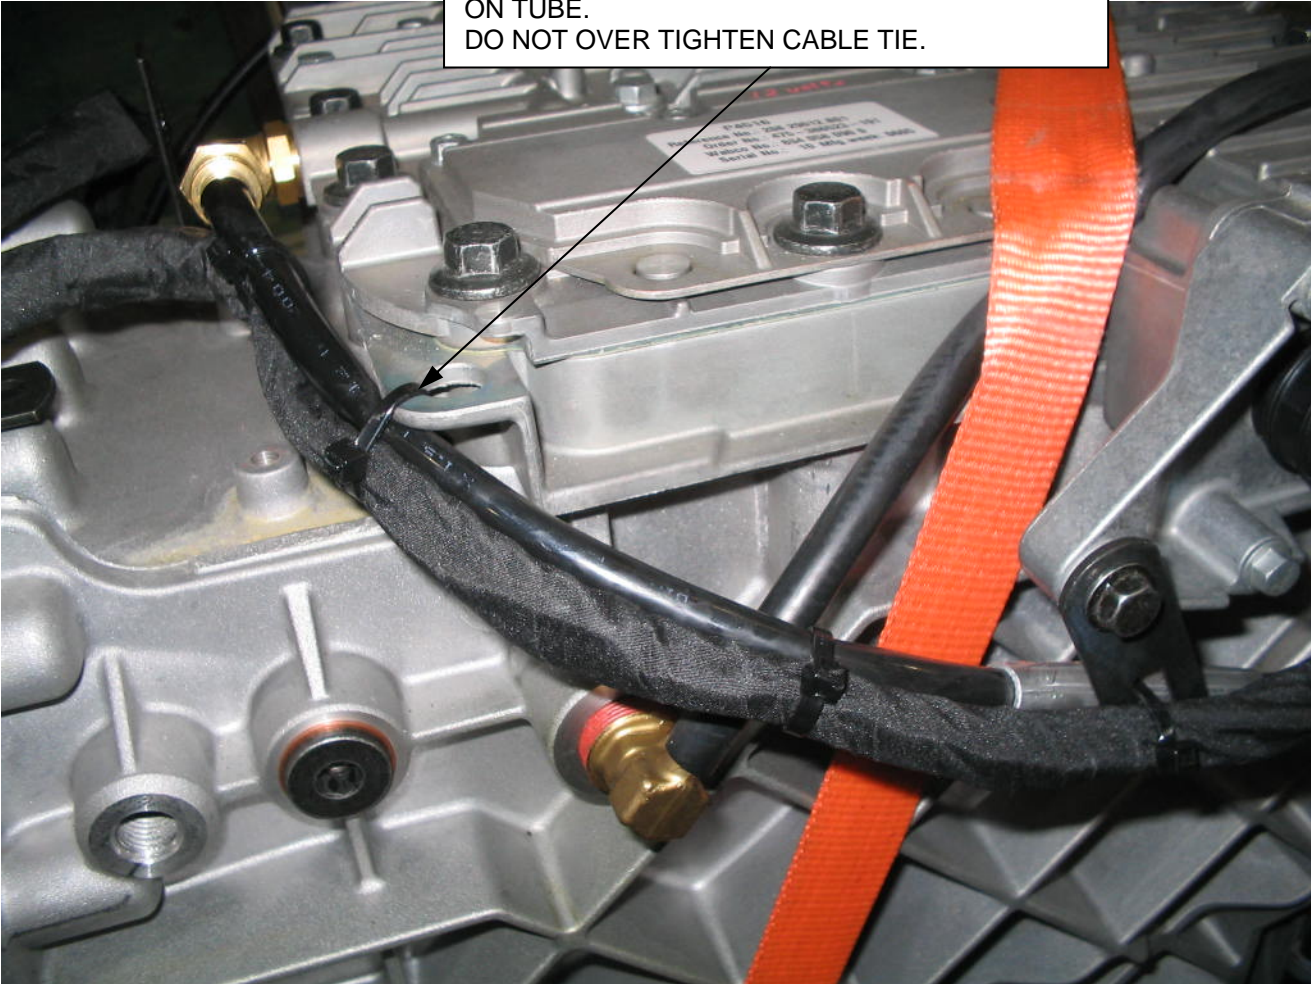
948211 – CABLE TIE.  
 NOT SHOWN IS A METAL SLEEVE AT TIE AREA ON TUBE.  
 DO NOT OVER TIGHTEN CABLE TIE.

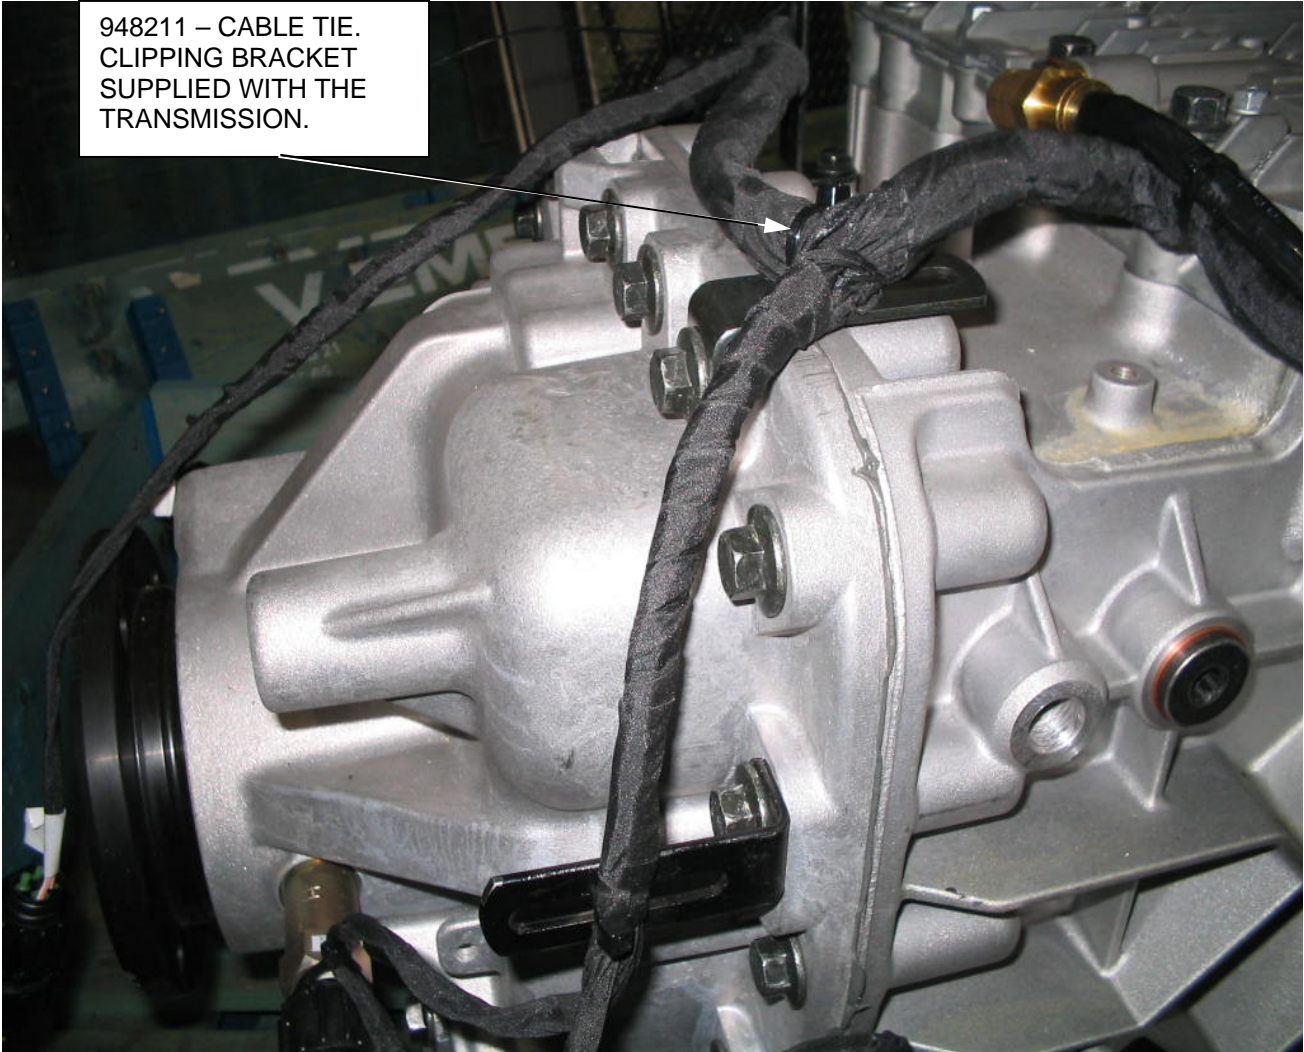
THIS VIEW SHOWS THE ROUTING AND CLIPPING OF THE WIRING HARNESS AT THE TOP RIGHT REAR CORNER OF THE TRANS AND ROUTING DOWN TO THE SPEEDO SENSOR CONNECTION.

948211 – CABLE TIE. CLIPPING BRACKET SUPPLIED WITH THE TRANSMISSION.

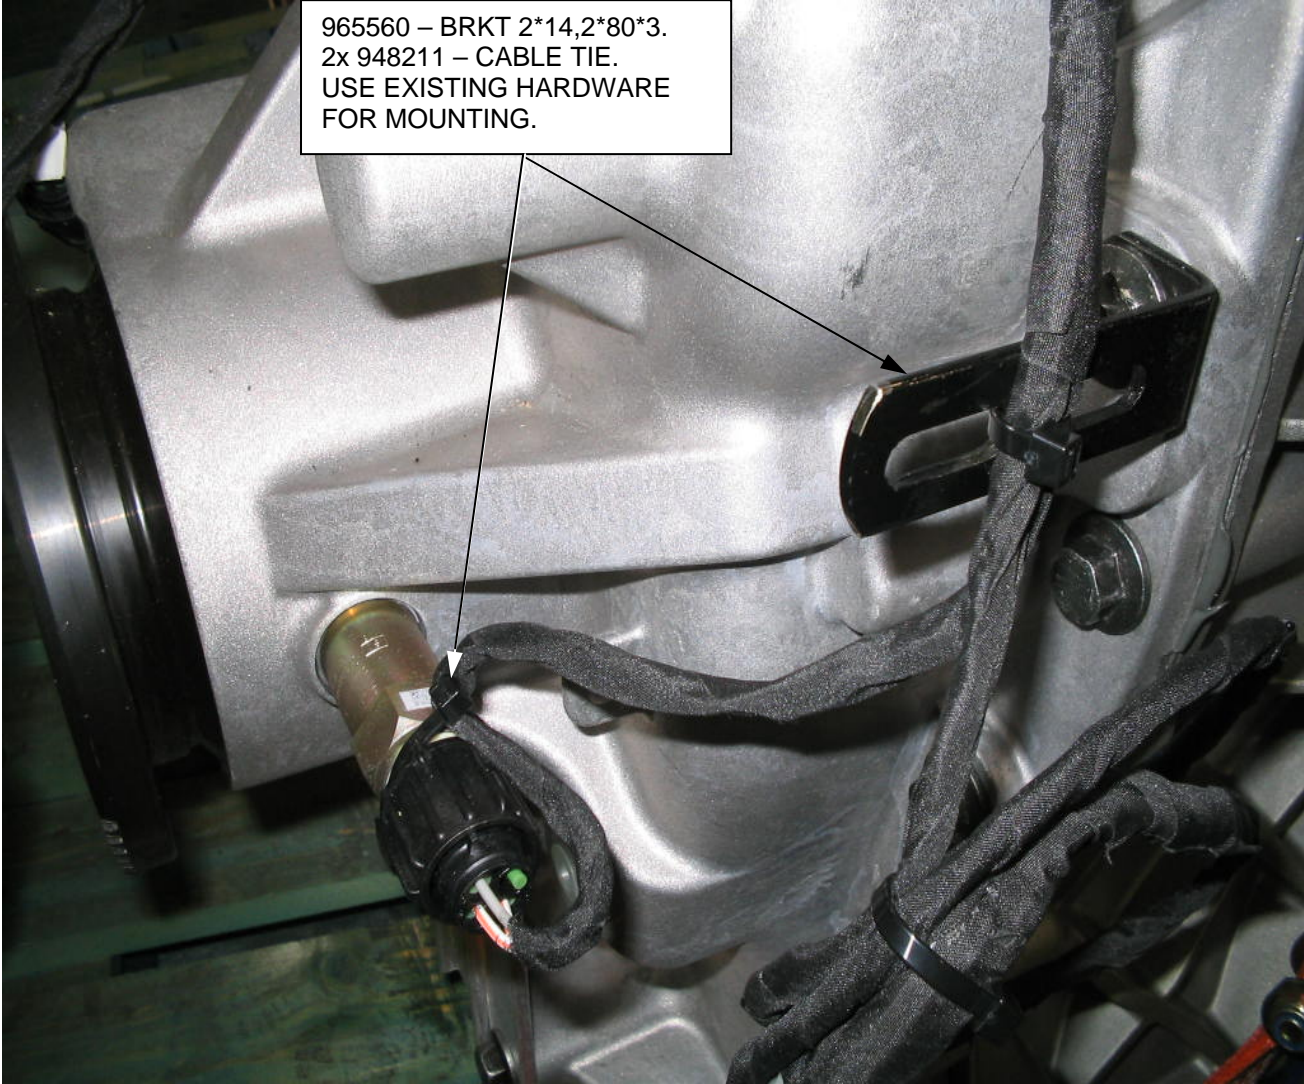
THIS VIEW SHOWS THE WIRING HARNESS ROUTED AND CLIPPED DOWN THE RIGHT REAR SIDE OF THE TRANSMISSION TO THE SPEEDO SENSOR.  
 NOTE: THE HARNESS IS TO BE TIED NEXT TO THE BRASS SPEEDO SENSOR INSERT NUT FOR STRAIN RELIEF CLIPPING.

NOTE: HARNESS TO CHASSIS AND DPF CONNECTION ARE TO BE COILED AND TIED SECURELY TO TRANSMISSION FOR SHIPPING.

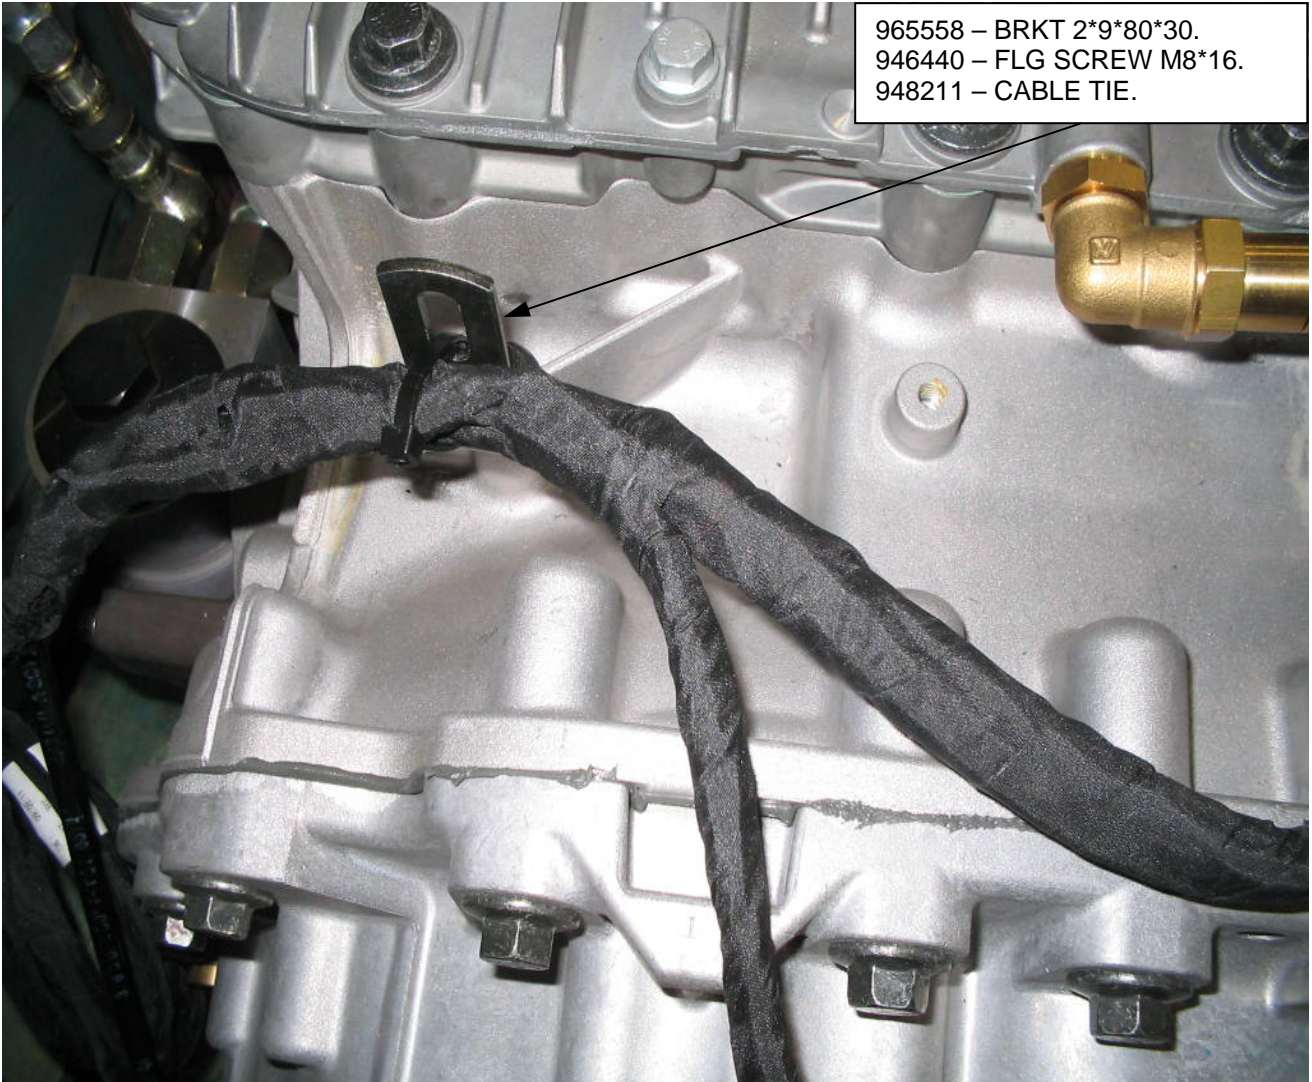
NOTE: PTO BREAKOUTS TO BE TEMPORARILY TIED BACK TO THE HARNESS AS RECEIVED FROM THE HARNESS MANUFACTURE AND WILL BE CUT LOOSE WHEN A PTO IS REQUIRED.

965558 – BRKT 2\*9\*80\*30.  
 946440 – FLG SCREW M8\*16.  
 948211 – CABLE TIE.

NOTE: HARNESS TO CAB AND GROUND CONNECTIONS ARE TO BE COILED AND TIED SECURELY TO THE TRANSMISSION FOR SHIPPING.

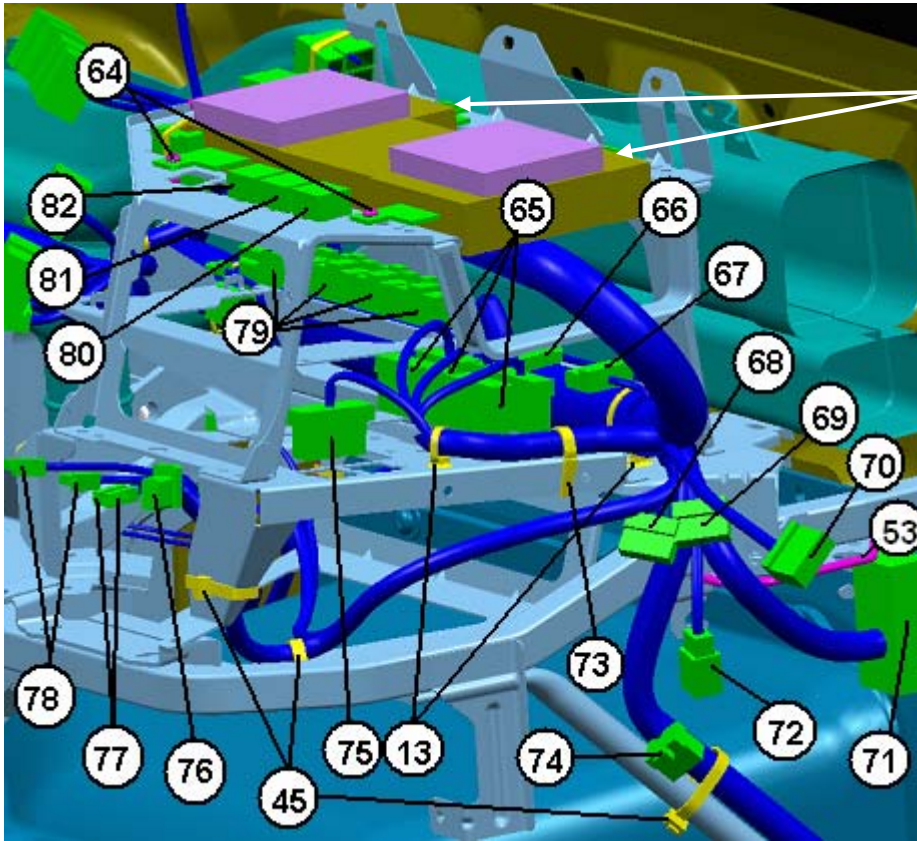
TECH CENTER PASS. SIDE

2 ADDITIONAL 971306 SCREWS (BALLOON 64) LOCATED BEHIND FRC UNIT

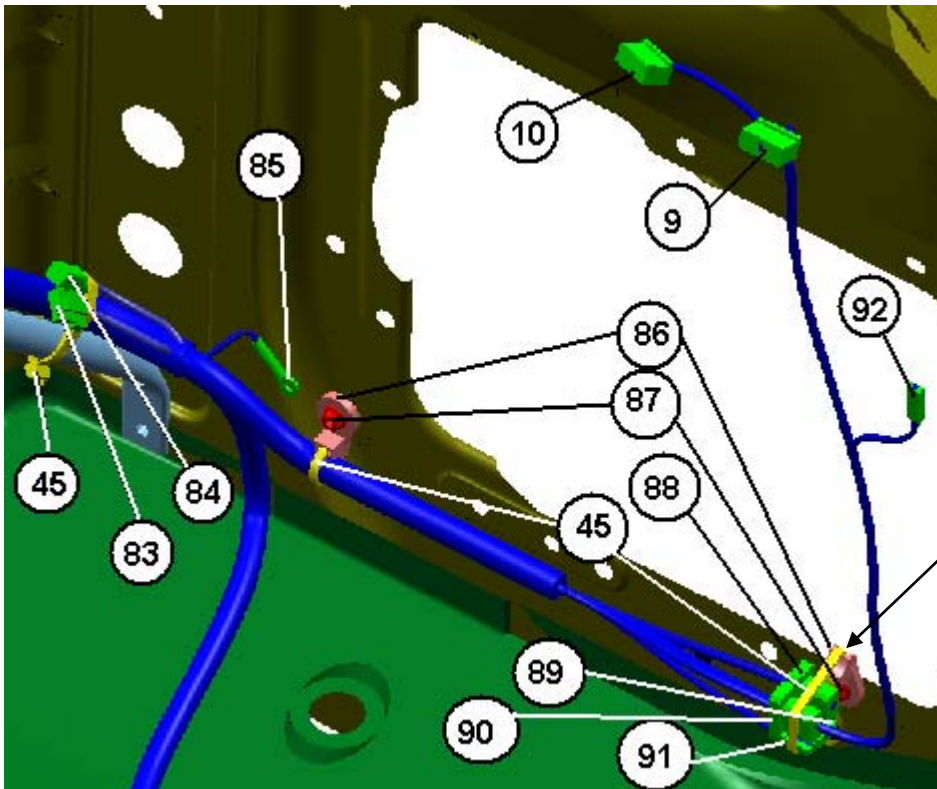
PASSENGER FLOOR AREA

NOTE: CABLE TIE CLIP (BALLOON 86) IS MOUNTED TO STUD POINTING UP AT THIS LOCATION. (CLIP POINTS DOWNWARD AT THE INBOARD STUD MOUNT LOCATION)

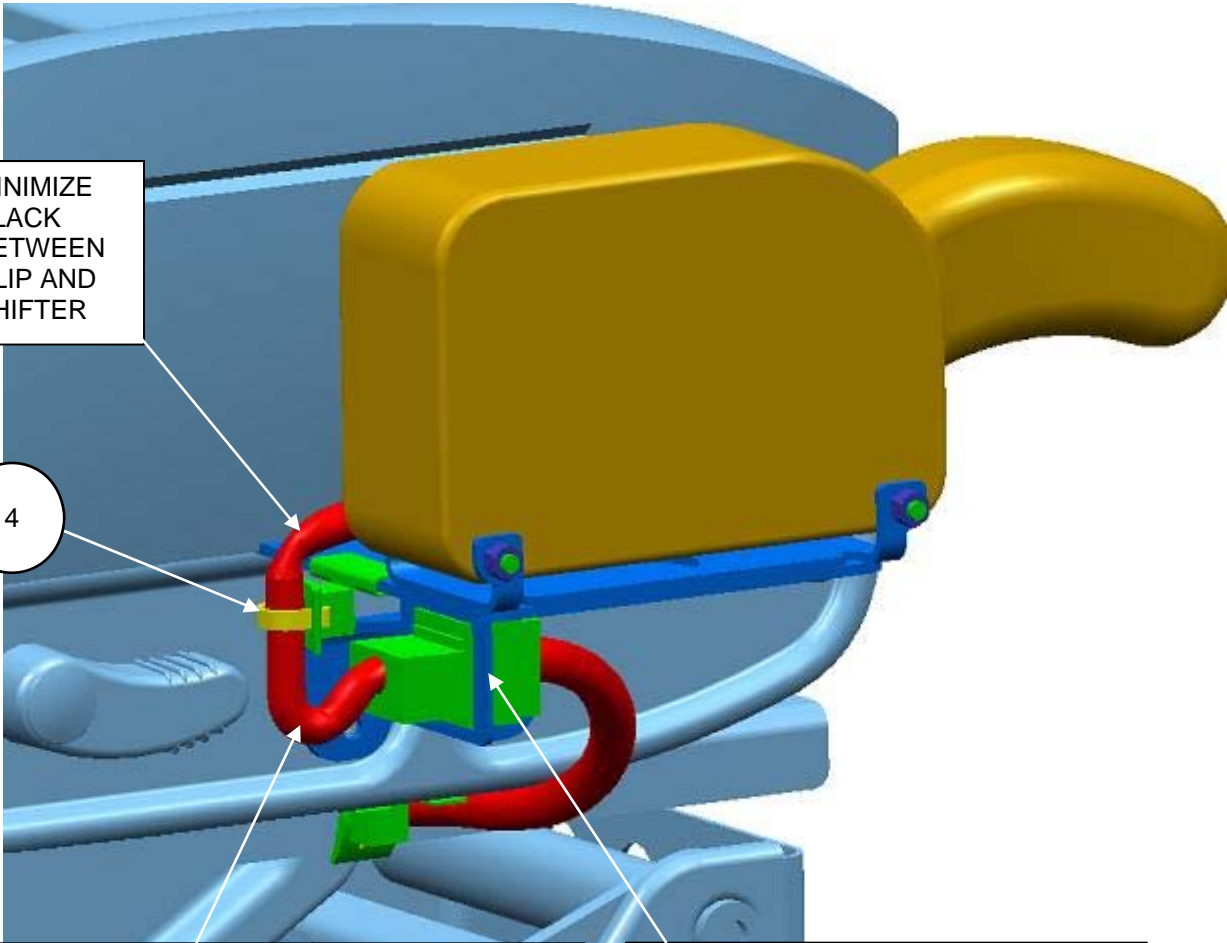
SHIFTER ON SIDE OF SEAT

MINIMIZE SLACK BETWEEN CLIP AND SHIFTER
