PE13-033 HYUNDAI-KIA

ATTACHMENT A

Field Report Files

- Hyundai has determined the affected vehicles may contain brake fluid that does not sufficiently inhibit corrosion in the zinc plating on the service brake system's Hydraulic Electronic Control Unit (HECU) module. Corrosion may lead to a gel buildup on the module's valves affecting the valve's operation, resulting in low/soft brake pedal with reduced brake effectiveness, which may increase the risk of a vehicle crash.

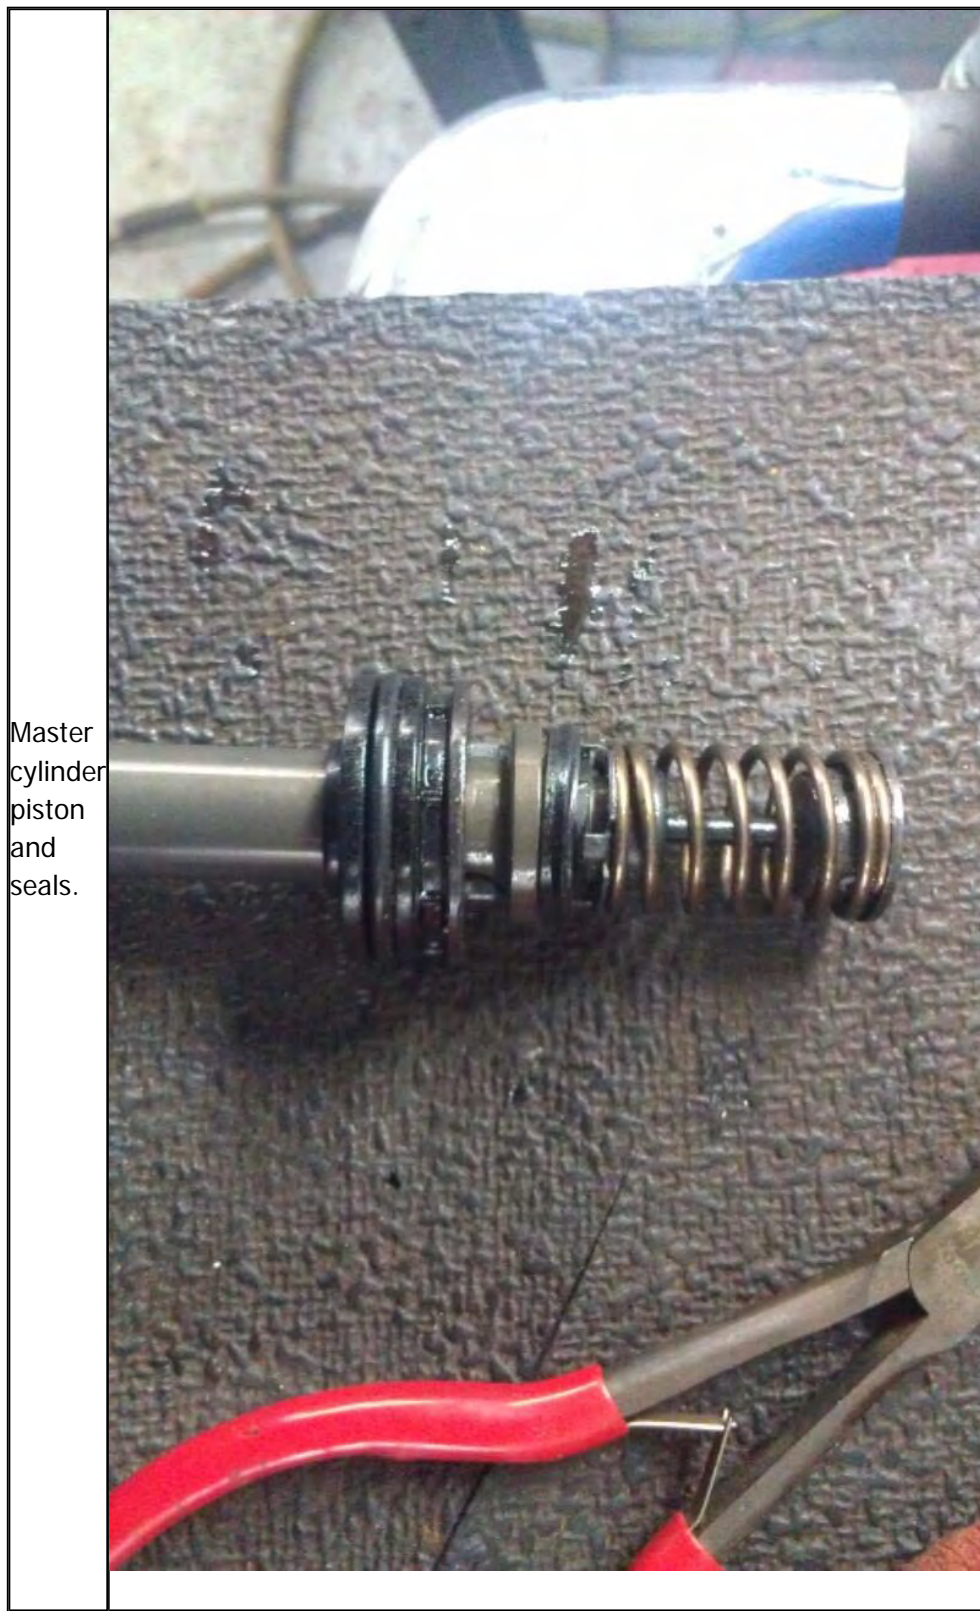
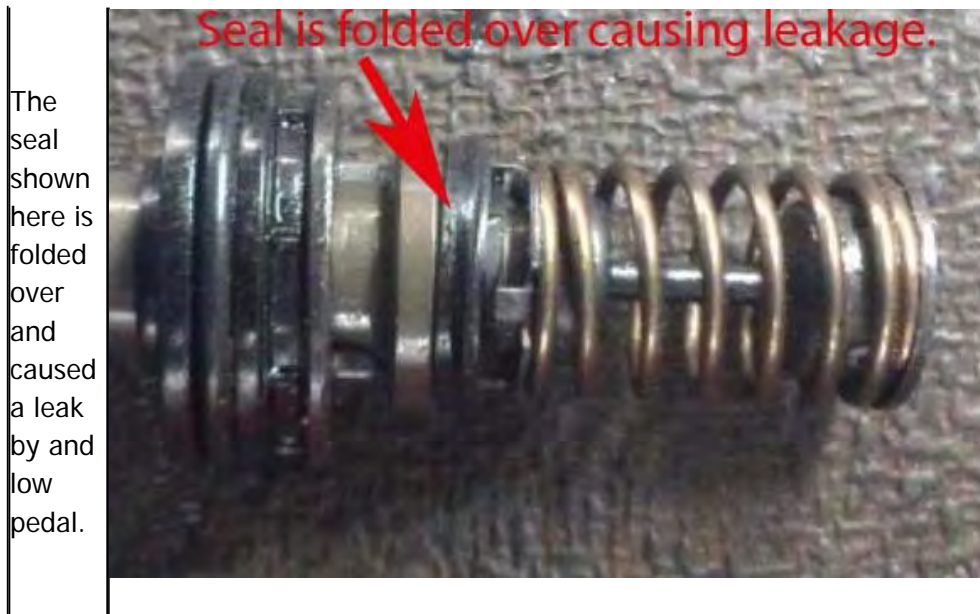
Master cylinder piston and seals.

Dealer took the master cylinder piston out and found on seal was folded over causing this issue.

The master cylinder piston had a seal that was folded over causing a soft pedal and only two wheels had brakes that worked.

Corrective Action Dealer replaced the master cylinder and bleed brakes. Now vehicle is operating as desinged.

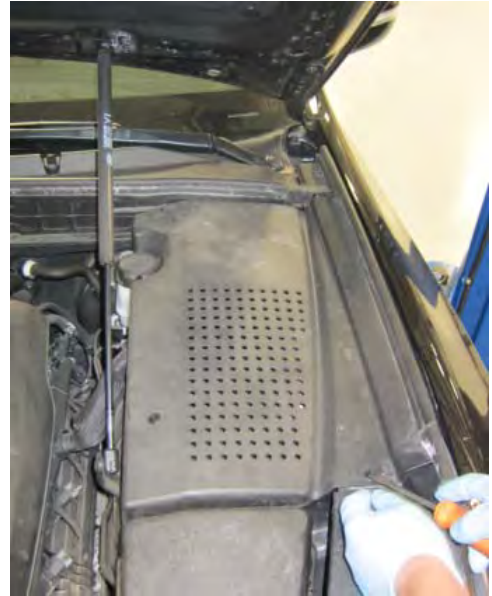
1. Remove the driver's side cover in the engine bay by unfastening the 3 retaining clips.

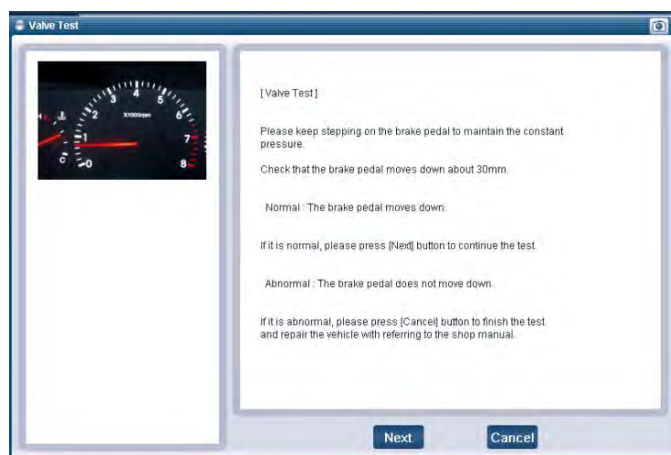
7. While maintaining foot pressure on the brake pedal, check that pedal moves down approximately 30mm (1.18”):

- Pedal moves down: Continue with the HECU inspection (step 8) by clicking “Next.”
- Pedal does not move down: Click “Cancel” to end the inspection procedure, then replace the HECU according to the applicable shop manual procedures.

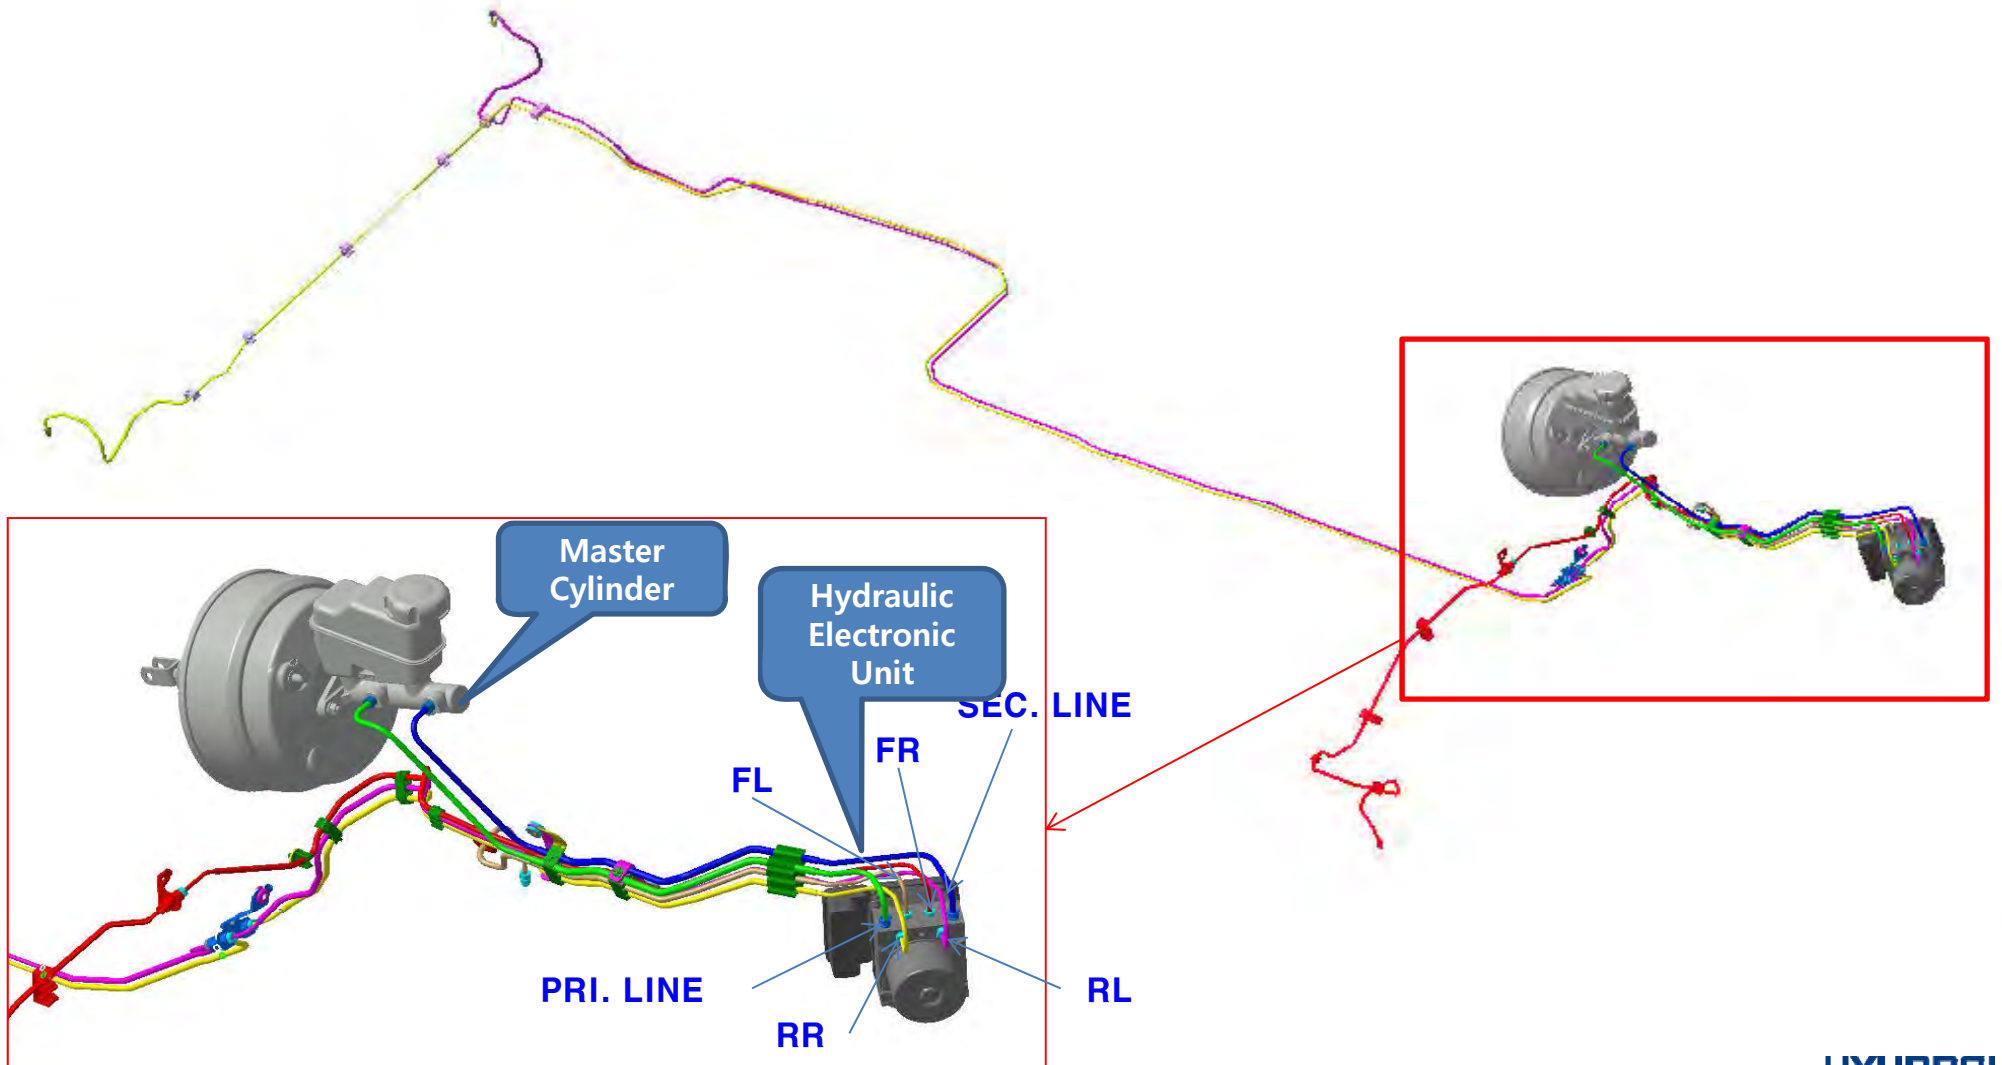
Brake System Hydraulic Line

Brake Hydraulic flow Diagram (BH, MK25E model)

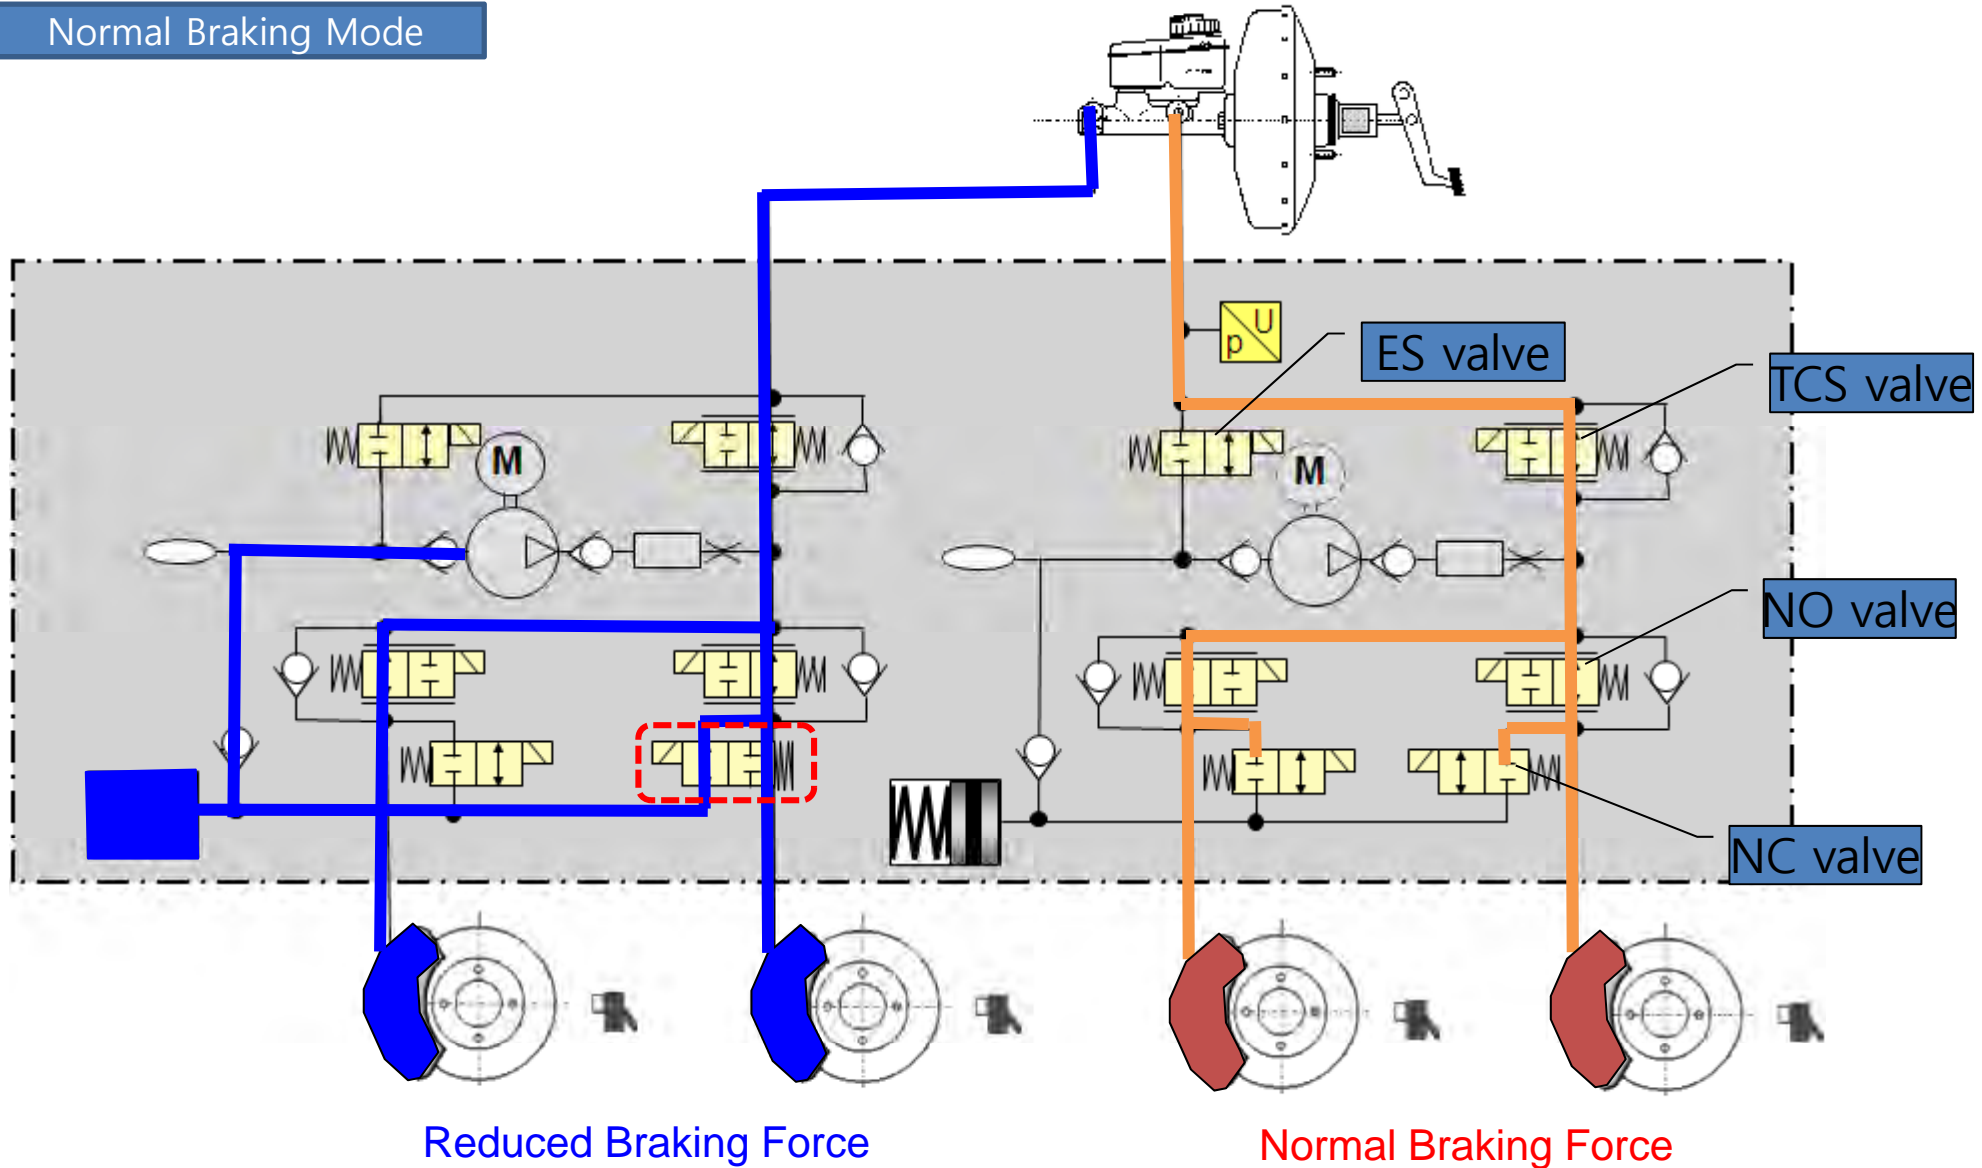
Brake Hydraulic flow Diagram – Comparison NC valve failure mode with normal condition

Normal Braking Mode

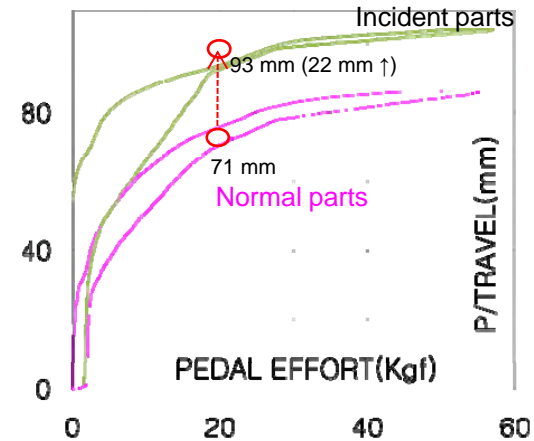
< Brake Pedal stroke at Static vehicle condition >

Incident part result:
As pedal effort increased, pedal stroke was increased 22mm in comparison with normal part (at 20 kgf)

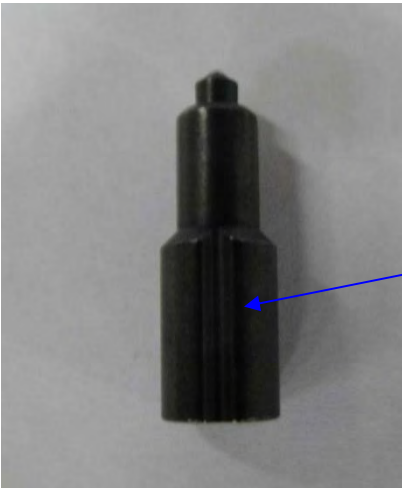
<p>Zinc Plating</p>		<p>■ Surface treatment : Black-oxide coating</p>

<p>Black-oxide coating</p>	
Improvement Description	<p>▶ Change the surface treatment of NC valve : 12. 3.16</p> <p>- Zinc Plating → Black-oxide coating</p>		
Verification	<p>▶ No Corrosion with Petri test method</p> <p>- Soaking Black-oxide coating armatures in BF DOT3 for 288 hours</p> <p>- Proven with other black-oxide coated HECU (MANDO product)</p>
