AT13-006

2013 JX; CVT FLUID LEAK AT COOLER HOSE

APPLIED VEHICLE: 2013 JX (L50)

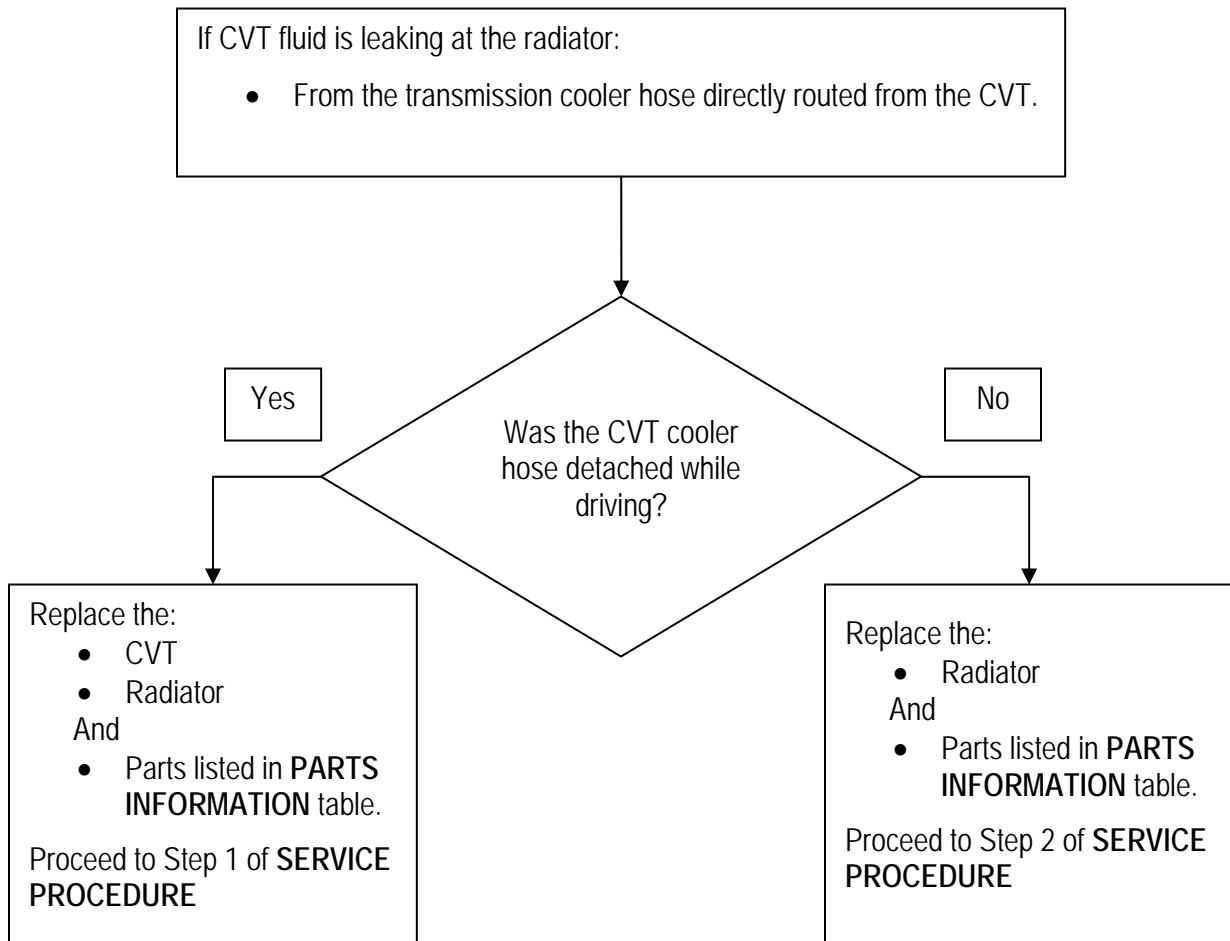
FLOW CHART

If CVT fluid is leaking, please refer to the flow chart on page 3 to determine the correct ACTION.

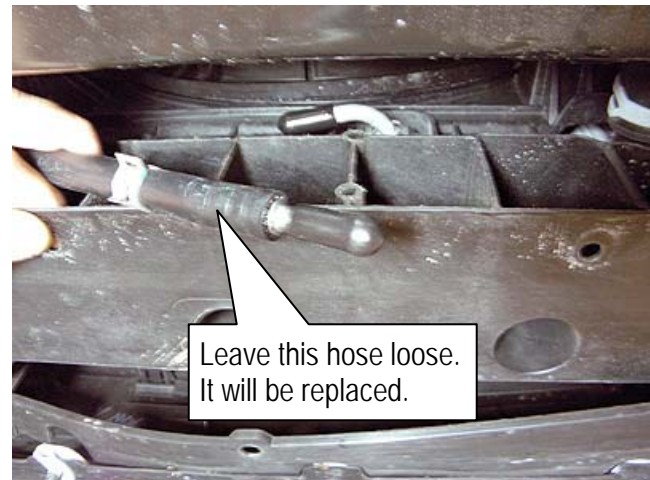
Figure 1

3. Re-attach the engine coolant hoses to the new radiator, and **only** the "auxiliary cooler to radiator hose" (CVT Fluid Cooler Hose C).

- Leave the "transmission to radiator cooler hose" loose at this time (CVT Fluid Cooler Hose A/B Assembly, Figure 1).
