AQ14-002

FOREST RIVER

RE: Safety Recall – tire & loading Information Label on VIN: «VIN»

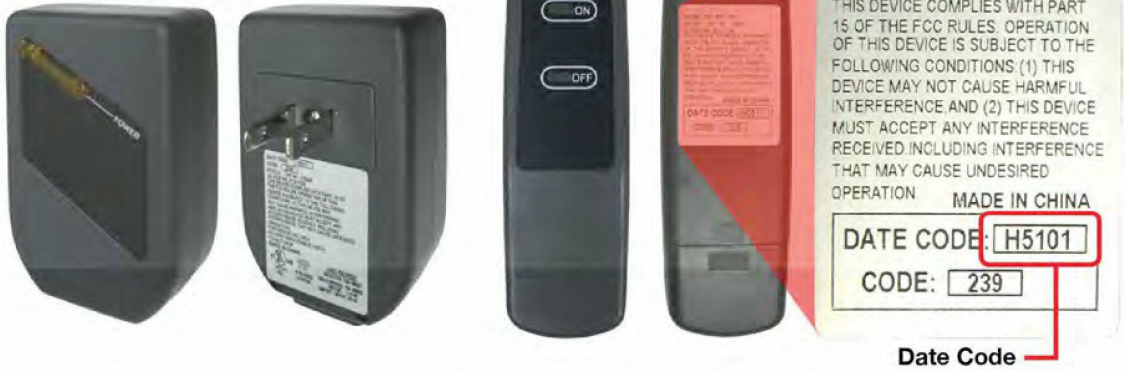
This style of recalled plug-in receiver has Model Number APT-1315

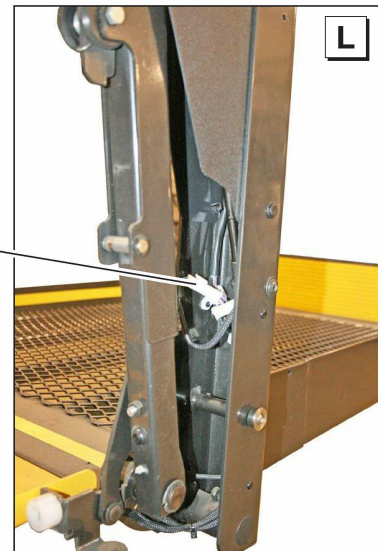
Figure 2

14. Install replacement outer barrier latch/bracket assembly using hex socket and washer removed in step 4. See Figure 2.

Microswitch
Harness
Connector

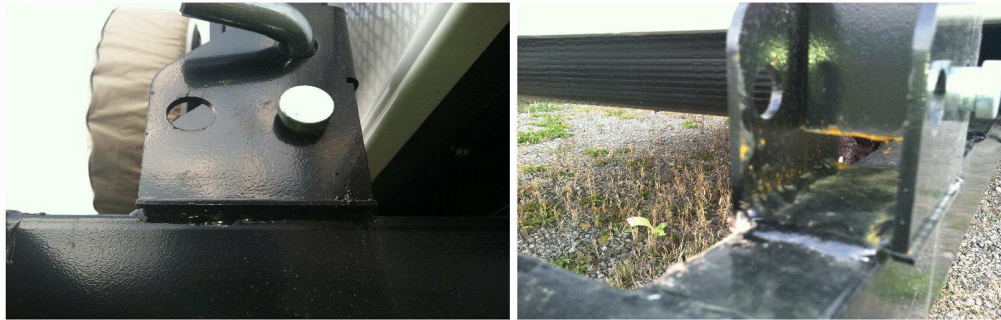
Lippert Components, Inc. ("LCI") has determined a defect which relates to the Flip Down Rack may exist on certain Forest River travel trailer models manufactured from June to August 2011. The affected units may have an insufficient weld on the rear rack attachment plate. The weld should be on four sides of the attachment plate as shown in the below picture. If the plate is not welded on all four sides, please complete the needed welds or contact Lippert Components, Inc.'s Customer Service Department by calling 1-866-524-7821 or emailing warranty@lci1.com and we will assist in arranging a sub-contract welder to assist in the repair.

If the Forest River unit(s) are equipped with the Flip Down Rack from the attached list and are still in your lot inventory, we are requesting the Service Bulletin be completed on the specified units before retail delivery. LCI stands ready to assist you in addressing this condition by arranging for our technician to complete the welds or by allowing for a sublet welder to add the welds. LCI will authorize a flat rate payment of .5hr for this welding.

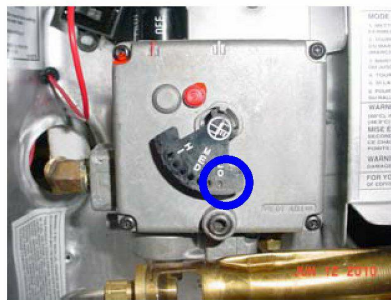
The area of concern is circled in blue in Figure 1 below.

1. Visually inspect the thermostat adjustment pin for any evidence of damage. The thermostat adjustment pin should be perpendicular to the valve body. If the thermostat adjustment pin displays any indication of having been bent, twisted or impacted remove and replace the water heater gas thermostat valve or the entire appliance with a unit that has been tested and found to be acceptable. Do not attempt to operate the water heater!

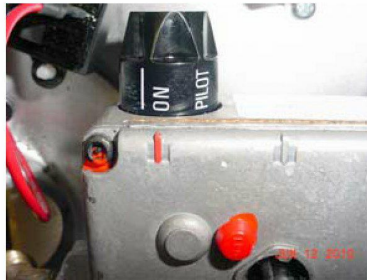
Figure 3

6. Depress and turn knob (A) counter clockwise ← to “Pilot” position, press down and switch the pilot reignitor module to “ON” position. Spark will start between electrode tip and pilot hood.
7. When pilot lights, the spark will stop. Continue depressing knob (A) for approximately one minute or until pilot light remains lit. On the initial start-up, it may take several minutes in order to purge the air from the gas lines for the pilot to remain on.
8. With the pilot lit, apply liquid gas leak detector solution to the base of the thermostat adjustment pin. Move the gas cock knob on the pilot valve to the “on” position as shown in Figure 3.

9. If any bubbles appear around the thermostat adjust pin base, immediately turn off the gas supply to the water heater at the closest shutoff valve. Someone must be located at this shutoff valve to immediately turn off the gas supply if bubbles are observed. With the gas off at the shutoff valve, rotate the gas cock knob on the pilot valve to the “off” position. If any evidence of bubbles is detected, remove and replace the water heater gas thermostat valve or appliance with a unit that has been tested and found to be acceptable.
10. If no bubbles are observed immediately upon ignition, allow the main burner to continue to operate for approximately one minute and watch for bubbles. If no bubbles are observed, the thermostat adjustment pin thread and gasket seal integrity has not been compromised.

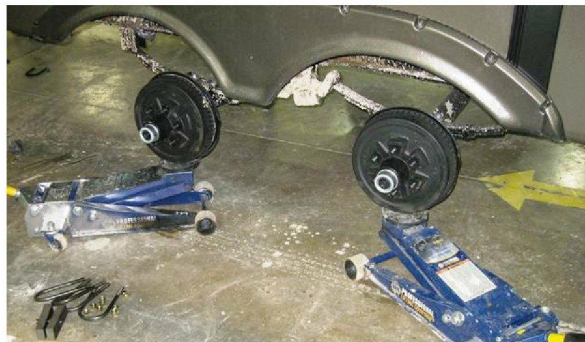
STEP 1.1 Using appropriately rated jacks to support the trailer, jack unit up and support frame with safety stands. Remove tires and support axles with floor jacks.

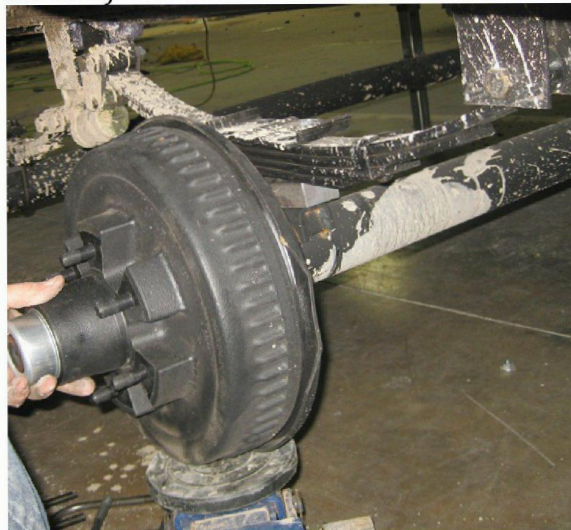
STEP 1.4 Line up the locating pin on the spacer block with the hole in the axle spring pad. (Locating pin should go down into the pad on the axle)

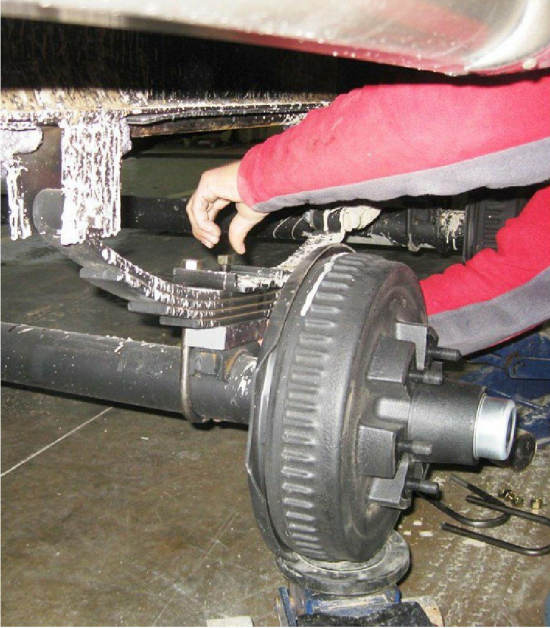
STEP 1.7 Install (4) of the new nuts as provided in the kit. Torque to 55 ft-lbs.

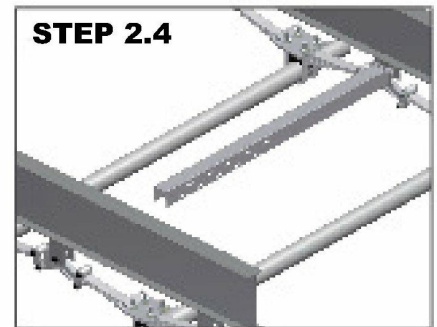
STEP 2.6 Make sure the cross member ends are pressed against the frame hanger. Line up holes on both cross members and insert flange bolts (4 on each side) into holes that are furthest from the center in both the top and bottom rows (do not tighten flange bolts at this time).

STEP 2.7 Tighten wet bolt nuts from step 2.4 on both sides to 40 ft-lbs. Insert clamp strap inside frame hanger and bolt to cross member. Tighten to 15 ft-lbs. Then tighten flange bolts from step 2.6 to 40 ft-lbs.

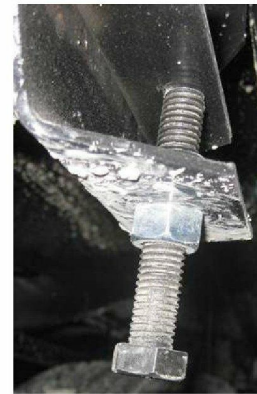
STEP 4.1 Replace the slide adjustment bolt that is located near the off-doorside (driver's side) front tire. Remove the 4" bolt and replace it with the provided 3" bolt (20X48421A) as provided in the kit.
