EA14-002

FORD

APPENDIX D

Appendix E - Panoramic Sunroof Assembly Information - Request 7

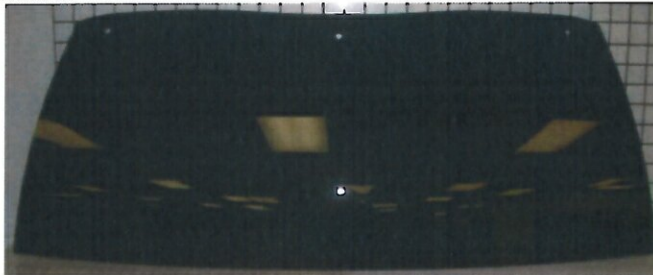
Test No. 7 - Fracture Test

Six (6) full size specimens were placed horizontally and taped to an identical specimen. The specimens were fractured one inch inboard at the midpoint of the longest edge with a spring-loaded center punch per the standard.

No individual fragments free of cracks and obtained within three minutes subsequent to test, **shall weigh no more than 4.25 grams** (0.15 ounce).
