CONSUMER COMPLAINTS

VIN of 2011 SPORTAGE EX_AWD KNDPCCA27B7 17,000 Prod. Date: 5/4/11 Stoughton, MA Dealer: MA038 Central Kia of Norwood

Kia Motors America Field Product Quality Report

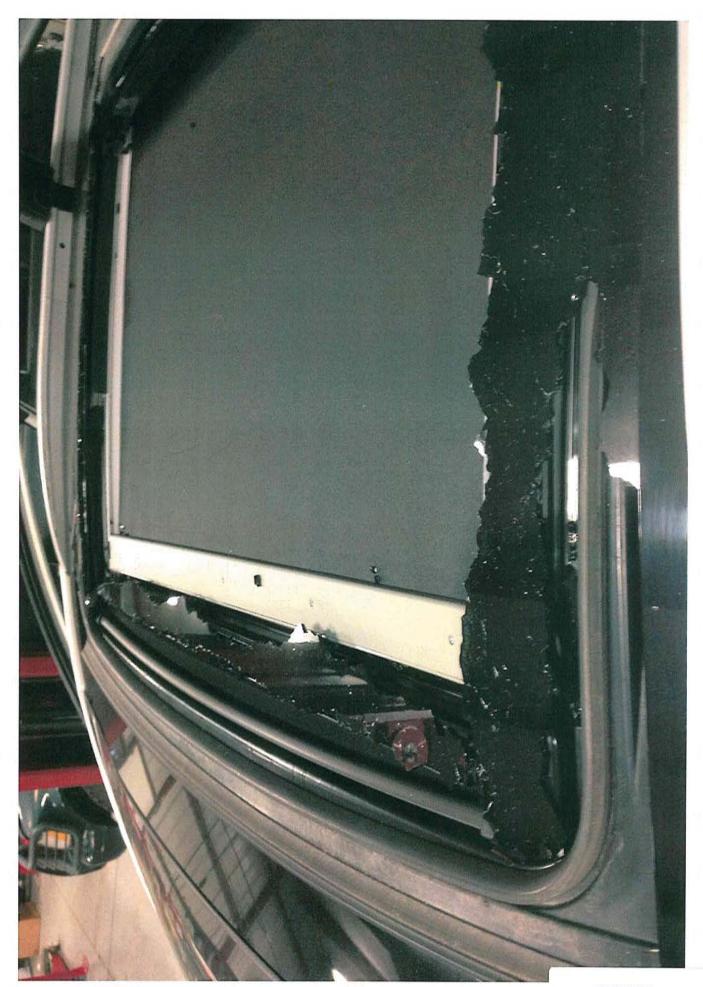
Found sunroof glass shattered.

Replace the sunroof assy.

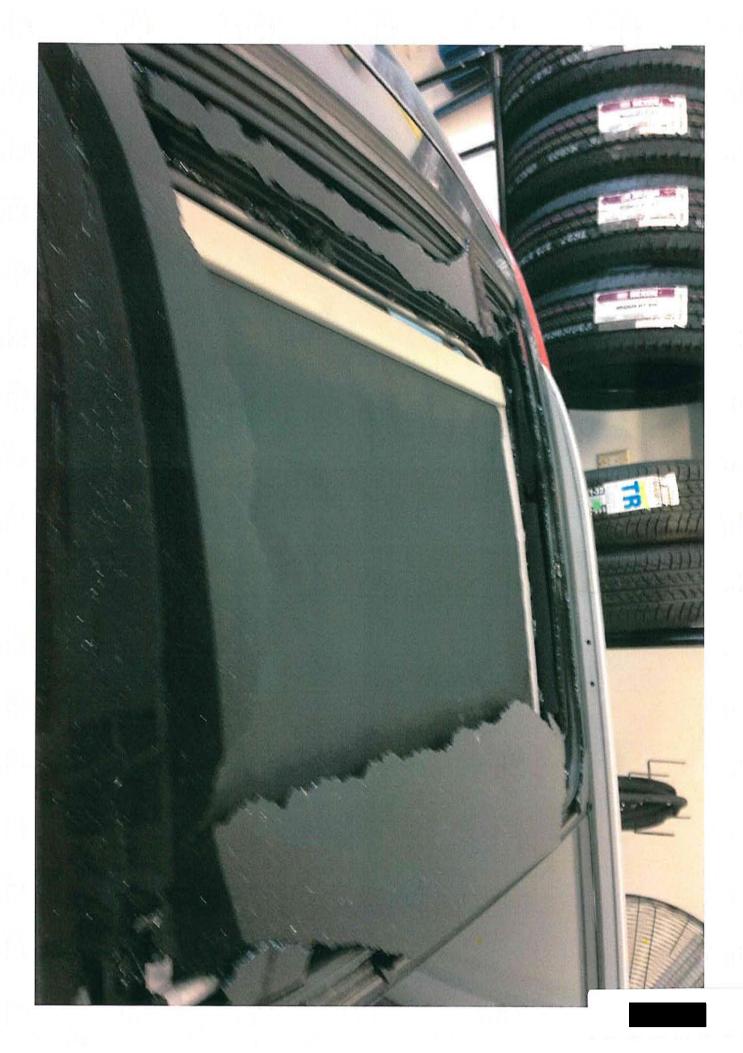
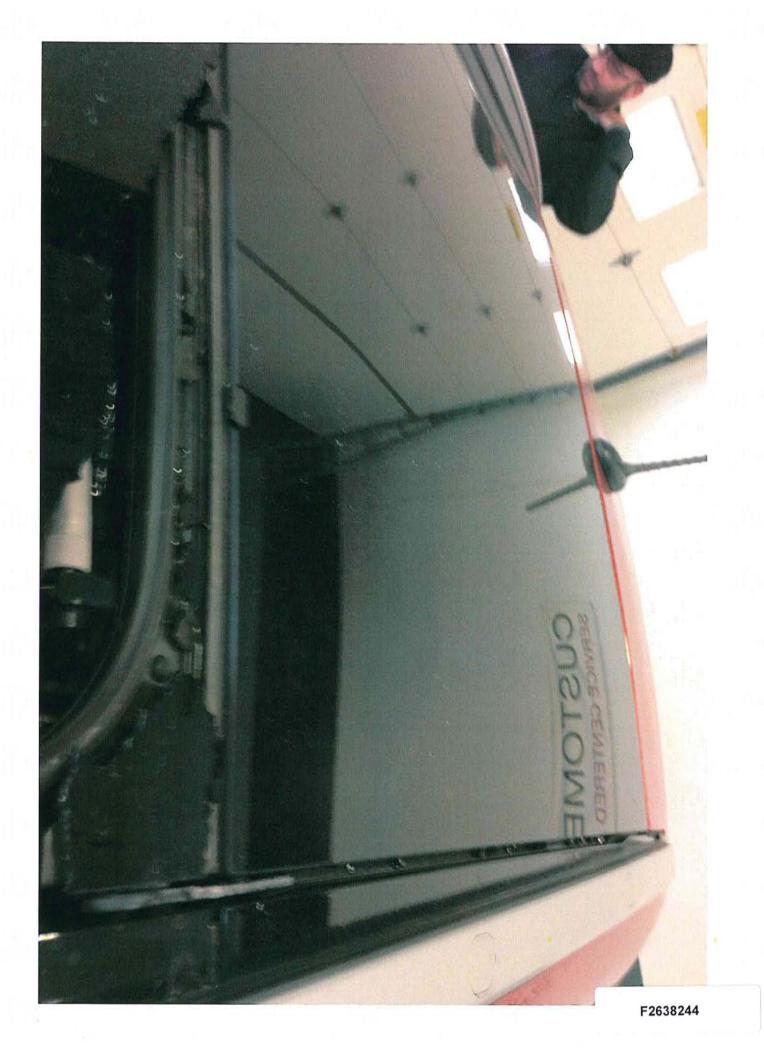
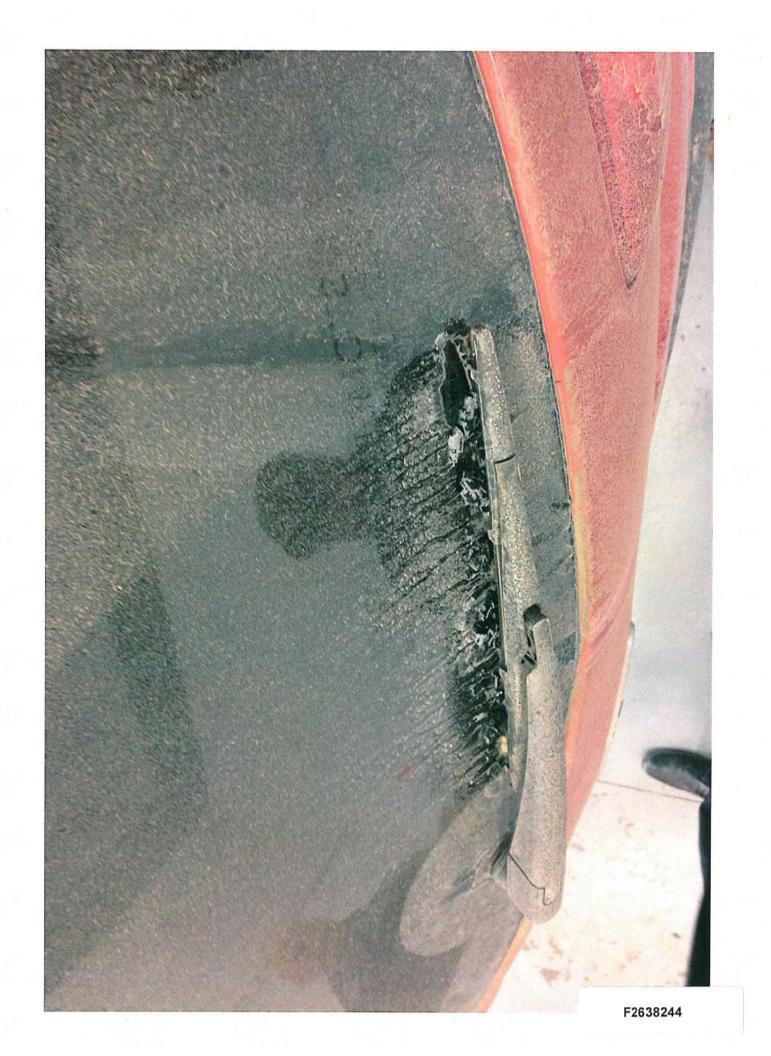
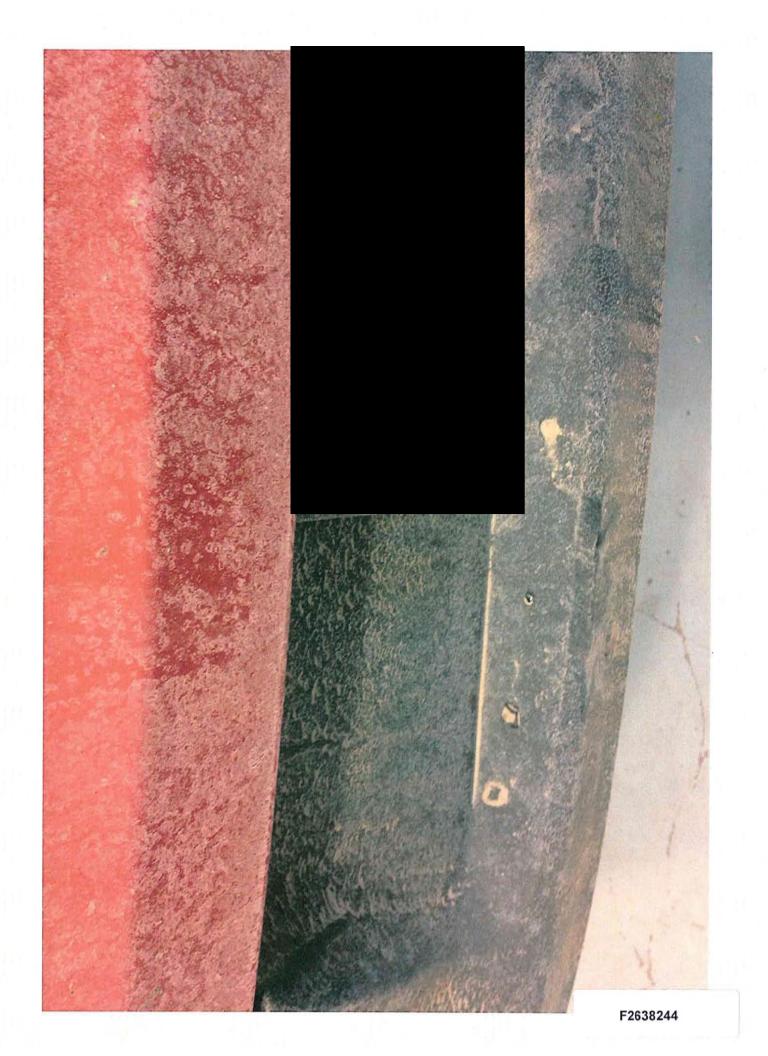
FTR visit requested by national consumer affairs analyst to investigate vehicle condition at the dealership the vehicle was dropped off at (towed in).

FTR inspected vehicle and found front panel of panoramic roof shattered. Sunshade was slightly opened (approx 10% of full travel) and there was glass debris sitting on top of the sunshade, located in the vehicle interior, and sprayed down the remainder of the roof/liftgate of vehicle. Vehicle has some random light paint chips on the front leading edge of the hood, on both exterior A-pillar panels, on both outside rear view mirrors, and on the trailing edge of the L/F door glass frame. Windshield glass has no evidence of stone damage and roof panel (rear of panoramic glass) had paint chips from shattered glass contacting vehicle body after breakage. There was broken glass debris (dust) present across the rear panoramic roof glass panel along with the painted roof panels and rear liftgate/rear bumper.

Unable to determine cause of shattered glass at this time. No foreign objects were found in the sunshade or mixed in with broken glass inside the vehicle.

Front panoramic roof glass panel replacement is required along with thorough cleaning of roof guide rails and glass tracks. Rear panoramic roof glass panel replacement along with painted roof panel repair would be needed for asthetic improvement (cosmetic damage).

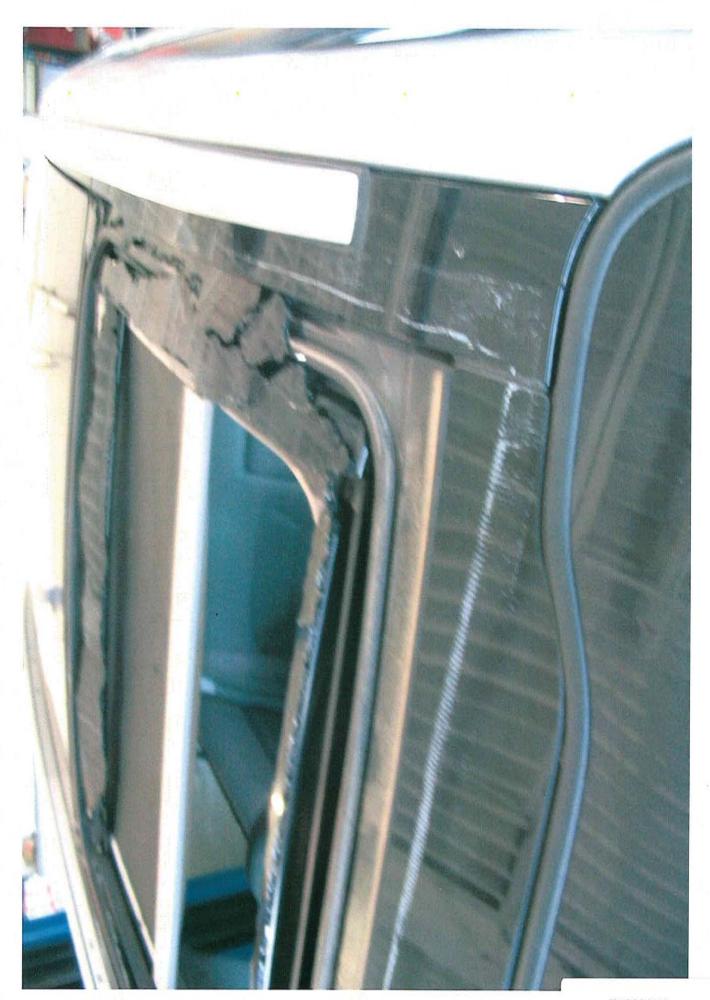
Panoramic roof glass broken.

The dealer took all pictures and did initial inspection. All results and pictures were forwarded to DPSM/FTR, Upon inspection by dealer personnel an existing impact point was noted at center leading edge of roof indicating impact damage may have been involved.

Root cause could not be accurately determined.

No action taken to date.

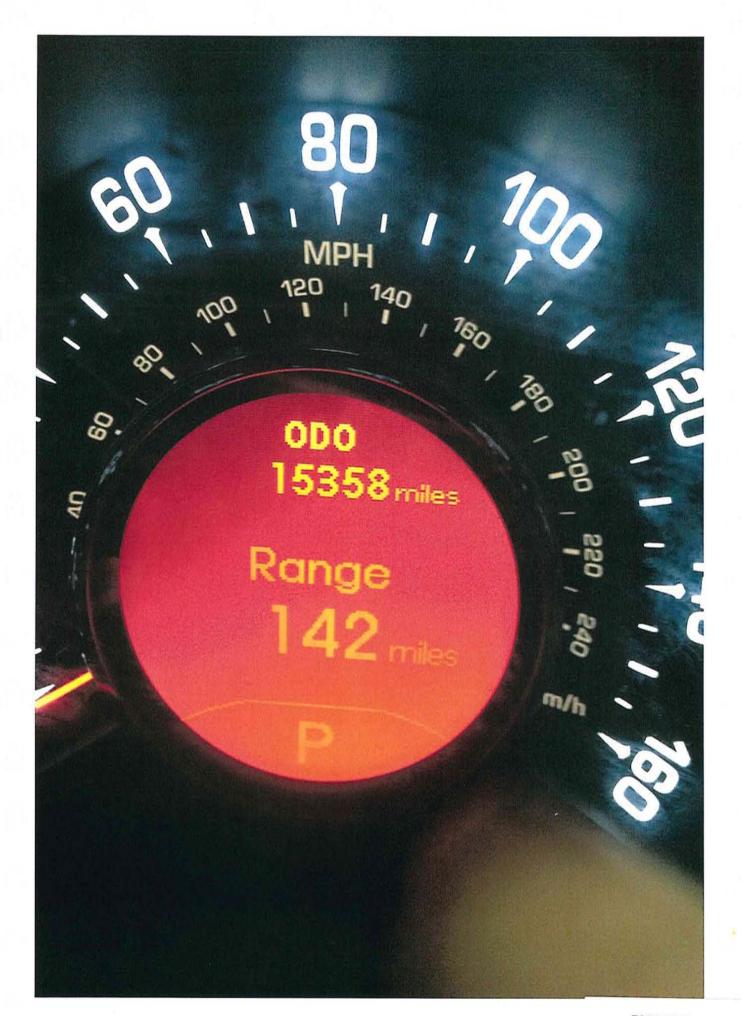
Possible roof glass failure due to impact from outside source resulting in weakening of glass integrity. Signs of impact hood and windshield was found.	t on
CORRECTIVE ACTION	
No action taken at this time. Results of inspection reported to Platform Engineer and NCA.	
RECOMMENDATIONS
