Kia Motors America
Consumer Affairs Department

Kia Case Type Lvl4: Windshield/Rear Glass(Breakaway)

Broken Sunroof Report

TF – Field Investigation Analysis Report

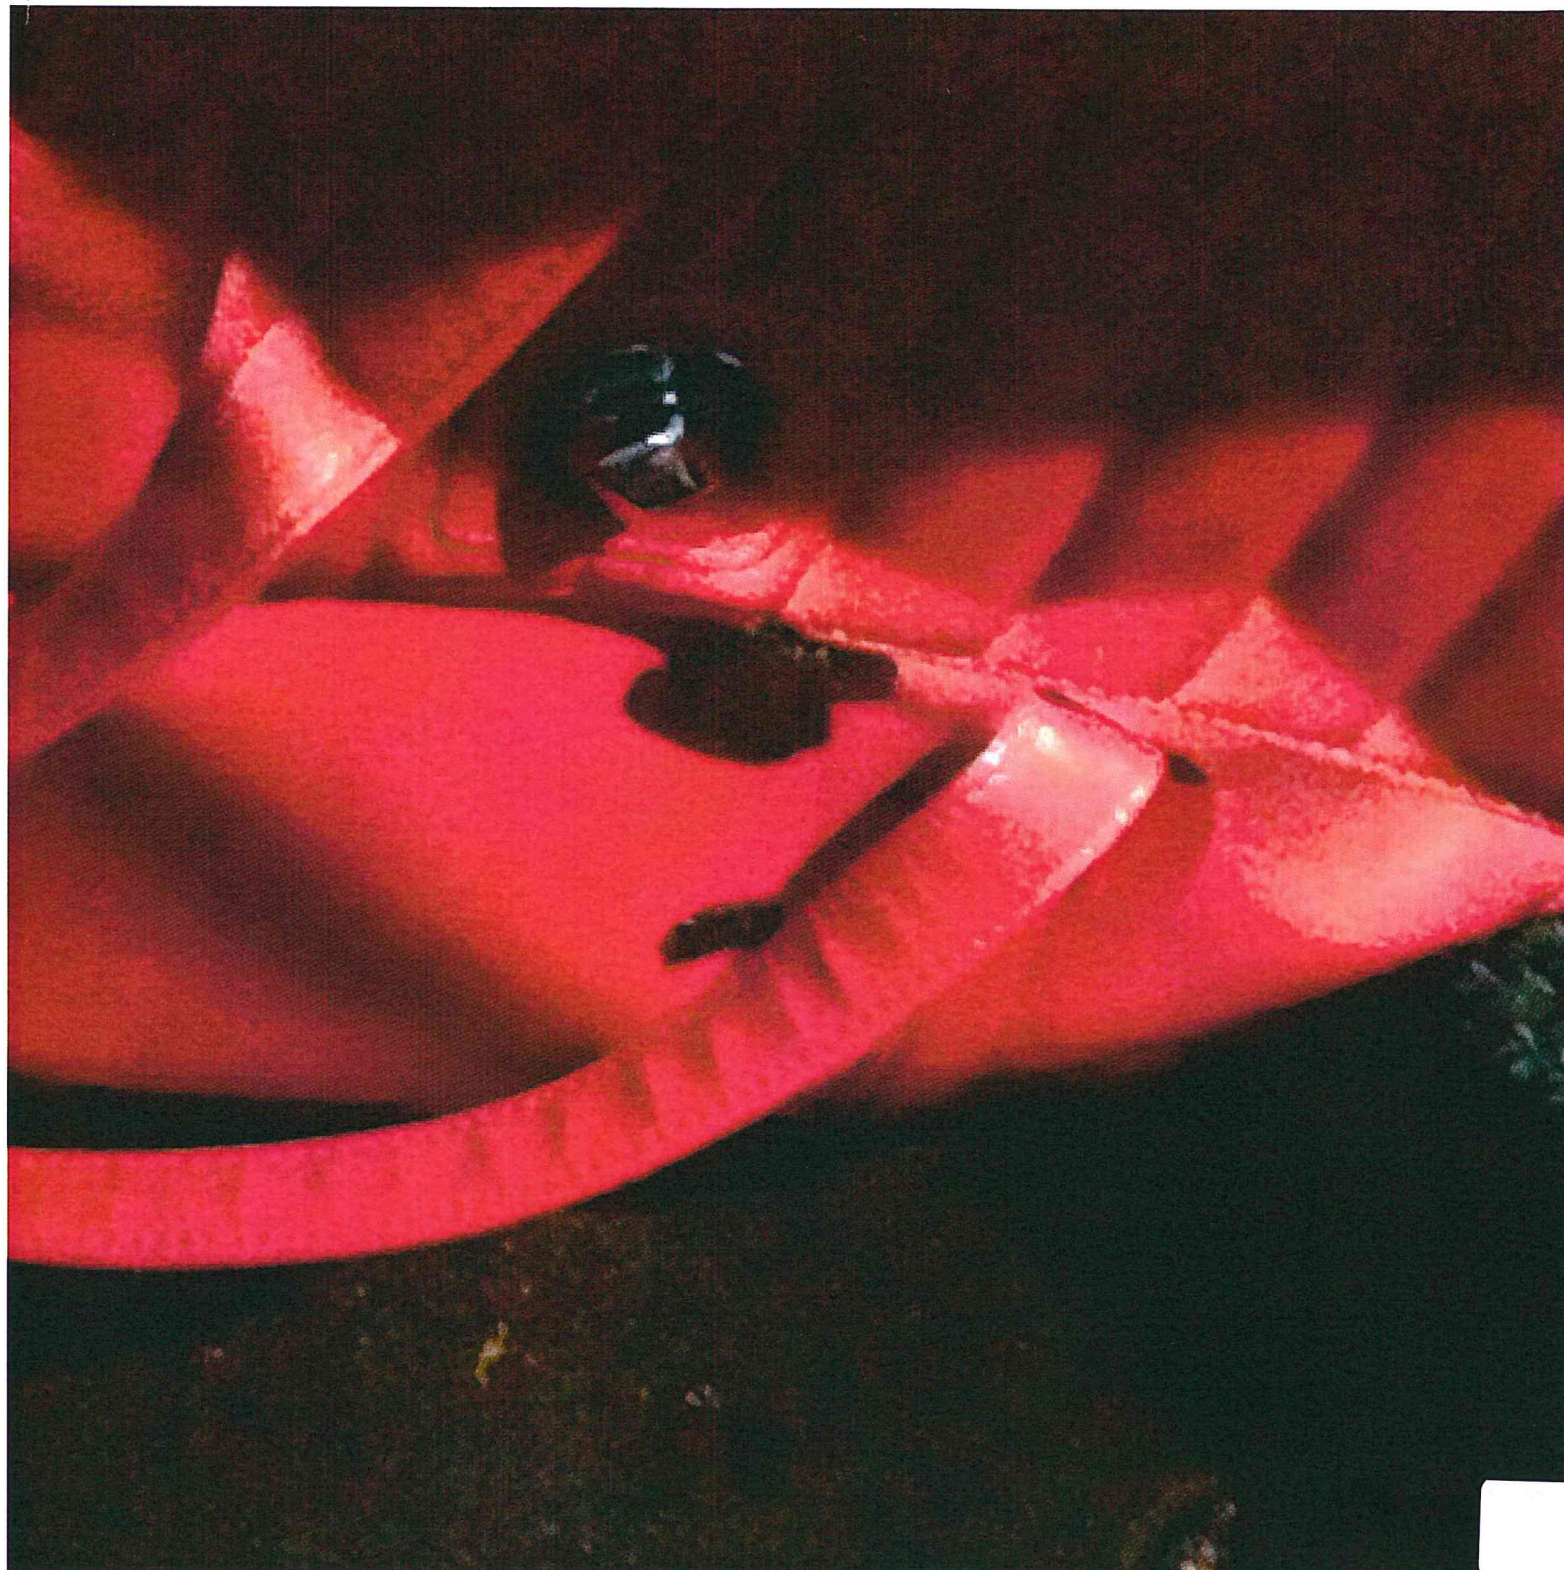
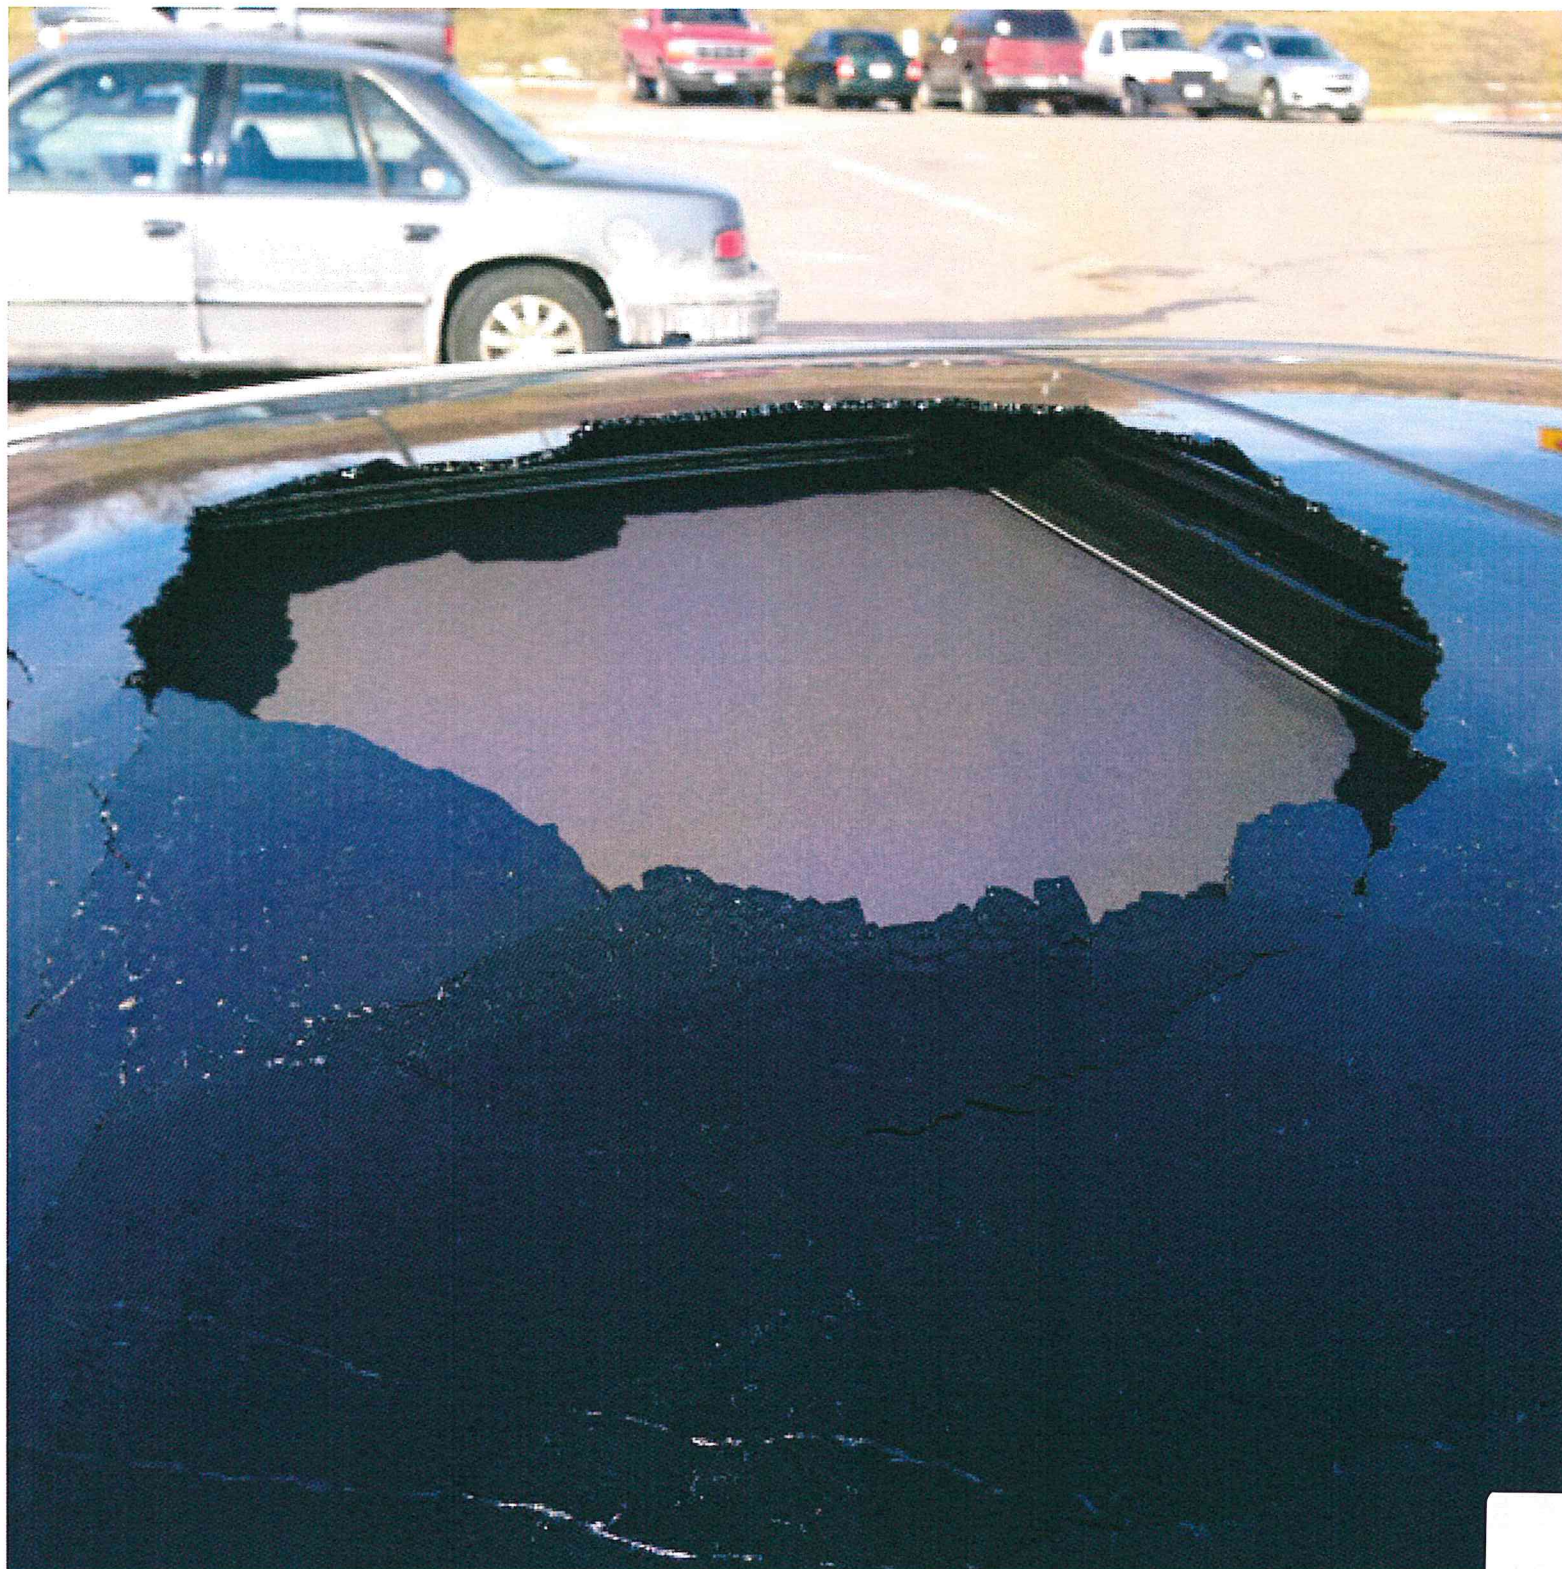
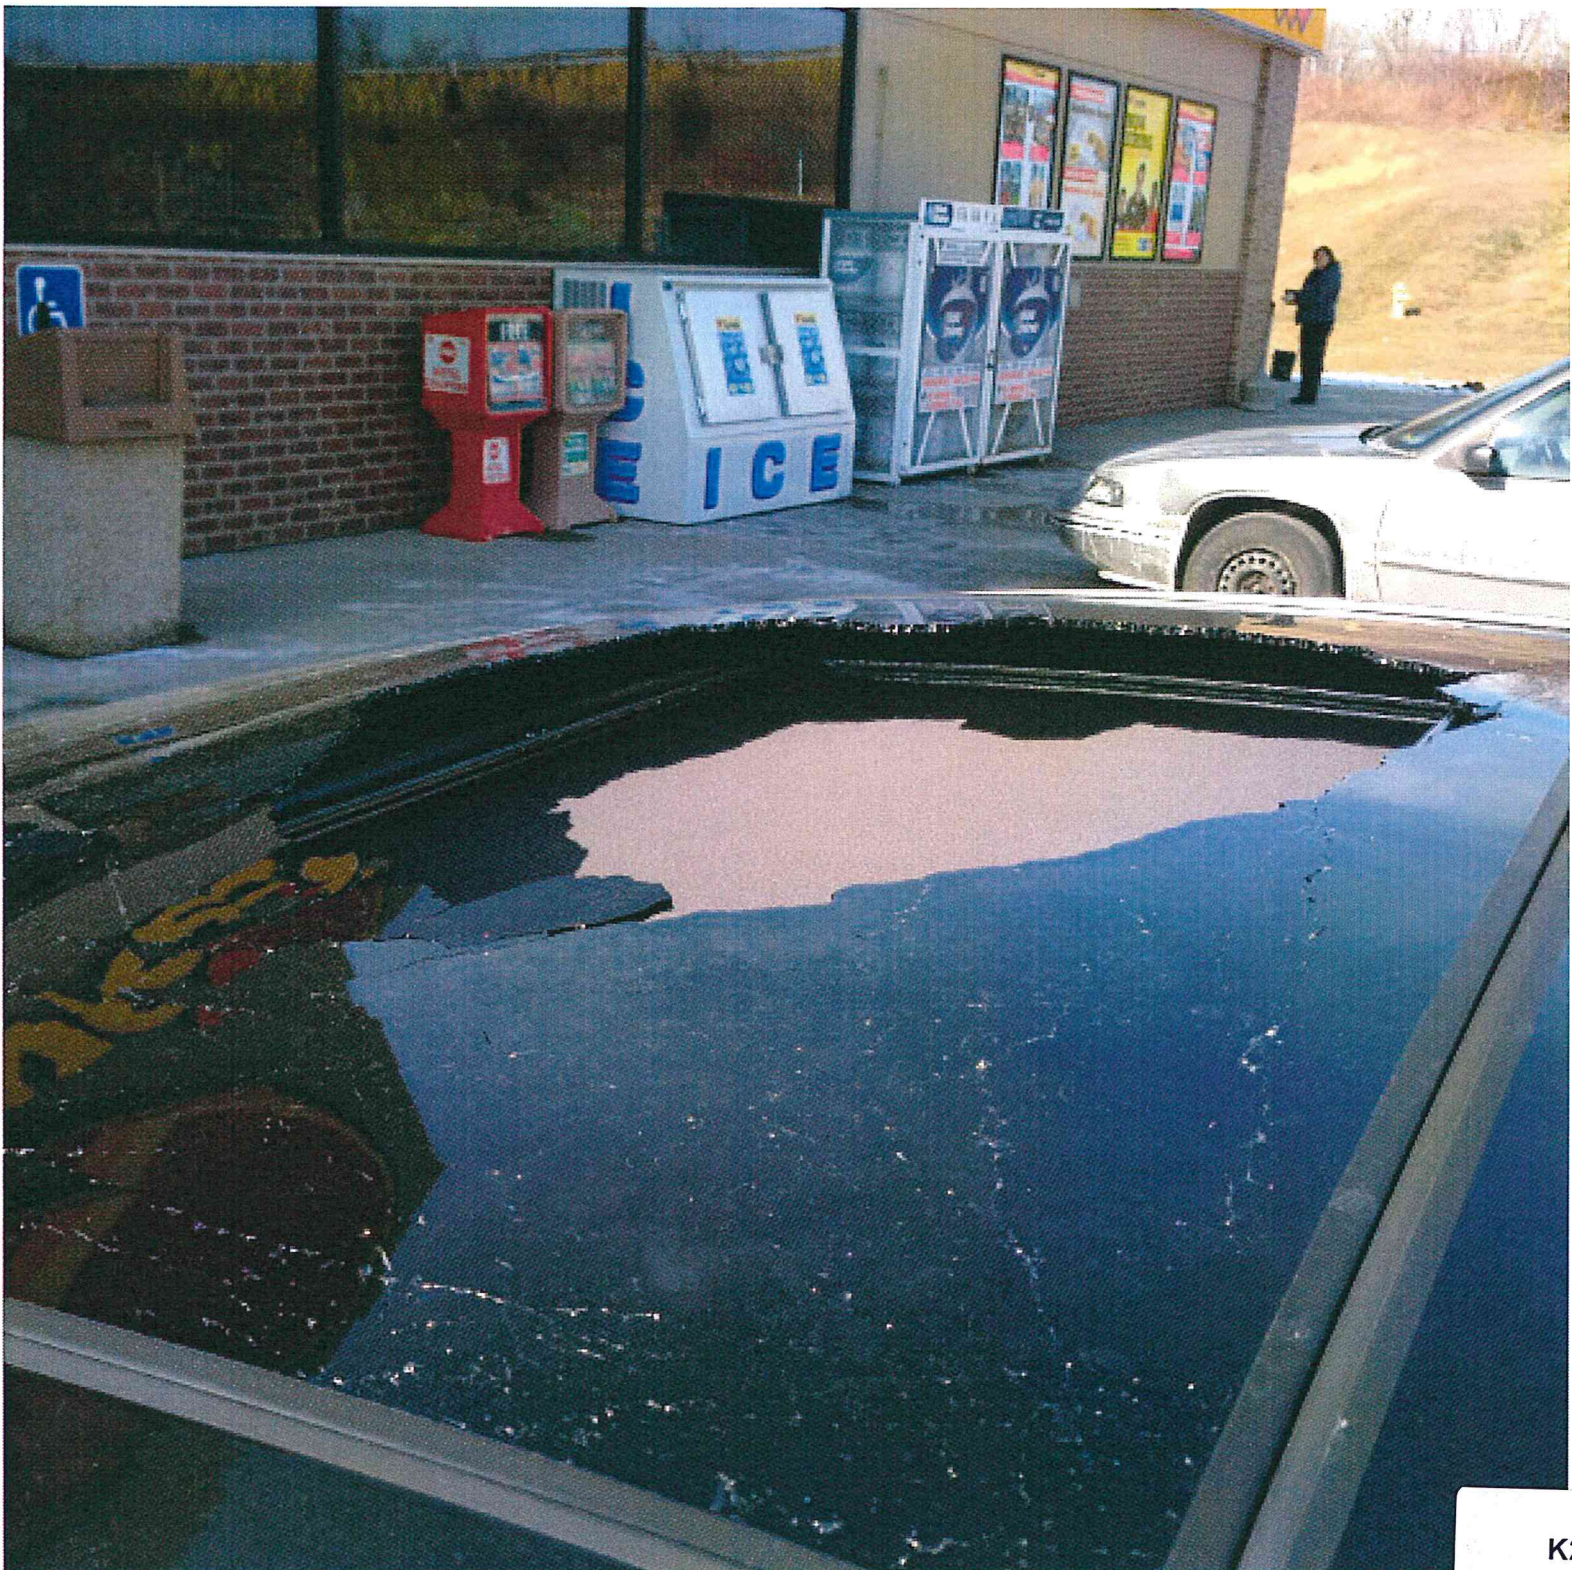
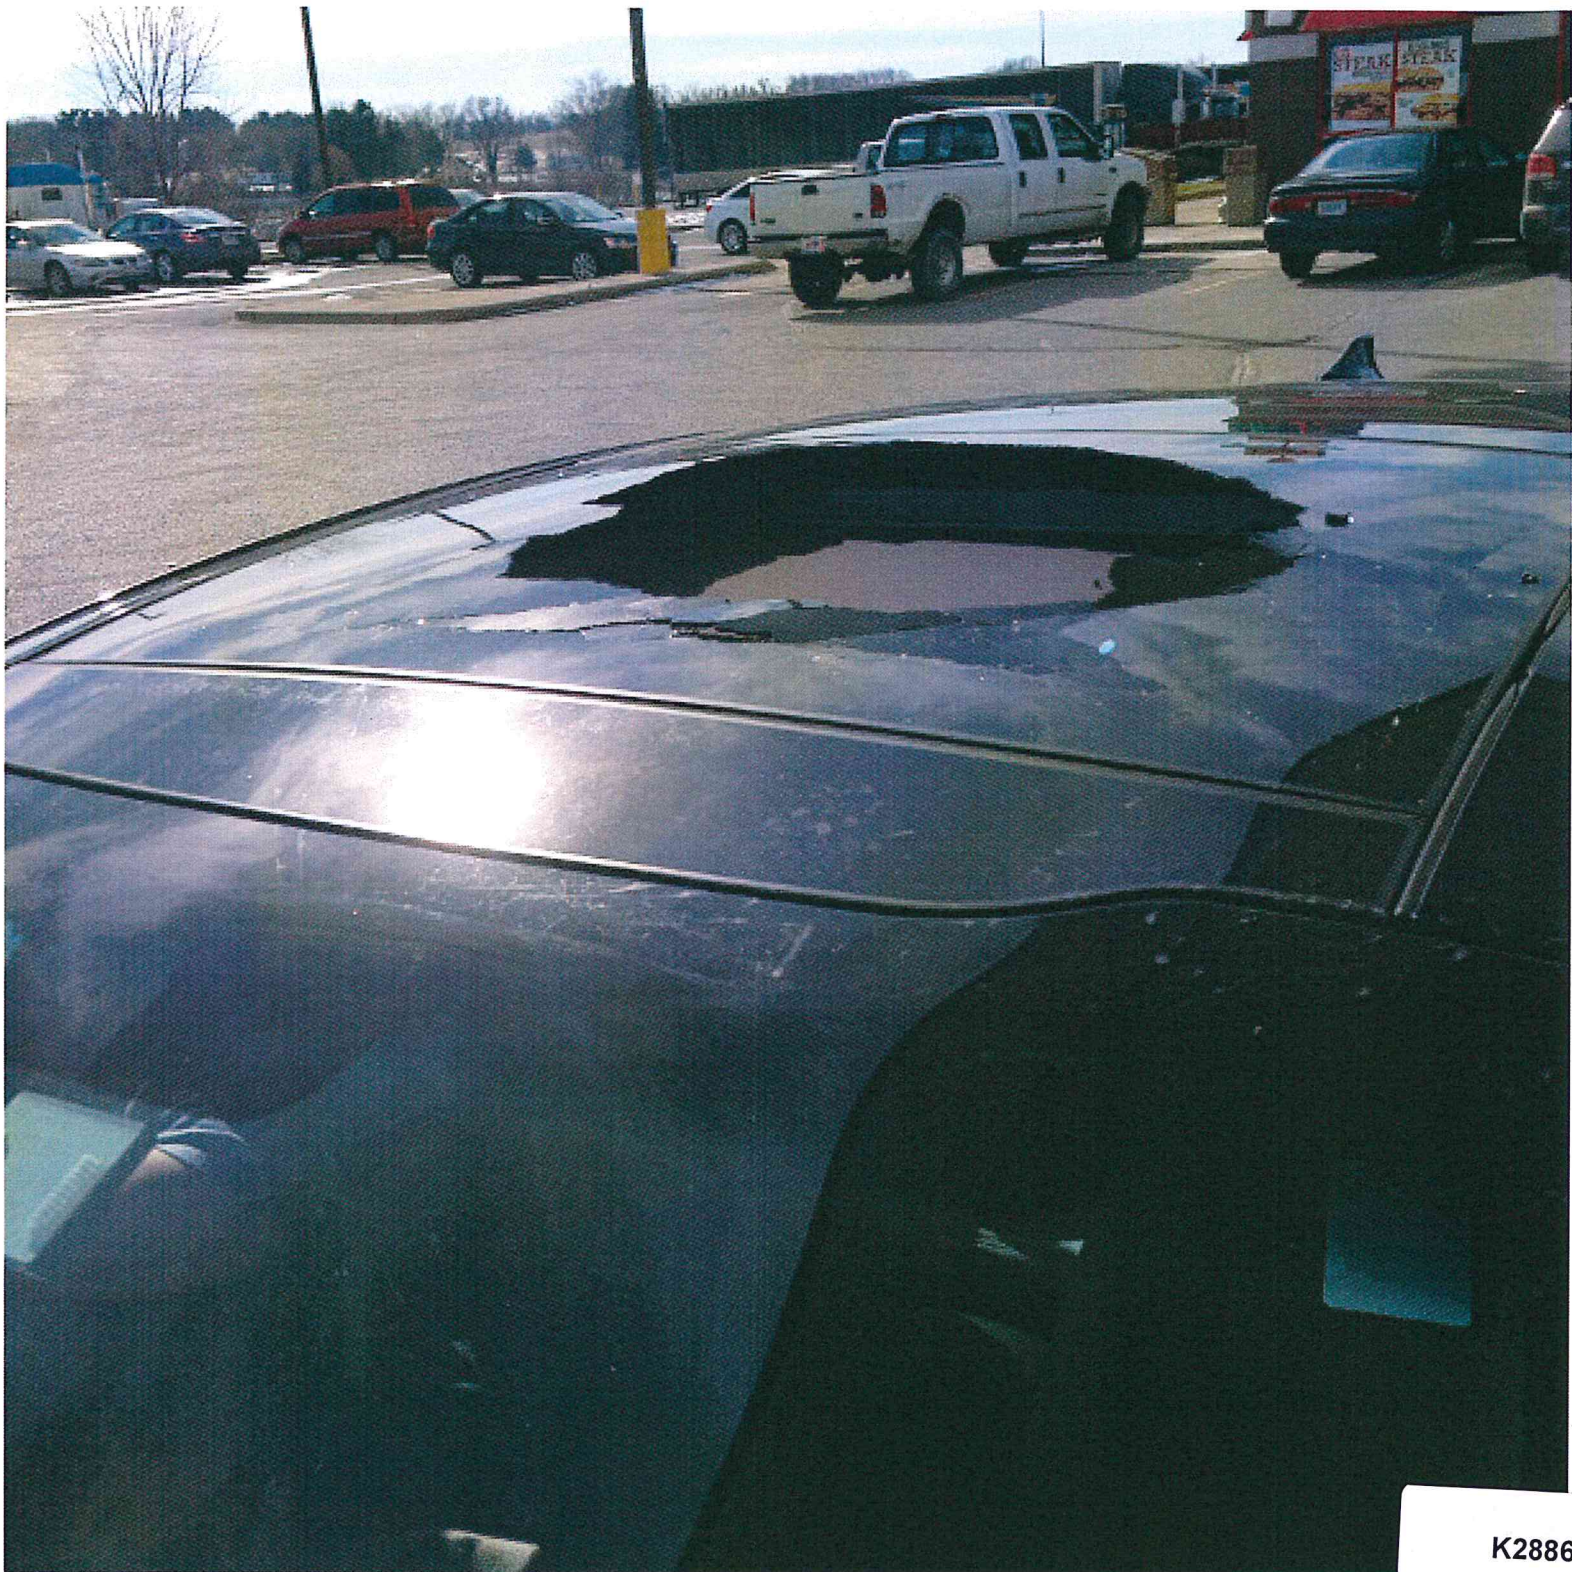
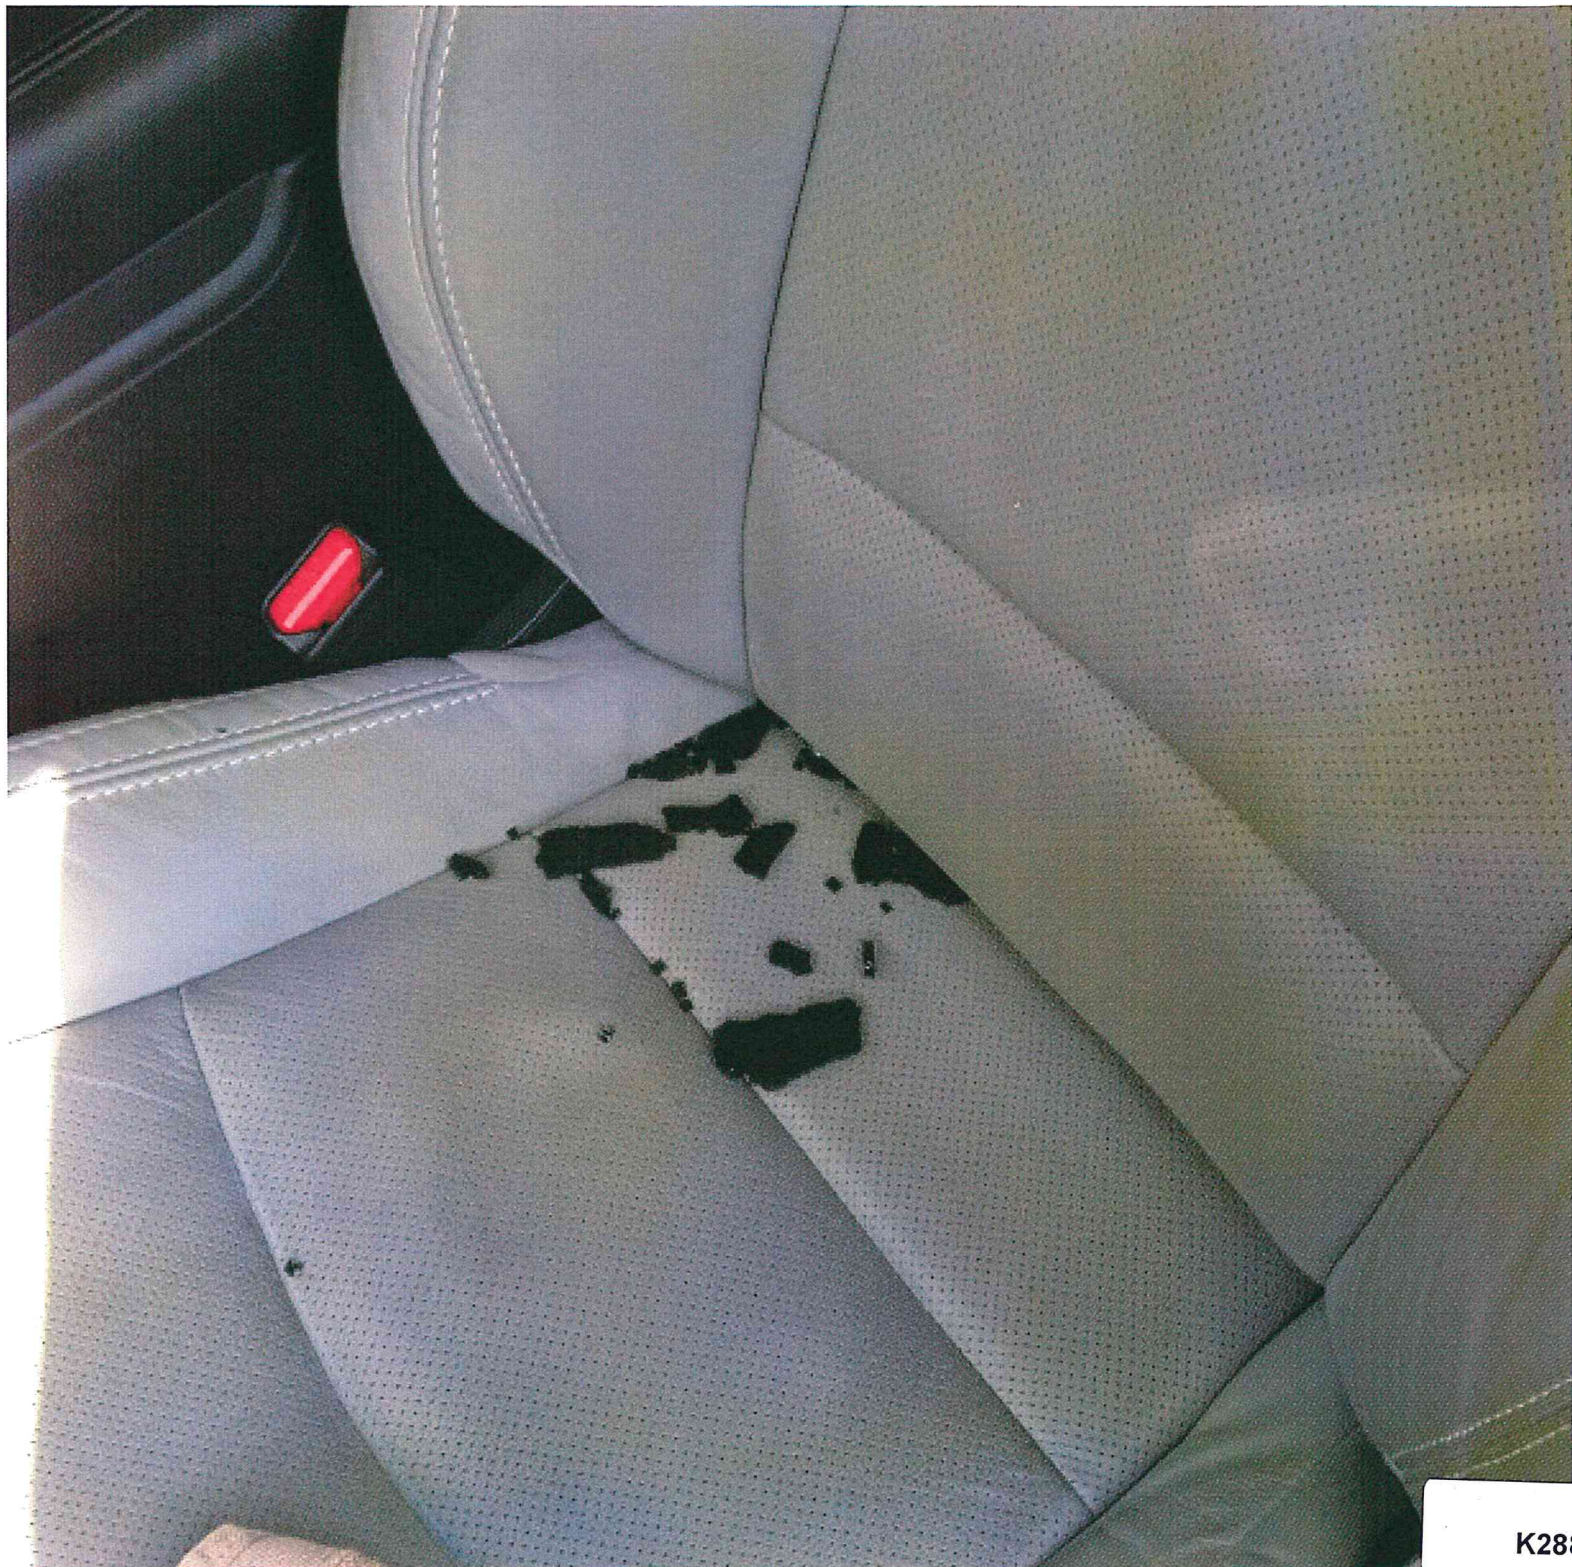
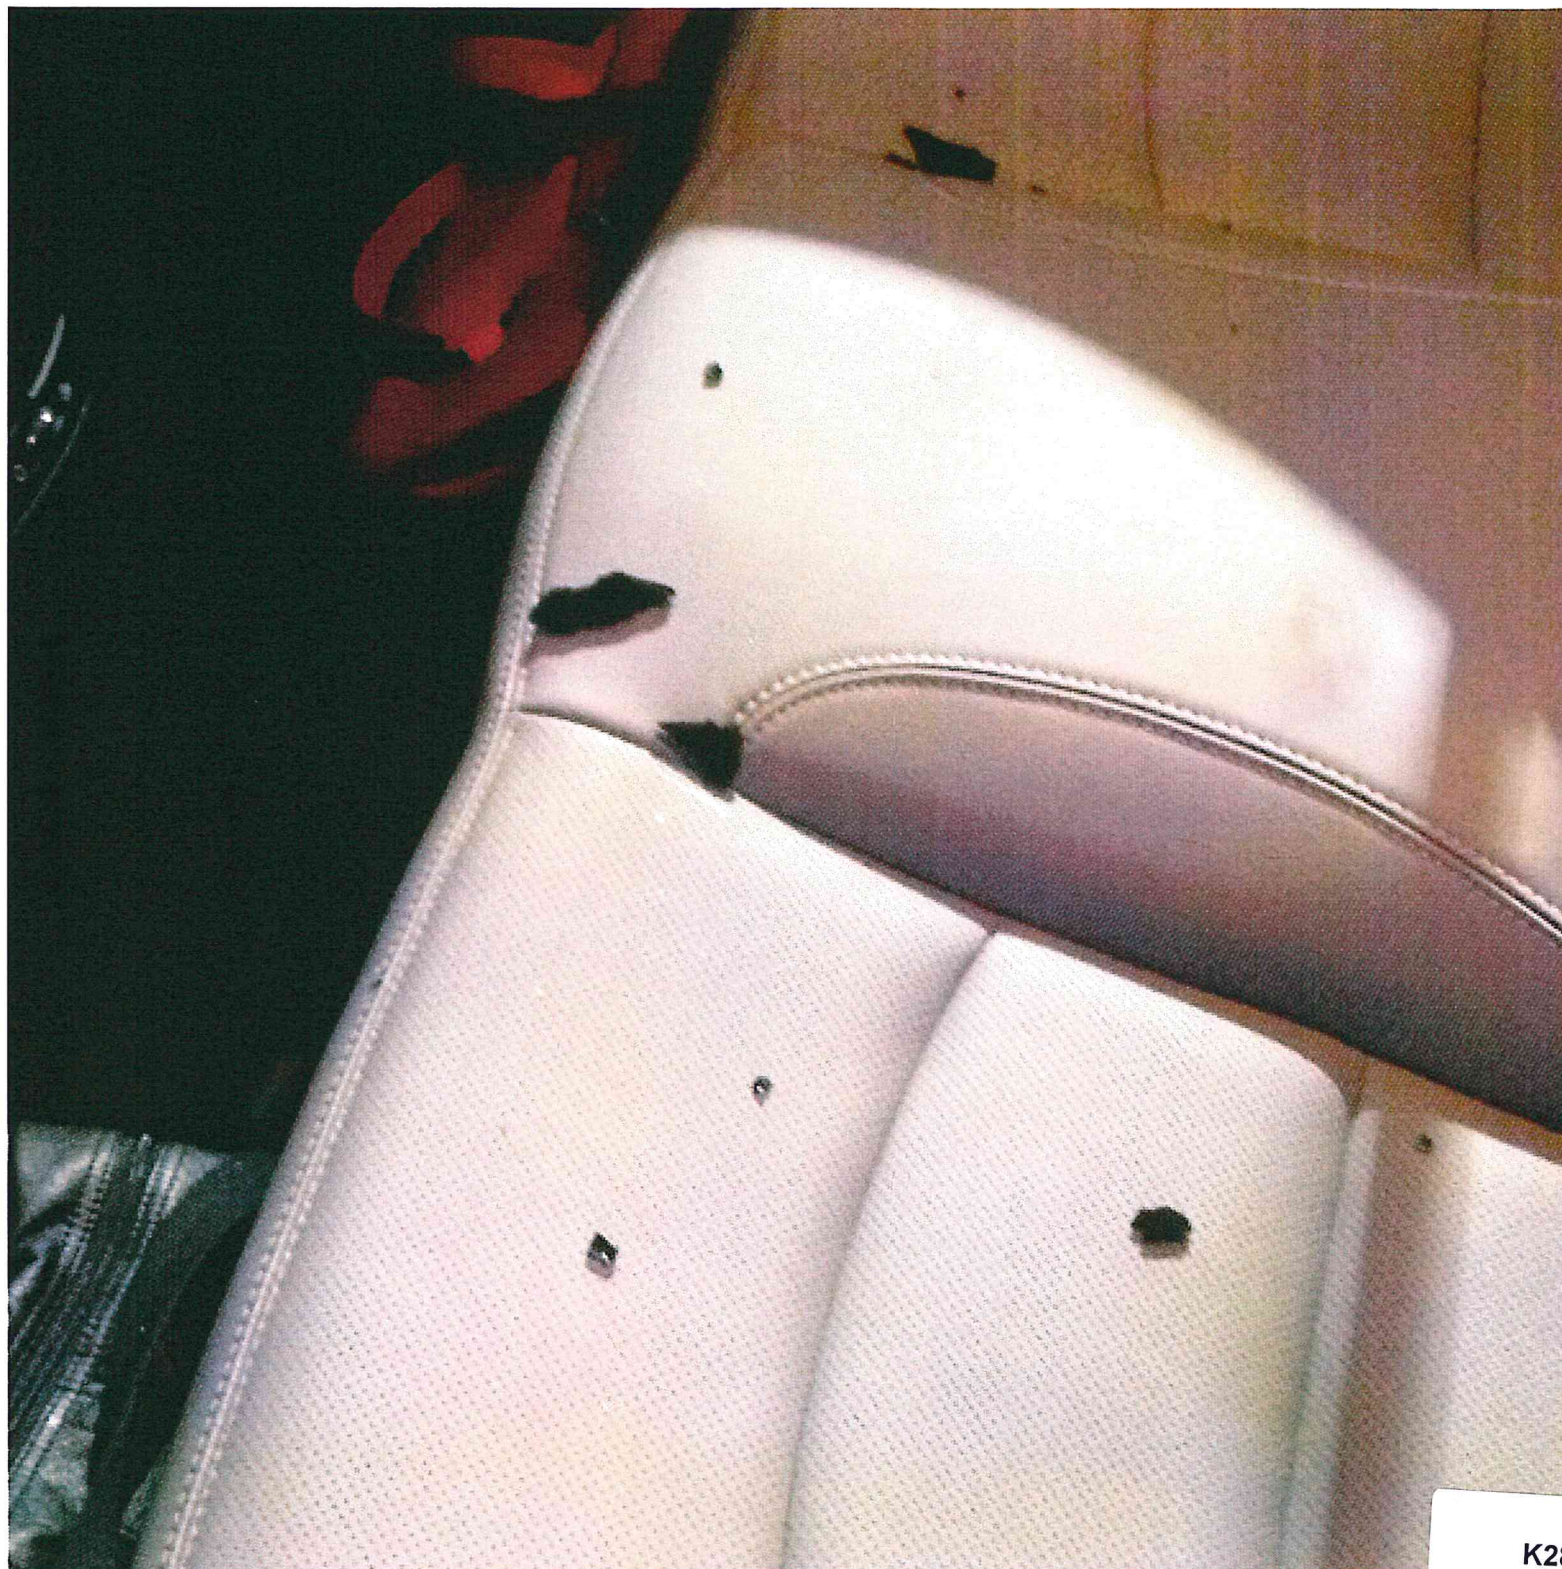
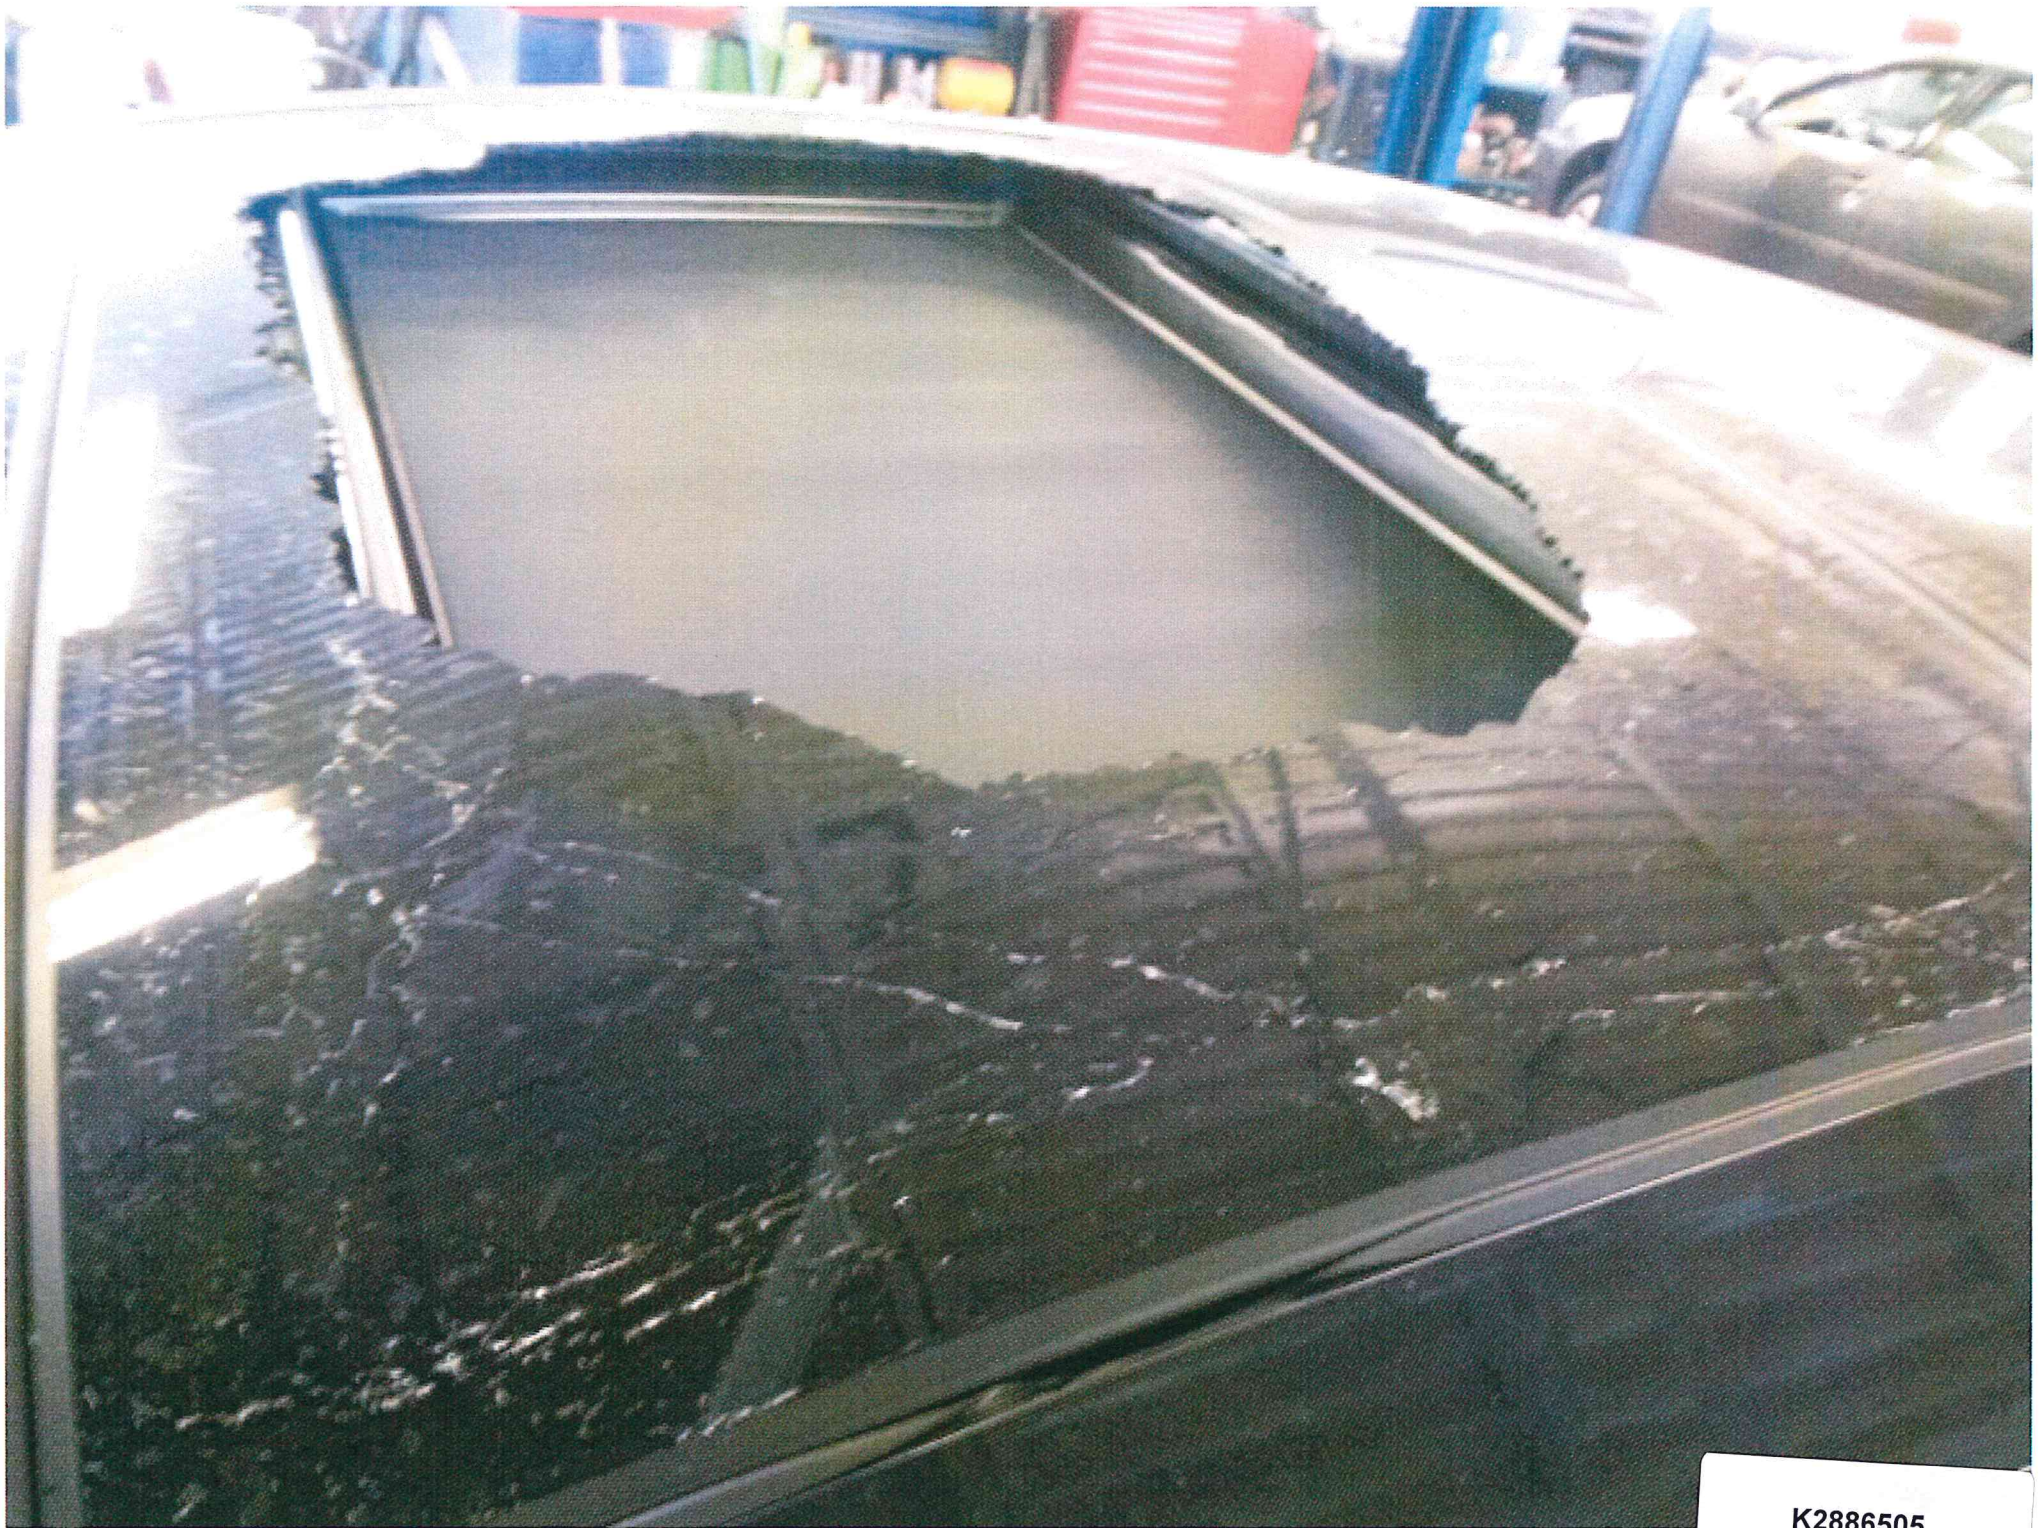
K2886505

1. My sun**ROOF EXPLO**ded
2. Talked to my dealer and no one was around
3. talked to RSA but wanted to tow 90 miles in the opposite direction
4. A very bad experience
5. Glass all over us

1. Cust alleges sun**ROOF EXPLO**ded while driving
2. Cust did not want to have car towed 90 miles in the wrong direction so drove home
3. Car is being towed this morning 2/10/15 to dealer
4. Dealer is expecting car this morning

1. Calling in reference to vehicle.
2. Informed customer that case was reviewed.
3. At this point in time, KMA was unable to find a cause for the **SHATTER** and whether it was due to external impact or not.
4. Therefore, KMA would like to offer to cover the cost of repairs as a GW gesture.
5. If that is something that customer is interested in, wtr will need to send out release that is to be signed and returned.

1. Wtr informed SM that repairs will be covered as GW.
2. SM will be ordering parts and will have vehicle ready for customer asap.
3. Wtr thanked and disconnected.

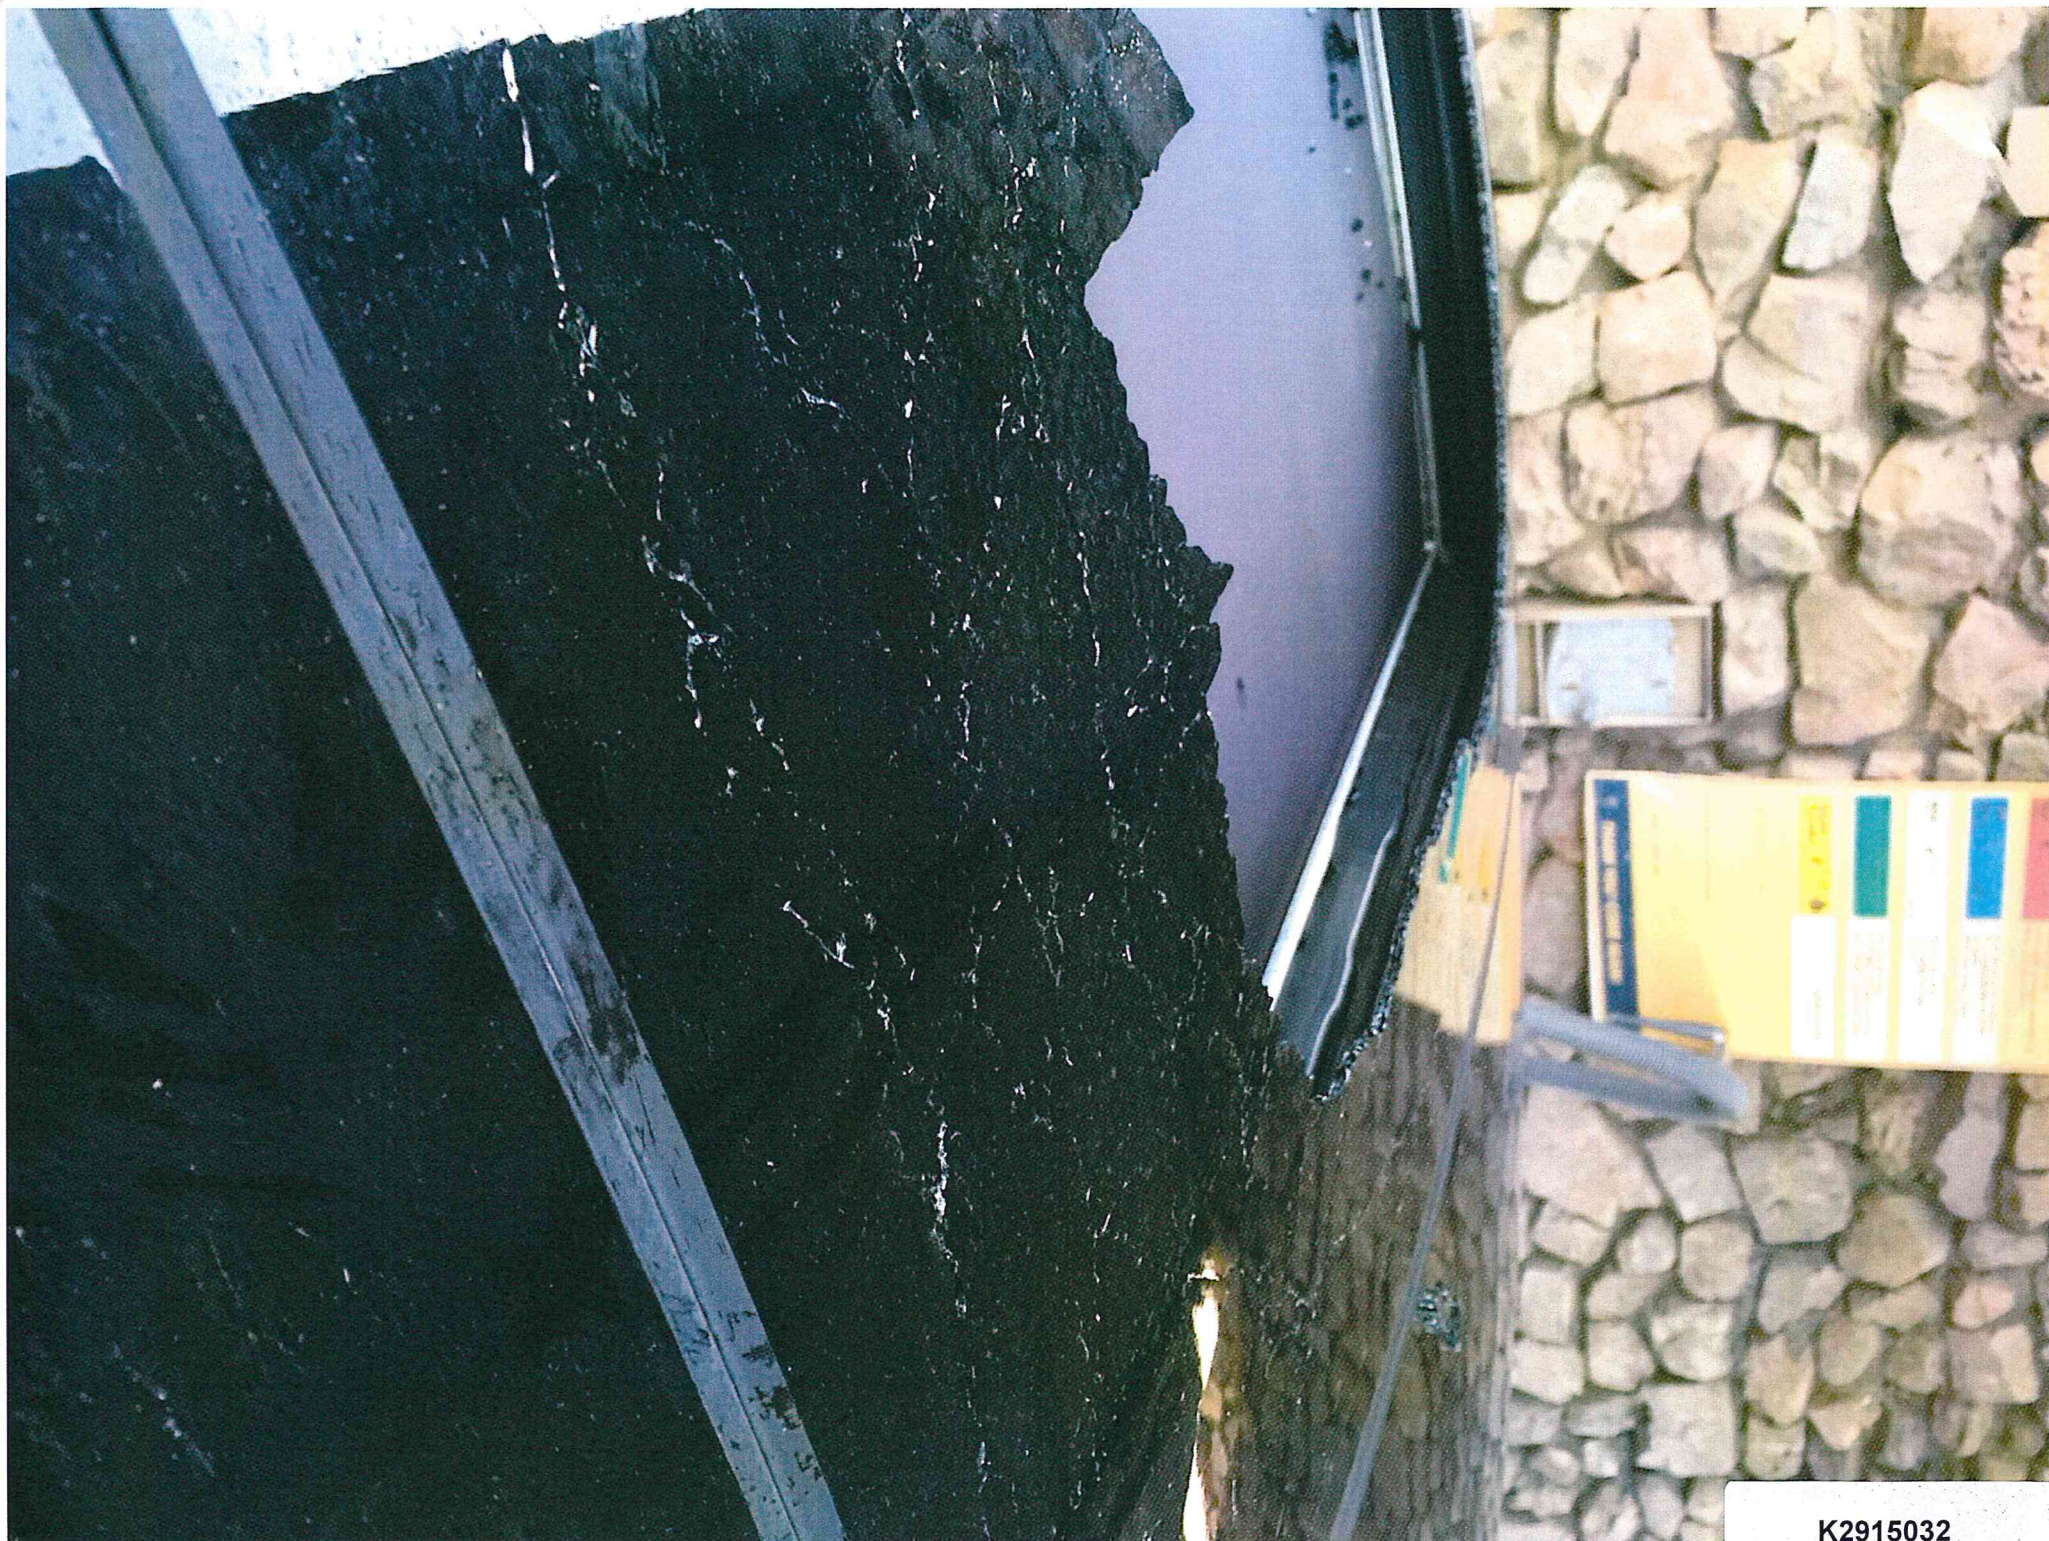
K2915032

It got hit in the rear of the car, approximately 6 months ago. They had to replace the trunk part of the car, it was pushed forward.

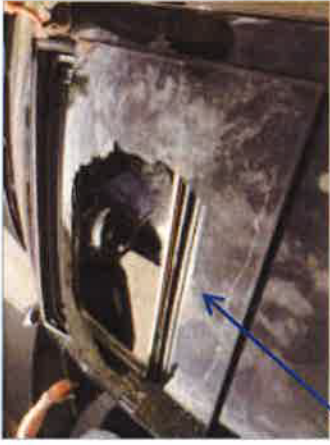
Upon inspecting the subject vehicle, it was observed that the sliding sunroof glass had a hole in the center; approximately 24" w x 16" h. It was observed that the glass fragmentation occurred from the center outwards (circular web pattern). The glass was recovered for further analysis.

<p>Explosion in Center of Glass</p>

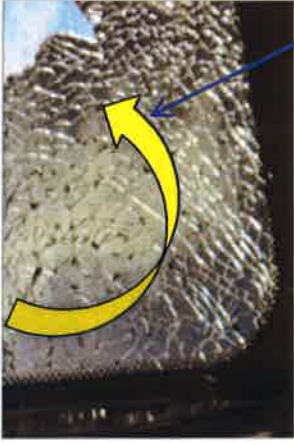
<p>Circular fracture configuration</p></div> <ul style="list-style-type: none">❖ KMC to investigate supplier sunroof heat treatment variability and material characteristics (heat expansion).❖ KMC to investigate body opening cavity variability and sunroof dimension variability for potential interference❖ KMC to investigate glass sample for material quality.
