Kia Motors America
Consumer Affairs Department

Kia Case Type Lvl4: Windshield/Rear Glass(Breakaway)

Broken Sunroof Report

TF – Field Investigation Analysis Report

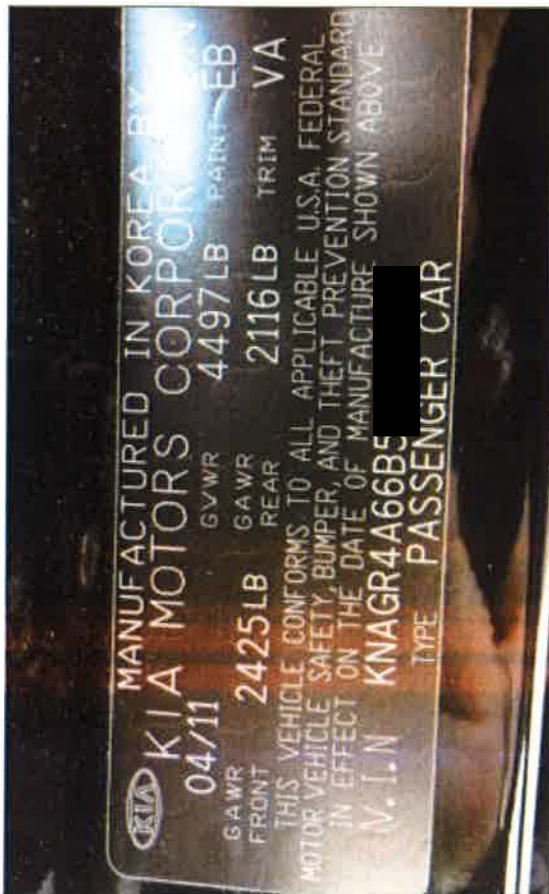
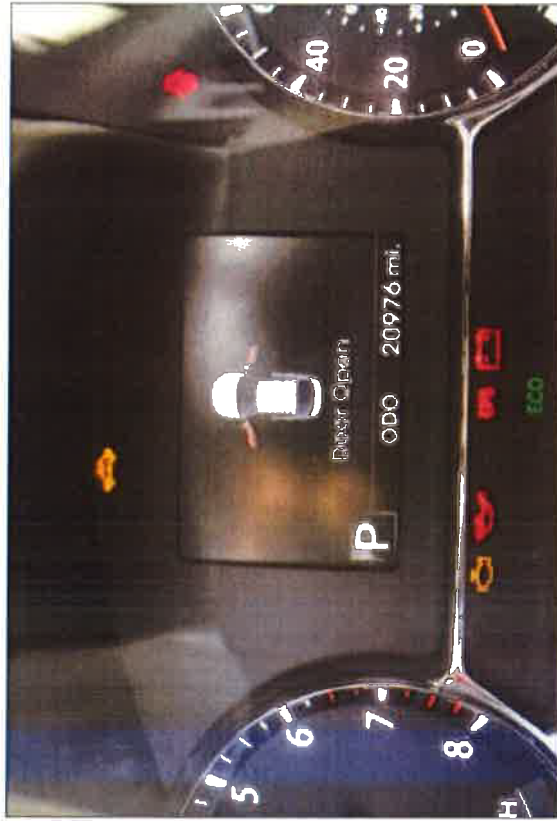
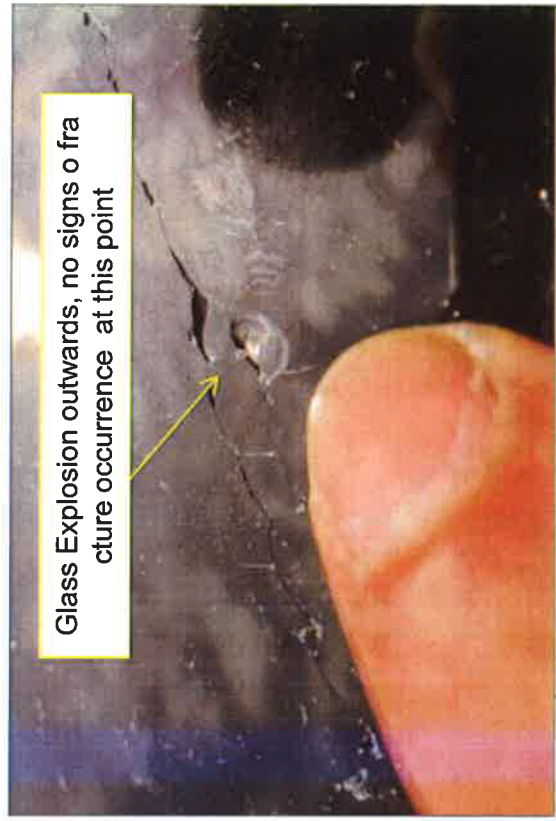
Problem

ACTUAL CONDITION

It was observed that the Sunroof Sliding glass had a hole in the center of the glass

<p>Circular fracture configuration</p></div> <ul style="list-style-type: none">❖ KMC to investigate supplier sunroof heat treatment variability and material characteristics (heat expansion).❖ KMC to investigate body opening cavity variability and sunroof dimension variability for potential interference❖ KMC to investigate glass sample for material quality.

Panorama Glass Exploded

Continue to investigate field issues and identify "Root Cause".

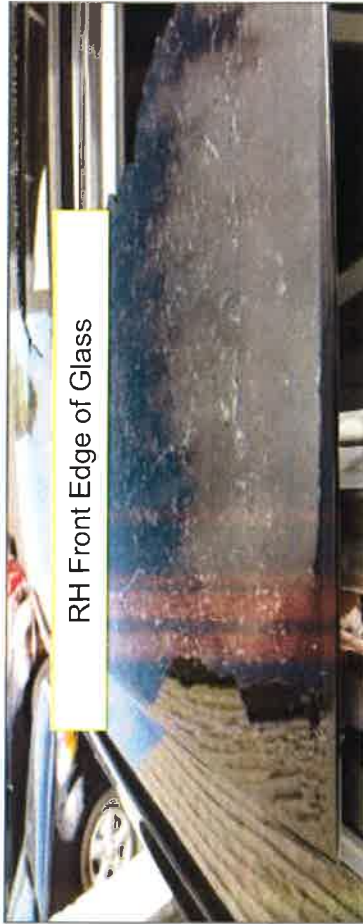
RH Front Edge of Glass

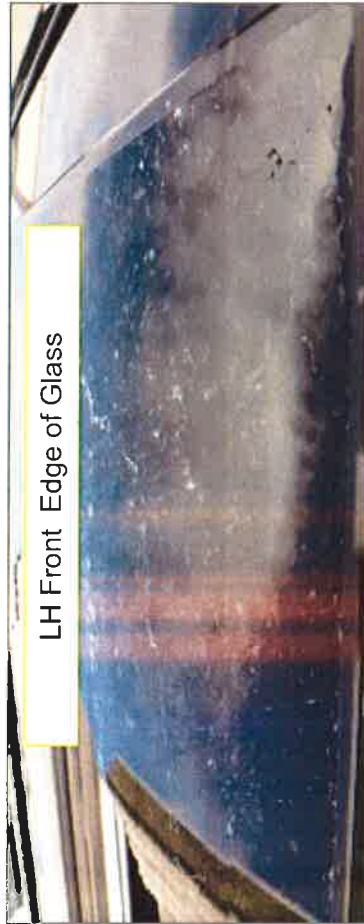
LH Front Edge of Glass

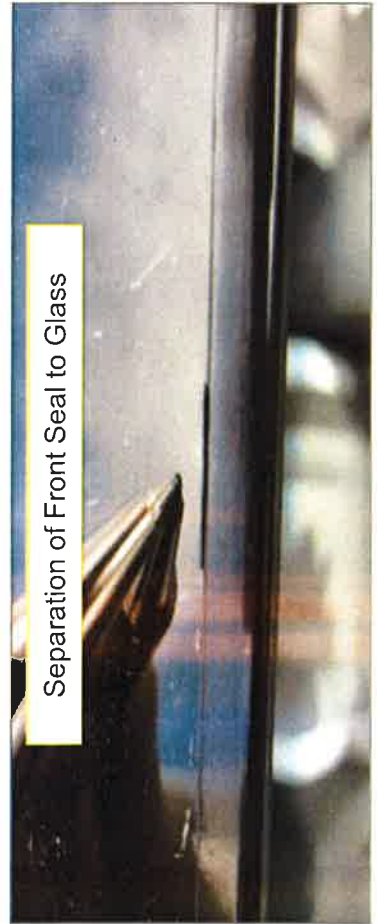
Separation of Front Seal to Glass

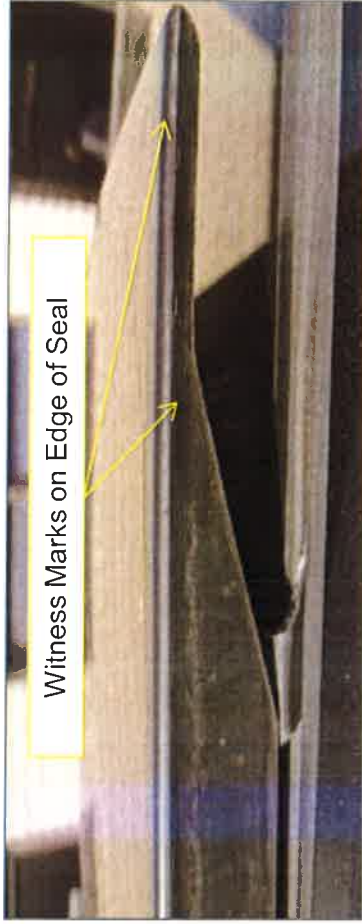
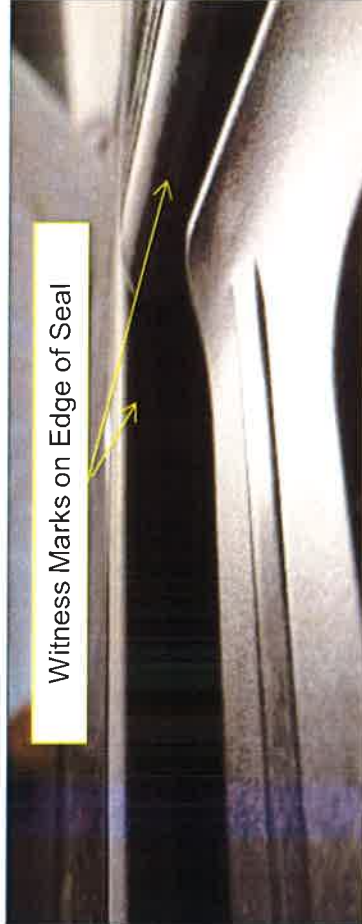
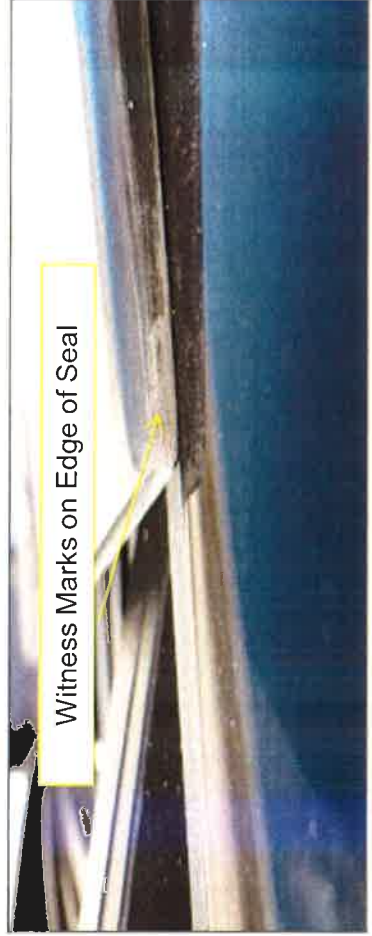
Witness Marks on Edge of Seal

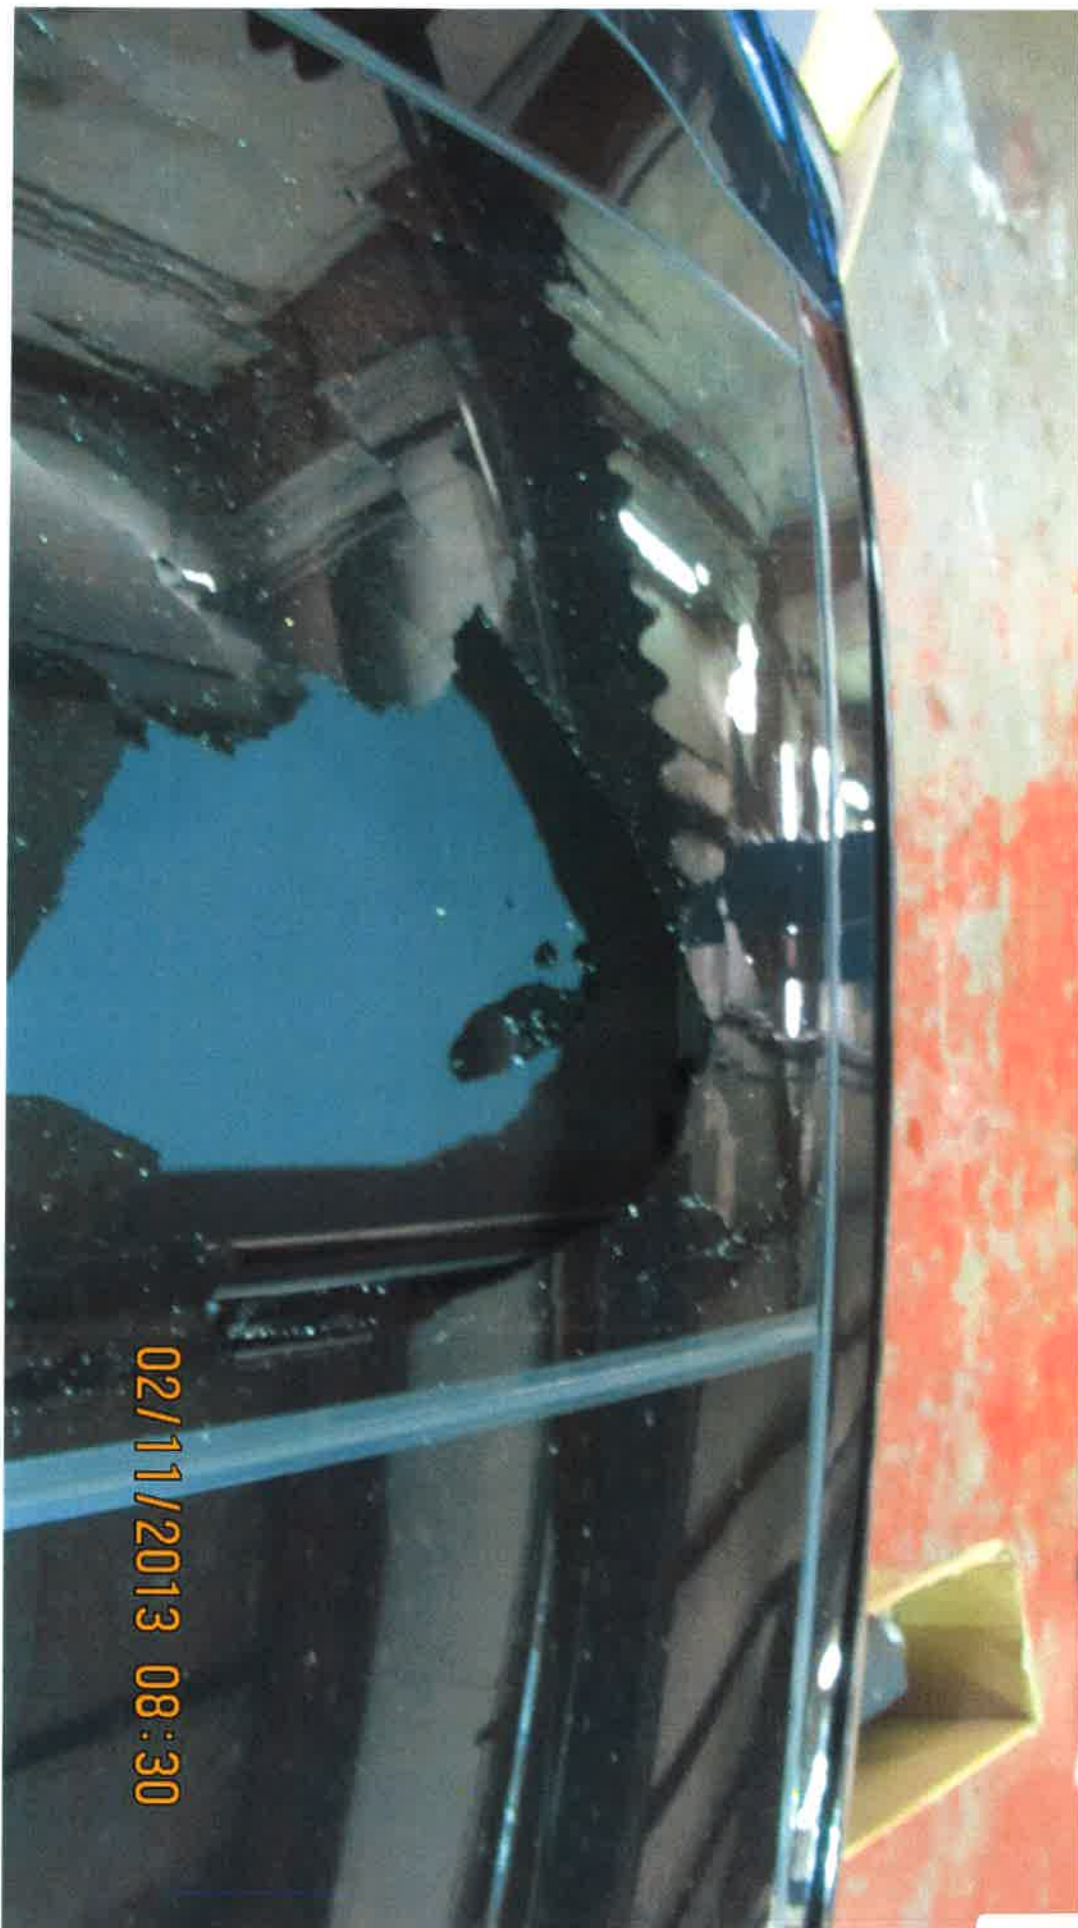
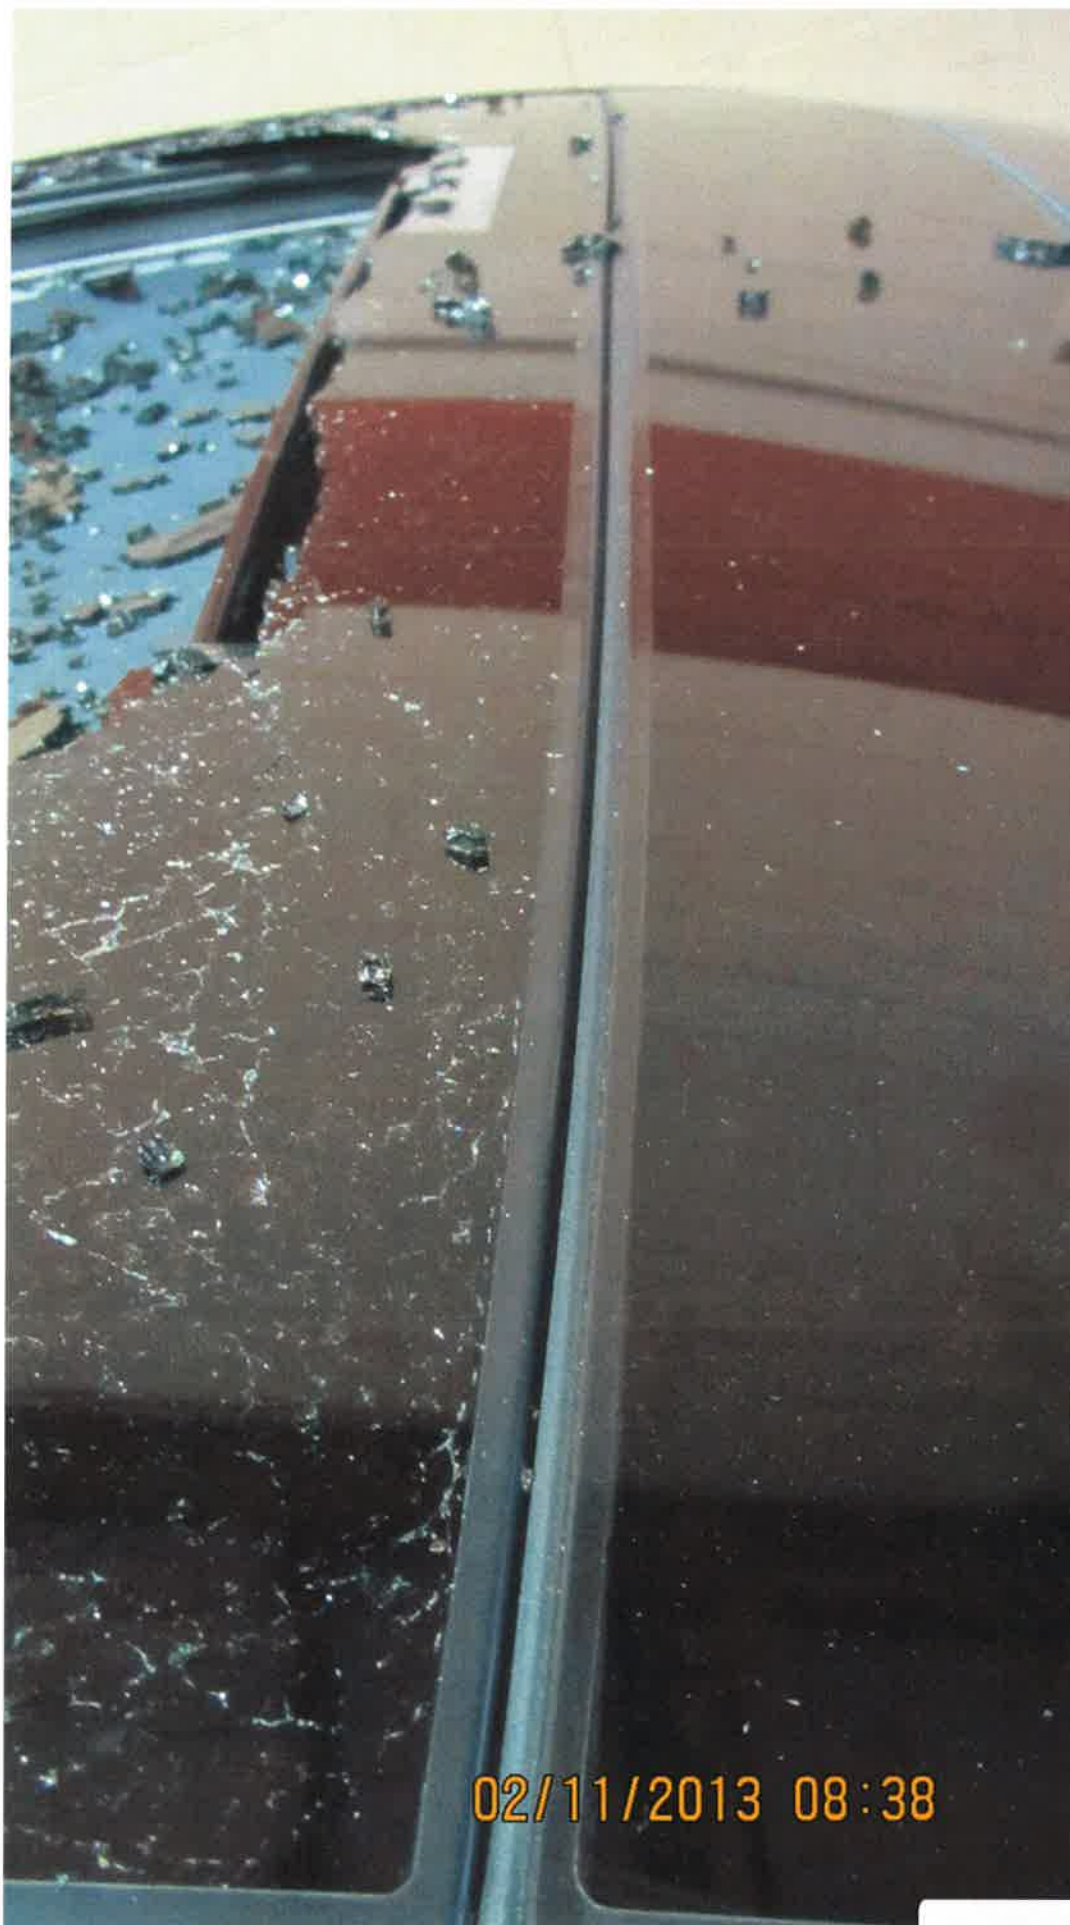
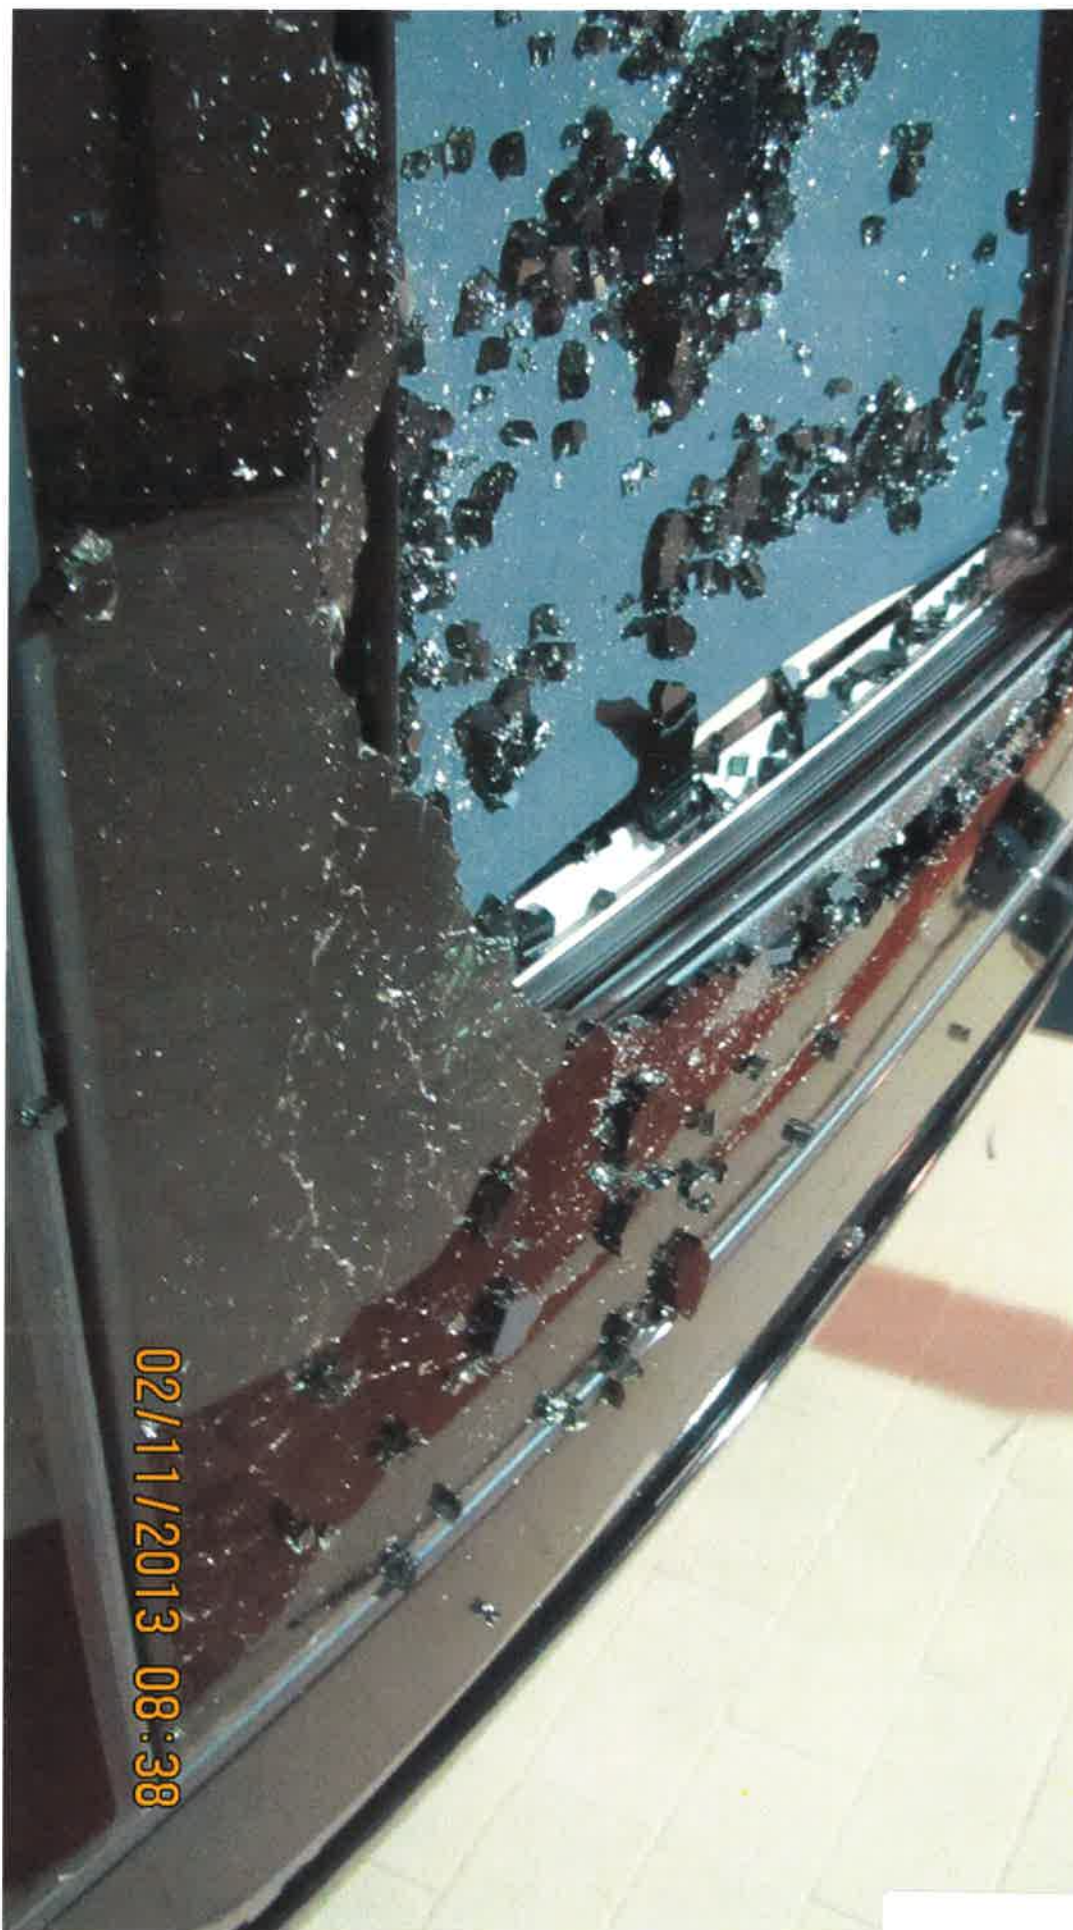
F2442098

Found that the glass was pushed up and out. There was no evidence of rock chip, around the edge.

Clean assembly and replace the panorama sunroof glass. Ship fragmented glass to KMA for inspection.

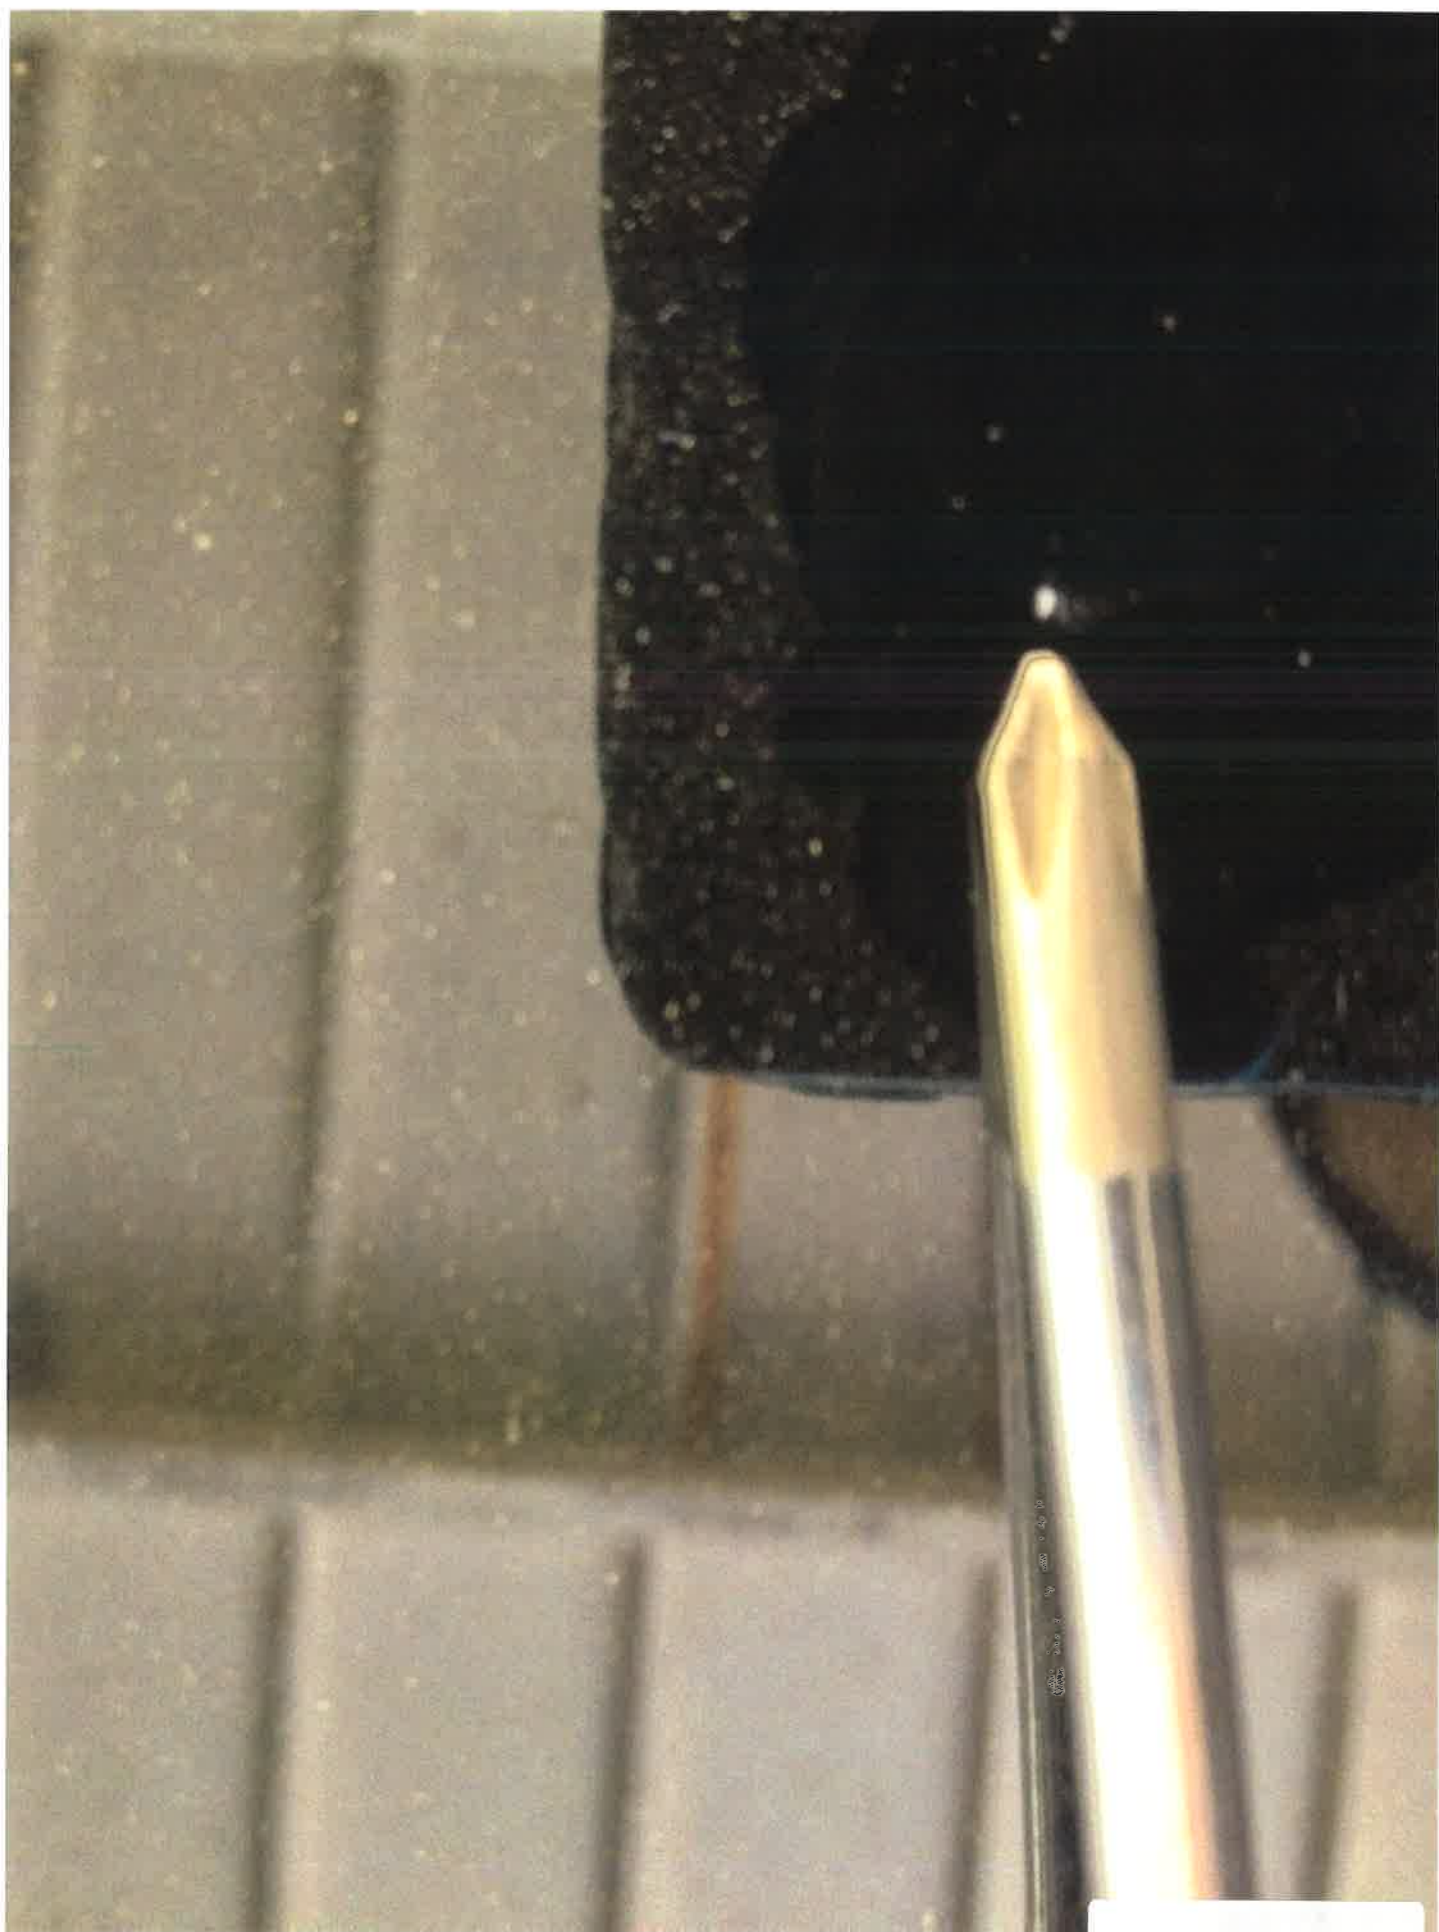
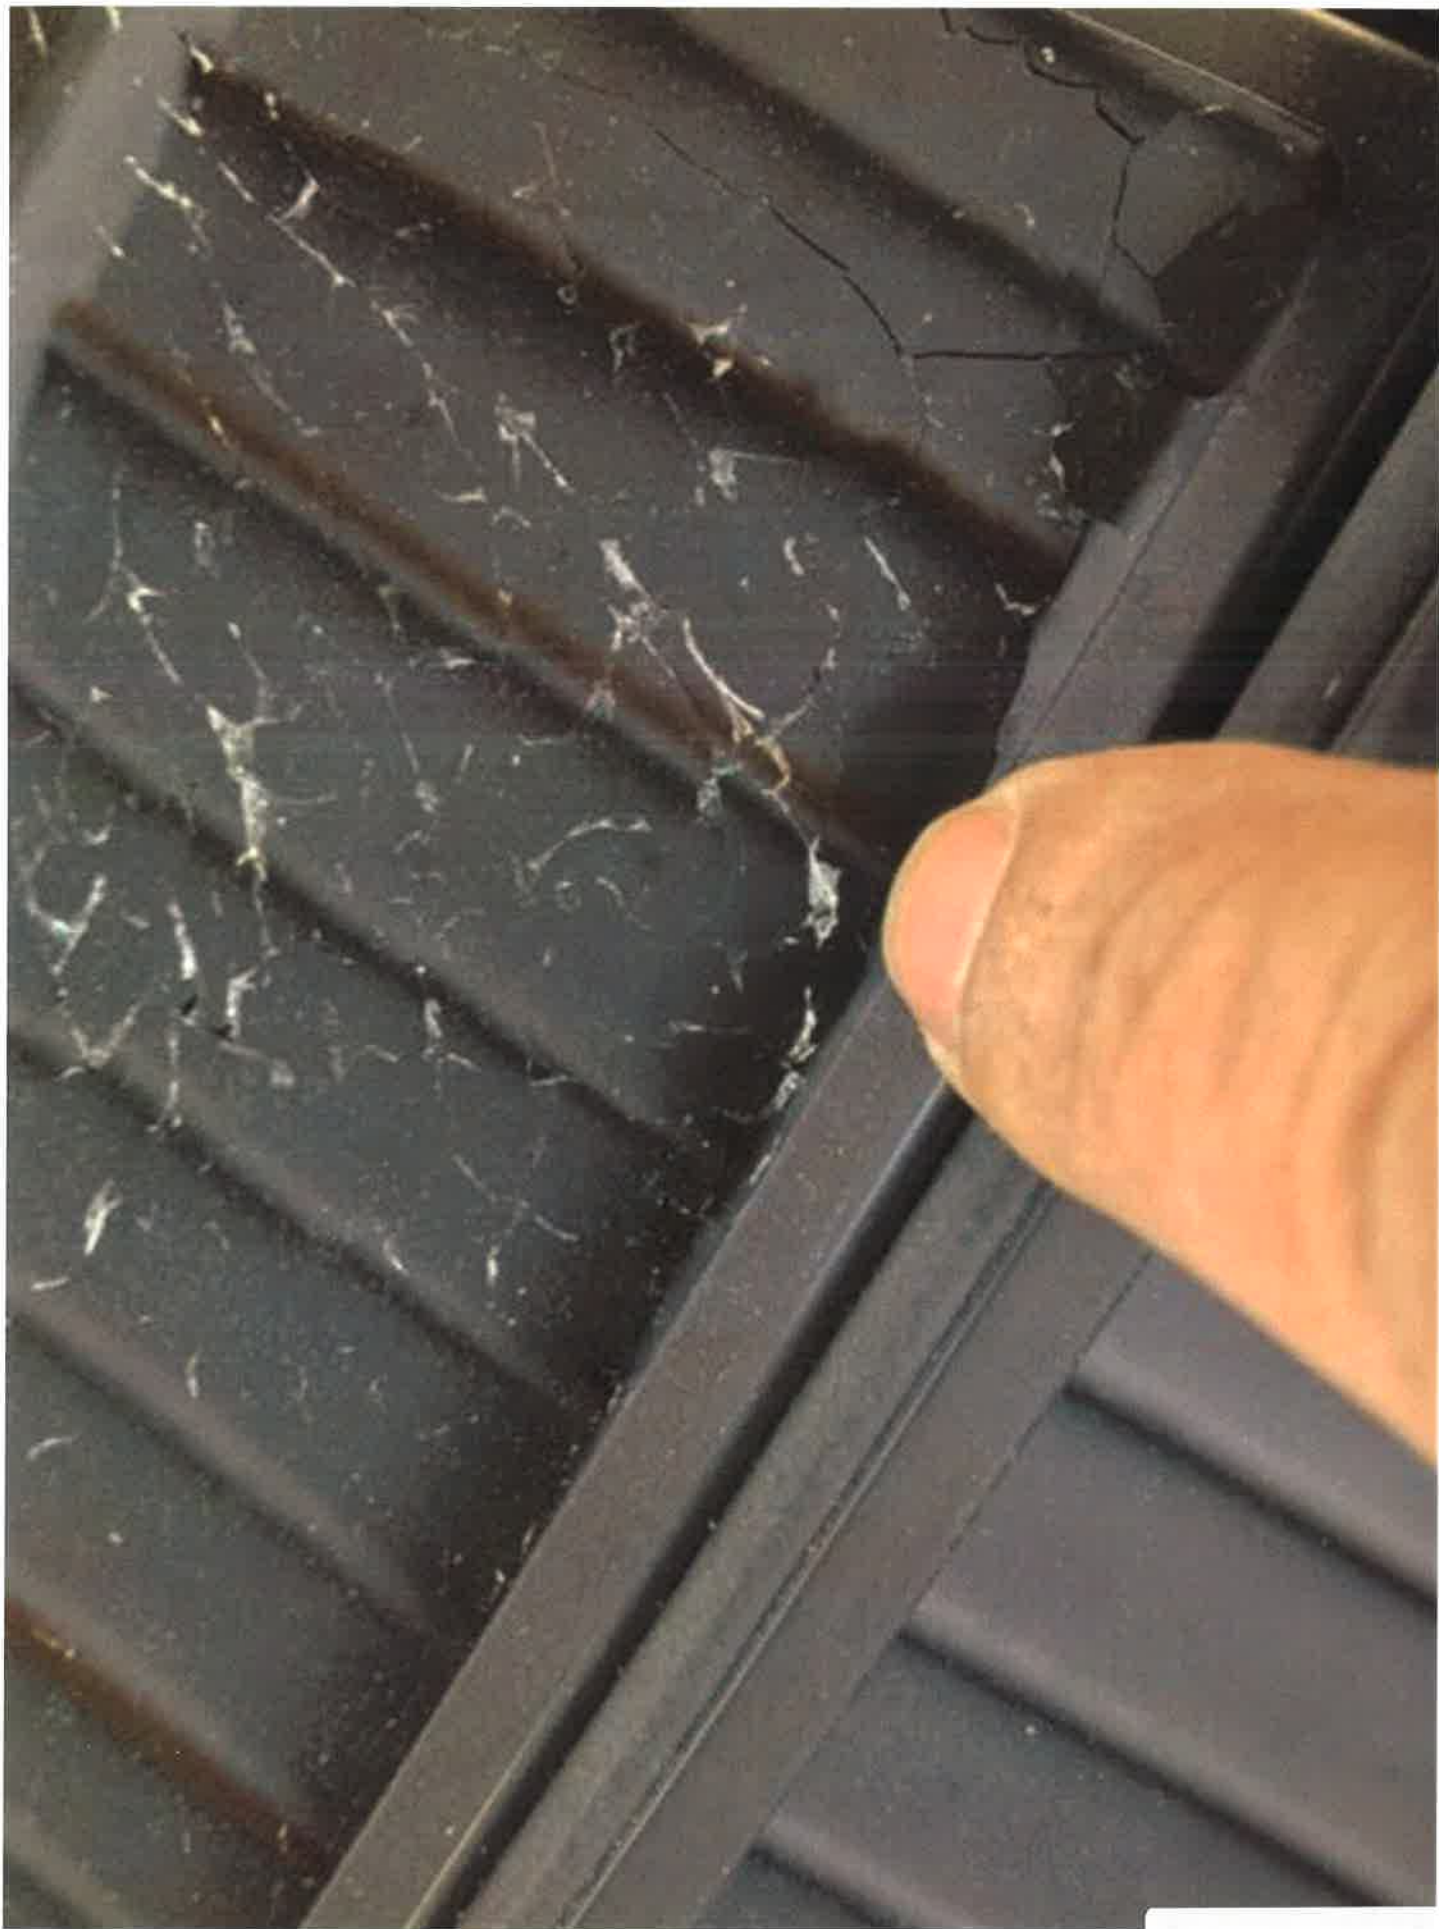
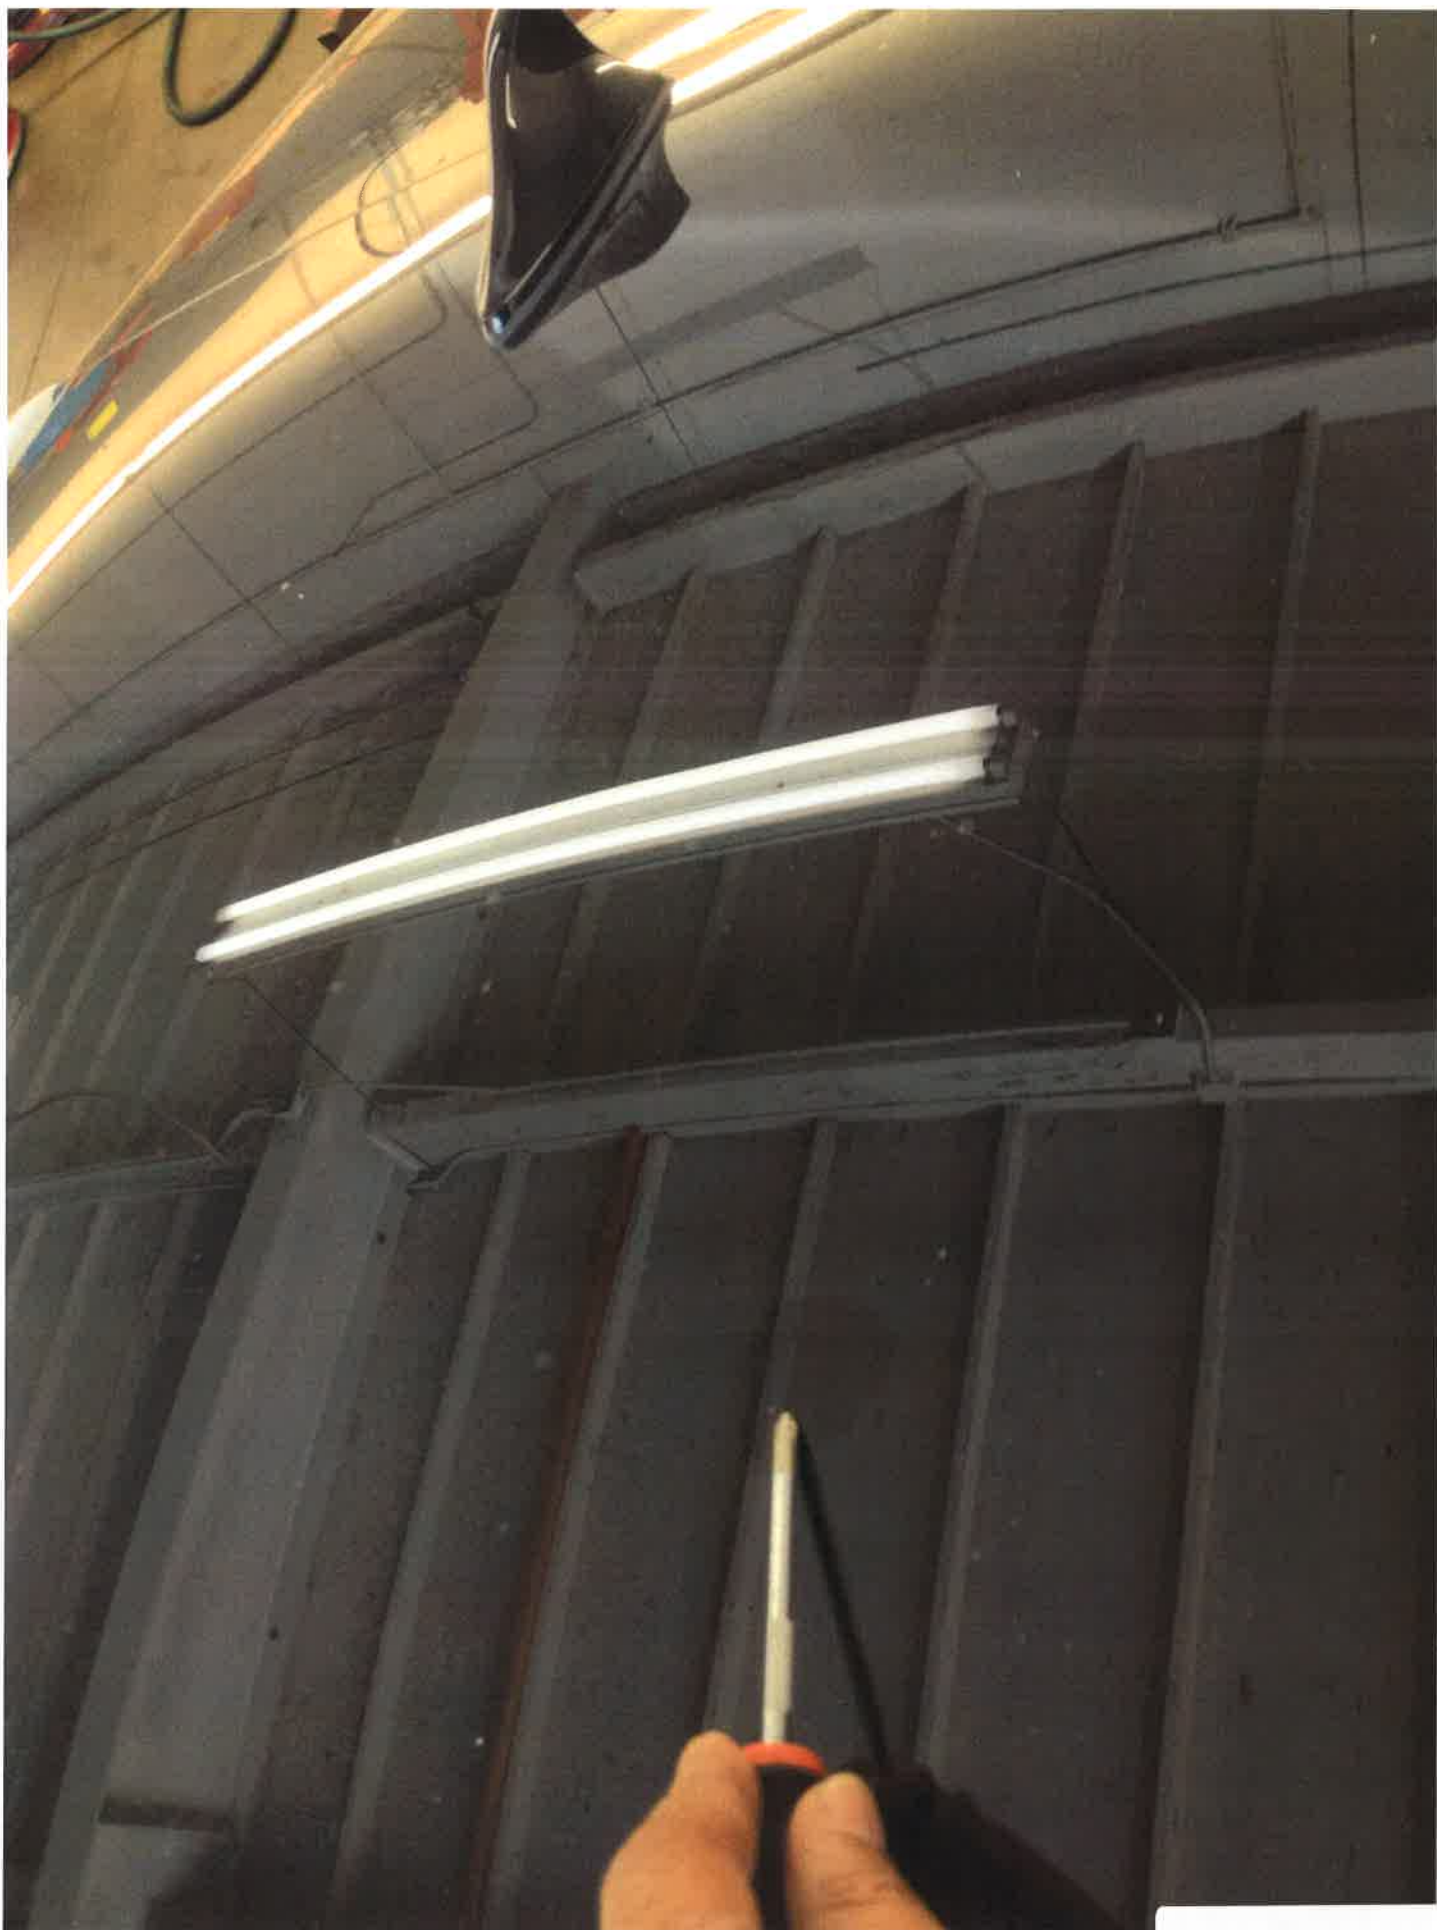
F2485275

POSSIBLE CAUSE

Panoramic sunroof glass assembly was replaced.
